# Determination of Fatigue Resistance of Coupler Connections in Aluminum Overhead Truss Structures

Final Report

THE KANSAS DEPARTMENT OF TRANSFORMATION  
TOPEKA, KANSAS

October 2021

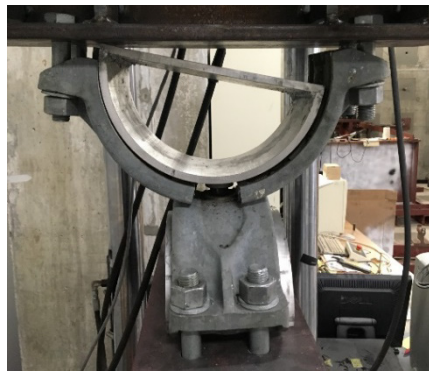
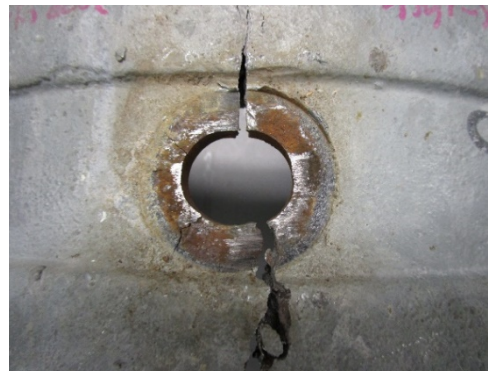
**Figure 4.4: Failure of FAT-TENS(USED)1 Tested at 26.6 ksi**

part of this research program and was loaded at a high stress range. The specimen failed at approximately 3,000 cycles. The failure occurred by a rapid fracture of the 10-inch coupler, in a brittle manner. There were no warning signs before the fracture. The photographs of the coupler after failure are presented in Figure 4.4.

(a) Failure of FAT-TENS(USED)1

(b) Cracked 10-in. Coupler

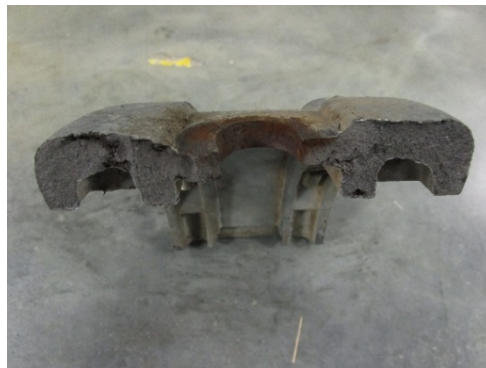
**Figure 4.5: Failure Surface of FAT-TENS(USED)1**

Some corrosion products were observed on the failure surface, as shown in Figure 4.5. This raised some concern whether there may have been pre-existing cracks before testing. The surface was examined under a microscope. The results were not conclusive. Section 4.4 of the report discusses more details regarding this topic.

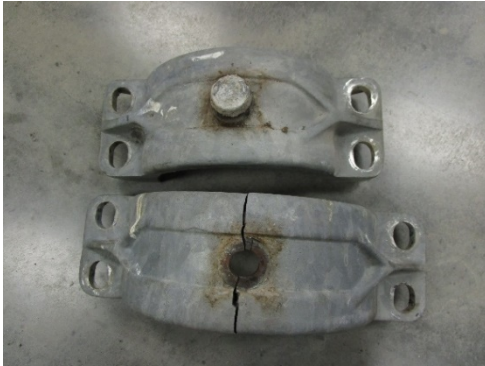
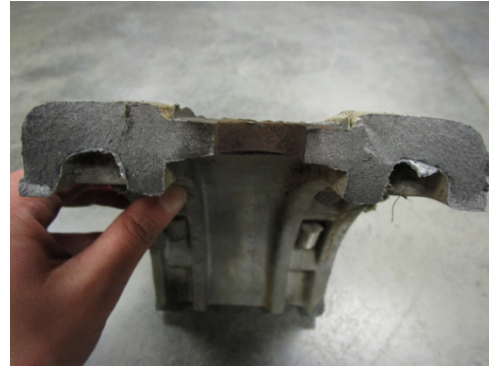
**Figure 4.6: Failure of FAT-TENS(USED)2 Tested at 26.6 ksi**

of 26.6 ksi, and failed at 10,581 cycles. The failure mode was the cracking of the 10-inch coupler. Photographs showing the specimen after failure are presented in Figure 4.6.

(a) Failure of FAT-TENS(USED)2

(b) Failure Surface of FAT-TENS(USED)2

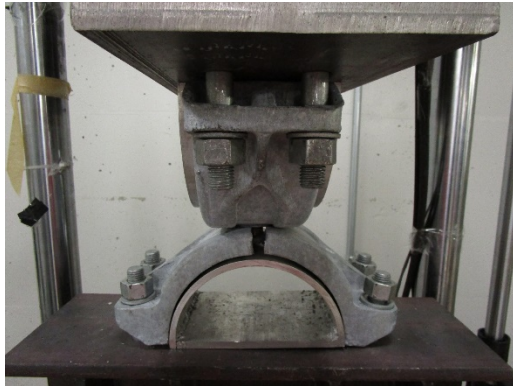
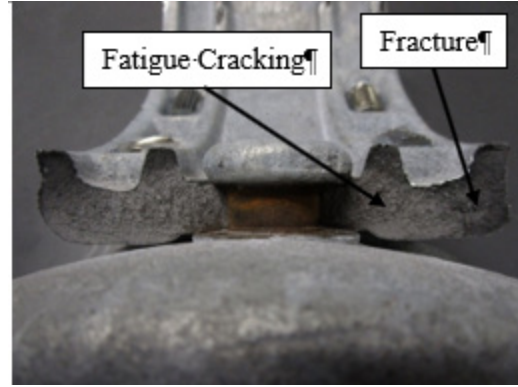
**Figure 4.7: Failure of FAT-TENS1 Tested at 26.6 ksi**

FAT-TENS1 was a new “off-the-shelf” coupler, tested at a high stress range of 26.6 ksi. Failure occurred in a brittle manner at 6,708 cycles. The 8-inch coupler broke into half at the position of the rivet hole in a brittle fashion, without no noticeable signs of distress before failure. After the test was concluded, the failure surface was inspected and two regions were identified: a smoother and brighter region, and a coarser and darker region. The smoother region was created during fatigue crack propagation, and the coarser region was the result of fracture. The failure surface indicated that cracks initiated at the rivet hole and propagated perpendicular to the tensile bending stress in the coupler. These two regions can be clearly seen in most of the specimens for which failures were characterized by cracking of the coupler.

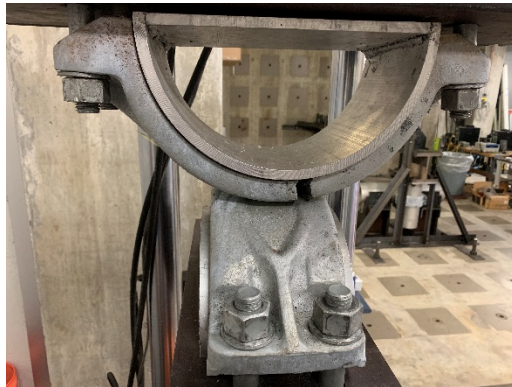
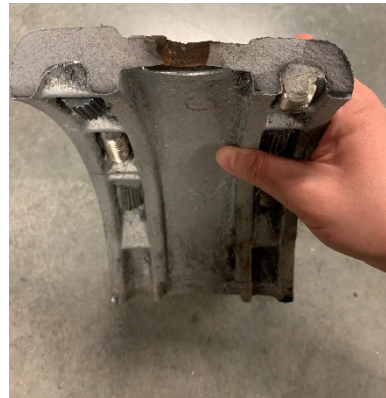
**Figure 4.8: Failure of FAT-TENS13 Test at 15.1 ksi**

FAT-TENS13 was a new “off-the-shelf” coupler, tested at 15.1 ksi. The specimen failed at 78,818 cycles, characterized by brittle cracking of the 10-inch coupler. Inspections were regularly performed during testing, but no cracks were observed before failure. Photographs of the specimen after failure are presented in Figure 4.8.

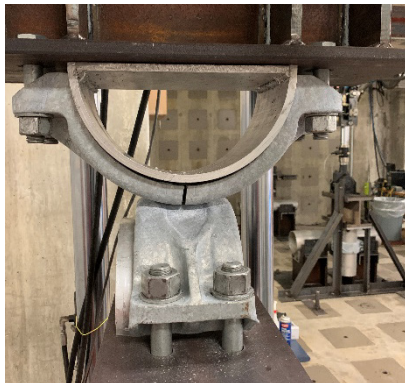
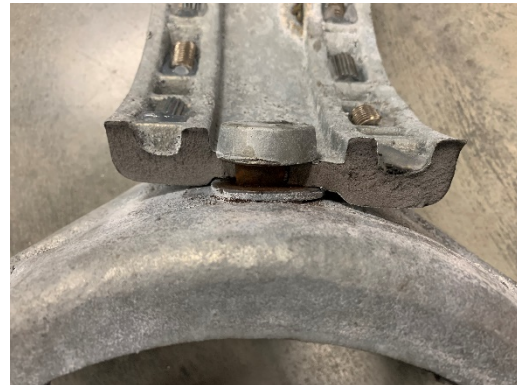
**Figure 4.10: Failure of FAT-TENS11 Tested at 10.5 ksi**

FAT-TENS11 was a new “off-the-shelf” coupler tested at 10.5 ksi. During an inspection at 195,754 cycles, it was observed that the stiffness of the assembly decreased, but no crack was observed. Over the next 3,000 cycles, stiffness continued decreasing but there was still no visible damage. At 228,327 cycles, a crack was identified as having propagated in the 10-inch coupler wall, extending through approximately two-thirds of it. After another 55 cycles, the 10-inch coupler broke in half. The final failure occurred at 228,382 cycles. Photographs of the specimen after failure are shown in Figure 4.10.

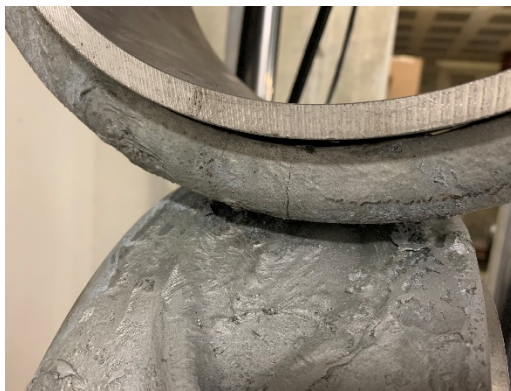
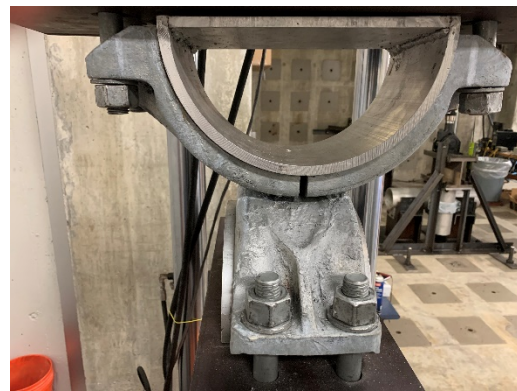
**Figure 4.12: Failure of FAT-TENS12 Tested at 10.5 ksi**

FAT-TENS12 was a new “off-the-shelf” coupler, tested at 10.5 ksi. During an inspection performed at 632,420 cycles, a thin crack was found on one side of the 10-inch coupler. The crack had not yet propagated through the thickness of the coupler. After another 323 cycles, the 10-inch coupler broke in half. The final failure occurred at 632,743 cycles. Photographs of the specimen are presented in Figure 4.12.

(a) Crack at 632,420 Cycles

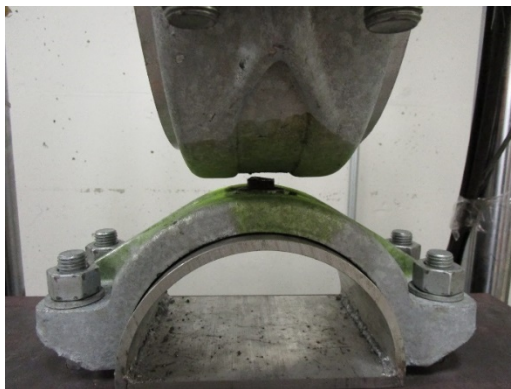
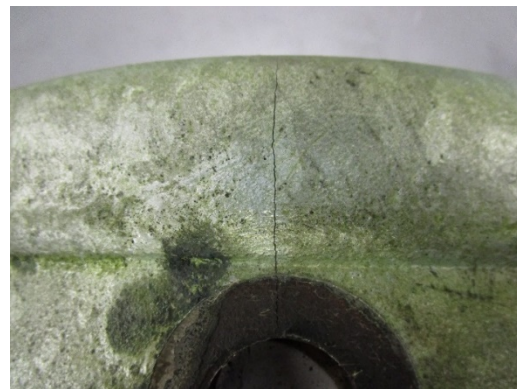
**Figure 4.14: Failure of FAT-TENS2 Tested at 8.3 ksi**

FAT-TENS2 was a new “off-the-shelf” coupler, tested at 8.3 ksi. The specimen failed by rivet cracking at 952,738 cycles. No visible signs of damage were observed before failure. As shown in Figure 4.14(a), cracking occurred at the intersection of the rivet head and shank, at the side connecting to the 10-inch coupler. After uninstalling and inspecting the specimen, a crack was also observed on the 10-inch coupler as shown in Figure 4.14(b). The failure of this specimen was classified as a combined mode since both the coupler and the rivet were damaged.

(a) Rivet Cracking

(b) Crack on the 10-in. Coupler

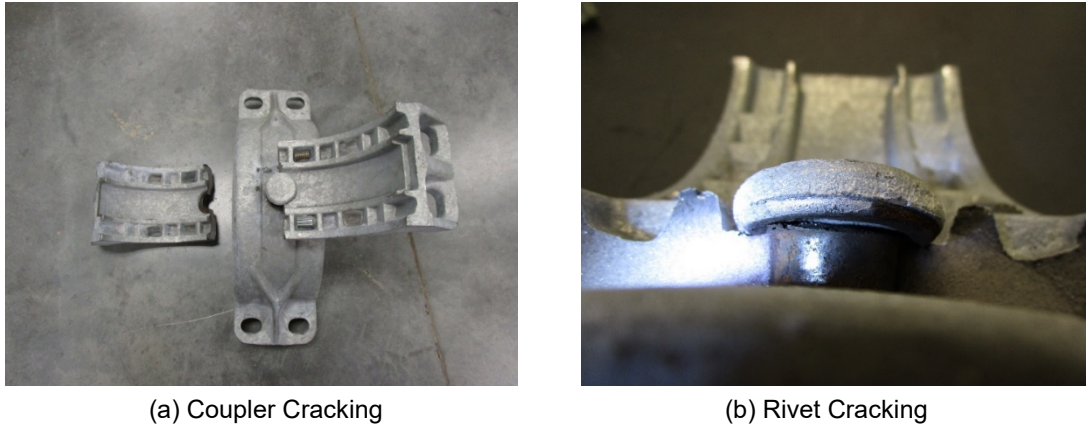
**Figure 4.15: Failure of FAT-TENS3 Tested at 8.3 ksi**

FAT-TENS3 was a new “off-the-shelf” specimen, tested at 8.3 ksi. The final failure of the specimen occurred at 1,263,601 cycles, and was classified as a combined mode. At 1,263,000

cycles, the 8-inch coupler wall cracked on one side. Fatigue loading was continued, and the other side of the 8-inch coupler wall cracked after another 600 cycles. Upon specimen removal and inspection, a crack was observed on the rivet at the intersection of the rivet head and shank, on the side that was connected to the 8-inch coupler. The crack had propagated more than halfway through the rivet. Photographs of the specimen after failure are presented in Figure 4.15.

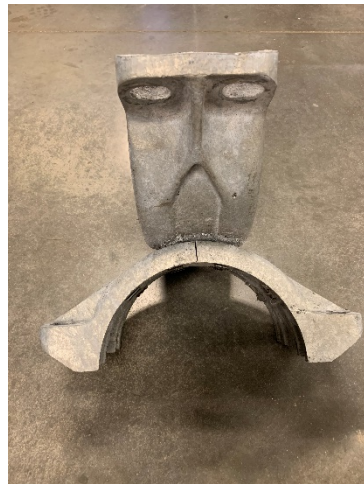
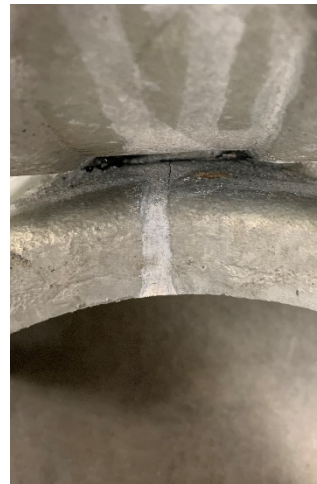
FAT-TENS9 was a new “off-the-shelf” coupler tested at a stress range of 8.3 ksi. The test was stopped at 2,124,128 cycles when cracking of the 8-inch coupler triggered the displacement interlock of the loading machine. A crack was found to have propagated through-thickness on one side of the coupler. On the other side, the crack propagated to the edge of the coupler but had not yet propagated through-thickness. Photographs of the specimen after failure are presented in Figure 4.17.

(a) Crack on One Side Cut Through the Thickness

(b) Crack on the Other Side Propagated to the Edge

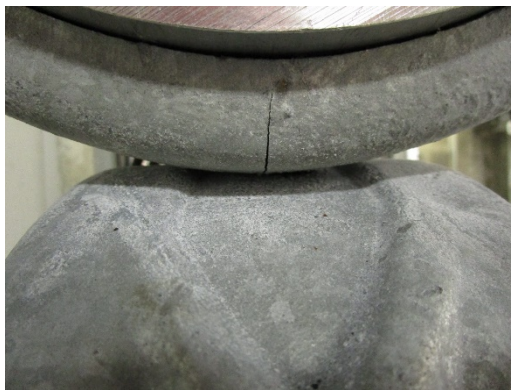
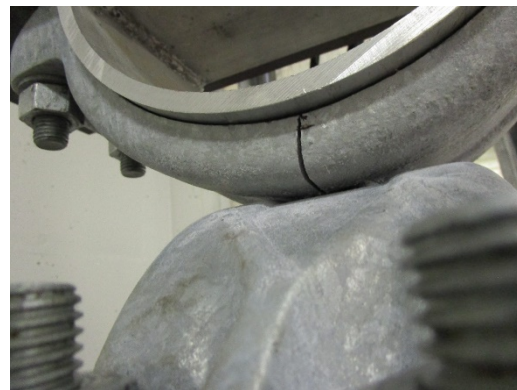
**Figure 4.19: Cracking of FAT-TENS4 Tested at 5.8 ksi**

FAT-TENS4 was a new “off-the-shelf” coupler, tested at a stress range of 5.8 ksi. Final failure was observed as occurring at 9,405,564 cycles, characterized by cracking of the 10-inch coupler. At 7,214,300 cycles, a crack was observed on half of the 10-inch coupler, as shown in Figure 4.19(a). At 7,433,422 cycles, the crack propagated through the thickness of the 10-inch coupler. An inspection was performed at 9,327,091 cycles. No other crack was observed besides the aforementioned one, however, it was observed that the crack had become wider, as shown in Figure 4.19(b). Complete failure occurred at 9,405,564 cycles, and the test was terminated after the crack propagated through the other half of the 10-inch coupler. A photograph of the specimen after failure is presented in Figure 4.20.

(a) Crack at 7,214,300 Cycles

(b) Crack at 9,327,091 Cycles

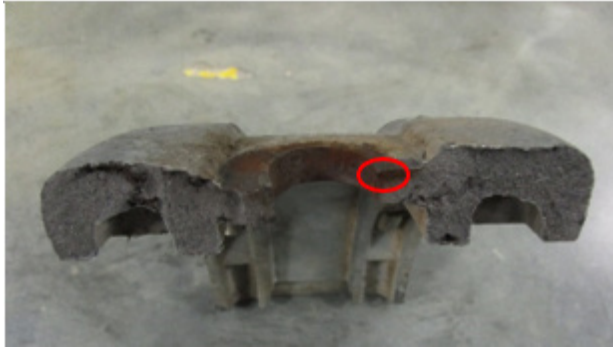
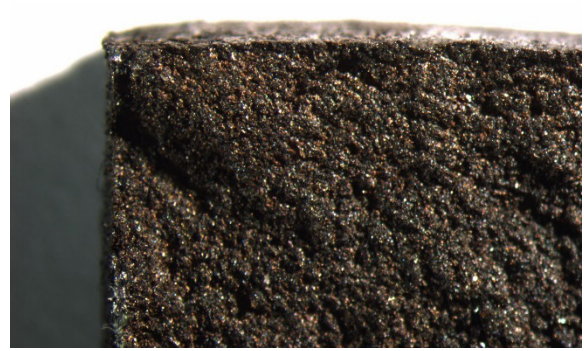
**Figure 4.28: Failure Surface of Microscopic Photograph of FAT-TENS(USED)1**

(a) Fracture Surface of FAT-TENS(USED)1

(b) Microscopic Photograph of FAT-TENS(USED)1

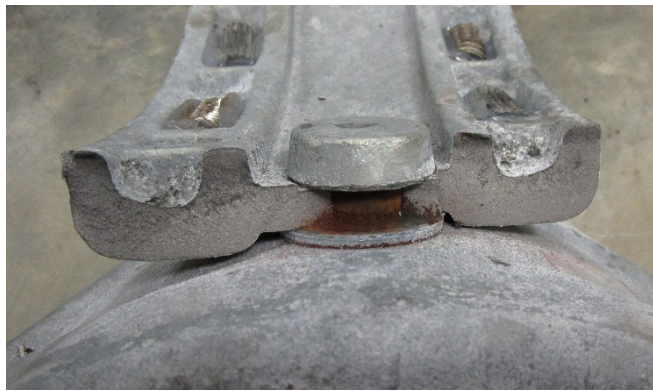
**Figure 4.29: Corrosion Products on Failure Surface of FAT-TENS4**
