Federal Railroad  
Administration

RR 21-24 | November 2021

## HIGHWAY-RAIL GRADE CROSSING COLLISION TEST OF A FUEL TENDER

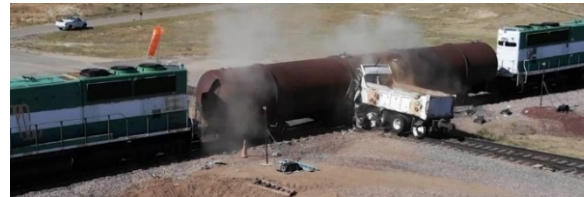
The tender resisted the impact without tearing either the inner or the outer tank. The tender and locomotives derailed but remained upright. No leaks were observed in any of the piping following the impact, and the locomotive fuel supply valve functioned as intended during the test. [Figure 2](#) shows the post-impact positions of the dump truck, tender, and locomotives.

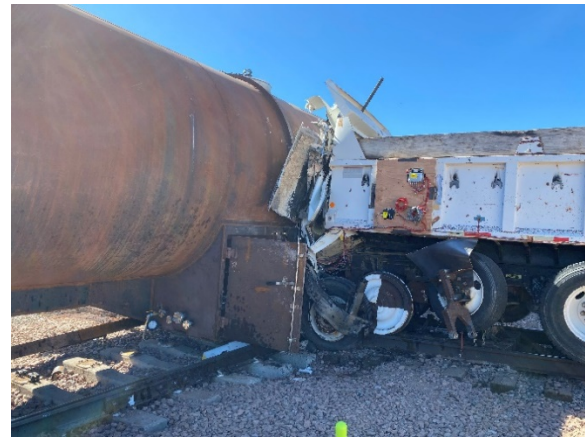
**Figure 4. Post-impact Dump Truck and Cabinet**

The impact occurred at approximately 43 mph. The track structure supporting the tender and locomotives experienced both tie shift and rail rollover, resulting in derailment of both tender trucks and the B-end trucks of each locomotive. The tender engaged with the rollover inhibitors on both ends and remained upright. The dump truck cab was destroyed, reducing in length from 10.5 feet pre-test to approximately 2 feet post-test. The welds attaching the dump bed's hinges to the truck frame failed, allowing the dump bed to displace forward approximately 20 and 11 inches relative to its original hinge points (i.e., right and left, respectively). [Figure 4](#) shows the post-impact dump truck and cabinet. Note that the cabinet door opened as a result of the impact, however, no piping damage occurred as a result of this behavior.

During the test, the hose supplying compressed air to the locomotive fuel supply valve was severed. This caused the fuel supply valve to automatically actuate from its open to closed positions. The valve successfully closed completely on its own, demonstrating the ability to shut-off fuel supply to the locomotives even after a grade-crossing impact to the tender. Post-impact examination of both the mechanical gauges and the test instrumentation confirmed that the tank was still holding pressure following the impact. Before the test, the internal pressure was 26 psig. The internal pressure dropped to 22 psig during the test, likely because cold liquid nitrogen splashed into the vapor space and caused it to condense. The inner tank maintained its integrity and no leaks of LN<sub>2</sub> were found in any piping. The outer tank maintained its vacuum after the impact.

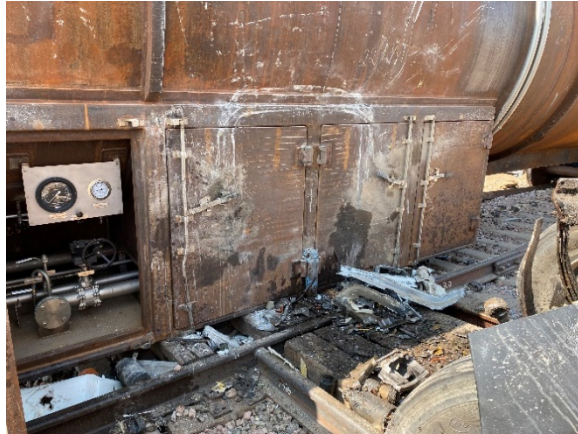
**Figure 5. Post-impact Cabinet Following Separation from Dump Truck**

Following documentation of the post-impact positions of the test vehicles, the tender and dump truck were separated. The dump truck was pulled back from the cabinet. The post-impact cabinet is shown in [Figure 5](#). Note the visible outline of the dump truck on the outer surface of the cabinet doors. Only minor areas of permanent deformation were observed on the cabinet and its doors.
