# Structures Research Services 2018-2021

## Task 1 Final Report - Overhead Sign Failure Investigation

Revision 1  
Final Report  
May 2019

1. Report No. <b>FHWA/OH-2019-11</b>	2. Government Accession No.	3. Recipient's Catalog No.	
4. Title and Subtitle <b>Division of Engineering Research on Call Task #1 - Overhead Sign Failure</b>		5. Report Date (Month and Year) <b>May 2019</b>

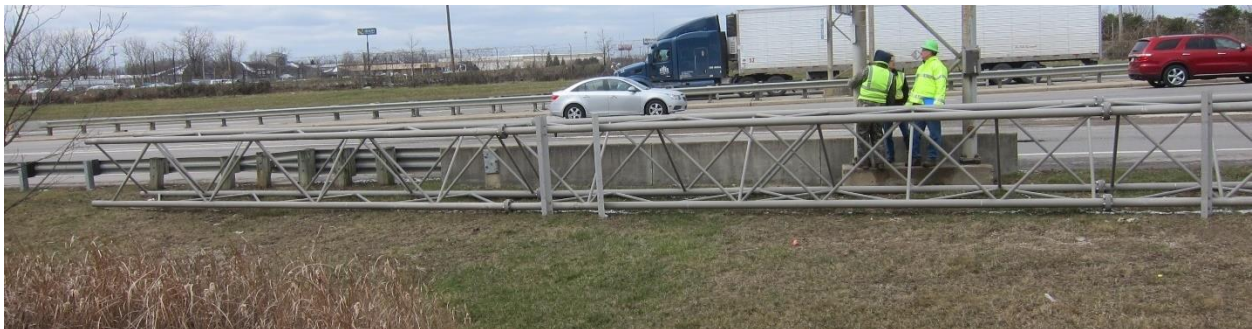
Fractures were observed in an overhead sign support truss on Alum Creek Drive at the I-270 interchange near Obetz, OH. The structure is a three-dimensional aluminum space truss having a span of 90' resting on tubular steel columns. The truss was mounted over steel supports using U-bolts at a height of 23' from the ground. Four parallel aluminum chords run along a 4' by 4' grid to which aluminum diagonals are welded at intervals. The chords of the truss are circular hollow tubes having outer diameters as 5.5" and a 0.25" wall thickness. The horizontal and internal diagonals have a 2" outer diameter with 0.188" wall thickness. The vertical diagonals are 1.9" circular hollow tubes with 0.145" wall thickness. At the time of installation two traffic signs of sizes 12'x7.5' and 13'x5.5' were mounted by 3-Z bar assemblies. These signs were later replaced by two smaller signs of size 5'x3'. The exact date of the truss installation is not known, but estimated to be in the late 1960's to early 1970's. After the failure was observed and documented, the truss was dismantled from the supports as shown in Figure 1. The dismantled truss was then further documented and cut into numbered sections for further study.

**Figure 1: Dismantled truss**

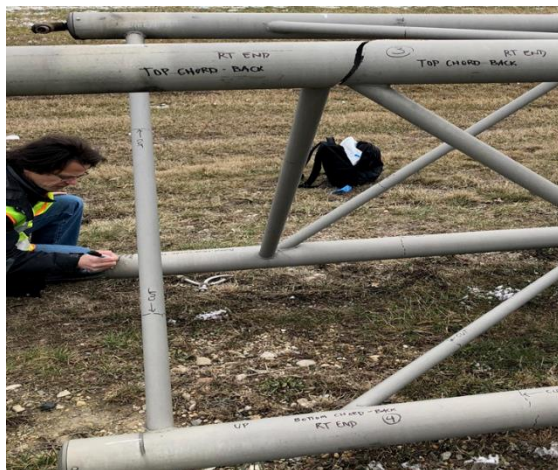
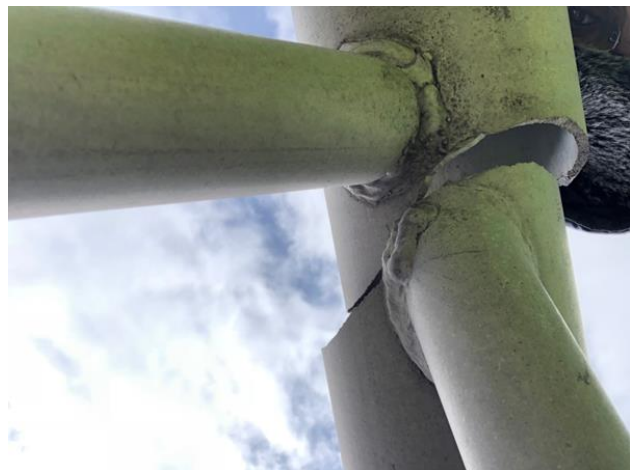
A team of UT researchers along with ODOT inspectors visited the site of failed truss to examine the failed truss, apparent fracture surfaces, and to identify pieces to be cut out for future study. Circumferential fractures were observed to occur in two different locations within the truss: at one location the aluminum truss chord was completely severed, shown in Figure 2, and a second location where the fracture had not yet advanced through the chord, shown in Figure 3. Both locations were near weld junctions of the diagonals and chord.

**Figure 2: Complete fracture observed at one location within the truss**

Preliminary visual inspection of the fracture surface revealed two different cross section characteristics: a smaller smooth surface (reflecting instantaneous material failure, likely a region of crack initiation) and a much larger uneven and irregular surface (likely due to a slower material failure, such as fatigue). However, there are several other factors that can exacerbate this failure mode (such as overloading, heat-zone effects, corrosion, weld defects, etc.) requiring more sophisticated laboratory material and failure analysis to be performed at the University of Toledo.

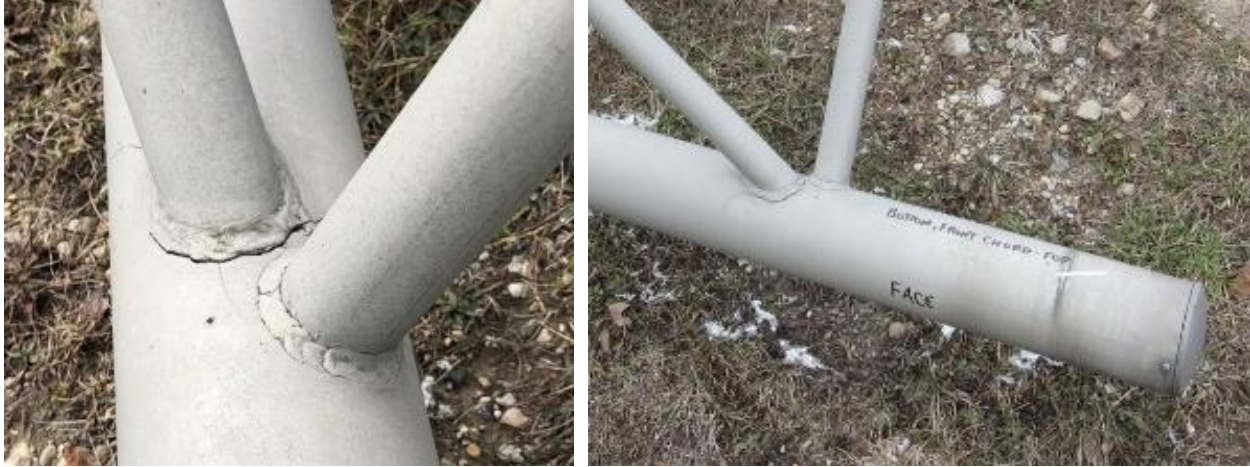
**Figure 3: Partial fracture observed at second location within truss**

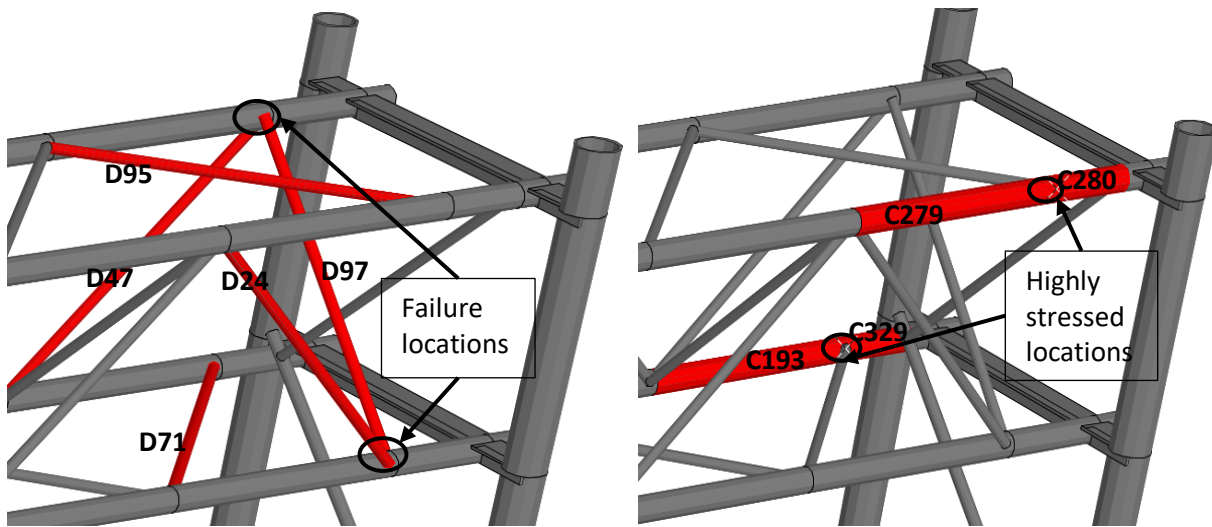
As the first step in the investigation, a finite element model of the aluminum truss was developed using the commercially available SAP2000 software package. Equivalent static wind loads calculated in accordance with AASHTO code (LRFD Specifications for Structural Supports for Highway Signs, Luminaires, and Traffic Signals-2015) and dead loads were applied on the truss and a linear elastic static analysis was performed. The results from the analysis were examined to determine the maximum stresses in the truss and to identify the critical members. Based on the location of highly stressed joints and failure locations, select members were identified as critical and are shown in red in Figure 4. Results for these critical members are presented in Table 1. As expected, the maximum stresses were found to occur for larger sign boards and at the end of the truss. The chord member C329 experiences the highest stress, however it is below the allowable stress for welded aluminum.

**Figure 4: Critical members identified during load simulations**

1. Maximum stresses in the truss occur at the two ends and are within the allowable limit for welded aluminum specified by AASHTO support specifications. Replacing the larger sign boards with smaller sign boards reduced the maximum stresses by 55%.
2. The nominal fatigue life of the critical members without consideration of the failed welded joints, exceeds the service life of the truss (typically 50 years).
3. The present fatigue analysis is performed assuming pristine state and no other factor except natural wind effecting fatigue performance. Several other factors such as diurnal temperature changes, truck gusts, subsequent corrosion of the members, weld deterioration etc., might affect the overall fatigue life of the structure. Truck gusts were assumed to have no statistically significant effect based on the work of (Li et al. 2006).

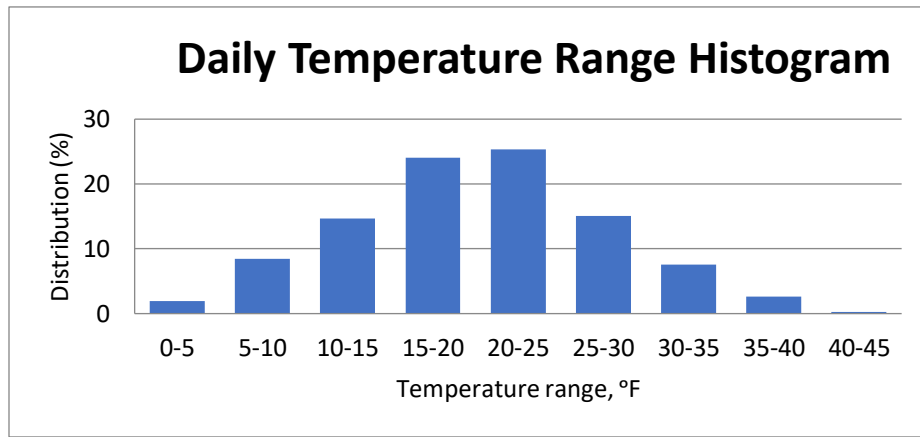
Temperature range histogram was plotted by using a bin size of 5 degrees Fahrenheit. This was used to find the number of cycles of individual temperature ranges. Figure 5 shows the daily temperature range distribution.

**Figure 5: Daily Temperature-Range histogram**

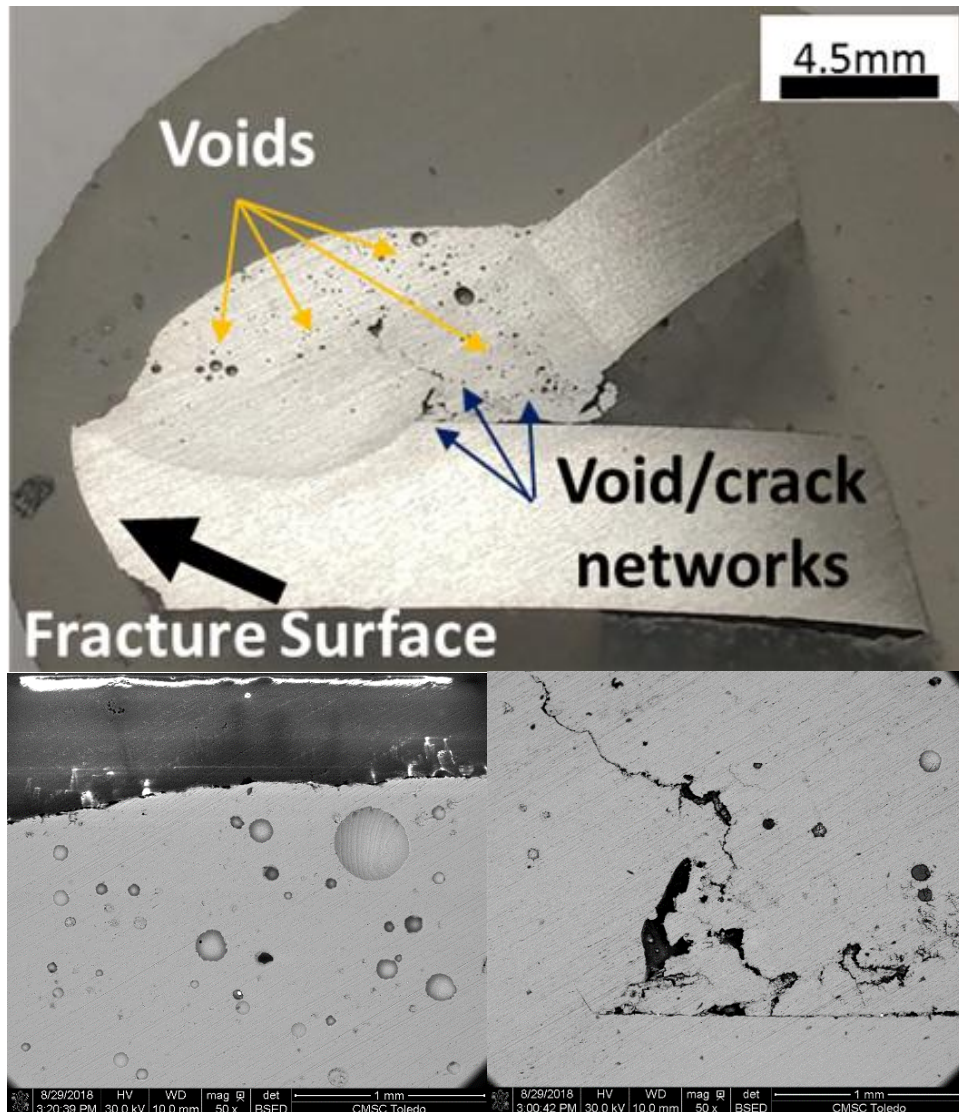
3. Mounted cross sections of various welds from the truss were prepared for both visual and SEM examination.
  - a. The weld nearest to the most severe truss fracture showed a high concentration of spherical voids dispersed throughout the weld as well as a highly interconnected network of micro-cracks between the voids (see Figure 6).

**Figure 6: Optical image of weld cross section adjacent to fracture site (top), with electron micrograph images of voids (bottom left) and microcracks (bottom right) within weld.**

The findings from the material testing appear to confirm the hypothesis that the welds were a key cause of the truss failure. The overall weld quality for this truss appears to be relatively poor. The high concentration of spherical voids in the welds are typical for aluminum welds without sufficient cleaning of the metal surfaces prior to welding and/or insufficient protective inert gas blanketing the site during the welding operation. These factors lead to moisture and/or organic contaminants contacting the weld while it is still molten, during which time the contaminants decompose and elemental hydrogen dissolves into the molten aluminum. As the aluminum cools, hydrogen gas collects together to form microscopic pockets within the weld. Also, the presence of highly non-uniform weld thicknesses are also an indicator of poor welding fabrication practices. Regions with very heavy welds (with large, rough beading) also induce high thermal cycling into the surrounding aluminum alloys, which can weaken the local alloy strength.

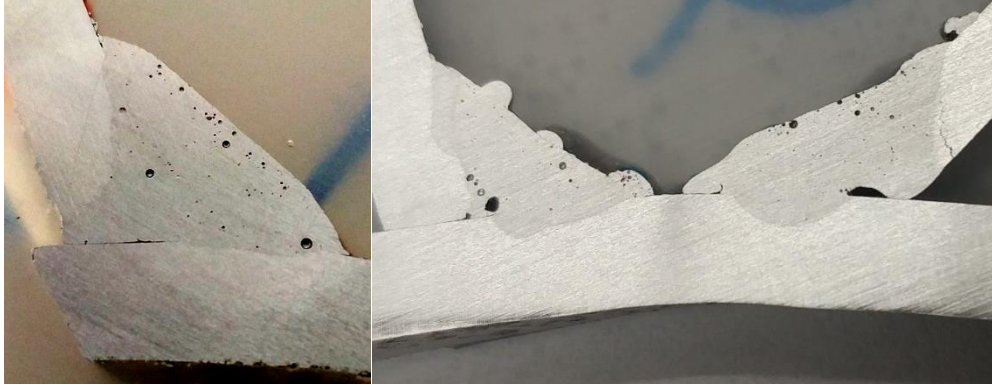
- b. Several welds from truss regions that were distant to any observed fractures were similarly examined. All of these welds showed the same presence of spherical voids through the weld but showed little to no evidence of micro-cracks (see Figure 7).

***Figure 7: Optical images of weld cross sections from locations in truss distant from observed fractures showing presence of voids within welds***
