PUBLIC ROADS

VOL. 9, NO. 8

OCTOBER, 1928

Page
Landslides and their Relation to Highways	153
The Modulus of Elasticity of Cores from Concrete Roads	164

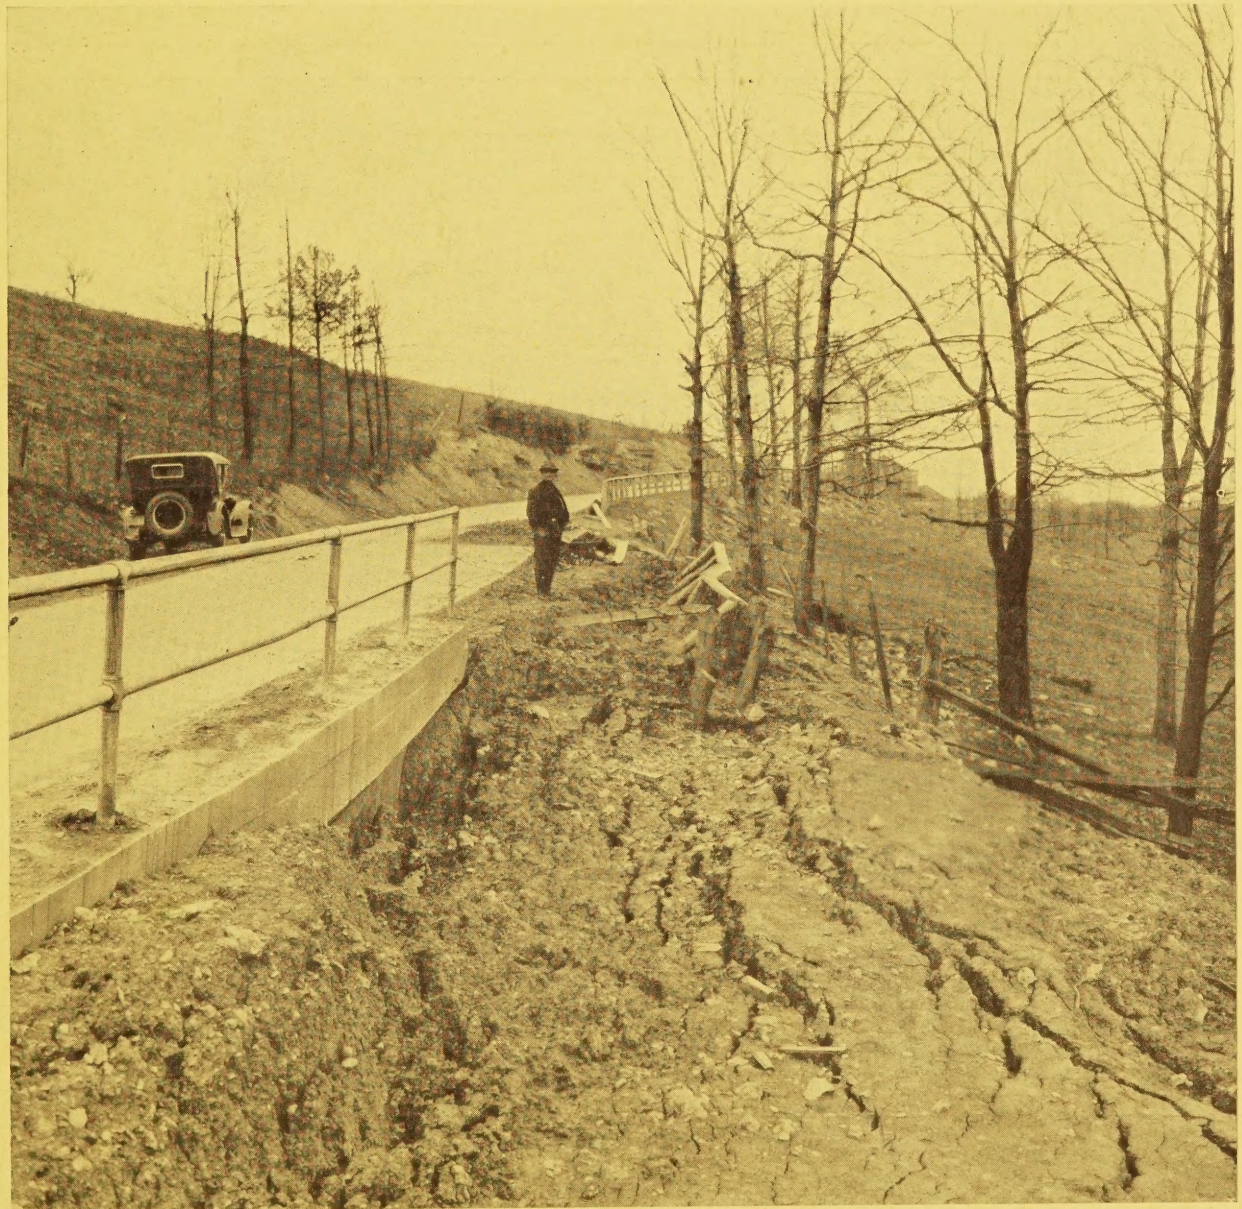
A TYPICAL LANDSLIDE IN WEST VIRGINIA

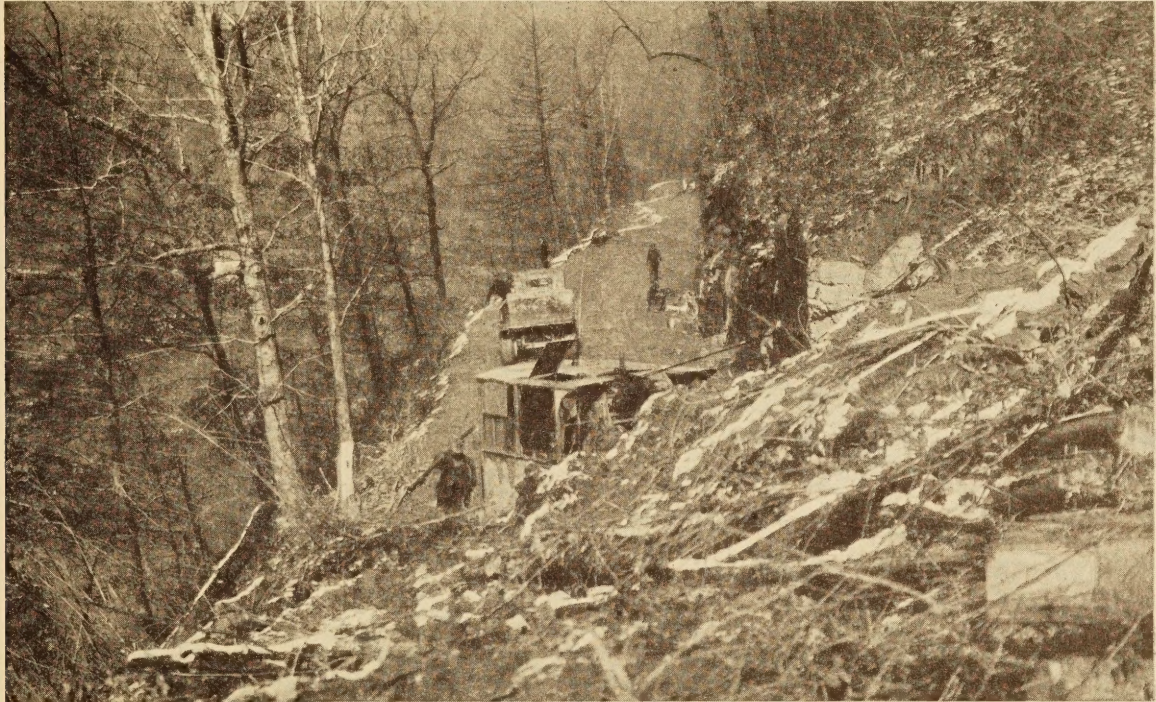
AVALANCHE TYPE SLIDE IN LOGAN COUNTY, W. VA.

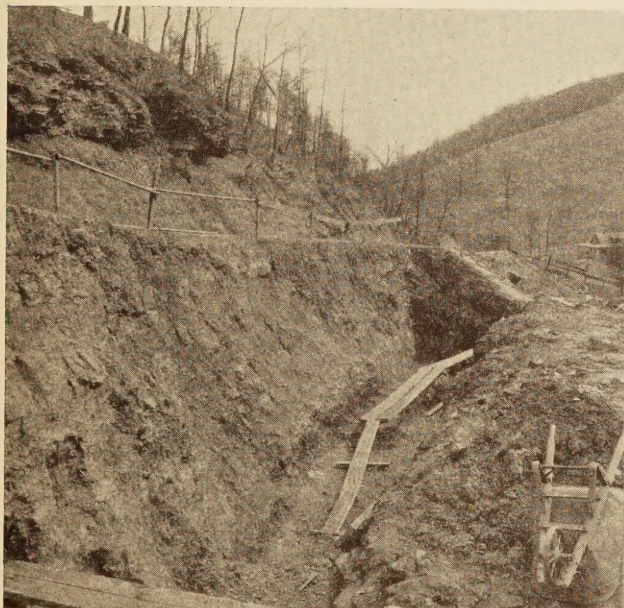
The illustration below shows the conditions at this location. More or less solid shale extends in places nearly to the level of the road, but it is not as compact as most shales in this district. It is quick to disintegrate under weathering influences, as shown by the retreat of its face beneath the ledge of sandstone above the road. The retaining wall has no surcharge, and

EXCAVATION FOR RETAINING WALL TO HOLD ROAD SHOULDER, NEAR WEST UNION, W. VA.

considering the amount of material to be held by it the cost seems unduly high. Well casing could have been deeply set in the shale extending beyond the foundation for the retaining wall (see illustration) and filled with reinforced concrete. If spaced closely, they would form a thin and light type of wall, which would have cost much less than a retaining wall. Such a wall could have been back-filled with sandstone taken from the ledge above the road, and, with proper weep holes, having no serious pressure to withstand, could easily have held the road shoulder. The writer was among those responsible for the construction of a retaining wall and shares fully in the responsibility for it, but wider observations of similar cases are convincing that there is a cheaper and quicker way.

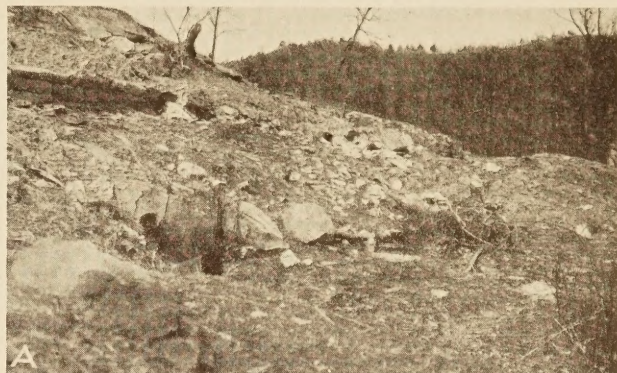
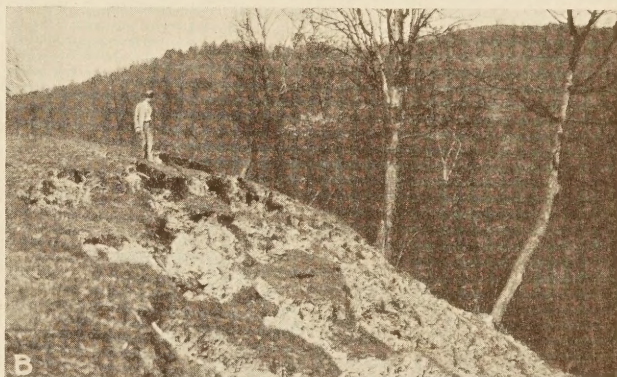
A SLIDE IN PUTNAM COUNTY, W. VA., WHICH OVERTURNED A RETAINING WALL

Another wall failure occurred in Putnam County, W. Va., where a cement-rubble retaining wall, 200 feet long, set in shale about 75 feet beyond, and well below

the road shoulder, went out during a rainy spell. The cause in this case was apparently an excessive surcharge of the saturated fill above. A number of natural slides occurred at the same time in the vicinity, one of them about 100 feet from the toe of the wall.

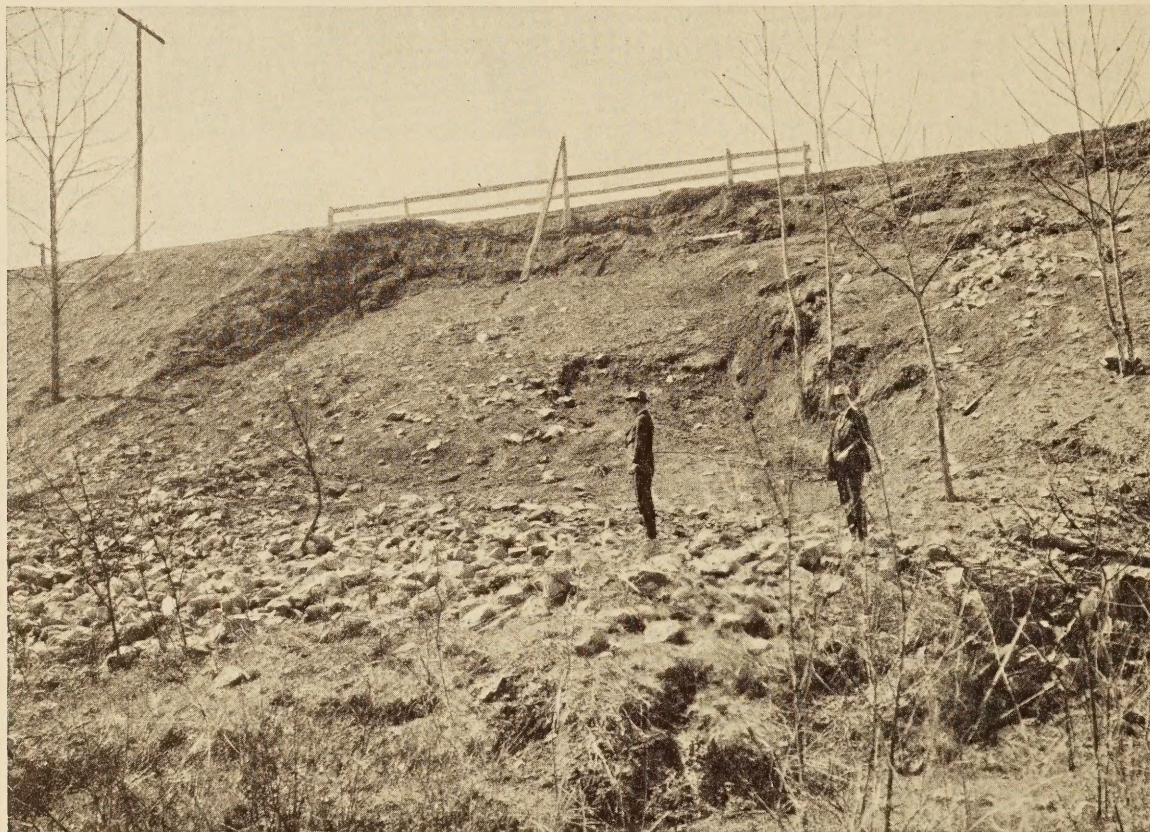
FILL SLIDE AT LEE'S CREEK, W. VA.

The road crosses a deep ravine on a fill about 450 feet long at Lee's Creek, 2½ miles east of Milton. During the winter of 1924-25 a section of the fill near the west end started to move from under the pavement on the north side. In the spring the movement increased and it was necessary to support the pavement by tamping rock and other material under it. A section about 40 feet long and half the width of the pavement finally failed.

During the winter of 1926-27 the fill continued to settle, although to a somewhat less degree than during the two preceding winters. Early in the spring of 1927, 12 of the casings where the rock was deepest showed signs of bending over. By the summer of 1927 they had failed completely. These were the casings which had been reinforced. The fill continued to sink from under the pavement in a section 40 feet long. The

It was decided to set well casing filled with concrete in this stratum. A well drill was used to sink 8-inch

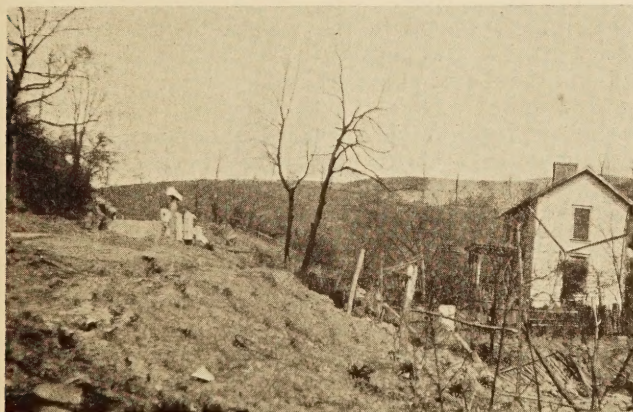
AN OLD SLIDE STARTED IN MOTION BY WEIGHT OF NEW HIGHWAY FILL OF ONLY MODERATE HEIGHT

Not long after construction was completed a section of pavement dropped about 6 feet vertically and the

pavement was dislocated laterally for a distance of 200 feet or more. A domelike bulge arose in the garden and the whole mass of the old slide moved sufficiently to break the foundation of the house, leaving the basement without walls on two sides, threatening the house and making it unsafe for occupancy. The construction of the highway added additional weight on the old slide but did not change conditions otherwise. The original mass must have been barely stable and a moderate load was sufficient to start it in motion.

The old slide was evidently fed by seepage through a noncompact shale near the road level. There are hundreds of cases similar to this in character. They are so frequent as to make imperative a study of local conditions before construction is begun. Such a study should include observation of wet spots following rainy

spells, but after a general superficial drying of the surface. Where seepage is indicated, ample drainage must be established on the inside of the road.

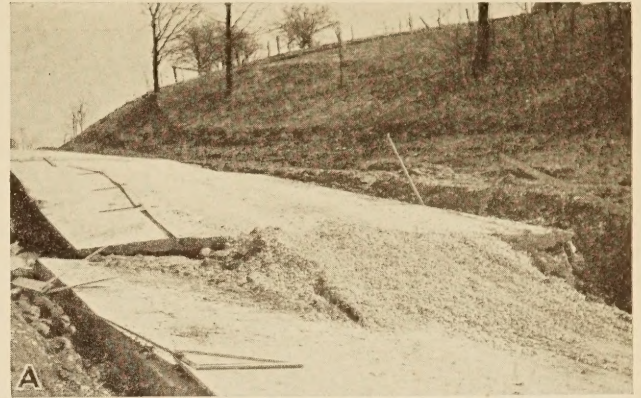
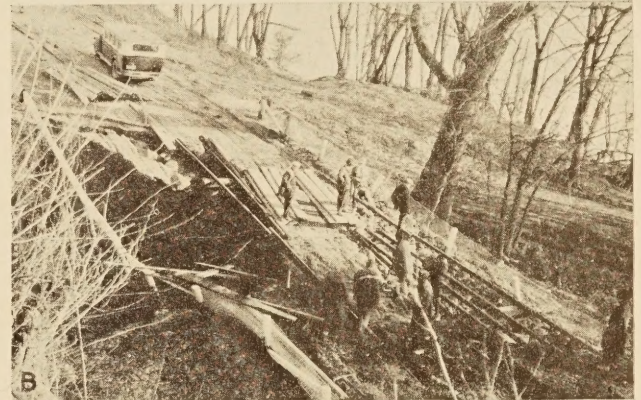
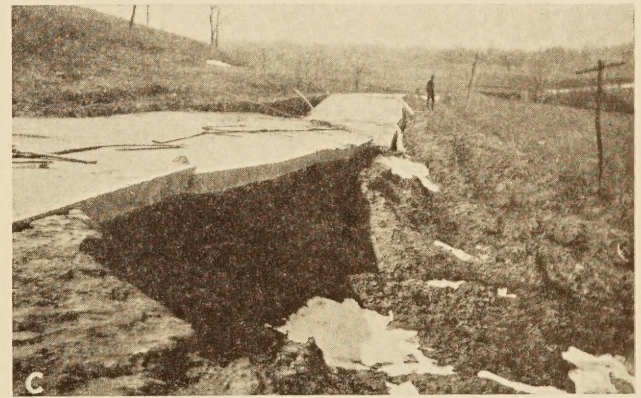
SIDE FILL SLIDES AND RESULTING DAMAGE TO HIGHWAYS

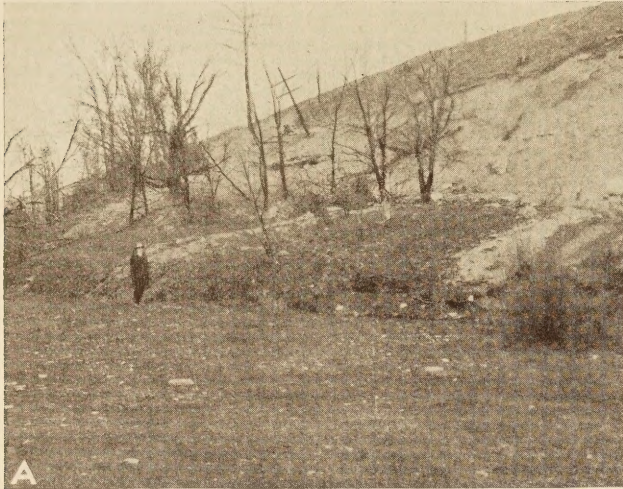
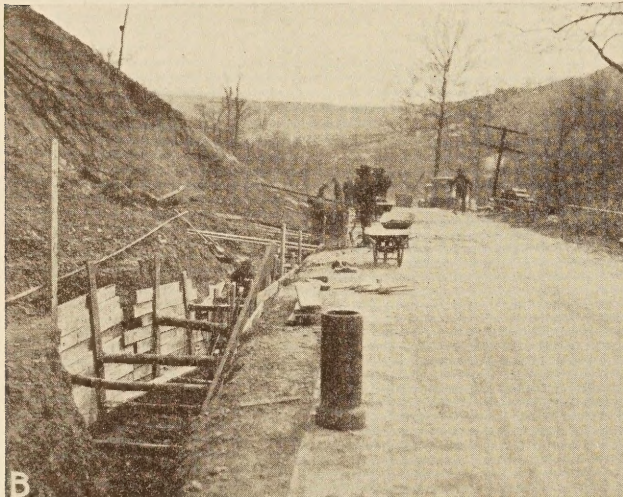
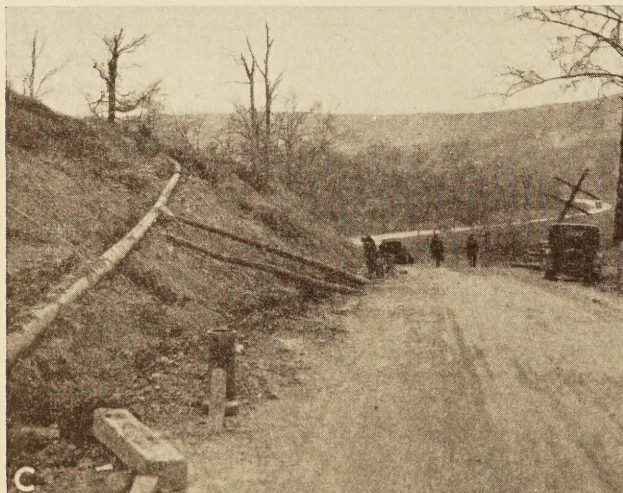
VIEWS OF SLIDE AND CORRECTIVE MEASURES ON BELL HILL NEAR MORGANTOWN, W. VA.

The road was graded in the summer of 1925, and in the fall or winter of 1925-26, a period of wet weather set in which was followed by a break extending diagonally across the road at a point about halfway down the hill. The location of this break is indicated in Figure 2, by the letter A. The road settled almost vertically, below the break. The bottom land below the slide showed unmistakable signs of many old slides indicated by rolls or slight hillocks. After the road settled it was observed that the land near the bottom began to upheave and there were indications of considerable pressure apparently transmitted from the weight of the fill to the plastic subsoil below.

A slip also occurred in the sidehill fill at the point marked B in Figure 2. After the slip occurred a stream of water could be seen emerging from the solid material approximately 8 feet below the surface of the road. This water had entered the loose fill on the hillside and so saturated the earth that it became semiliquid, and settled down into the bottom on an angle of repose not exceeding 20°. At the top of this slip the ground rose almost vertically to the surface of the road, 8 feet above the point where the water emerged.

It is believed that the breaking of the water main thoroughly saturated the slip and caused the maximum settlement for such material. There has been subsequent drying out and no further settlement has taken place excepting some slight readjustments.

Discovery of this stream of water led, quite naturally, to control by drainage. A ditch was dug along the upper side of the road which extended from the top of the grade two-thirds of the distance toward the small stream. Flowing water was encountered at a depth of approximately 8 feet. The ditch was carried approximately 10 feet deep and into solid rock, and an 8-inch tile drain with open joints was laid on a gradient of approximately 3 per cent. The ditch around the tile was filled with broken stone and over this several feet of cinders were placed. The remainder of the ditch was filled in with earth. This drain intercepted the water as it flowed from the rock and discharged it into the open ditch near the small stream. The drain effectually stopped the flow of water into the slip below the road. Even in dry periods the discharge of water from the drain was sufficient to fill a 2-inch pipe. The fill along the lower side of the road (at point B) was then replaced to form a shoulder, and this fill has shown no signs of settlement since that time.

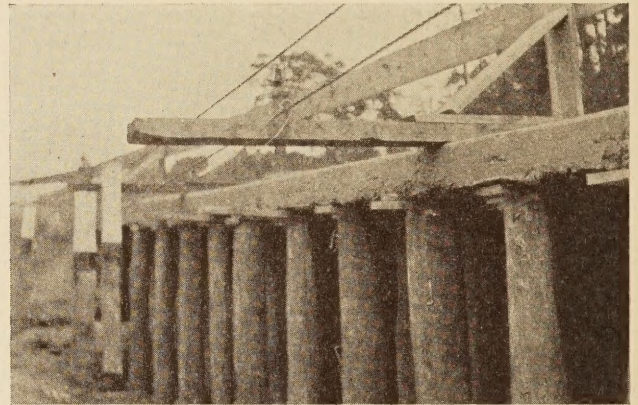
A CONCRETE ROAD SUPPORTED ON POSTS AFTER A SIDEHILL SLIDE

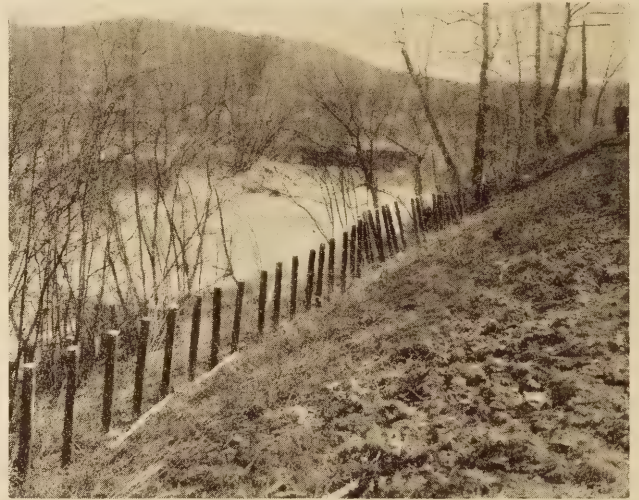
CASING FILLED WITH REINFORCED CONCRETE USED TO RETAIN A FILL. OAK PILING NEARER THE RIVER HAS FAILED AND THE CONCRETE PILING IS BEGINNING TO FAIL. DRAINAGE OF A SWAMPY AREA ON THE OTHER SIDE OF THE ROAD APPEARS TO BE THE REMEDY

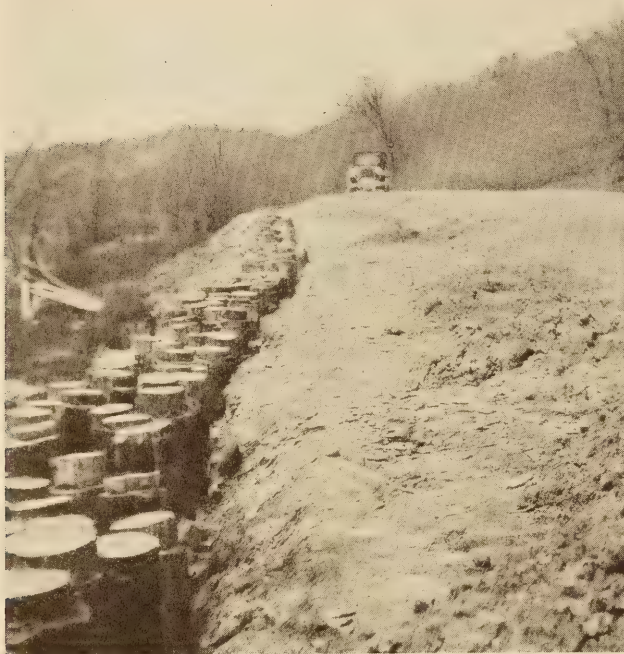
CLOSELY SPACED PILING TO HOLD A ROAD IN PLACE
USE OF WOOD PILES HAS DISADVANTAGES

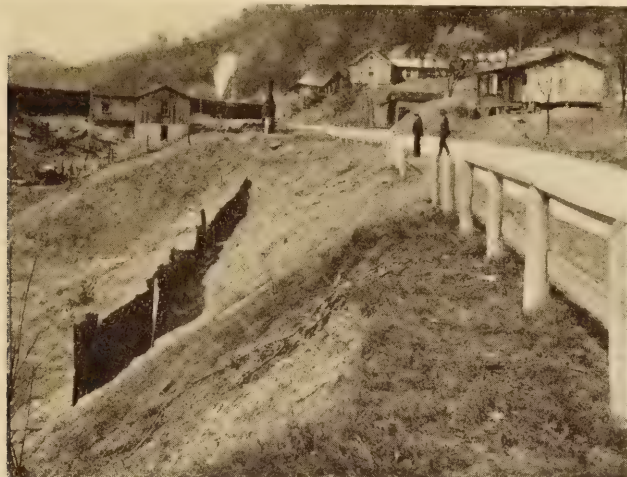
SHEET PILING USED TO HOLD A FILL

Only one case of the use of sheet piling has been observed. On this job the sheet piling appeared to have stabilized the mass above it which was already nearly stable, but it has not prevented high water in the stream below from penetrating the fill, which was the intent of the experimental undertaking. The cost per lineal foot of such piling is intermediate between that of oak and reinforced concrete.

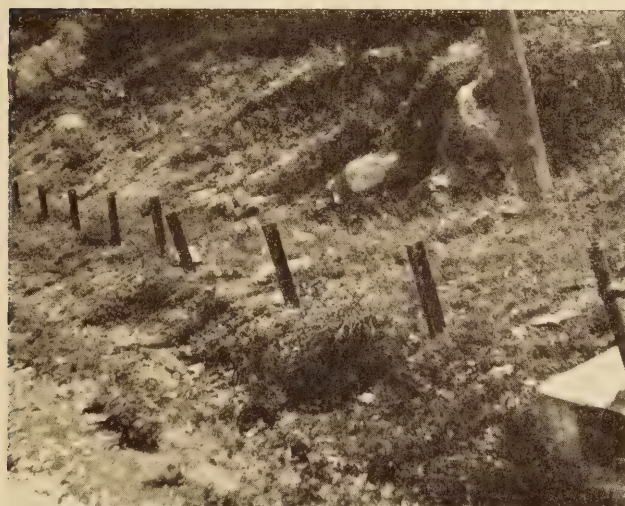
STEEL RAILS USED TO HOLD A SLIDE

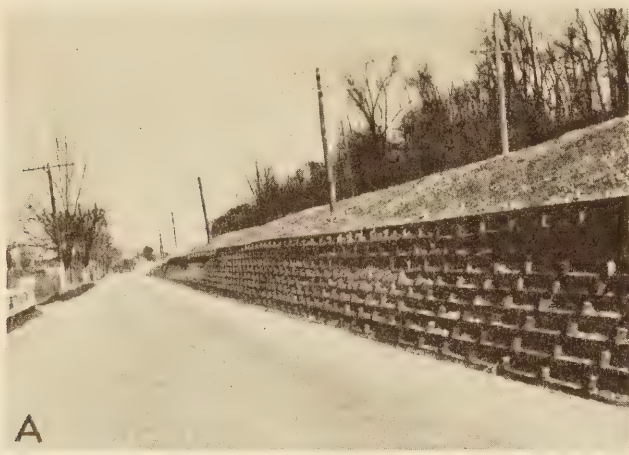
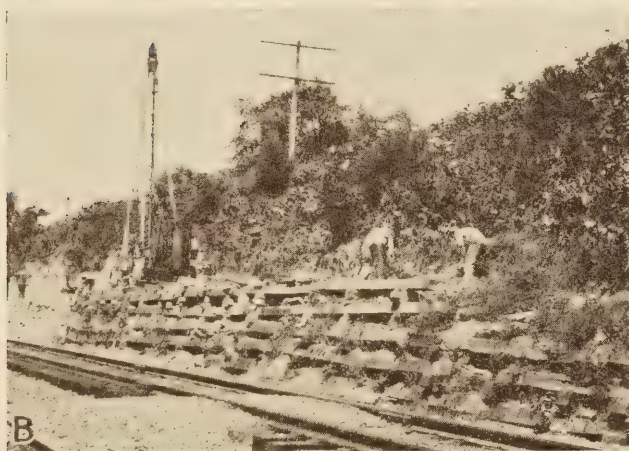
TIMBER CRIBBING FOR SLIDE CONTROL

The illustration of cribbing on this page shows a case where the timber has become so rotten as no longer to prevent detrital movement. The old cribbing is being removed and reinforced concrete piling placed in its stead. It is not safe to depend on cribbing to retain an unstable mass which extends beneath the road. In such a case if a brute-force method seems necessary, cribbing must be supplemented by piling. In typical cases observed, oak cribbing cost \$10 and concrete cribbing \$38 per lineal foot of road.

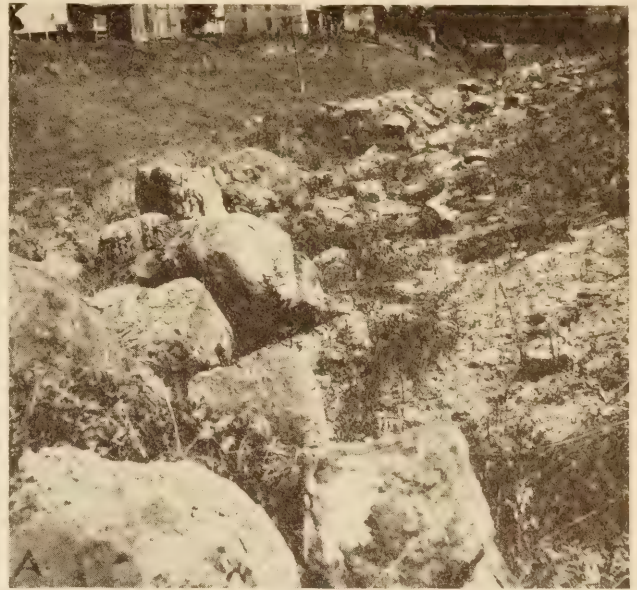
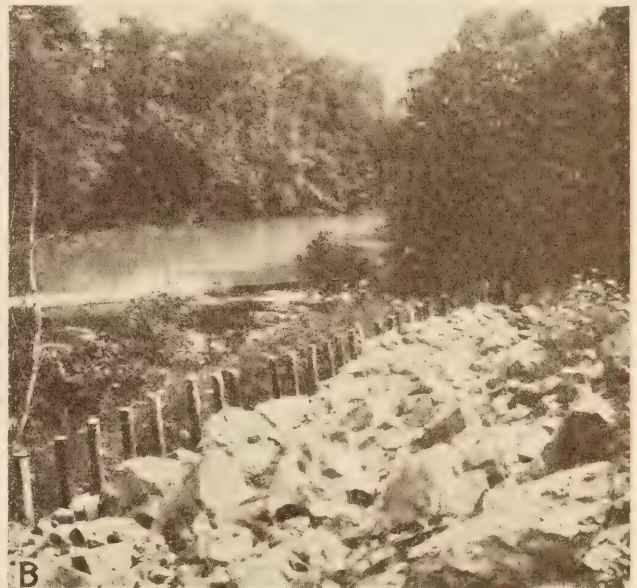
MASSSES OF ROCK PLACED AT TOE OF SLIDING FILL TO SUPPLEMENT PILING
