U.S. Department
of Transportation
**Federal Railroad
Administration**

Evaluation of Damaged Tank Car Structural Integrity

1. Report No. DOT/FRA/ORD-88/02		2. Government Accession No.		3. Recipient's Catalog No.	
4. Title and Subtitle Evaluation of Damaged Tank Car Structural Integrity			5. Report Date January 1988

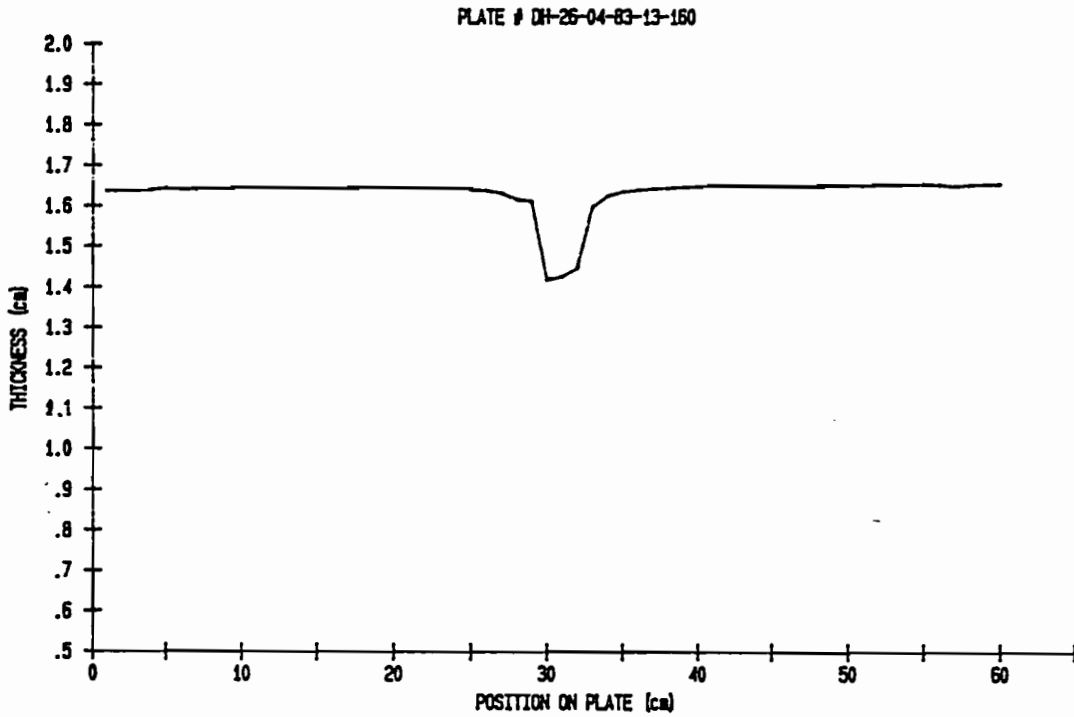
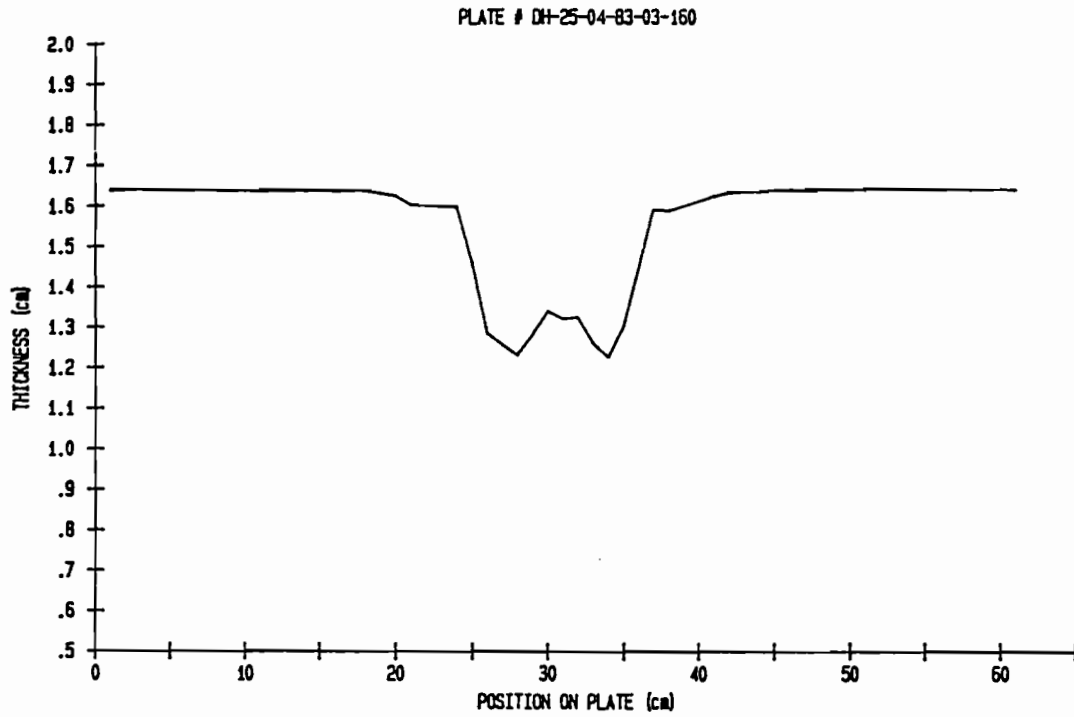
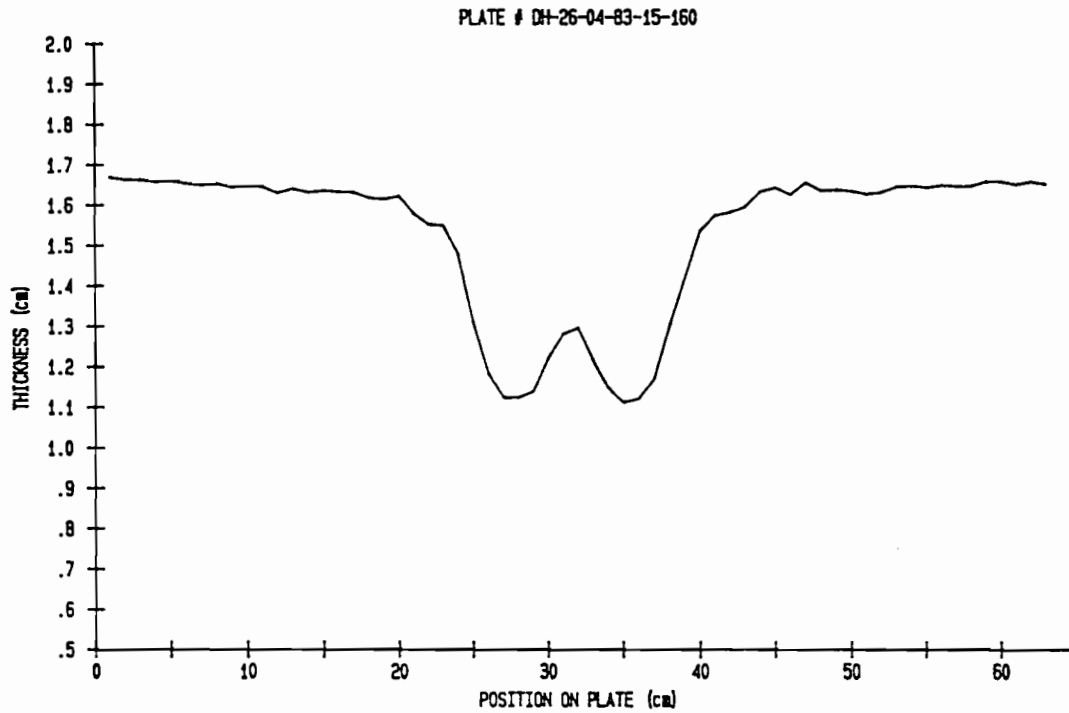
(a) Slightly damaged (dent depth of 2.78 cm).

(b) Dent depth of 4.28 cm.

Figure 1. Typical measurement of thickness vs. position, obtained by use of ultrasonic thickness gauge, for 3 BRL plates.

(c) Deeply dented (dent depth of 9.98 cm). The two lobes on this plot represent the areas of greatest thinning.

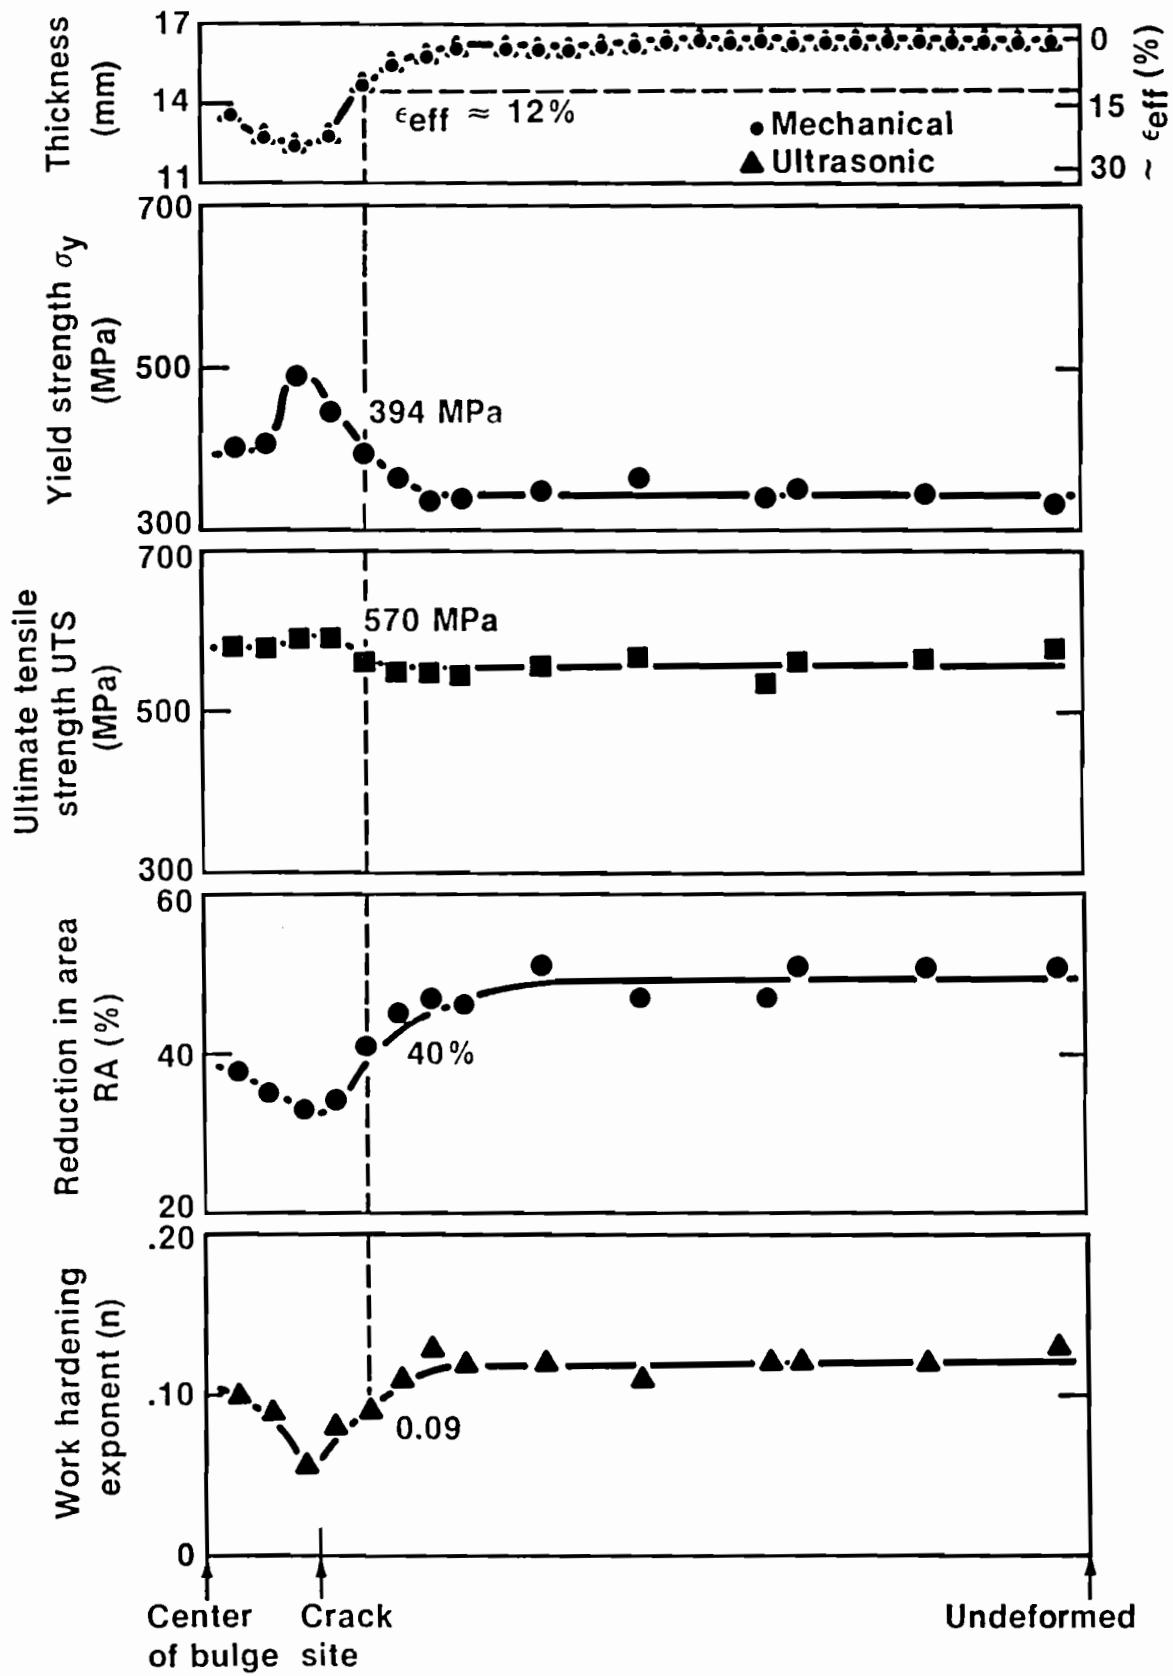
As the crack site is approached, the thickness decreases, the strain increases, and the properties change accordingly. At the crack site itself, the yield strength increases to 490 MPa, the ultimate tensile strength (UTS) increases slightly to 593 MPa, the RA drops to $\approx 33\%$, and the work hardening exponent (n) drops to ≈ 0.06 . The changes in yield strength, RA, and n are much more dramatic than the UTS. With the exception of the yield strength,

Figure 10. Variation of properties with position in bulged plated.

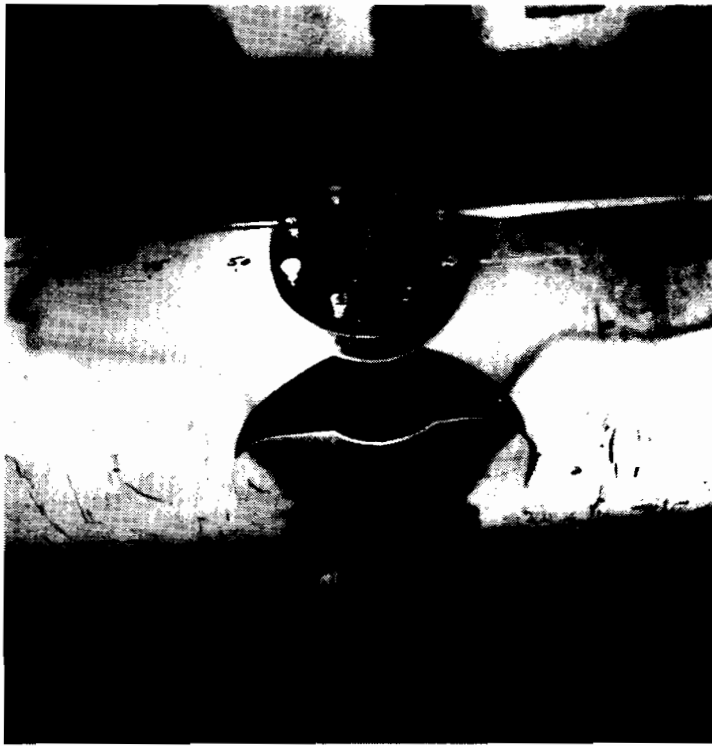
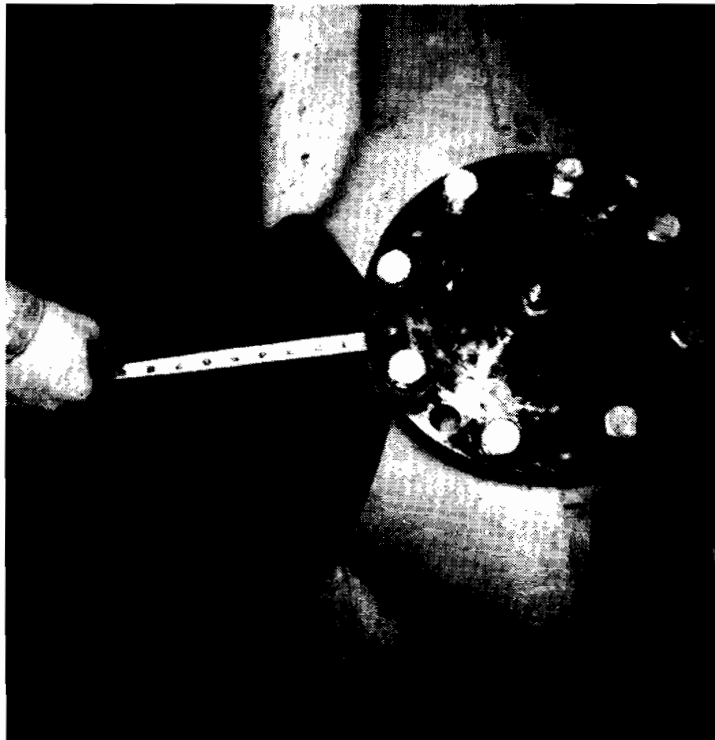
Figure 32. Location of rupture on Tank #401A.

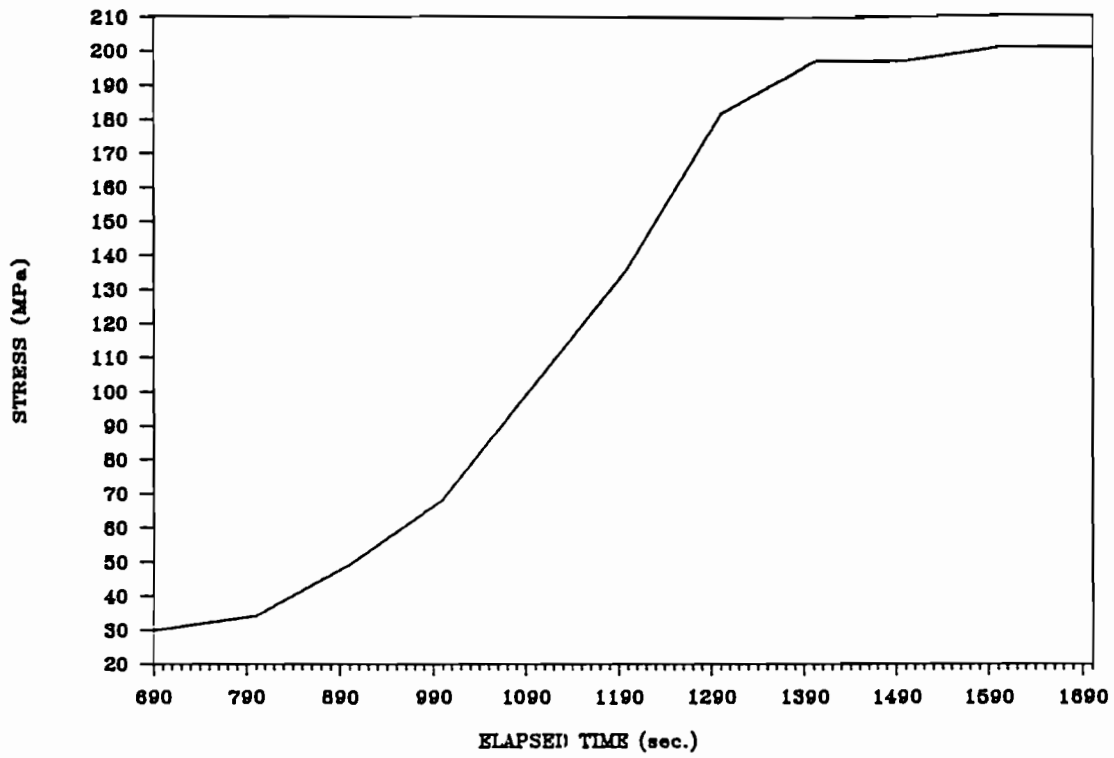
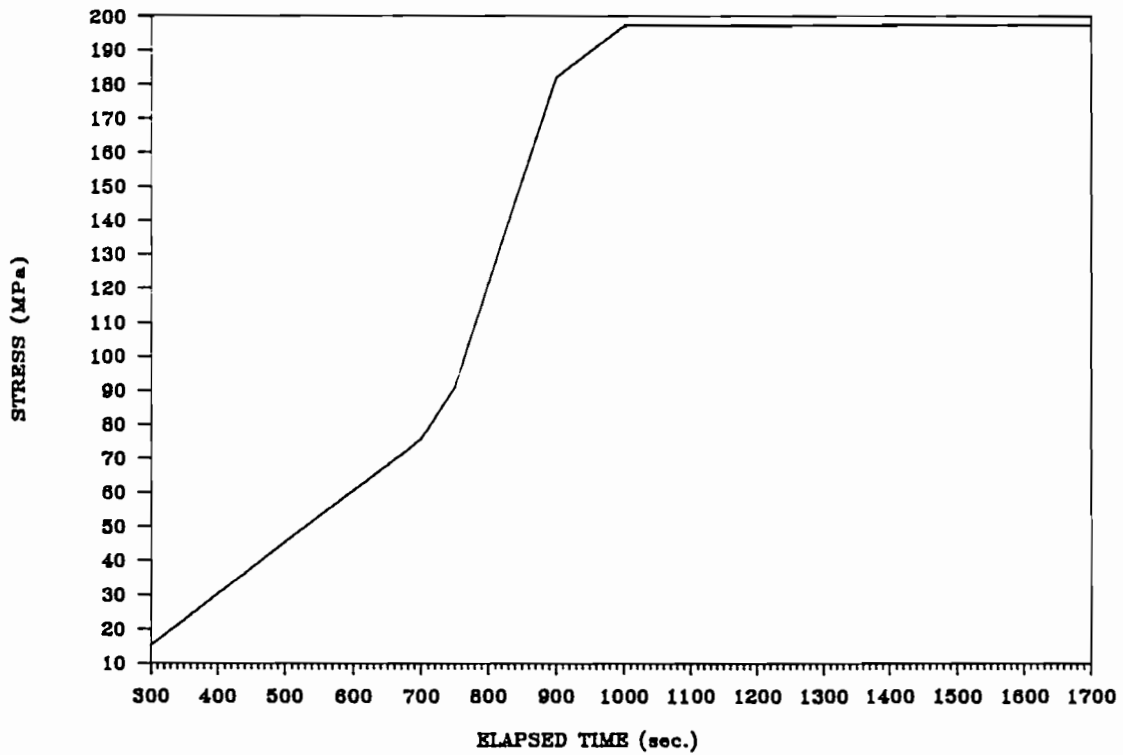
Figure 33 shows stress versus elapsed time for Tanks #401A and #410A. The figure shows that Tank #401A ruptured at a stress of approximately 200 MPa and Tank #410A ruptured at a stress of approximately 197 MPa. The figure does not show the failure portion of the test because the time required to conduct each test was approximately two hours. Once the peak pressures, shown were obtained they remained constant even though pressurization continued throughout the test. Therefore, the stress increased only due to the change in radius, but the failure strain was substantial for each test. The average failure strain for Tank #410A was 27.6% and lower for the other tank.

Figure 33. Axial stress vs. elapsed time for Tanks #401A and #410A.
