Experimental Study of Various Techniques to Protect Ice-Rich Cut Slopes

Construction Report

July 2013

INE/AUTC 13.07

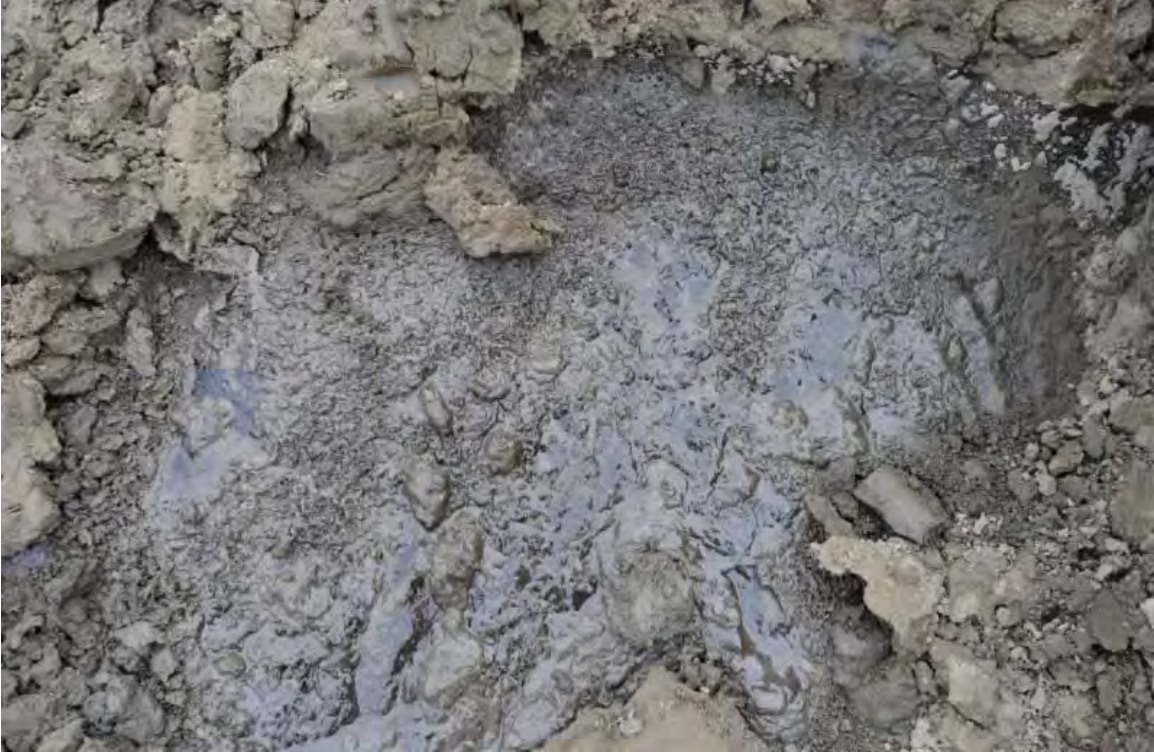
Figure 4.9 Ice exposed in the cut slope

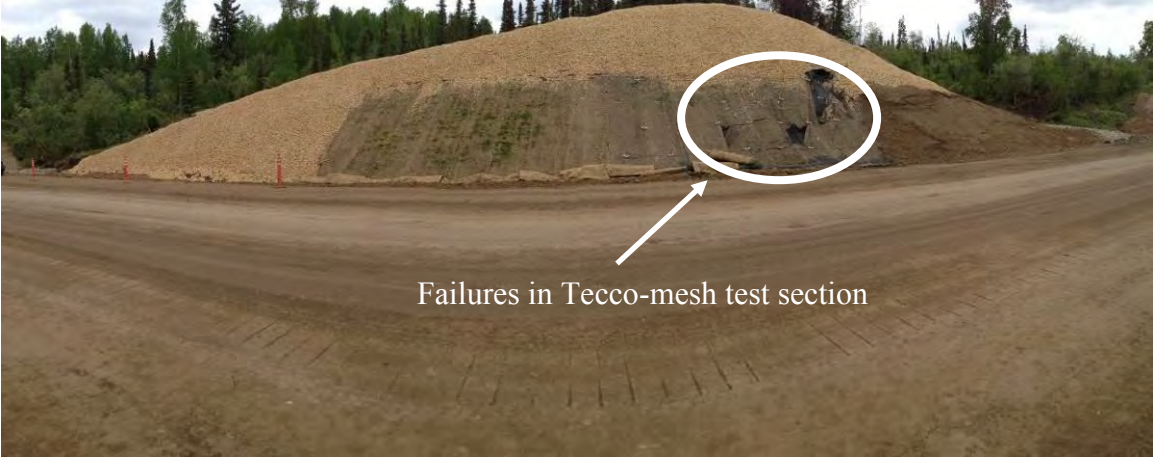
irregular thawing surface with an intact Tecco-mesh covering (a sort of tent) suspended one to several feet above the present soil/ice surface. At that time, none of the Tecco-mesh and only small areas of the coconut matting within Section C had failed.

Figure 6.1 Panorama view of Experimental Feature showing failure in Tecco-mesh section

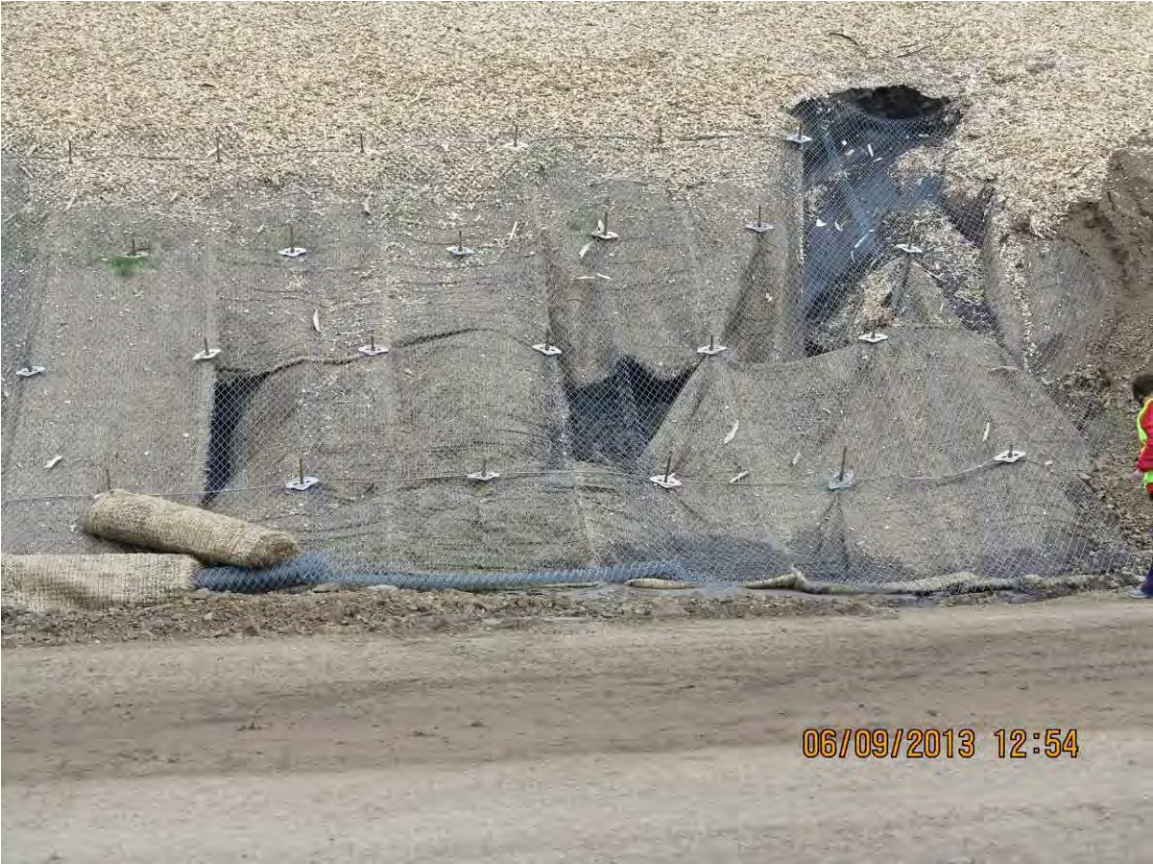
Figure 6.2 Close view of failure within the Tecco-mesh section

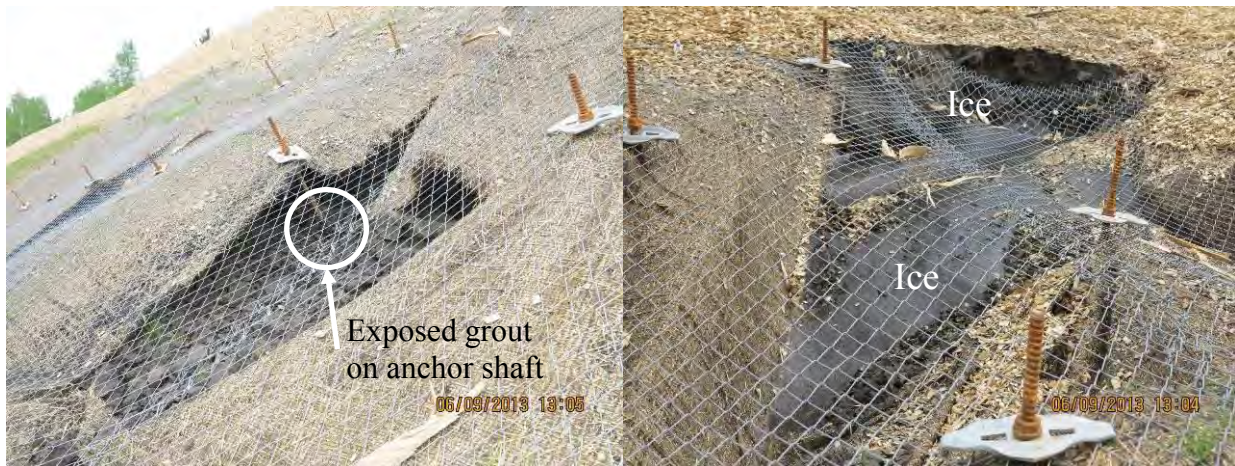
The significant loss of material from the original cut slope is evident in the left side of Figure 6.3 where the anchor grout is exposed. The nominal plan depth from cut slope face to top-of-grout was 3 feet. The lighter gray material labeled in the right side of Figure 6.3 is some of the massive ground ice that caused serious problems with the Tecco-mesh experimental section.

Figure 6.3 Close views showing exposure of soil anchor grout (left) and portion of massive ice feature under Tecco-mesh (right)

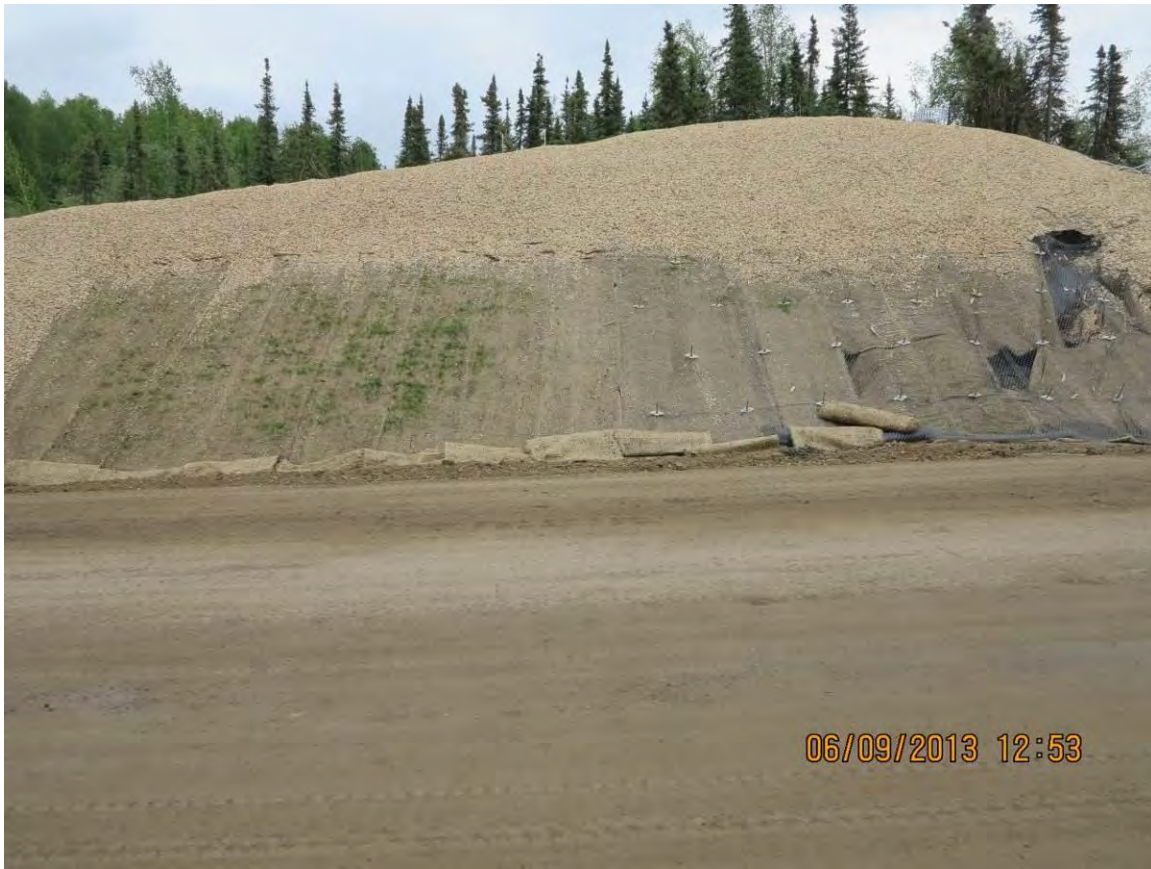
In Figure 6.4, the areas where the ground surface is not in contact with the Tecco-mesh or the adjoining coconut matting are those areas where no grass had yet appeared. As Figure 6.4 shows by the appearance of grass, only the very top portion of the Tecco-mesh section still has soil-Tecco-mesh contact.

Figure 6.4 Surface protection matting in areas showing no grass growth are not in direct contact with ground surface

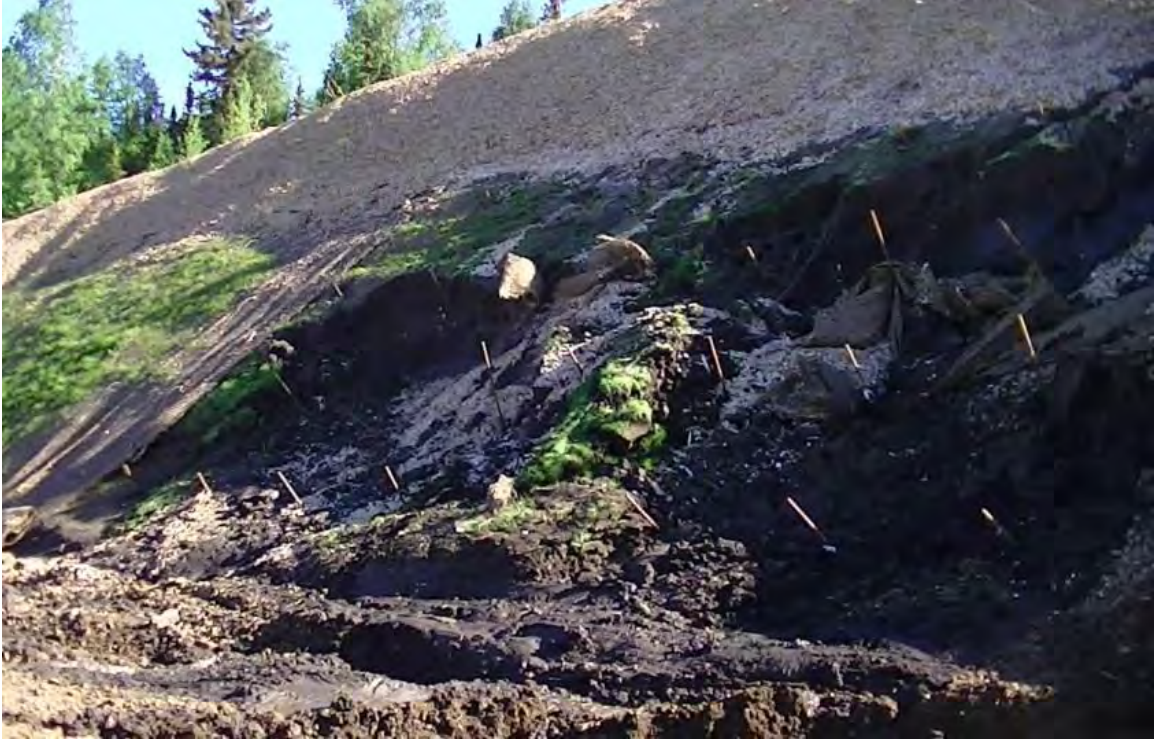
Figure 6.5 Section C without Tecco-mesh and coconut blanket

According to the recommendations listed above, on June 17th 2013, Tecco-mesh and the coconut erosion control blankets at Section C were removed which is shown in Figure 6.5. The great loss of volume in Section C can be seen especially where massive ice is exposed as shown in Figure 6.6. Crushed rock was hauled to the test site. Then, an excavator was used to cover Section C with crushed rock (see Figure 6.7). The hollow rebar anchors were left intact during these repairs to serve as survey and photogrammetric reference points. Figure 6.8 shows the cut slope after completion of repairs on June 17th 2013.

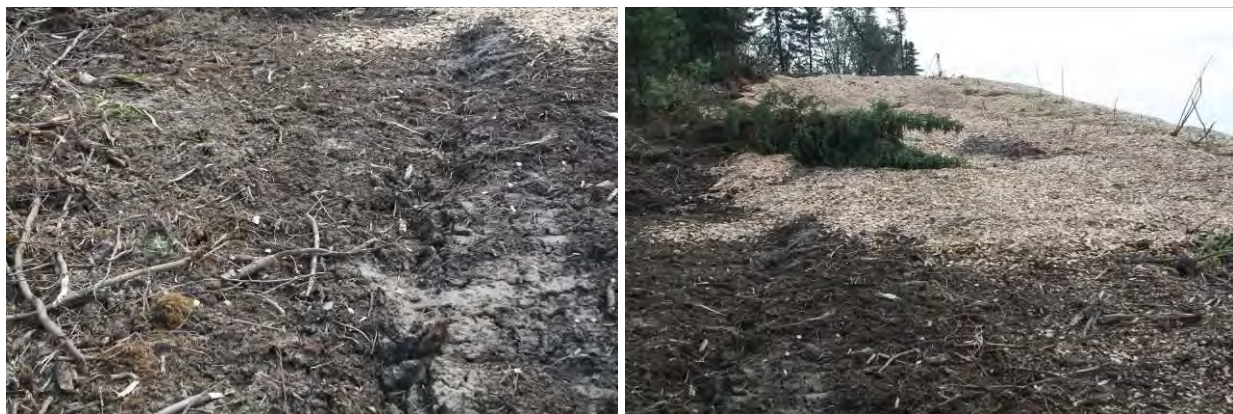
Figure 6.9 Start of thaw related damage at top of Experimental Feature cut slope

This recommended work remains to be done at the time of this report's preparation (February 2014).

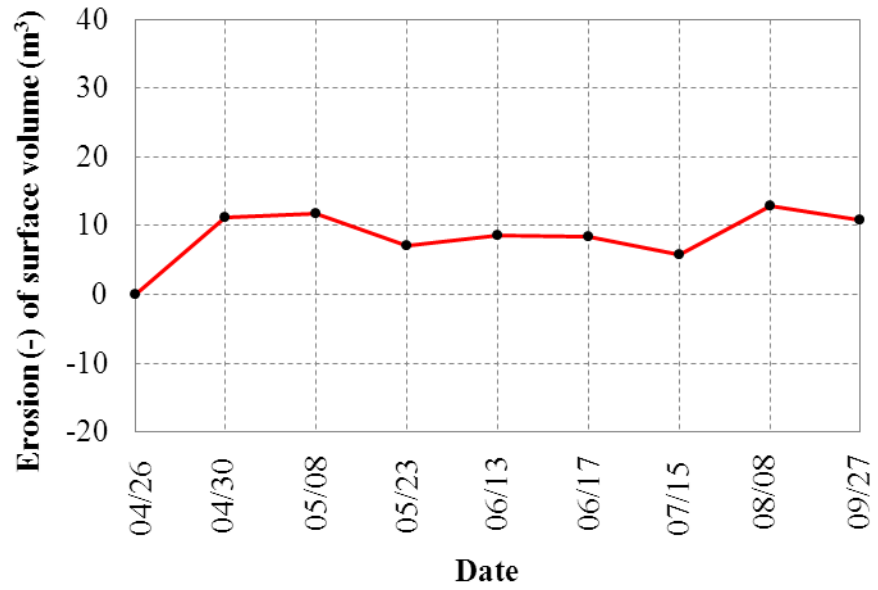
Figure 7.22 Erosion on Section A

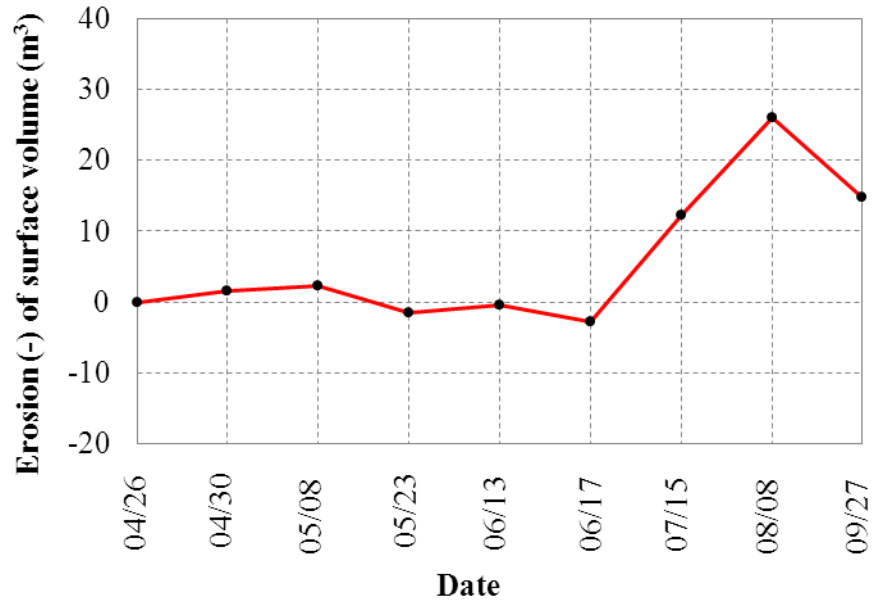
Figure 7.26 Erosion on Section B

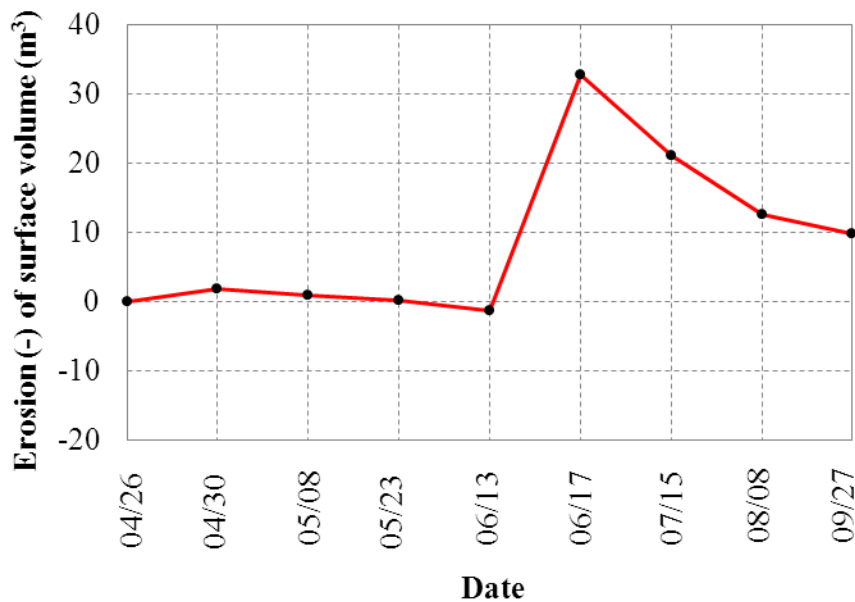
Figure 7.31 Erosion on Section C

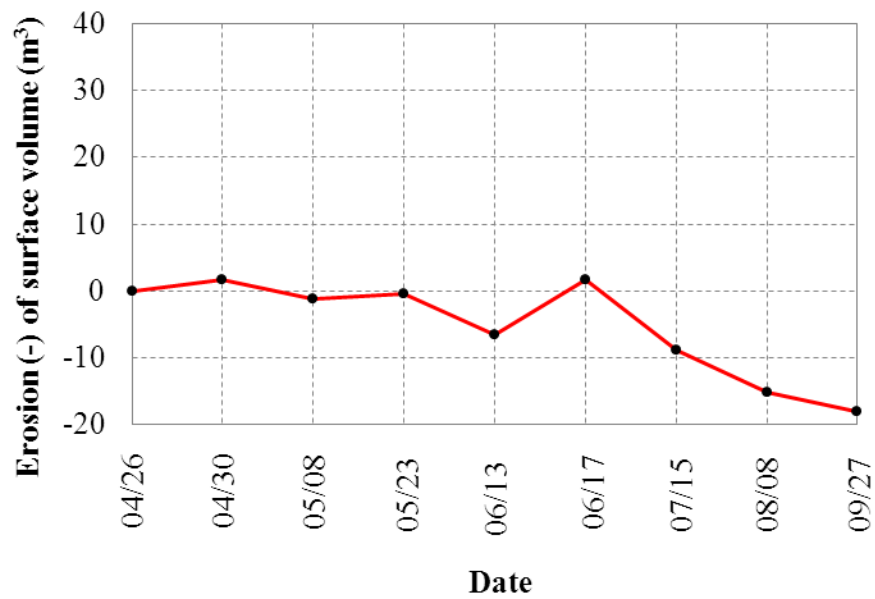
Figure 7.36 Erosion on Section D
