# DEVELOPMENT OF MODIFIED TxDOT SINGLE-POST SKID-MOUNTED SIGN SUPPORT

## Test Report 0-6968-R3

TEXAS A&M TRANSPORTATION INSTITUTE  
COLLEGE STATION, TEXAS

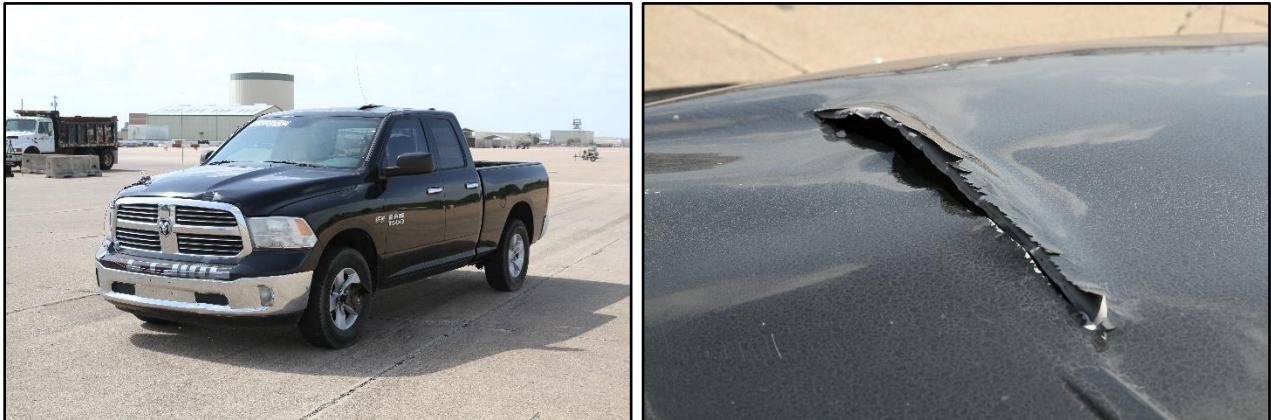
Figure 4.6. Test Vehicle after Test No. 469680-03-2.

Figure 4.6 shows the damage sustained by the vehicle. The front bumper sustained a 4-inch  $\times$  4-inch  $\times$  0.5-inch deformation 13 inches to the left of the centerline of the vehicle. There was also a 4-inch  $\times$  3-inch  $\times$  0.5-inch deformation at the front edge of the hood 13 inches to the left of the centerline of the vehicle. There was a 22-inch-long cut in the roof 13 inches to the left of the centerline and starting 1 inch rearward of the front windshield. No fuel tank damage was observed. Maximum exterior crush to the vehicle was 0.5 inches on the bumper and hood 13 inches left of the centerline of the vehicle. The sign panel penetrated the roof of the occupant compartment over the driver's seat. Figure 4.7 shows the interior of the vehicle after the test. Tables B.3 and B.4 in Appendix B.1 provide exterior crush and occupant compartment measurements.

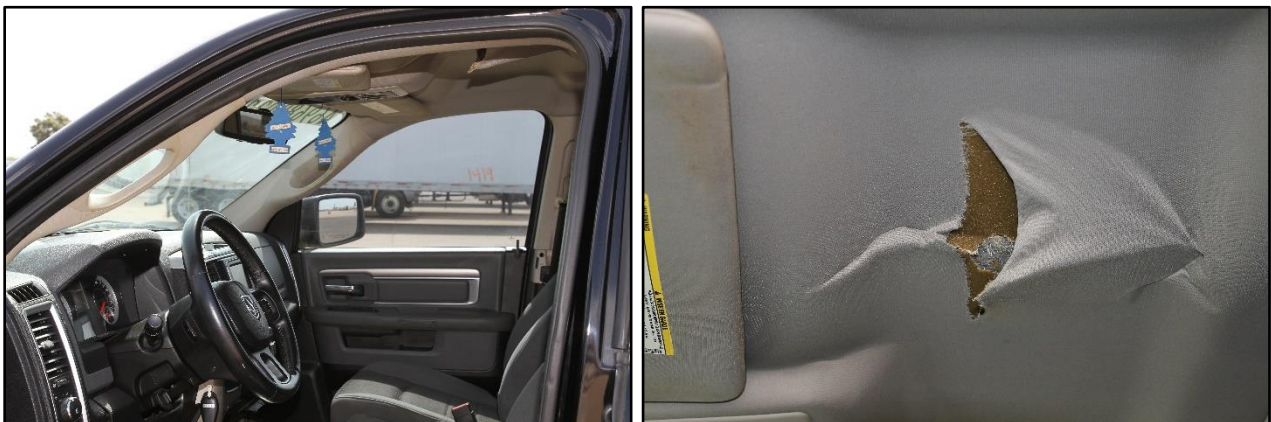
Figure 4.7. Interior of Test Vehicle after Test No. 469680-03-2.

During Crash Test No. 469680-03-2, the sign panel contacted the roof of the 2270P vehicle, sliced a 22-inch-long hole in the roof, and penetrated the occupant compartment over the driver’s seat. Film analysis indicated that while the tether cable prevented the fractured segments of the support post from separating, the amount of slack in the cable delayed its effectiveness in influencing the trajectory of the connected segments. A decision was made to reduce the length of the tether cable and remove the excess slack to more quickly engage the hinge mechanism provided between the two fracture segments of the support post. *MASH* Test 3-72 at 90 degrees was repeated on the redesigned single skid-mounted sign support, as described in the next chapter.
