Evaluation of Roadway Concrete Barriers and Materials

Vista Shahriari, M.S.
Pavana Prabhakar, Ph.D.
Jose A. Pincheira, Ph.D.

University of Wisconsin – Madison
Department of Civil and Environmental Engineering

WisDOT ID no. 0092-19-03

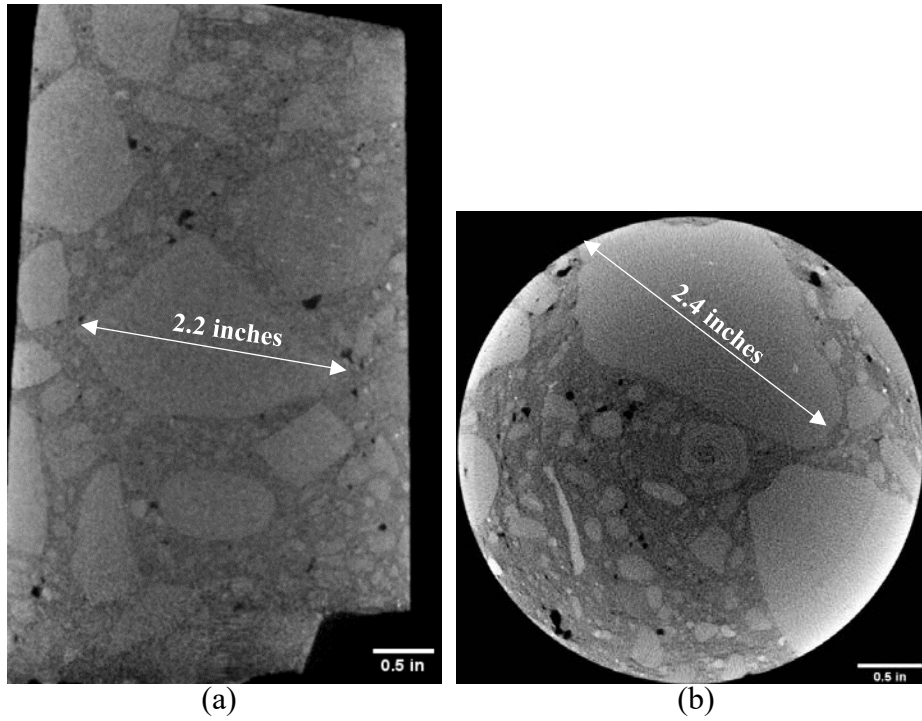
Figure 8.3: Coarse aggregate greater than the specified dimension at site SE-1: a) longitudinal view, b) cross-section view
