Report No. UT-21.23

SALT LAKE CITY AIRPORT PARKING GARAGE VISUAL INSPECTION REPORT

Utah Department of Transportation
Research & Innovation Division

**Final Report
August 2021**

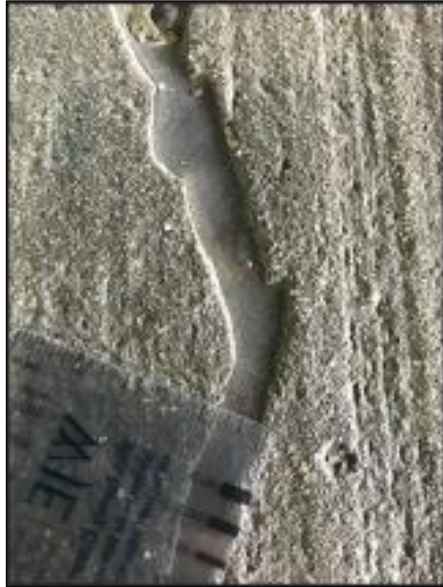
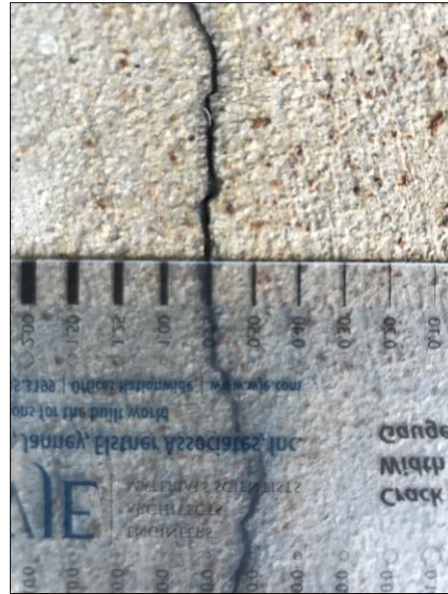
Figure 2-3 (a) Typical epoxy-filled crack found on suspended levels of parking garage and (b) unsealed surface cracking on the 1st level in structure B with a 0.75mm width.

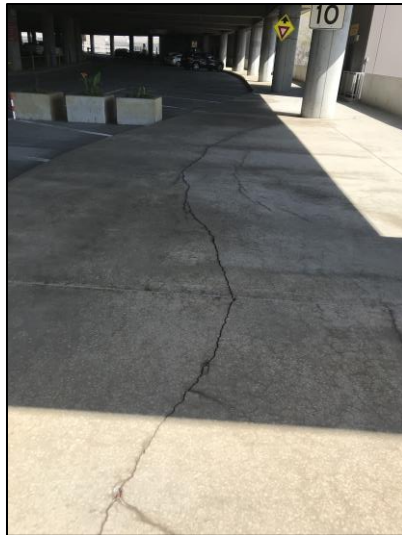
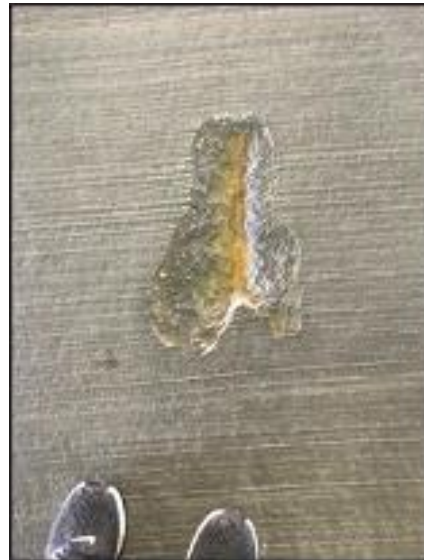
Figure 2-4 (a) Wide floor crack found on the sidewalk on the southeast corner of the 1st level structure D, near the entrance ramp and (b) spalling and exposed rebar near the surface on the 1st level near northwest end of parking garage.

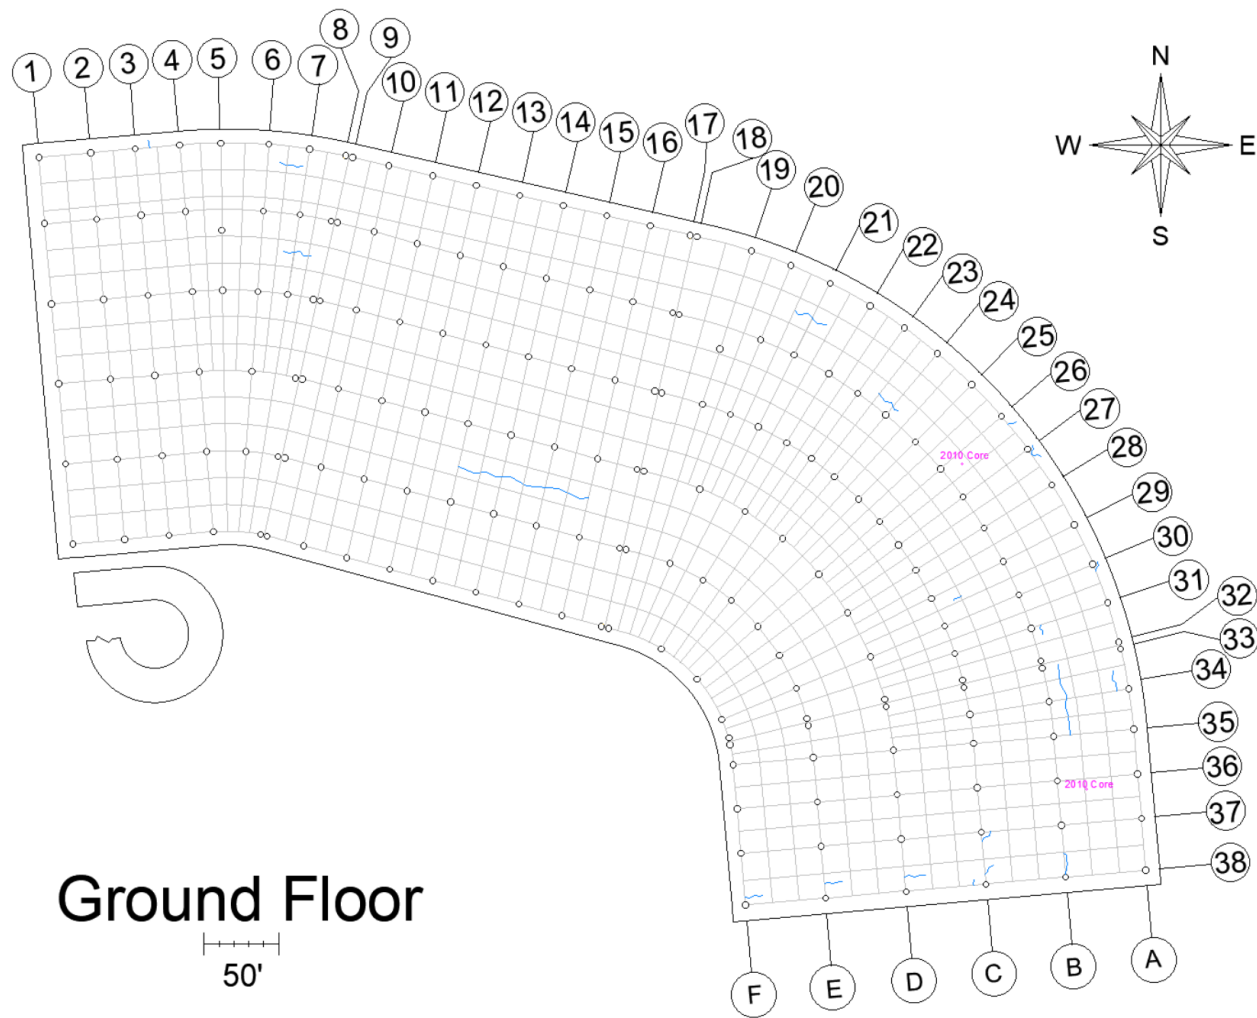
Figure 3-1 Crack map of plain concrete, unreinforced ground floor showing blue top-down cracks, gray saw-cut joints, and locations of the cores taken in 2010 study by Hooton et al. This floor was used only by rental car companies.

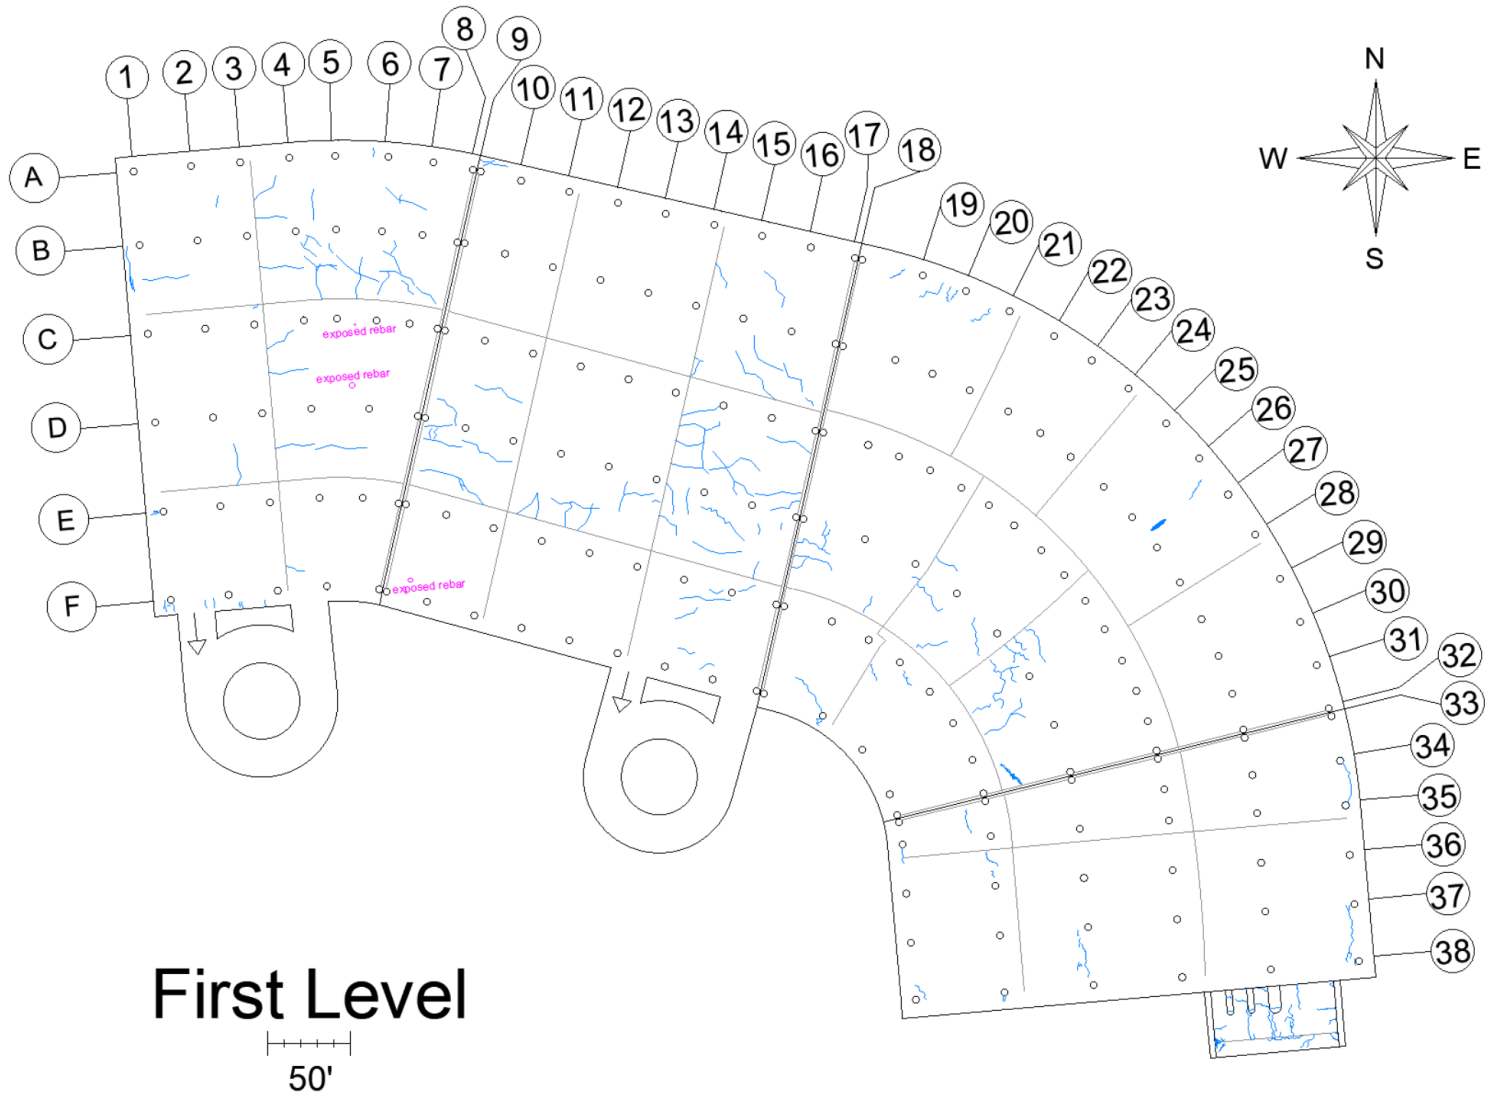
Figure 3-2 Crack map of silica fume concrete suspended, reinforced first floor and entrance bridge with blue top-down cracks, gray epoxy-filled construction joints, and locations of visually exposed rebar.

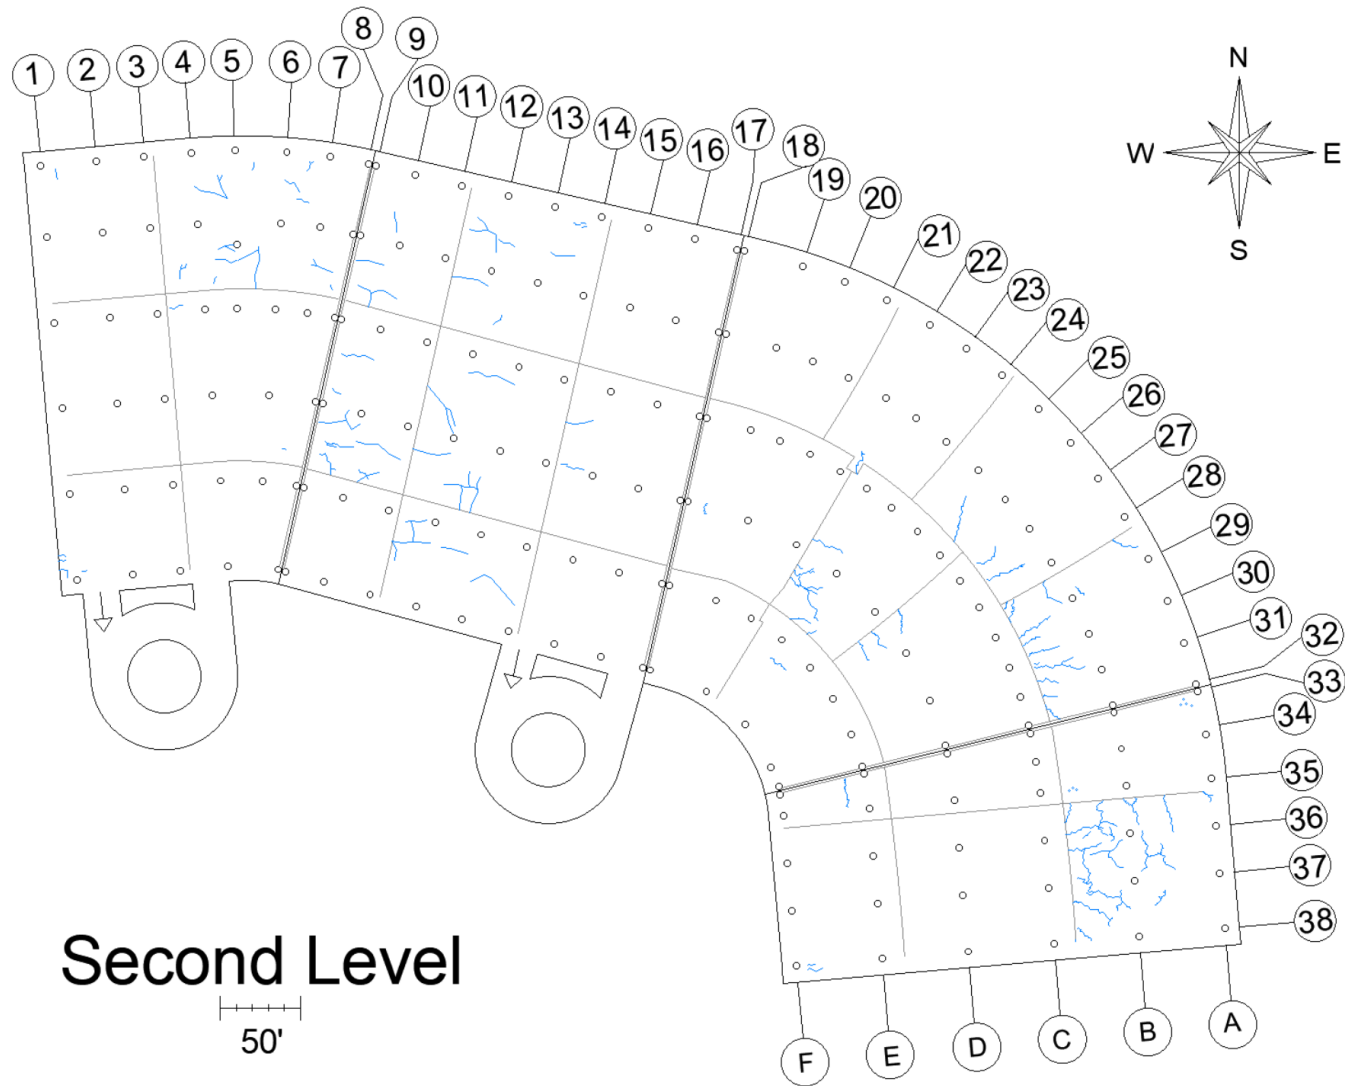
Figure 3-3 Crack map of silica fume concrete suspended, reinforced second floor with blue top-down cracks, gray epoxy-filled construction joints, and no locations of visually exposed rebar.

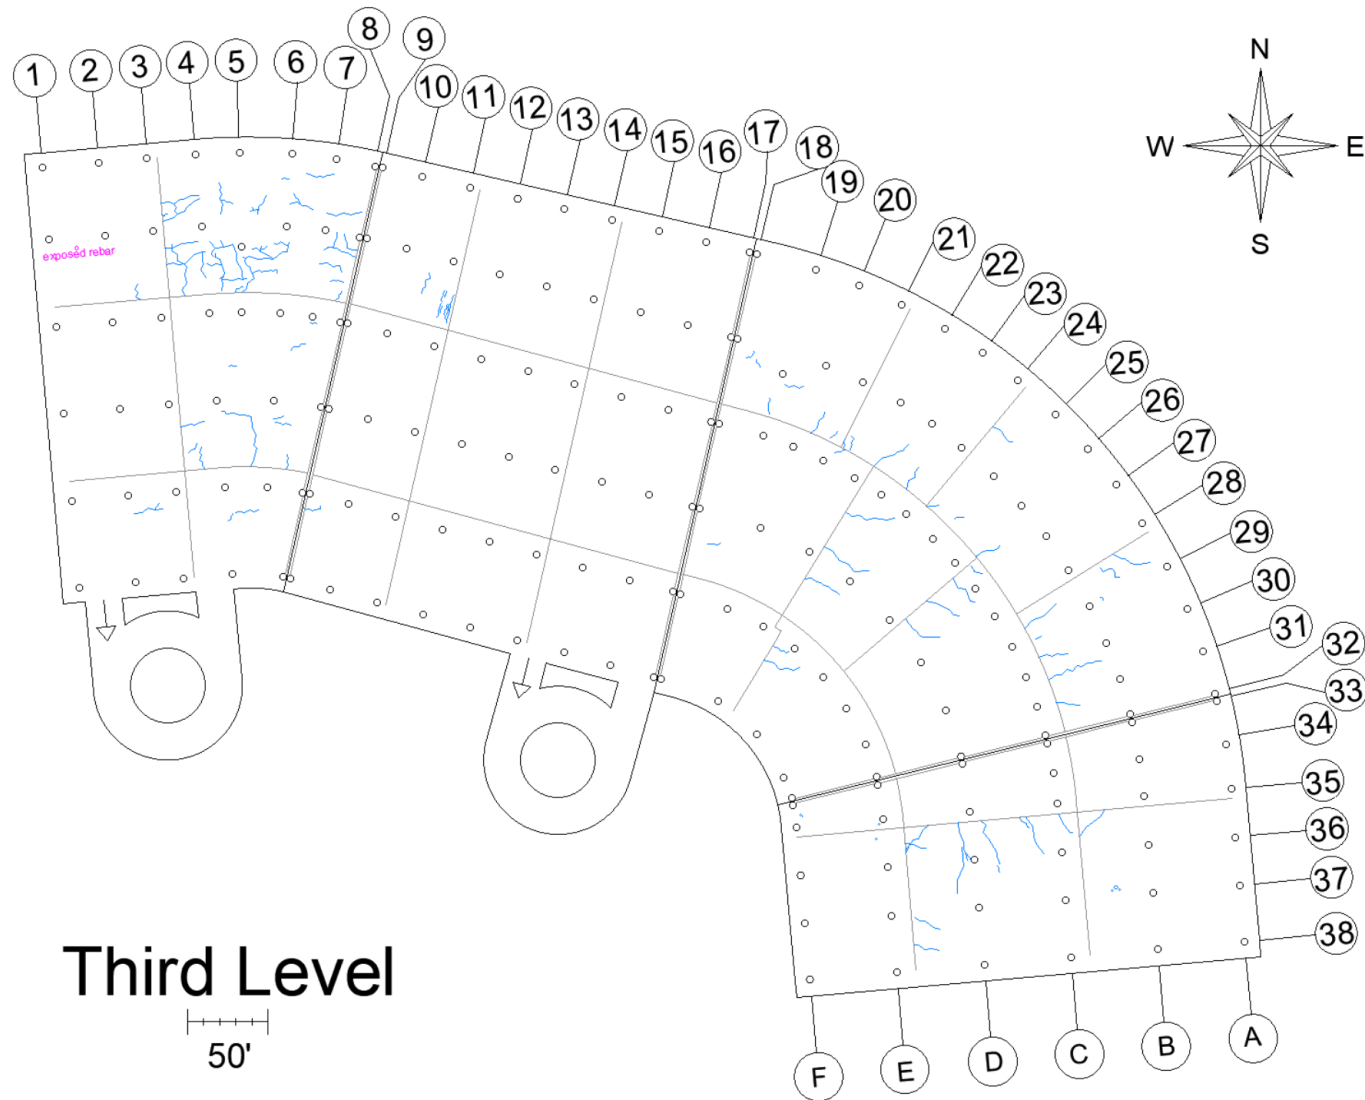
Figure 3-4 Crack map of silica fume concrete suspended, reinforced third (top) covered floor with blue top-down cracks, gray epoxy-filled construction joints, and location of a visually exposed rebar.

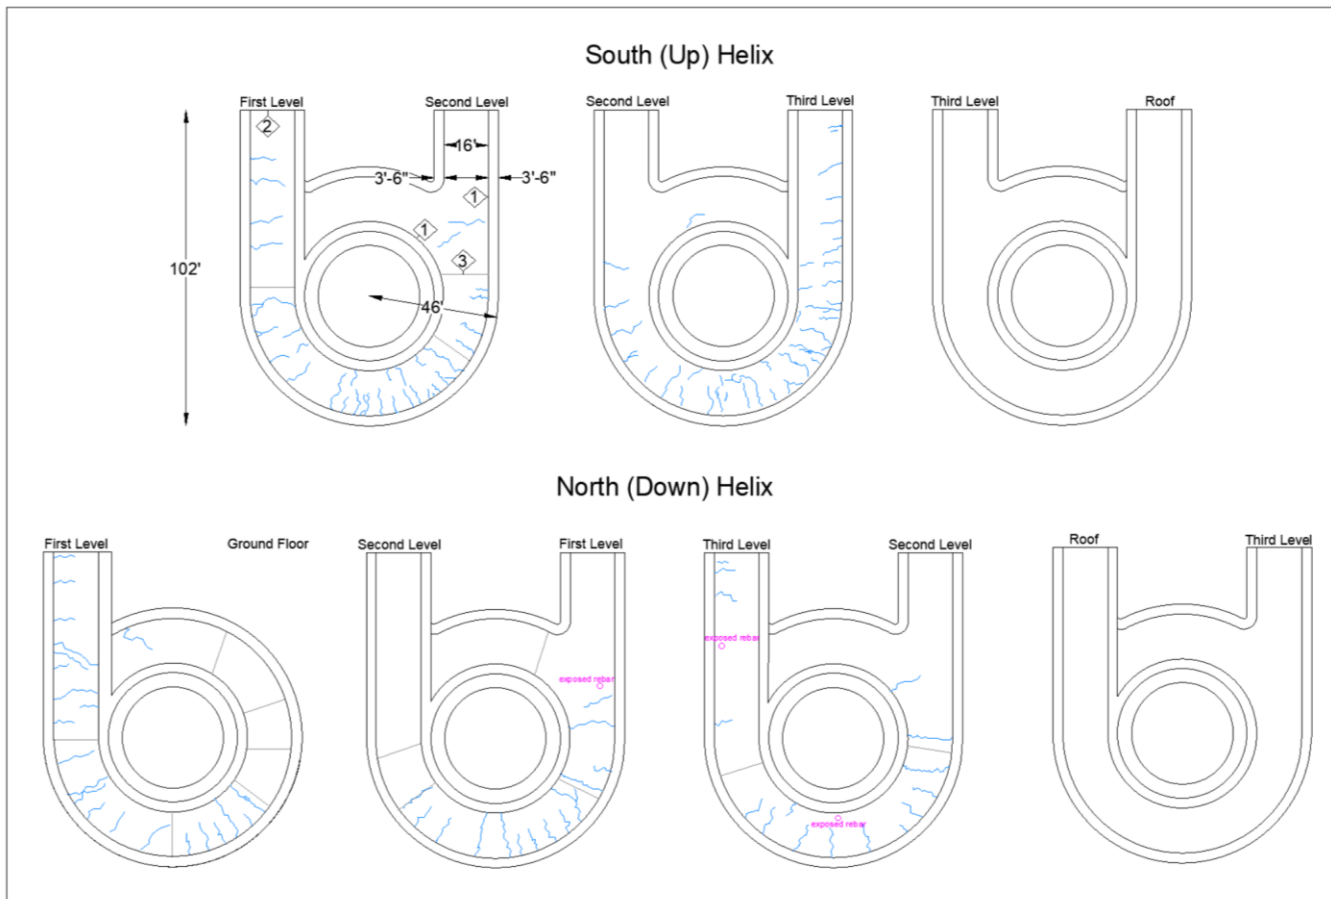
Figure 3-5 Crack maps of reinforced silica fume concrete helixes with blue top-down cracks, gray epoxy-filled construction joints, and locations of visually exposed rebar.

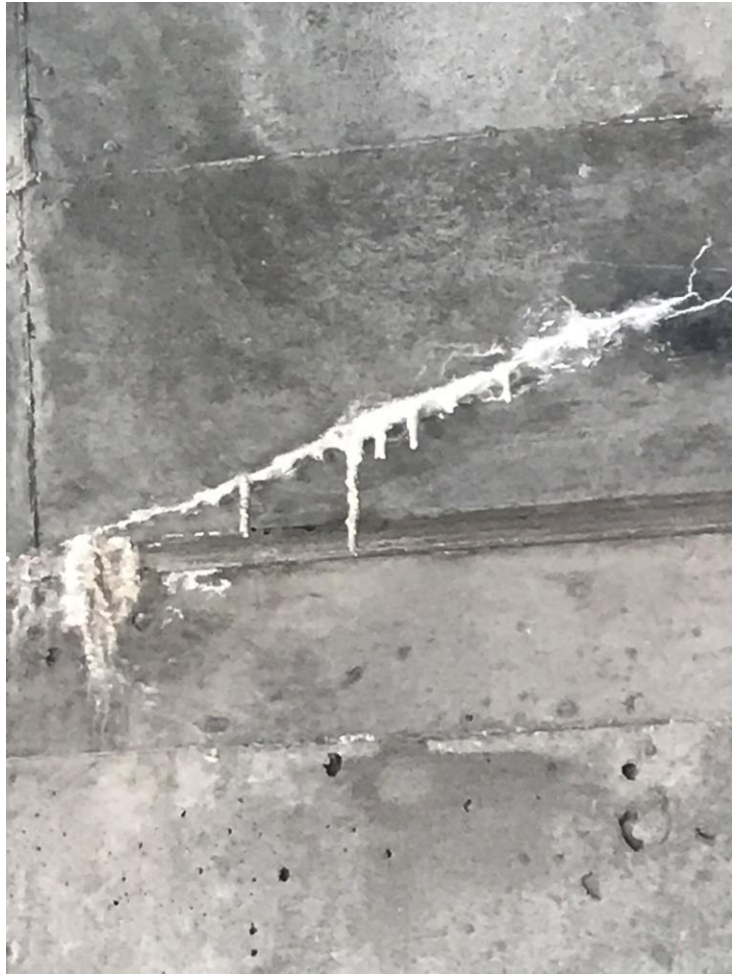
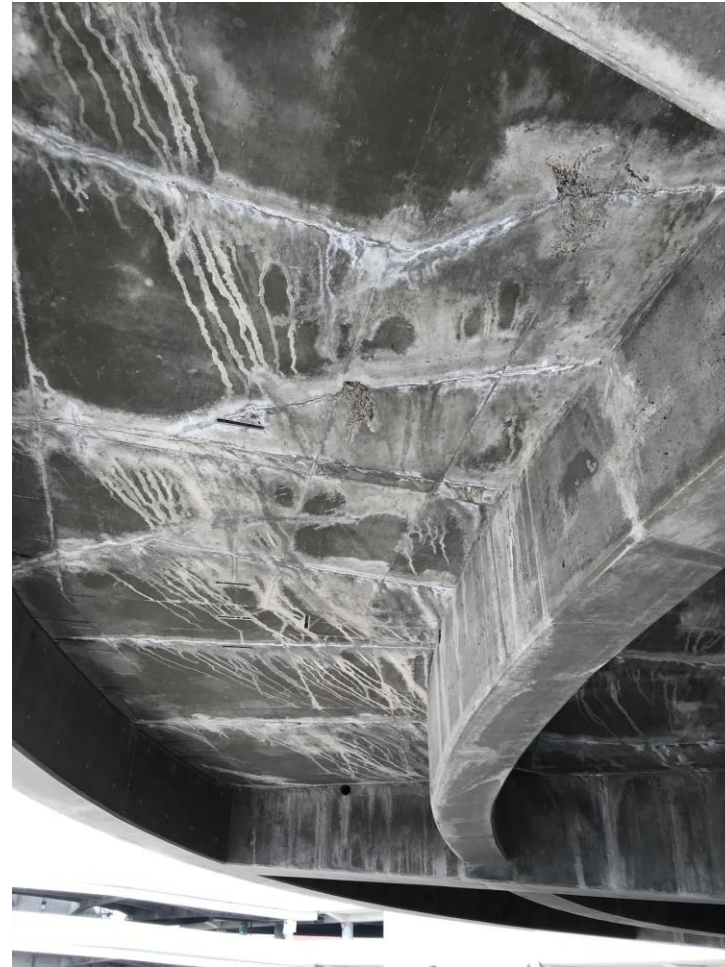
Several instances of exposed rebar were also present on the ceilings of the helices. Where the rebar was exposed, there were large amounts of discolored efflorescence present suggesting rebar corrosion.

Figure 3-6 (a) Photo of stalactites growing on the ceiling between first and second level on southeast helix, and (b) photo of the ceiling halfway between the first and second levels on the southeast helix. The efflorescence and cracking in this photo are similar to efflorescence and cracking on the ceilings of both helix structures.

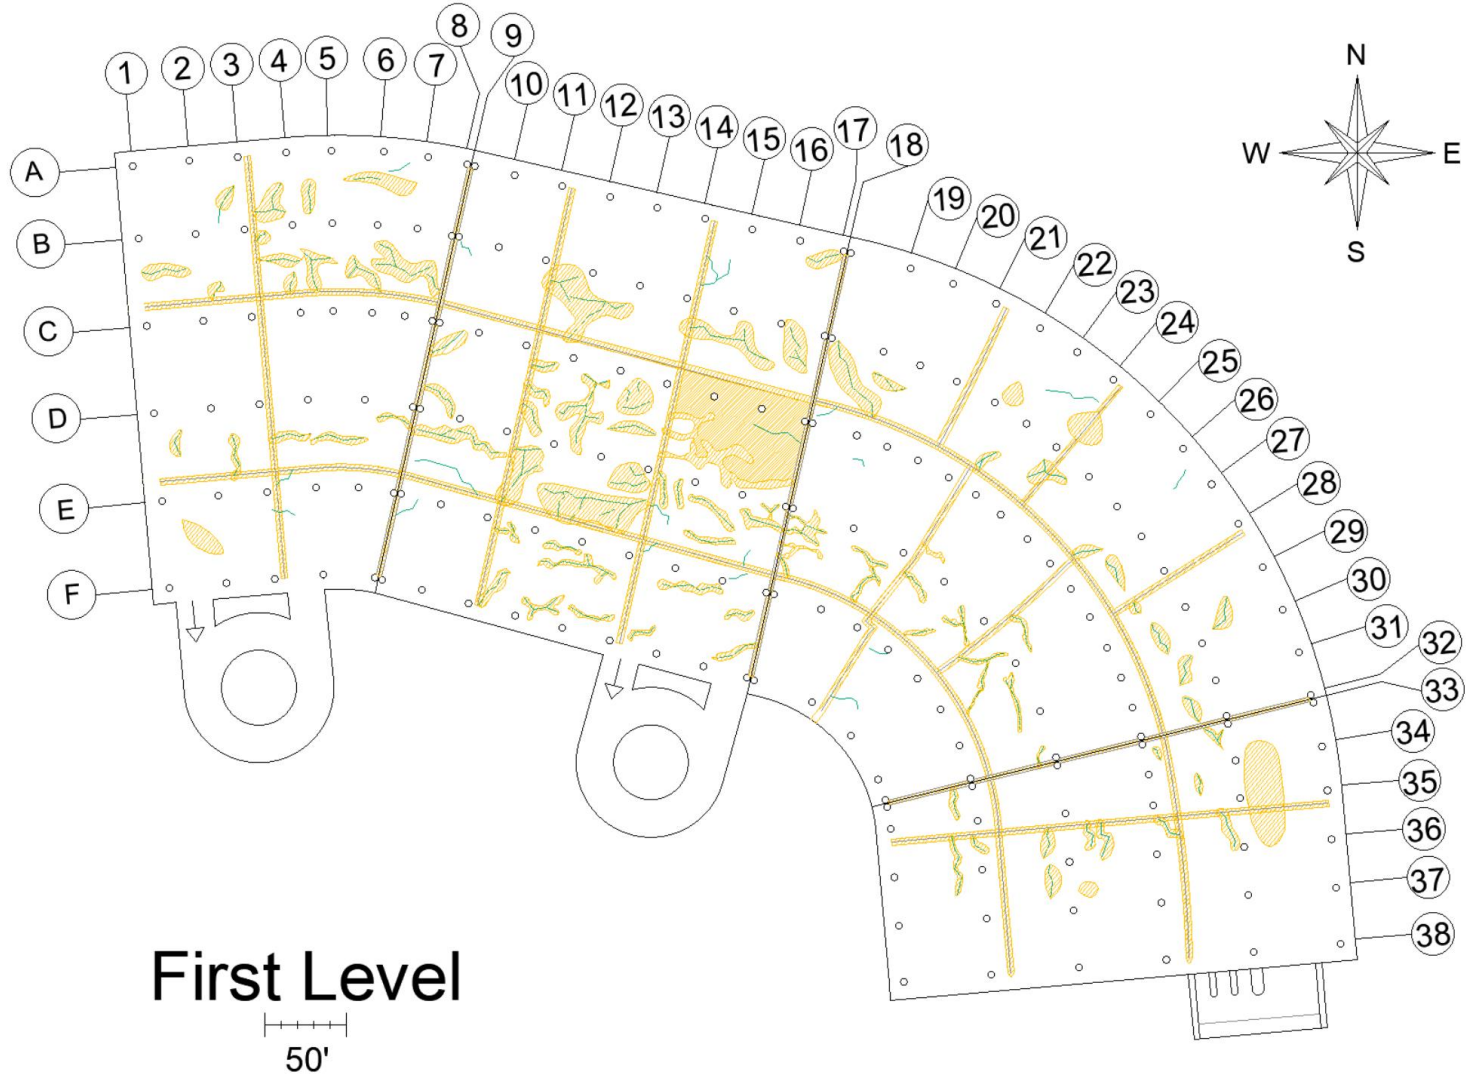
Figure 3-7 Crack map of the first suspended, reinforced silica fume concrete slab with green bottom-up cracks (some occurring along gray epoxy-filled construction joints) and yellow zones of efflorescence.

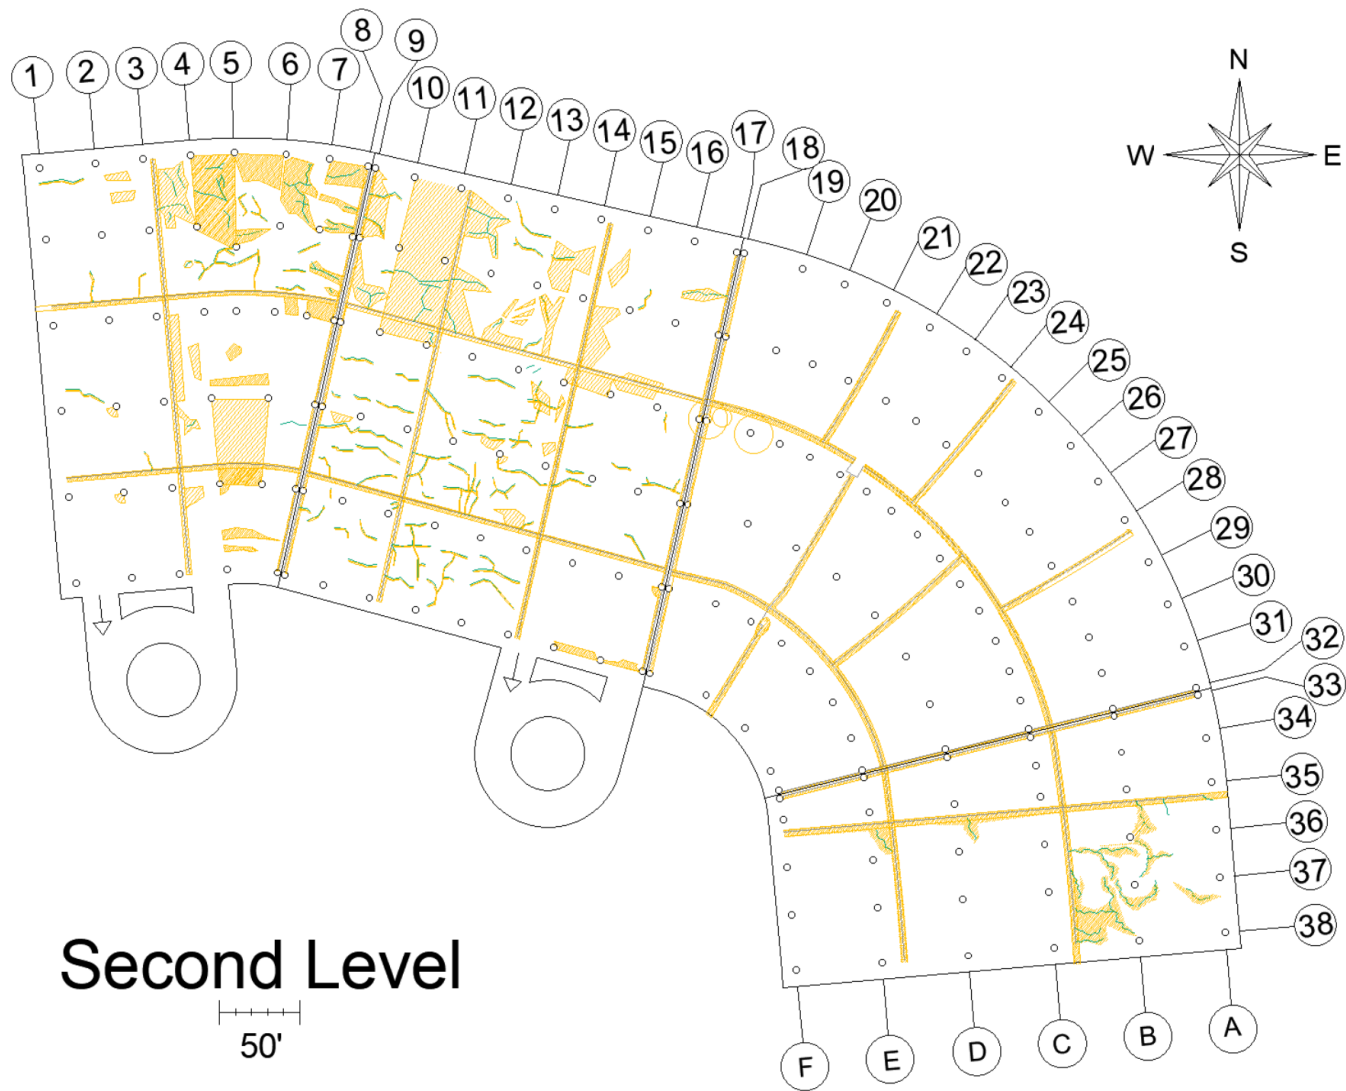
Figure 3-8 Crack map of the second suspended, reinforced silica fume concrete slab with green bottom-up cracks, yellow zones of efflorescence, and gray un-cracked epoxy-filled construction joints.

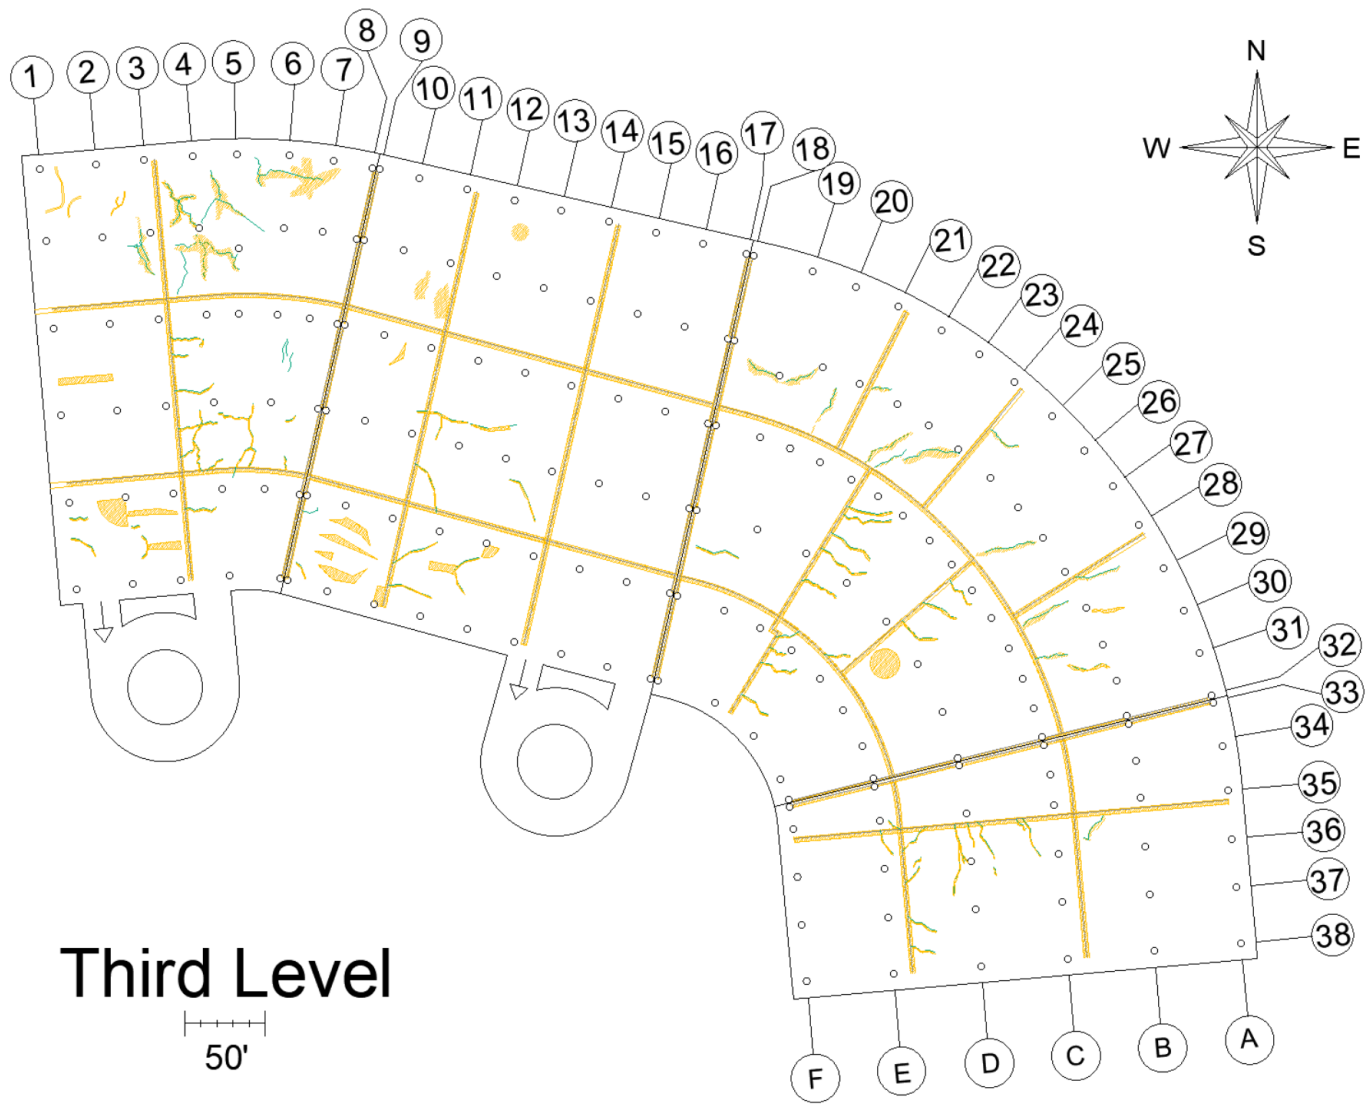
Figure 3-9 Crack map of the second suspended, reinforced silica fume concrete slab with green bottom-up cracks, yellow zones of efflorescence, and gray un-cracked epoxy-filled construction joints.

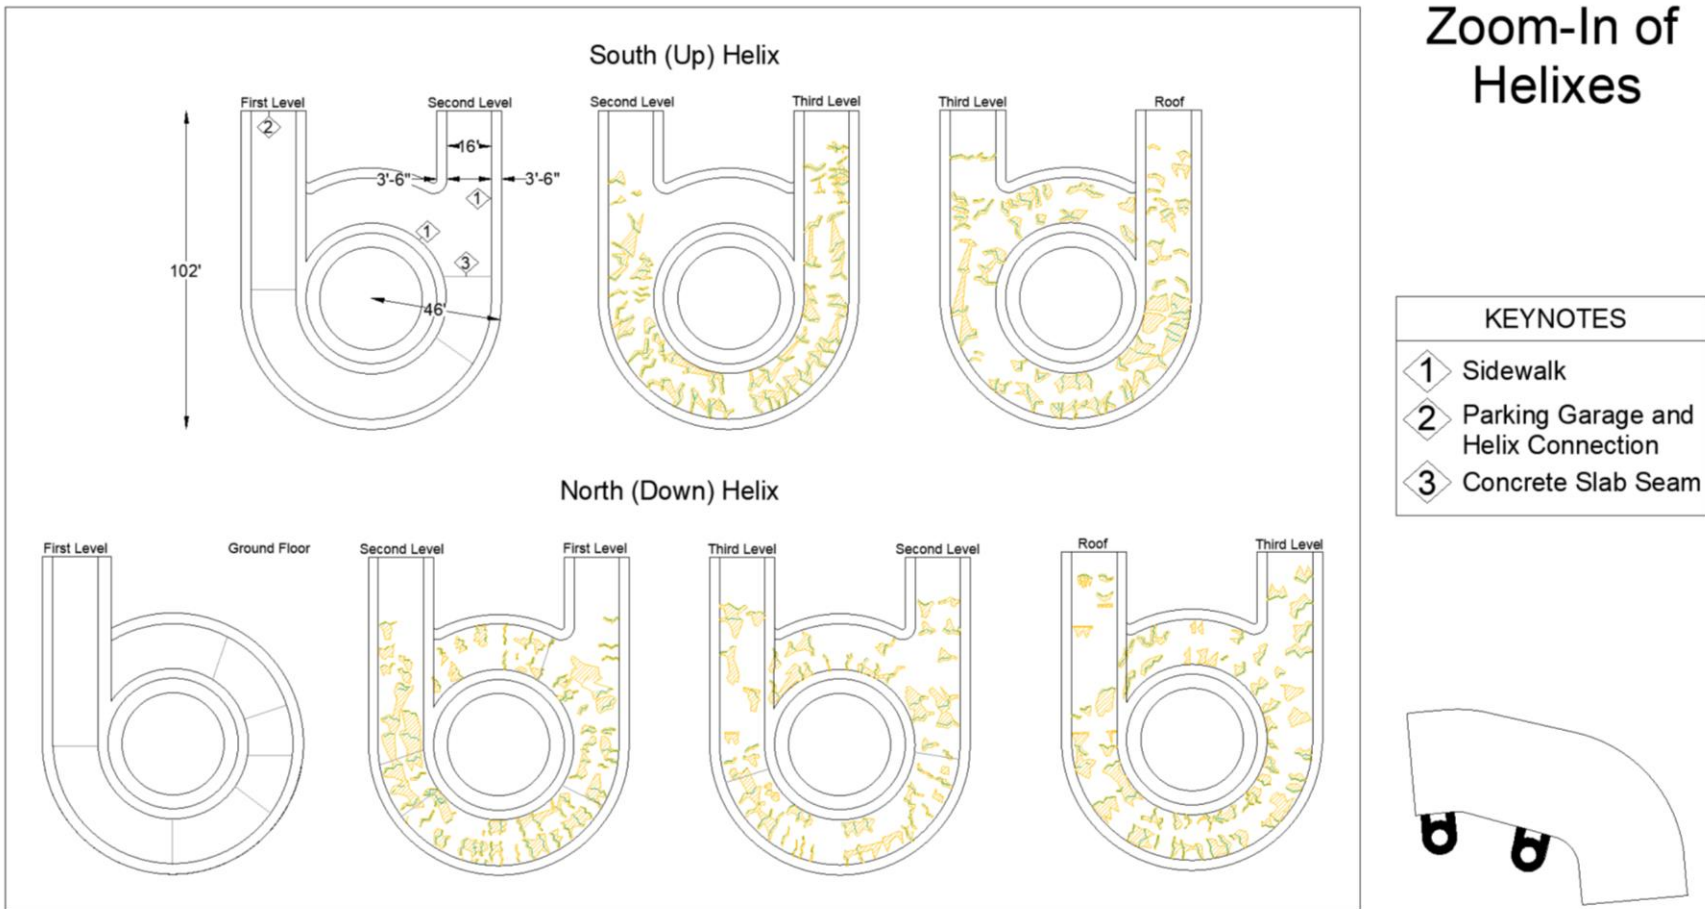
Figure 3-10 Crack map of the suspended, reinforced silica fume concrete helix ramps with green bottom-up cracks, yellow zones of efflorescence, and gray un-cracked epoxy-filled construction joints.
