Protecting Piers of Overhead Structures from Degradation Due to Snow and Ice Chemical and Material Usage Phase II

Project ID Number: 106177

April 2021

Final Report

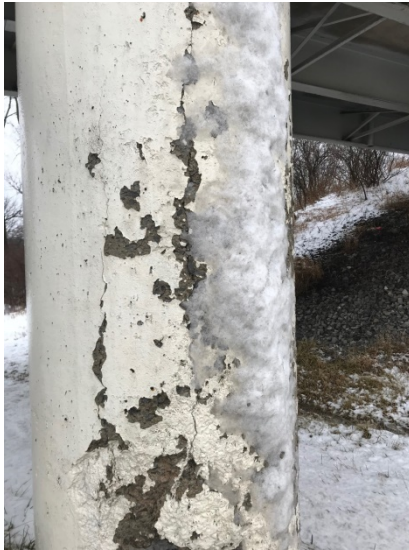
The deterioration of bridge piers is caused by two factors: chloride laden snow thrown onto the pier columns by snowplows (Figure 1) and improperly placed reinforcing bars. The reinforcing bars are supposed to have 3 inches of cover, but construction errors sometimes result in bars that are too close to the surface. The chloride laden snow adheres to the pier columns for some time, allowing the chlorides to leach into the concrete and cause corrosion in the reinforcing bar. The ODOT standard is to use an epoxy- urethane sealer but these do not seem to be effective. In particular, the epoxy- urethane either deteriorates in a few years leaving the pier column unprotected or the concrete below the epoxy- urethane fails.

Figure 1 - Pier column with snow thrown from a plow. (Courtesy D. Wise, ODOT)

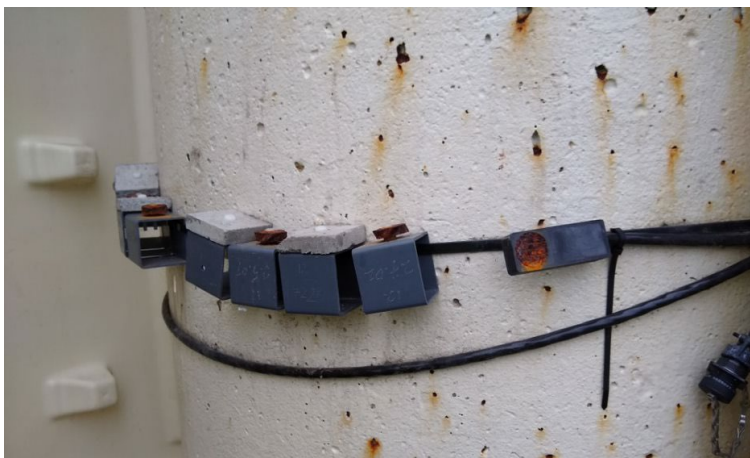
For the most part, the specimens seemed in good condition except for the expected corrosion on the reinforcing bar specimens (Figure B7). However, the RT did notice two problems. On a few specimens, rodent nests were found (Figure B9) and these were discarded. On other specimens there was an accumulation of grit on the samples (Figure B8). This occurred because the samples formed a shelf under the shields which could accumulate grit; had they samples not been there grit would have likely fallen out the open bottom of the shield.

Figure B 7 - Specimens and probe under shields after one year of exposure

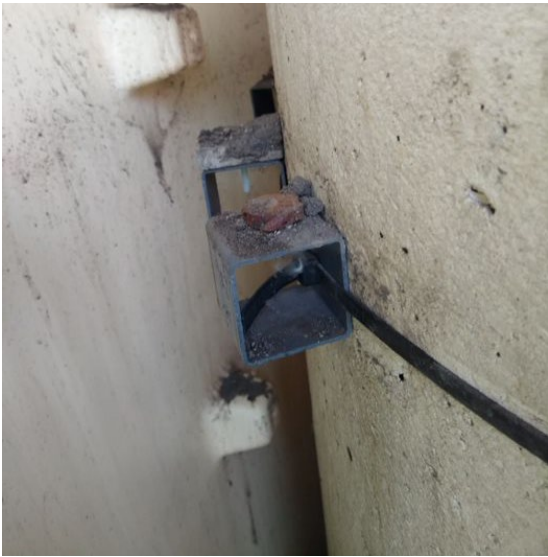
Figure B 8 - Specimens with grit

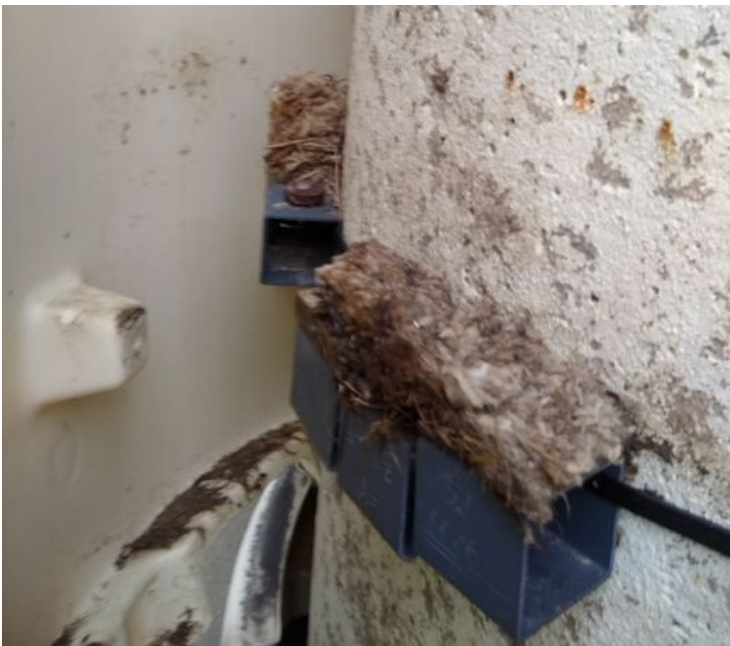
Figure B 9 - Specimens with a mouse nest (discarded)

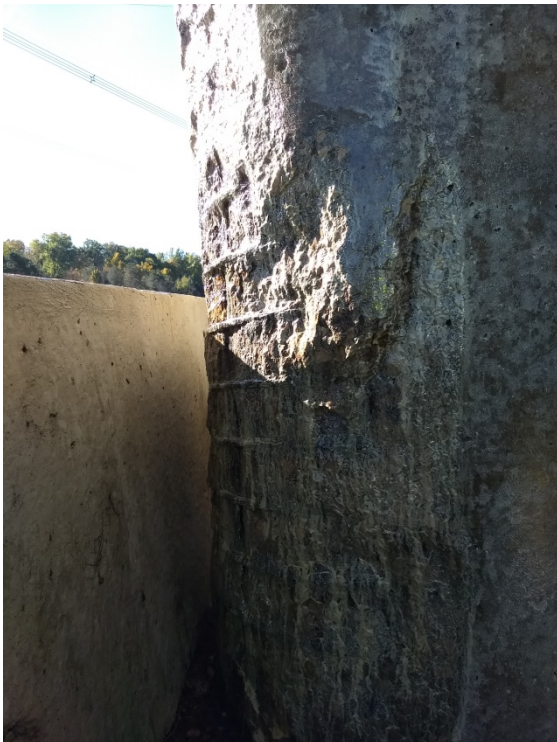
Figure C 3 - - Spalled area on center SB column

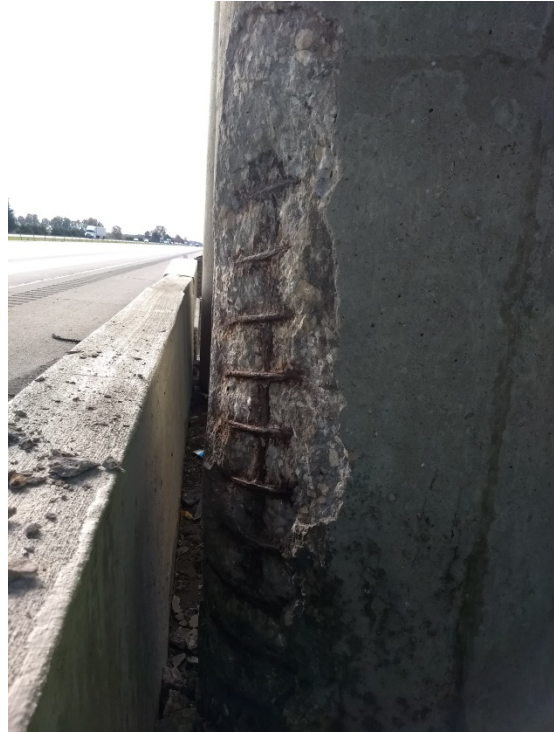
Figure C 5 - Spall on center SB column DEL 71-1093

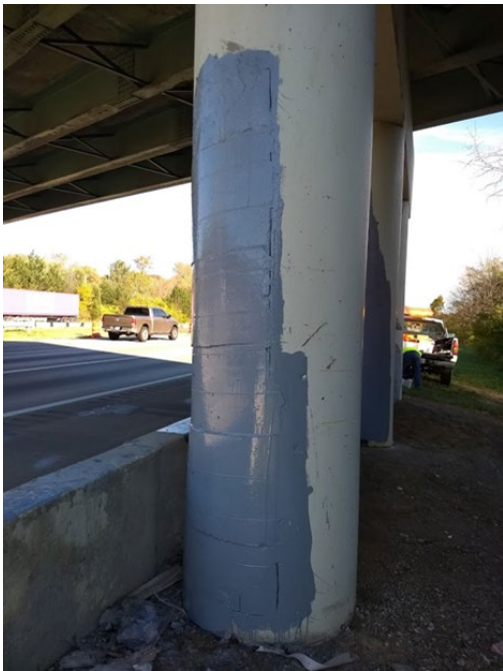
The patches on the FRA 270 960 (Gantz Road) bridge were evaluated. Visual inspection showed that the coatings appeared intact and looked the same as when they were installed. However, when the “V” notch test was applied, both materials easily peeled off the patch. It was noted that patching material was very dense and smooth. It seemed that the lack of adhesion was due to the smoothness of the surface. Recall that the manufacturers recommend roughening the surface by sandblasting or some other method. That may have helped adhesion in this case. However, there was no sign of deterioration in the patch and the lack of adhesion was only apparent when an overt attempt was made to remove the material. Figures C8-11 show the results.

Figure C 8 Citadel patch FRA 270-960 west column after 2 years.

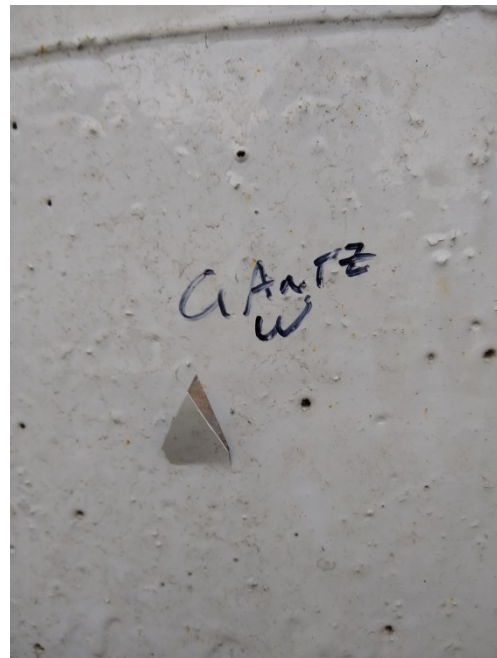
Figure C 9 - V notch test Citadel FRA 270-960 west column

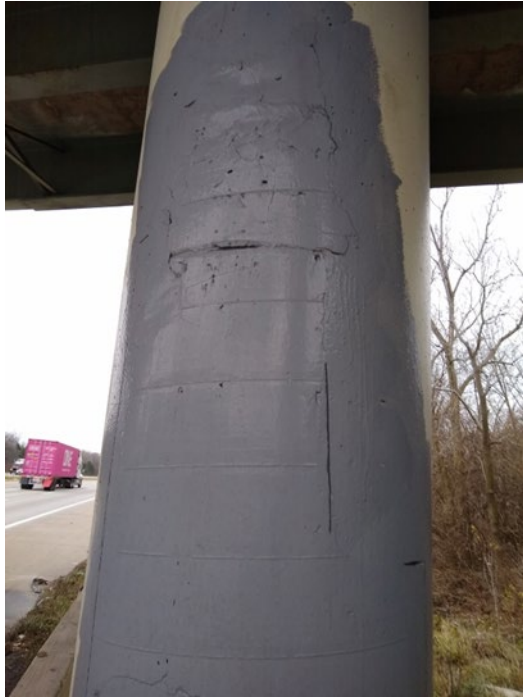
Figure C 10 - Creative Materials patch FRA 270 960 center column after 2 years.

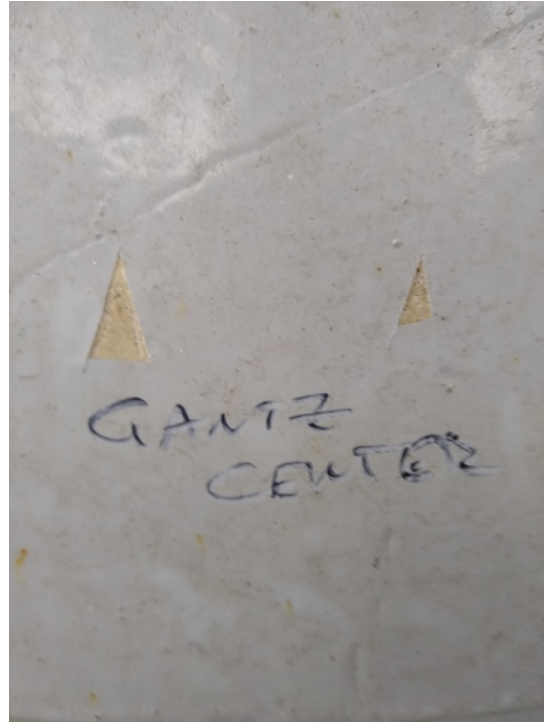
Figure C 11 - - V notch test FRA 960 center column

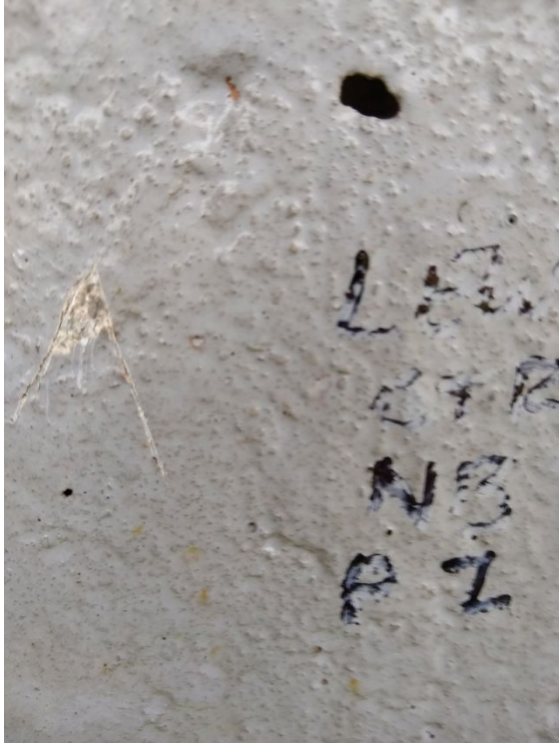
Figure C 12 - - V notch test. Material had to be chipped off; failure in substrate. DEL 71 498

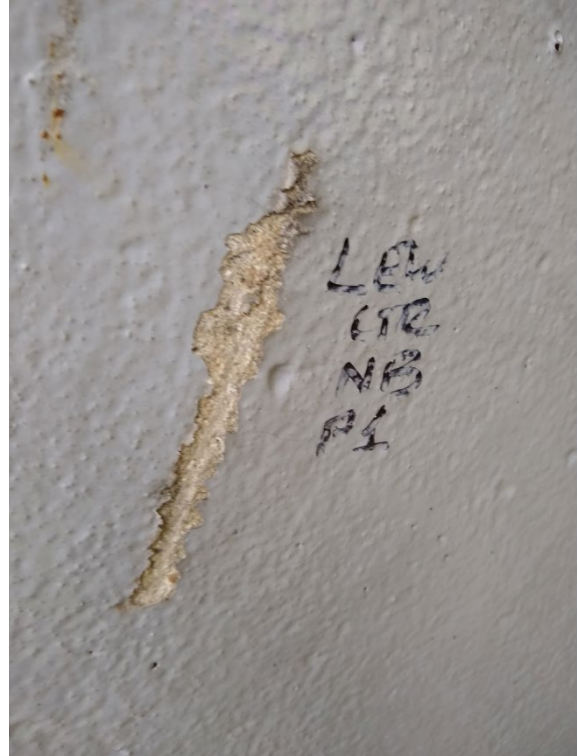
Figure C 13 - Damage to coating NB shoulder first pier; Del 71 498

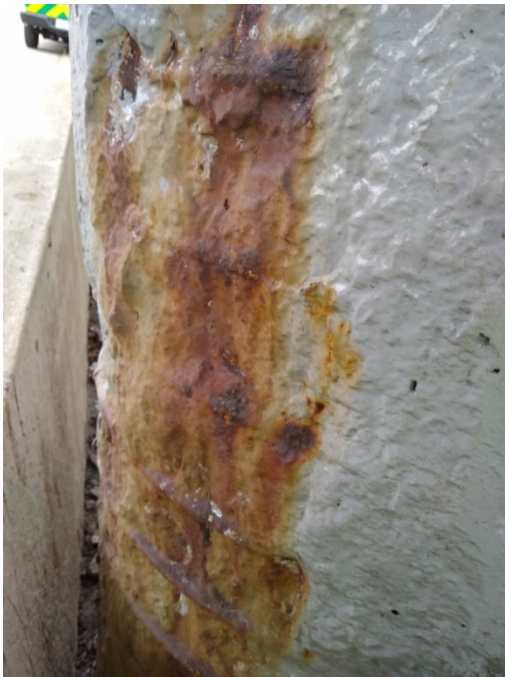
Figure C 14 - DEL 71 498 center column SB over spall

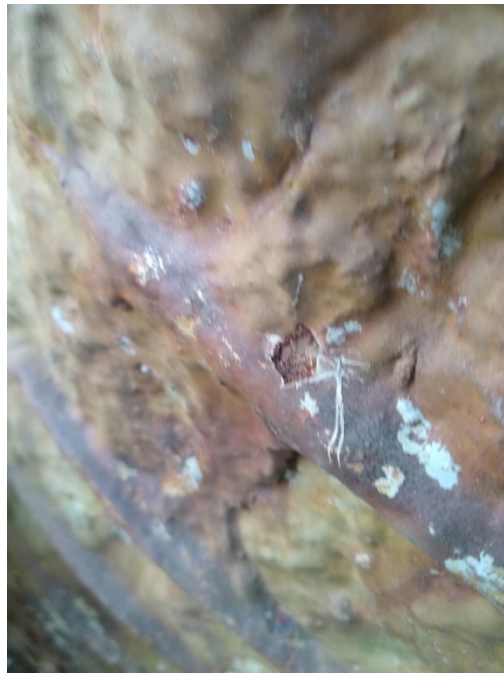
Figure C 15 - DEL 71 498 V notch center column SB at spall.

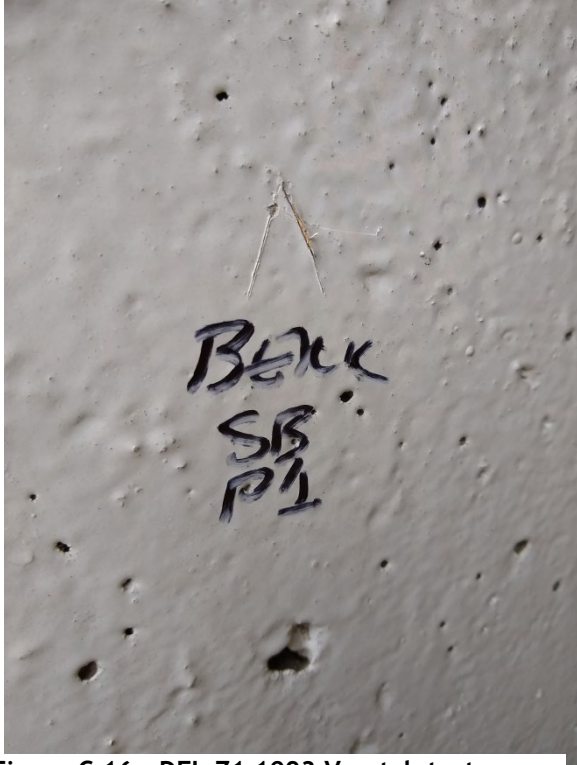
The results for the Citadel product on the Berkshire Road bridge (DEL 71-1093) were similar as shown in Figures C16-C18.

Figure C 16 - DEL 71 1093 V notch test

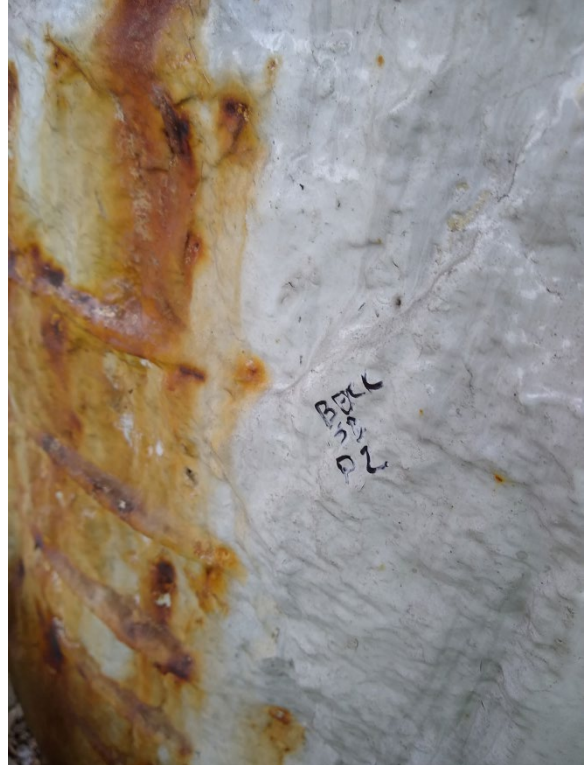
Figure C 17 - - DEL 71-1093 center column SB over spall

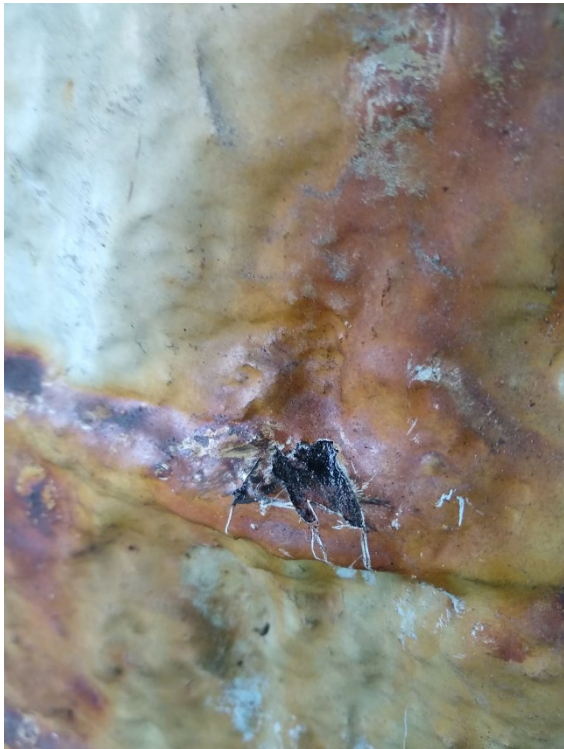
Figure C 18 - DEL 71-1093 V notch over spall on center SB column.

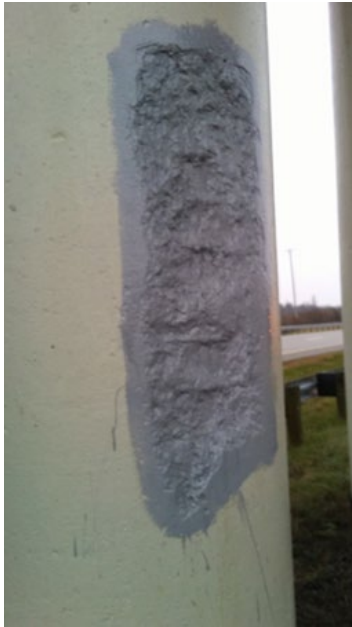
Figure C 19 - Spall on MIA 75 1995

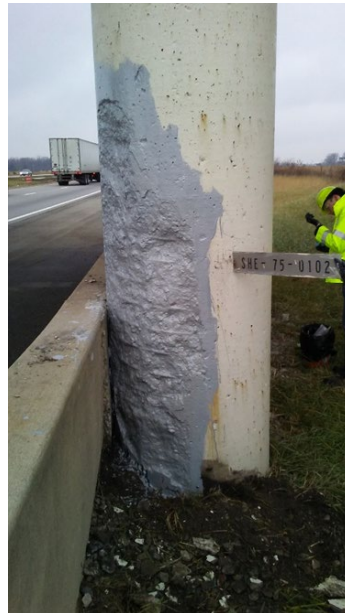
Figure C 20 - Spall on SHE 75-0102

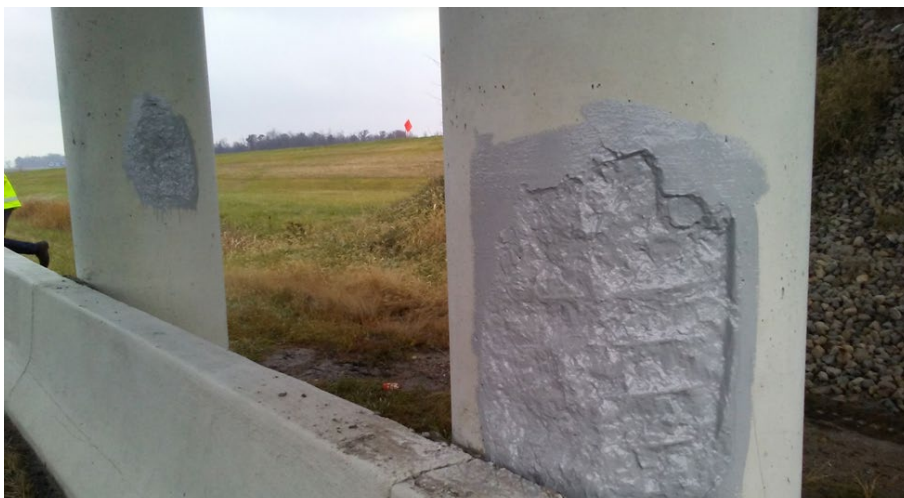
Figure C 21 - Spalls on SHE 75 1954

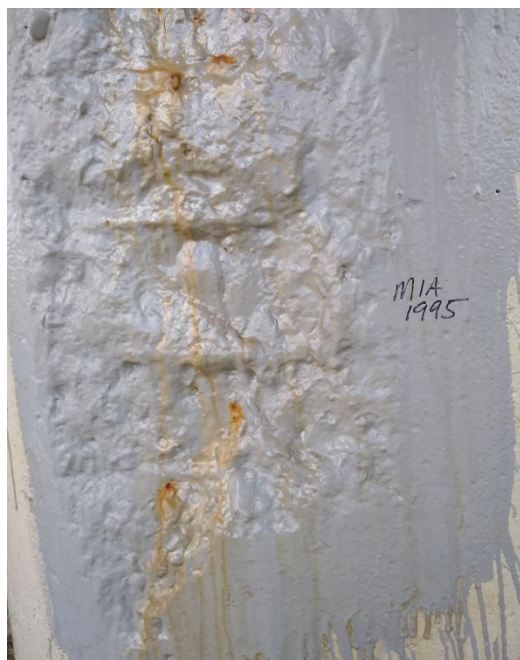
For bridge MIA 75-1995, the coating appeared in good shape visually (Figure C22). The V notch test showed that material bonded in some places and did not bond well in other (Figure C23).

Figure C 22 - MIA 75 1995 after two years

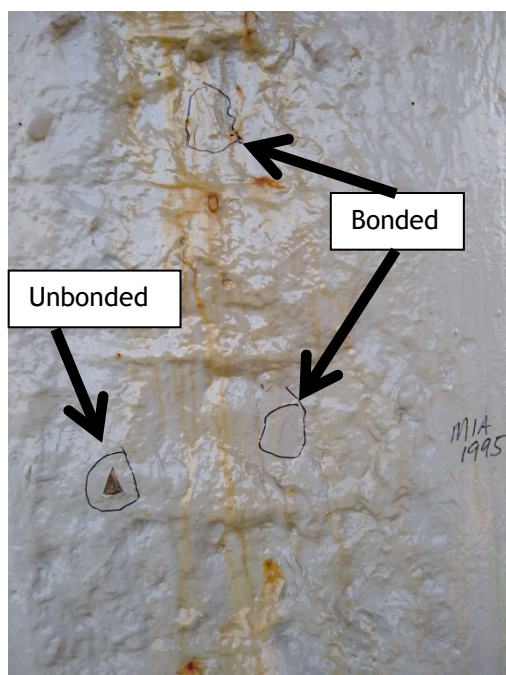
Figure C 23 - - Bonded and unbonded areas MIA 75 1995.

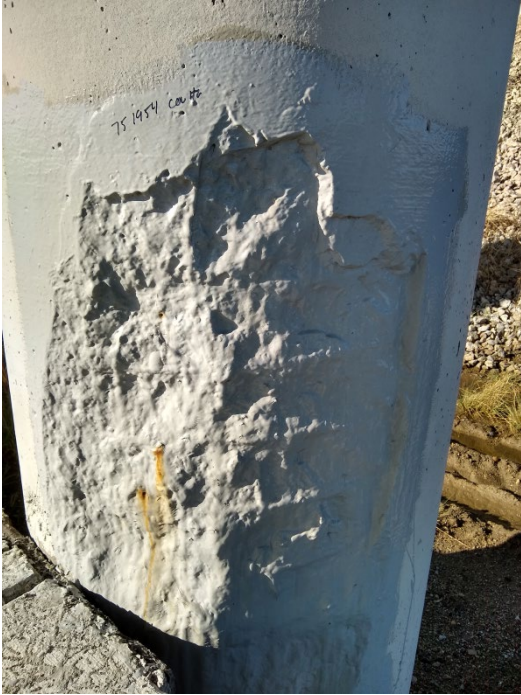
Figure C 24 - SHE 75-1954 middle column after two years.

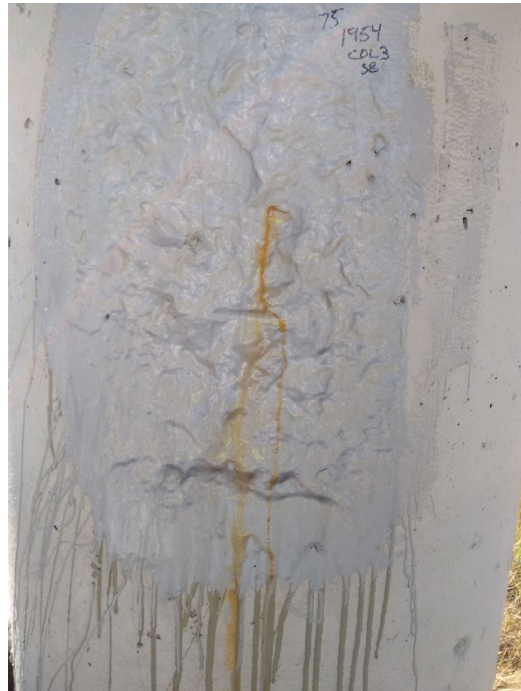
Figure C 25 - SHE 75-1954 south column after two years

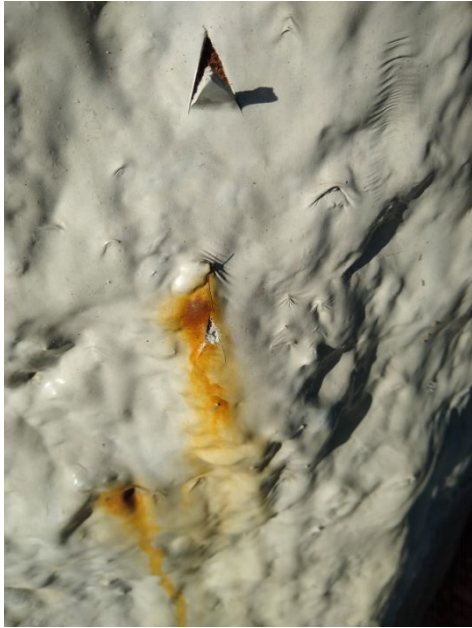
Figure C 26 - SHE 75-1954 south column V notch test

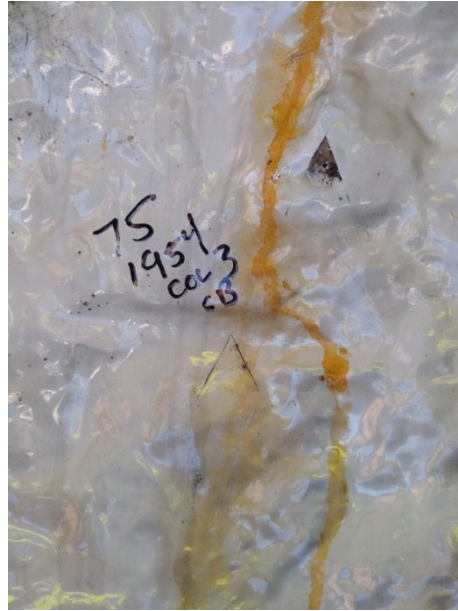
Figure C 27 - SHE 75 1954 middle column V notch test.

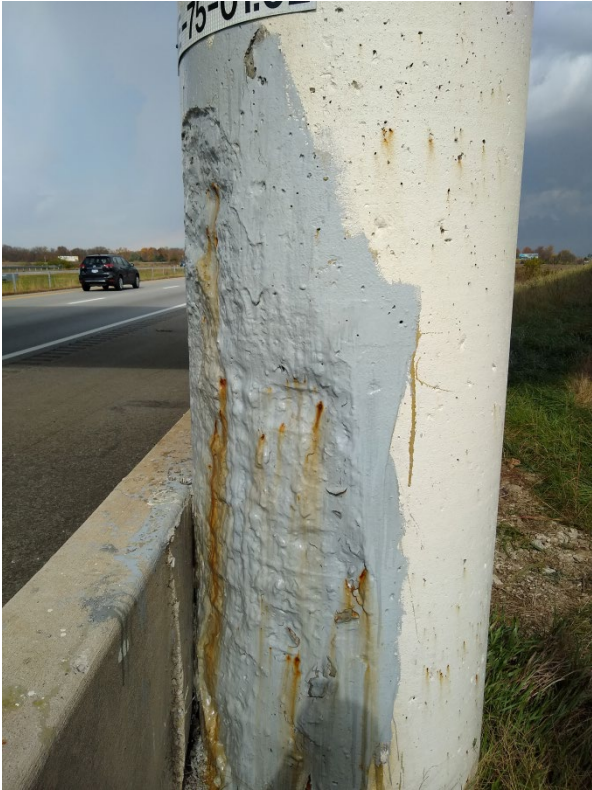
Figure C 28 - - SHE 75-0102 coating failure

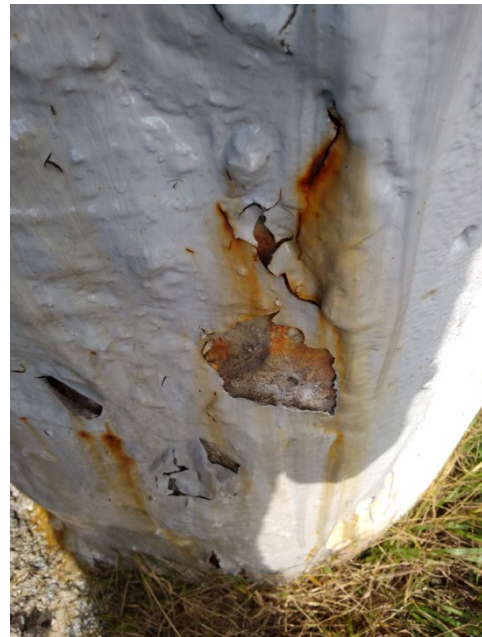
Figure C 29 - SHE 75 0101 south column after two years
