JRC2021-1075

UPDATED FUEL TANK PUNCTURE SURVEY: 1995-2020

Karina Jacobsen

Volpe National Transportation Systems Center
United States Department of Transportation
Cambridge, Massachusetts, USA

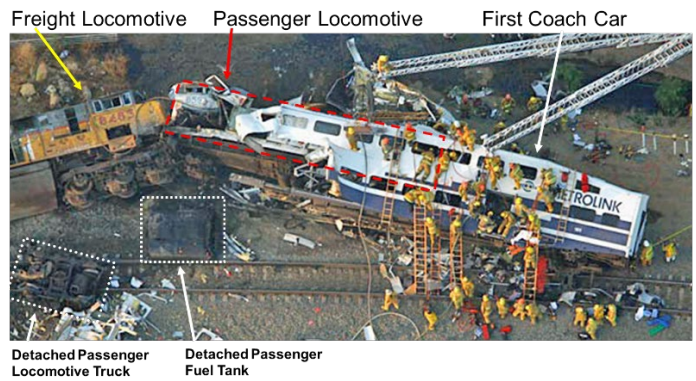
Figure 5. Aerial Photo (from LA Times Online News Article) of Two Lead Locomotives and First Coach; Annotations Added to Indicate Position of Detached Fuel Tank and Lead Truck

Figure 5 and Figure 6 show the final positions of the passenger locomotive fuel tank and lead truck. Both the fuel tank and front truck were separated from the locomotive, and found proximate to the lead freight locomotive after the accident, the fuel tank just next to the tracks and the trucks further ahead straddling one of the rails. It appears that the front truck separated owing to crush of the attachments on the locomotive body bolster, and that the fuel tank then detached as the lead truck struck it once detached. With significant breaches of the fuel tank, a fire ensued near the lead freight locomotive, which threatened the lives of the crew trapped inside the cab of toppled locomotive.

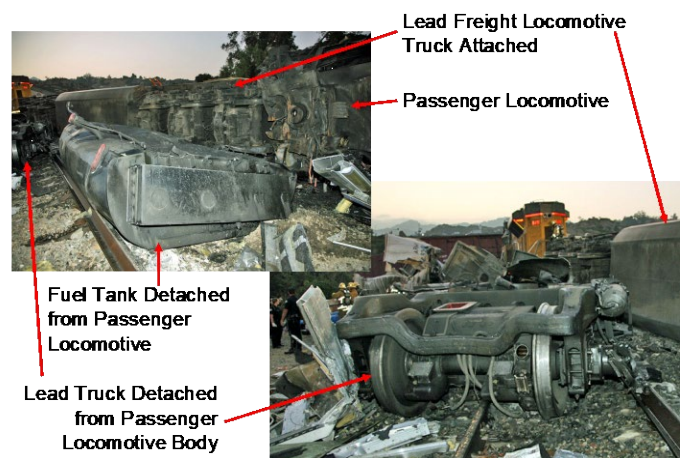
Figure 6. Ground Level Post-collision Photos of Passenger Locomotive Fuel Tank and Truck

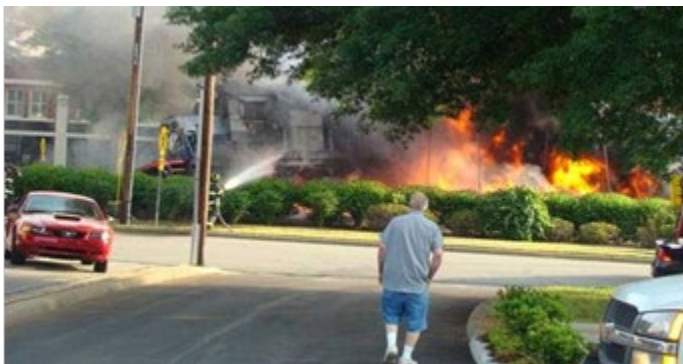
Figure 7 shows a post-collision photo of the firefighters working to extinguish the diesel fire. The fire broke out around the fuel tank but extended up to the area around the left side cab window. The locomotive crew was able to exit through the right side door.

Figure 7. Photo Showing Locomotive in Flames as a Result of Its Punctured Diesel Fuel Tank. (Photo Source: WRAL.com)

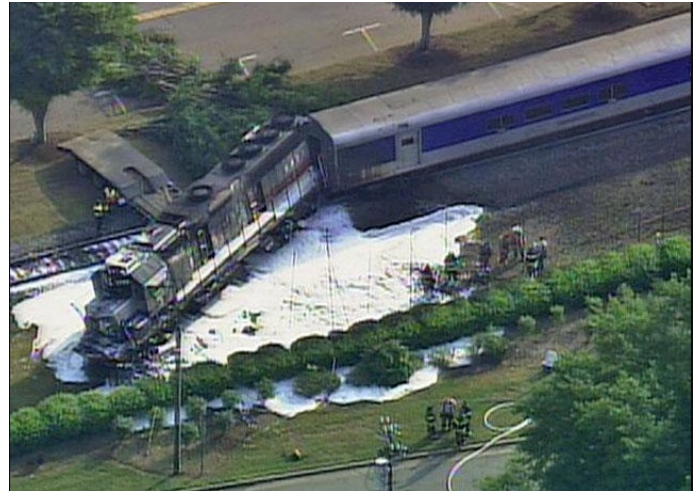
The photo in Figure 8 shows the final positions of the tractor-trailer lowboy and lead vehicles of the passenger train. The lowboy frame is fractured and wedged beneath the passenger locomotive. The lowboy frame had significant structural damage, such that the fractured lateral frame members are exposed along at least half its length. The cab of the tractor-trailer, not visible in the photo, was located near the third coach car.

Figure 8. Photo Showing Locomotive Derailed with Tractor-trailer Lowboy Underneath. (Photo Source: WRAL.com)

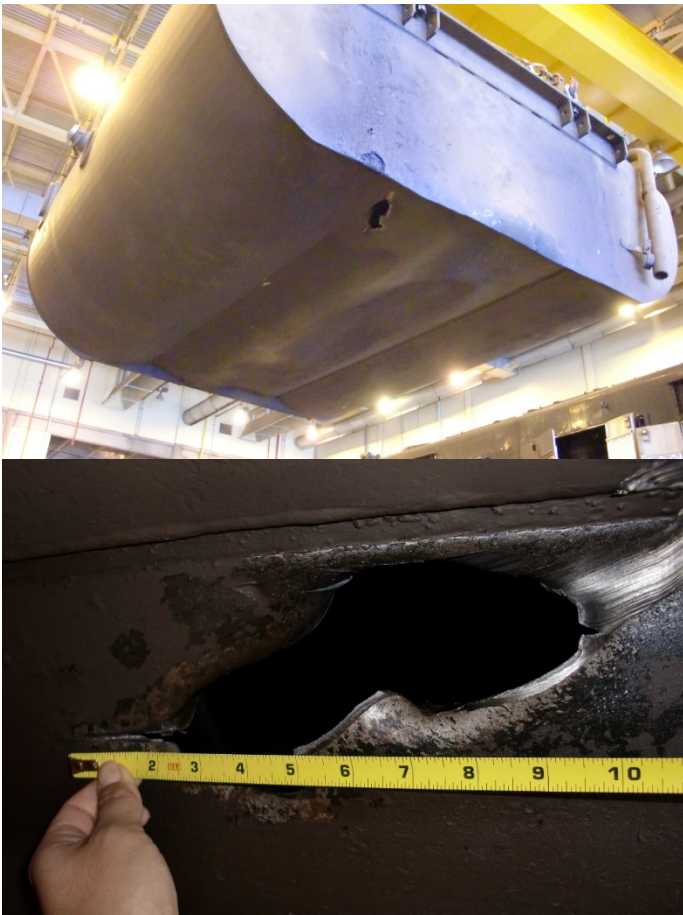
The fuel tank involved in the puncture incident is shown in Figure 10. A detailed inspection determined a single puncture in the center lobe of the bottom of the tank; the size, shape and location are shown in the photos of Figure 11. As there had been nothing unusual about the commuter rail operation when the damage occurred, it was presumed that a piece of debris may have been kicked up and struck the bottom of the fuel tank. Striation marks that spanned from front to back of the tank led up to the puncture indicating that an impact object dragged along it until it puncture the bottom surface at the location adjacent to the internal baffles.

Figure 10. Puncture on Bottom Sheet (Concord, MA)

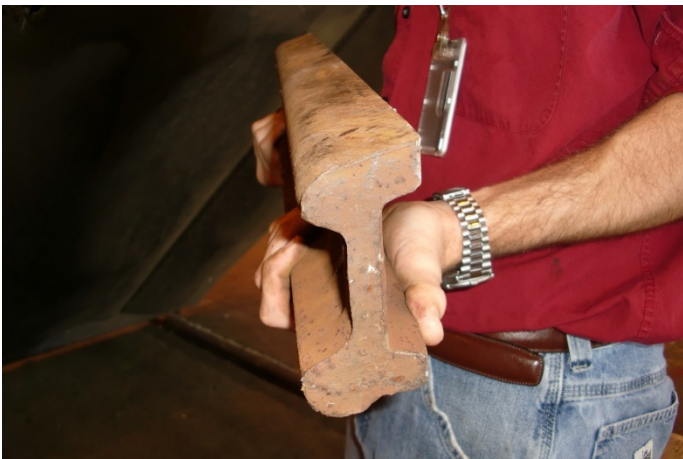
From examining the size and the shape of the punctured bottom sheet of the fuel tank, it was determined that the puncture was caused by a joint bar which are sometimes left alongside the tracks. Figure 12 shows an exemplar joint bar. Figure 13 shows that the exemplar joint bar fits perfectly into the contour of the fuel tank puncture. The speed at which the impact occurred is not known.

Figure 11. Identified Impact Object, an Exemplar Joint Bar Section

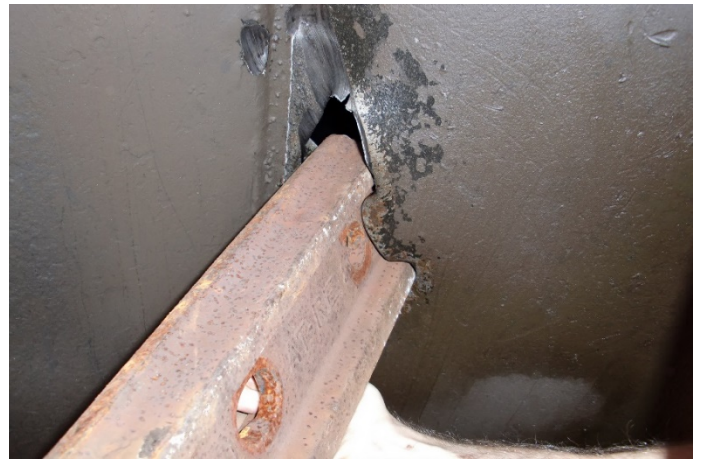
Figure 12. Identified Impact Object, an Exemplar Joint Bar Section and Joint Bar Inserted into the Fuel Tank Puncture Matches the Exact Contour

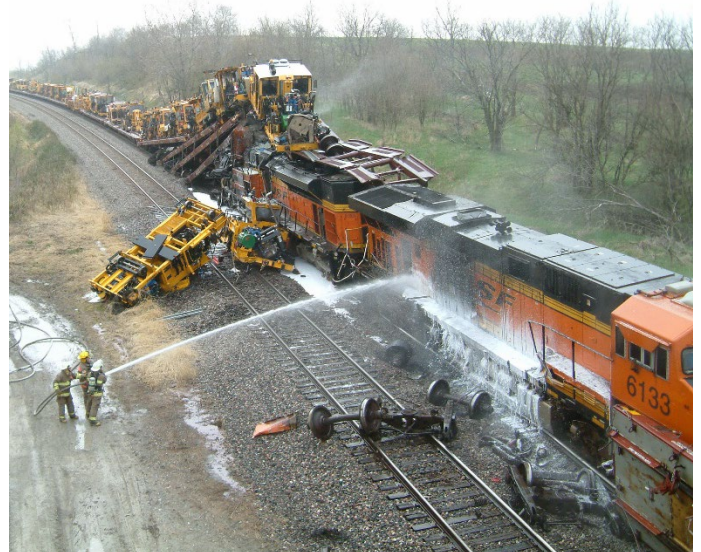
Figure 13. Post-collision Photo of Red Oak, IA Train-to-train Collision. (Photo Courtesy of Red Oak Fire Department)

Interviews with first responders report fires in three distinct locations of the post-collision wreckage: 1) at the front of the coal train's lead locomotive, 2) at the coal train's second locomotive and 3) at the impact point near the elevated trailing MoW vehicle. An ancillary flash fire was also reported on the highway overpass, which part of the overriding equipment impacted as the collision unfolded [8]. Equipment inspection found that the EMD SF70ACe fuel tank had scrape marks along the left side of the tank but was not ruptured. The GE ES44AC fuel tank had a visible puncture. The fuel tank extends along more than a third of the locomotive underframe, occupying most of the length between front and rear trucks. The fire at the lead end locomotive was attributed to diesel fuel that leaked from the MoW equipment as it overrode the locomotive. It took about two hours to fully extinguish all the fires.

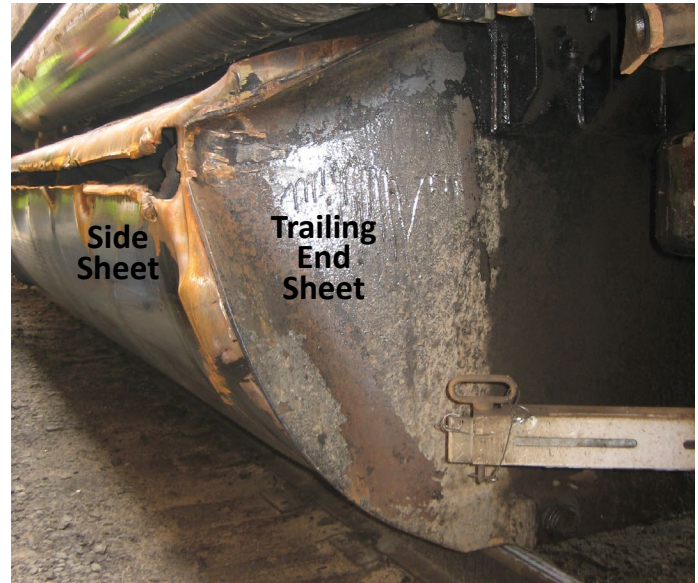
On April 28, 2012, two coupled CSX locomotives rolled down a siding and into a switch, sideswiping a freight consist traversing the main line. This incident occurred in the Oak Island Rail Yard in Newark, New Jersey. As illustrated in Figure 15, the impact scenario created an oblique raking impact between the two trains. The main line freight train was traveling at around 7 mph with the fifth to last freight car of the consist on the switch at the moment the runaway two-locomotive consist rolled through the switch at about 4 mph. The impact caused the locomotives of the runaway consist to derail and the outside rail of the siding rolled outward. As the freight train continued along the tracks, the right side doortrack of a boxcar (the last freight car) impacted the left side of the lead runaway locomotive fuel tank, dragging along the tank [9] and piercing into it. As can be seen in Figure 16, the fuel tank puncture extends along nearly the entire length of the tank. The end sheet at the lead end of the fuel tank, presumably the primary impact point, was torn away from the side sheet of the fuel tank at its weld. The door track of the trailing freight car was broken with part of it recovered from inside the fuel tank.

Figure 15. Damage to Trailing Locomotive Fuel Tank

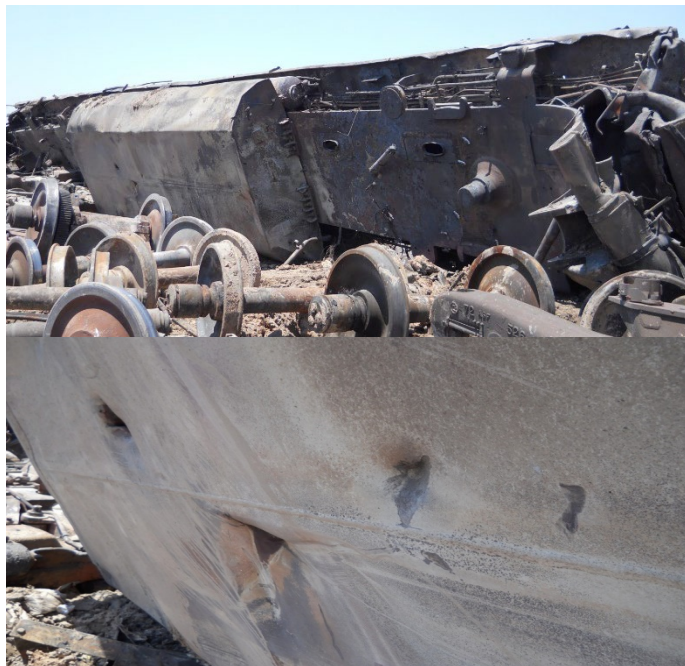
The eastbound train's lead locomotive, UP8542 is shown in Figure 18. The bottom of the fuel tank is facing outward and multiple impacts are visible on the bottom of the tank. It is apparent that the fuel tank experienced a series of blunt impacts by an object or structure about 3-6 inches puncturing through the tank's bottom surface.

Figure 17. Post-collision Photos of Lead Locomotive, UP8542 Fuel Tank

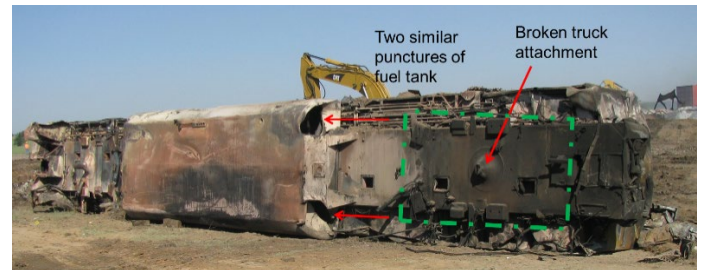
The eastbound train's second locomotive is shown post-collision in Figure 19. Like the first locomotive it came to rest on its side. While there was evidence of multiple impacts to the bottom of the fuel tank, none punctured the surface. As is visible from the photo, this tank experienced the most serious impact on the front end of the fuel tank. Further inspection found a broken truck attachment and the measured distance between the two puncture locations match the distance between wheels of the missing truck. It seems likely that during the collision sequence the truck attachment sheared off allowing the truck to push back directly into the fuel tank, puncturing at the locations of the wheels.

Figure 18. UP5482 Fuel Tank

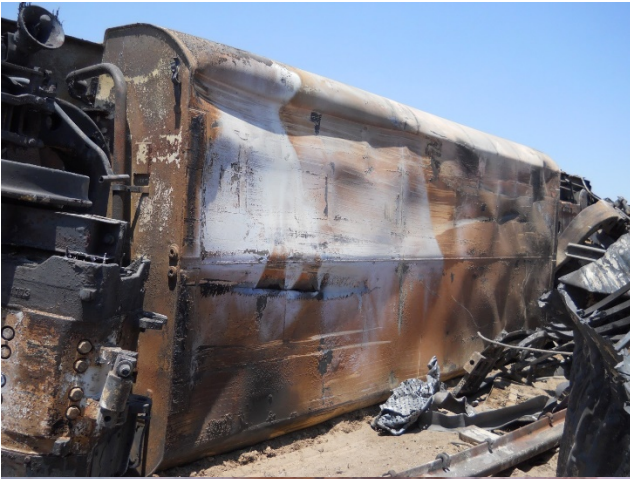
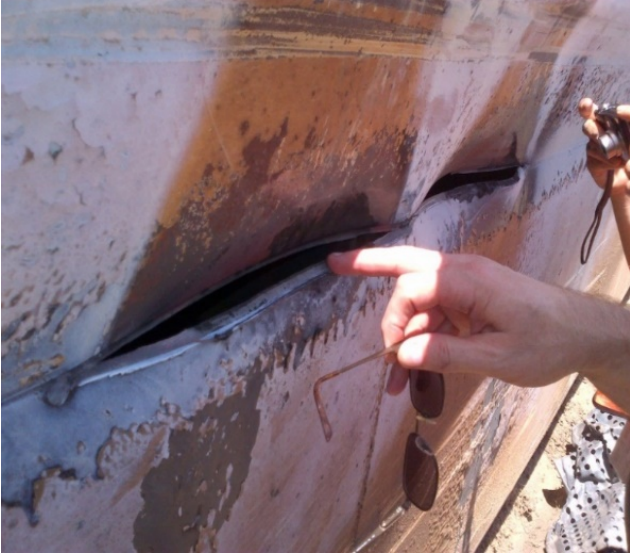
Figure 19. UP4855 Fuel Tank

Figure 20 shows the fuel tank of the westbound train's second locomotive. The bottom of the fuel tank includes clear markings that run the full length of the fuel tank and suggest the tank was moving along the ground for a length of time. At a certain point the fuel tank impacted a rigid object or structure that cut into the tank. The detail of this fuel tank puncture measured two distinct 1-foot long tears. The pause in a continuous 2-foot long tear occurred at the location of where a lateral baffle attached to the bottom surface, thereby strengthening the bottom surface at the location. This correlates to fuel tank deformation behavior modeled and tested in the FRA's fuel tank research program [11].

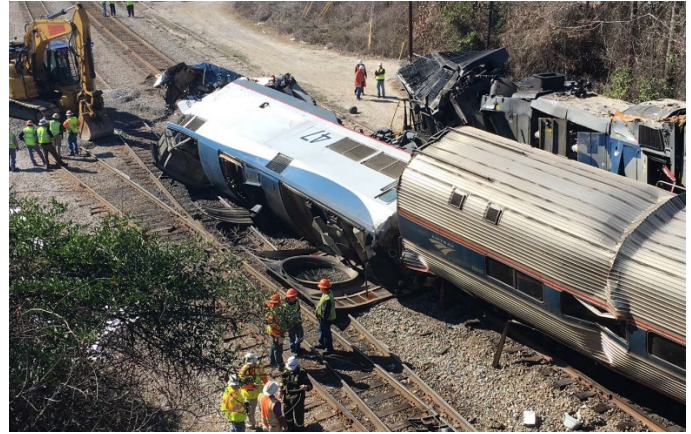
Figure 20. Post-collision Photo of Amtrak Lead Locomotive

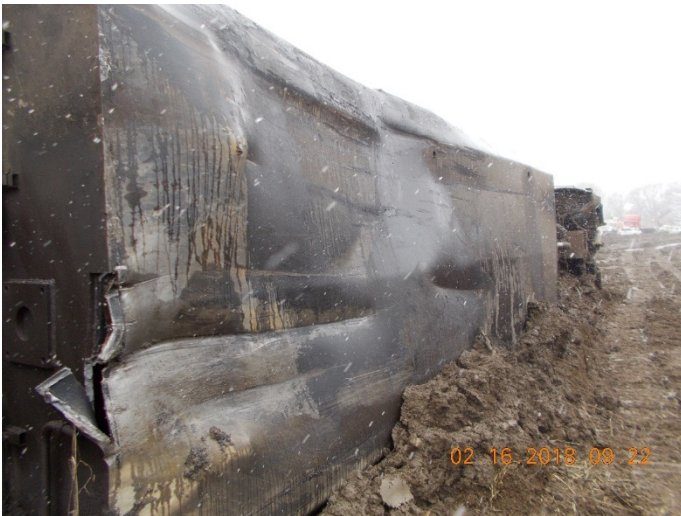
Figure 21. Trailing Locomotive Fuel Tank 9274

On February 15, 2018, Norfolk Southern freight train No. 28N14 derailed. The train consisted of two locomotives and 43 automobile carriers. During the derailment, the two lead locomotives and multiple cars derailed, came over the railbed and down an embankment into a ravine. Figure 22 shows a photograph from the derailment site. The bottom of the second locomotive's fuel tank is shown. The fuel tank displays evidence of large scale bending visible laterally across the center of the tank. Additionally, evidence that it dragged across a more rigid structure or object is clear from the prominent longitudinal striations that span from nearly the center of the bottom fuel tank to the end plate. A distinct section of the end plate is fractured and peeled back exposing a hole in the fuel tank. The lead locomotive did not roll over but the fuel tank was buried in the mud post-incident so photos were not taken.

The Attica derailment helps highlight the importance of the fuel tank end plate performance during impacts as well as some of the nuances of the design effects on performance. In this accident a discrete panel located on the end plate pulled away. Much like observed in fuel tank testing, areas where discrete panels are connected are more likely for a tear or puncture to be initiated.

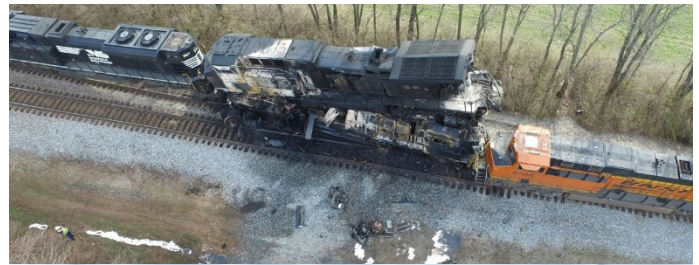
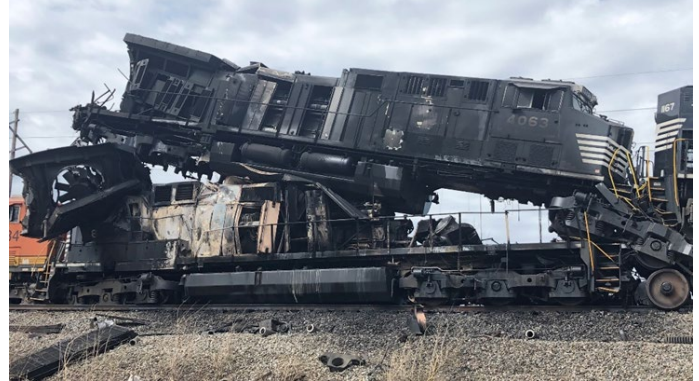
Figure 23 shows the final positions of the two locomotives from two different sides of the tracks. The lead locomotive, NS 8798 of the southbound train was forward facing and the second locomotive, NS 4063, was rear facing during operation. The fuel tanks of both locomotives remained attached to the underframe. As NS 4063 overrode NS 8798, the fuel tank was breached causing the diesel to spill along the length of NS 8798. As such fire broke out around the cab of NS 4063 and just behind the cab of 8798.

Figure 22. Post-accident Photo Showing Override of Second Locomotive on Leading Locomotive of Freight Train 175T817 (on Left) and Lead Locomotive of Freight Train M74T817 (on Right)

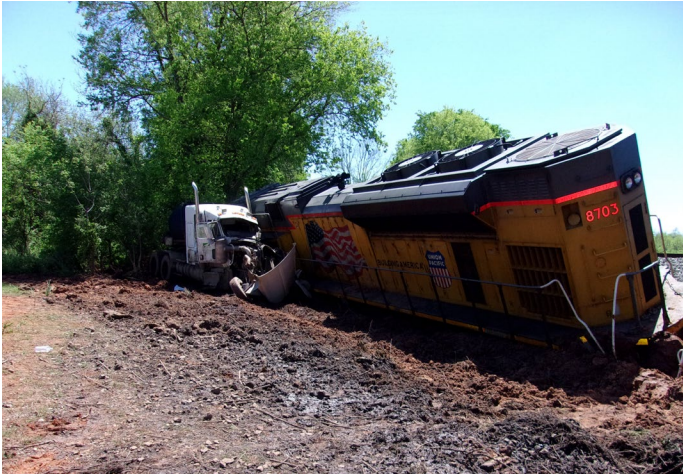
Figure 23. UP Locomotive 8703

On April 9, 2019, a Union Pacific freight train collided with a tractor-trailer at a grade crossing near Caspiana, Louisiana. The freight train consisted of three locomotives and 106 loaded freight cars. During the impact, the three lead locomotive derailed along with the preceding 20 freight cars. The locomotives plowed through gravel and dirt coming to rest at an angle partially down an embankment with their underframes buried in the gravel and mud. As the locomotives derailed, the preceding freight cars experienced large scale lateral buckling causing at least the eight of them to pile up and spilling their contents, mostly grain and dirt. Figure 24 shows the final position of the lead locomotives. Figure 25 shows a photo looking back along the consist with the second and third locomotives at an angle along the embankment and the trailing freight cars having rotated nearly 90 degrees from their original position of travel. The fuel tank of the lead locomotive was breached, most likely from impacting or dragging across a rigid

structure as it traveling over the tractor trailer. The fuel tank released approximately 500 gallons of diesel.

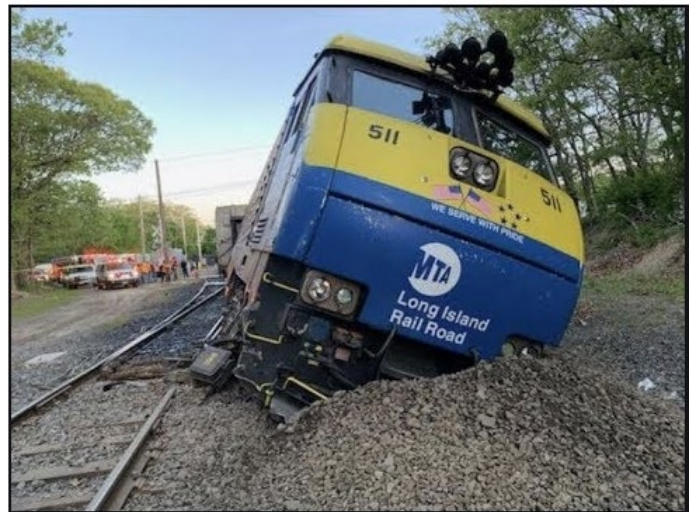
Figure 25. Photo Showing Lead Locomotive 511 Post-accident in Speonk, NY. (Photo Source: *Railroad.net*)
