Federal Railroad
Administration

Research Results

RR08-17
December 2008

Gas Pressure Welds and Hollink Slot Welds Testing at the Facility for Accelerated Service Testing

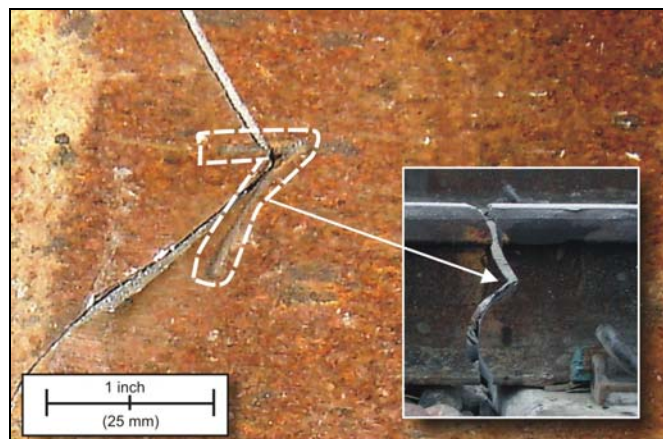
Figure 1. Example of GPW Break at Rail Manufacturer's Stamp. Inset shows the Full Break in Track.

The test experienced its second weld failure at 165 MGT when GPW No. 05 fractured during train operations. Examination revealed that the fracture originated in the web of the rail in the heat-affected zone. Further examination identified the origin of the failure as being a rail manufacturer number stamped in the rail, which acted as the crack initiation site. Figure 1 shows the fracture origin. Similar failures have been noted recently at FAST involving electric flash-butt welds in which rail manufacturer stamps located in the heat-affected zone have acted as the initiation site for fatigue cracking.

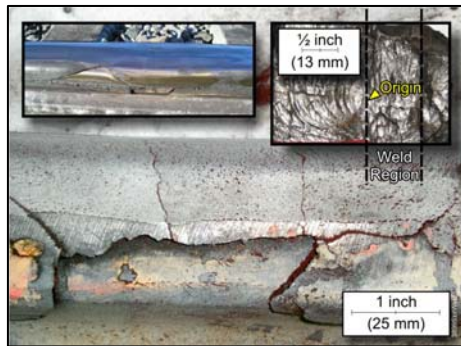
Figure 4 shows the first failed slot weld that occurred at 124 MGT. The left inset of Figure 4 shows the barred weld in track and the right inset shows the fracture surface after opening the break for inspection. The fracture initiated at the weld fusion line approximately 0.9 inch from the gage face and at a depth of 0.5 inch. The arrow in the right inset indicates the origin of the crack and the dashed lines show the approximate fusion line location. The slot welds were examined approximately weekly for UT indications. Table 2

Figure 4. Slot Weld Horizontal Fracture in the Railhead.
