Evaluation of Roadway Worms/Distortions

Final Report

Prepared by:
Applied Research Associates, Inc.
430 W 5th Street, Suite #700
Panama City, Florida 32401
850-914-3188 / 850-914-3189 Fax

Contract No. BE491

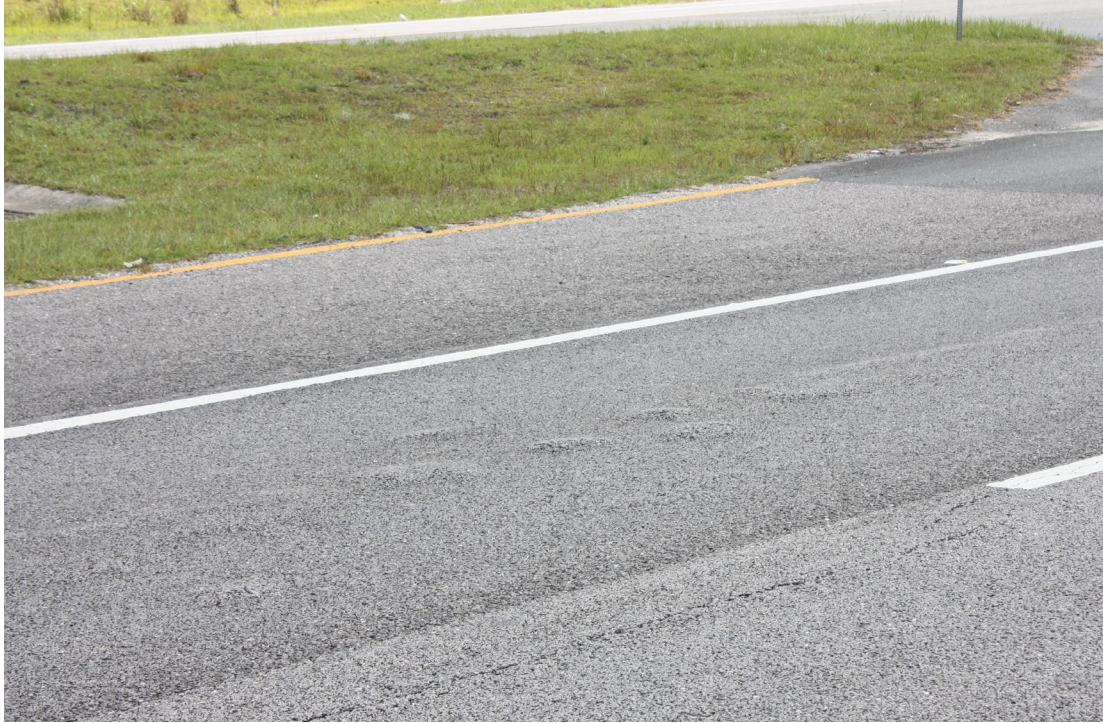
Figure 3-4. SR 79 Worm Distress

No separate, discrete area was available for a control section. The selected control section with no visible surface worm distress was limited to a 310-ft segment that begins 243 ft south of the northern test section boundary and ends 553-ft south of the northern test section boundary. The worm distresses are prominent in magnitude and density, occurring as both round and roughly rectangular in shape (Figure 3-4). The roadway surface is an open-graded friction course (OGFC). The worm distresses ranged in height from approximately 0.25 to 0.5 in. The area of the project studied is composed of a superelevated section of roadway where worm distresses increase in density with lanes at lower elevation. The most severe worm distresses were observed in the turning lane at the lowest elevation point. No standing water or drainage issues were observed.

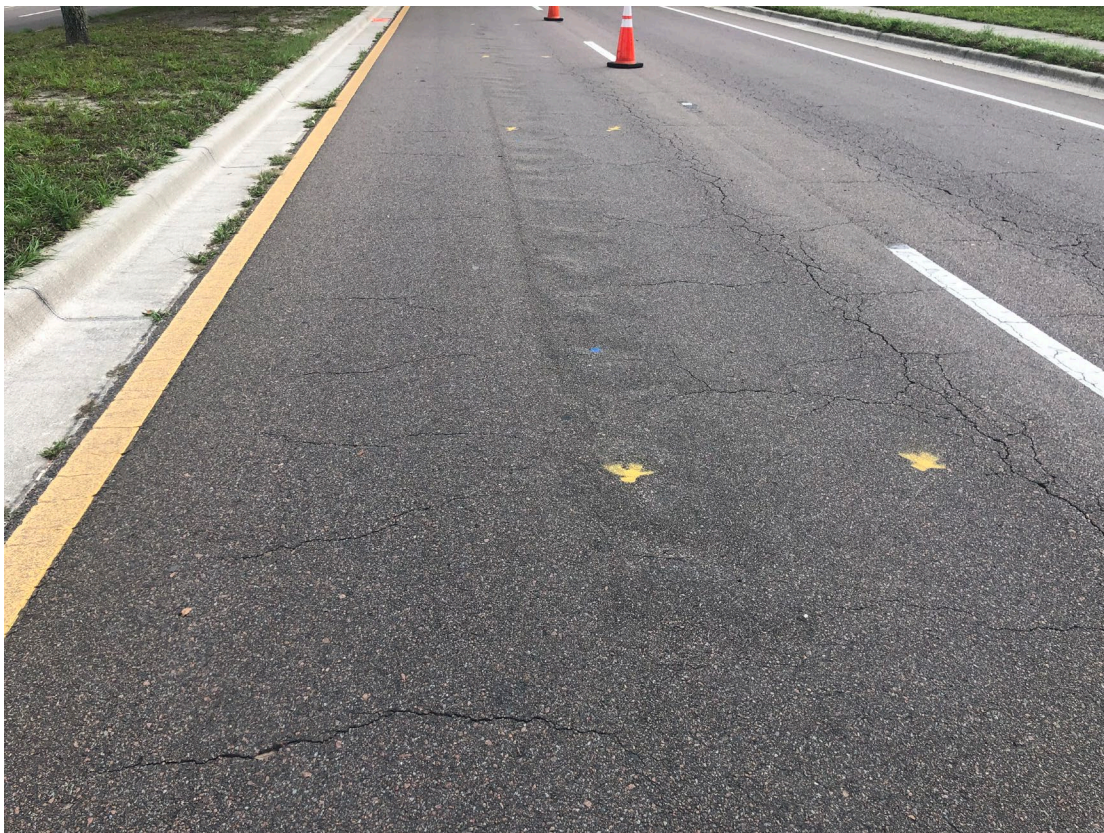
Figure 3-6. SR 26 Worm Distress

Worms are present in un-trafficked areas of the lane but primarily between the wheel paths. A greater density of the worm distress is present where the longitudinal crack component of block cracking occurs (Figure 3-6). The research team originally assumed the presence of cracking would provide relief for the mechanism causing worms; however, this does not appear to be the case. Worms occur on the site despite there being a substantial amount of age-related cracking on the pavement surface. The roadway consists of 12-ft lanes and a divided median. Curb and gutter are present throughout. A cross-slope drains water from the inside lanes to the outside lanes. The cross-slope ranges from 1.3% to 2.3% in the worm section and 0.8% to 2.9% in the control section. No standing water or drainage issues were observed.

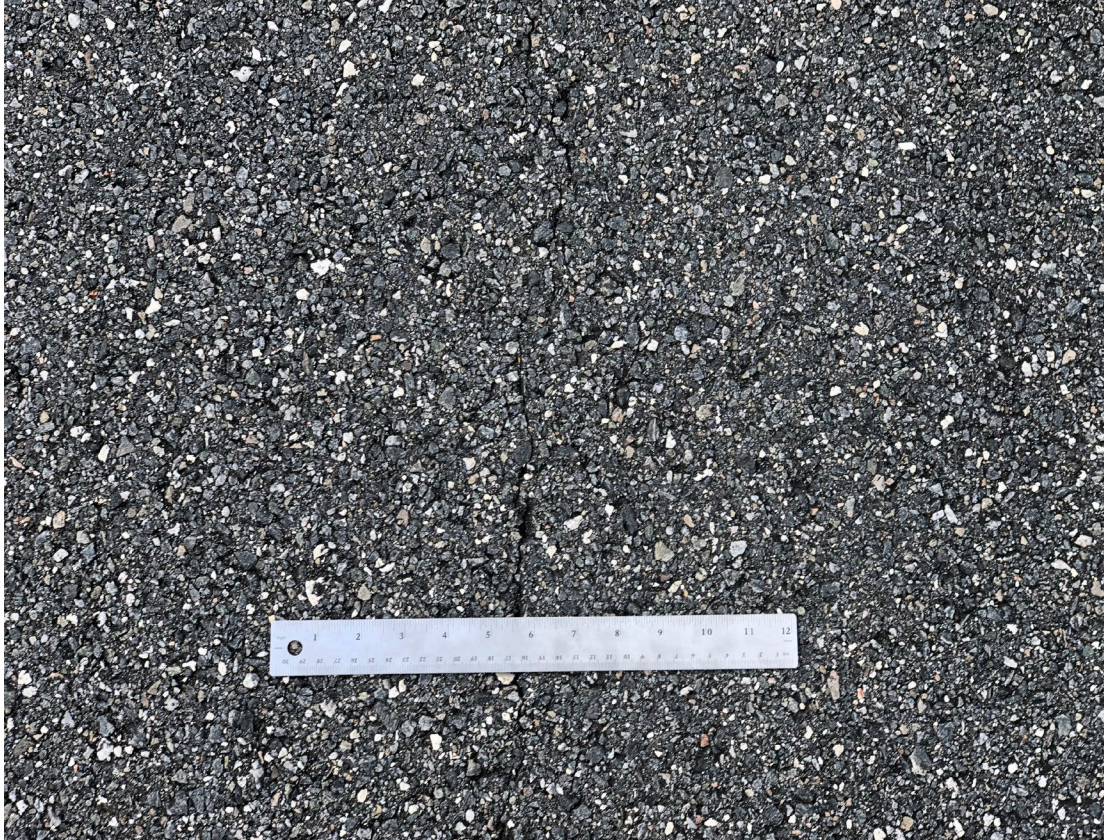
Figure 3-8. SR 24 Worm Distress

The worm distress uplift height observed on SR 24 was approximately 0.25 in. The majority of the worm distress did not accompany cracking and was difficult to photograph. Figure 3-8 presents a worm occurrence that caused a fracture in the wearing course. The worm distresses occurring on the test section are relatively small in size (footprint), low in frequency of occurrence, and low in severity (height), making them difficult to detect visually on the ground. The distresses are more easily detected in early morning/late evening lighting conditions or by driving the road in an automobile to feel intermittent roughness that occurs due to worms between wheel paths. The roadway consists of two 12-ft lanes. The centerline is crowned. The longitudinal paving joint at the crown of the roadway has opened to form a crack for approximately 50% of the length of the worm section; however, the control section did not have cracking at the paving joint. Cross slopes range from 1.4% to 2.4% in the worm section and 1.9% to 2.0% in the control section. No standing water or drainage issues were observed.

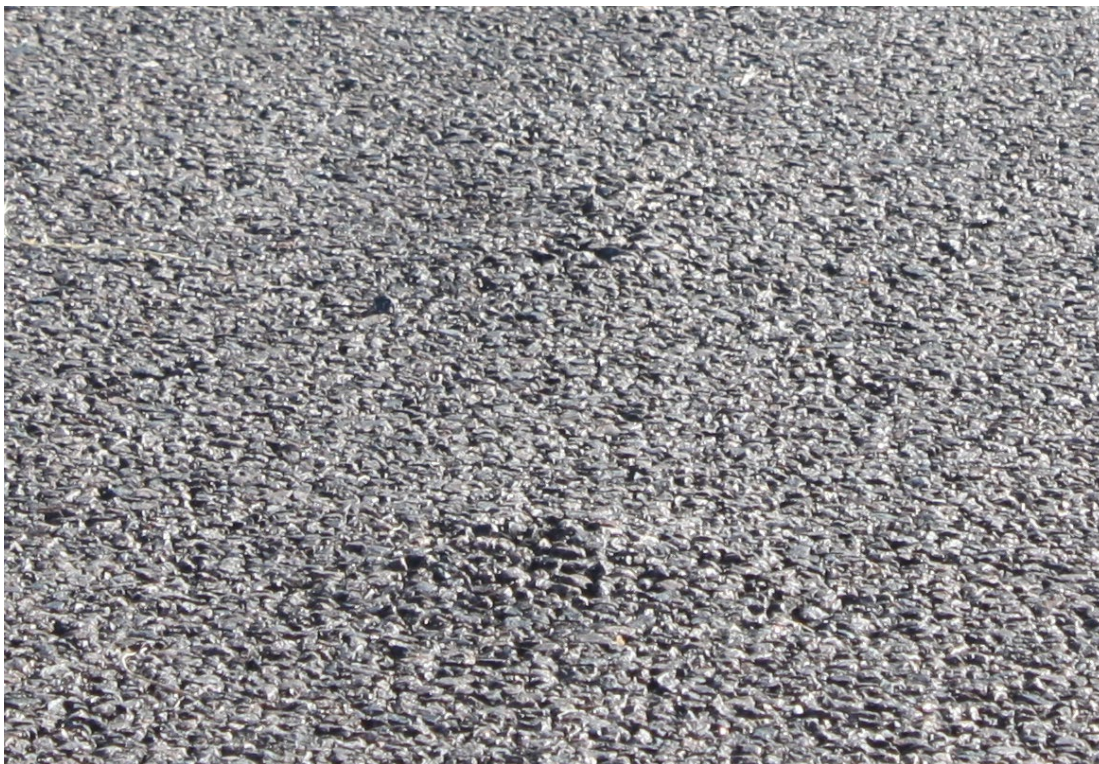
Figure 3-10. US 17 Worm Distress

The worm distresses occur both as round and roughly rectangular in shape (Figure 3-10). The roadway surface is an OGFC. The worm distresses ranged in height from approximately 0.25 to 0.5 in. The control section is at a higher elevation on a vertical curve. The severity of worm distress increases in areas of lower elevation. The roadway consists of two 12-ft lanes. The centerline is crowned. Cross slopes range from 1.1% to 3.1% in the worm section and 1.2% to 2.6% in the control section. No standing water or drainage issues were observed.

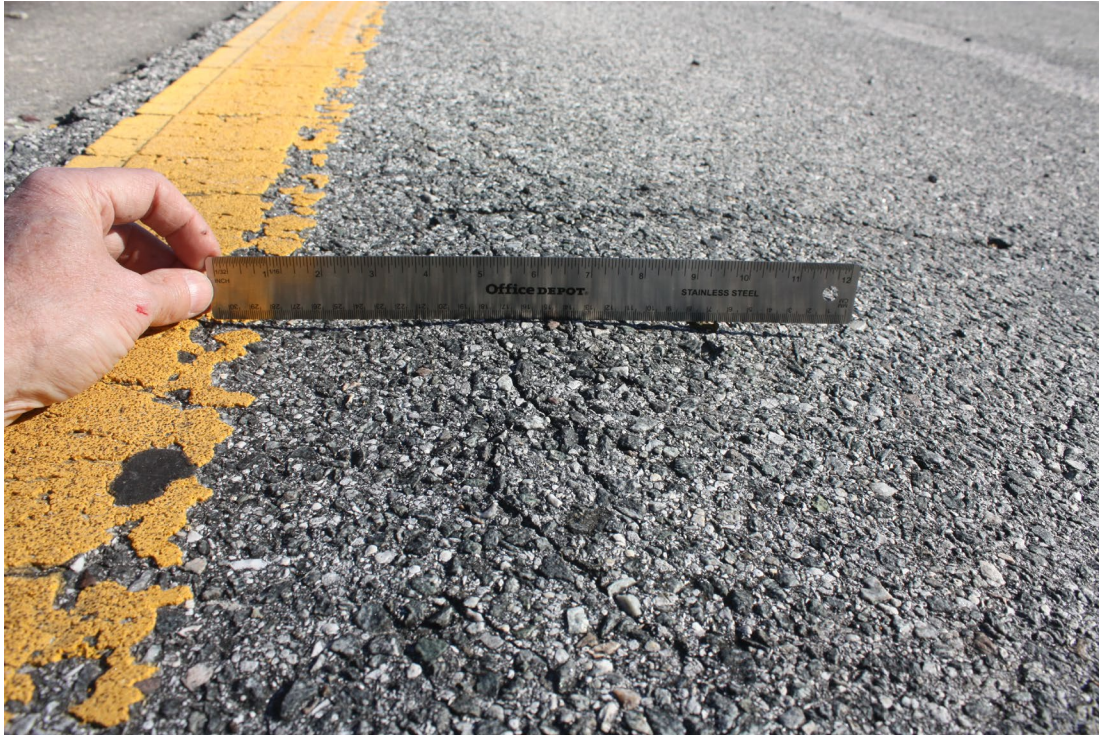
Figure 3-12. SR 20 Worm Distress

This roadway features two different dense-graded asphalt (DGA) surface mixes. Both lanes exhibit worm distresses, indicating worm distress may not necessarily be being associated with factors related to the top AC lift. Worm distresses are not considerably severe (< 0.25 in tall) and occur infrequently. No worm distresses were observed over 390 ft of the 581-ft test section. Figure 3-12 presents a close-up of a worm distortion on the left edge of the worm section. The roadway consists of 12-ft travel lanes, with a 5-ft gore area separating the mainline from a 6-ft parking lane. Curb and gutter are present throughout. A cross-slope drains water from the inside lanes to the outside lanes. The cross-slope ranges from 1.6% to 2.7% in the worm section and 1.9% to 2.8% in the control section. No standing water or drainage issues were observed.

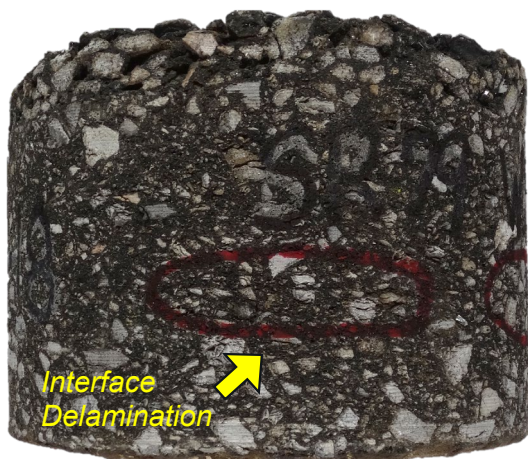
All cores collected from SR 79 were intact. Typical field cores are presented in Figure 4-47 through Figure 4-50. Delamination between the bottom two structural asphalt layers was observed more frequently in worm section cores. Some segregation of aggregate was evident on the bottom AC lift. AC layer thicknesses were consistent between the worm and control sections. The overall AC layer thickness and individual lift thicknesses are presented in Figure 4-51.

Figure 4-47. SR 79 MP 0.427 Worm Section Core – Structural AC Layer Delamination

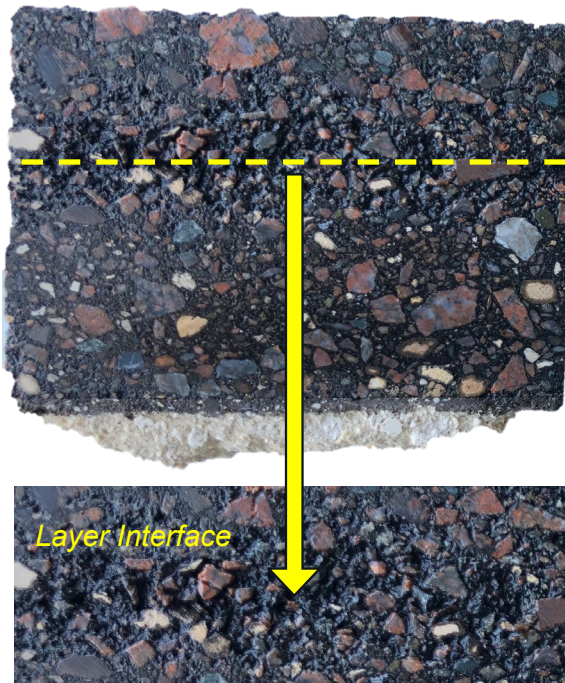
All cores collected from SR 26 were intact. Typical field cores are presented in Figure 4-52 through Figure 4-55. Voids in the pavement structure were noted in both the top two DGA layers for control and worm section cores. The greatest concentration of voids was at the interface of these two layers in the worm section, especially at the bottom of the surface course. The stripped aggregate at this subject interface, shown in Figure 4-52, could be indicative of water traveling along the interface. SR 26 AC layer thicknesses are presented in Figure 4-56. Surface mix lift thicknesses were within 0.1-in agreement on average. The bottom lift AC was 0.6-in thicker in the worm section.

Figure 4-52. SR 26 MP 8.837 Worm Core Cross-Section – Stripping/Voids at Layer Interface

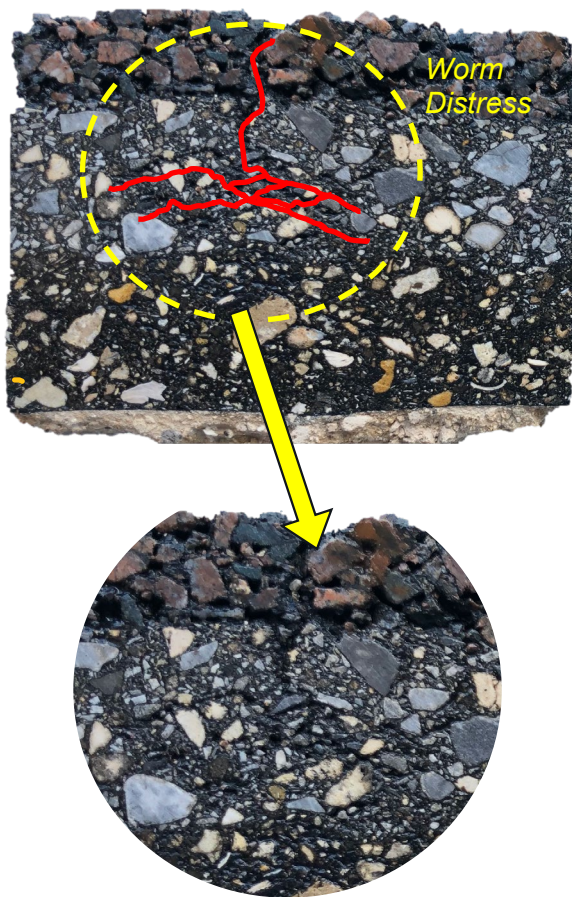
All cores collected from US 17 were intact. Typical field cores are presented in Figure 4-62 through Figure 4-65. Voids, segregation, and cracking were observed in the top DGA layer of worm section cores. Discoloration and pitting were also observed in both control and worm section layers. These defects are mostly concentrated in the top DGA layer. Figure 4-62 presents the cross section of a worm distress that was cored and sectioned, showing a crescent shaped fracture pattern consistent with the profile of a worm distress. The AC layer interfaces appear to be undamaged/not delaminated. US 17 AC layer thicknesses are presented in Figure 4-66. The composite asphalt structure is 1-in thicker than the control asphalt, on average.

Figure 4-62. US 17 MP 17.762 Worm Distress Cross-Section Showing Crack Pattern in Upper Structural AC Layer

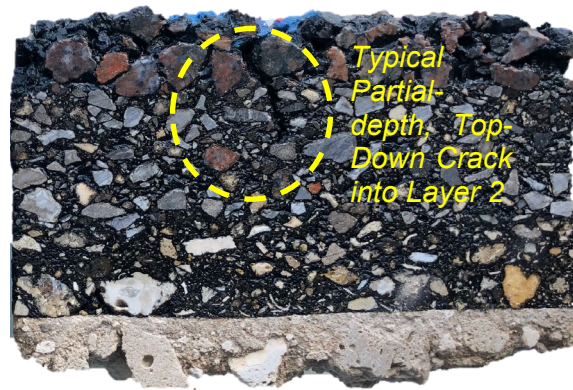
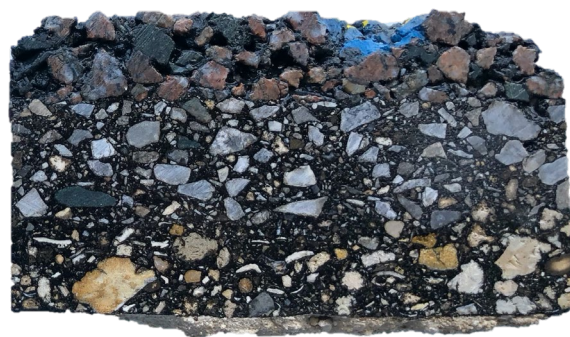
Figure 4-63. US 17 Typical Control AC Cross-Sections at (a) 17 MP 17.740 with Partial Depth Crack and (b) MP 17.406

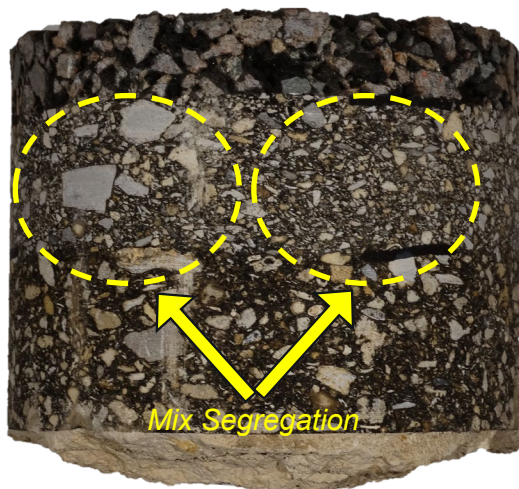
Figure 4-64. US 17 Worm Core at MP 17.795 – Layer 2 Segregation

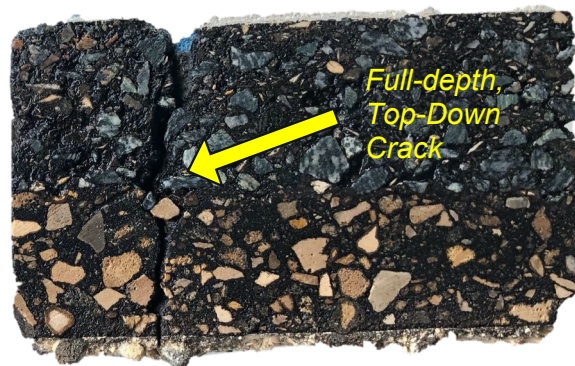
Figure 4-68. SR 20 MP 2.973 Control Section Paving Lane Joint Cross-Section Showing Top-Down Crack

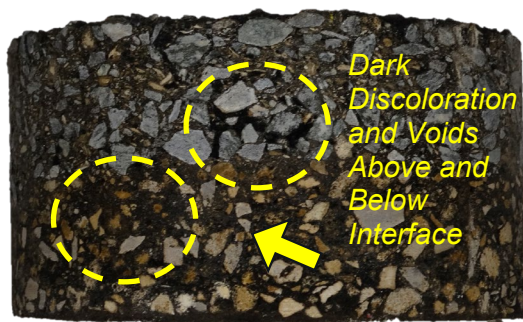
Figure 4-69. SR 20 Worm Section Paving Lane Core with Large Air Voids at MP 2.442

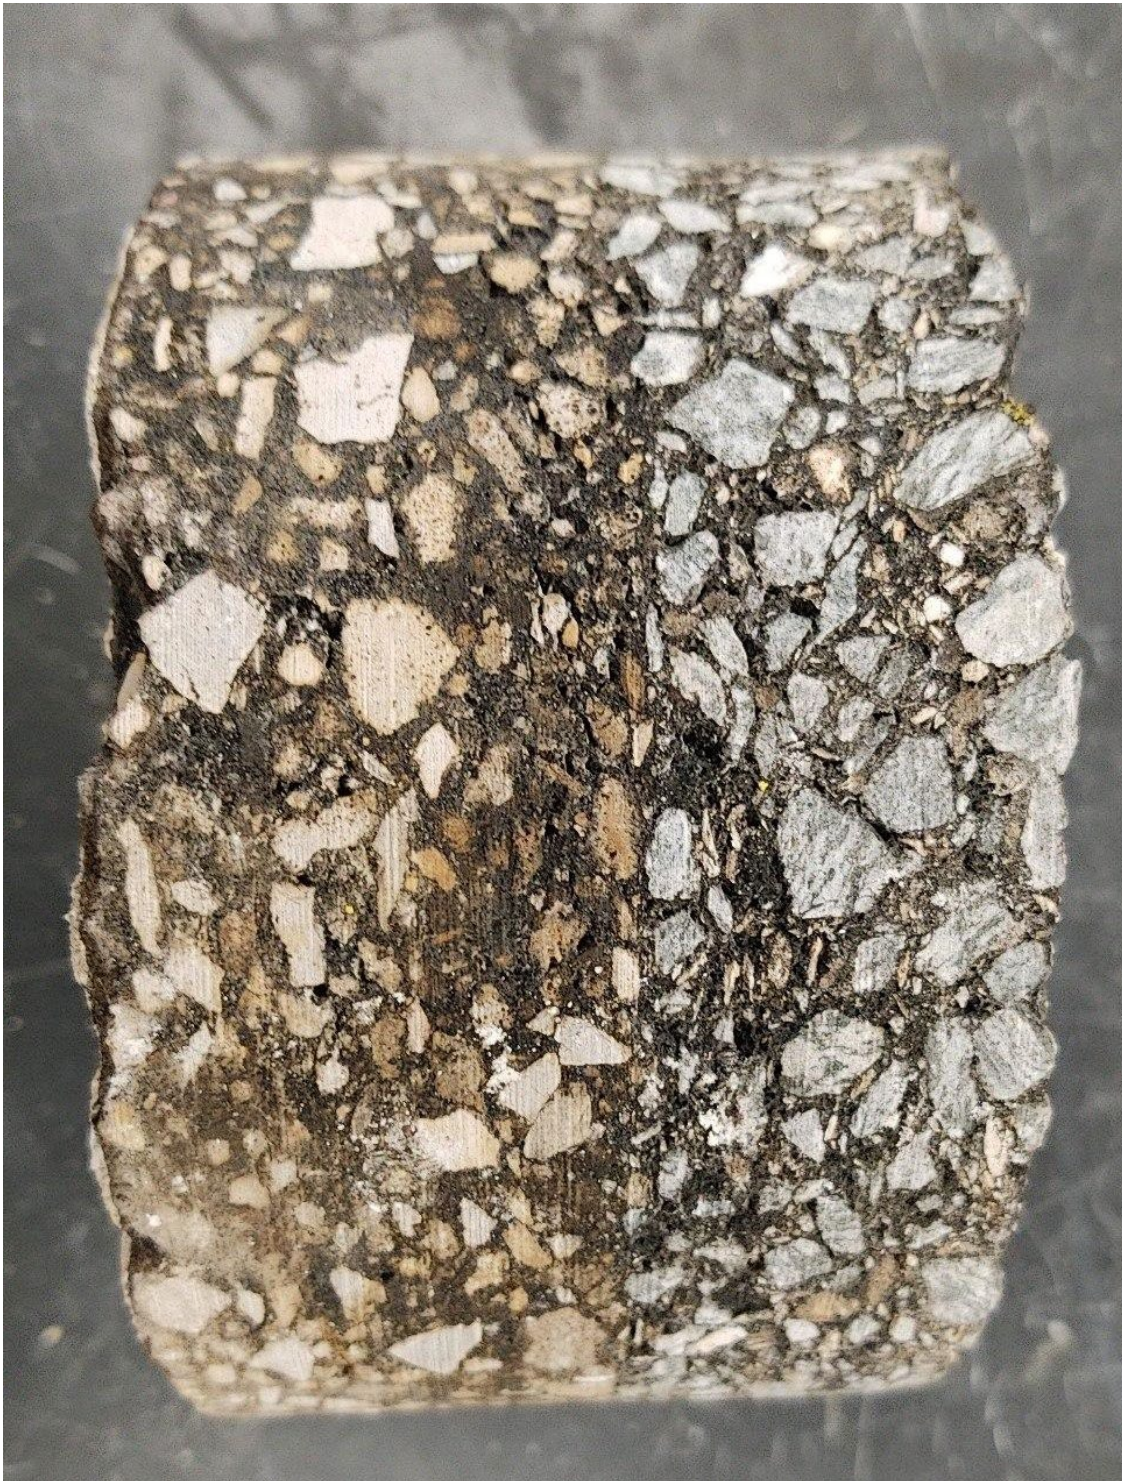
possibly indicating a loss of durability, stiffness, and strength of the AC at the subject interface. Of the 58 tests performed, 14 failures were observed in the top AC layer, 8 failures were observed in the bottom layer, 30 cores sheared at the interface, and 5 cores exhibited fractures in both the upper and lower AC layers. No core samples from US 17 fractured along the interface. Both AC layers at the interface were considerably deteriorated; however, the lower layer exhibited the most severe pitting and voids. A close-up of these distresses along the interface are shown on a typical worm section core in Figure 4-89.

Figure 4-89. Close-up of Air Voids at US 17 Worm Core Layer Interface

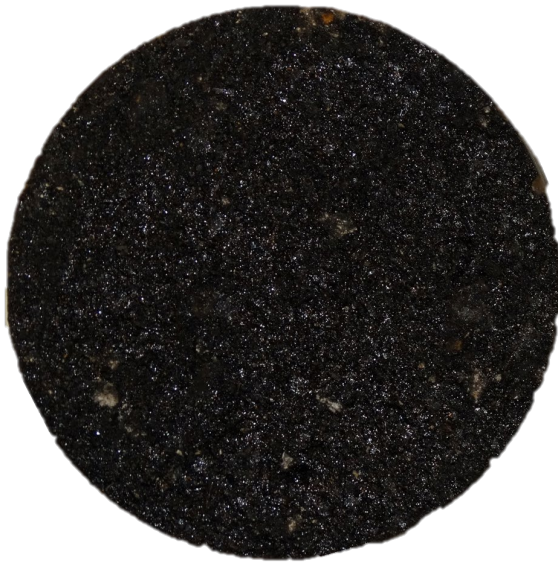
Control Section MP 0.391

- Control Section: No evidence of tack coat; voids in the surface texture may be a product of the movement of water in the interface.
 - Worm Section: No evidence of tack material; significant pitting and voids could be a product of the movement of water in the interface.

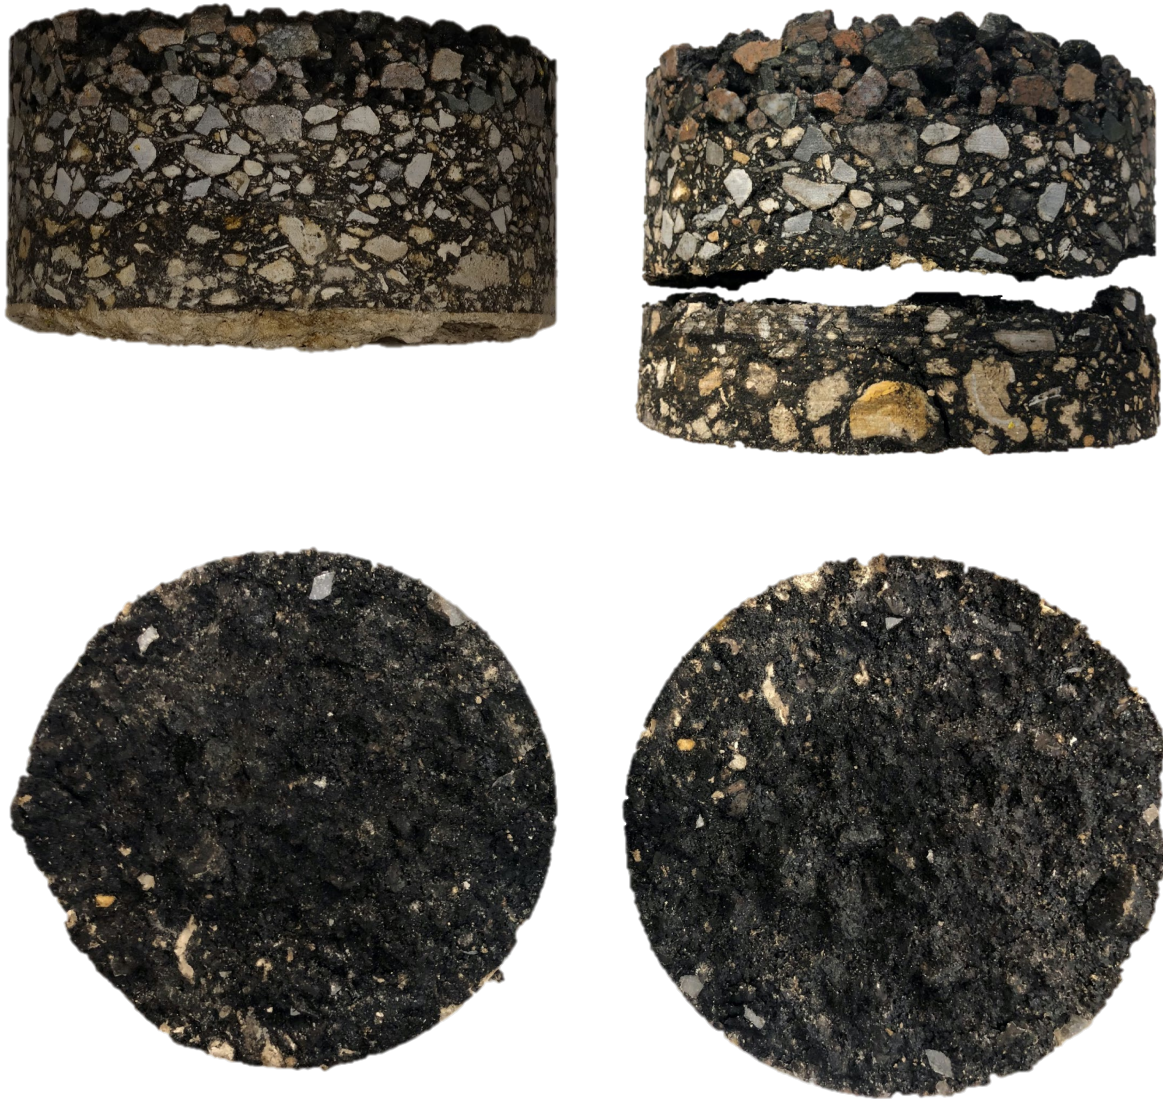
Figure 4-93. US 17 Control Section MP 17.403 Bond Test Failure Outside of Interface

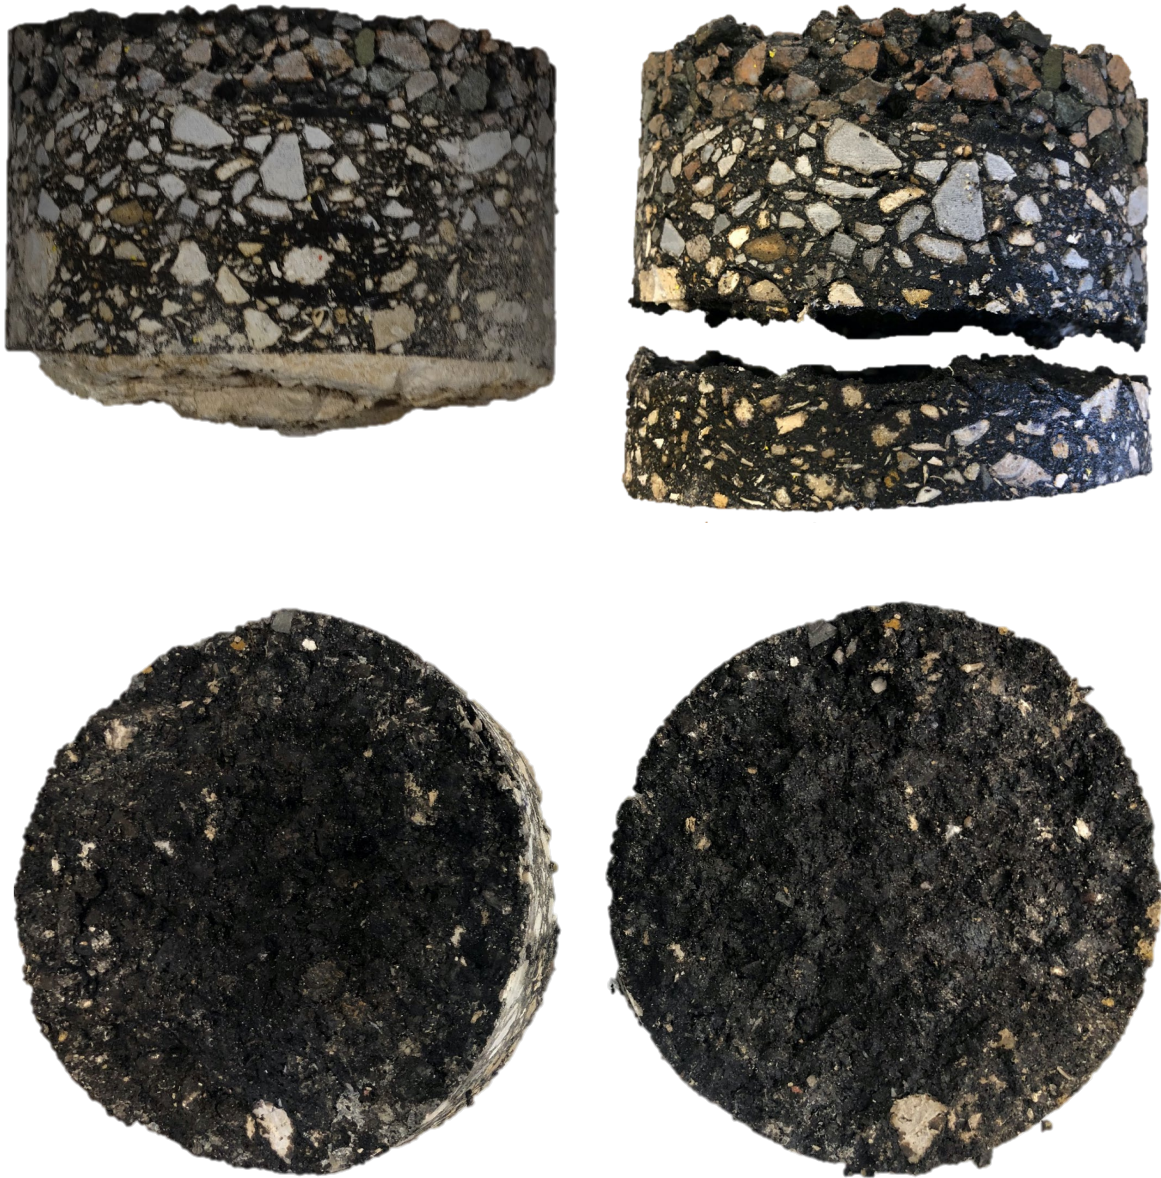
Figure 4-94. US 17 Control Section MP 17.401 Bond Test Failure Outside of Interface

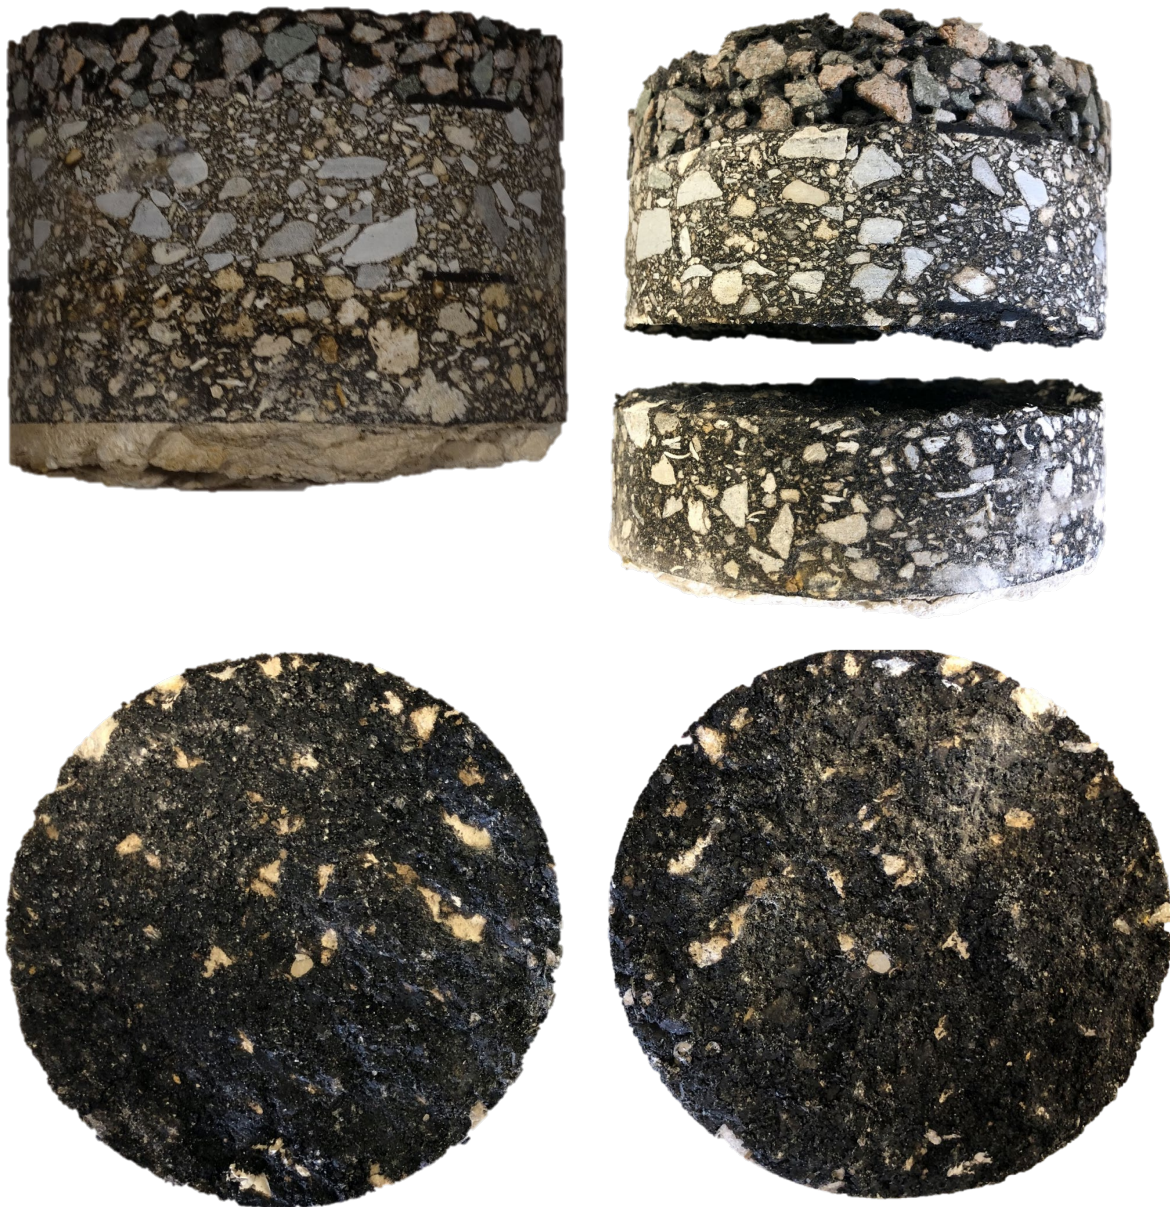
Figure 4-95. US 17 Worm Section MP 31.130 Bond Test Failure Outside of Interface

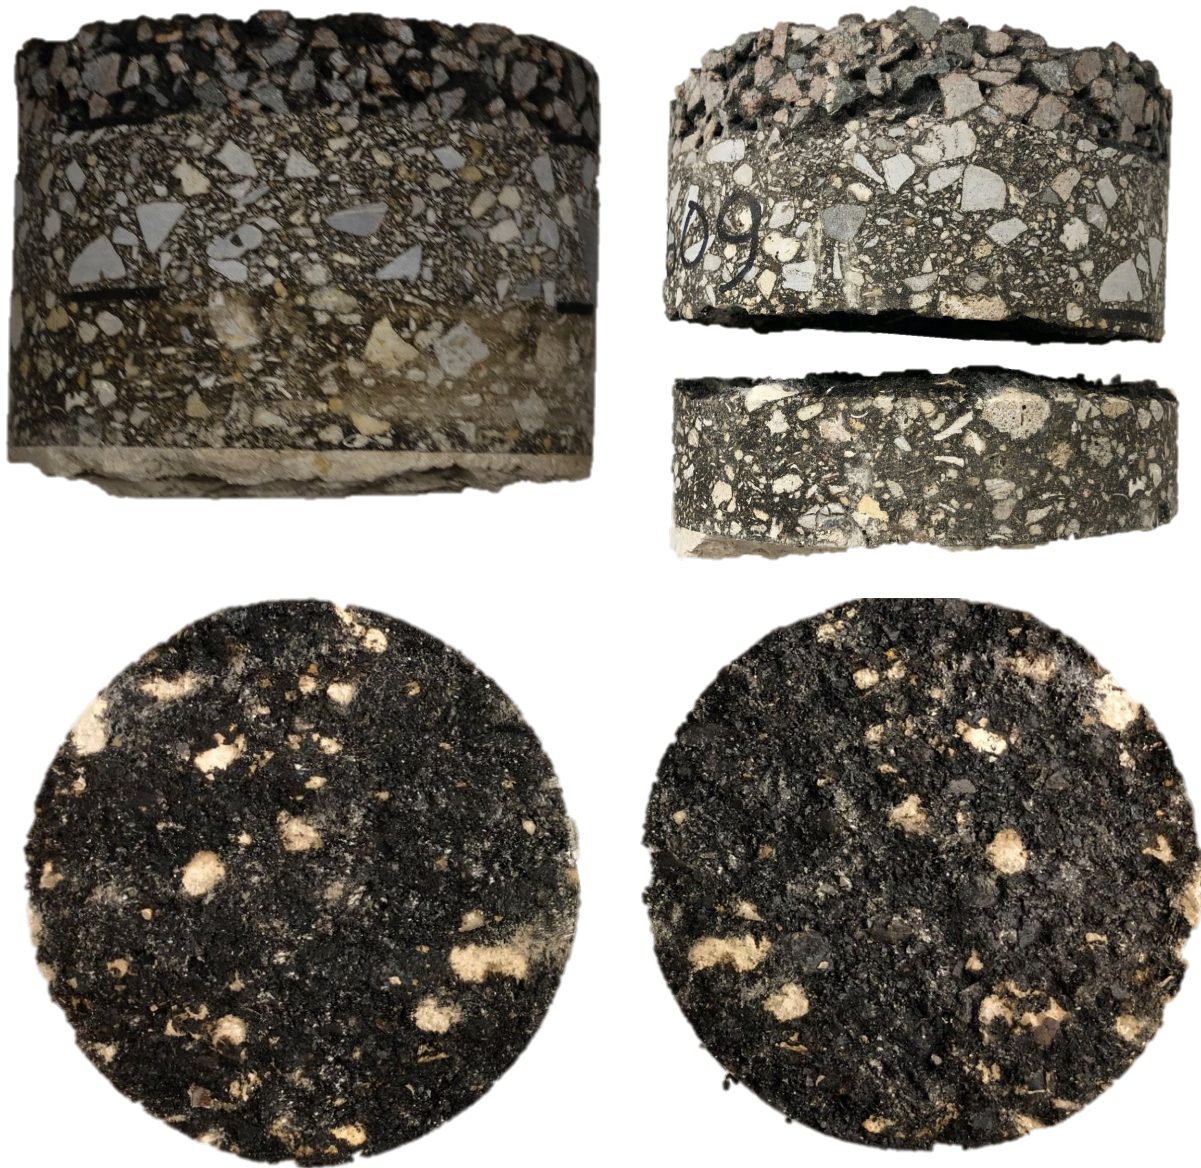
Figure 4-96. US 17 Worm Section MP 31.146 Bond Test Failure Outside of Interface

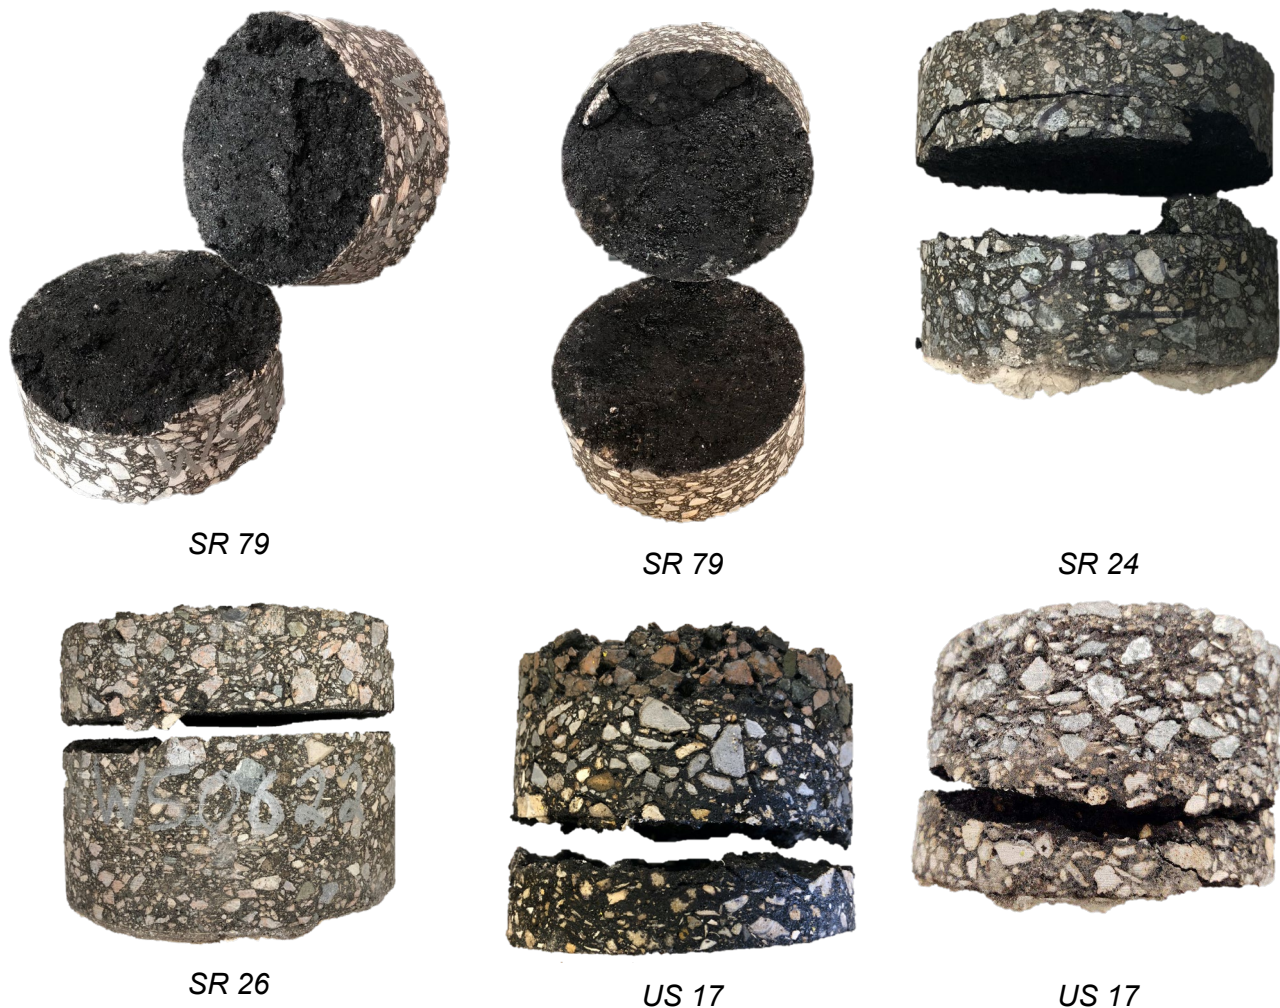
Figure 4-98. Additional Examples of Failures outside of Interface on Roadway
