Bridge Deck Repair Investigation and Quantity Estimation

APPLIED RESEARCH &
INNOVATION BRANCH

COLORADO
Department of Transportation

University of Colorado Denver Inspection of Bridge Decks Utilizing Ground Penetrating Radar

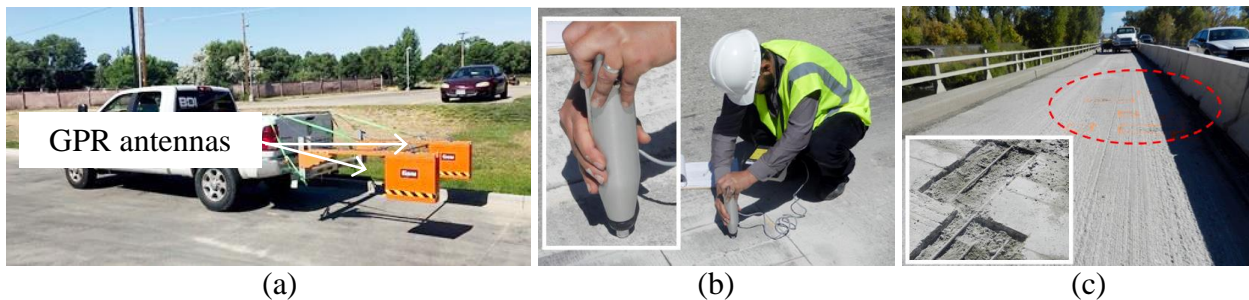
Fig. 2. Nondestructive tests: (a) air-coupled ground-penetrating radar; (b) rebound hammer; (c) marked areas and exposed rebars for repair after chain dragging

Chain drag was performed as guided by ASTM D4580 (ASTM 2012) to determine the quantities of repair. Even if this method is empirical and cannot detect local delaminations, it is broadly used owing to convenience. An experienced field engineer dragged steel chains on the deck surface, compared tonal differences (clear vs. dull), and marked possible delaminated regions. Afterward, the designated areas were saw-cut and the deck concrete was in part replaced (Fig. 2(c)).

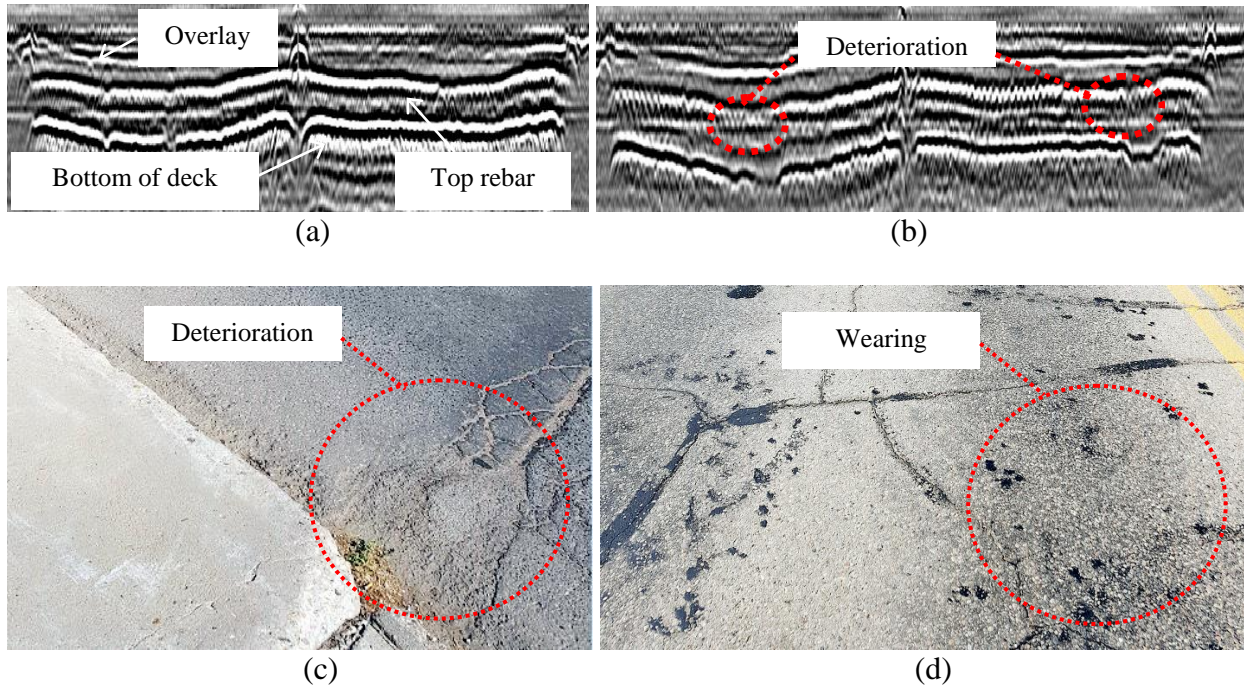
The cross-sectional images of pristine and deteriorated deck regions are displayed in Figs. 3(a) and (b), respectively, where the representative views of B06A are given for brevity and other bridges showed similar GPR results. The magnitudes of the bounced wave signals depended upon electrical conductivity and relative dielectric permittivity (Gucunski et al. 2013), which produced visually distinguishable layer structures in the deck. The attenuated signals in the deteriorated regions (Fig. 3(b)), resulting from dissipated electromagnetic energy (Benedetto and Benedetto 2011), signify the presence of chlorides, cracking, and delamination in the deck concrete (Gucunski et al. 2013). Since electromagnetic waves were not able to penetrate the steel reinforcement (Giannopoulos et al. 2002), the top-bar location was conspicuous. Likewise, the interface between the asphalt and concrete was detected via their difference in dielectric contrast. Table 3 enumerates the depth of the top steel and overlays measured from the deck surface. Due to cracking, wearing, and abrasion (Figs. 3(c) and (d)), the actual overlay thickness varying from 1.7 in. to 2.6 in. was shallower than the nominal thickness shown in Table 1 (1.3 in. to 6.0 in.). The net depth of the reinforcement was between 2.1 in. and 3.2 in. at an average coefficient of variation (COV) of 0.141 without the overlays, which was reasonably close to the concrete cover of 2.5 in. specified in the American Association of State Highway Transportation Officials (AASHTO) Load and Resistance Factor Design (LRFD) Bridge Design Specifications (AASHTO 2017).

Fig. 3. Scanned images of ground-penetrating radar and conditions of overlays: (a) pristine section (B06A); (b) deteriorated section (B06A); (c) deterioration of overlay (B06A); (d) wearing of overlay (B06V)

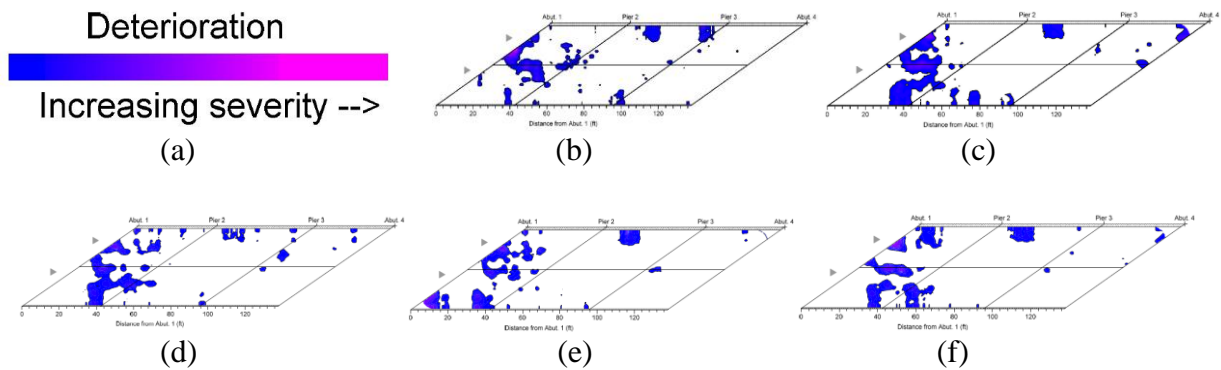
The severity of deterioration used for the assessment of the GPR data is defined in Fig. 4(a), which aligns with the weakened electromagnetic signals (Fig. 3). The scale bar was developed with decibel thresholds, based on ASTM D6087 (ASTM 2008) and experts' refined mesh; however, details are not reported due to the proprietary claim of the contractor. Figures 4(b) to (f) plot the deteriorated regions of B06S at variable scanning frequencies. Although the GPR data generated analogous images, the areas of deterioration varied from 659 ft² to 847 ft², as summarized in Table 3. This illustrates that the GPR readings were influenced by the scanning frequency and that the amplitude of the signal reflection was not a deterministic quantity, supported by other GPR analyses (Shin and Grivas 2003). Furthermore, as reported in literature (Hing and Halabe 2010), the accuracy of GPR is another notable factor affecting the quantification of deteriorated areas since its minimal detectable ability is limited to 4 in.².

Fig. 4. Variable data collection rates on deck of B06S: (a) deterioration scale of ground-penetrating radar; (b) 4 scans/ft; (c) 8 scans/ft; (d) 12 scans/ft; (e) 16 scans/ft; (f) 20 scans/ft

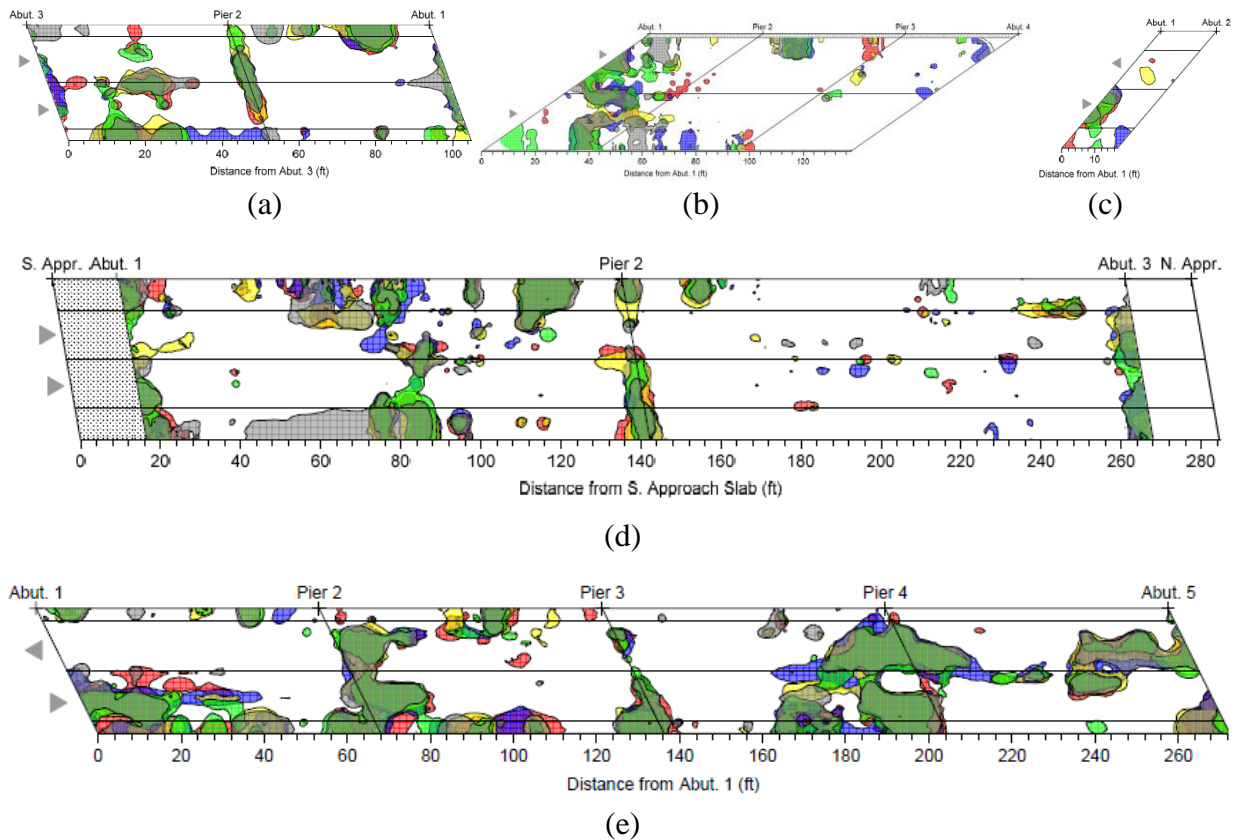
Figure 5 shows the GPR maps of the five decks. For the convenience of a visual assessment, the severity scale was not present and the maps obtained from the respective scanning frequencies were combined. As quantified in Table 3, the average deterioration of C08A was the least (7.6% of the total deck area) and the deterioration of B06A, B06S, and B06V was similar (12.6%, 12.1%, and 12.7% of the total deck areas, respectively). On the contrary, relatively large areas were detected in the case of C07A along all spans (21.4% of the total deck area). Provided that patching is typically conducted if deterioration is less than 30% of a deck area (Hema et al. 2004), these bridges were repaired accordingly (to be discussed in a later section).

Fig. 5. Scanned bridge decks by ground-penetrating radar: (a) B06A; (b) B06S; (c) C08A; (d) B06V; (e) C07A

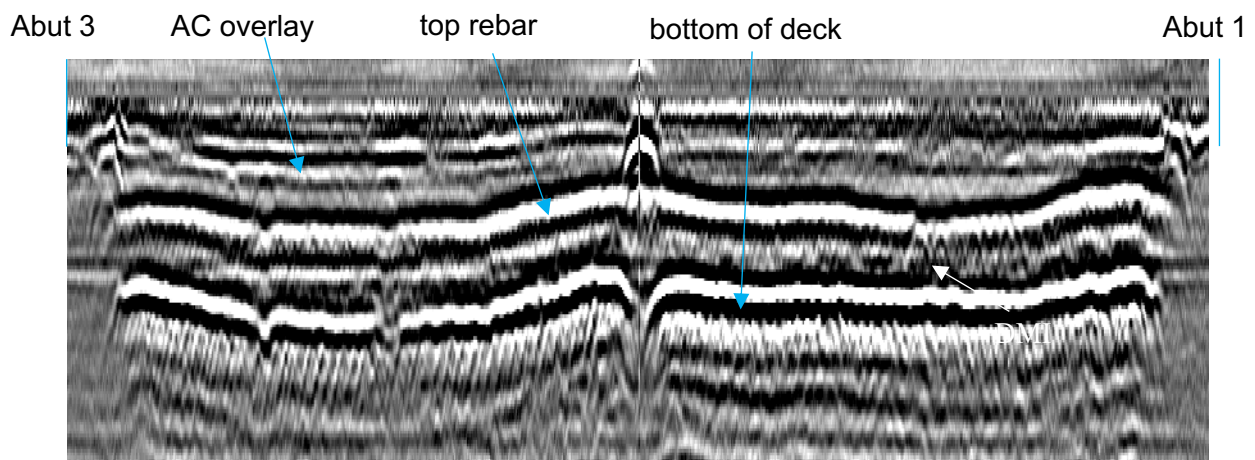
Figure 2 - Sample Single Scan GPR Data Presenting Limited Evidence of Deterioration on Structure B-06-A. This is a Sectional View of the Concrete Deck and is the Data from One Antenna.

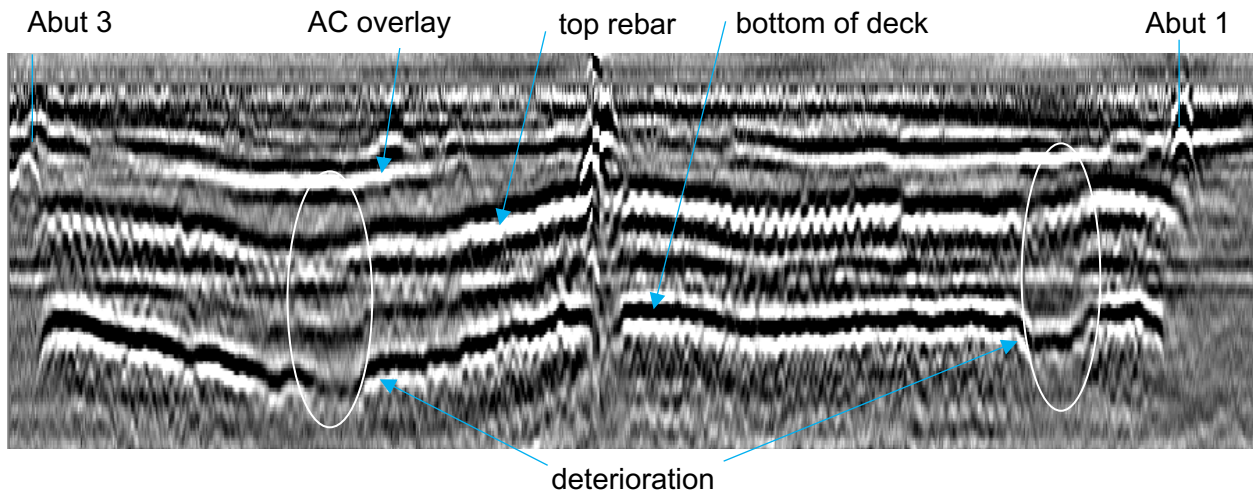
Figure 3 - Sample GPR Data Presenting Evidence of Deterioration on Structure B-06-A
