1. Title and Subtitle
**Forensic Evaluation of Pavement Structure:
Ponderosa Drive in East Baton Rouge Parish**
2. Author(s)
Qiming Chen, Ph.D., P.E., Nicholas Ferguson, P.E., Moses Akentuna, Ph.D., P.E., Saman Salari, P.E., Gavin Gautreau, P.E., Samuel Cooper, III, Ph.D., P.E.

5. Report No.
FHWA/LA.17/21-01TA-P
6. Report Date
January 2022
7. Performing Organization Code
LTRC Project Number: 21-01TA-P
8. Type of Report and Period Covered
Technical Assistance Report
August 2020-August 2021

Forensic Evaluation of Pavement Structure: Ponderosa Drive in East Baton Rouge Parish

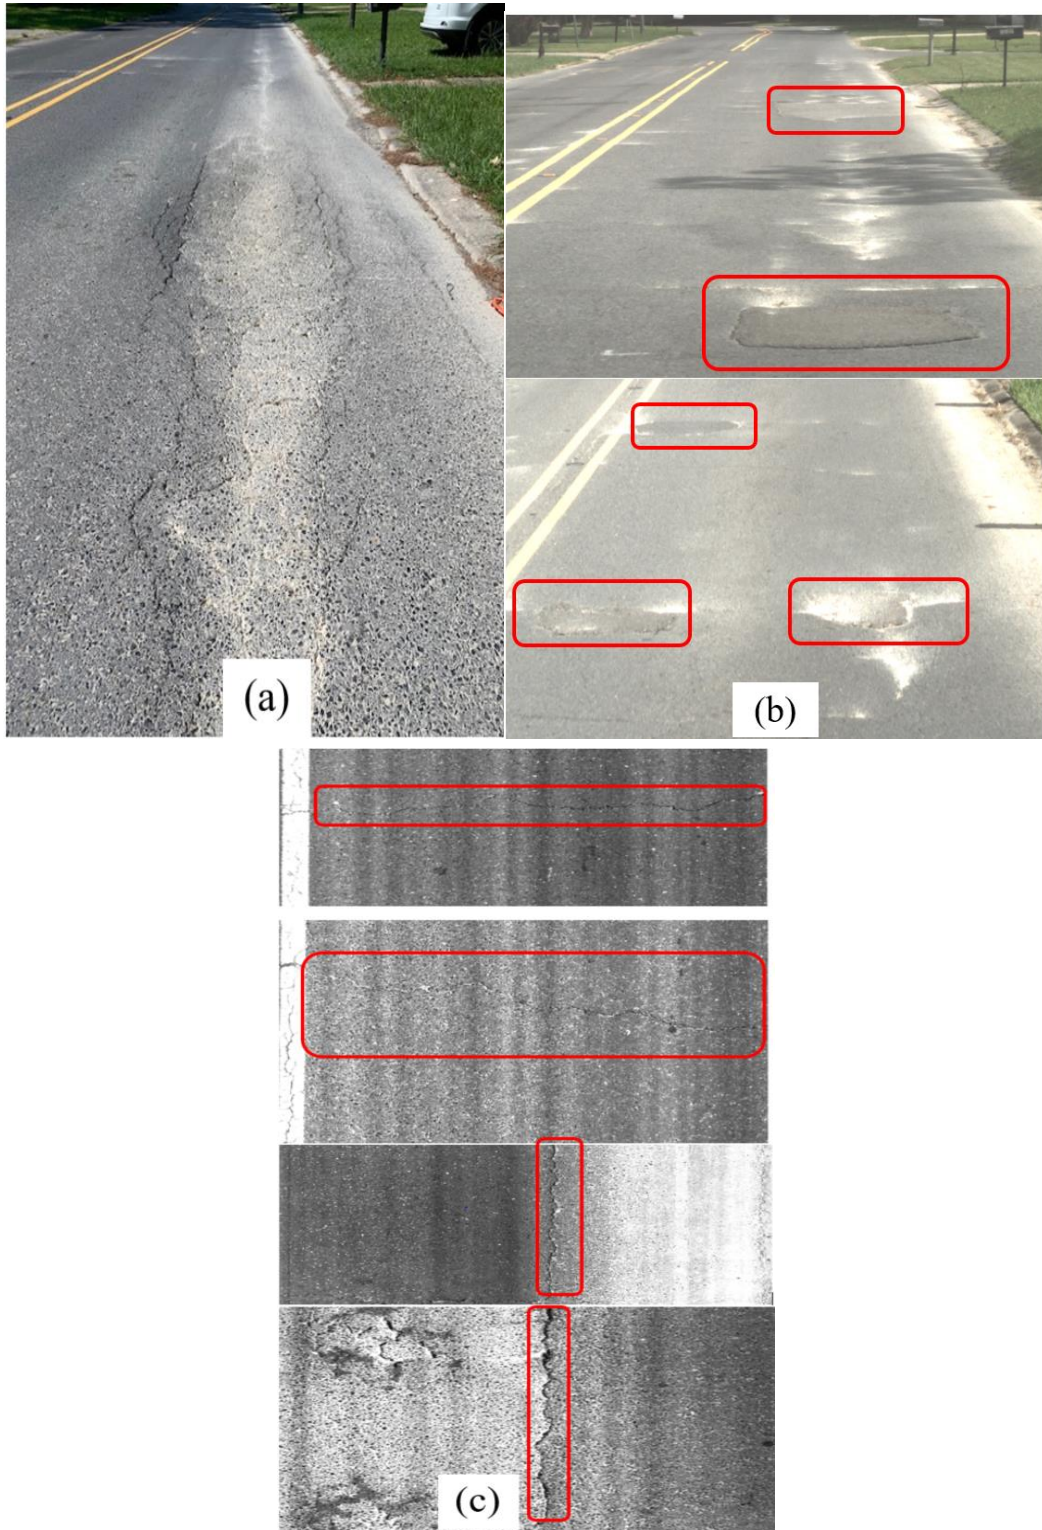
layer was overlaid with a 2-in. asphalt wearing course. The roadway boring report indicates that the pavement structure prior to rehabilitation consisted of 2 to 4-in. of asphalt wearing course supported by 12 to 13-in. of soil cement base; see Table 1. According to the East Baton Rouge Transportation and Drainage Department, the road has performed poorly over the years. Based on preliminary investigation, excessive rutting and fatigue cracks were observed in the wheel paths along the road segment; see Figure 2a. Several patched areas were also detected on the asphalt surface with white streaks, which was an indication of early wear and problems likely associated with moisture damage; see Figure 2b. The white streaks at the surface indicate that material is pumping up from below the asphalt layer. In addition, transverse and longitudinal cracks were also seen along the pavement section; see Figure 2c.

Figure 2. (a) Rutting and fatigue cracks, (b) patched areas, and (c) transverse and longitudinal cracks

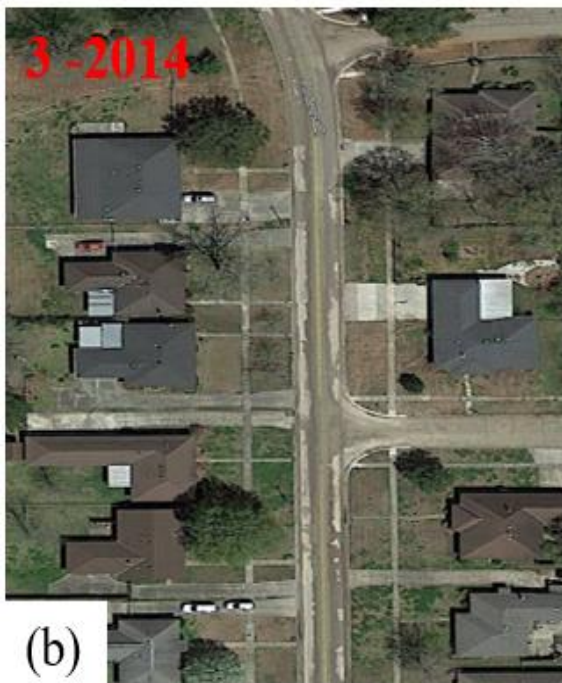
Figure 3. Google Earth images of road section in (a) March 2013 and (b) March 2014

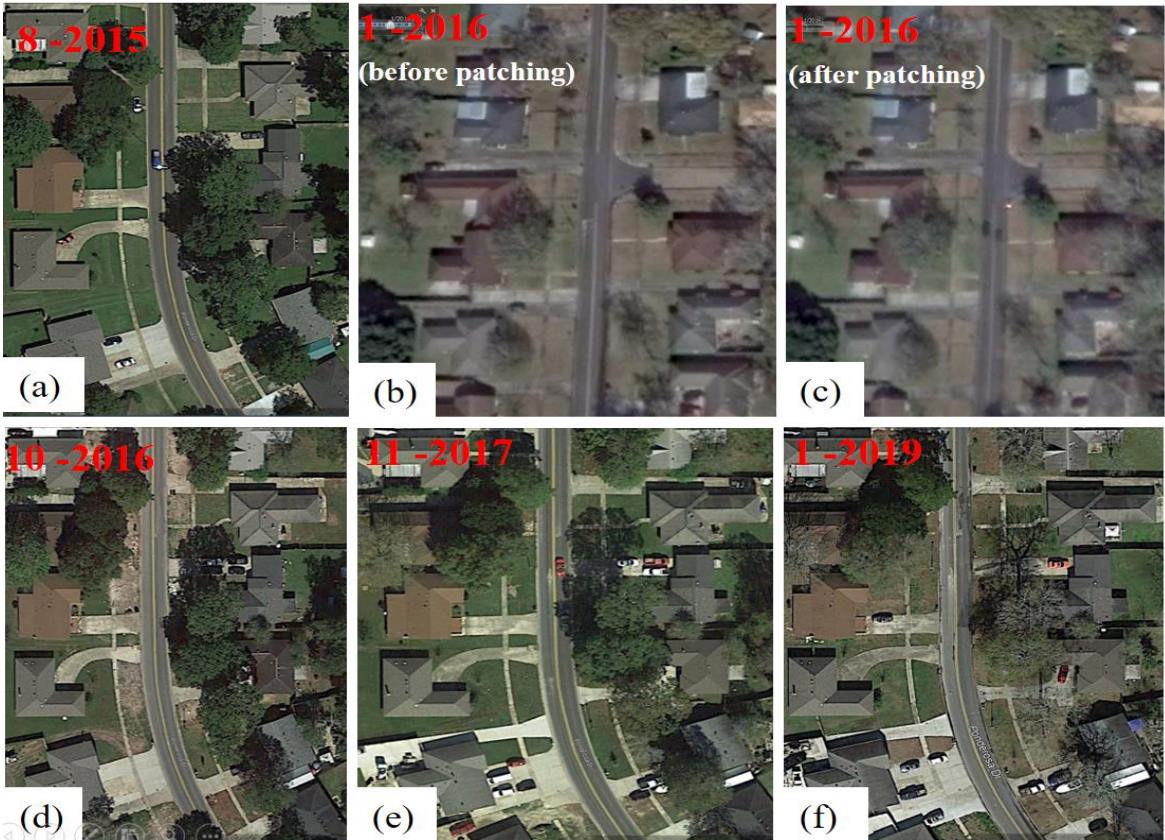
Figure 4. Google Earth images of pavement section taken in (a) August 2015, (b) January 2016 (before patching of areas with white streaks), (c) January 2016 (after patching of areas with white streaks), (d) October 2016, (e) November 2017, and (f) January 2019

A preliminary investigation utilizing Google Earth identified historical issues along the road. Figure 13 shows two photos of Ponderosa Drive from 2010 and 2014, respectively. In 2010, visible distress can be seen with white spots visible like those currently seen at the site; see Figure 13a. In March 2014, more white spots can be seen (possible evidence of milling operations); see Figure 13b. Figure 13a shows evidence of road distresses prior to rehabilitation in 2014, and the catastrophic flooding event of August 2016 (a non-named storm) that affected 21 parishes spanning from Lake Charles to the Louisiana-Mississippi border. In addition, January 2016 images show white spots after rehabilitation, indicating problems were recurring prior to the August 2016 flood; see Figures 4b and 4c.

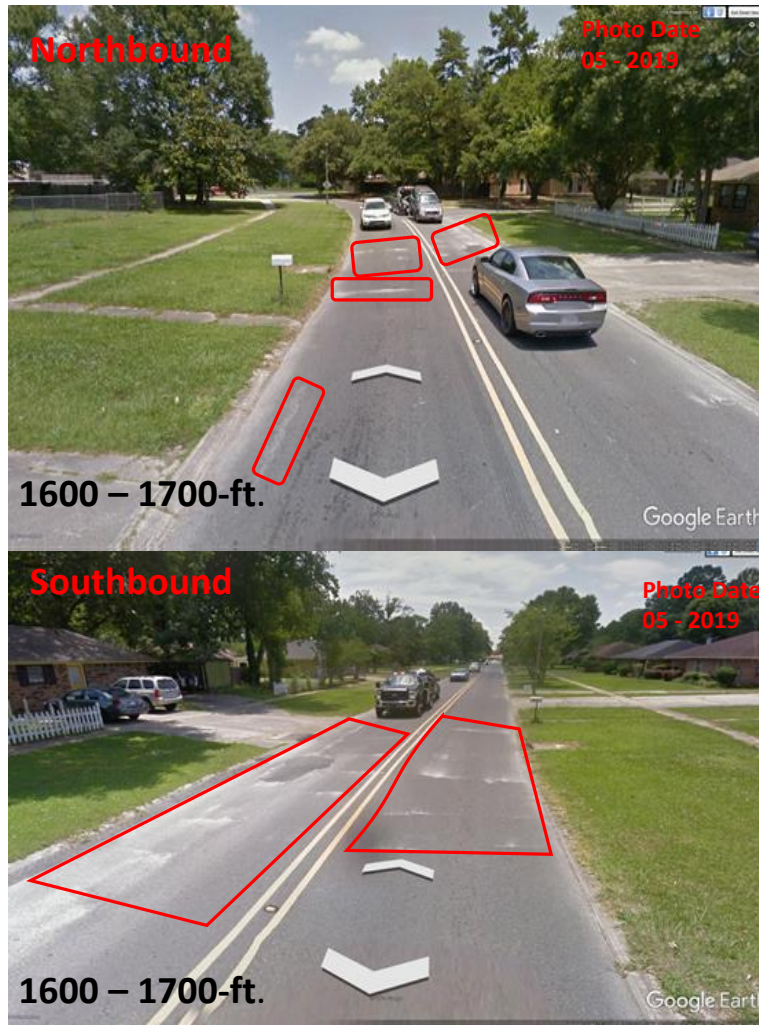
Figure 5. Distress locations in May 2019

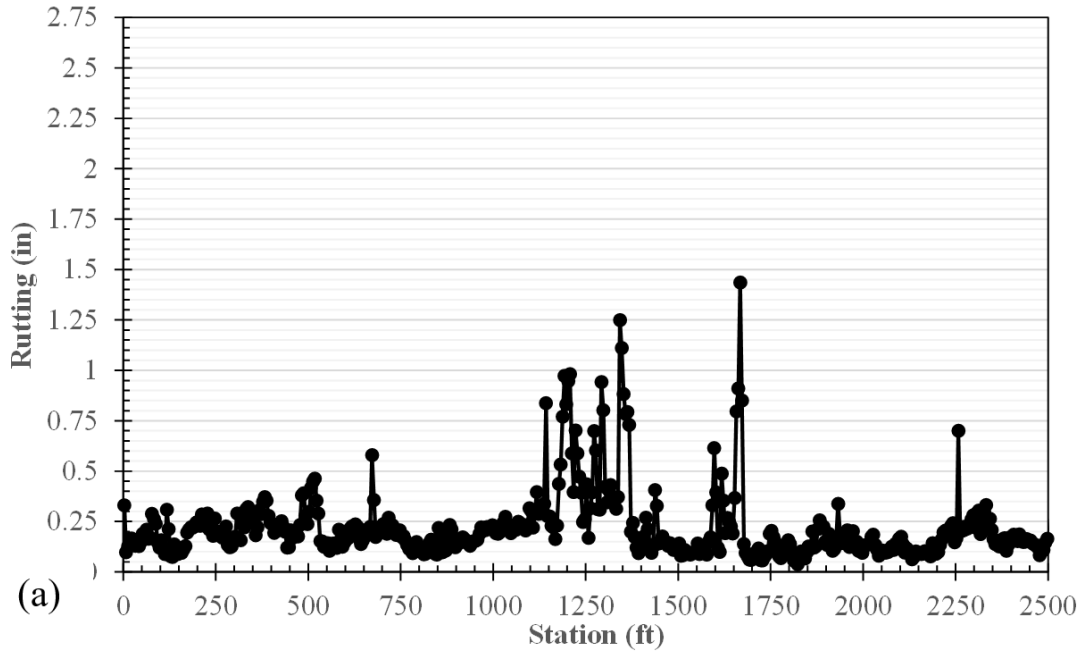
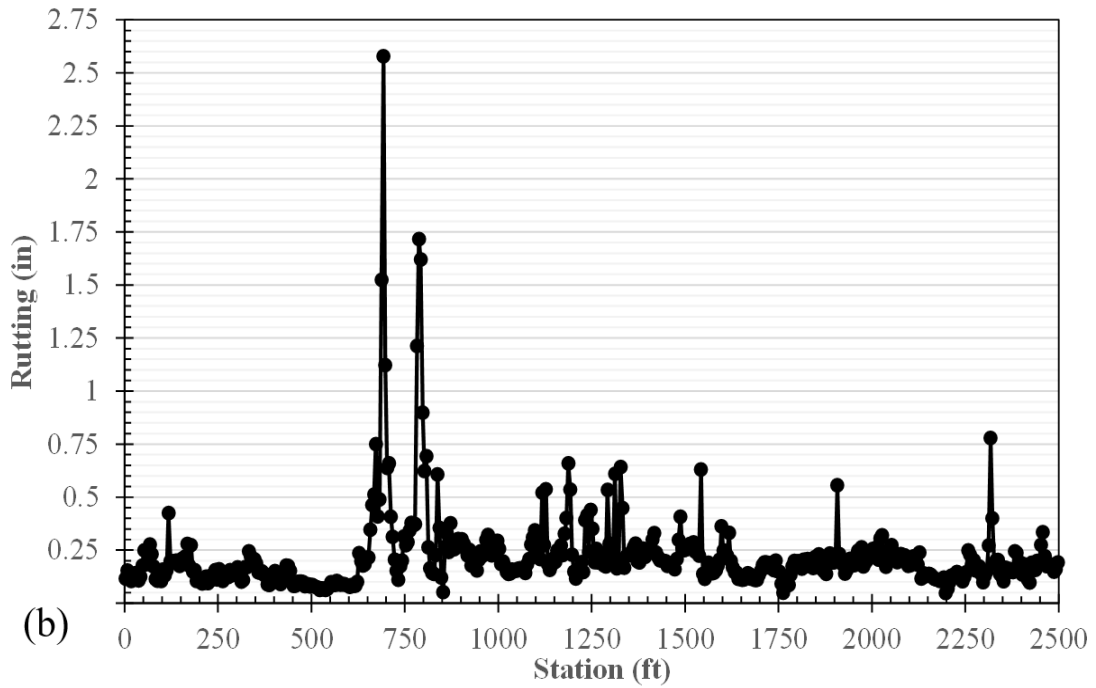
Rut depths were measured using LTRC's road profiler, which uses a 5-point rut bar system for pavement rut depth measurements. The rut depths were continuously measured as the survey van drove on the pavement section. The measured rut depths are presented in Figure 7. A couple of locations along the section exhibited rut depths greater than 0.75 in. The rut depths at a few locations were greater than 1 in. Such high rut depths are not typically observed in asphalt pavements with soil cement base. This observation may be attributed to a weakened base or subgrade layer.

Figure 7. Rutting values along (a) Northbound and (b) Southbound lanes

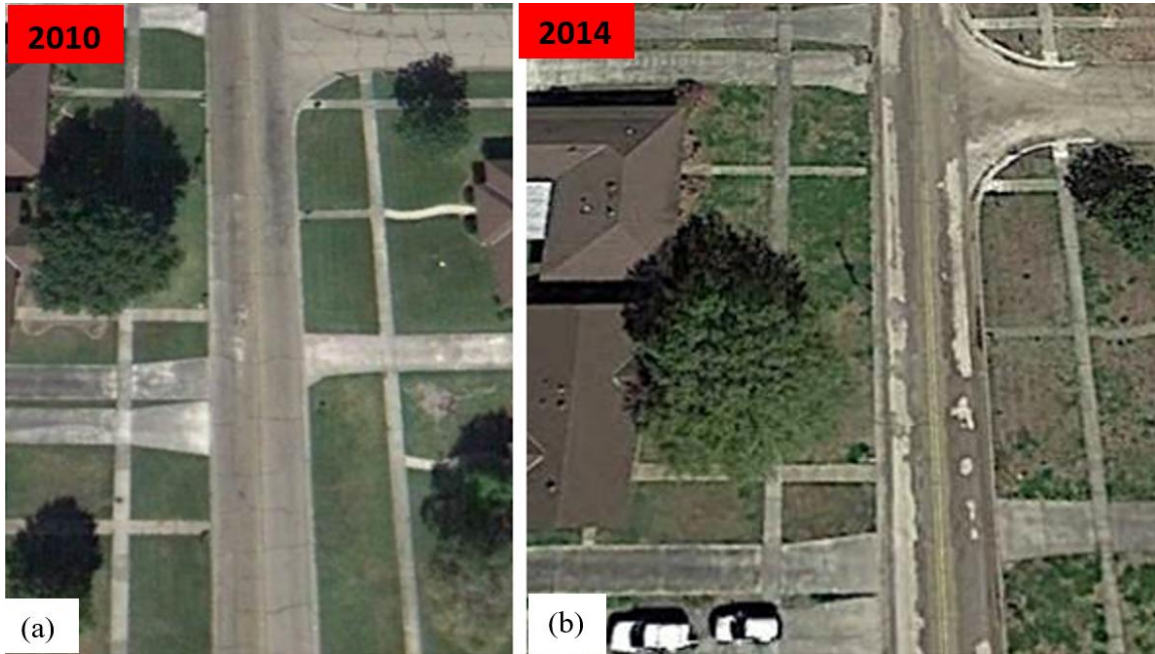
Figure 13. Google Earth photos from (a) 2010 and (b) 2014

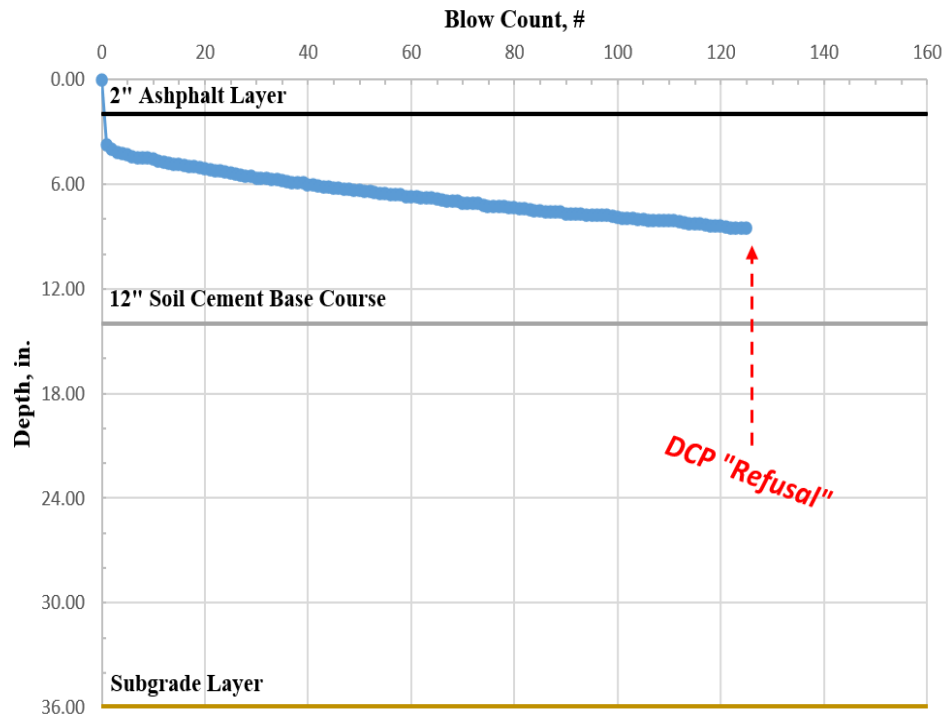
Zone 4 was initially deemed a “bad spot” based on the FWD results; however, the conducted DCP met refusal and was stopped. In response, a second test was conducted right next to the asphalt core hole, and the DCP test was performed the full 3 ft. Figure 14 shows “Zone 4 Take 1,” where a DCP refusal was recorded. The graph is a representation of the extent of DCP steel rod’s penetration due to each blow of the hammer. There are reference lines representing the presumed thickness of the asphalt and soil cement base layers, and the total rod length into the subgrade at 36 in.

Figure 14. Zone 4 Take 1 blow count versus depth

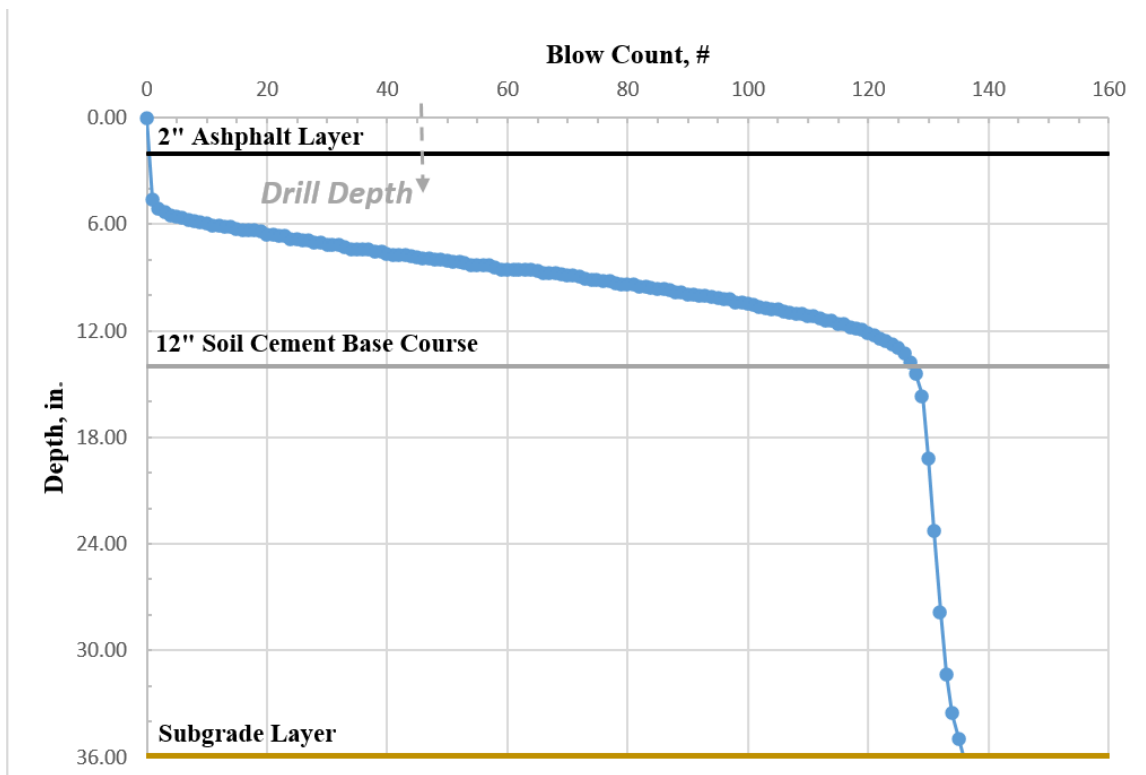
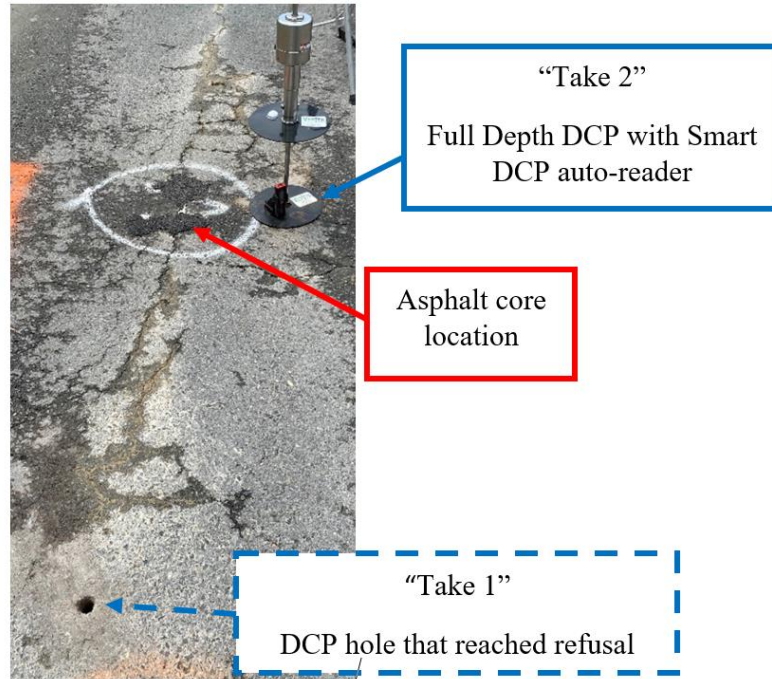
Figures 15 and 16 show “Zone 4 Take 2” blow count versus depth, and the location where the DCP was conducted to the full depth, respectively. The “Take 2” DCP at Zone 4 was initiated because “Take 1” DCP refusal contradicted the FWD results that indicated this area as a “bad zone. This DCP location is closer to the coring location, which was cored utilizing water. The coring technique may have affected the DCP results. This “Take 2” DCP test was able to penetrate through the soil cement in contrast to “Take 1” that reached refusal just 4-ft. away. This shows a possible inconsistency in the distribution of cement across the soil cement base.

Figure 15. Zone 4 Take 2 blow count versus depth

Figure 16. Photo of Zone 4 Take 2

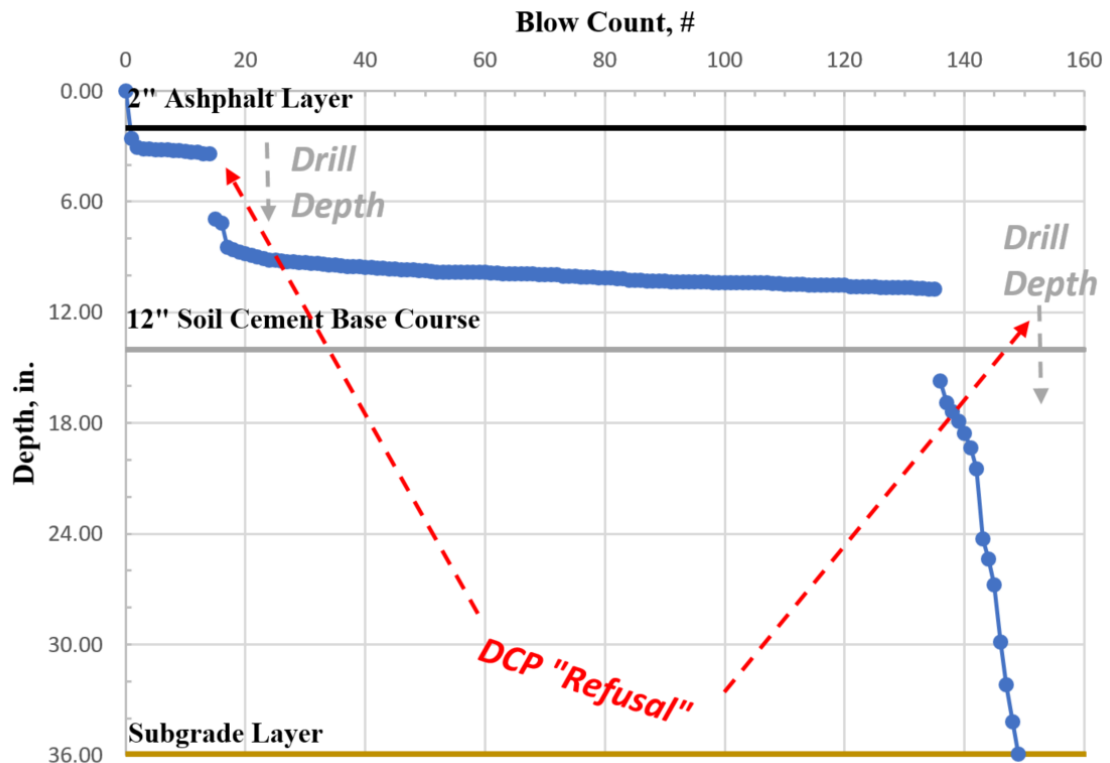
Zone 6 was initially deemed a “good spot” based on the FWD results. The DCP was performed within 2 ft. of the asphalt coring location. The soil cement base at this location was so stiff that it caused two DCP refusals. When the top of the soil cement reached refusal, the geotechnical group drilled to test the top of the lower half of the soil cement base course. When that also reached refusal, another hole was drilled to test the subgrade. Figure 17 presents a combination of three DCP tests plotted together on the same graph. The two steep sections/gaps represent drilling efforts.

Figure 17. Zone 6 blow count versus depth

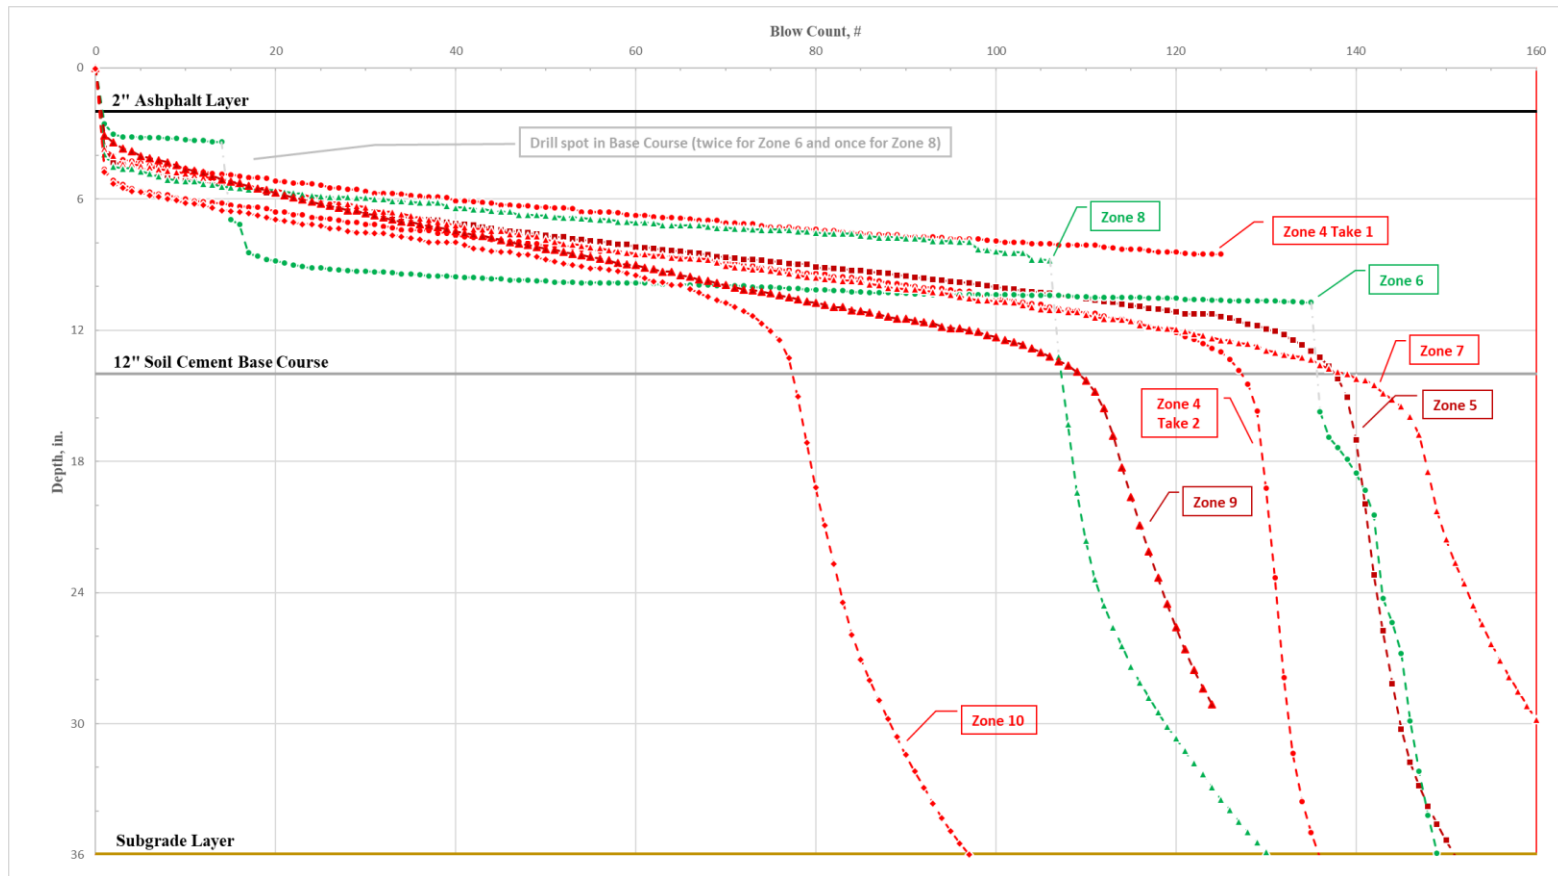
Zone 10 was initially considered a “bad spot” based on the FWD results. The graph of blow count versus depth for this zone can be found in the Appendix. The DCP was performed about 4 ft. away from the asphalt coring location in the deepest depression of the right wheel path rut as seen in Appendix. The soil cement base at this location was the weakest of all locations tested in this investigation. The DCP test was conducted to the full depth without reaching refusal. This test did not reach 100 blows in total and crossed from soil cement to subgrade in under 80 blows. In contrast, all other full-depth DCPs crossed over into the subgrade at over 100 blows; see Figure 18.

Figure 18. DCP analysis for all zones

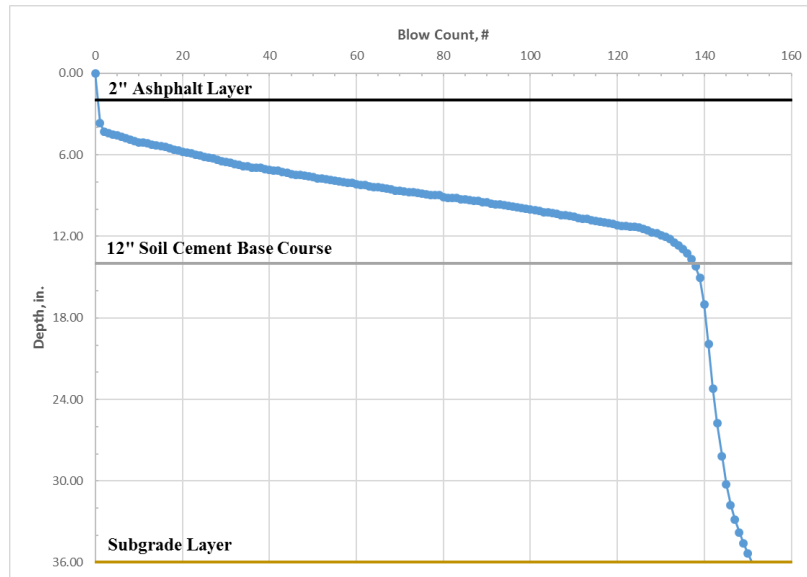
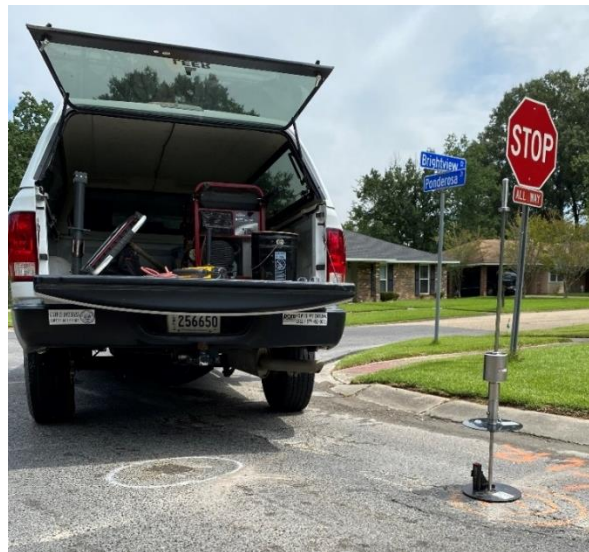
Zone 5 was initially deemed a “bad spot” based on FWD results, and the asphalt group confirmed that the core at this location broke in half, perhaps due to poor quality of the base course. The graph of blow count versus depth for this zone can be found in the Appendix. The DCP was performed 3 ft. away from the asphalt coring location. A photo of the test and coring locations is presented in the Appendix.

Figure 22. Zone 5 blow count versus depth

Figure 23. Photo of zone 5 DCP and core location

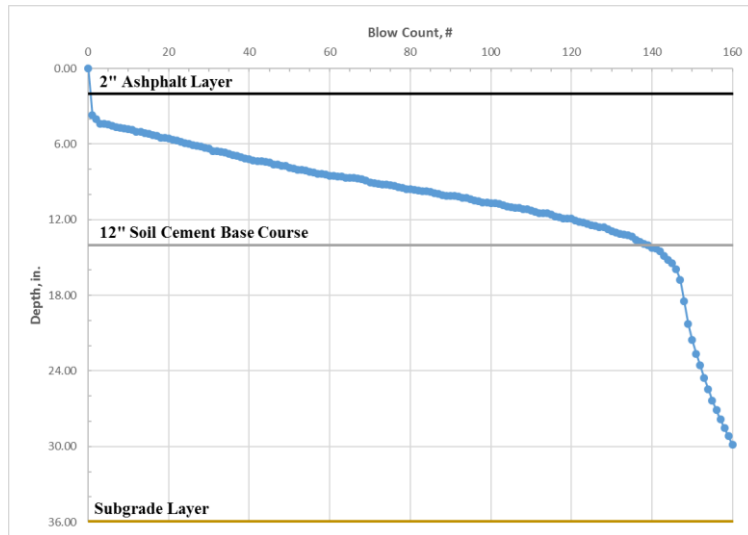
Zone 7 was initially deemed a “bad spot” based on the FWD results. The geotechnical group conducted the DCP test within 2 ft. of the asphalt coring location. The graph of blow count versus depth for this zone can be found in the Appendix. The soil cement base at this location was not as stiff, and the DCP test was conducted to its full depth without reaching refusal.

Figure 24. Zone 7 blow count versus depth

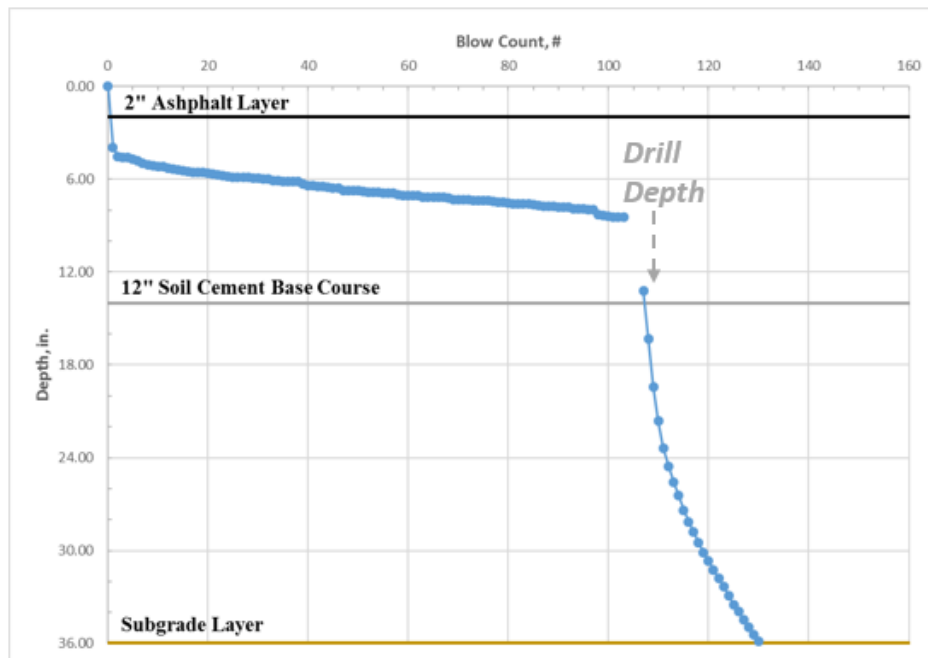
Zone 8 was initially deemed a “good spot” based on the FWD results. The geotechnical group conducted the DCP test within 2 ft. of the asphalt coring location. The graph of blow count versus depth for this zone can be found in the Appendix. The DCP test conducted at the top of the soil cement met refusal after 5 in. An adjacent hole was drilled to test the lower half of the soil cement base. This second test penetrated the lower portion of the base course and continued into the subgrade.

Figure 25. Zone 8 blow count versus depth

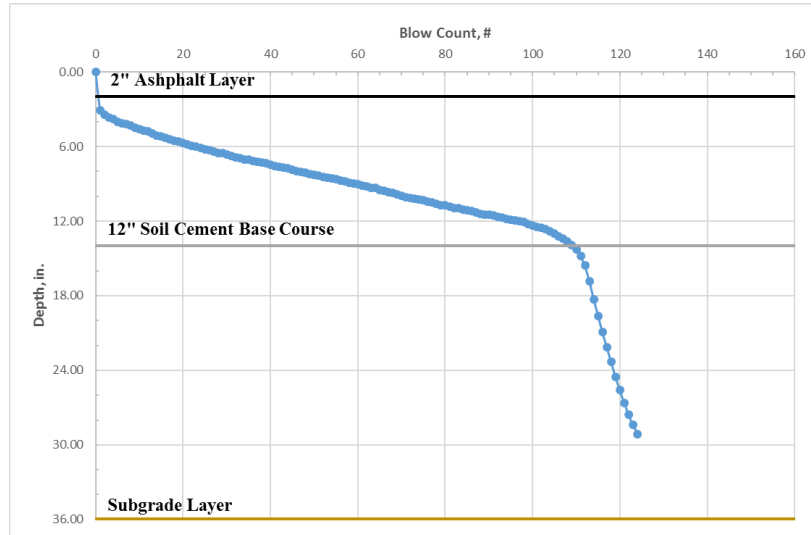
Zone 9 was initially deemed a “bad spot” based on the FWD results. Zone 9 is the first of two locations tested in the southbound lane on the Ponderosa Drive project. This was the geotechnical group’s first DCP performed on site, and it was within 2 ft. away from the asphalt coring location. The graph of blow count versus depth for this zone can be found in the Appendix. The soil cement base at this location was not as stiff as compared to other locations and the DCP test was conducted to the full depth without reaching refusal. This DCP only penetrated 2.5 ft. into the ground due to the initial concerns of possibly getting the device stuck into the ground.

Figure 26. Zone 9 blow count versus depth

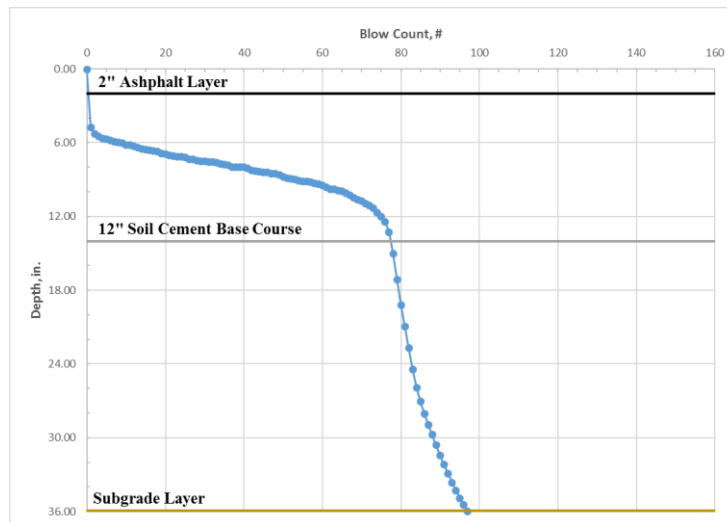
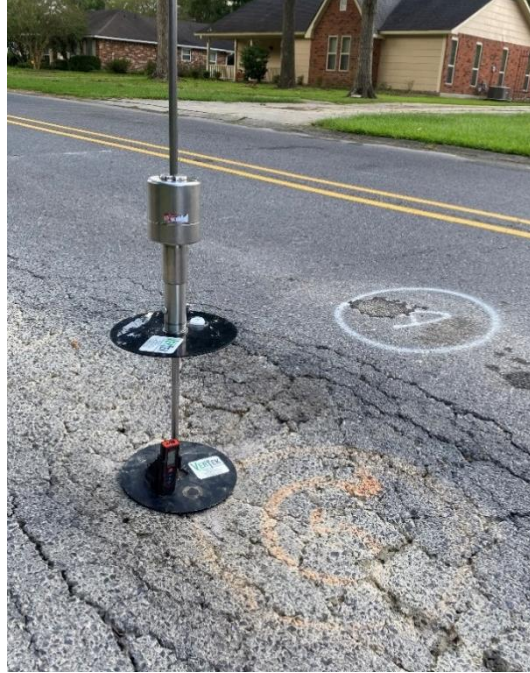
Figure 27. Zone 10 blow count versus depth

Figure 28. Photo of Zone 10 DCP and core location
