Louisiana Transportation Research Center

Final Report 595

Evaluation of Dowel Bar Alignment and Effect on Long-term Performance of Jointed Pavement

LTRC Project No. 14-1C

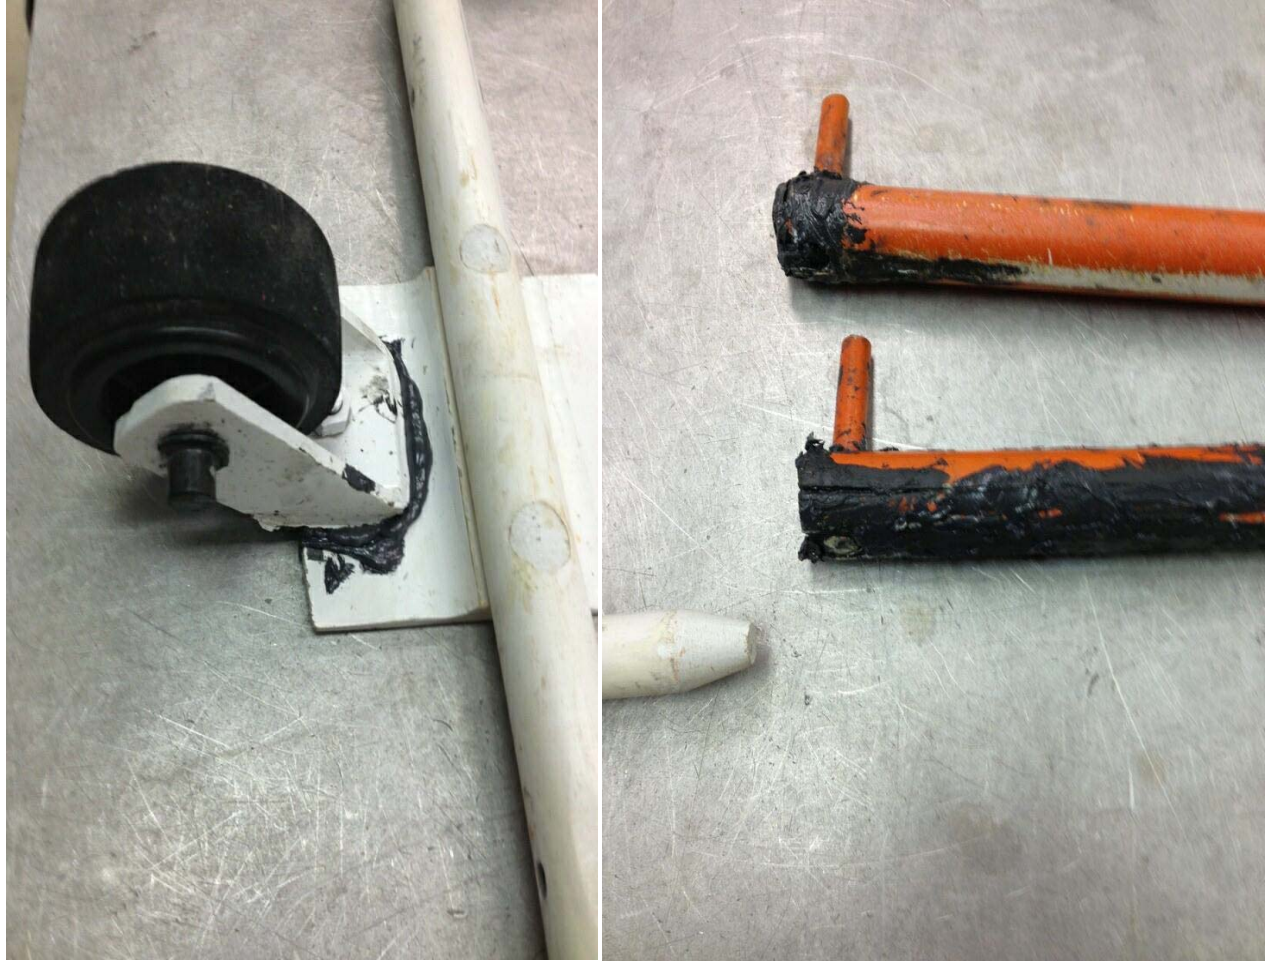
The MIT-SCAN2-BT testing brought forth some key observations for the authors. First, when testing at full pavement width, the fiberglass track is extremely flexible and fragile. LTRC had to purchase an additional track and repair both significantly to continue testing operations. Figure 11 shows some of the repairs that had to be made to the track.

Figure 11
Examples of epoxy repair to the fiberglass track

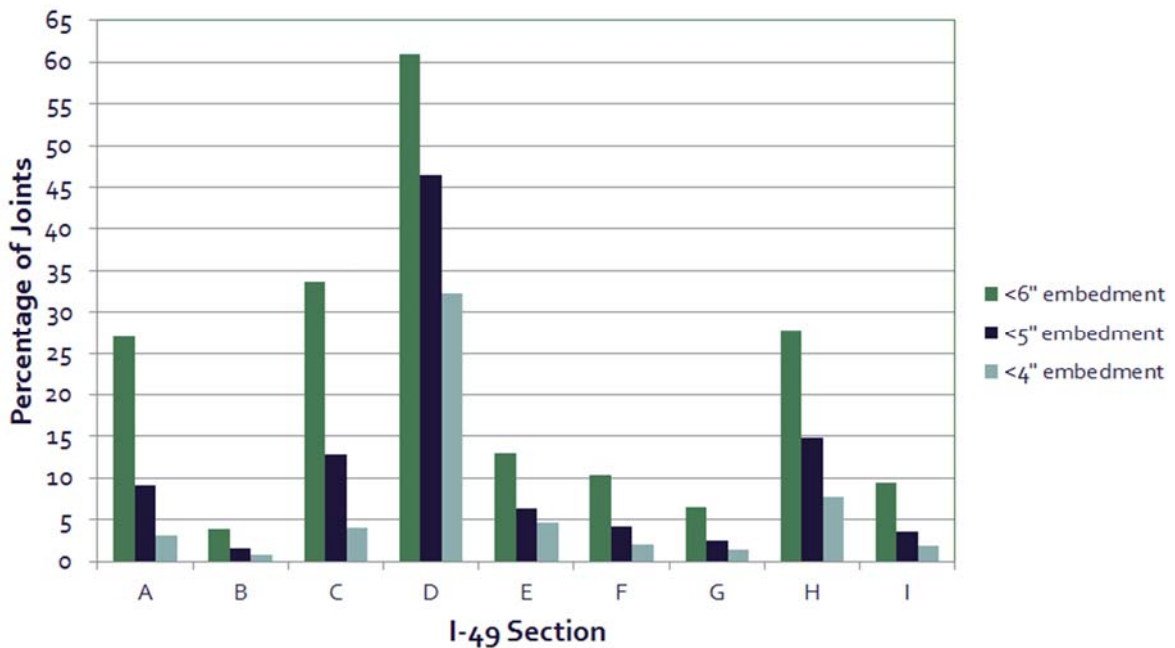
Figure 12 shows the results for the I-49 corridor by individual sections. The results showed overwhelmingly that vertical tilt, horizontal skew, vertical translation, and horizontal translation are not an issue for constructed JPCP joints within the corridor. Longitudinal translation was the most commonly observed type of misalignment. Longitudinal translation generally occurs when the joints are marked and sawn in an incorrect location relative to the

installed dowel bars or dowel baskets. A slight bit of longitudinal translation is expected from the midpoint of the bar due to the difficulty in marking and locating dowels exactly and precisely sawing said joint. Note that although longitudinal translation may exist, it will only be detrimental when subjected to significant truck loading.

The results showed that Section B was built with dowel baskets while the remaining sections were built using a DBI. Section B also had the one instance of a rolled, or shoved basket. This can occur if the basket is not properly attached to the subgrade or if the basket is caught on a piece of equipment in the paving train.

Section D was the section that caused the most concern for the Department and led to the creation of this research effort. Note that although longitudinal translation does occur, with the exception of Sections D and H, the number of joints with dowels with less than 4 in. of embedment is less than 5 percent of the project joints. Past literature reviewing longitudinal dowel misalignment on an interstate section indicates that as little as 2.5 in. is needed for sufficient load transfer [5]. Upon completion of the I-49 testing, LTRC personnel continued testing older pavement sections to determine the effect of longitudinal translation on long-term JPCP performance.

Figure 12
Percentage of joints on the I-49 corridor with measured embedment lengths less than 6, 5, and 4 in.

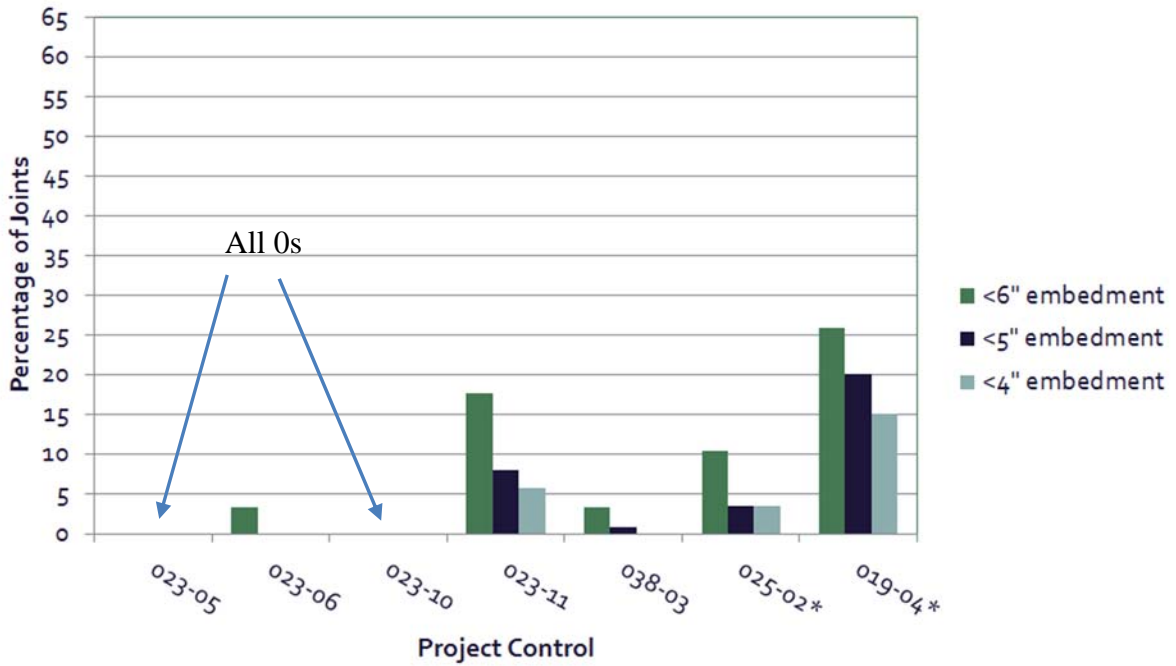
Figure 13 shows the results for the 0- to-10-year-old JPCP sections. The results show that for two pavement sections, no measurable longitudinal translation was found among tested joints. Granted, only 5 percent of the joints were measured, but this is a remarkable feat for any construction operation. The remaining sections had between 0 and 15 percent of the joints with dowels less than 4 in. of embedment.

Although the 019-04 project results showed 15 percent of the joints tested with less than 4 in. of embedment, LTRC field testing personnel found it very difficult to find any measurable faulting at the joint. With faulting being the major distress occurring with short embedment lengths, the authors believe that the embedment lengths of 4 in. are sufficient for long term load transfer. LTRC personnel will continue to observe the 019-04 projects to determine if any faulting issues arise with the number of dowel bars with less than 4 in. of embedment.

Percentage of joints in pavements 0-10-years old with measured embedment lengths less than 6, 5, and 4 in. (*outside lane measured only)

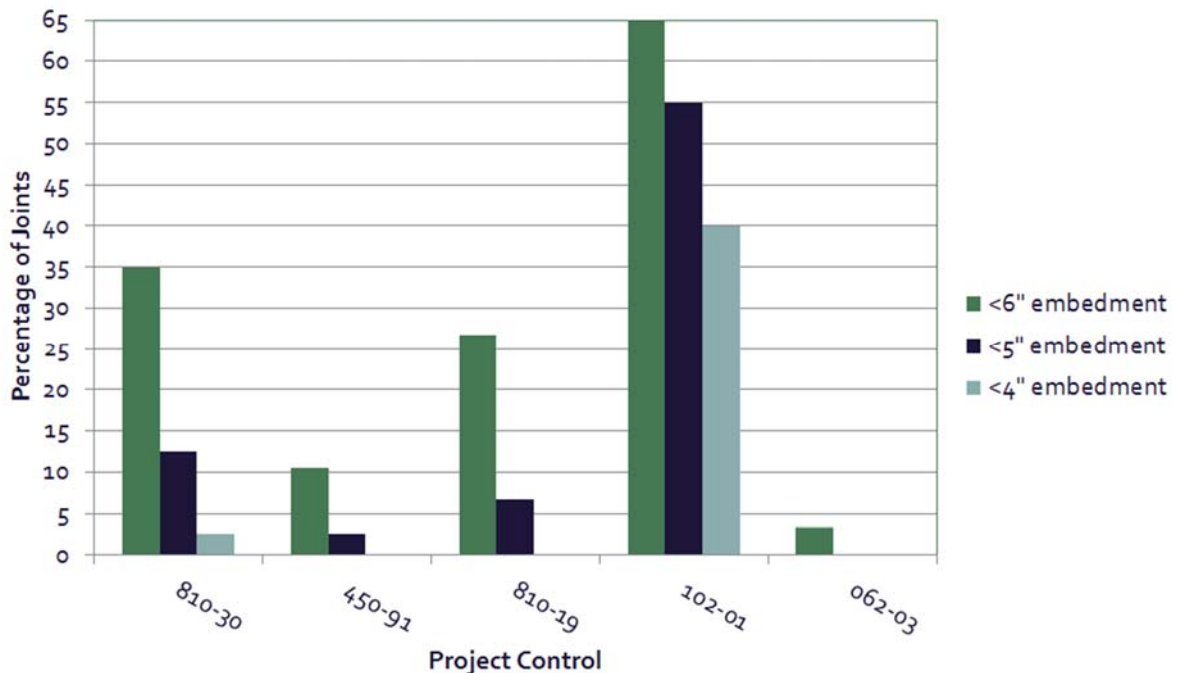
Figure 14 shows the results for the 10- to-20-year-old JPCP sections. The results show that, in general, these projects were constructed well with many joints having embedment lengths exceeding 5 in. The 102-01 project showed that nearly 40 percent of the joints measured have dowels with an embedment length less than 4 in.

The 450-91 project showed about 2.5 percent of the joints measured to be constructed with dowels less than 5 in. of embedment. With the high ADT and large percent trucks in this interstate section, one would expect to see faulting if the embedment length was an issue. In this field project, faulting was manually measured to be less than 1/16 in.

Although the 102-01 project results showed 40 percent of the joints with less than 4 in. of embedment, LTRC field testing personnel found it very difficult to find any measurable faulting at the measured joints. This may be due to the low volume nature of the roadway with an ADT of about 2900. The traffic spectra measure 16 percent trucks, and, at an age of over 15 years, if the embedment length were to cause an issue such as faulting, DOTD personnel would have measured it by now.

Figure 14
Percentage of joints in pavements 10-20-years-old with measured embedment lengths less than 6, 5, and 4 in.

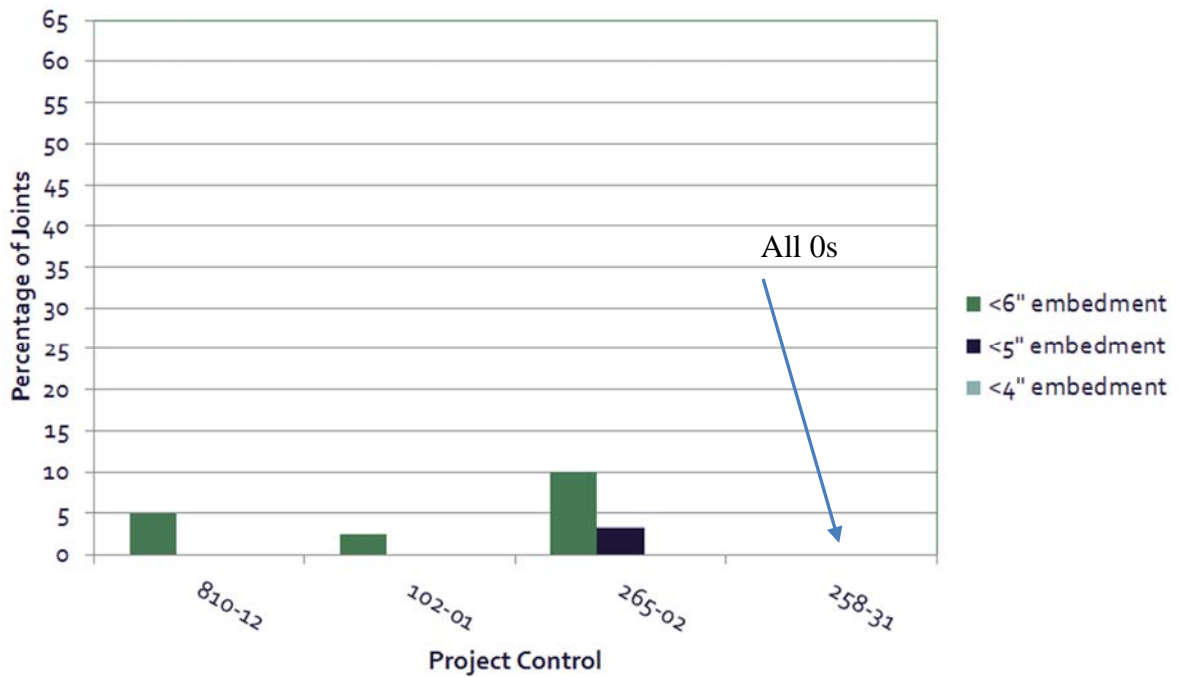
Figure 15 shows the results for the 20+ year-old JPCP sections. The 258-31 project shows the joints being constructed such that no measurable translation can be determined. That being said, the pavement exhibits no faulting at the joints, but the slab condition is significantly deteriorated, most likely due to poor subgrade support conditions.

Percentage of joints in pavements 20+ years-old with measured embedment lengths less than 6, 5, and 4 in.

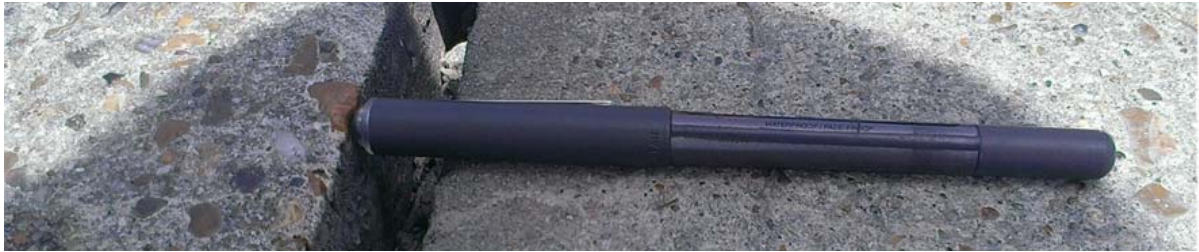
The 810-12 project showed significant faulting, as well as mid-panel cracking. The results were further analyzed and the contour map images shown in Figure 16 showed an “abnormal” dowel. Investigation by the authors uncovered that this pavement section was constructed using star lugs. Figure 17 and Figure 18 show magnitude of the faulting, in once case exceeding $\frac{1}{4}$ in.

Figure 17
Faulting of adjacent pavement slabs for the 810-12 project slightly less than 1/4 in.
