Technical Report Documentation Page

| 4. Title and Subtitle<br>Materials Selection for Concrete Overlays: Information Survey<br>Review and Evaluation of Existing Concrete Overlays in Texas | | | | 5. Report Date<br>October 2010; Revision April 2011 | |
| 7. Author(s)<br>Dong hyun Kim, Manuel Trevino, David P. Whitney, David W.<br>Fowler, Raissa Ferron | | | | 8. Performing Organization Report No.<br>0-6590-1 | |

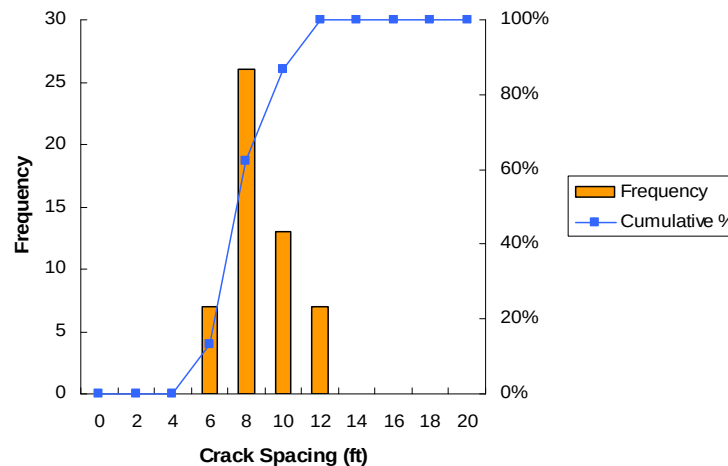
Figure 8.14: Crack spacing distribution

The existing transverse crack locations on the outside lane were recorded as seen and measured from the shoulder. Figure 8.14 shows the crack spacing distribution.

The average crack spacing was 7.8 ft, with a standard deviation of 1.6 ft, and a coefficient of variation of 21.2%. These numbers indicate that, regarding crack spacing, the section is behaving as designed.

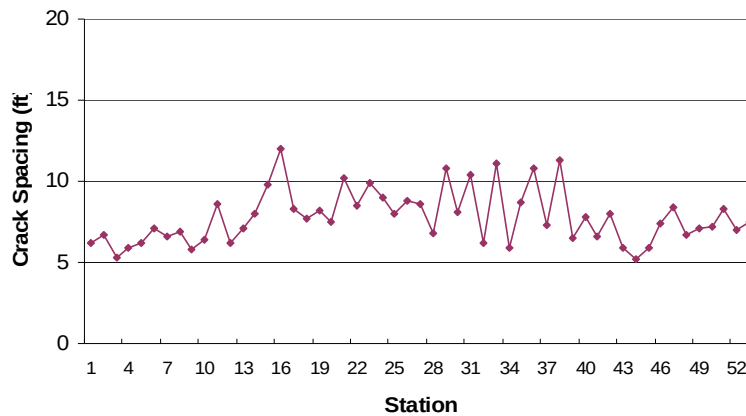
*Figure 8.15: Average cracking spacing by station*

To assess the crack spacing pattern throughout the section, the one-mile stretch of road was divided into 100-ft-long stations, and the average crack spacing for each of these stations was computed. Figure 8.15 illustrates the average crack spacing by station. For the purposes of the survey, Station number 1 starts at milepost 51, at the southernmost end of the whitetopping section; station 53 ends at milepost 52, at the northernmost end of the section.

The plot shows that almost all of the average crack spacings are between 5 and 10 ft. This is a normal pattern for CRCP sections.

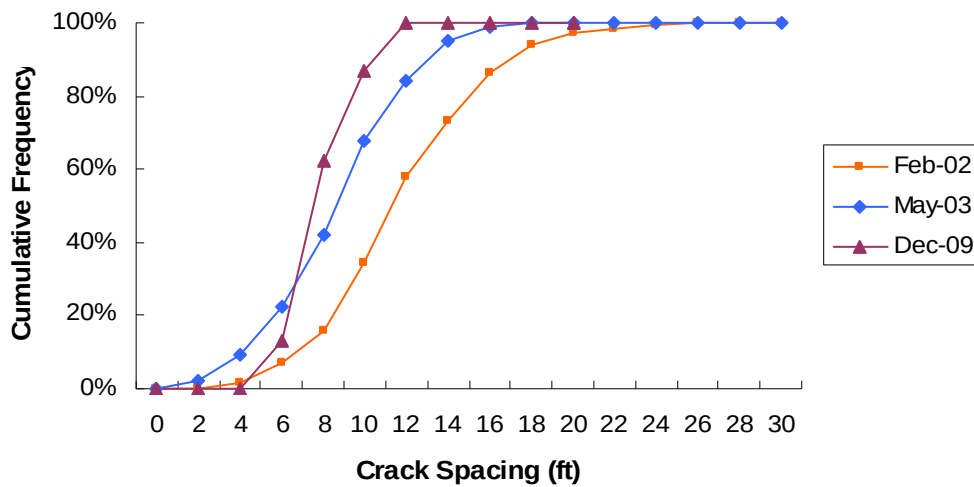
Figure 8.16: Crack spacing distribution

In May 2003, a new condition survey was conducted. As expected, a few more cracks appeared after the previous survey. Nonetheless, the results continued to be excellent; the mean crack spacing was 9.2 ft, the standard deviation was 1.3 ft, and the coefficient of variation was 14.6%. Figure 8.16 illustrates the cumulative frequency distributions obtained in the three surveys. No distresses were found during the previous two surveys.

Table 8.11 summarizes the crack spacing results for the three surveys. It can be seen that the crack spacings are getting smaller and that the variability has increased over time. With the two previous surveys occurring in the early stages of the pavement's life, and the current survey being performed more than six years after the last one, it can be concluded that the crack spacing has stabilized.

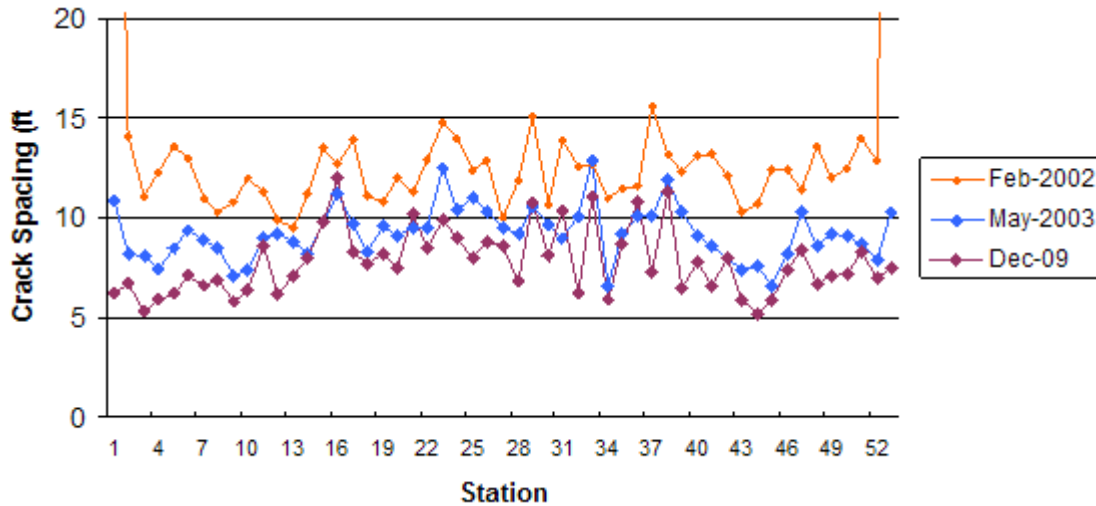
Figure 8.17: Average crack spacing with time by station

A comparison of the changes of crack spacing with time can be seen in Figure 8.17, in which the average crack spacings by station are plotted for the three surveys.

During the two previous surveys the condition of the section was excellent. The cracks were narrow, none of them were spalled, and the section did not show any early age distresses. There were no punchouts. Another indication of the good condition of the pavement at the time of those surveys was the crack pattern: all the cracks were transverse, none of them were meandering. On this occasion, a few meandering cracks were found, and the occurrence of distresses shows signs of deterioration, but the condition is still very good, and those distresses, even though some of them are severe, are normal given the traffic that the section carries.

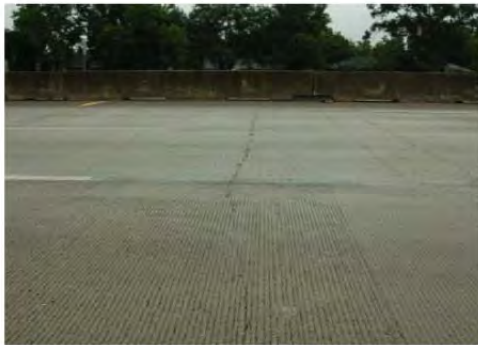
Transverse cracks

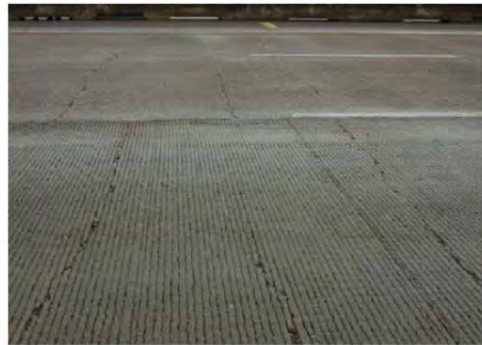
Closely spaced transverse cracks

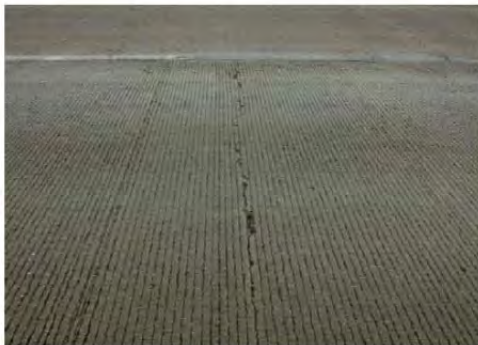
Minor spall

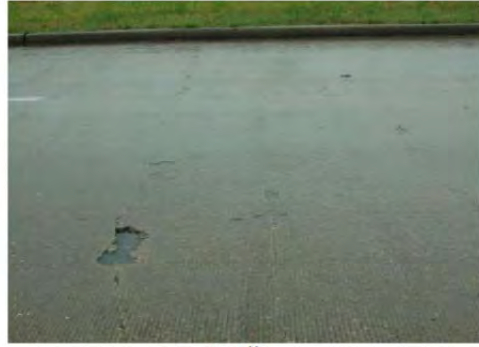
Spalls

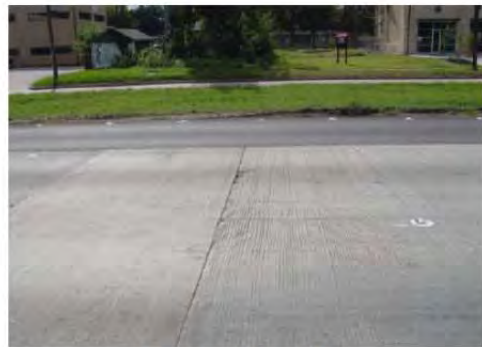
Patch with spall

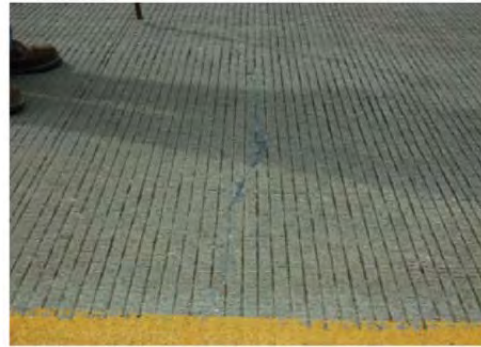
Small spalls  
1989-1990 Experimental sections (EB)

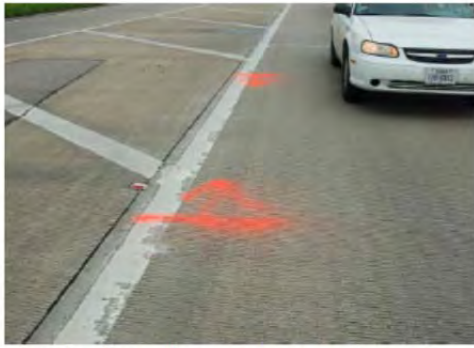
Delaminated area, next to exit ramp  
1983 Experimental sections

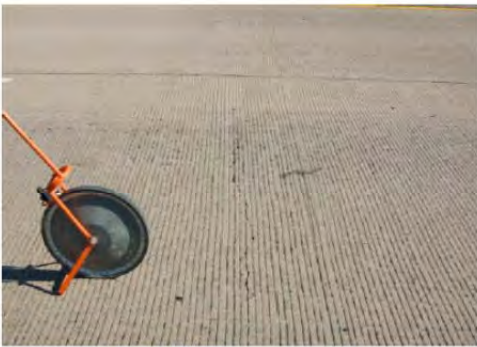
Typical transverse crack
