DOT/FAA/TC-21/17

Bonded Repairs to Composite Wing Panel Structure: Phase 2, Baseline Study

July 2021

Final report

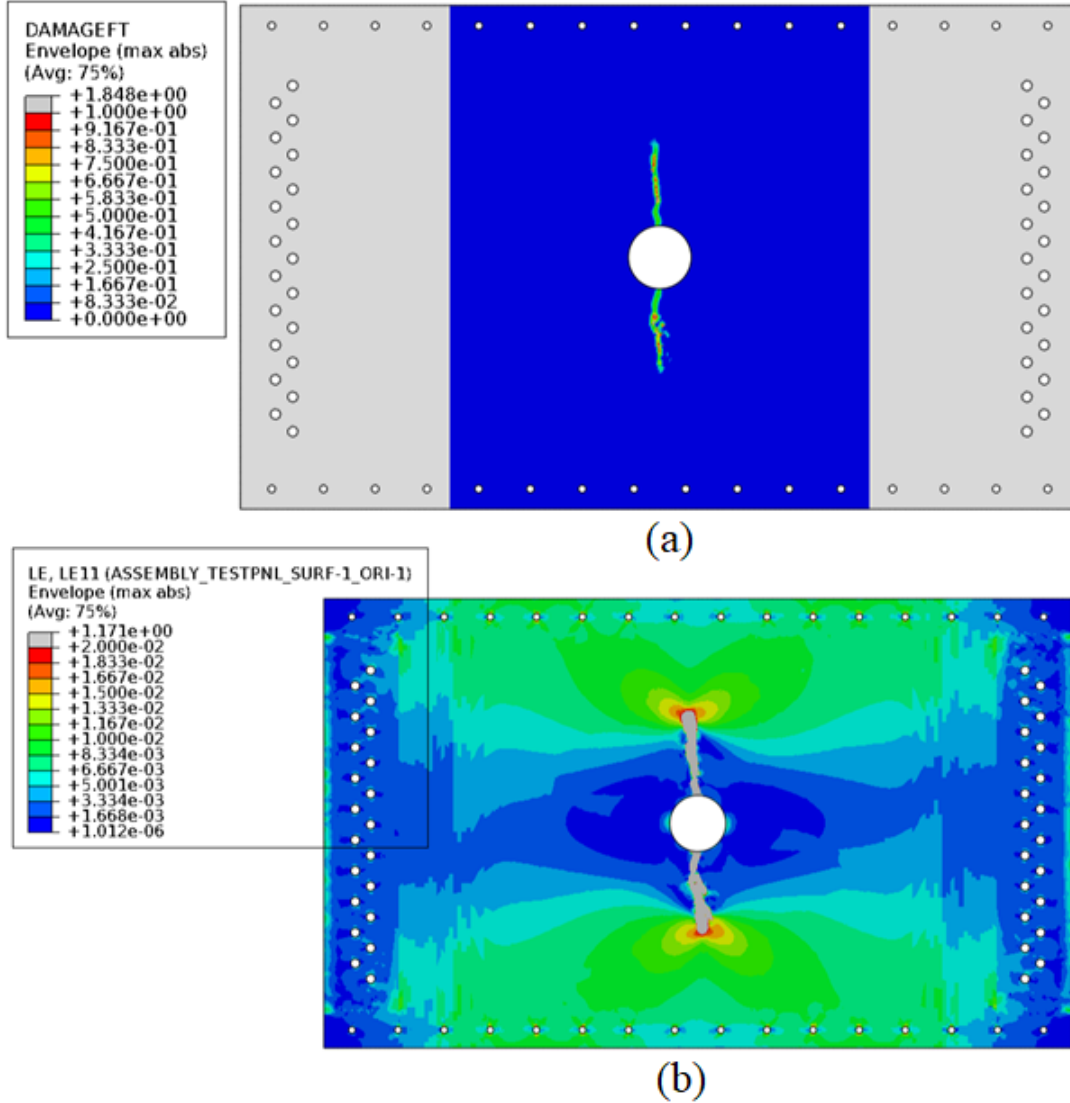
Figure 18. PFA prediction of fiber tension failure and axial strain at final failure

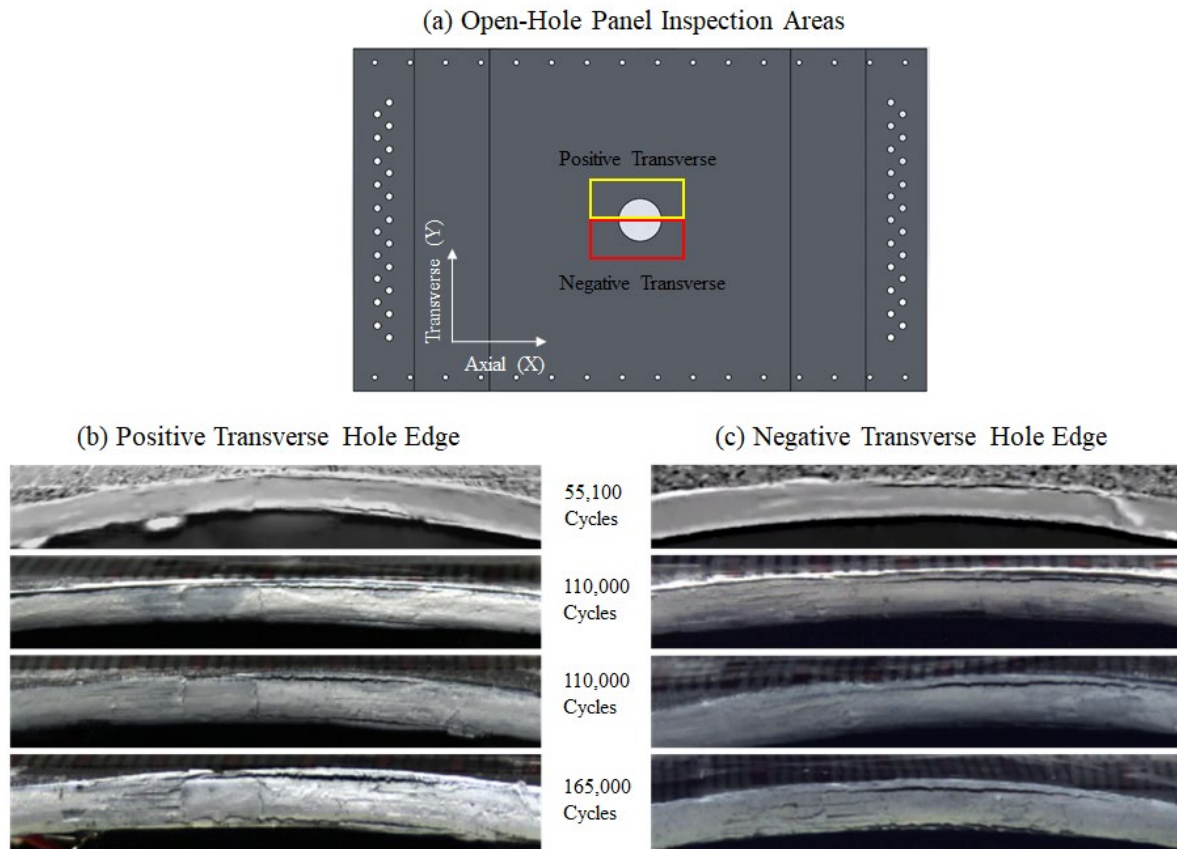
In step two, panel 2 was fatigued tested to 165,000 cycles in 55,000-cycle intervals (each 1 DSO) at three different target strain levels of 2400, 3000, and 3600 $\mu\epsilon$. The increase in load levels was to promote the development of damage. Localized hole-edge delaminations were initially detected visually during the 3000 $\mu\epsilon$ target strain fatigue test and were subsequently monitored using NDI. At the end of fatigue testing, delaminations approximately 0.5-in wide, located near the surface at 15%–20% of the panel depth along the hole boundary at the 6 and 12 o'clock positions were measured. Indications of visual damage are provided in Figure 24, while those captured by flash thermography, phased array ultrasonic, and by pulse-echo ultrasonic are provided in Figure 25. The detailed thermography, phased array, and pulse-echo results are

Figure 24. Visual results for the open-hole panel throughout fatigue

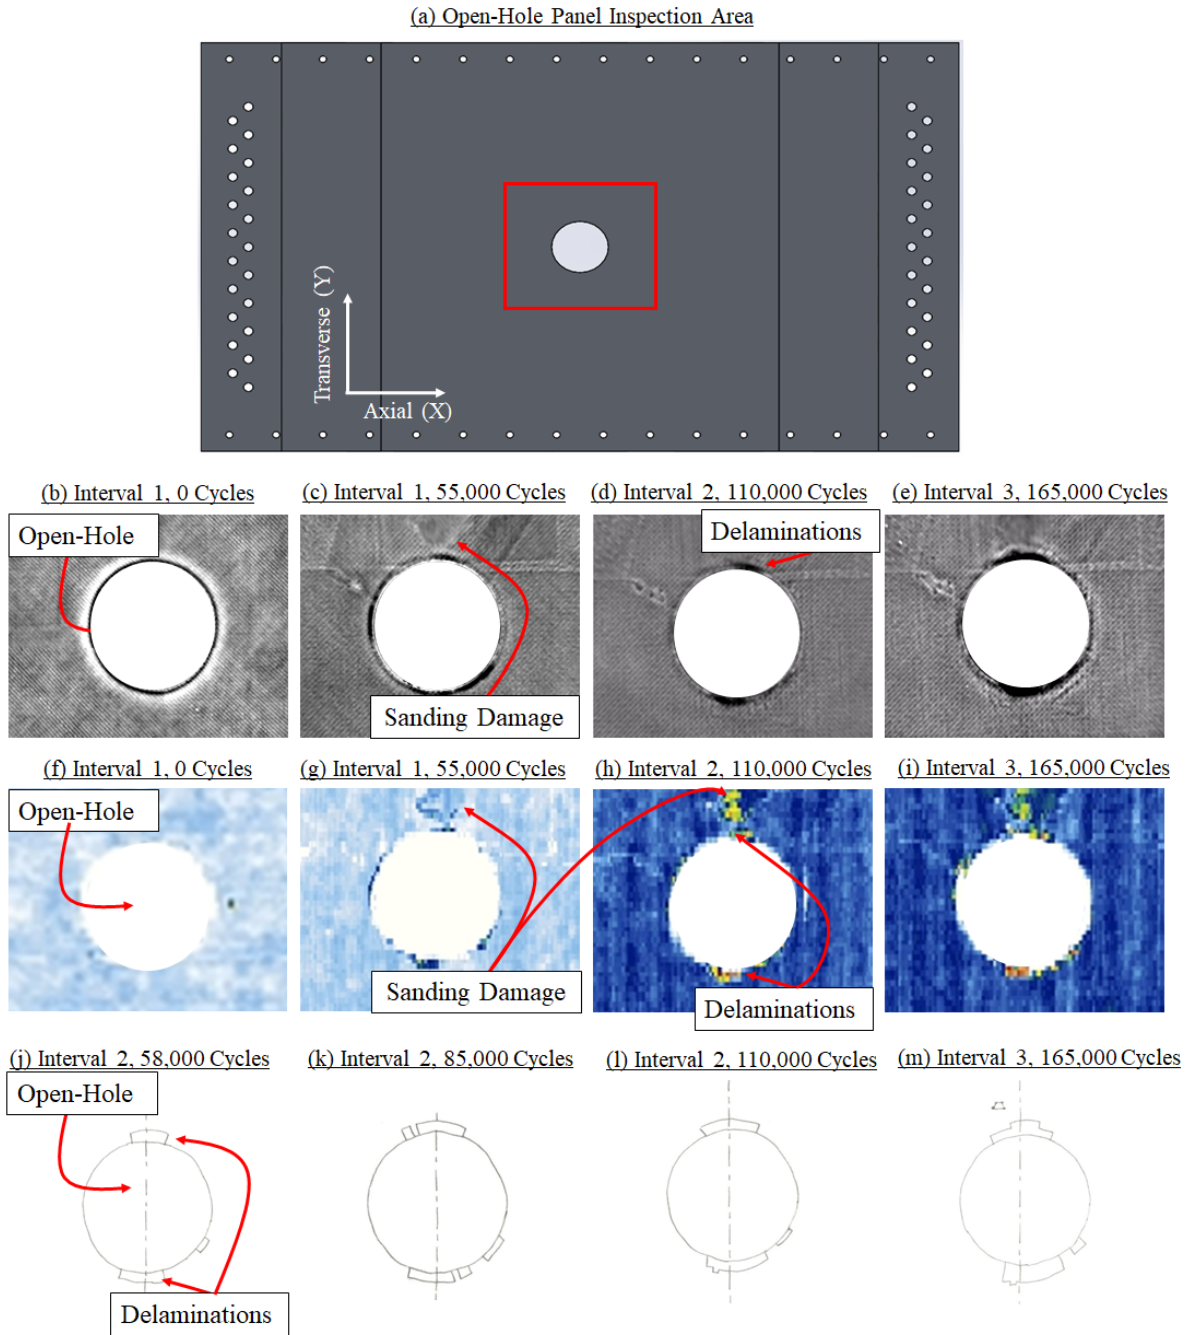
Figure 25. Flash thermography results for the open-hole panel throughout fatigue

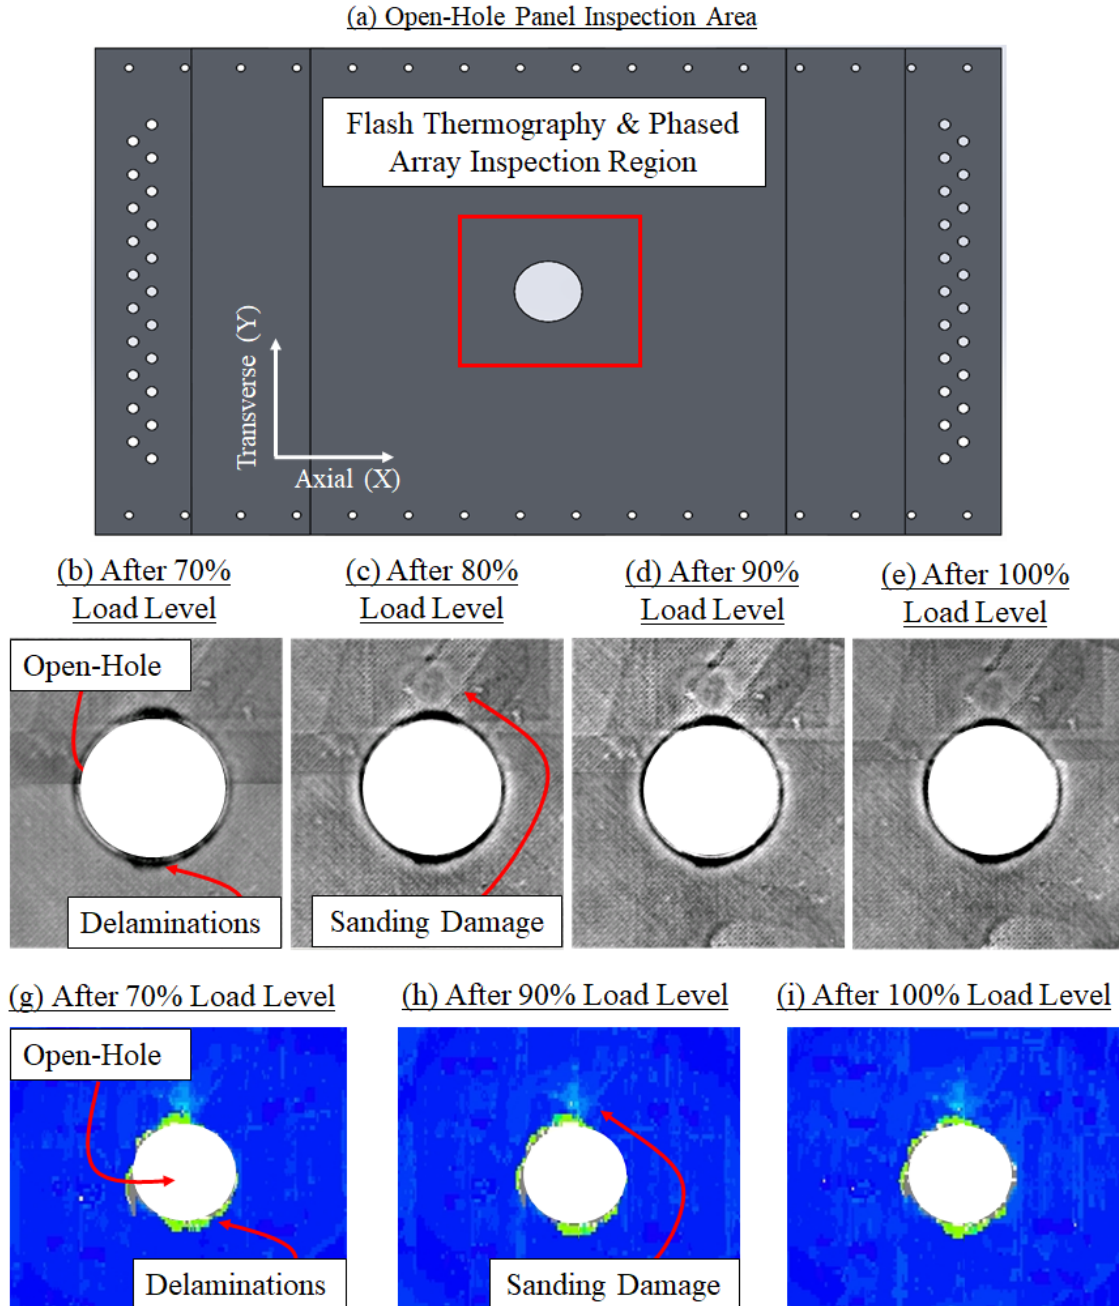
Figure 30. Inspection results during panel 2 residual strength test

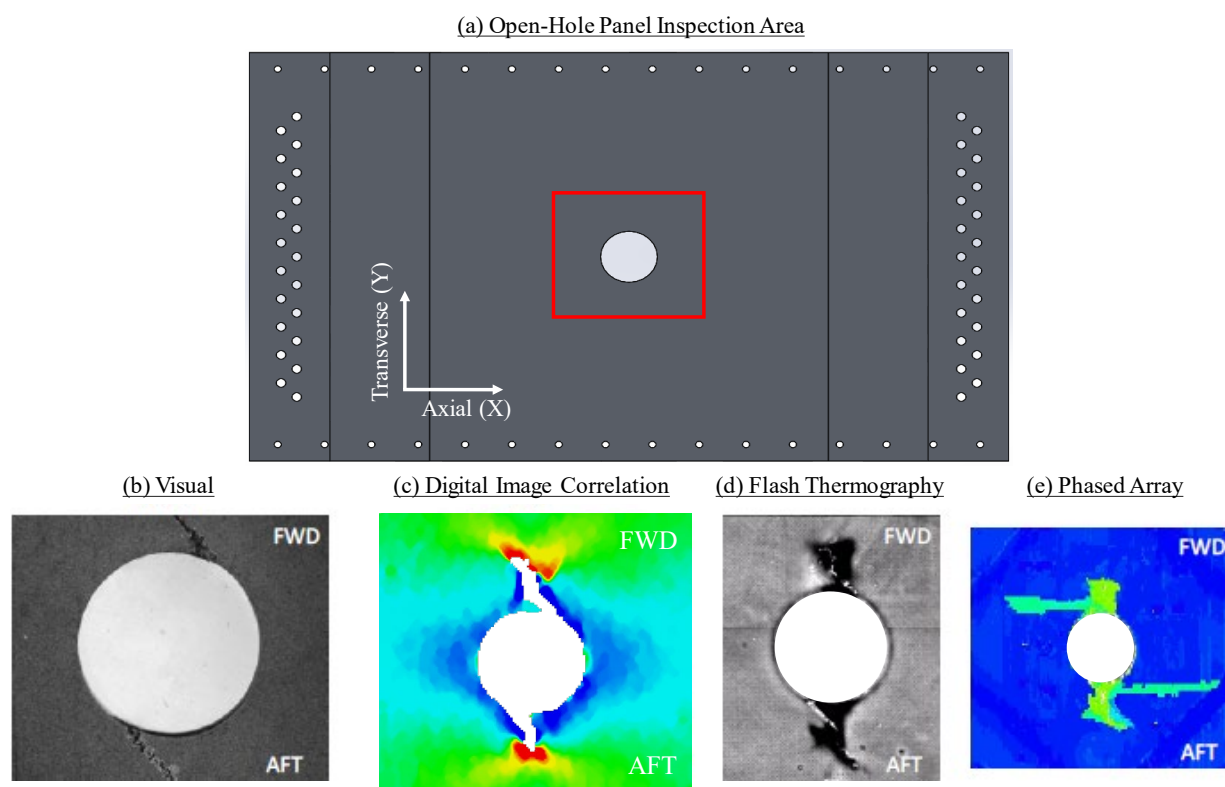
In the final load increment, the panel was quasi-statically loaded to failure. The panel failed through the net section at an applied moment of 116,535 lbf-ft, comparing well to the prediction of 104,734 lbf-ft (as obtained by K_t -based analysis). The damage growth from the hole in the transverse direction was quite rapid and the strain redistribution was evident from DIC results, as shown in Figure 31. This figure also shows the visual image and the NDI results captured by flash thermography and phased array after failure, which were all able to capture the breaking of

the fibers in the net section. The phased array inspection along with the fiber breakage in the net section also showed one of the internal 0° ply delamination. The residual strength test was terminated after the significant failure emanated from the hole edges to conserve the panel for future NDI or fractography studies. The detailed load, strains, and displacement information for each load step is provided in appendix C.

Figure 31. Visual, flash thermography and phased array results after failure of panel 2
