FINAL REPORT

Effects of Service Life of Aluminized Steel Corrugated Pipe with Visible and Not Visible Coating Deficiencies within the Lock System

FDOT Contract Number: BDV25-977-62

July 2021

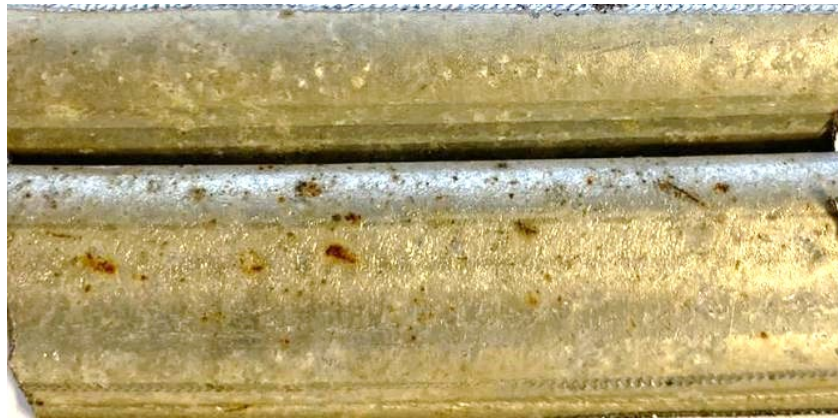
Figure 3.11. Preexisting corrosion in the form of pits around the corrugations and the lock-seam aluminized steel from Plant A.

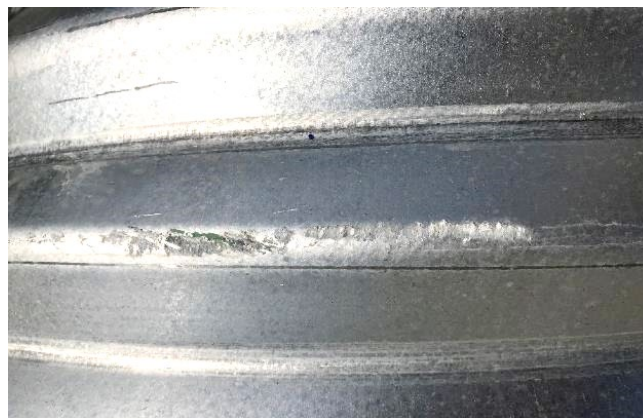
Figure 3.12. Common scrapes in the lock-seam and the corrugations of galvanized steel from Plant B.

Both of the aluminized and galvanized steel pipes had coating scrapes along the corrugations likely a result of transportation and handling as shown above in Figure 3.12. The scrapes did not seem to penetrate the full thickness of the coatings but did result in coating losses of as much as half the coating thickness. Figure 3.13 shows the two types of dents that are common in the metal corrugated pipes. Subfigure A shows an example of a bigger dent that is commonly located in the corrugations, while image B shows the smaller dents that are mostly located in the lock-seams. Figure 3.14 shows a metallographic image of a common coating break in the lock-seam. Not only is there a break in the coating but also delamination from the base metal around the break.

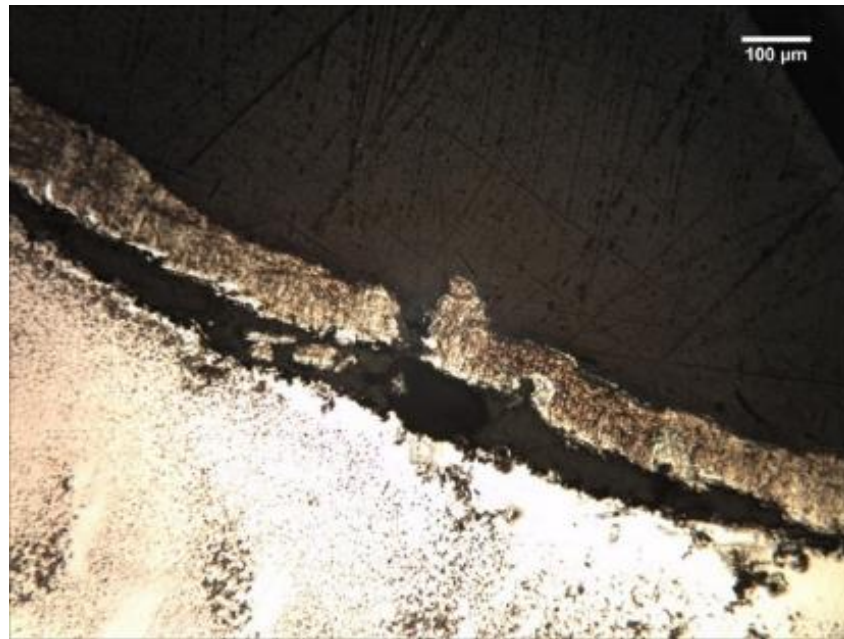
Figure 3.14. Metallographic image of a common coating break in the lock-seam in PLANT A-Al.

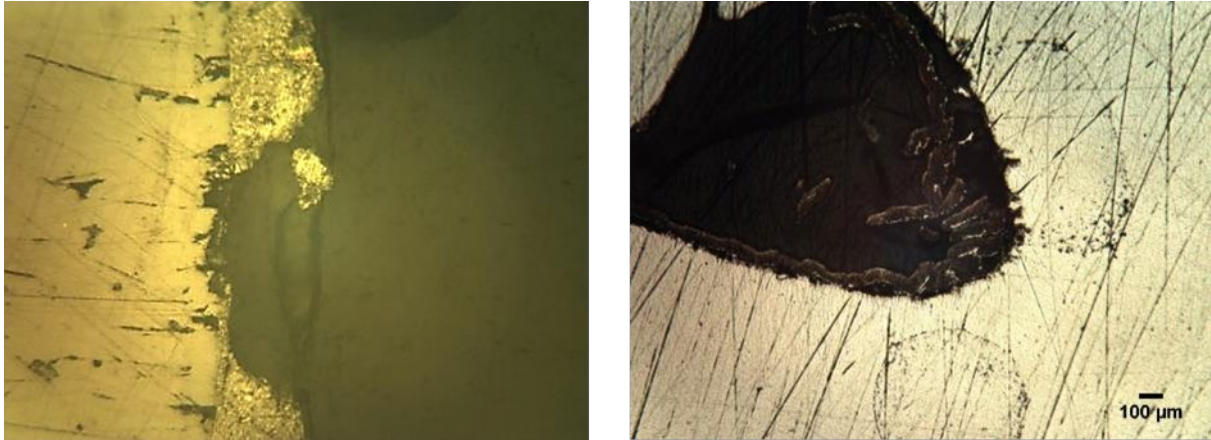
Figure 3.15 and Figure 3.16 show two types of defects in the lock-seam in the aluminized and galvanized steel pipes from Plant A. In both aluminized and galvanized steel, coating breaks and breaks in the intermetallic portions of the coating were observed in all lock-seams. Similar images were obtained from samples of lock-seams from the other plants as well. Since defects within the lock-seams were visible in all of the pipes analyzed, the remainder of the report presents only the size of the defects with only a single photo example from each plant.

Figure 3.15. Metallographic images of coating break and shreds in aluminized steel pipe from Plant A.
