# Durability and Inspection of Hybrid Composite Beams

Final Report VTRC 20-R7

**DURABILITY AND INSPECTION OF HYBRID COMPOSITE BEAMS**

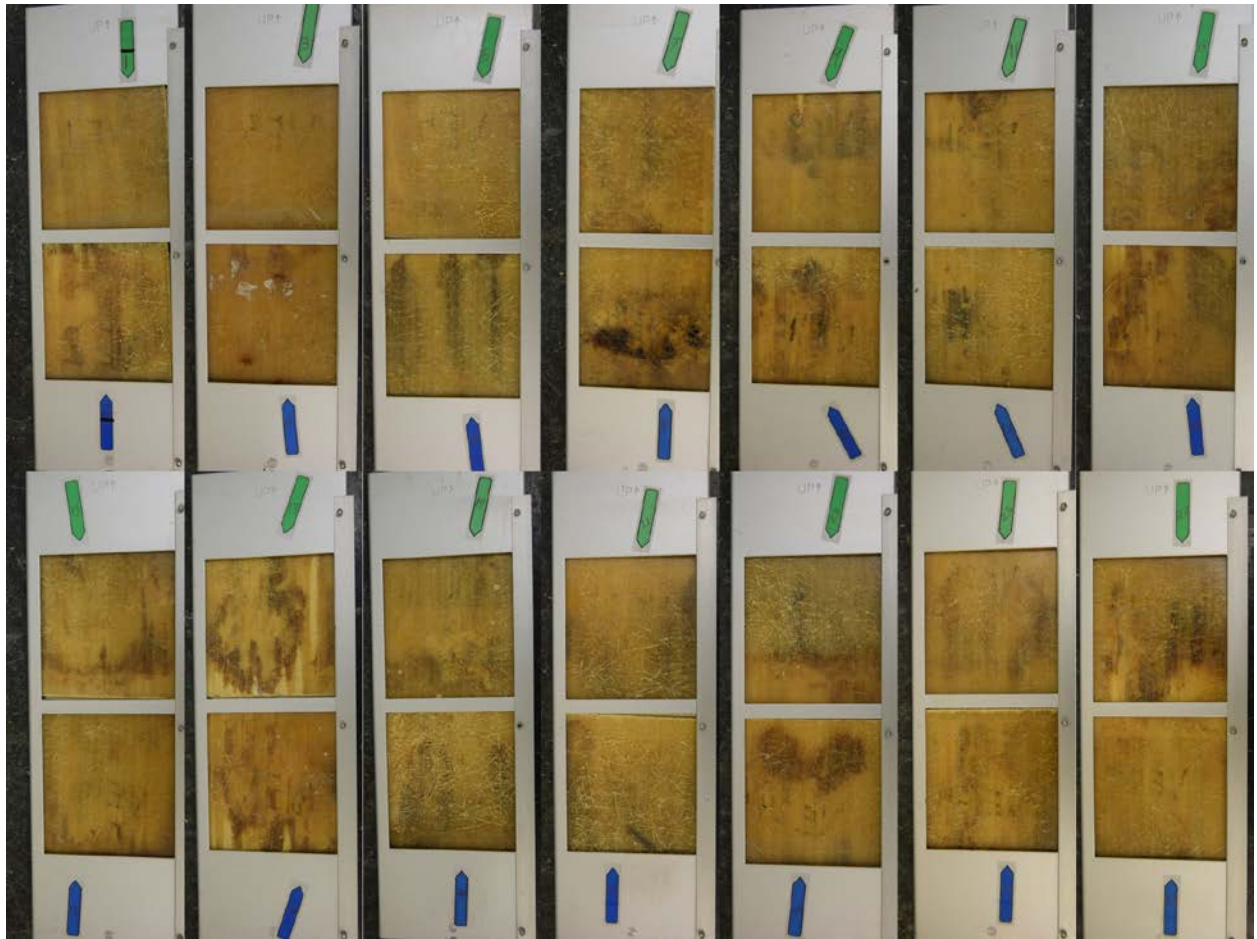
Figures 10 through 12 show the laboratory specimens at 0 hr, 920 hr, and 2,000 hr of UV aging, respectively. Visually, the specimens appear to become darker. However, no damages such as pitting, cracking, or crumbling were observed except on Specimen 8, which developed a burn on the surface at 920 hr (Figure 11). This black spot can be observed to grow bigger at the end of 2,000 hr of UV aging (Figure 12). This might have been because of the presence of a thin delamination from the load testing at Virginia Tech. Based on this, there was a suspicion that the accelerated exposure might be too aggressive in the later stages of the degradation and might not represent the actual conditions of the field structures, so the aging was stopped at this stage.

**Figure 12. Laboratory Specimens at 2,000 Hours of Aging by Ultraviolet Radiation**

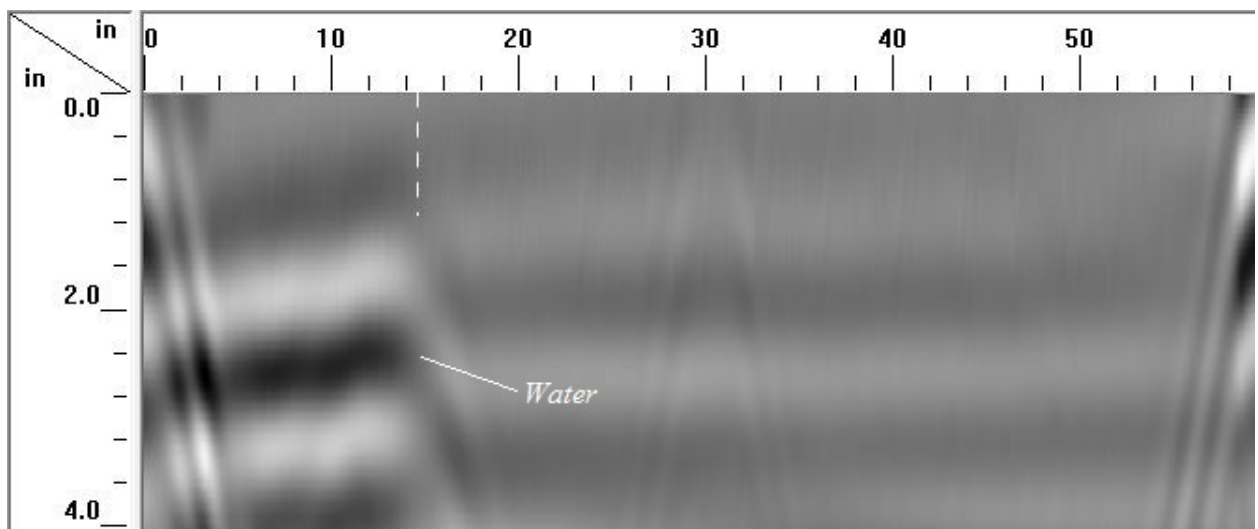
To test the sensitivity of GPR in detecting moisture, three circles of moisture of different sizes were dabbed using a brush at three locations along the same longitudinal section: 5-in, 1-in, and 4-in diameter from the left. Figure 27 shows the results from this scan. The locations of the water locations, even the one as small as 1 in, are clearly visible except that the first location from the left (5 in) was partly hidden by the edge effect.

**Figure 26. Ground Penetrating Radar Scan of Bottom Flange With Moisture**

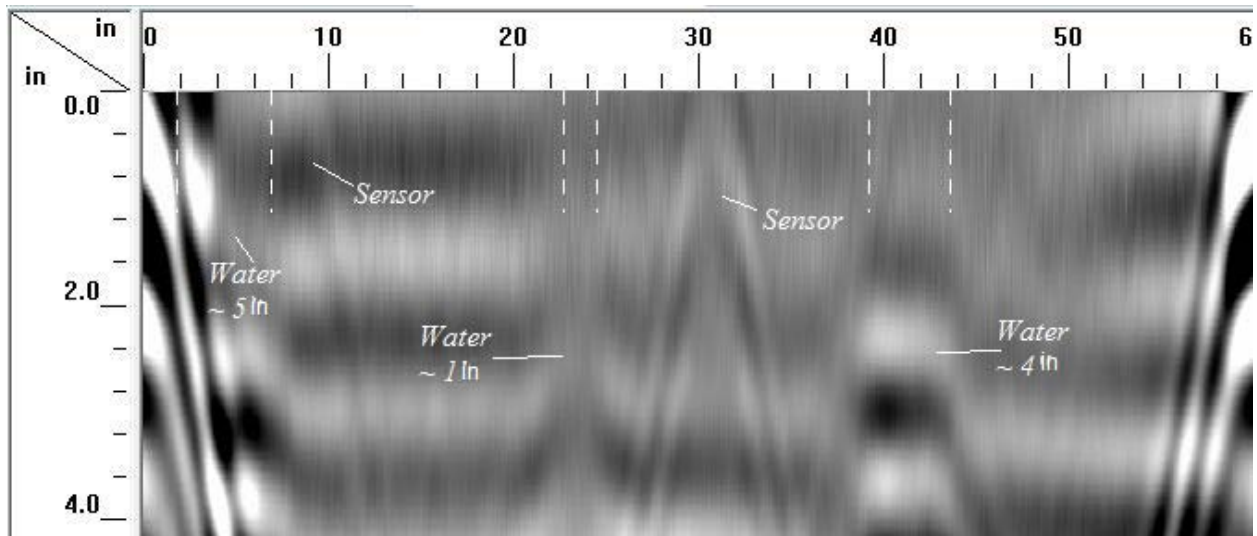
**Figure 27. Ground Penetrating Radar Scan of Bottom Flange With Three Moisture Locations**

This laboratory experimentation proves GPR's capability to detect even a trivial moisture presence inside the HCB.

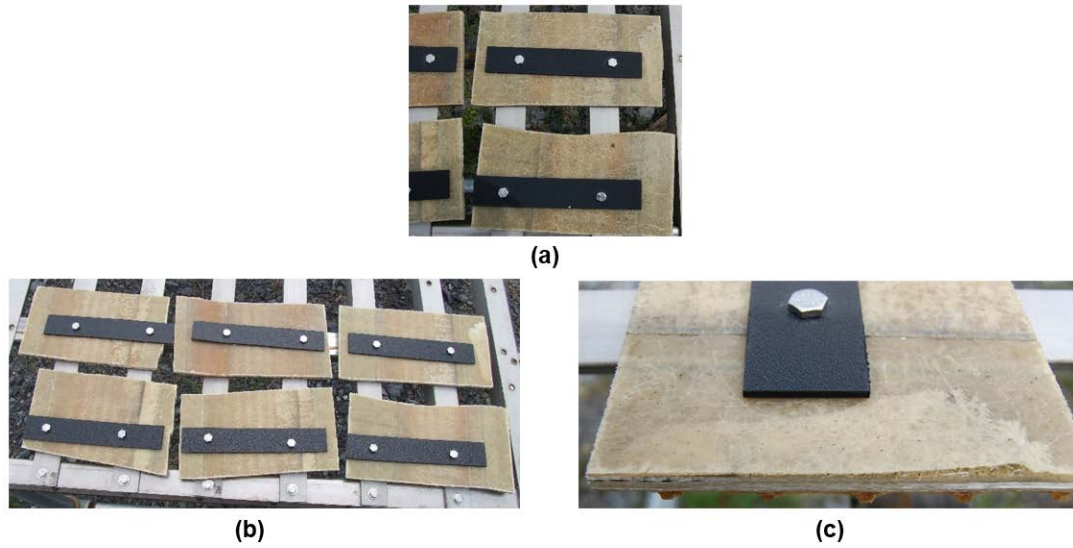
Delamination of the glass layer was observed along a cut edge (Figure 33) in one sample, which was probably attributable to moisture penetrating the sample and expanding and contracting during seasonal cycles of freezing and thawing. Most of the specimens, however, visually seemed to have performed well and did not show signs of substantial degradation. This response was especially surprising for the foam specimens (Figure 35) since this component of the composite beam was somewhat protected from the weather because it was placed inside the fiberglass shell that makes up the beam.

**Figure 33. Comparisons of Fiberglass Specimens: (a) initially; (b) several specimens after 1 year and 8 months; (c) close-up of delaminated edge after 1 year and 8 months**

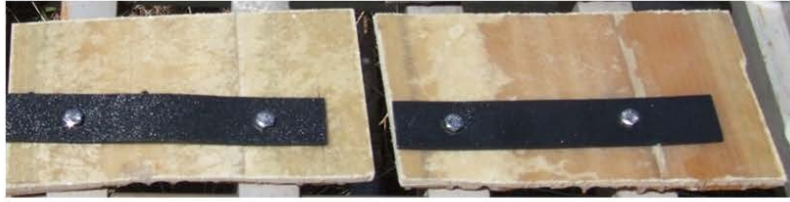
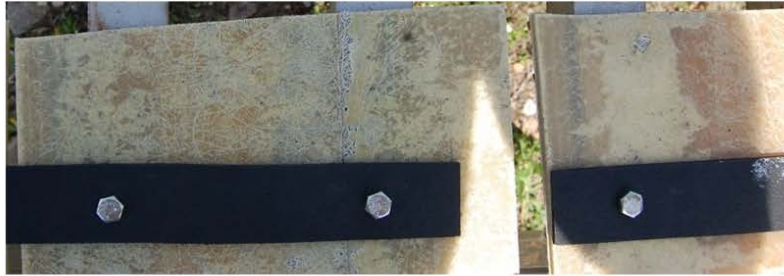
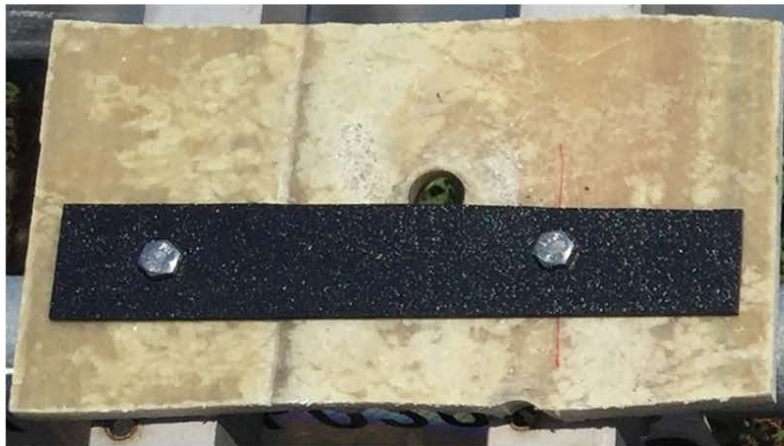
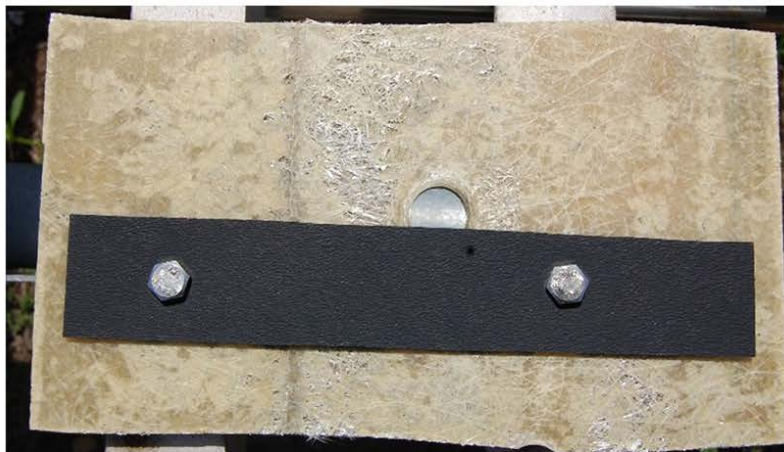
Delaminations and damage to the exterior surface of the fiberglass layer were observed (Figure 36) in several specimens. Other test specimens that exhibited damage also included the foam, which clearly exhibited more damage, as seen in Figure 38. This was interesting since the weather data for this site were less extreme as compared to the Harrisonburg site with the exception of the UV index data. Therefore, it appears that although the composite beam components showed only minor deterioration, UV exposure most likely contributed the most to damaging the exposed components.

**Figure 36. Comparisons of Fiberglass Specimens: (a) initially; (b) after 1 year and 8 months, exhibiting delamination and exposure of the fibers; (c) in an area that initially had some fibers showing; (d) observed to have grown larger after 1 year and 8 months**

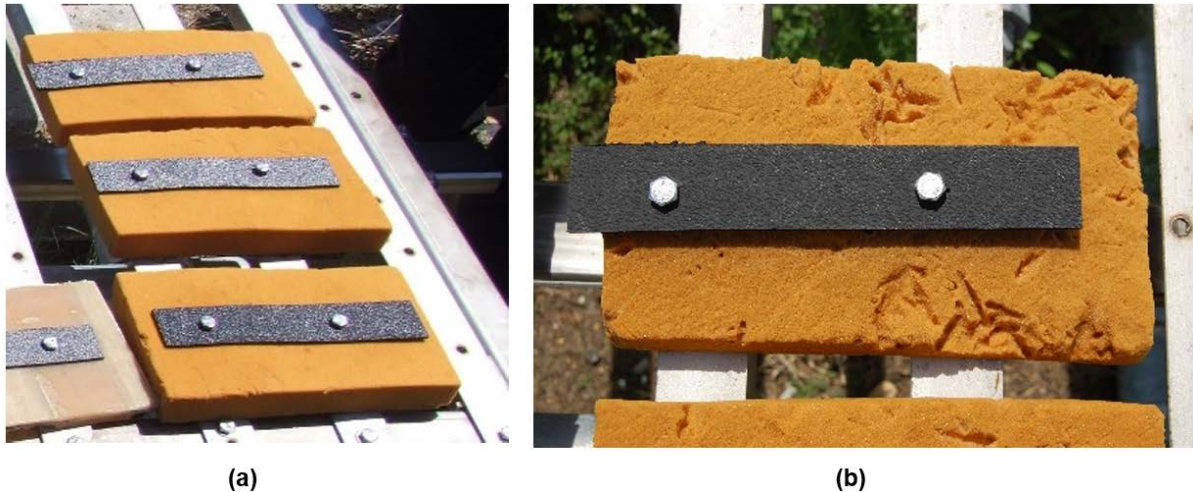
**Figure 38. Comparisons of Foam Specimens: (a) initially; (b) after 1 year and 8 months showing how foam has degraded and exhibits loss of material, especially along the edge because of exposure**
