# Best Practices for Pavement Restoration of Open Cut Utility Installations/Repairs on Local Roadways in Ohio

Prepared by Mary Robbins, Roger Green, Teruhisa Masada, and Dane Redinger (Resource International, Inc.)

June 2019

Final Report

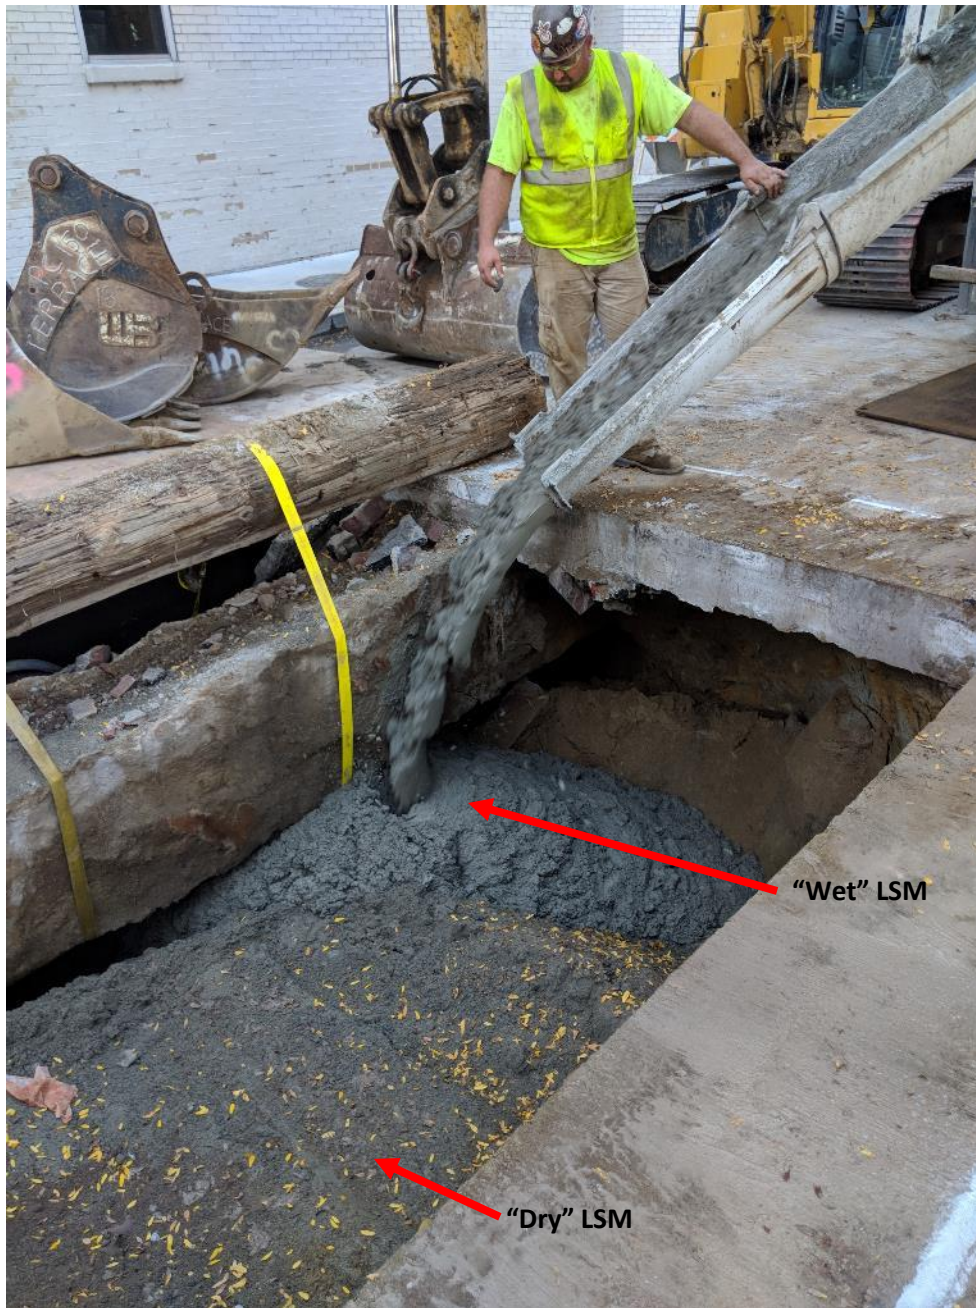
A large open utility cut repair on a concrete pavement for the repair of a sanitary sewer line in City of Cleveland was being restored when the research team visited. It was observed that the first load of LSM delivered to the site appeared dry, whereas the second load appeared wet, as shown in Figure 23. Samples of both materials were collected and allowed sufficient time for the material to set. The sample of "wet" LSM, shown on the left in Figure 24, set, whereas the "dry" sample of LSM remained granular. As shown, the "dry" sample did not set, and therefore will not provide the level of performance anticipated with LSM. This highlights the importance in adherence to the specification for backfill material.

Figure 23 Observed open cut utility repair in progress, City of Cleveland.

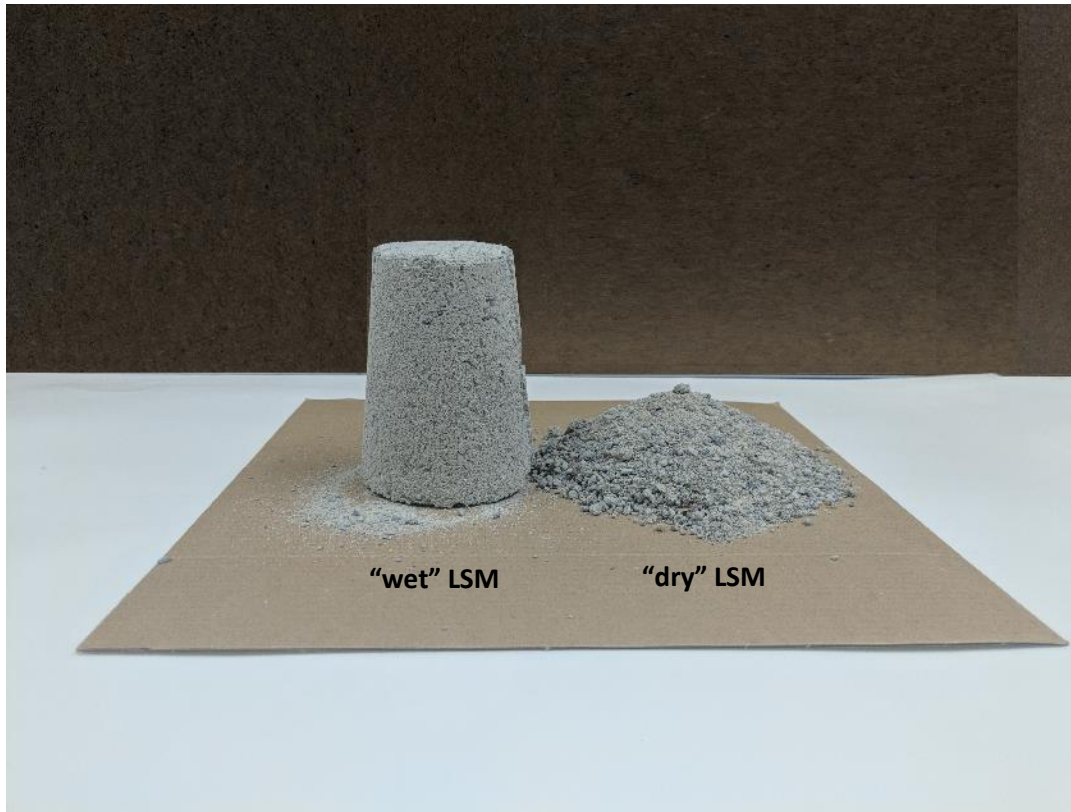
**Figure 24 LSM samples from observed repair after allowed to set, City of Cleveland.**

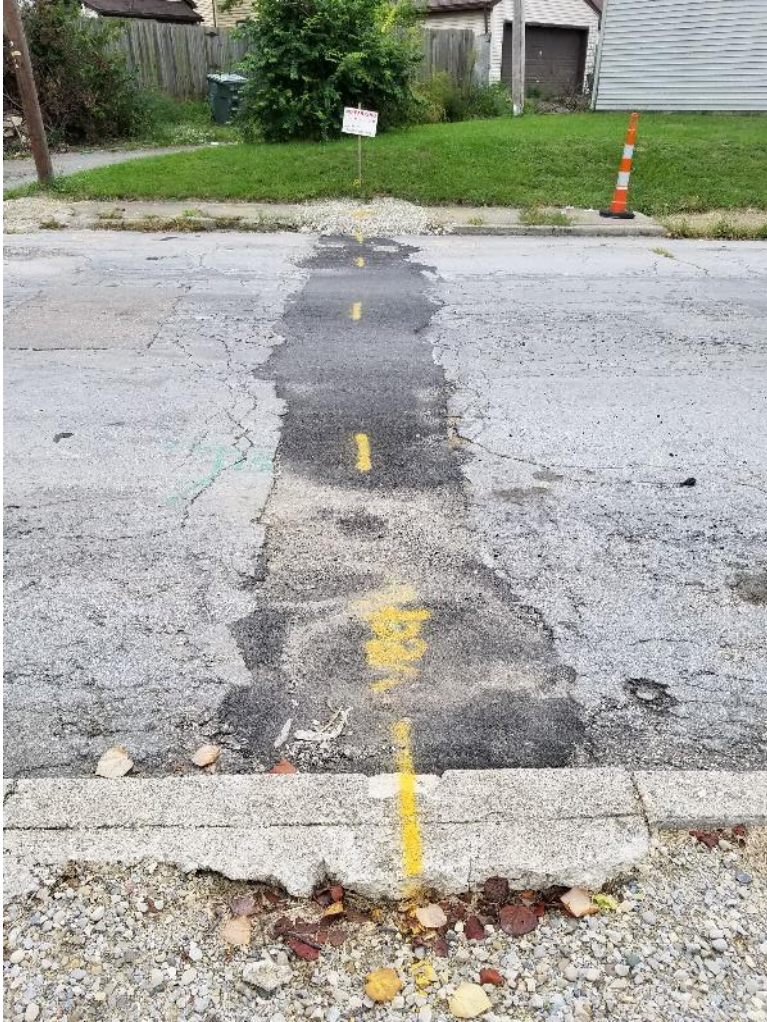
The research team observed the permanent repair of a gas service line on an asphalt pavement. It was revealed during the in-person interview that all repairs are initially performed as temporary repairs. Numerous repairs were being repaired or had been recently completed by the same contractor on the same street as the repair in-progress. Therefore, the research team had an opportunity to observe the repairs at different stages of the process. An example of the surface of temporary repair is provided in Figure 25. In Figure 26, the repair has been saw cut to provide the overcut and straight edges, and granular base is being compacted as part of the permanent repair. An example of the permanent repair surface is shown in Figure 27.

**Figure 25 Example of temporary repair prior, City of Dayton.**

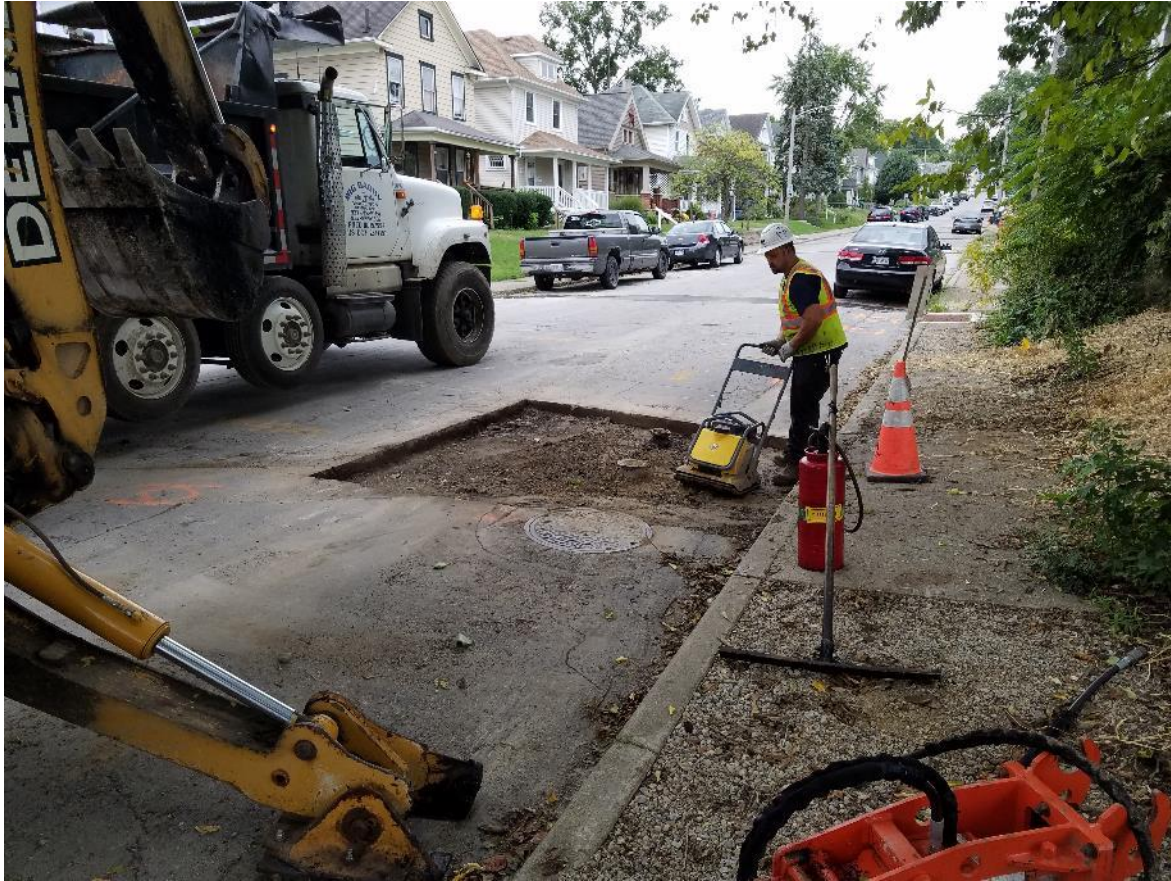
Figure 26 Example of granular base compaction during repair of open utility cut, City of Dayton.

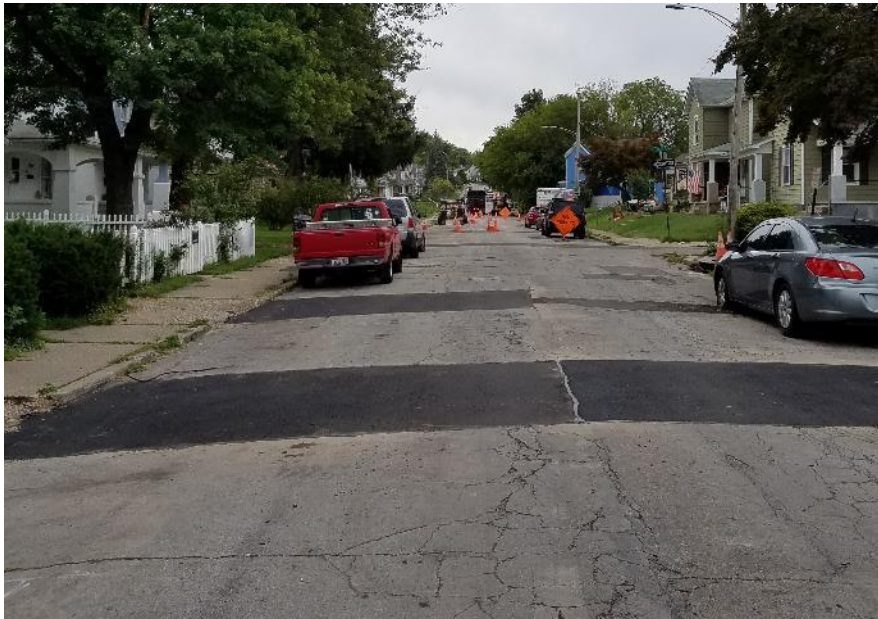
Figure 27 Example of completed permanent repair, City of Dayton.

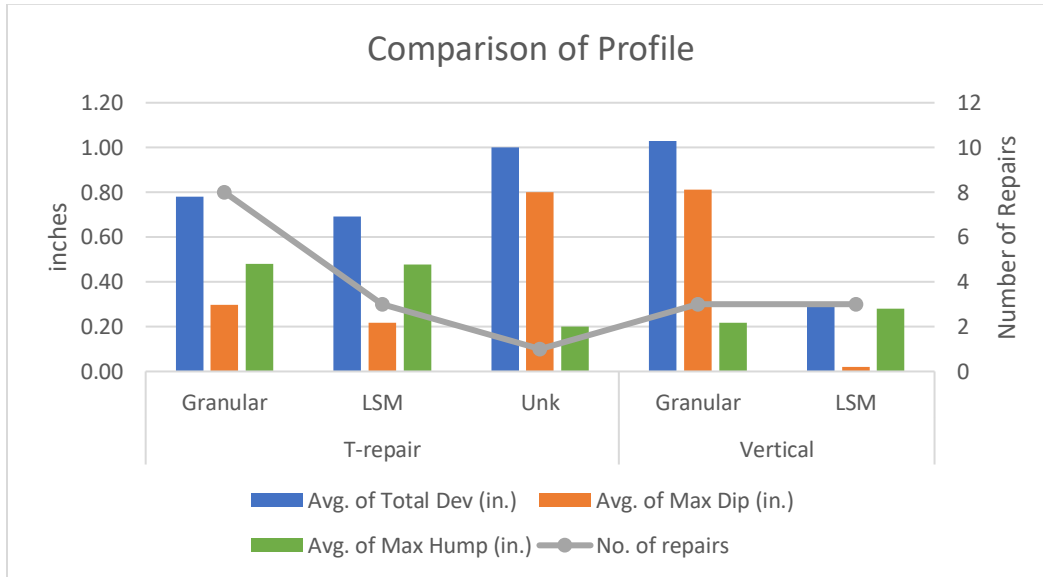
three vertical repairs backfilled with granular material, the average total deviation and average maximum dip were greater than the average total deviation and average maximum dip for all other combinations of repair and backfill material. While this may indicate there is a tendency towards settlement for vertical repairs backfilled with granular material, there are too few repairs of each combination to truly draw conclusions on this topic.

**Figure 79 Comparison of average profile characteristics by repair type and backfill material used (1 in = 2.54 cm).**
