# FINAL PROJECT REPORT #00059416

## Durability of GFRP Bar Reinforcement Extracted from In-service Concrete Structures

**Participating Consortium Member:**  
Missouri University of Science and Technology

Dr. John J. Myers, Ph.D., P.E., (PI)  
Ali Al-Khafaji, P.E.

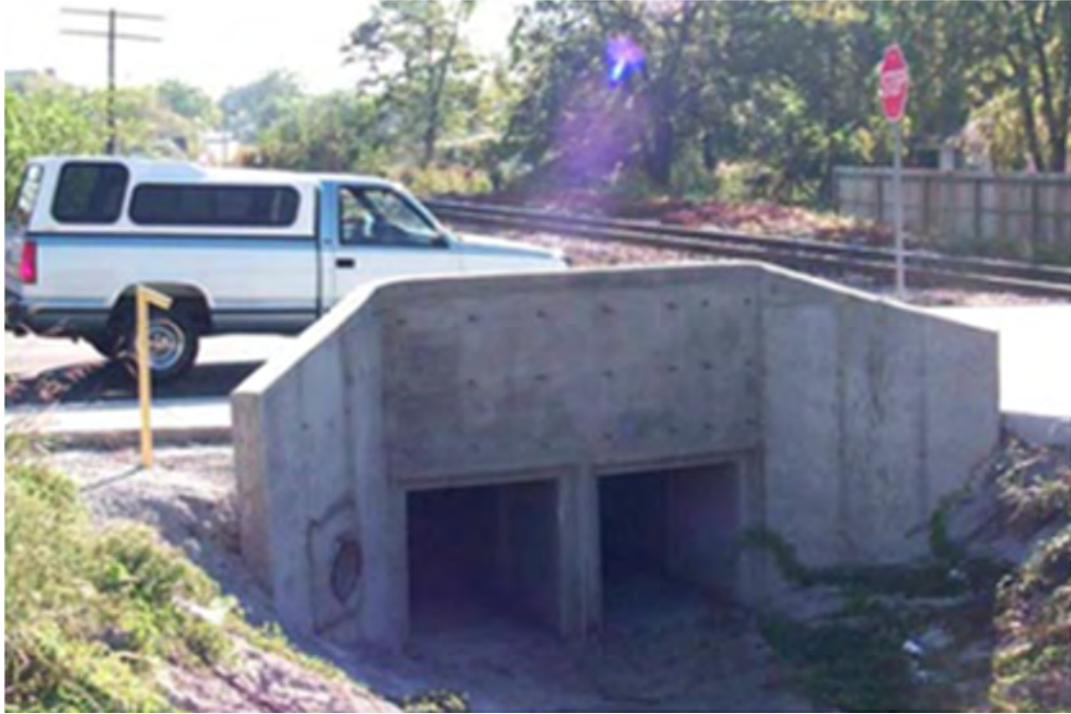
*Fig. 30–Walker Box Culvert Bridge*

Six concrete cores were extracted from Walker Box Culvert Bridge. The extracted cores were taken near cracked areas, where the concrete is most affected by environmental conditions, as shown in Fig. 31.

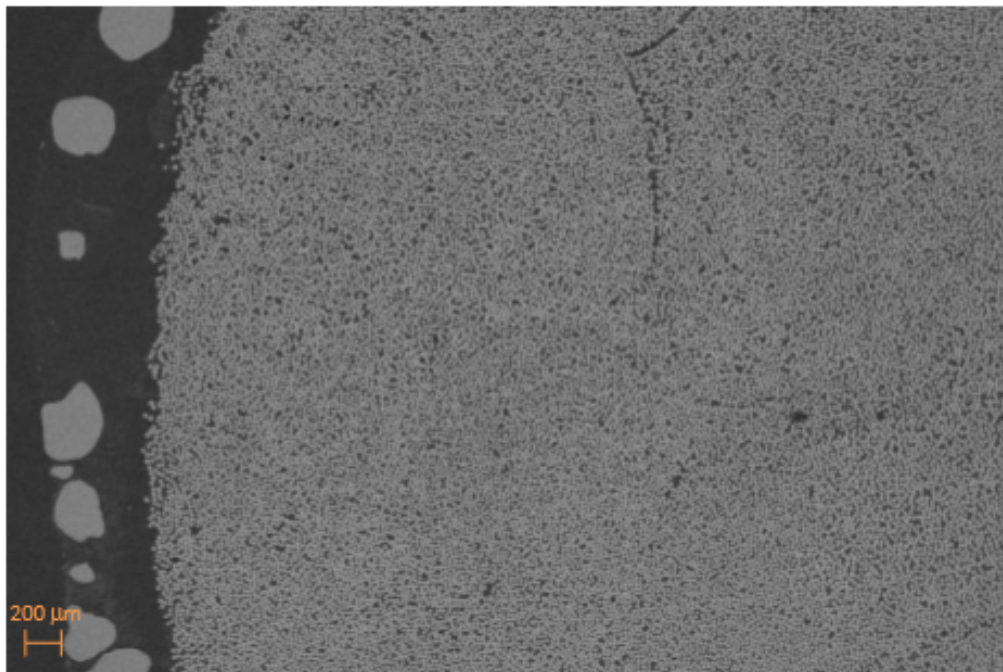
Fig. 28: VA\_C4\_B2

The fibers evidently affected (192 out of 352,000 fibers) were estimated from counting fibers with obvious signs of damage in 1 quadrant, multiplied by 4. The extrapolation for affected fibers (412 out of 352,000 fibers) was estimated from counting fibers with obvious signs of damage and fibers with polishing artifacts in 1 quadrant, multiplied by 4. This quantity is much less than expected or predicted by accelerated test methods, The results of each bar is shown in Fig. 28 through Fig. 31.

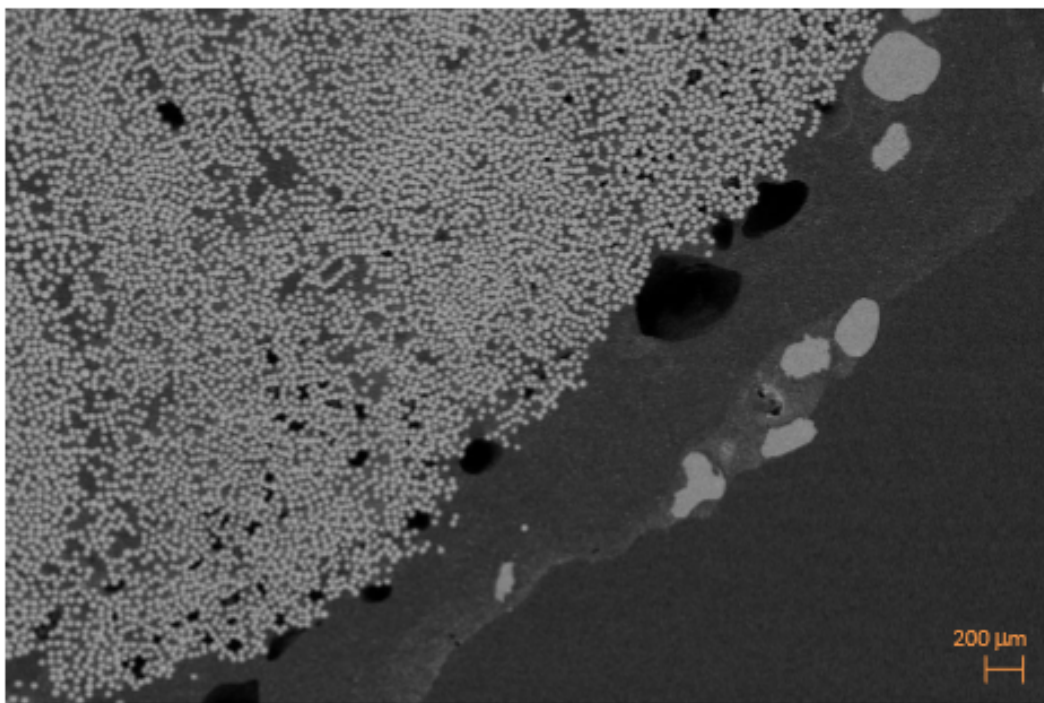
*Fig. 32: OH2\_C5\_B2*

SEM imaging for *Cuyahoga Bridge* was performed at Owens Corning. GFRP rebar extracted from Cuyahoga bridges show some damage on 0.05 to 0.12 % of the glass fibers. This is much less than expected or predicted by accelerated test methods, and has a negligible impact on mechanical properties. The affected fibers were typically on the outer edge of the rebar. The results of each bar is shown in Fig. 32 through Fig. 35.

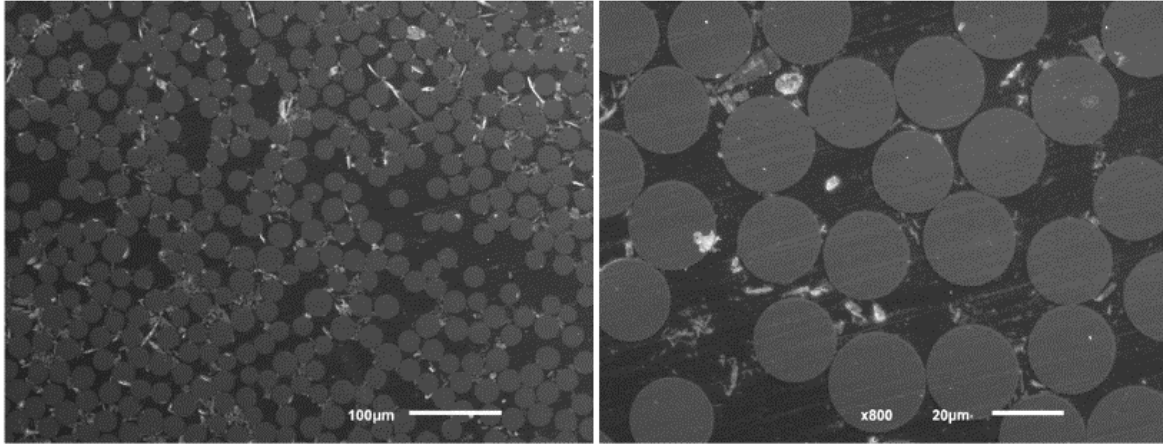
SEM analysis suggests that there was no apparent sign of deterioration in the GFRP coupons. No damage was observed in the matrix and at the matrix-fiber interface. Glass fibers appeared to be intact without no loss of cross-sectional area.

Fig. 113. SEM image of GFRP bar after 16 years of service in Walker Bridge at magnifications of 200x (left) and 800x (right)
