APPENDIX A: AASHTO PROVISIONAL STANDARDS FOR CRACK SEALANT TESTS

APPENDIX T: PERFORMANCE EVALUATION OF NEWLY-INSTALLED CRACK SEALING PROJECTS (PHASE 3)

APPENDIX U: PERFORMANCE EVALUATION OF OLD CRACK SEALING PROJECTS (PHASE 4)

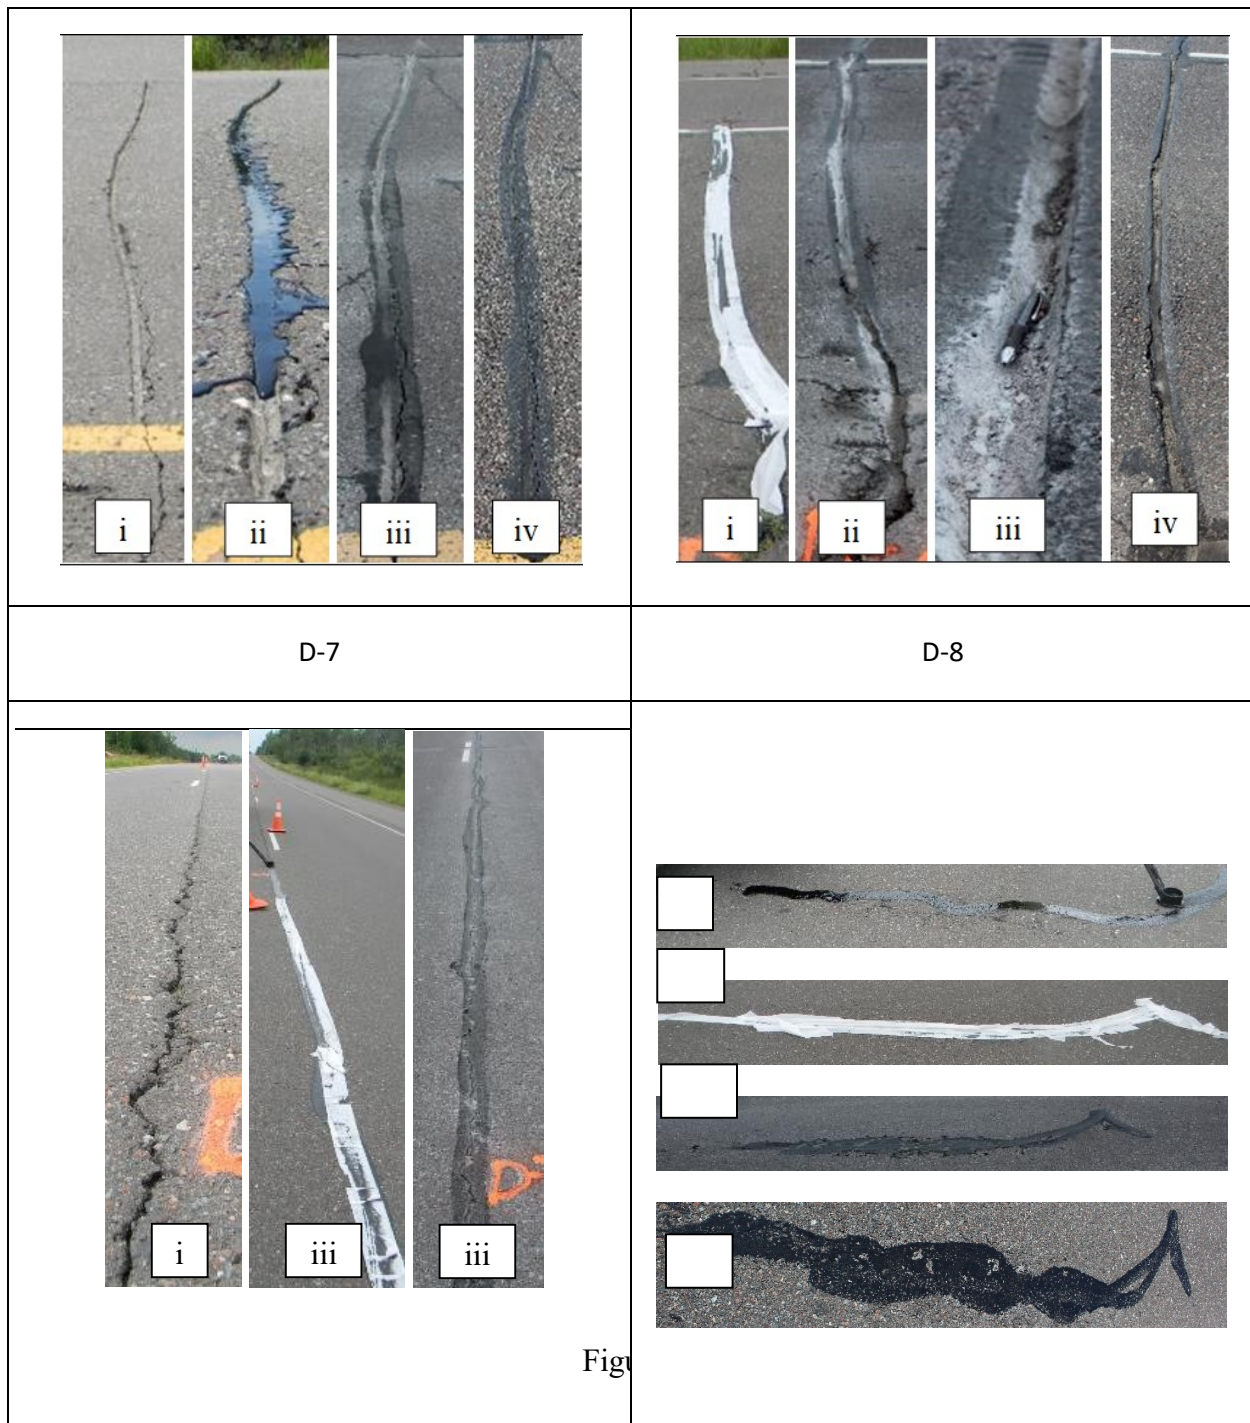
Photographic documentation of seal performance at Site D. D-1-i Shows Crack D-1 prior to being sealed. D-1-ii shows Crack D-1 immediately after being sealed. D-1-iii shows Crack D-1 at the end of its first winter after being sealed, and D-1-iv shows Crack D-1 fter its second winter of service. This same sequence of photos follows for cracks D-2, D-4, D-5, and D-8. The images presneted for Cracks D-4 and D-7 show the cracks prior to being sealed, immeditaeyl after being sealed, and during the frist winter since being sealed. D-6-iii shows the

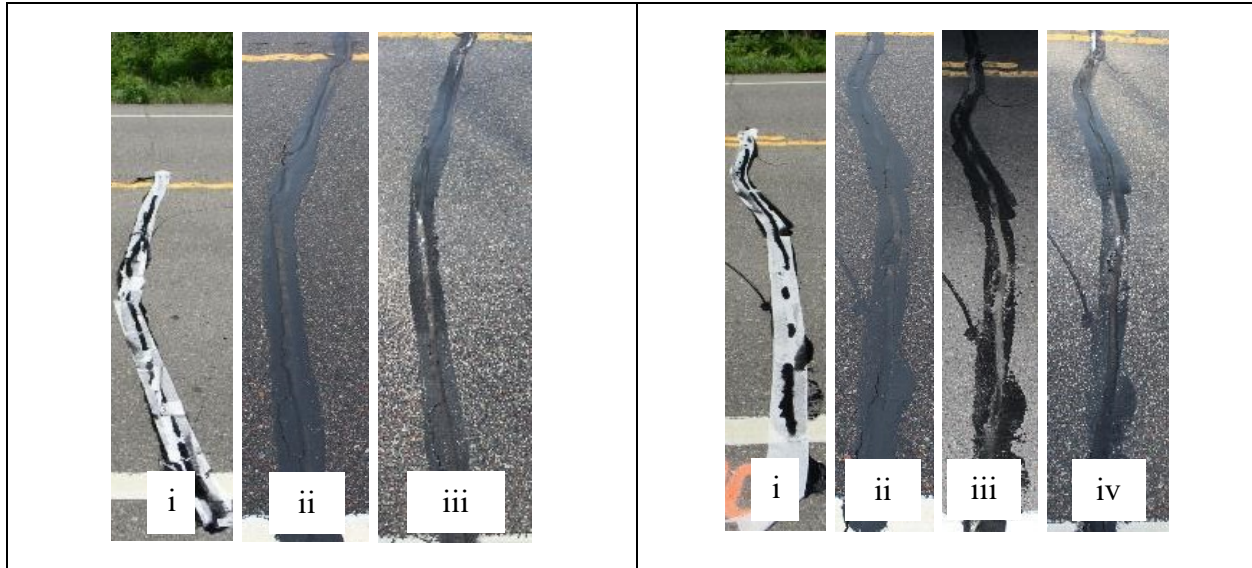
Photographic Performance Documentation of Site E. E-1-i Shows Crack E-1 upon being sealed. E-1-ii and E-1-iii shows Crack E-1 at the end of its first winter and during the second winter after being sealed. This same sequence of photos follows for cracks E-2, E-3, E-4, E-5, E-6, E-7, E-8, E-9, and E-10. E-10-iv shows the seal performance at the end of the first winter compared to the mid-winter performance presented in E-10-iii.

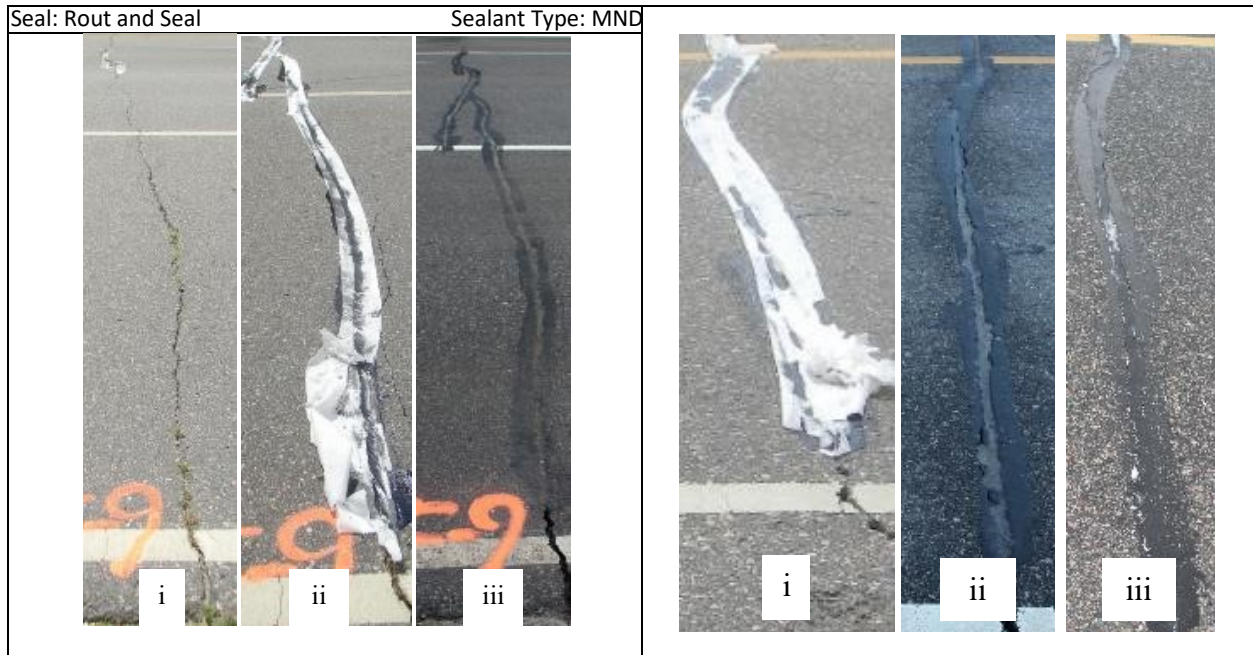
Photographic performance documentation of Site F. F-1-i shows Crack F-1 prior to being Sealed. F-1-ii shows Crack F-1 immediately after being sealed. F-1-iii and F-1-iv show Crack F-1 at the end of its first and second winter after being sealed. This same sequence of photos follows for Cracks F-2 and F-3. F-4-1 shows Crack F-4 immediately after being sealed. F-4-ii and F-4-iii show Crack F-4 after the first and second winter since being sealed. This same sequence follows for F-6, F-7, F-9 and F-10. Cracks F-5 and F-9 were not sealed and saw no noticeable deterioration over the two-year analysis.

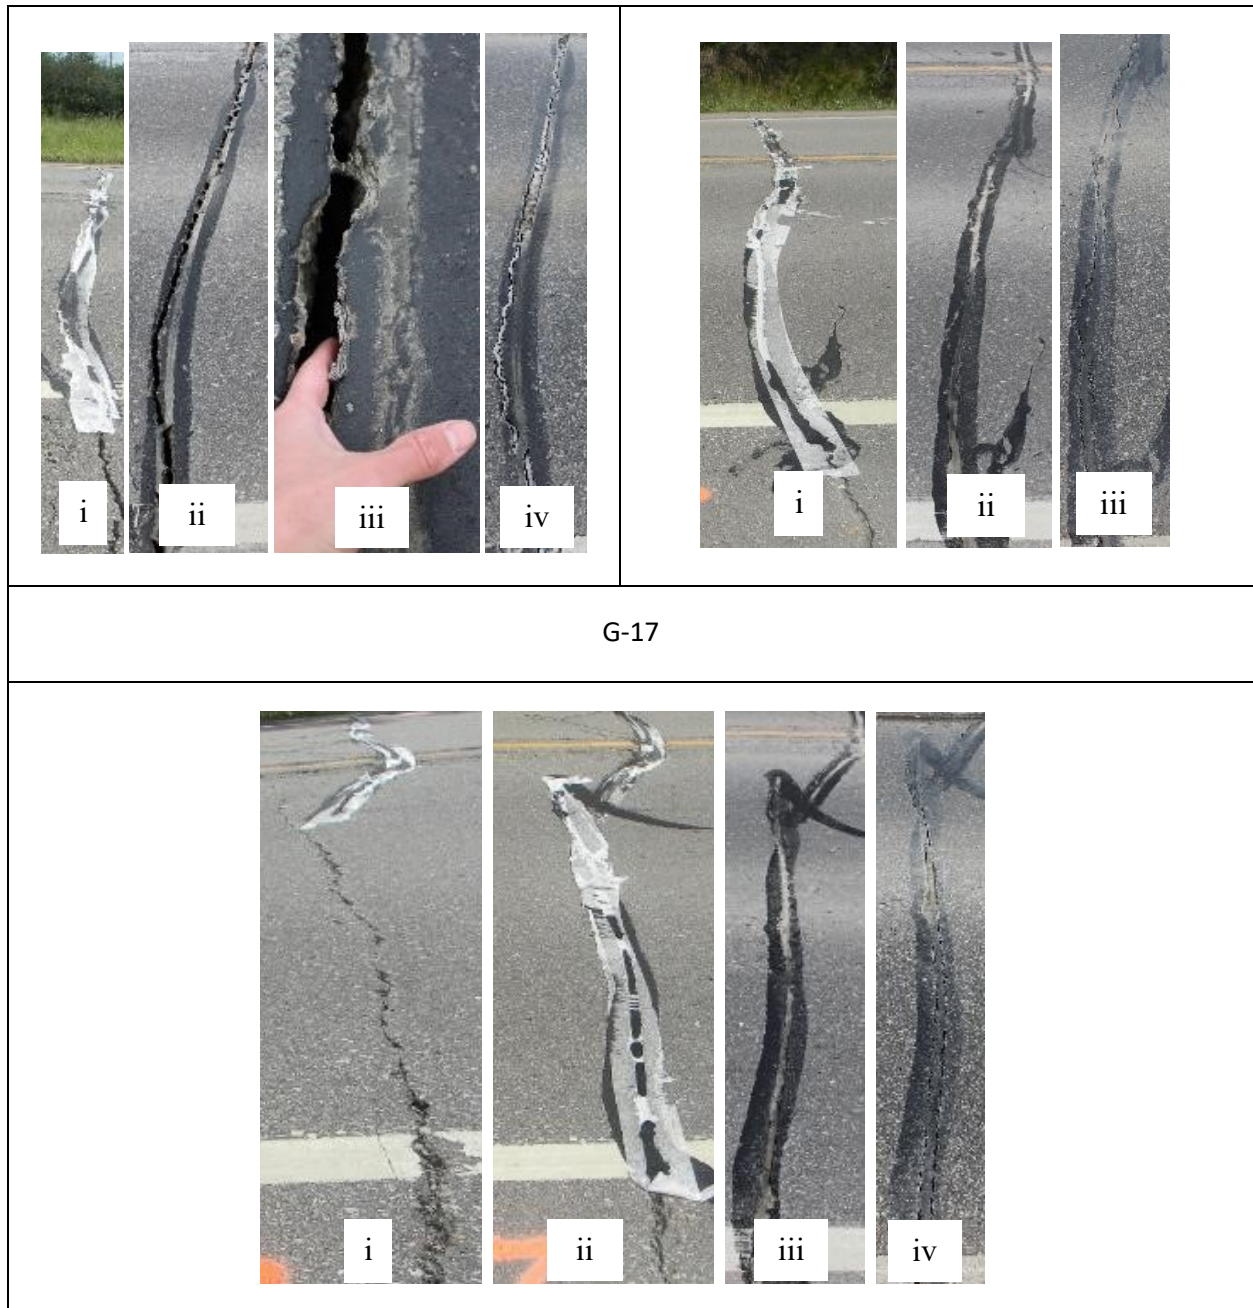
Photographic performance documentation of Site G. G-1-i shows crack G-1 immediately after being sealed. G-1-ii and G-1-iii show Crack G-1 during the first and second winter since seal installation. This same sequence follows for Cracks G-3, G-4, G-5, G-6, G-7, G-8, G-9, G-10, G-11, G-13, G-14, and G-16. Photos i, ii, and iv of cracks G-15 and G-15 show the seal immediately after installation and during the first and second winter since installation, while photo iii shows a close-up of seal failure in each crack. Crack G-17 shows images before, after and during the first and second winter.

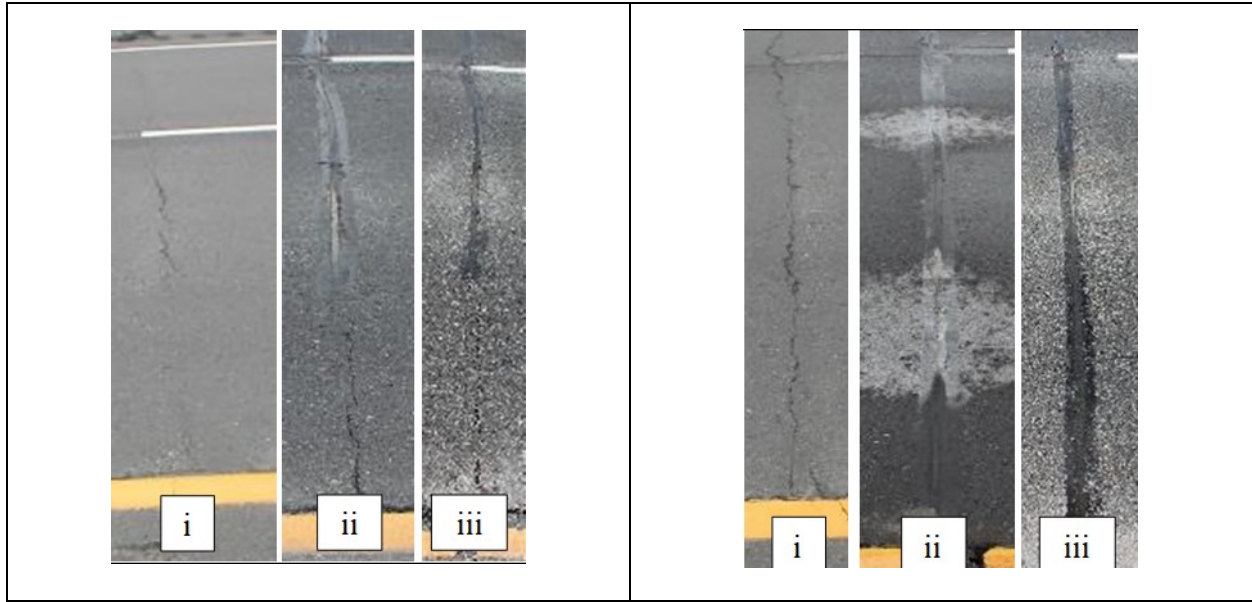
Photographic documentaion of site H performance. Photos i, ii, iii, and iv show cracks H-1, H-2, and H-6 before, after, and during the first and second winter. Photos i and ii show cracks H-3 and H-8, left unsealed, during the first and second winter. Crack H-4 is represented by photos immediately after sealing, a close up during the first winter, and overviews of the first and second winter. Crack H-5 is represented by four photos taken immeditaly after being sealed, during the first summer, and the first and second winter. Crack H-7 is represented immeditaely after being sealed, then during the first and second winter. Cracks H-9 and H-10 are depicted by photos taken before being sealed, then during the first and second winters.

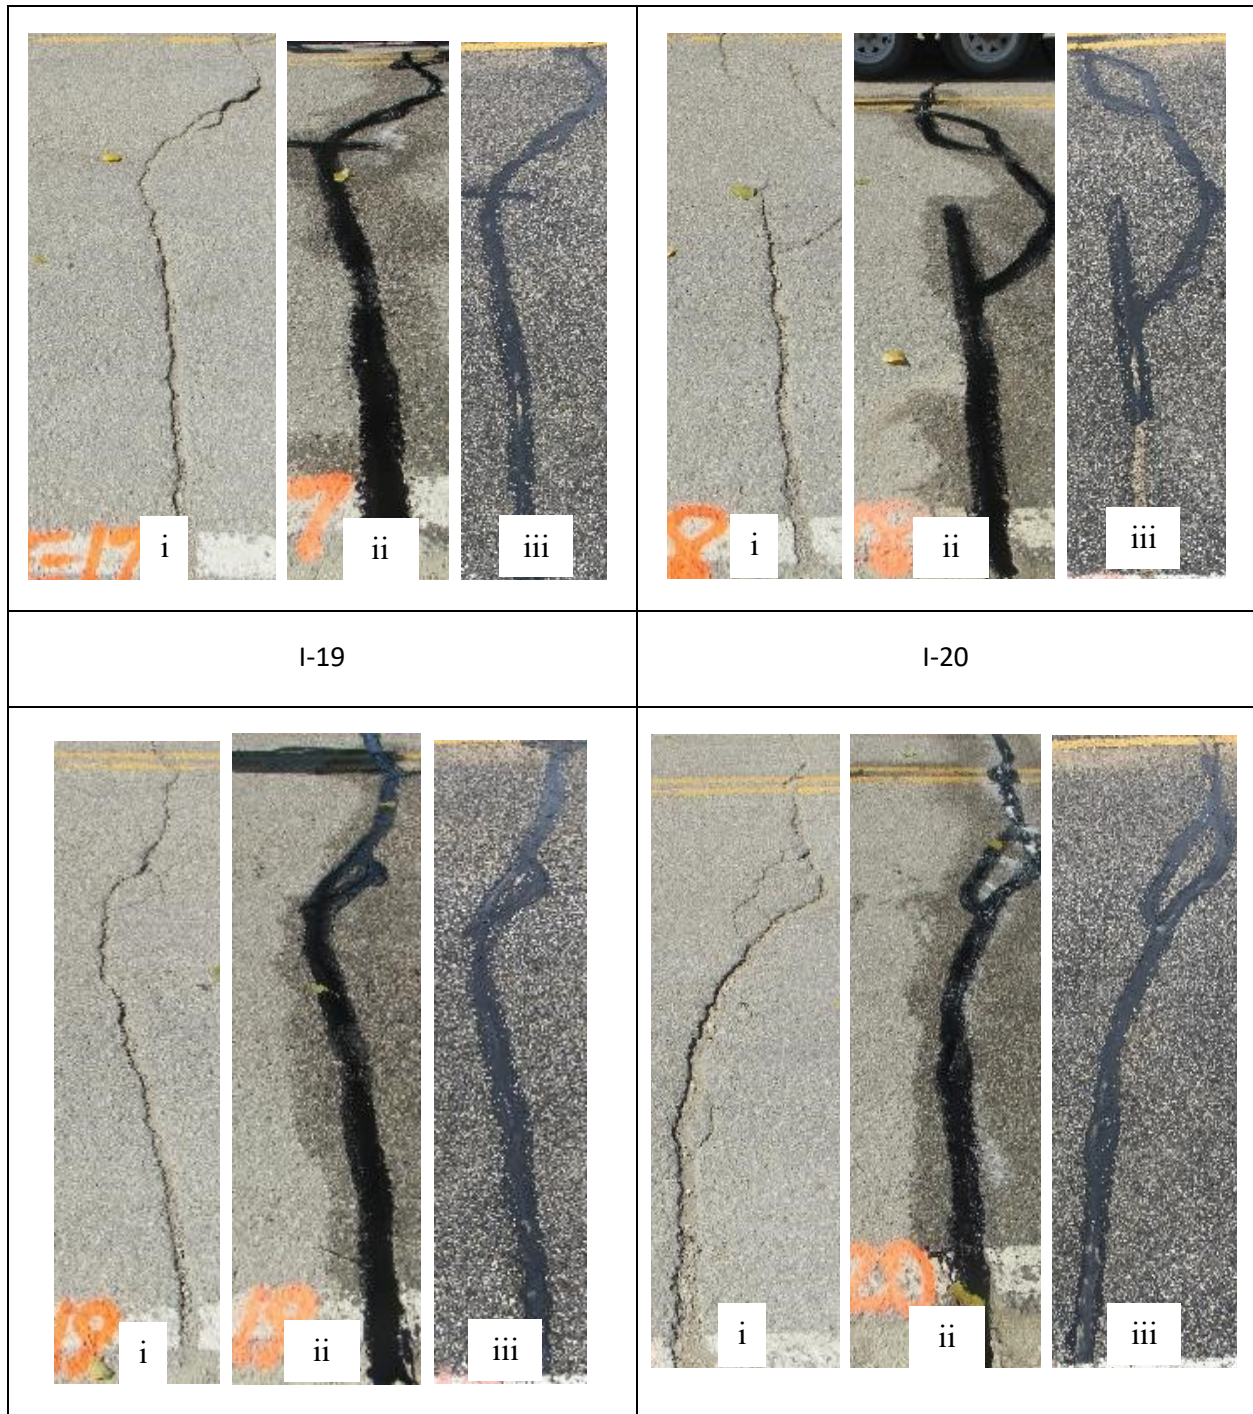
Photographic Performance Documentation of Site I. I-1-i Shows Crack I-1 prior to being Sealed. I-1-ii Shows Crack I-1 immediately after being Sealed. I-1-iii Shows Crack I-1 after the First Winter since being Sealed. This same sequence of photos follows for cracks I-2 through I-20.

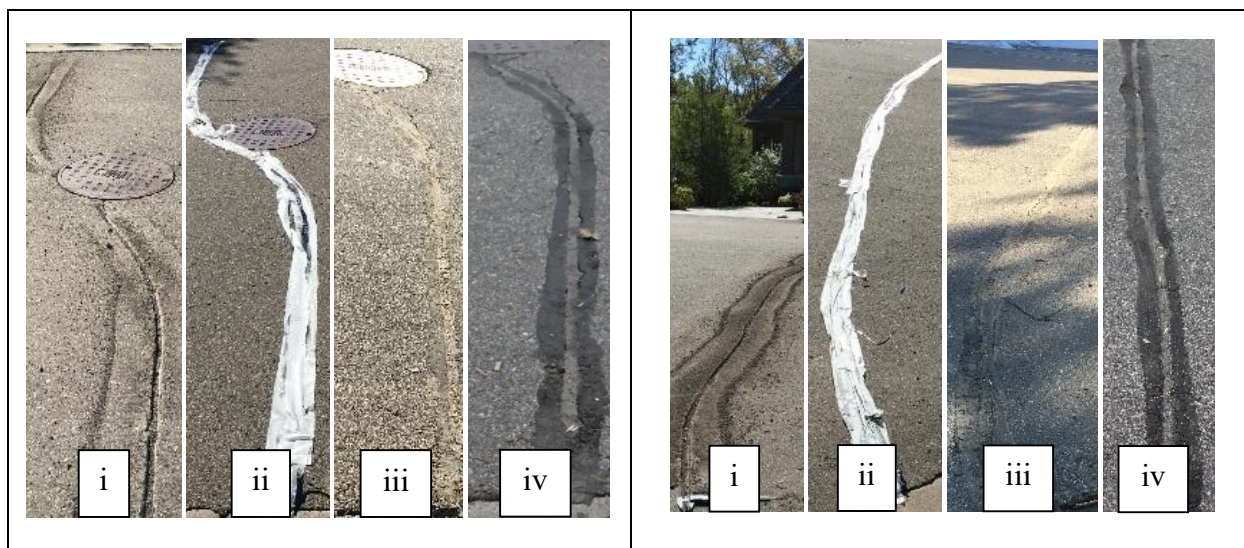
Photographic performance documentation of Site M. M-1-i Shows Crack M-1 prior to being sealed. M-1-ii shows Crack M-1 immediately after being sealed. M-1-iii and M-1-iv show Crack M-1 at the end of its first and second winter after being sealed. M-1-This same sequence of photos follows for cracks M-2, M-3, M-4, M-5, and M-6.

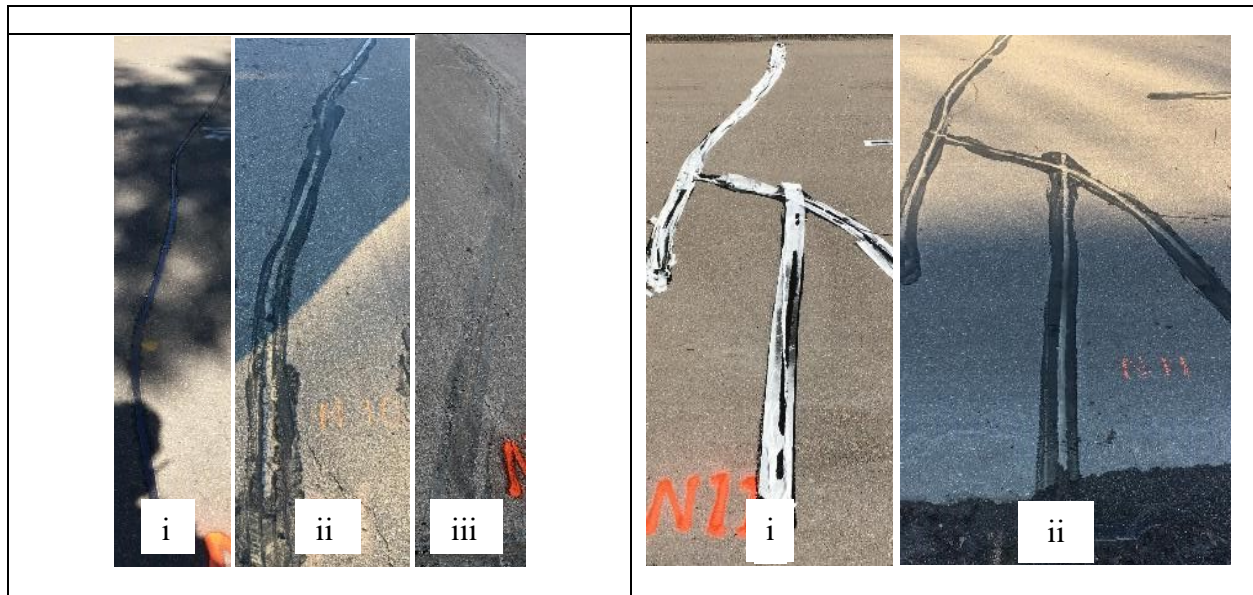
Photographic performance documentation of Site N. N-4-i shows Crack N-4 immediately after being sealed. N-4-ii and N-4-iii show crack N-4 after the first and second winter since being sealed. This same sequence follows for cracks N-5, N-6, N-7, N-8, N-9, and N-10. and N-11. N-1-i and N-2-ii show crack N-1 after being sealed and during the second winter. N-3-i shows Crack N-3 before being sealed. N-11-i shows immediately after being sealed and during the first winter.

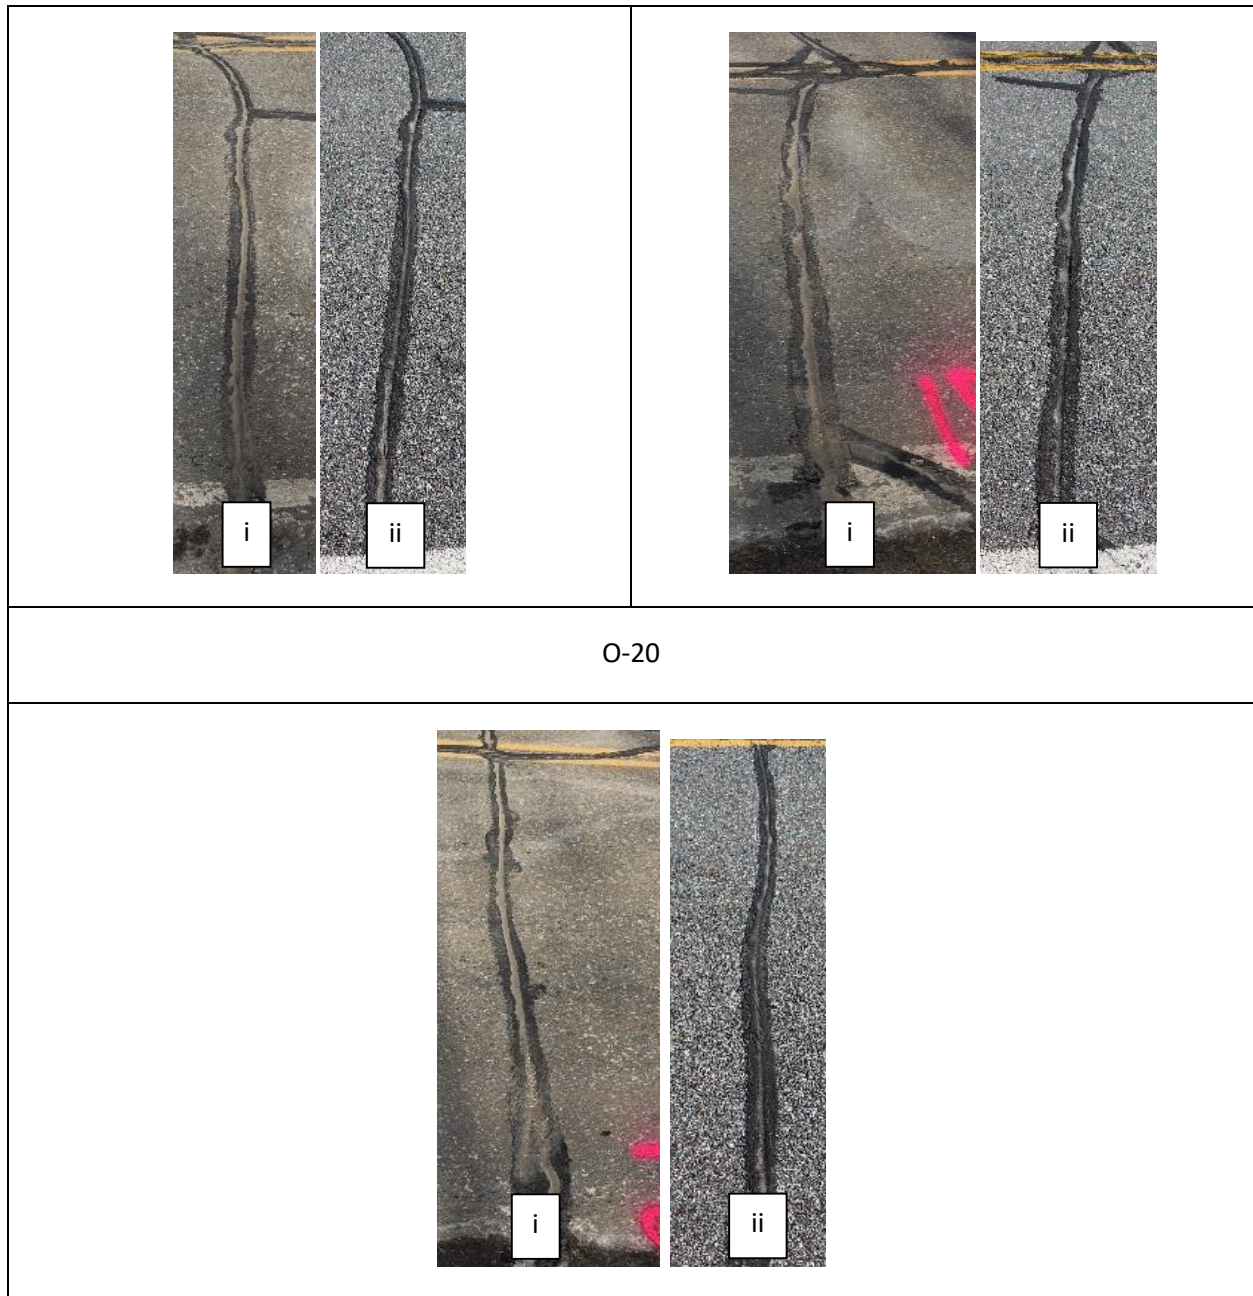
Photographic documentation of seal performance at Site O. O-2-i and O-2-ii show Crack O-2 during the first and second winter after being sealed. This same sequence follows for Cracks O-3, O-5, O-6, P-7, O-9, O-11, O-12, O-13, O-14, O-15, O-16, O-17, O-19, and O-20. Cracks O-1, O-8, and O-10 are shown a week after being sealed, then during the first and second winter. Crack O-4 is shown in this same manner, with the addition of a close-up of a spalling failure in image O-4-iii.
