Synthesis of Repair Practices of Damaged Precast/Prestressed Concrete Girders

SPR-P1 (19) M090

March 2020

Nebraska Department of Transportation (NDOT)

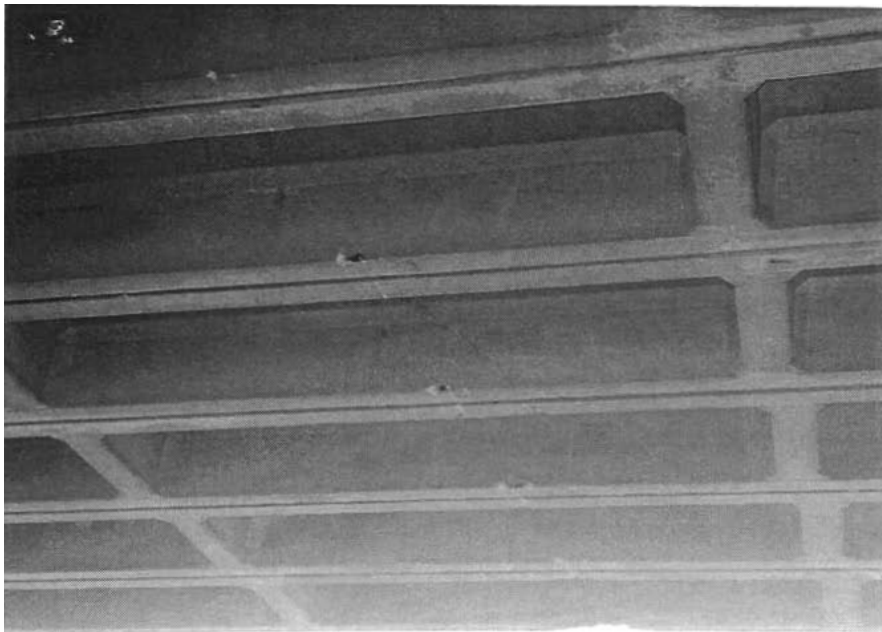
Figure 1: Minor damage, courtesy of Feldman et al., 1996

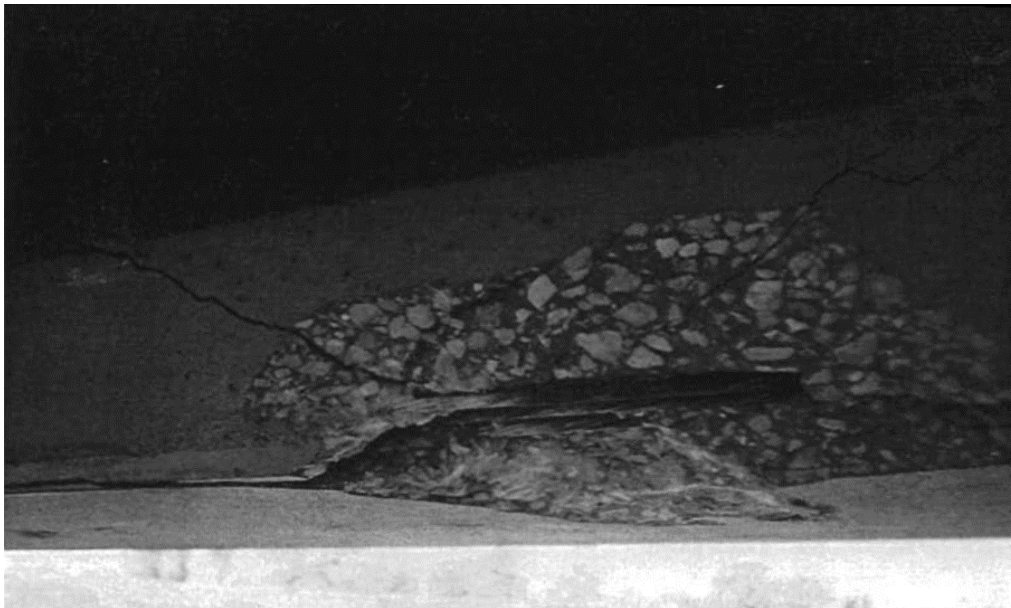
Figure 3: Moderate damage, courtesy of Feldman et al., 1996

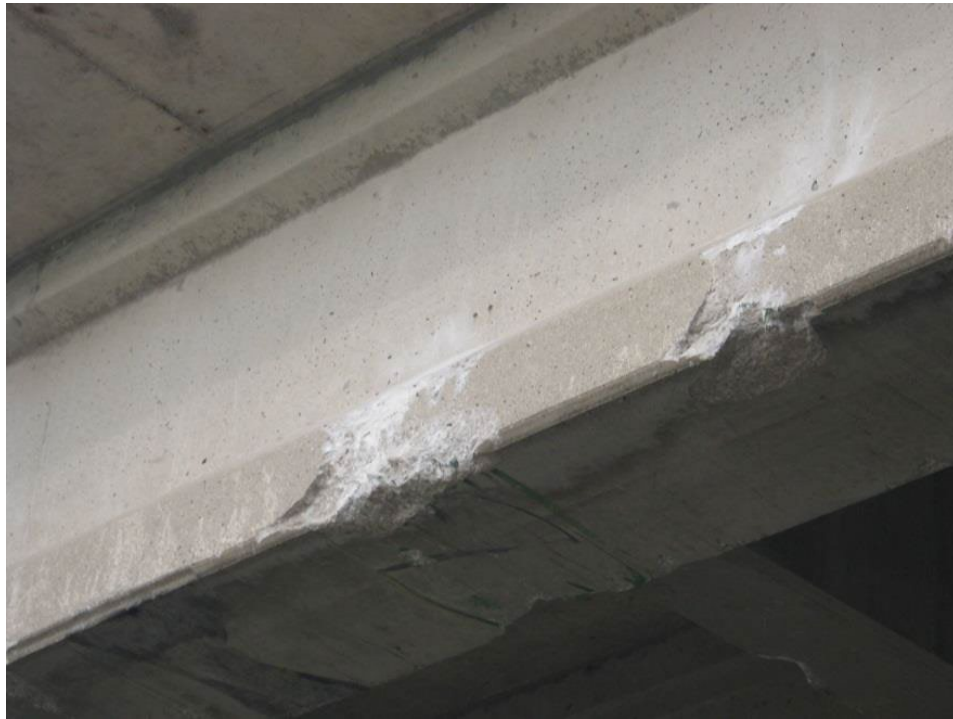
Figure 10: Minor bottom flange spalling, courtesy of Iowa DOT, 2014

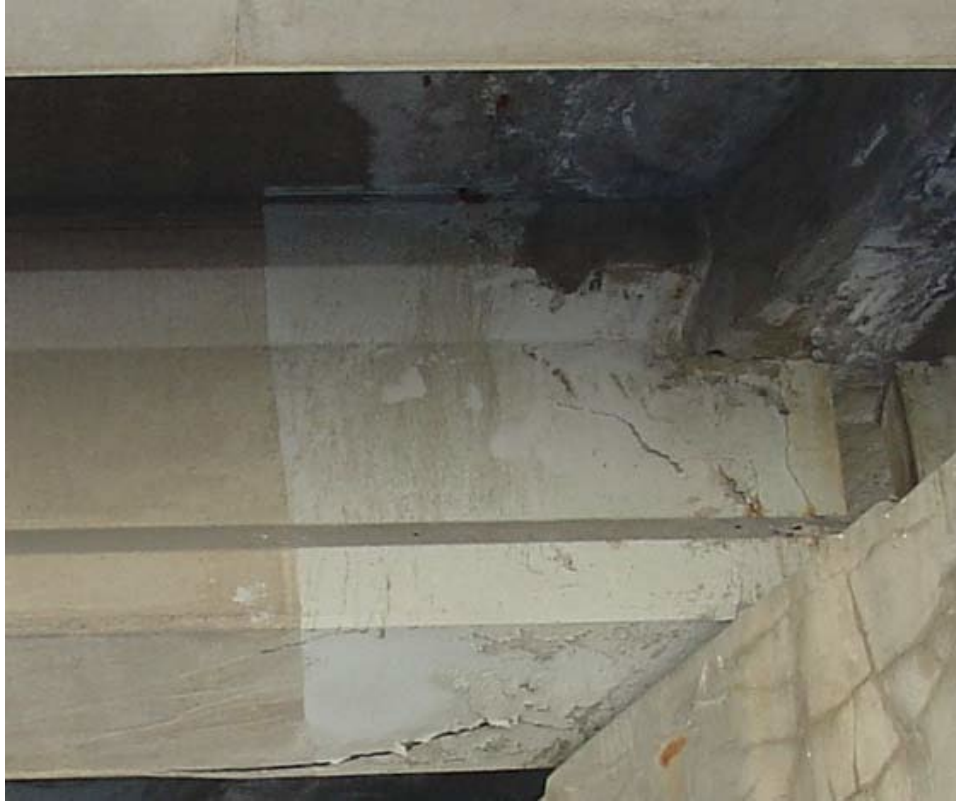
Figure 48: Severe class corrosion damage at girder end causing severe cracks, courtesy of Pantelides et al., 2010

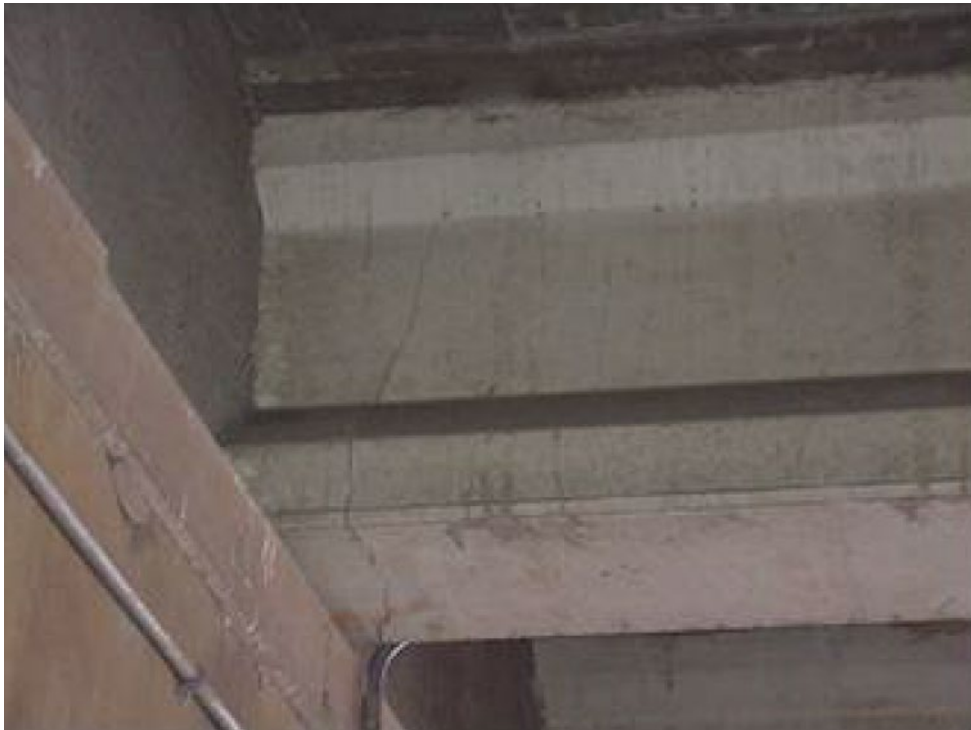
Figure 49: Severe class corrosion damage at girder end causing severe cracks, courtesy of Choo et al., 2013

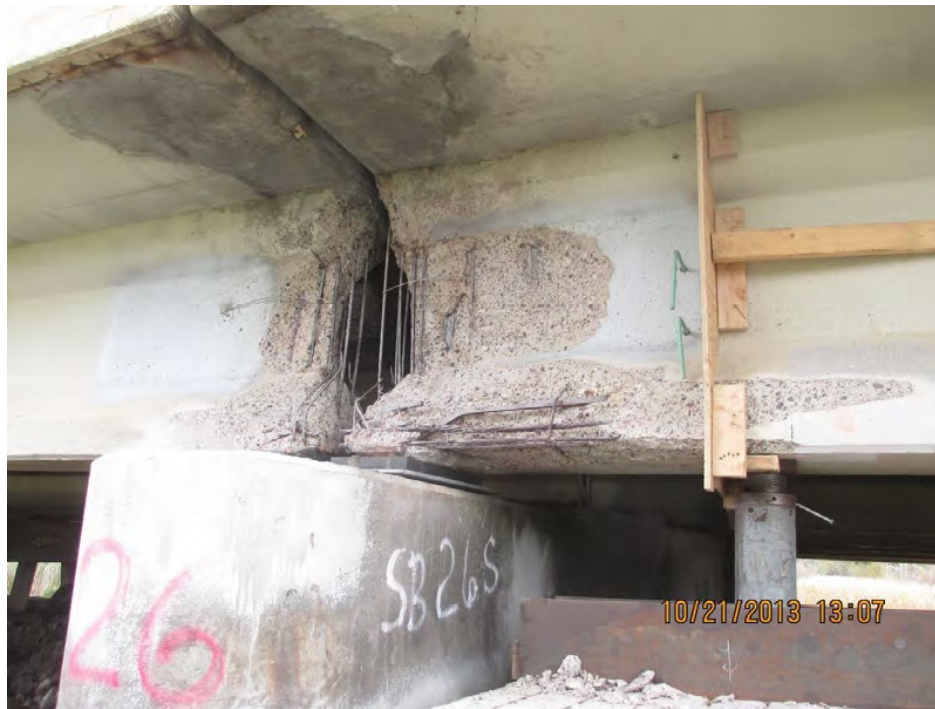
Figure 50: Severe class corrosion damage at girder end, MN/RC 2018-07 Report

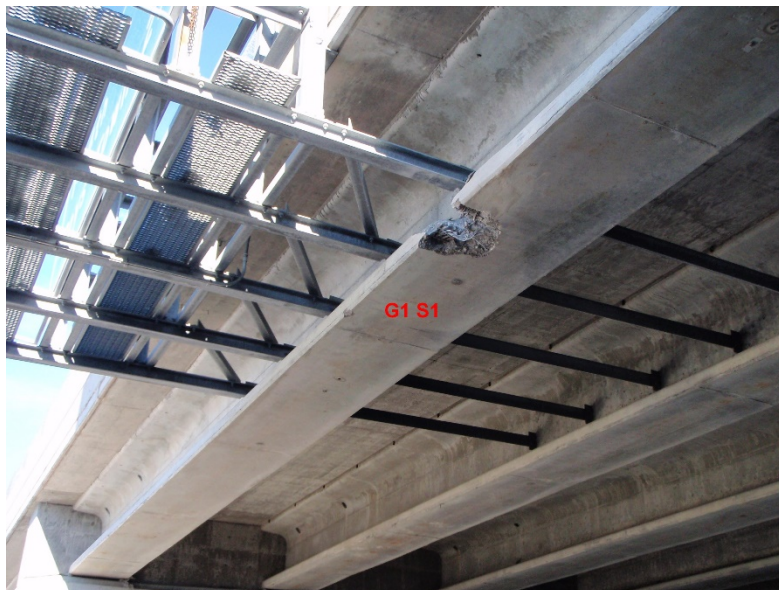
Figure 64: Level of damage, 168th St. over West Dodge Road Bridge, courtesy of NDOT

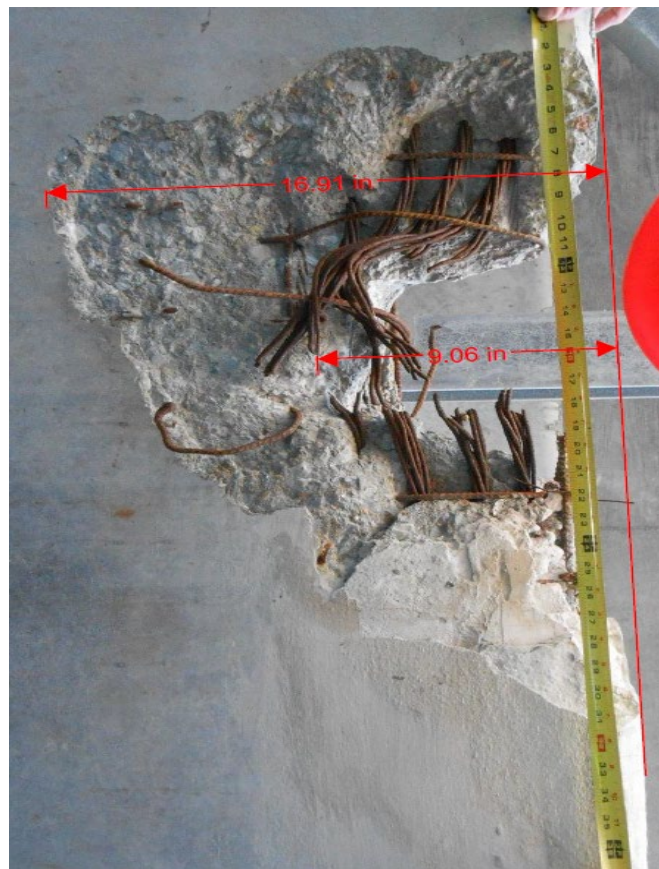
Figure 66: Level of damage, 168th St. over West Dodge Road Bridge, courtesy of NDOT

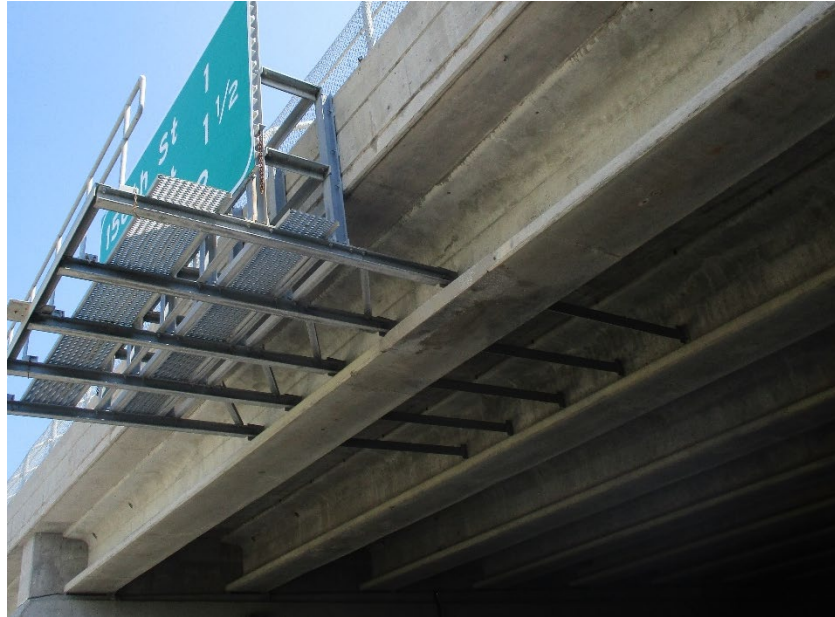
Figure 67: Repaired girder with no notable deficiencies, 168th St. over West Dodge Road Bridge, courtesy of NDOT

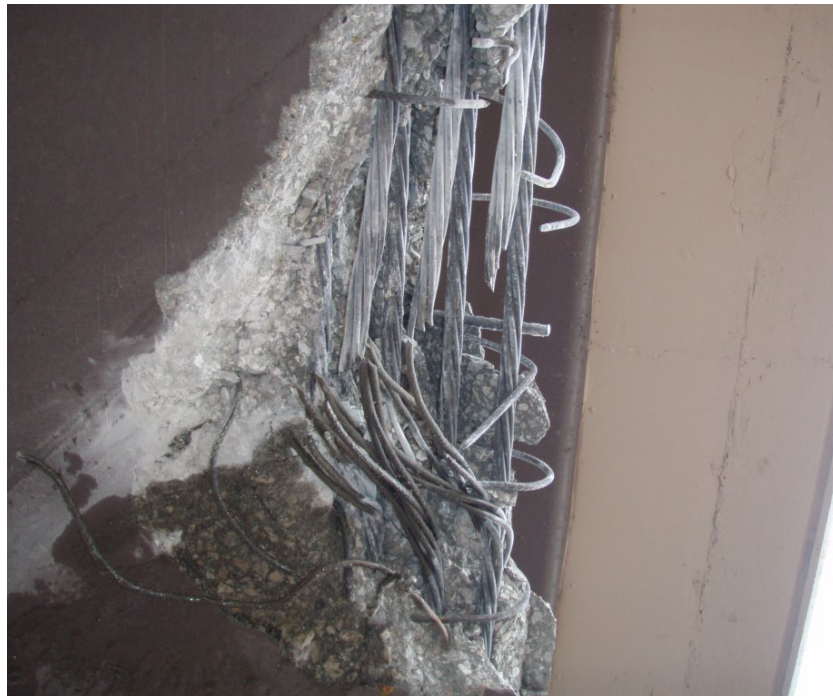
Figure 76: Level of damage, Scottsbluff Gering Bypass Bridge, courtesy of NDOT

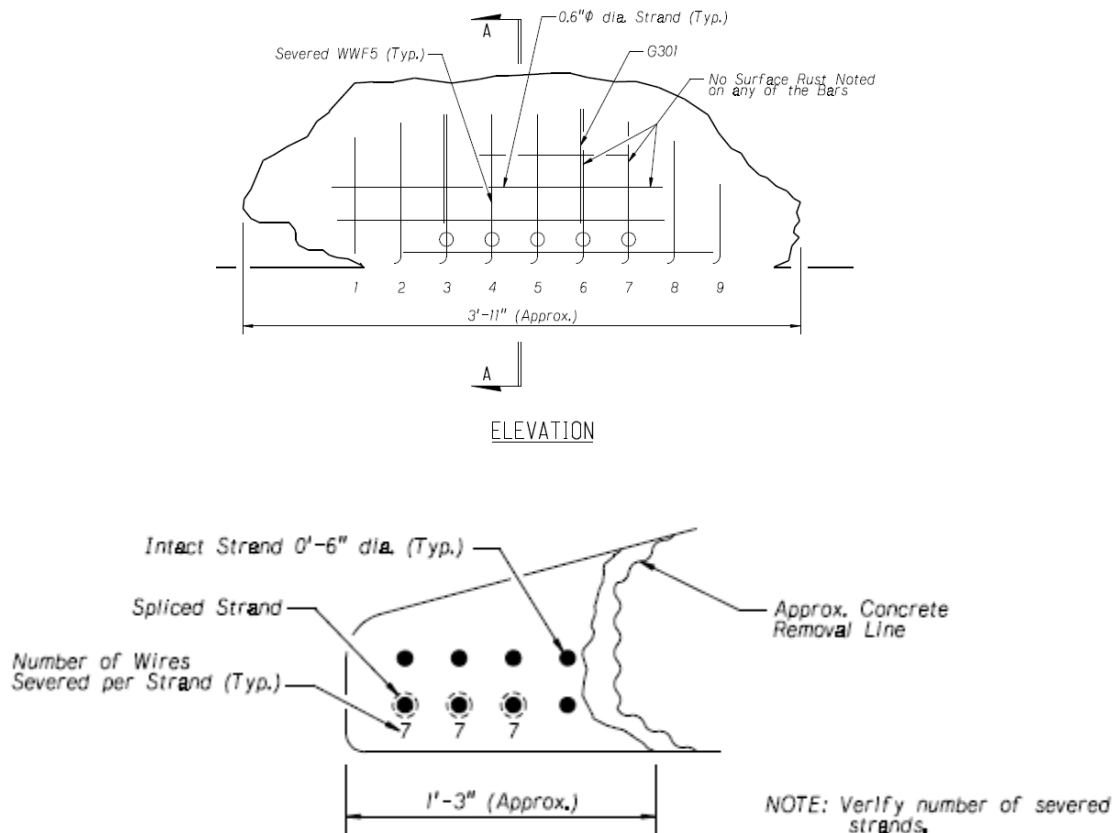
Figure 77: Severed strands and transverse reinforcement, from the repair documents of Scottsbluff Gering Bypass Bridge, courtesy of NDOT

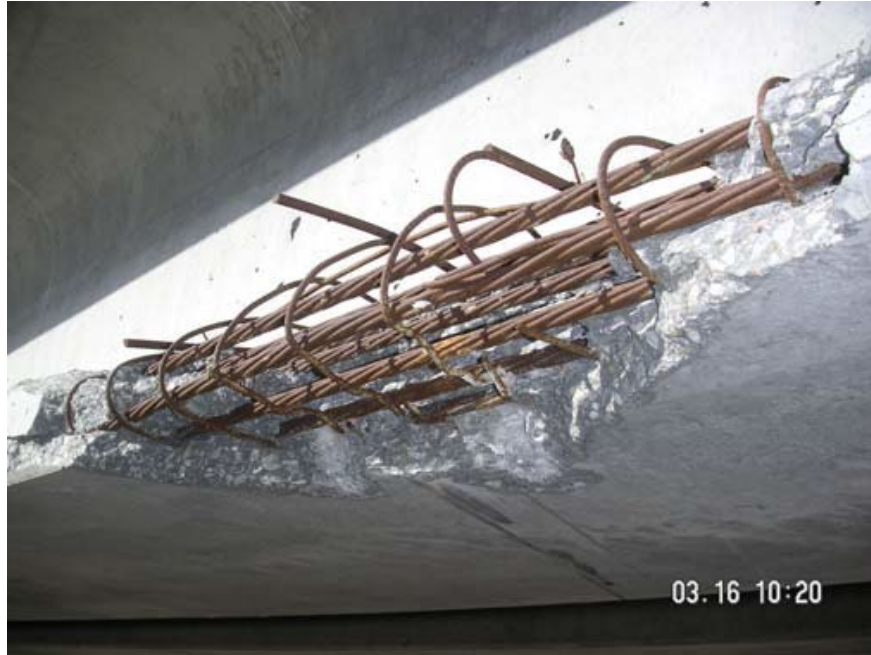
Figure 82: Girder (A) level of damage, Wood River Interchange Bridge, courtesy of NDOT

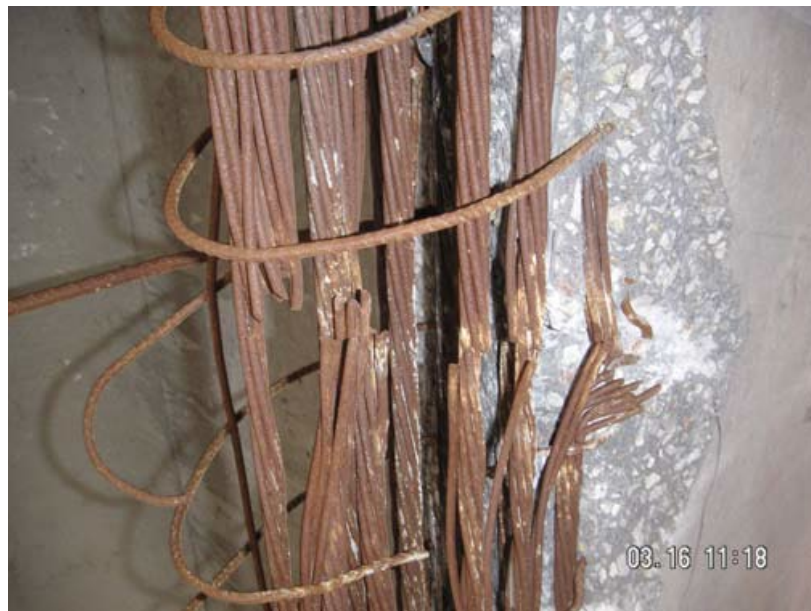
Figure 83: Girder (E) level of damage, Wood River Interchange Bridge, courtesy of NDOT

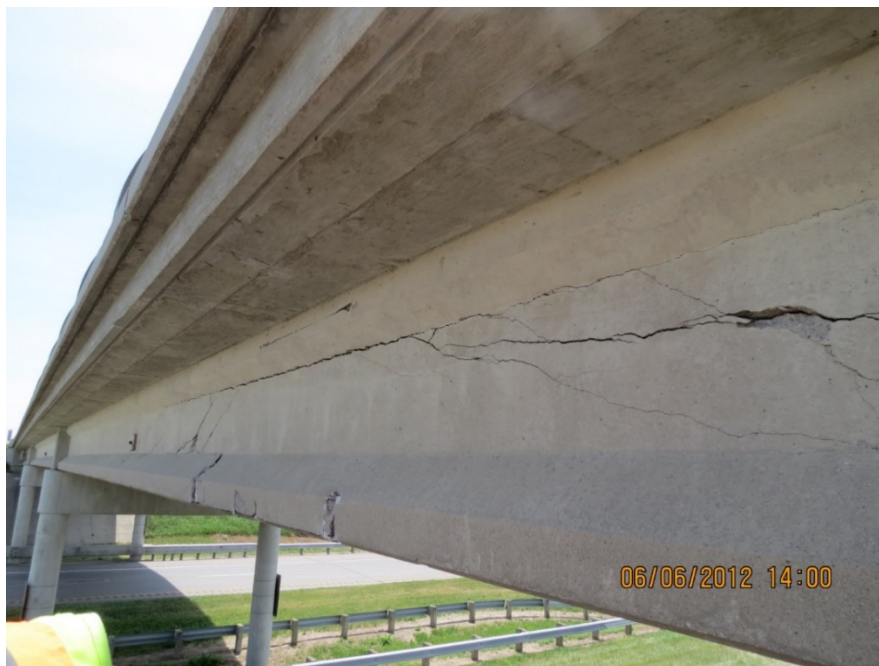
Figure 89: Level of damage, York East Bridge, courtesy of NDOT

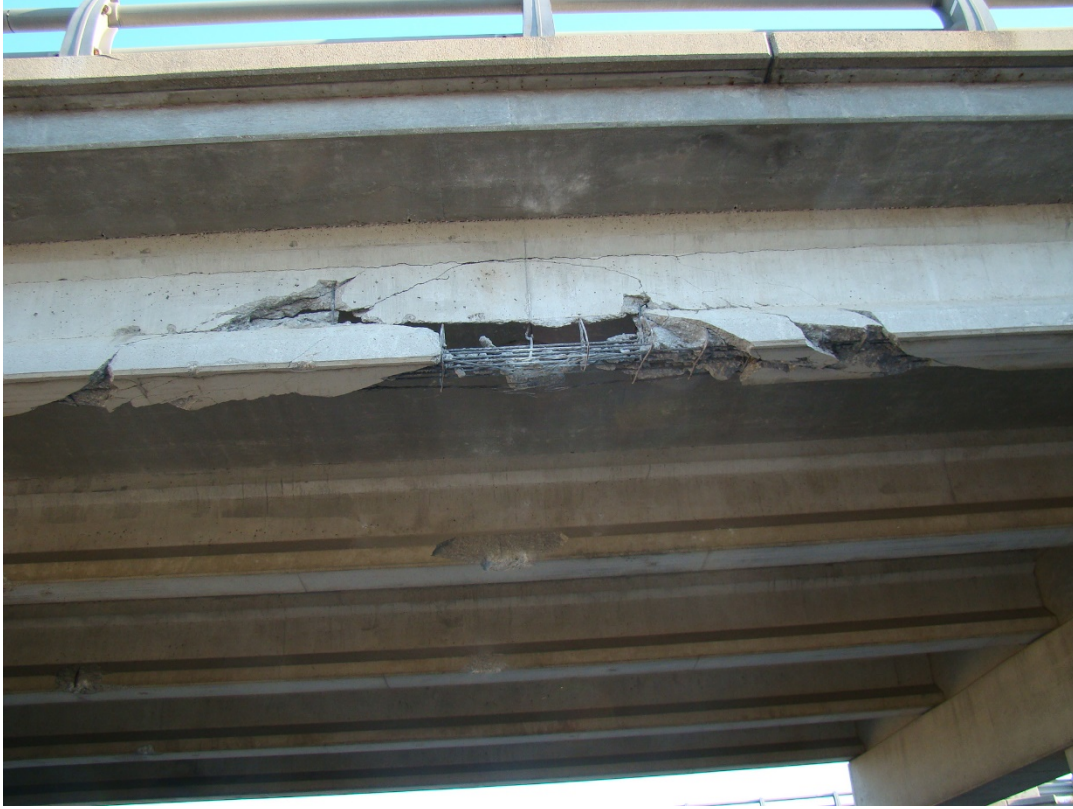
Figure 97: Level of damage, I-680 over US-75 Bridge, courtesy of NDOT

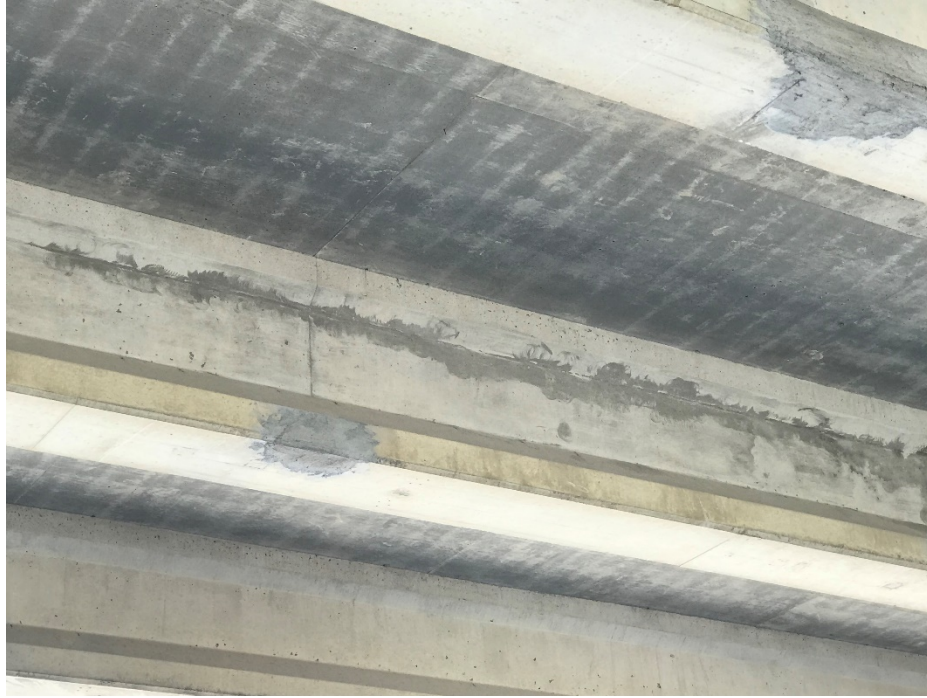
Figure 102: Girders with patching and epoxy injection works, I-680 over US-75 Bridge, courtesy of NDOT

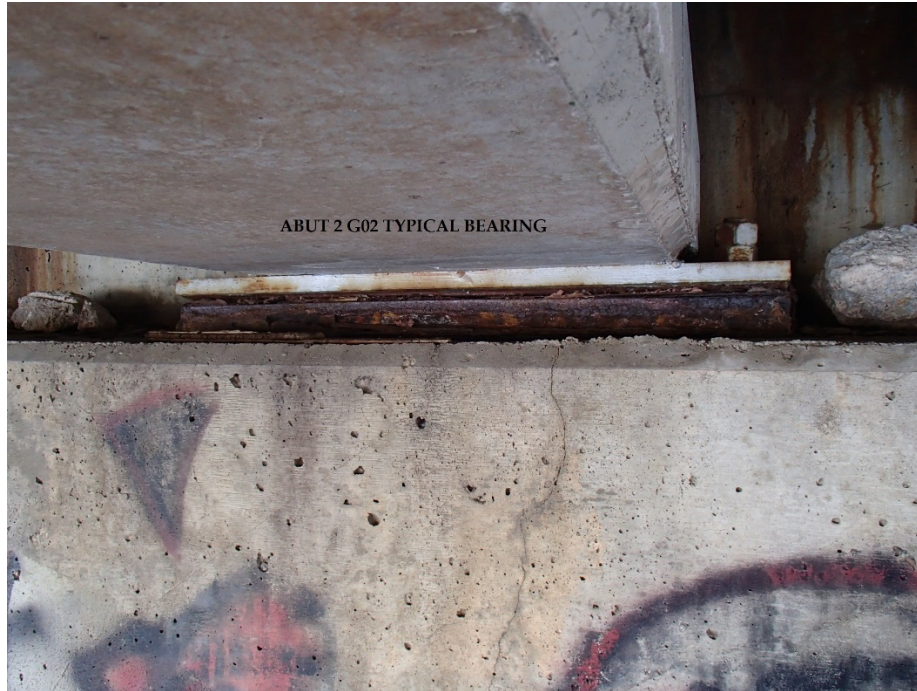
Figure 107: Corrosion damage at bearing assemble, Platte River Bridge East of Grand Island, courtesy of NDOT

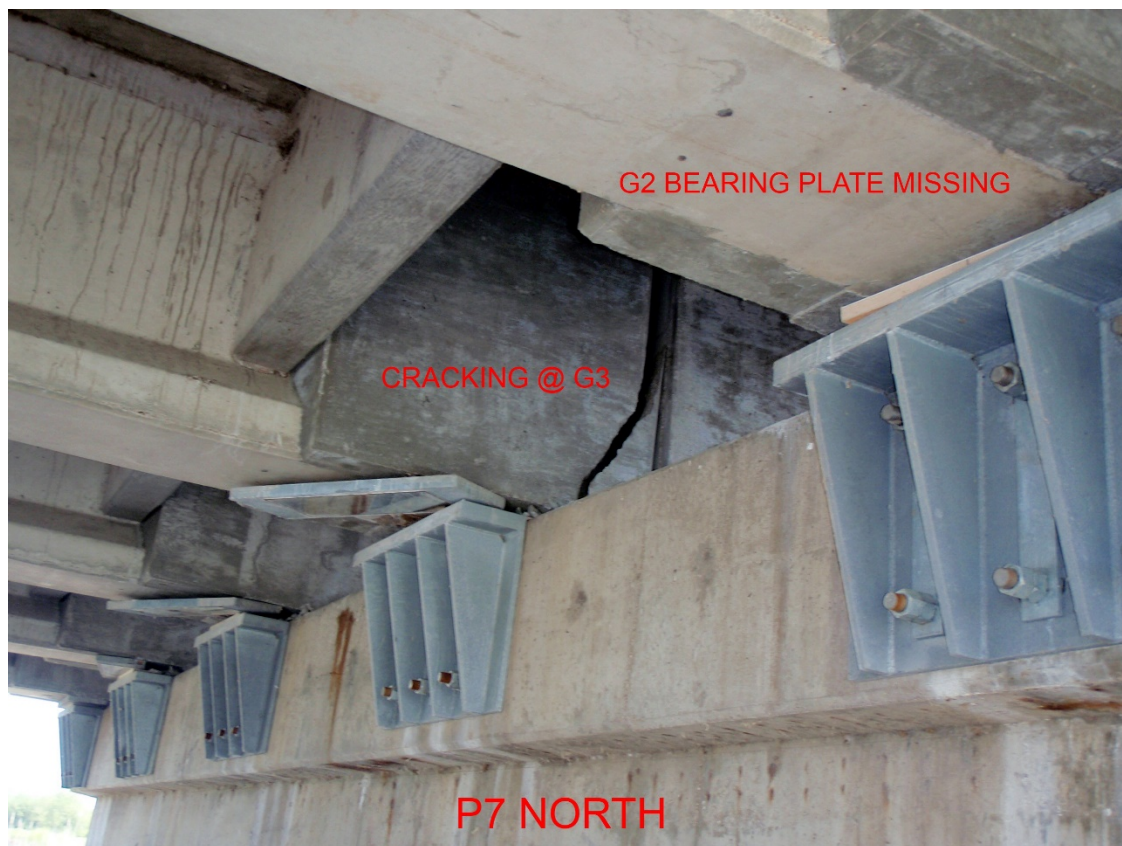
Figure 114: Damage at girder end, Kearney South Platte River Bridge, courtesy of NDOT

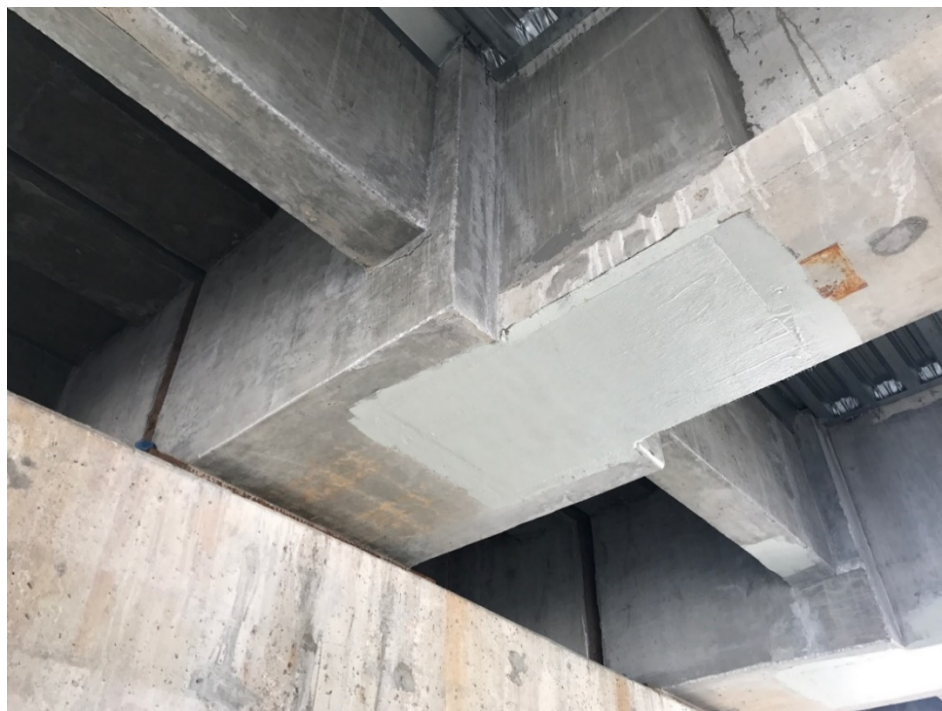
Figure 118: Girder end encasement and CFRP layers, visible crack at the diaphragm, Kearney South Platte River Bridge, courtesy of NDOT

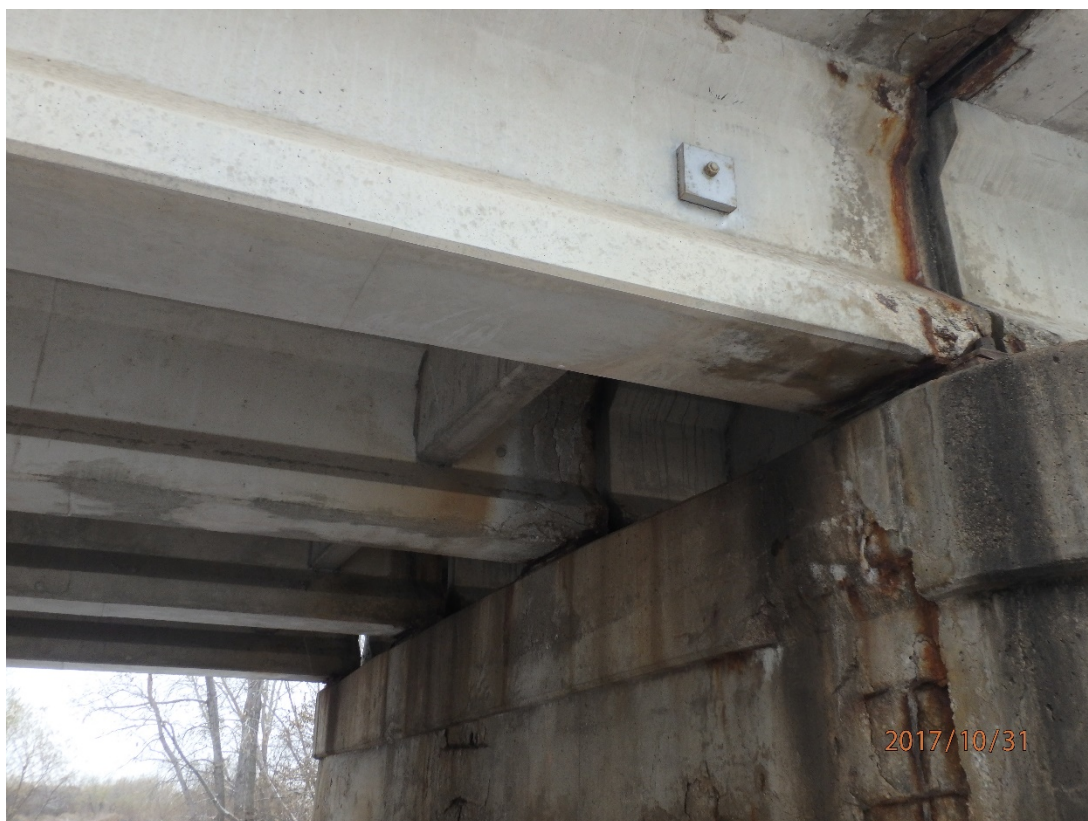
Figure 123: Damage at girder ends, Platte River South Bridge, courtesy of NDOT

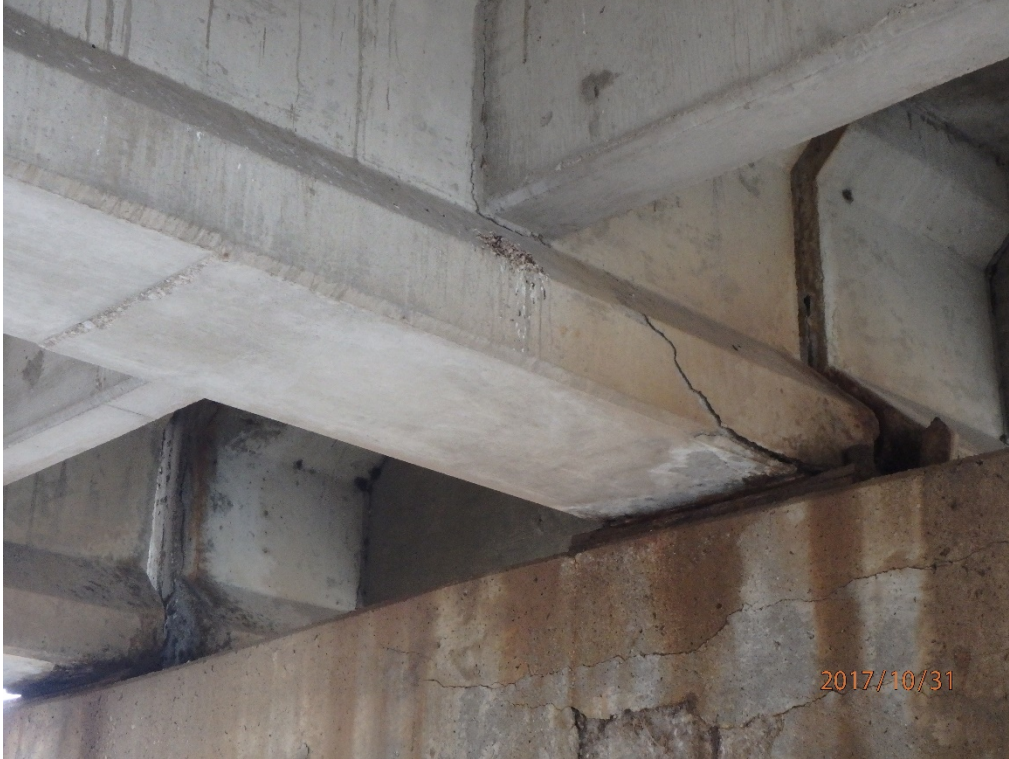
Figure 124: Damage at girder ends, Platte River South Bridge, courtesy of NDOT

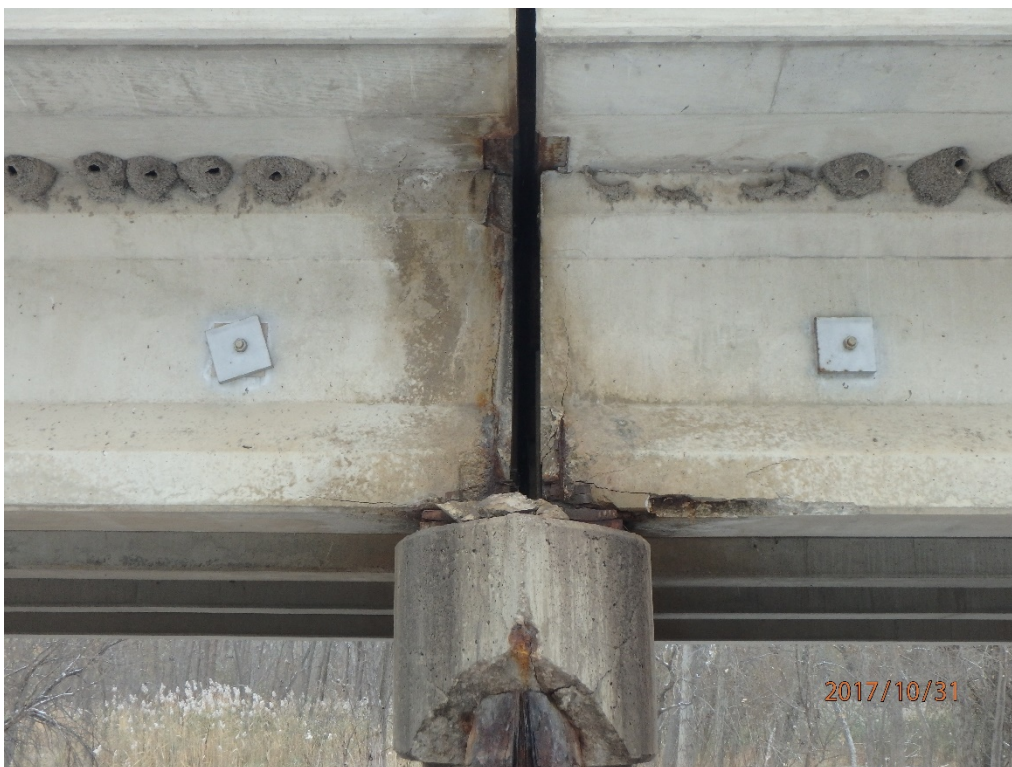
Figure 125: Damage at girder ends, Platte River South Bridge, courtesy of NDOT

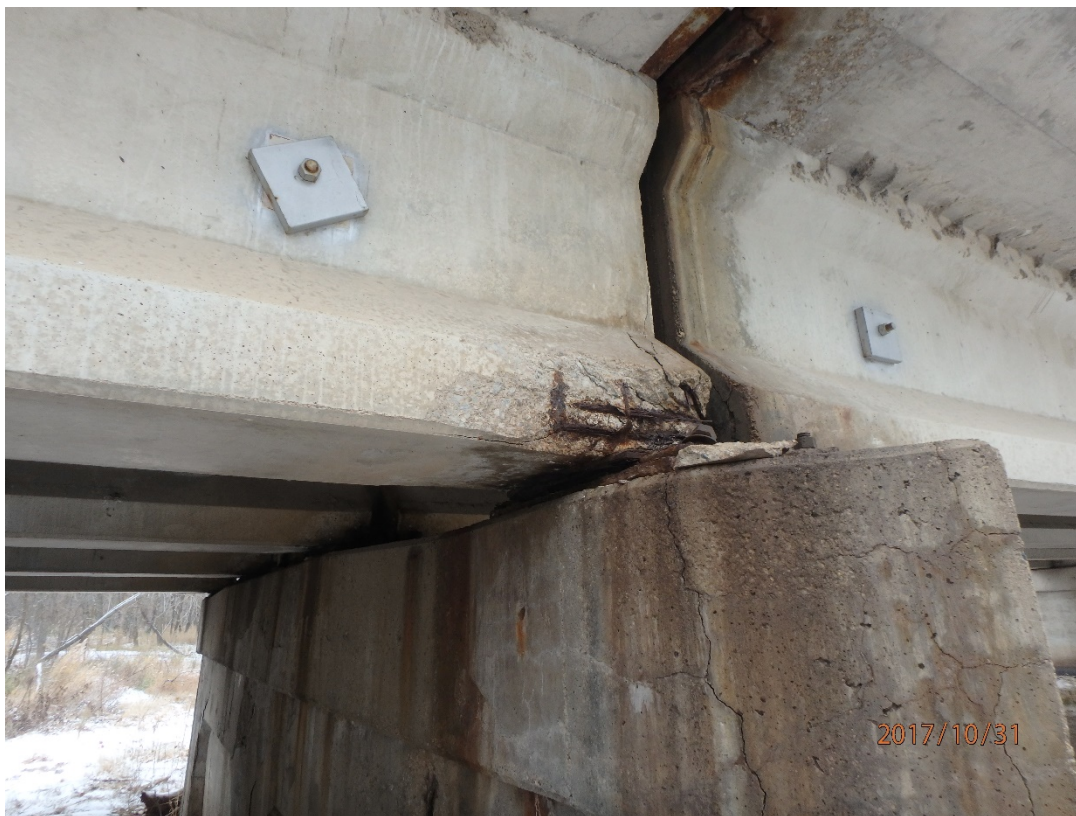
Figure 126: Damage at girder ends, Platte River South Bridge, courtesy of NDOT

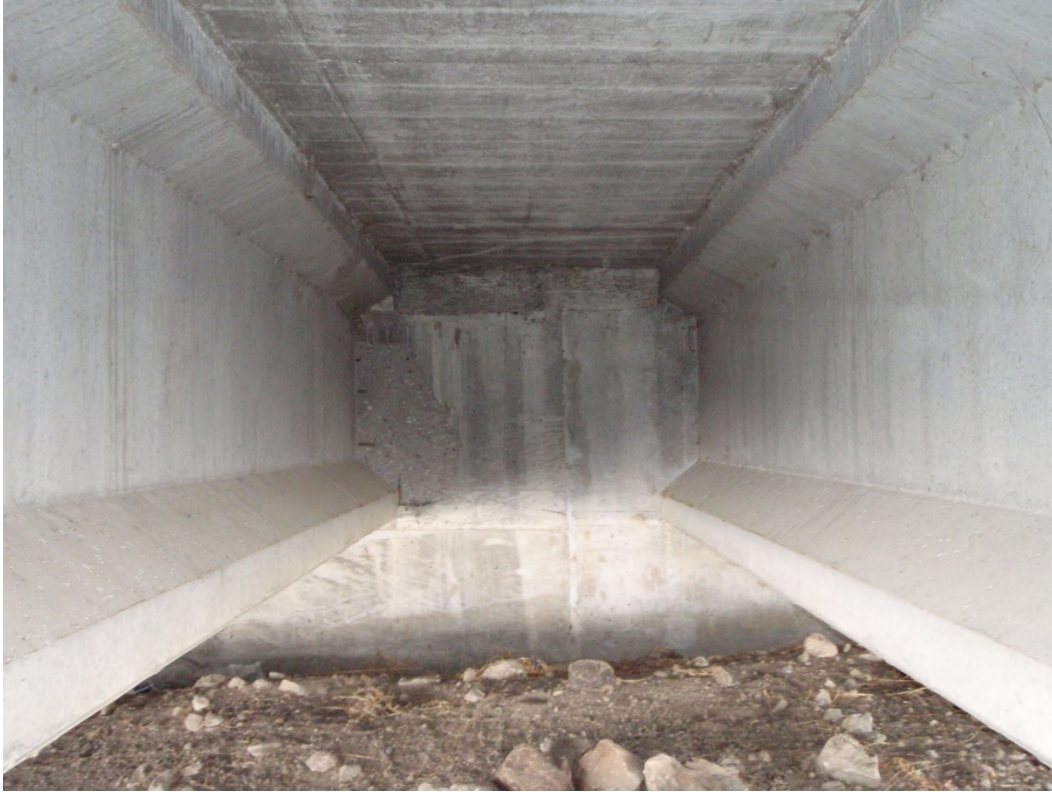
Figure 129: Exposed reinforcement at the abutment, Alma South Bridge, courtesy of NDOT

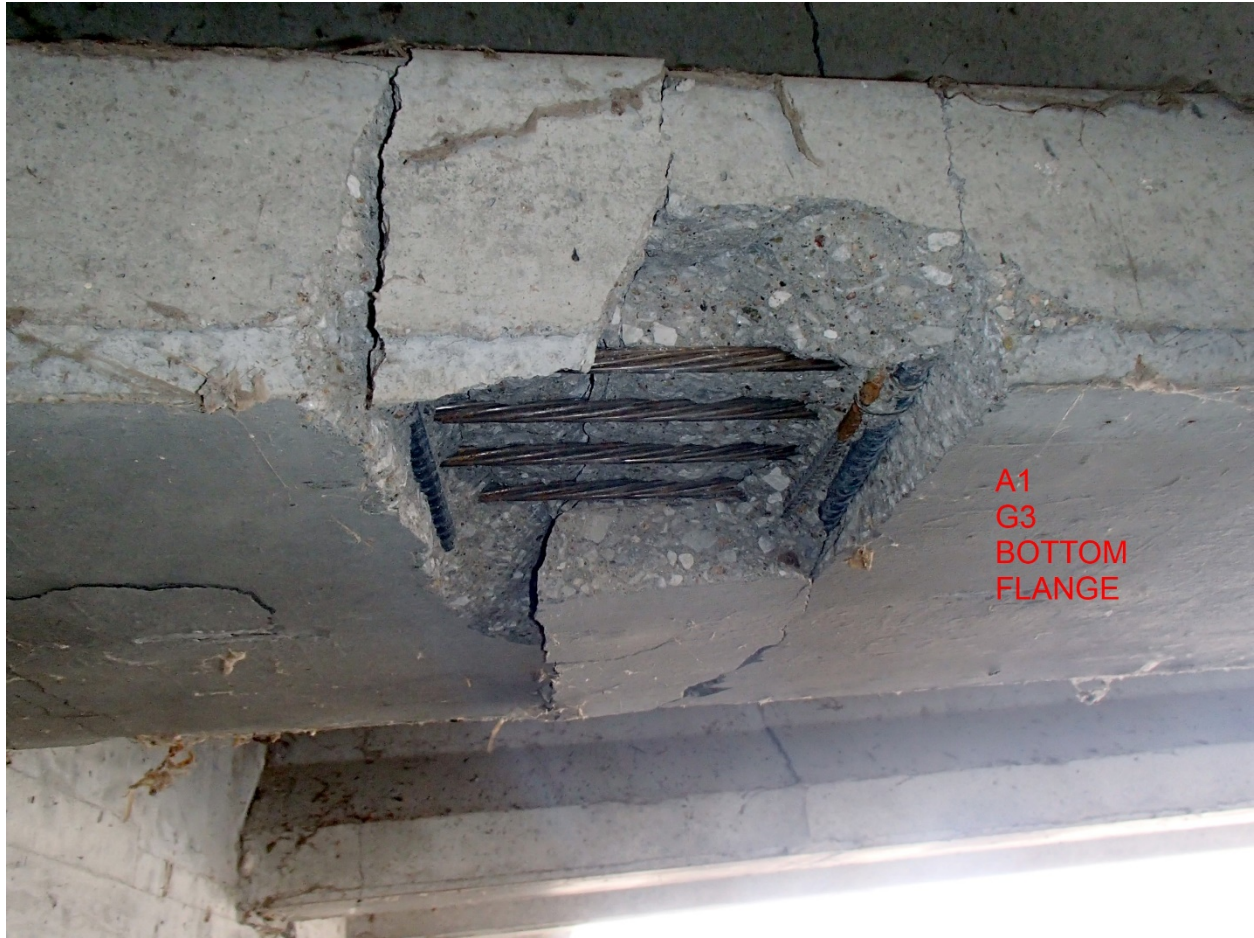
Figure 131: Exposed strands at bottom flange, Alma South Bridge, courtesy of NDOT
