**Preservation of Missouri
Transportation Infrastructures:
Non-Destructive Testing of FRP Materials
and Installation, Gold Bridge**

**UTC
R96**

In 2003 the Missouri Department of Transportation contracted to retrofit five county bridges with FRP materials. This paper deals with non-destructive testing of FRP material performance of the Dallas County Bridge P-0962, codenamed the "Gold Bridge"

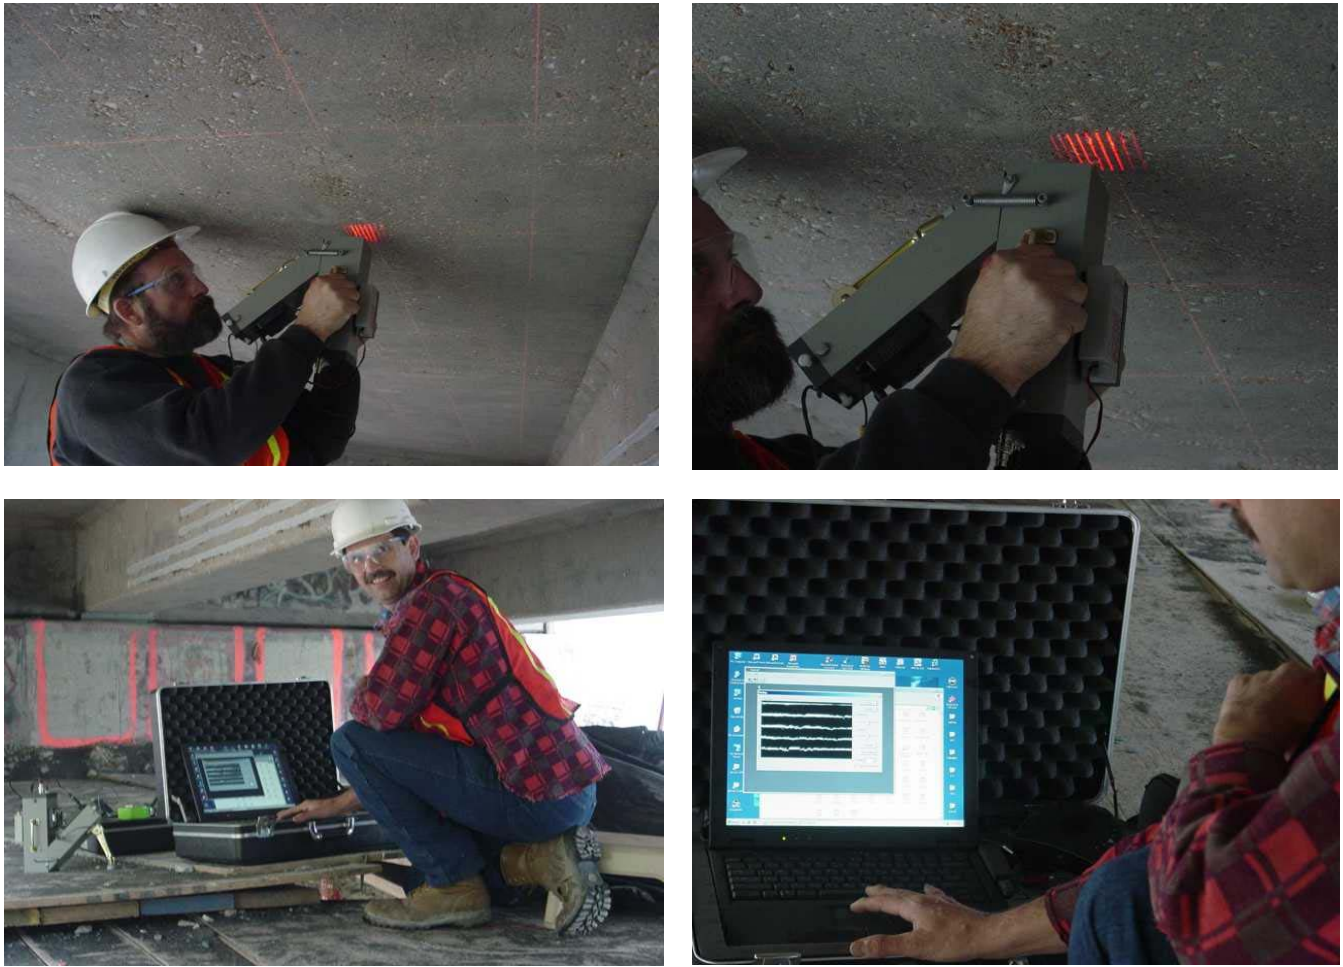
Figure 1.3: Using the laser profilometer under the gold bridge.

Under the bridge deck, which was sand blasted with no specific instructions, measurements were made along on a 1' by 1' grid that was marked with chalk line (Figure 1.3, Appendix 1). Measurements along nodes were recorded to 1) Determine if optimum roughness has been achieved, 2) Determine a relationship between roughness should future delamination take place, and 3) Selection locations of varying roughnesses for installing

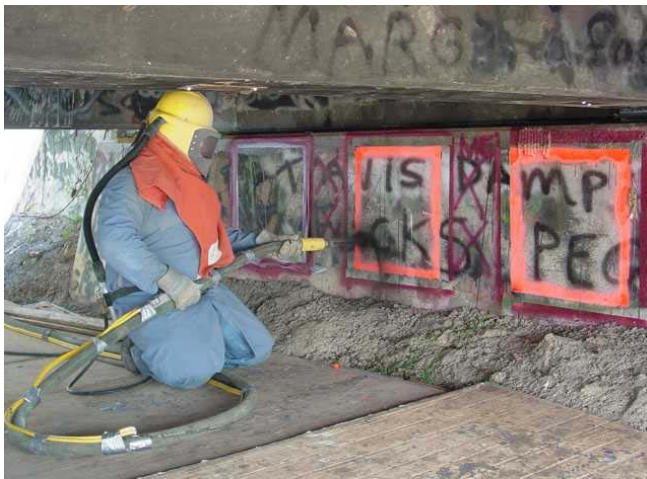
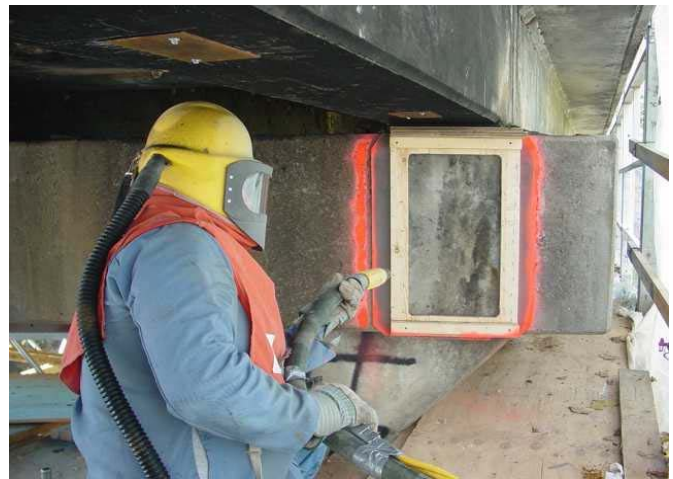
Figure 1.5: Sandblasting for the test panels on the abutment (left) and one of the bents (right).

Roughness measurements after sand blasting (Figure 1.5) were made in two different areas, under the bridge deck and on the test panels where test FPR panels with forced delaminations were planned to be installed (Figure 1.6).

The roughness values of the locations for the abutment and bent panels were also measured (Tables 1.2, 1.3). For the abutment patches the sand blasting instructions were not well executed and the roughness measured reflected that. For the bent patches the instructions were executed correctly. The end of the bent around patches c and d later underwent unrelated masonry repair, and so the roughness numbers in Table 1.3 are no longer relevant.

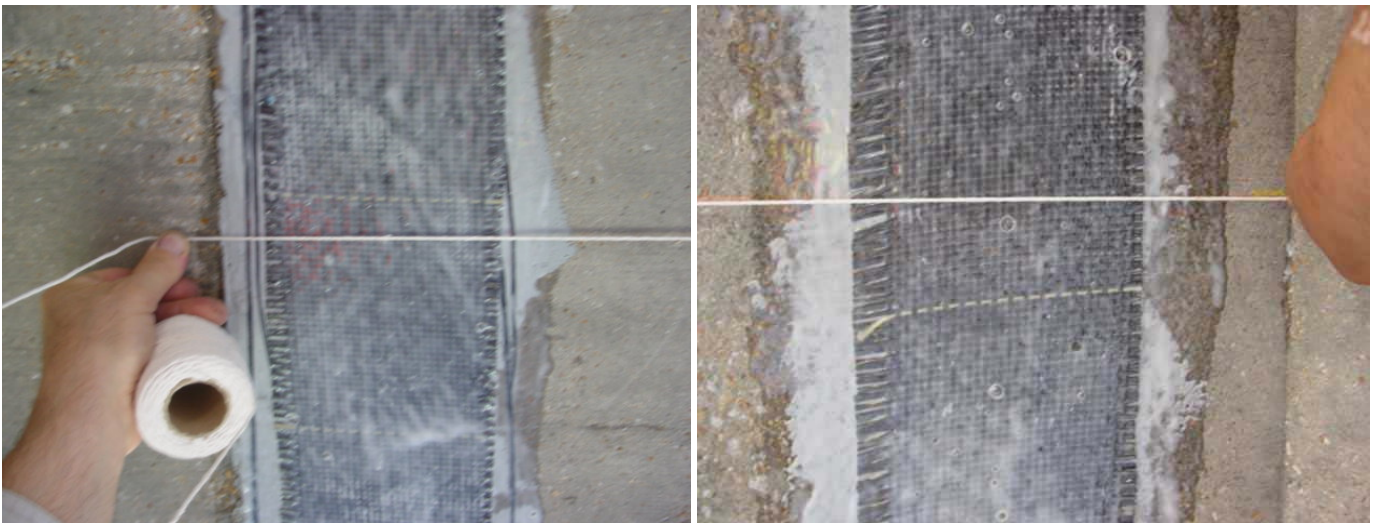
Fiber alignment measurements (Figure 11) were taken on four sections of the bridge deck. In all 421 measurements were made. The mean alignment error was 3.6° with a maximum error of about 11°. Almost 25% of the measurements indicated alignment errors over 5°. In tests with a broad sheet applied to the center girder, the alignment error in 12 measurements was about 1.2°, with no measurements above 5°

Fiber alignment was successfully measured in all the required locations. For the broad sheet applications, all installations were within 5° of optimum. For the strips the error was higher, above the 5° of optimum. In fairness to the contractor, these thin strips of bi-direction fabric are difficult to keep aligned when installing. Normally for this type of application, a unidirectional fabric would be used.

Figure 2.1: Stretching a chord parallel to the correct direction of the embedded fibers. Left: Well aligned, right, poorly aligned.

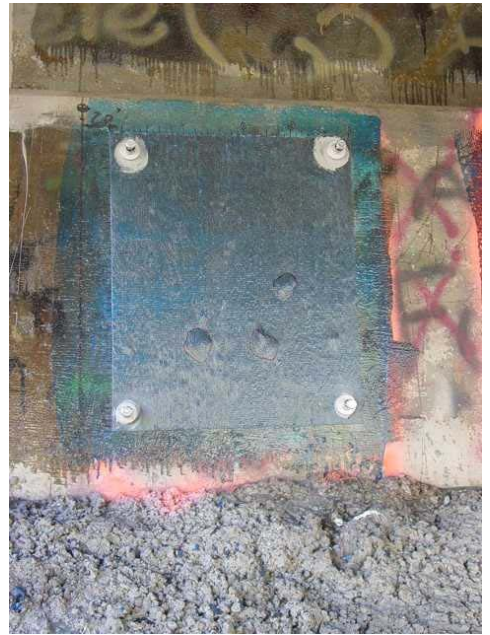
Figure 3.4: Patch with delaminations shown.

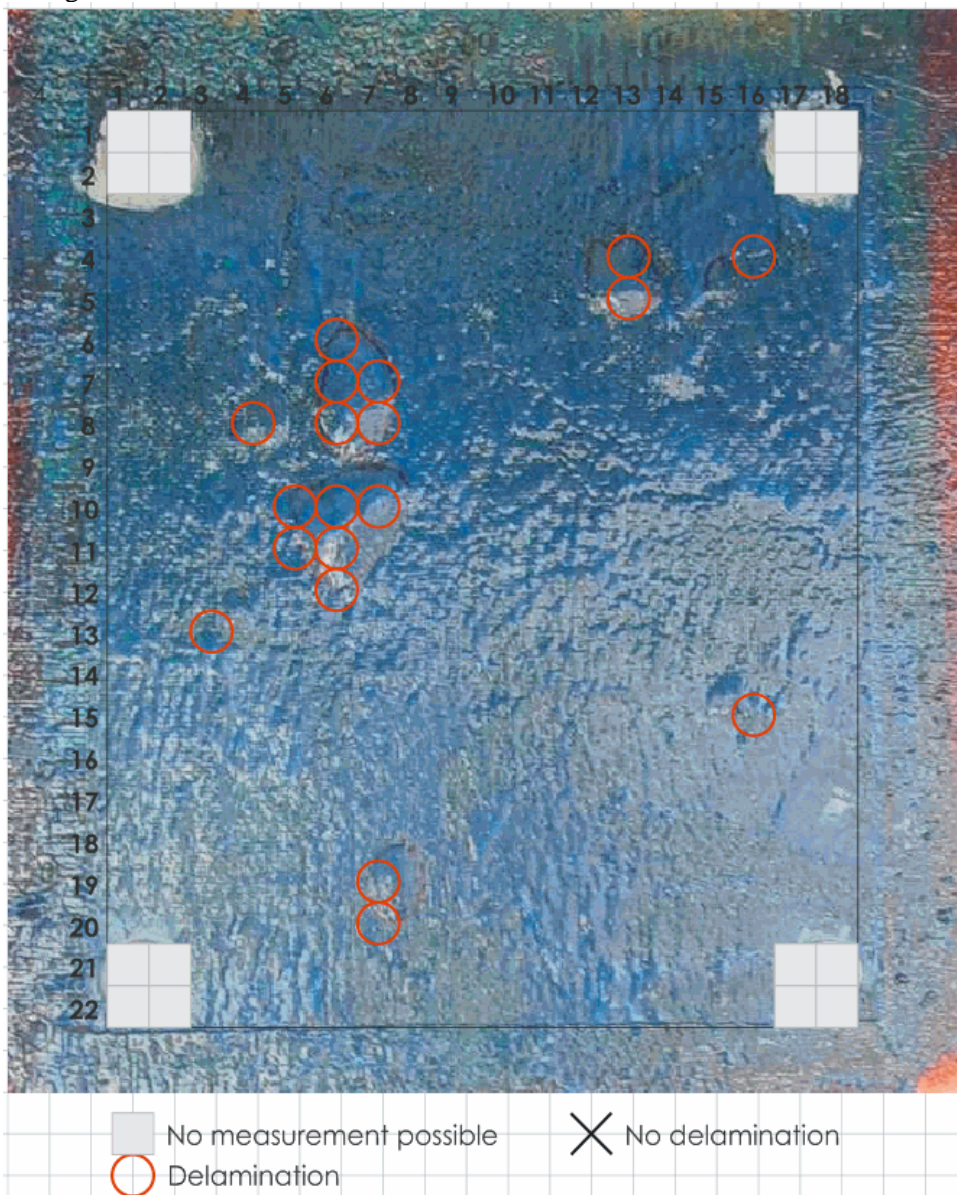
The impact echo delamination measurements were successful in identifying the “forced” delaminations. In addition, some small unplanned delaminations were found. Figure 3.8 shows the results of testing on panel number 4. Appendix 2 show the testing results. Delaminations were shown as circles and x’s were used to indicate measurement areas where delaminations were measured one time but subsequently measured as not delaminated.

In general there is no evidence that any of these delaminations grew over the period of time in which they were monitored. There are clearly areas that were measured as delaminated during one session and not delaminated during another.

Figure 3.8: Measurement results on panel 4 (red circles indicate delaminations) superimposed on an image of the panel.

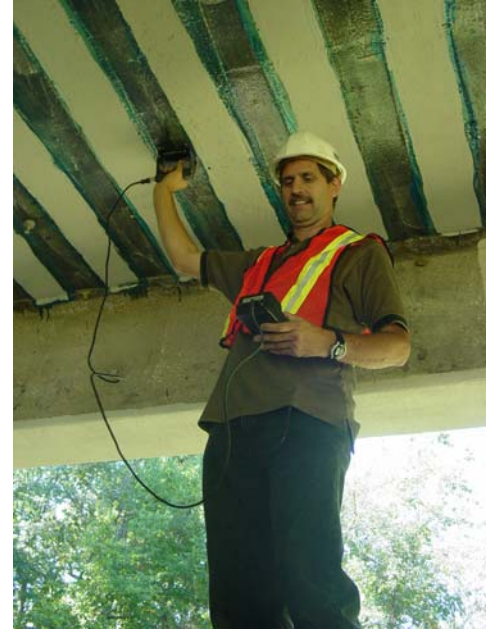
Figure 4.6: Impact echo test on the deck failed plug location.

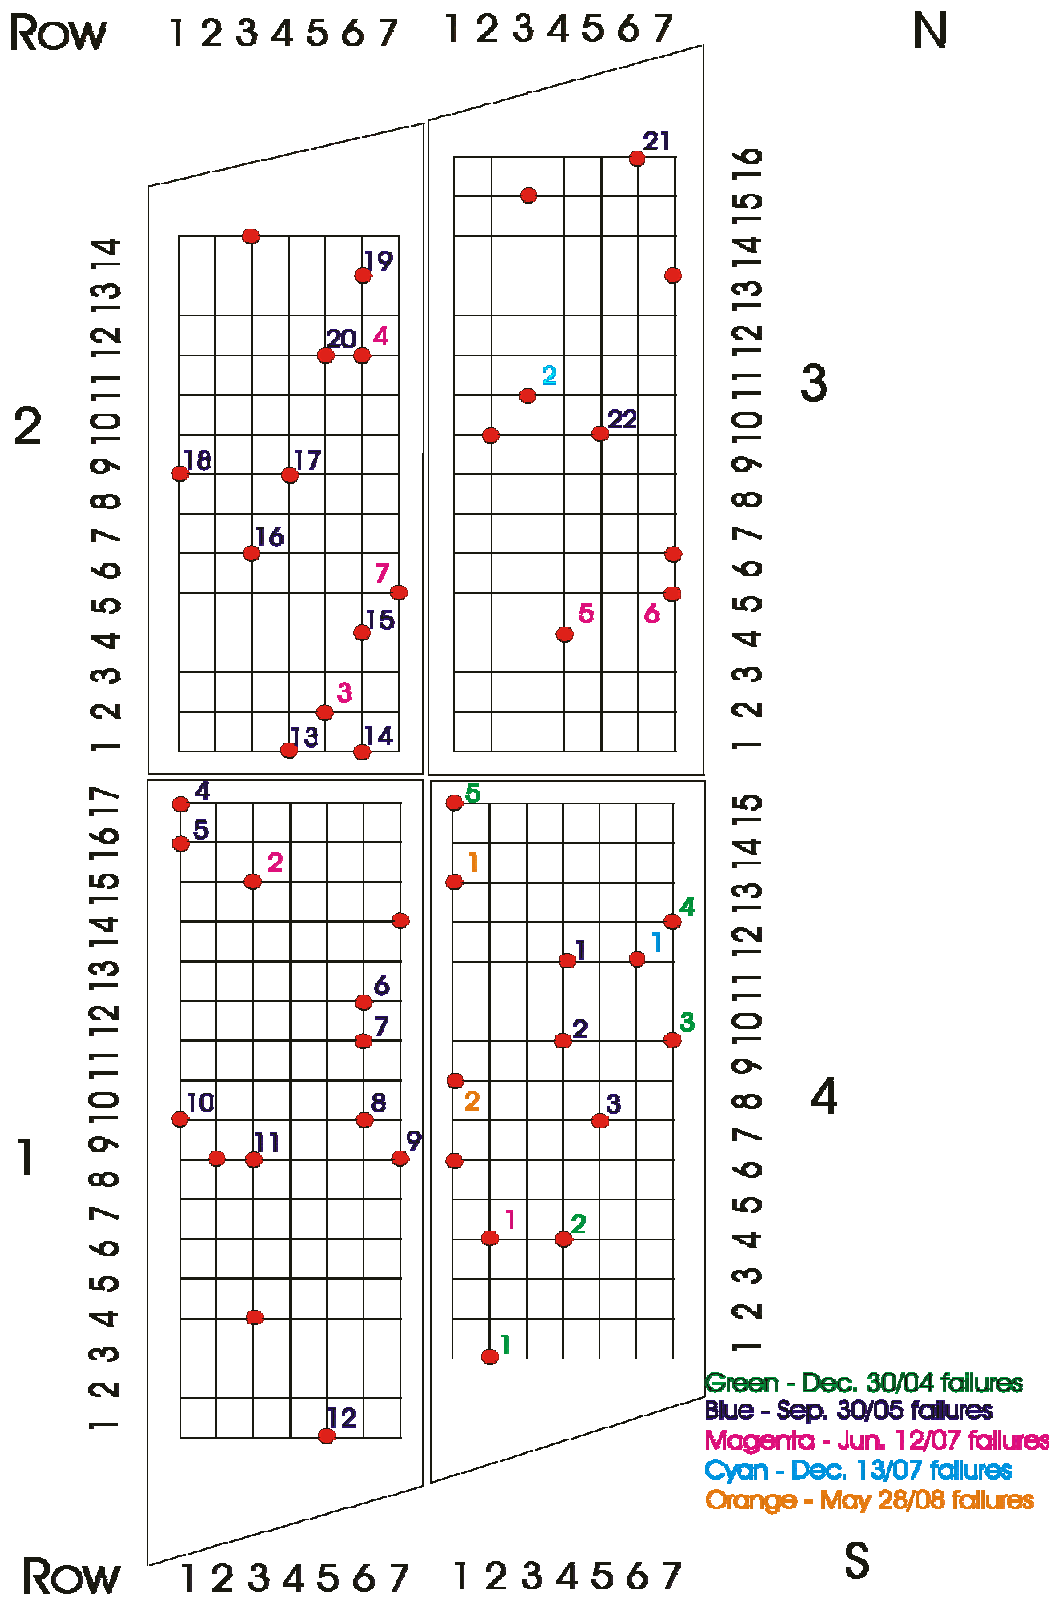
In reality 38 of the plugs failed during the operation (Figure 4.7). On the first visit 5 of the 14 plugs tested in one section of the bridge failed. Ultimately 12 of the fourteen plugs failed in that section, some as late as 4 years later and as many as 4 tests where the plugs did not fail. Similarly over the entire bridge 38 out of 45 plugs ultimately failed, some only after considerable time and multiple tests.

Figure 4.7: Pull-off plug failures and dates

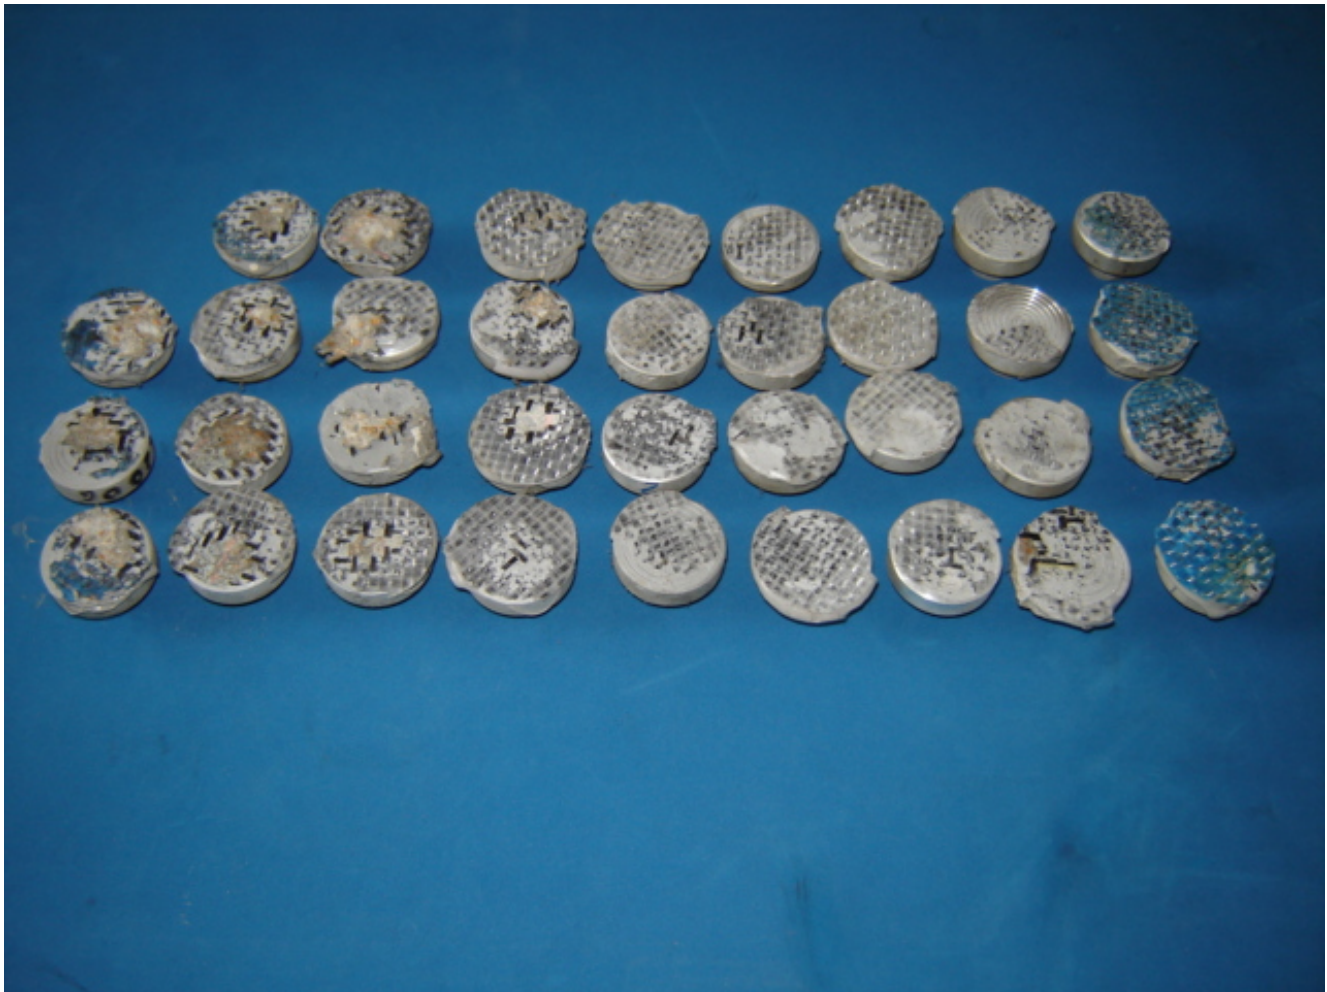
The mode (place) of failure was also unexpected. The original expectation was that these plugs would fail either at the concrete FRP interface or at the surface of the plug. In reality neither of these occurred. Figure 4.8 shows the failed plugs.

Of the 35 failed plugs depicted in Fig. 4.8, 2 show separations at the plug bond (Figure 4.9), 20 show separation at the top coat of epoxy over FRP (Figure 4.10), and 13 plugs show composite failure (Figure 4.11) that start either at the plug bond or top coat of epoxy (outside of the plug) and propagate into concrete substrate (in the center of the plug). (During the relocation to the storage room, five of the failed plugs went missing.)

Figure 4.8: Failed pull-off plugs.

In not one single case was failure initiated along the concrete substrate/FRP interface. This indicates that surface preparation was adequately done, and the epoxies used performed well enough to say that the prepared surface roughness was not a factor in the performance of these. Indeed the evidence shows that in many cases the concrete substrate/FRP interface is stronger than the concrete itself.

The surface coating of epoxy may degrade over time. Many plugs failed the second, third, or fourth time they were tested, over a period of up to four years. In each case the plugs were loaded to the same level. The majority of the plugs eventually failed, even though they were loaded only to 50% of the average stress at failure of the 20 original sacrificial test plugs. The epoxy was not exposed to UV, as the materials were installed on the underside of the bridge, and locally the epoxy was protected by the plugs themselves. The only alternative explanation is that repeated loading weakened the strength of the materials.

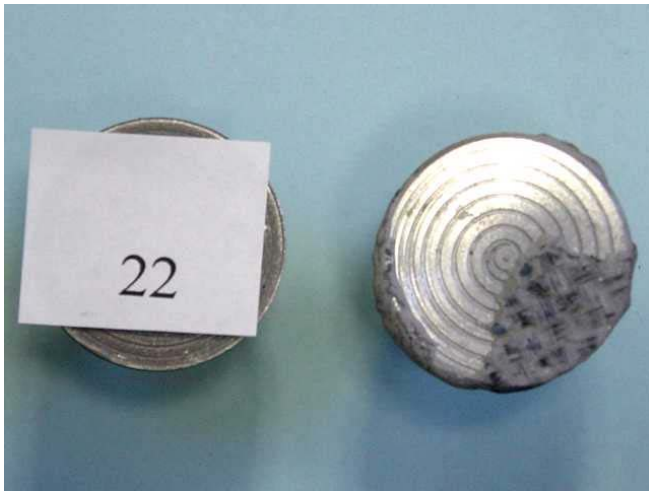
Figure 4.9: Example of separation at the plug bond.

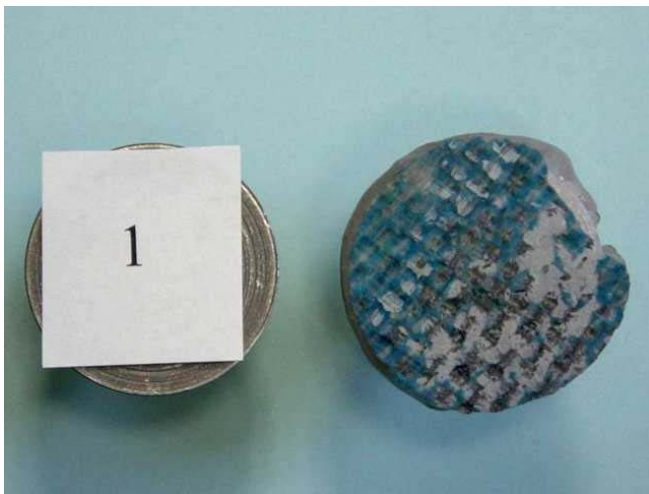
Figure 4.10: Example of separation at the top coat of epoxy. (Note that the texture is the impression of the FRP fibers, and not the fibers themselves).

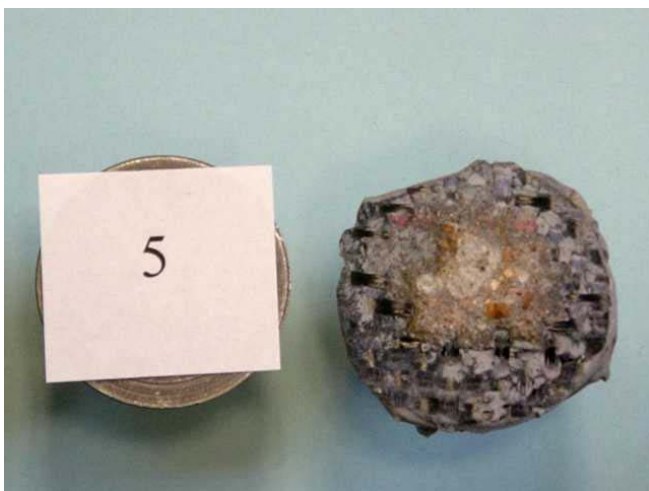
Figure 4.11: Example of composite separation, starting at the top coat of epoxy and extending into the concrete.

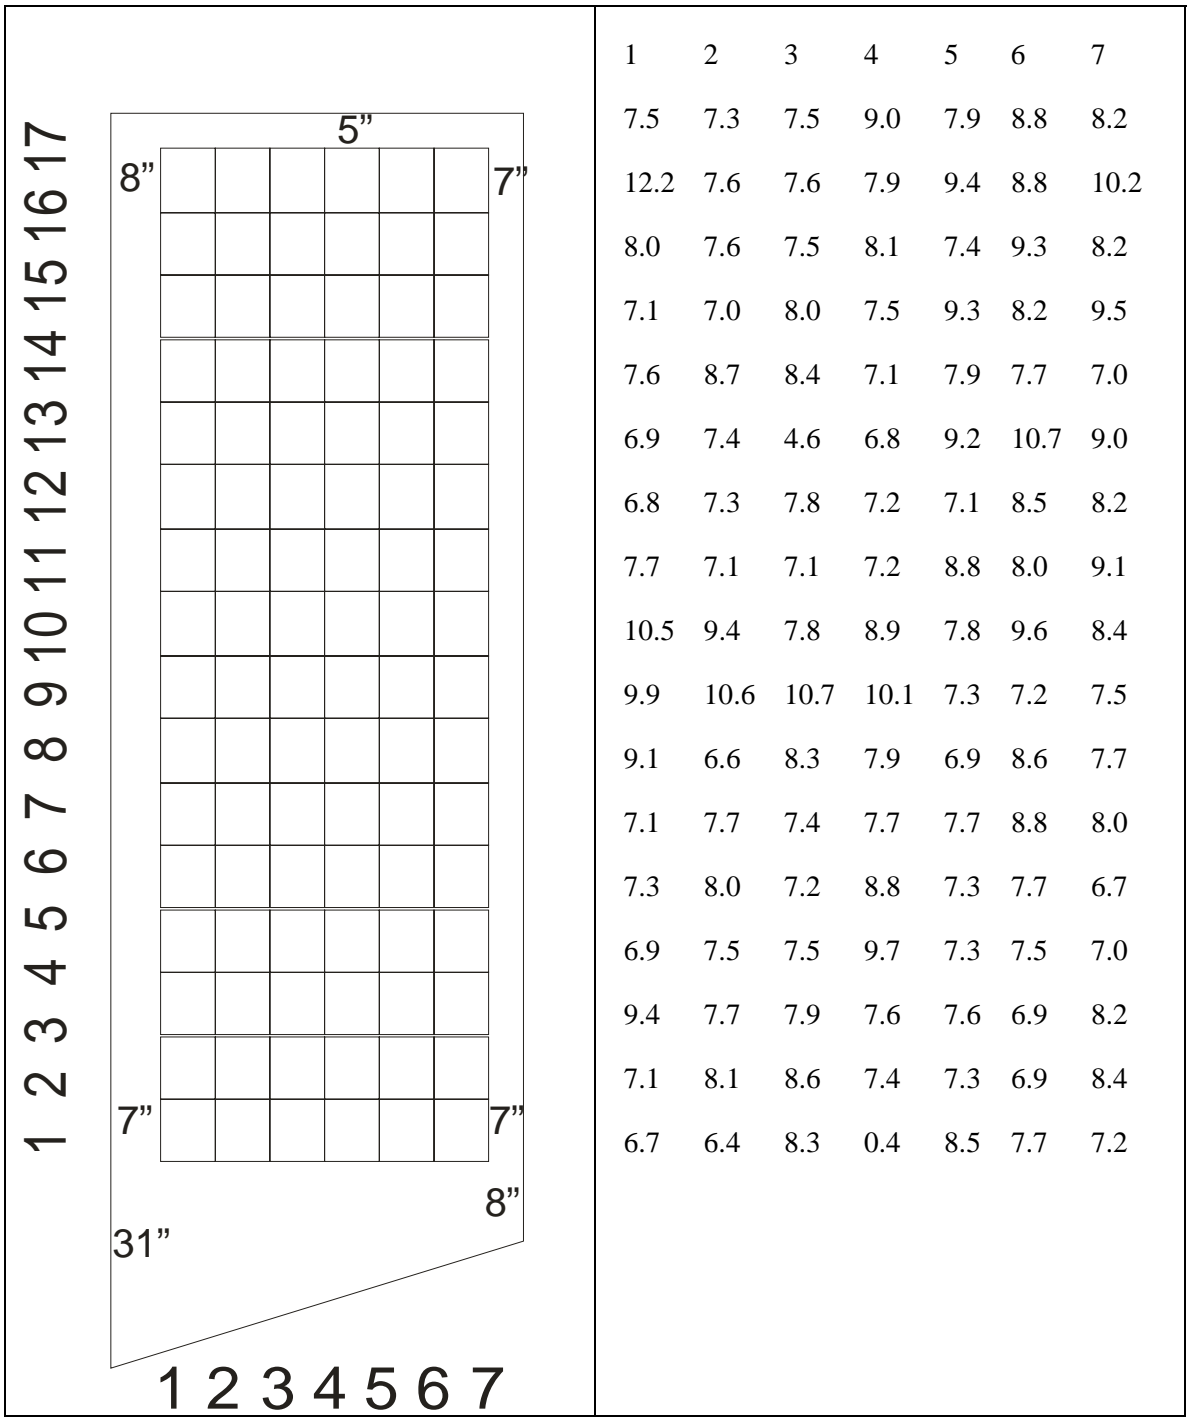
Deck area 1. Roughness matrix, Ia, (Micro-average inclination angle)

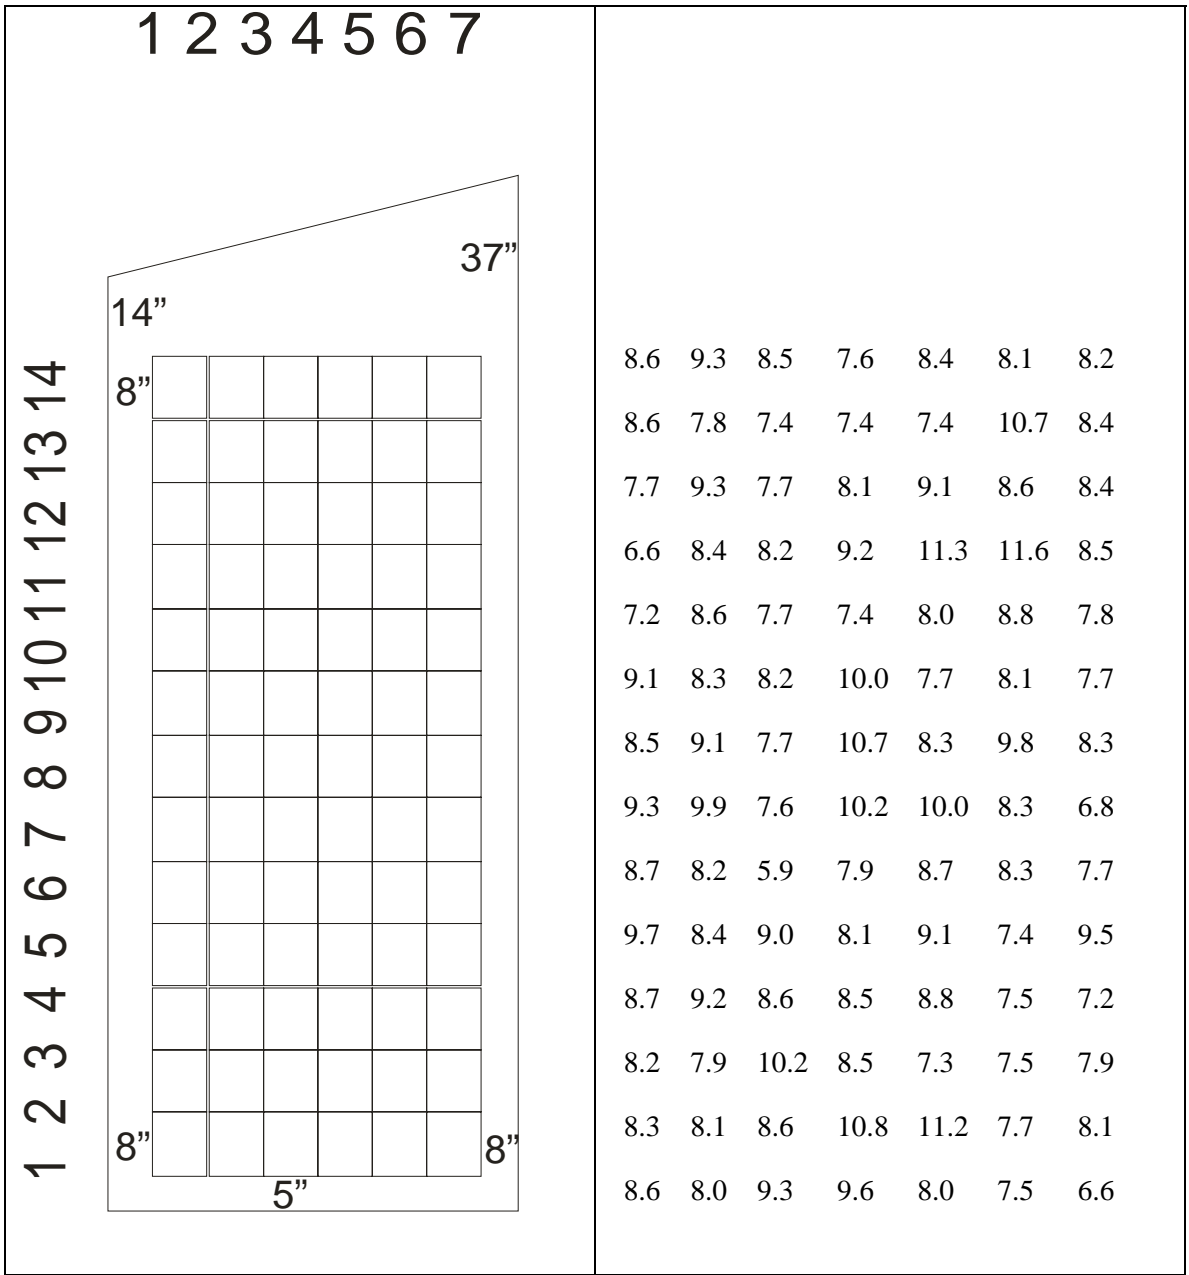
Deck area 2. (Micro-average inclination angle)

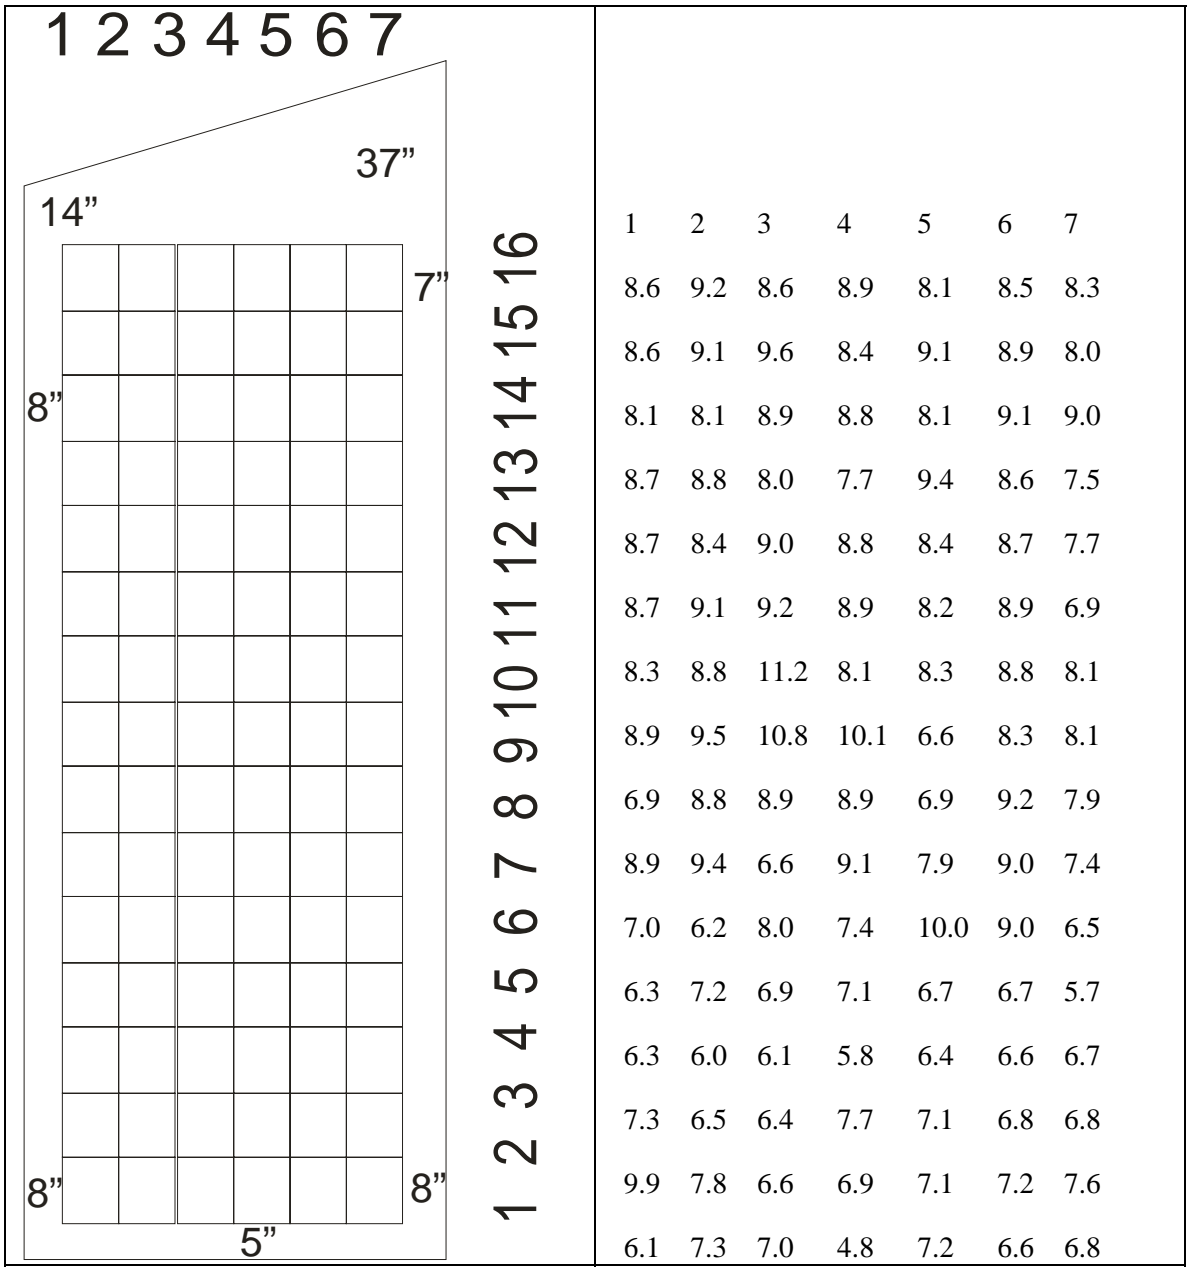
Deck area 3. (Micro-average inclination angle)

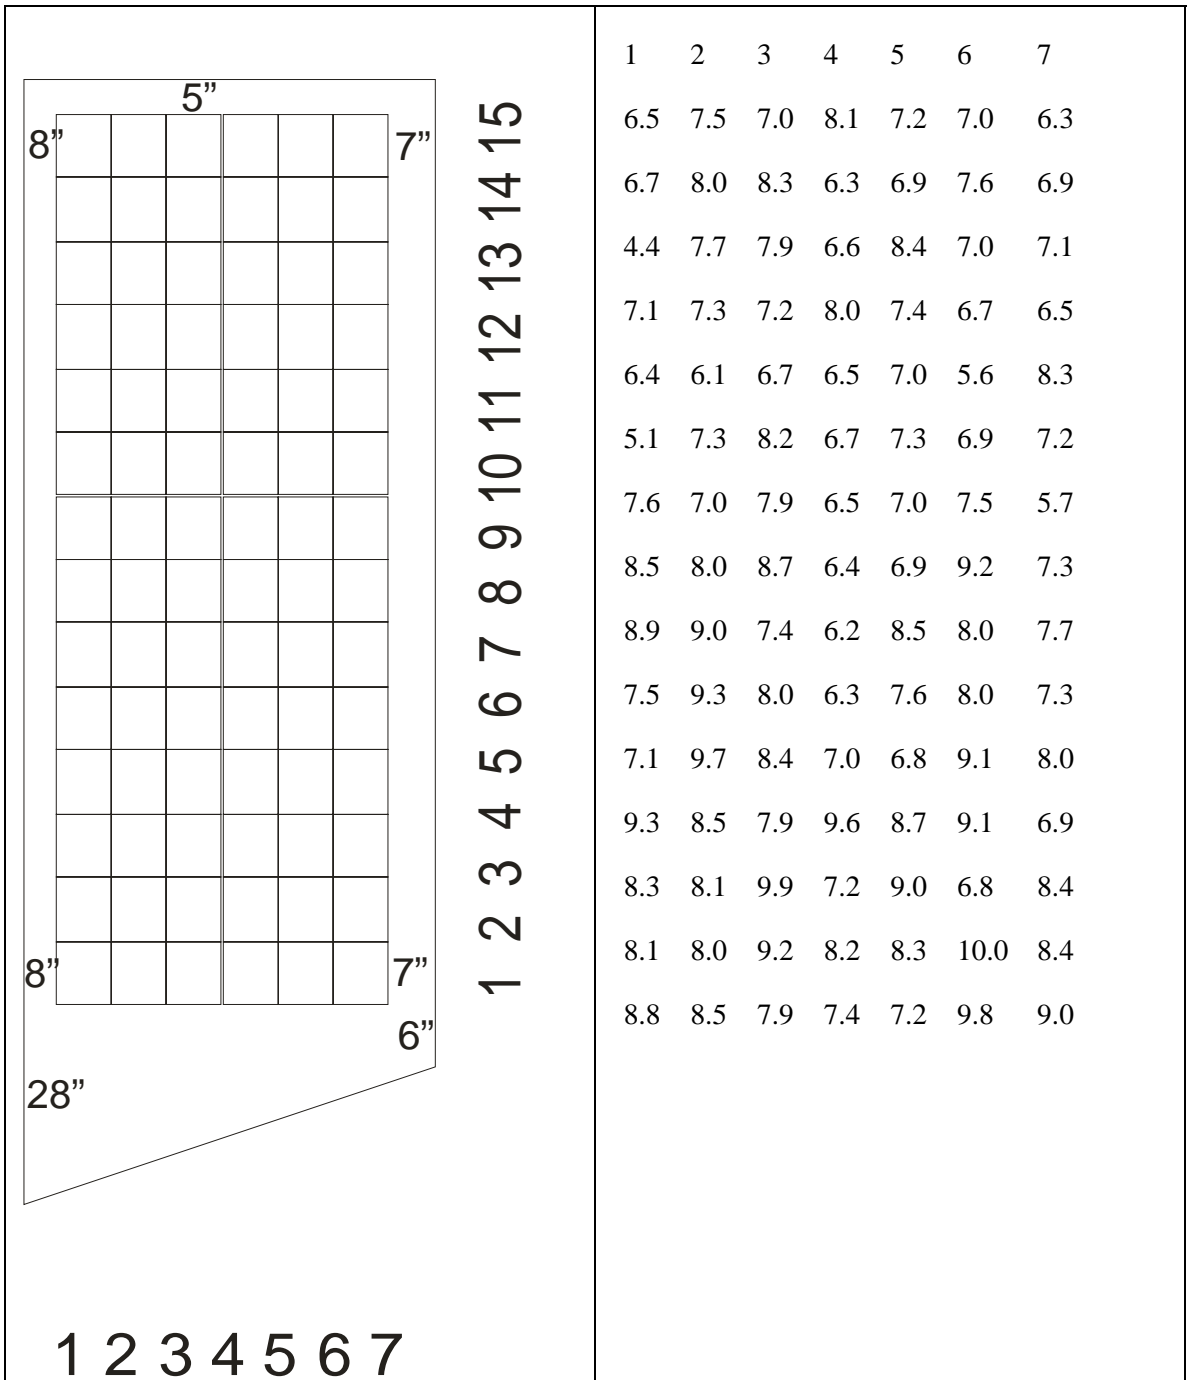
Deck area 4. (Micro-average inclination angle)
