**PAVEMENT EVALUATION
I-265 JEFFERSON COUNTY
MP 15.0-19.0**

**Research Report
KTC-03-22/FR-122-03-1f**

Pavement Evaluation, I-265 Jefferson County MP 15.0 - 19.0

November 2003

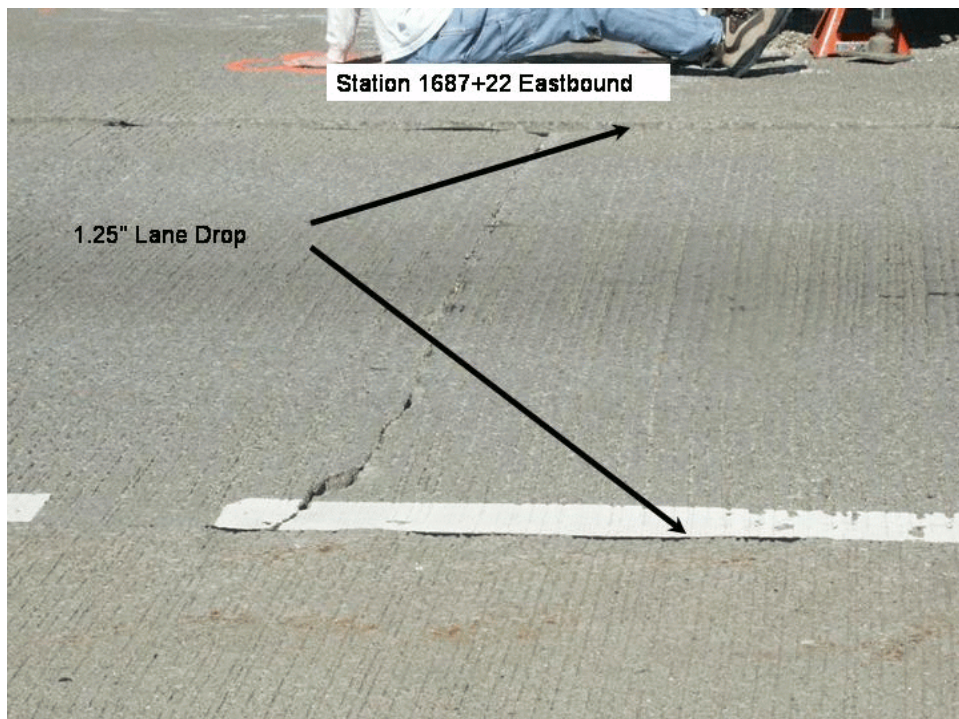
The existing pavement exhibits numerous areas of differential settlement of the right lane in relation to the left lane of up to 2.5 inches. In some areas, differential settlement is also present between the right lane and the outside shoulder. Mid slab transverse cracking was also observed in many areas along the project. These distresses will be summarized later in this report. Faulting of the transverse joints and some of the transverse cracks was also observed. An example of the distress which was observed is shown in Figure 1.

Figure1: Differential Settlement and Transverse Cracking, Station 1687+22, Right Lane Eastbound

After compiling the results from the previously mentioned tests contained in this report, it is recommended that this 3.17 mile section along the I-265 east and west bound corridor be considered for a full reconstruction. However, if there are constraints to performing a full reconstruction at this time, it is recommended that the areas that are experiencing the most severe distress be reconditioned/replaced (Figures 14 and 15). It is also recommended that some type of drainage structure be installed along this 3.17 mile long section to extract water away from the pavement structure.

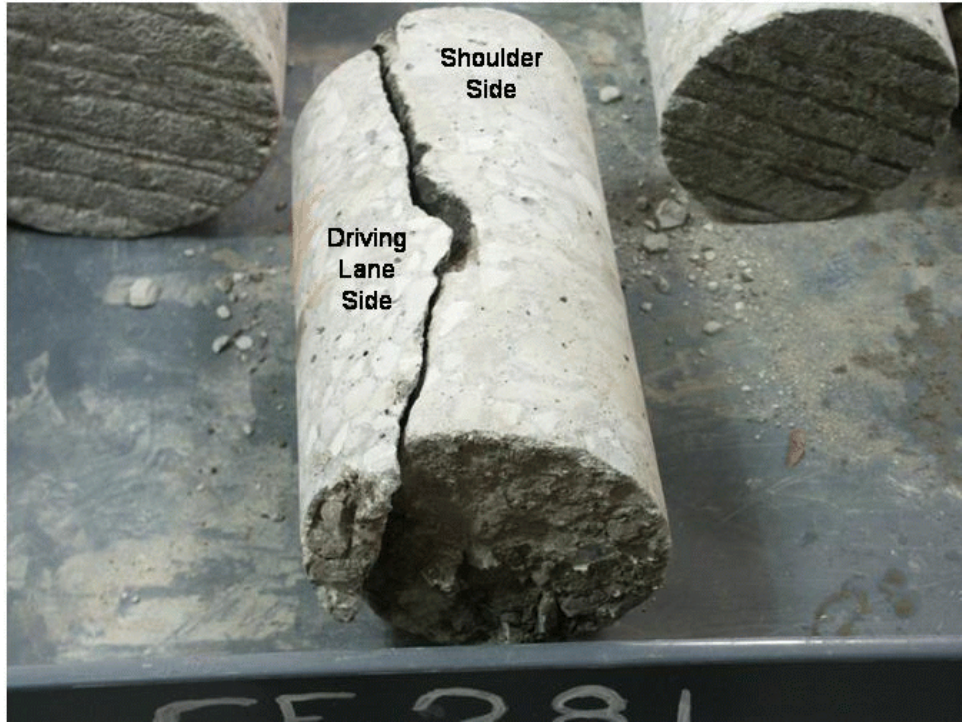
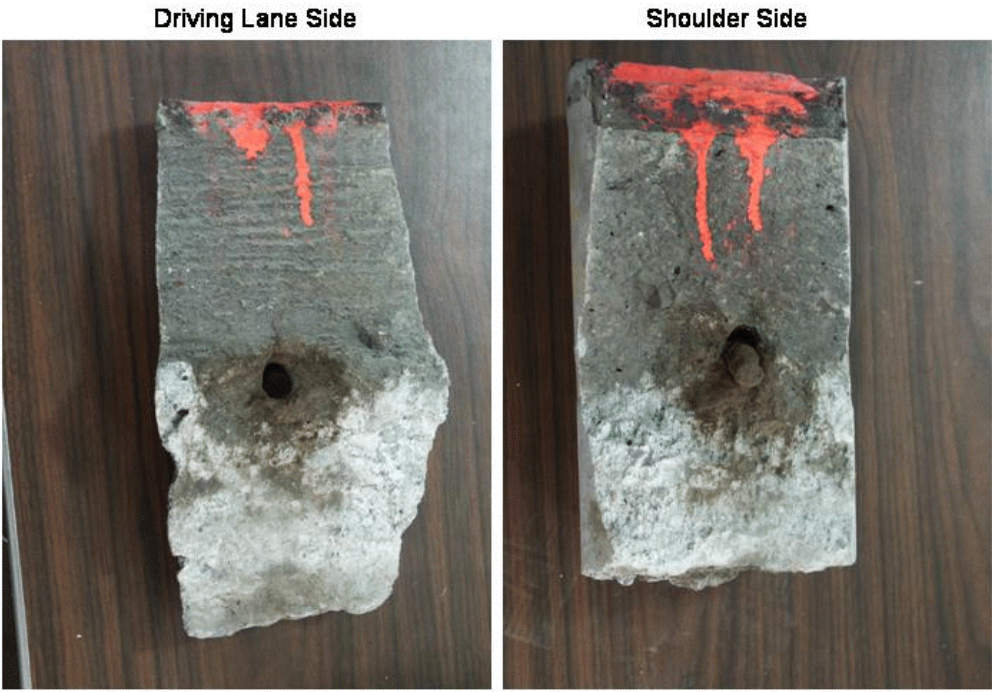
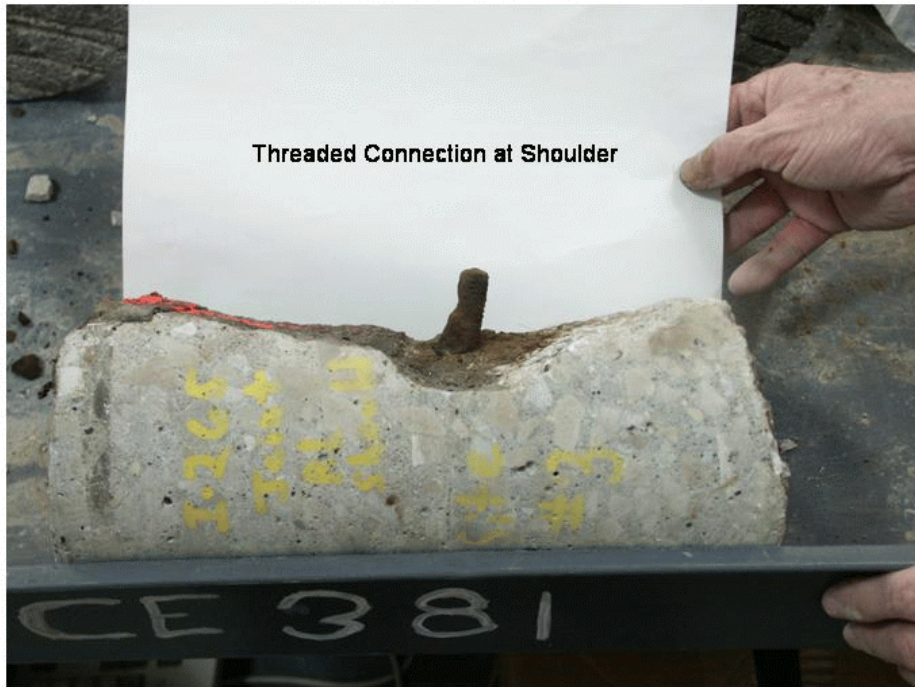
Cores were also taken to evaluate the condition of the transverse pavement joints and the longitudinal outside shoulder joint. Figures 2 through 4 illustrate the condition of the shoulder tie assembly at station 1687+22 eastbound. It may be seen from these photographs that the assembly has corroded and is not providing the necessary load transfer. Figure 5 illustrates the condition of the shoulder joint at station 1681+66, westbound. Deterioration of the tie assembly may also be observed in this location. Figures 6 and 7 illustrate the condition of the transverse joints where low load transfer efficiency was observed with the FWD. It may be seen from these figures that deterioration of the dowel bar has begun and thus the load transfer efficiency is diminished. In addition, the Neoprene joint seal material has appears to have lost some of its elasticity and is permitting water to infiltrate the transverse joints.

Figure 2. Shoulder Joint, Eastbound Station 1687+22

Figure 3. Shoulder Joint, Eastbound Station 1687+22

Figure 4. Tie Bolt, Shoulder Joint, Eastbound Station 1687+22

In light of both the longitudinal ties bars and the transverse dowel bars experiencing a severe amount of corrosion, it may indicate that the Neoprene water seals are not performing properly. It is suggested that other highway routes with similar Neoprene water seals be evaluated to determine the integrity of the Neoprene seals.

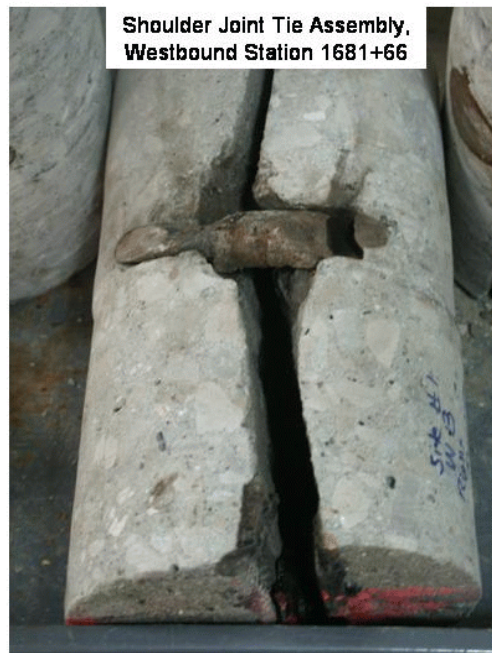
Figure 5. Shoulder Tie Assembly, Westbound Station 1681+66

GPR technology was also used to locate both the longitudinal tie bars and the transverse dowel bars. After extracting cores from both the tie bar and dowel bar locations a visual inspection was performed on each of the bars. Preliminary results indicate that both bars are being subjected to a wet environment because of the amount of corrosion each bar is experiencing. The amount of corrosion the longitudinal tie bars are experiencing maybe an indication that the Neoprene water seals maybe failing. In addition, the longitudinal tie bars are bending downward. This may indicate that the tie bars are structurally failing, and thus allowing the right driving lane to settle. The corrosion around the transverse dowel bars may be attributing to the low load transfer across the transverse joints.

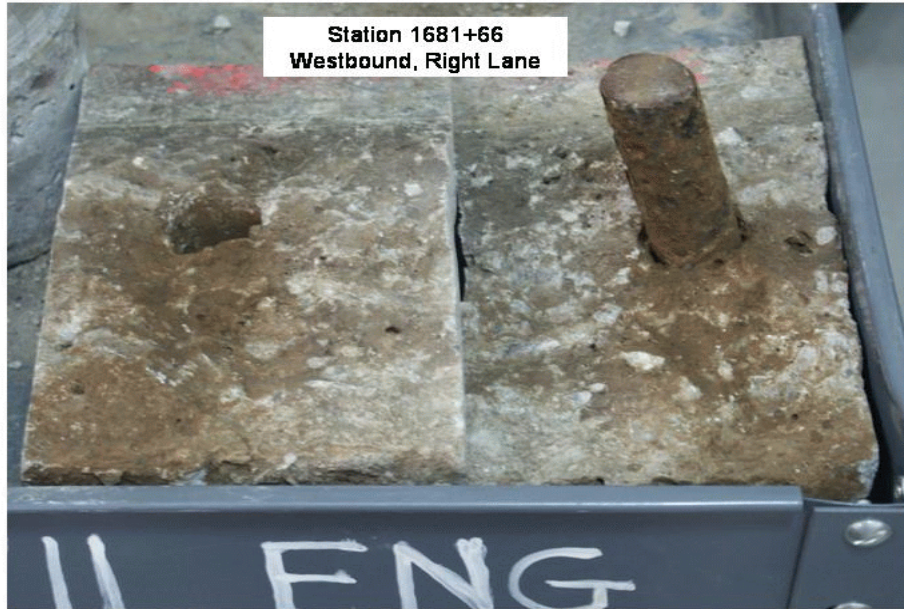
Figure 6. Transverse Joint Dowel Bar, Right Lane Westbound Station 1681+66

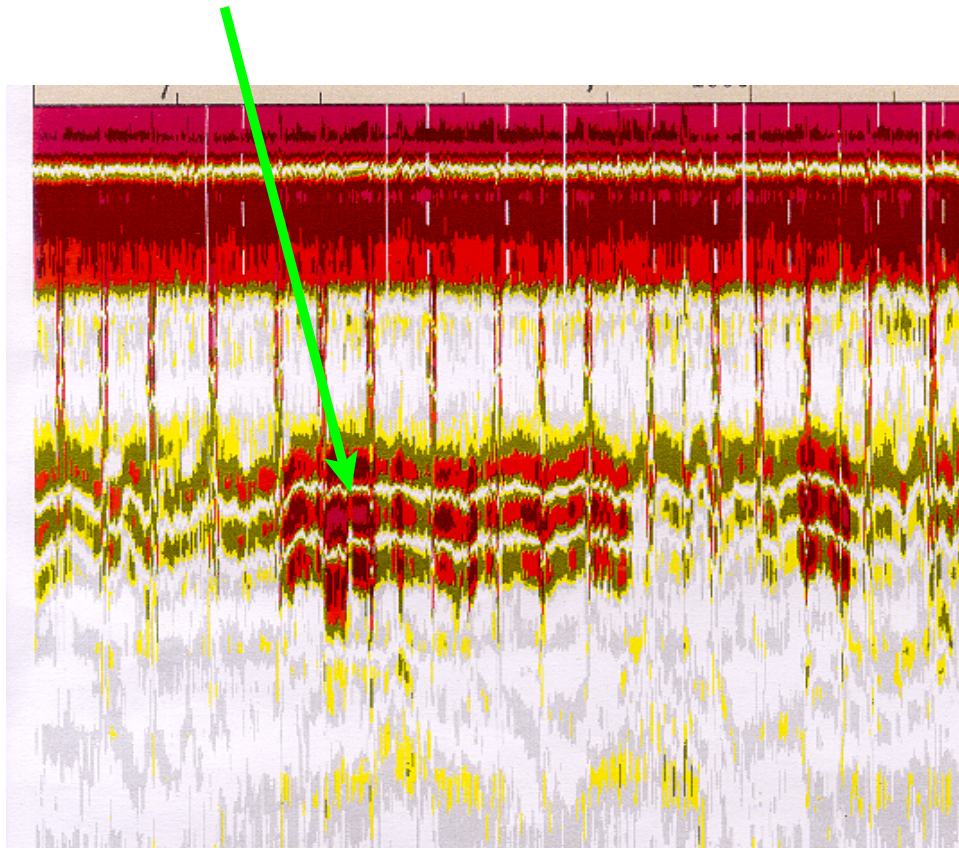
Figures 8e, 9e, 10e, and 11e indicate GPR's interpretation of water beneath the PCCP or in the DGA layer. However, GPR does not have a way to quantify the amount of water being displayed in the said figures. Therefore engineering judgement has been used to quantify the amount of water that GPR graphically displays. Figure 12a has been determined to be an area that represents severe water (where the DGA layer appears red in color), figure 12b has been determined to be an area that represents moderate water (where the DGA layer appears more green in color), and figure 12c represents an area that is determined to have little or no water beneath the PCCP (where the DGA layer appears more yellow in color).

Figure 12a: Example of Severe Water in DGA Layer

Once a visual threshold was established for the amount of water present in the DGA layer, a rating was given to every 200 feet in both the right and left lanes of both the east and west bound directions. Ten points were given to the sections with severe water, five points were given to the sections with moderate water, and zero points were given to the sections with little or no water. In order to determine how each 200-foot section varied along the route all water ratings were graphed. Figures 8e and 9e show the left and right lanes of the eastbound direction, and figures 10e and 11e show the left and right lanes of the westbound direction, respectfully. It appears that edge drains should be installed along this section of I-265 to help drain the subgrade/DGA layer. However, if providing edge drains throughout the entire project is not possible, it is suggested that subgrade drainage be provided to those areas that have a rating of ten.

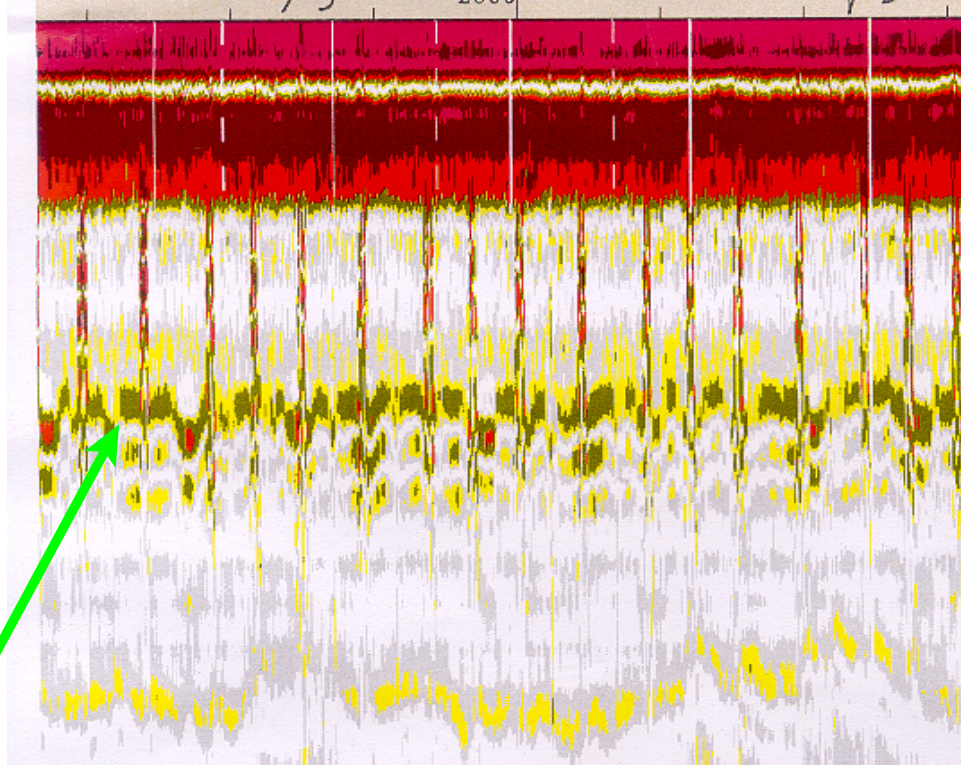
Figure 12b: Example of Moderate Water in DGA Layer

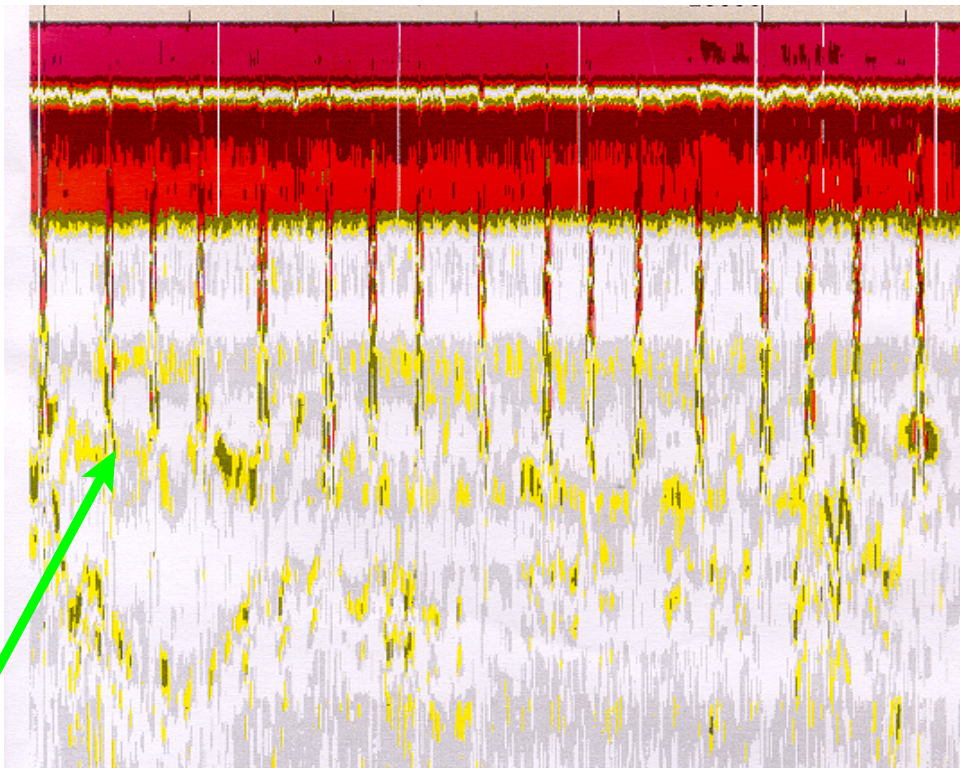
Figure 12c: Example of Little to No Water in DGA Layer

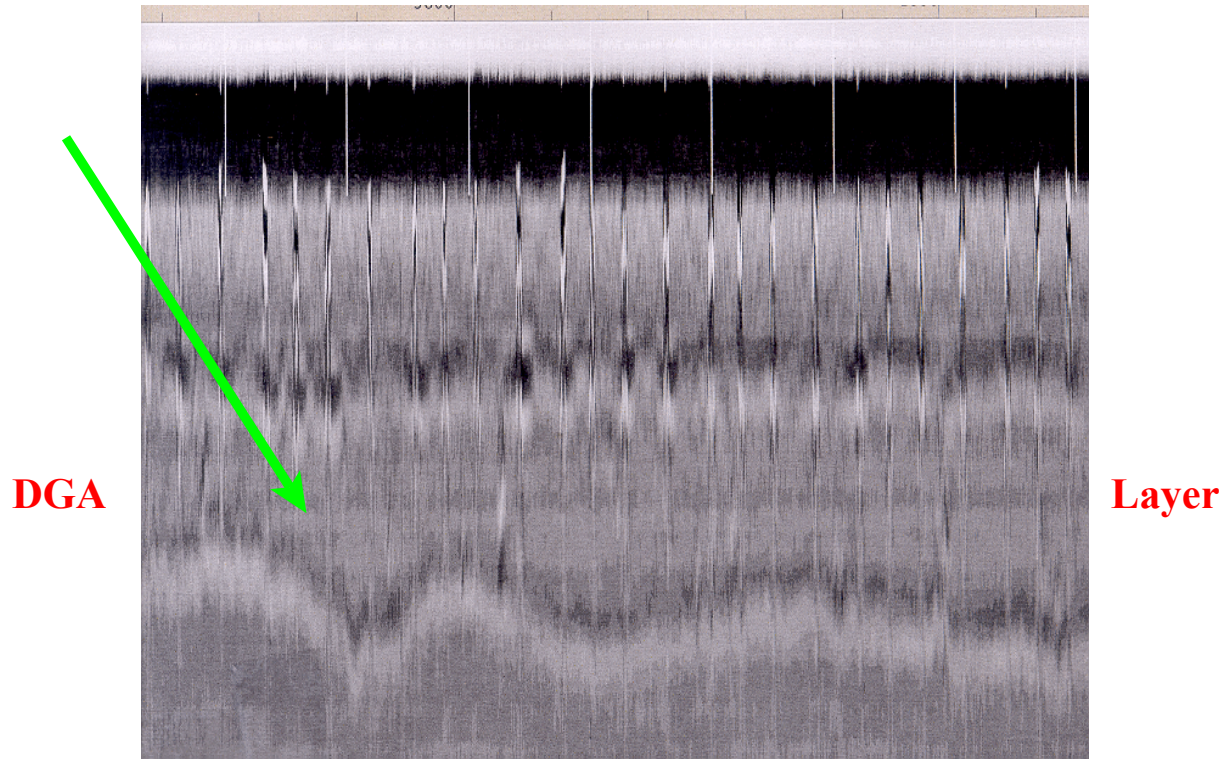
Although it was an unexpected find, GPR was able to determine an additional layer of material that was located between the rock subgrade and the DGA layer. Core analysis indicates that this material is a clayey type material and/or weathered shale. It is believe that this material maybe compressive in nature, and do to heavier traffic loads in the right lane, this may be the cause of the differential settlement between right and left lanes.

Figure 13a indicates an area where the additional layer was observed. Figure 13b indicates an area where the additional layer was not observed. The entire project was scanned using GPR, attempting to define the limits of this material along the tested section. A simple yes/no ranking was given to every 200-foot section that identifies whether the extra layer was present or not. Graphs that identify the location of the additional layer along the entire project for each lane can be found in Figures 8f, 9f, 10f, and 11f. It should be noted a ranking of 1 means, yes, the layer was present, and 0 means, no, the layer was not present in Figures 8f, 9f, 10f, and 11f.

Figure 13a. G.P.R., Additional Weathered Shale/Clay Layer Found

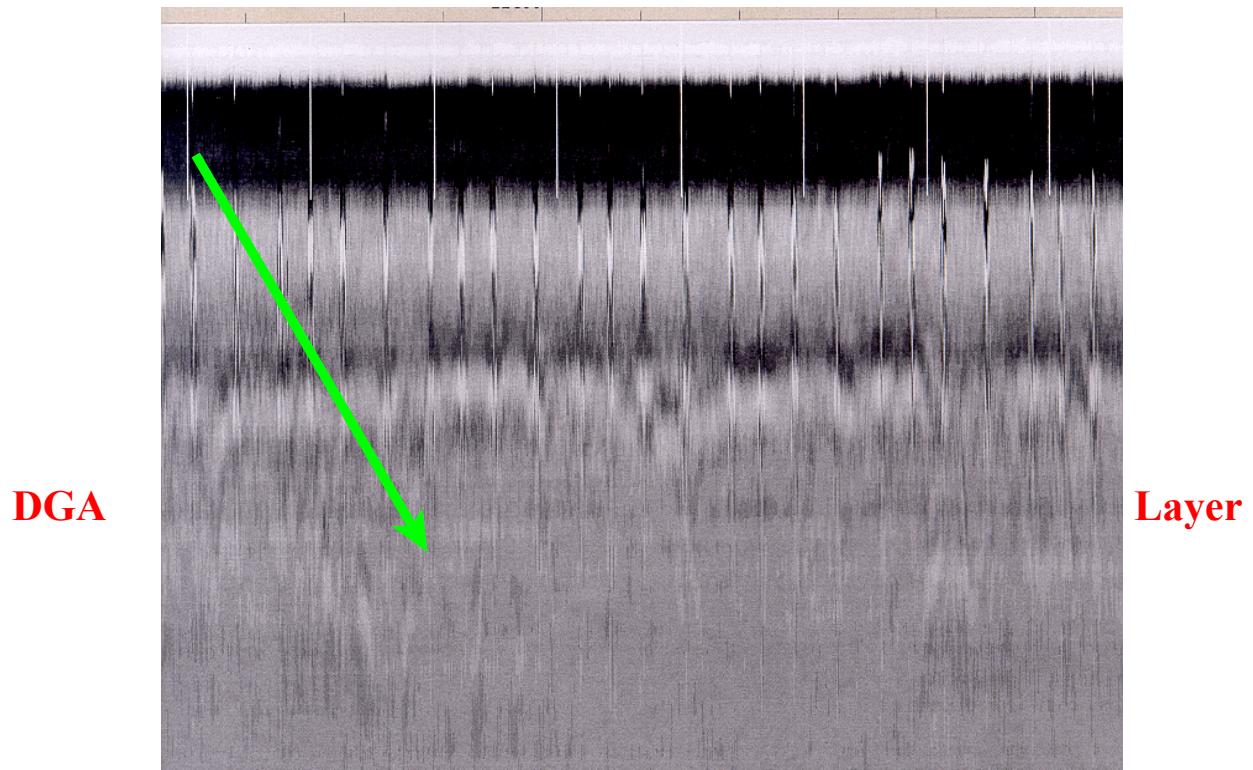
Figure 13b. G.P.R. No Additional Layers Found

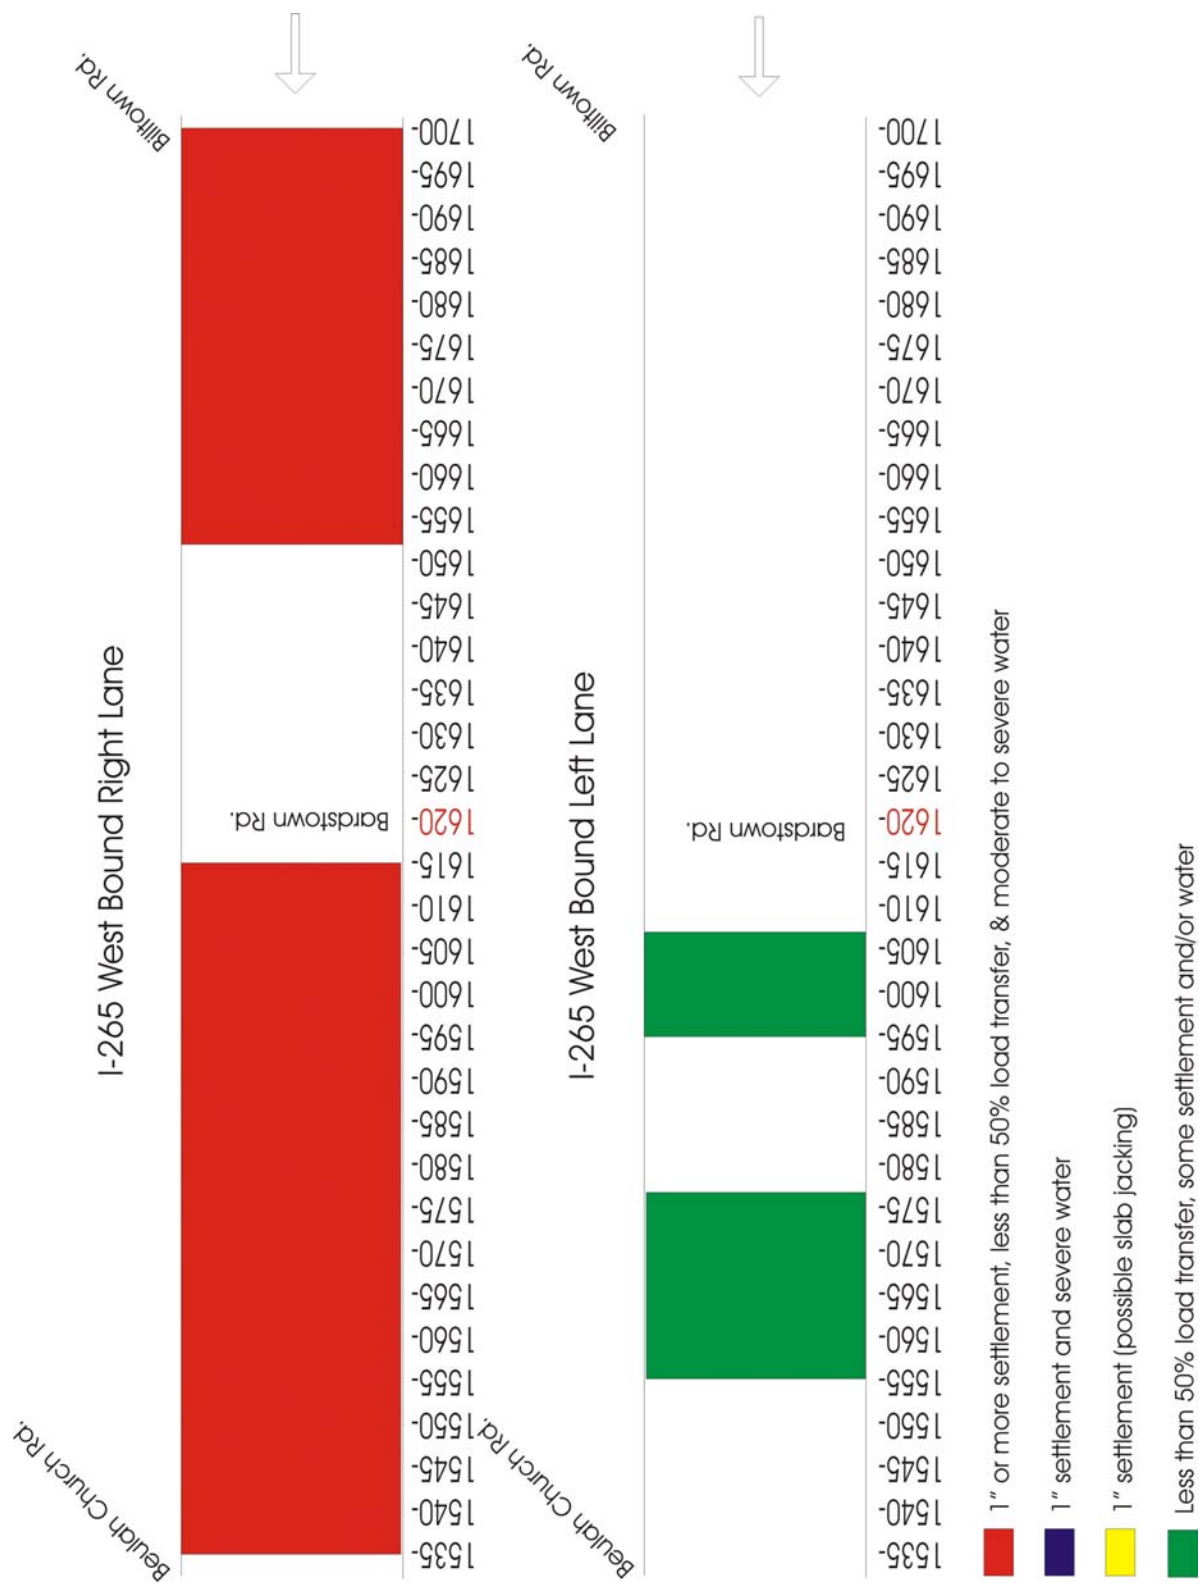
Figure 14. Westbound Strip Map

Although it is recommended that both the driving lanes be reconstructed in both directions for this project, Figures 14 and 15 identify areas that are considered to be more distressed than others. As can be seen in Figures 14 and 15, different areas with different levels of distress have been identified. The areas shaded in red indicate areas that have settled more than one inch, have less than 50% load transfer over the transverse joints, and have moderate to severe water located under the pavement slab. Areas that are shaded in blue indicate areas that are experiencing approximately one inch of settlement and have a severe amount of water located under the concrete pavement. Areas that have been shaded in yellow indicate areas that are experiencing approximately one inch of settlement only. The least moderately distressed areas have been shaded in green. These areas are exhibiting less than 50% load transfer, and have some settlement and/or water beneath the concrete pavement. All other areas displayed with a white background are experiencing moderate to no distress at this time. However, as noted in figures 8f, 9f, 10f, and 11f the majority of the tested sections display the presence of a clay layer between the D.G.A. layer and the rock roadbed.
