Galvanized and Aluminized Pipe Durability Field Review and Evaluation

Kansas State University Transportation Center

Final Report

September 2019

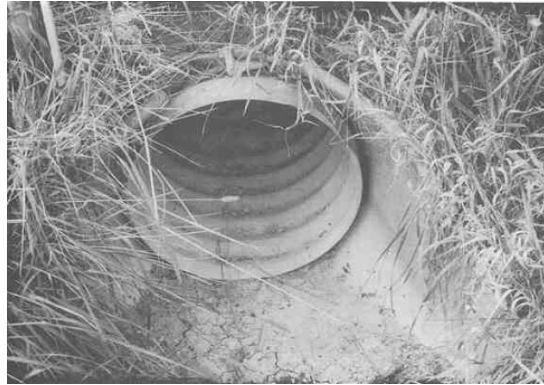
Figure 2.7: Example of a Culvert with a 1 Rating

removed). The CMP shown in Figure 2.7 was given a rating of 1, or excellent condition. The thickness of the zinc coating and overall CMP thickness were also recorded.

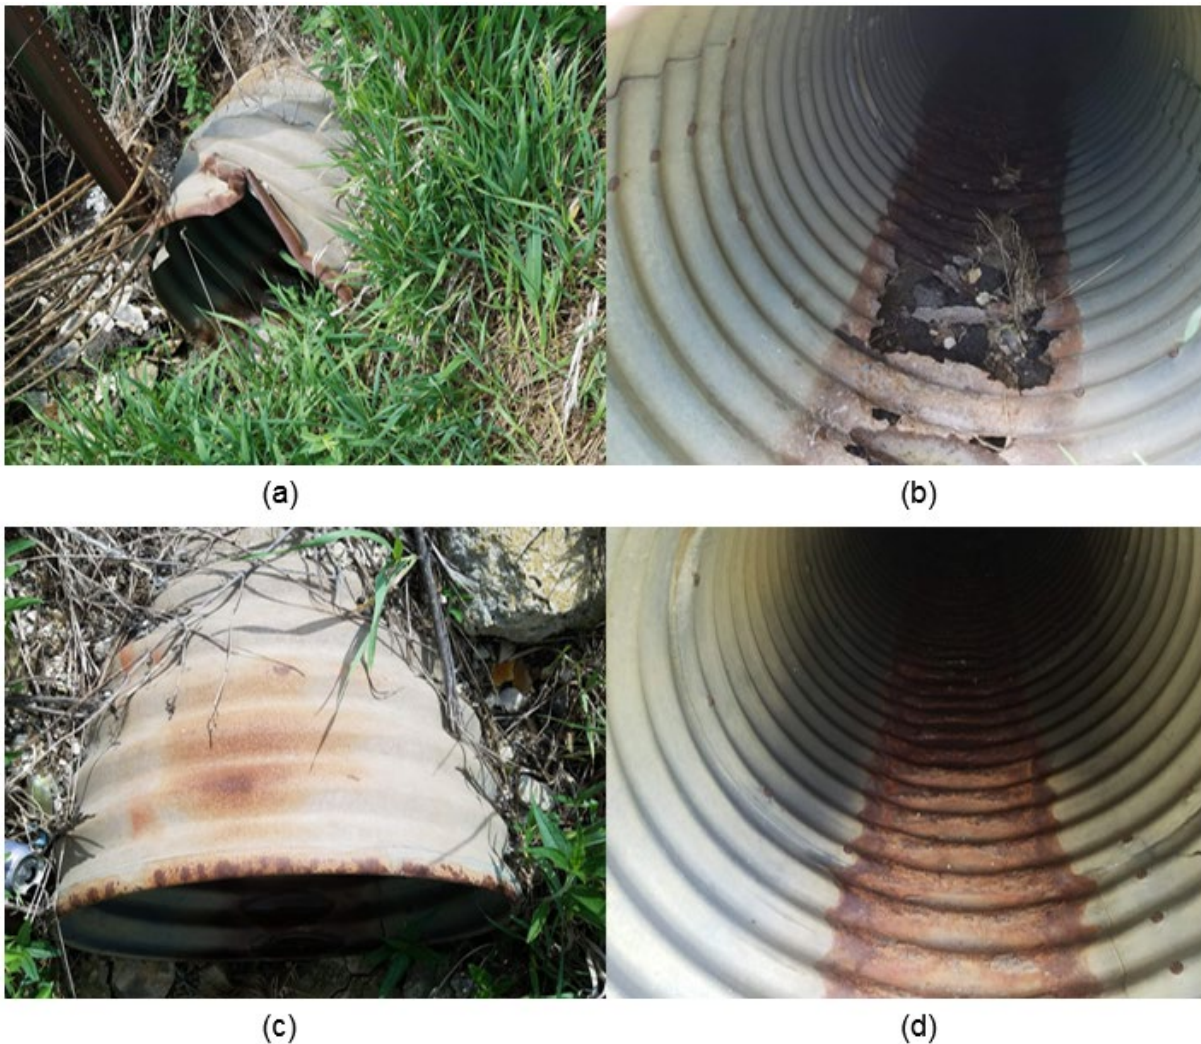
Figure 4.2: Field Photos Included in ARCGIS Database for Sample Data: (a) Side A External, (b) Side A Internal, (c) Side B External, (d) Side B Internal

Data Field	User Input	Data Field	User Input
Project/Route Number	K-63	General Condition (A)	62.5
County	Pottawatomie	External (A)	80
Material	Galvanized	Crown (A)	85
Age (yr)	78	Side (A)	85
Diameter	24	Invert (A)	0
Pitch (in)	2.67	General Condition (B)	70
Depth (in)	0.5	External (B)	80
Resistivity (Ohm-cm)	700	Crown (B)	85
Description	na	Side (B)	85
Photos	Figure 4.2	Invert (B)	30

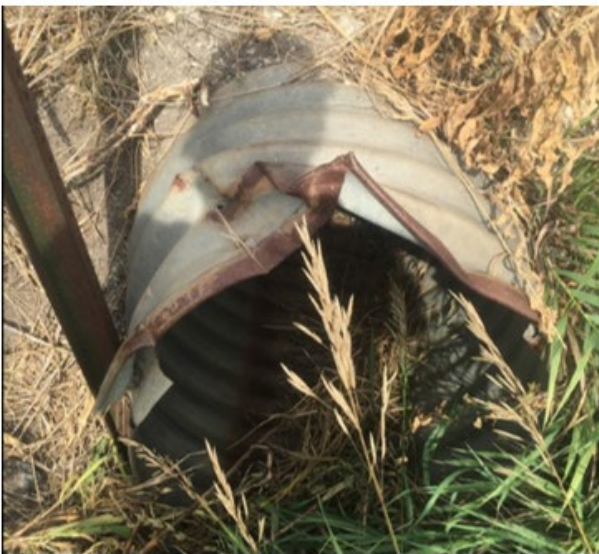
(a)

Some CMP damage included in this study was likely not caused by the type and/or quality of the CMP. For example, a number of CMP appeared to have been run over, likely by tractor or lawnmower. These CMPs showed signs of corrosion where surfaces were damaged. Figure 4.3(a) and Figure 4.3(b) shows CMP with external damage to the side and invert likely not caused by corrosion, although these data are included in the overall summary. Some CMP were disconnected from their end section, as seen in Figure 4.3(c). Other CMP exhibited increased corrosion along welded seams, shown in Figure 4.3(d).

Figure 4.3: Non-Corrosion Induced Damage: a) Damage to the Top Face; b) Damage to the Side; c) Disjointed CMP; d) Corrosion Along Welded Seam
