# Optimized Taconite-Based Pavement Repair Compound and Deployment System

**Lawrence Zanko, Principal Investigator**

Natural Resources Research Institute  
University of Minnesota-Duluth

Research Project  
Final Report 2019-46

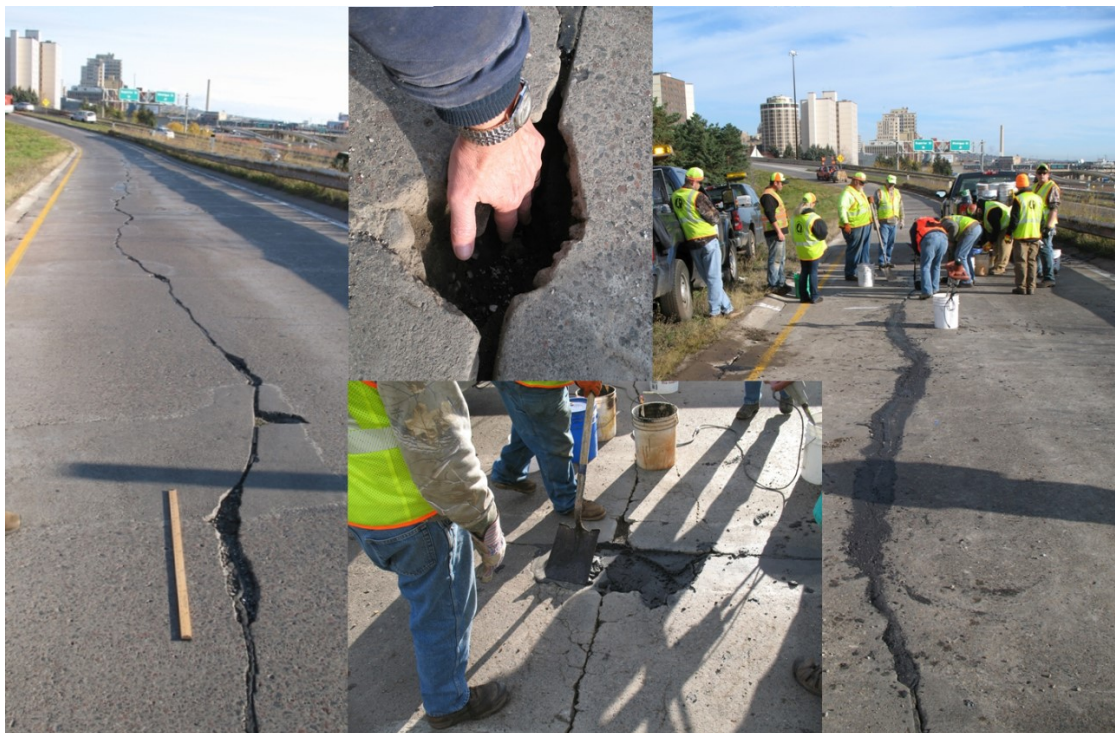
Figure 2.15 Pavement condition and initial repairs: Mesaba Avenue, Duluth - November 2, 2016

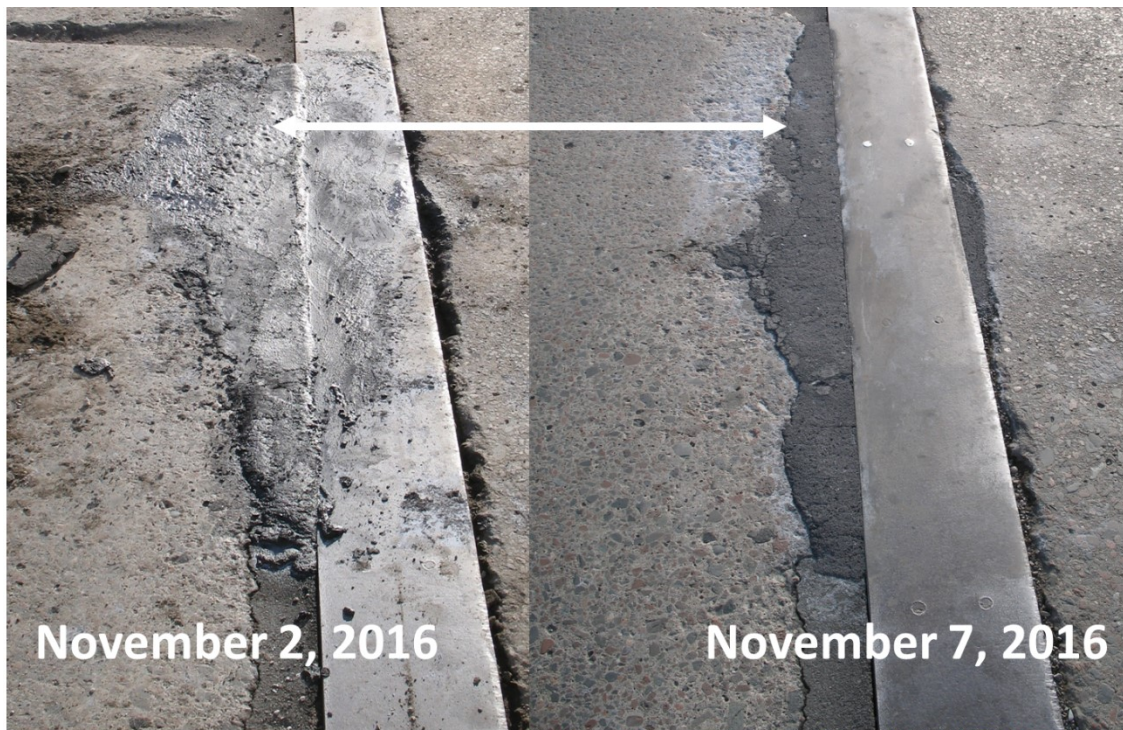
The condition of the repairs was observed and documented following installation, revealing that the formulation needed further modification to improve performance and optimize set times relative to ambient pavement and air temperatures. Excessive expansion of the compound following placement in the repair can lead to a weaker product, especially at the surface. Abrasion and deterioration of the repairs occurred within a week, as Figure 2.17 shows, especially where the repair was thin and shallow. The repair compound is better suited for deeper/thicker repairs. Formulation modification is underway and continuing, as described previously.

**Figure 2.16 Condition of repair made at Mesaba Avenue expansion joint:  
November 2 (left); and November 7 (right), 2016.**

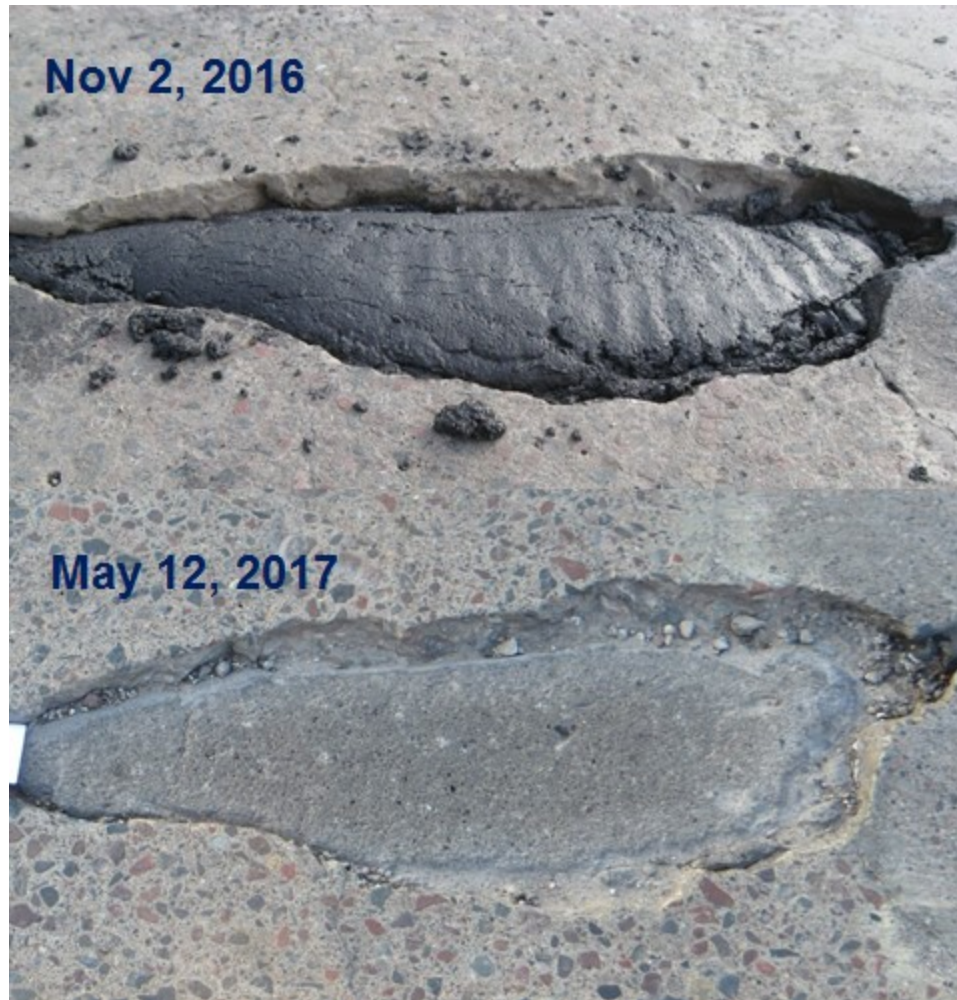
The Mesaba Avenue site was visited again on May 12, 2017. Surprisingly, many of the repairs were still in place six months later, albeit with some loss. This was not entirely expected, given the early rapid abrasion evidence. While the repair compound had abraded fairly quickly following its installation, especially where it had expanded above the plane of the pavement, it remained largely intact below the plane of the pavement, as Figure 2.18 shows. Similar results were shown for some of the narrow but deeper crack repairs. This outcome suggests the repair compound could be an effective tool for partially filling cracks and other pavement distresses, and act as a foundation for finishing the repair with mastic. By filling most of the volume of a pavement distress, the compound could significantly reduce the quantity of mastic used for completing the repair, saving cost and reducing mastic cure time.

Figure 2.17 Condition of Mesaba Avenue repair following installing on November 2, 2016 (top photo) and on May 12, 2017 (bottom photo).

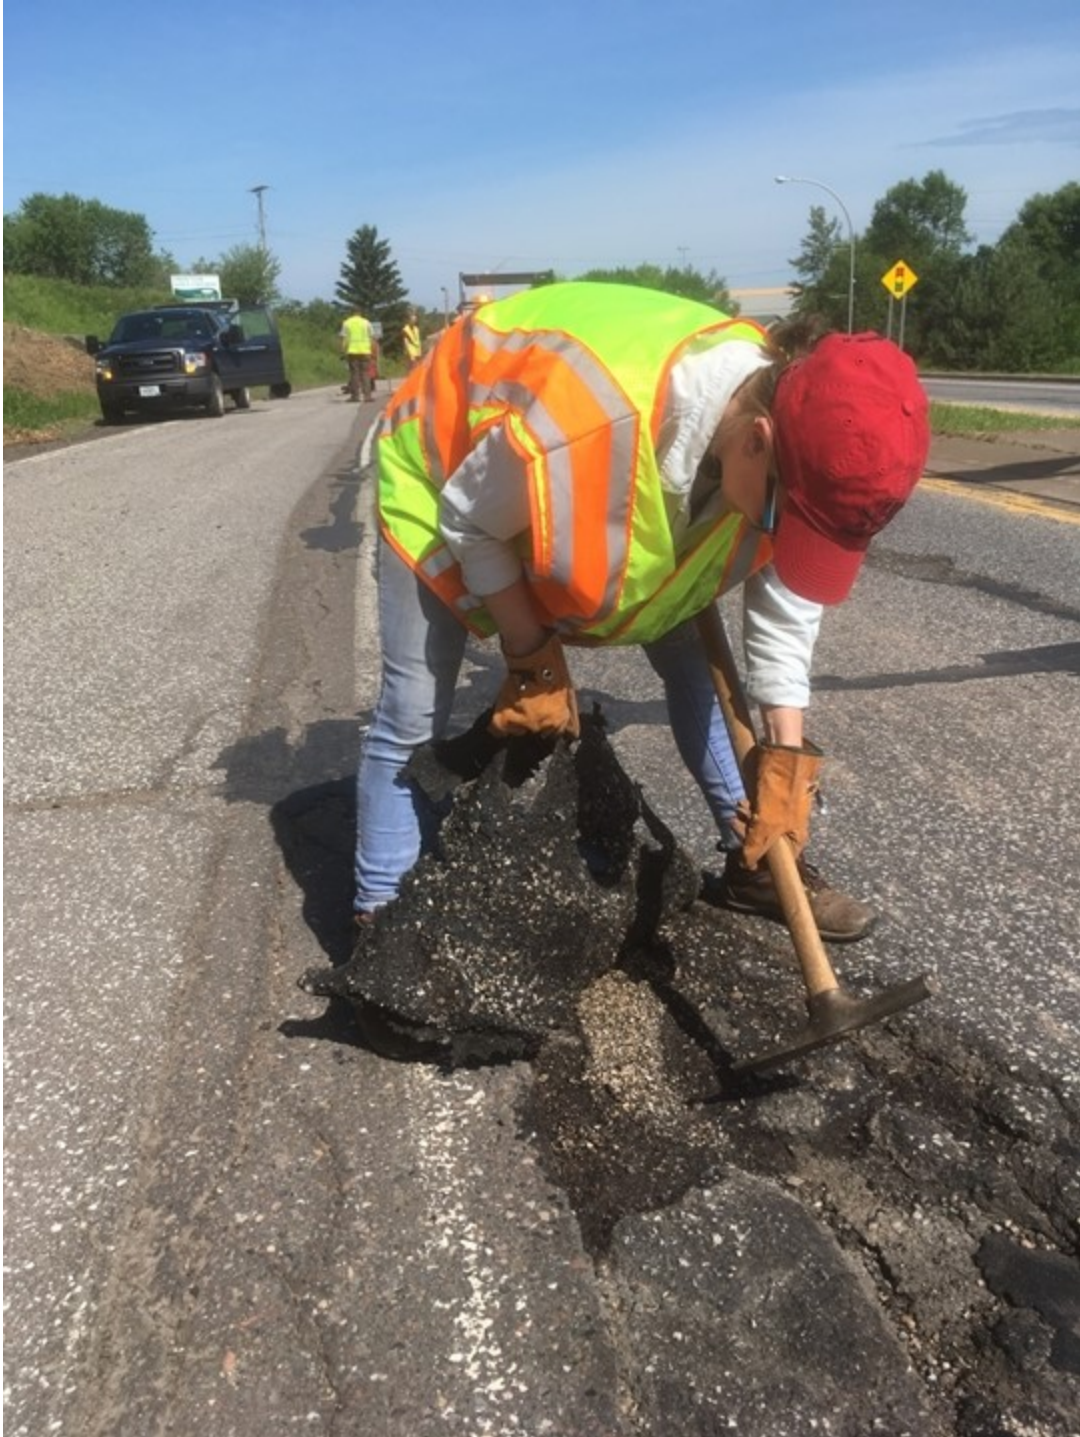
**Figure 2.50 Delaminating mastic repairs, Proctor, MN, field trial site: June 20, 2018.**

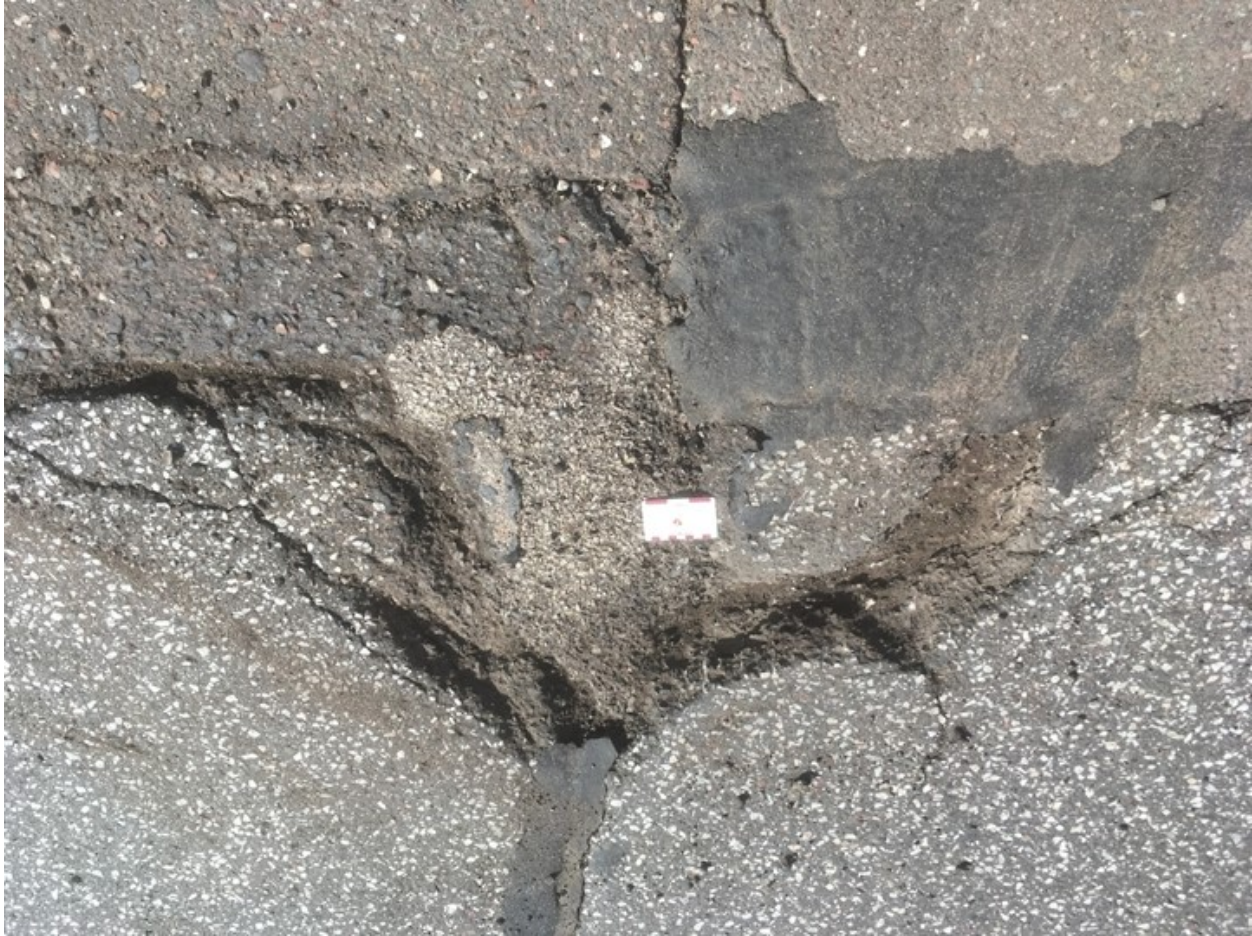
**Figure 2.51 Pothole prior to repair: Proctor, MN, field trial site, June 20, 2018.**

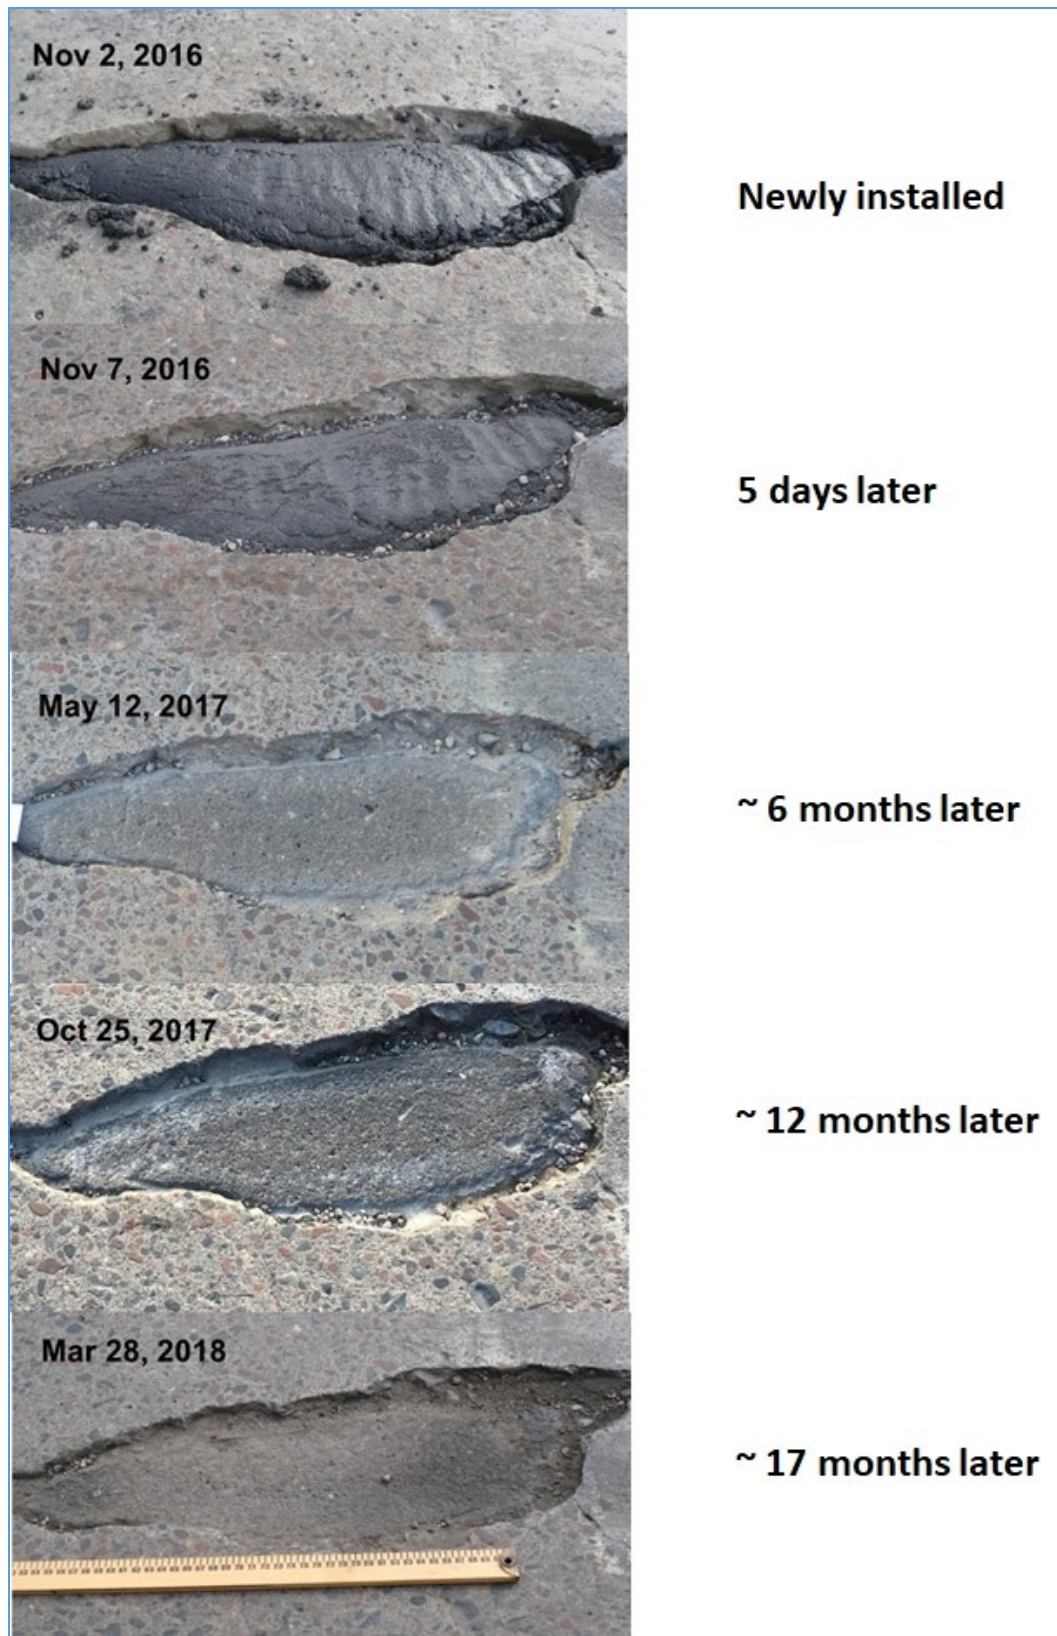
Figure 2.58 Condition of Mesaba Avenue repair from November 2, 2016, to March 28, 2018.

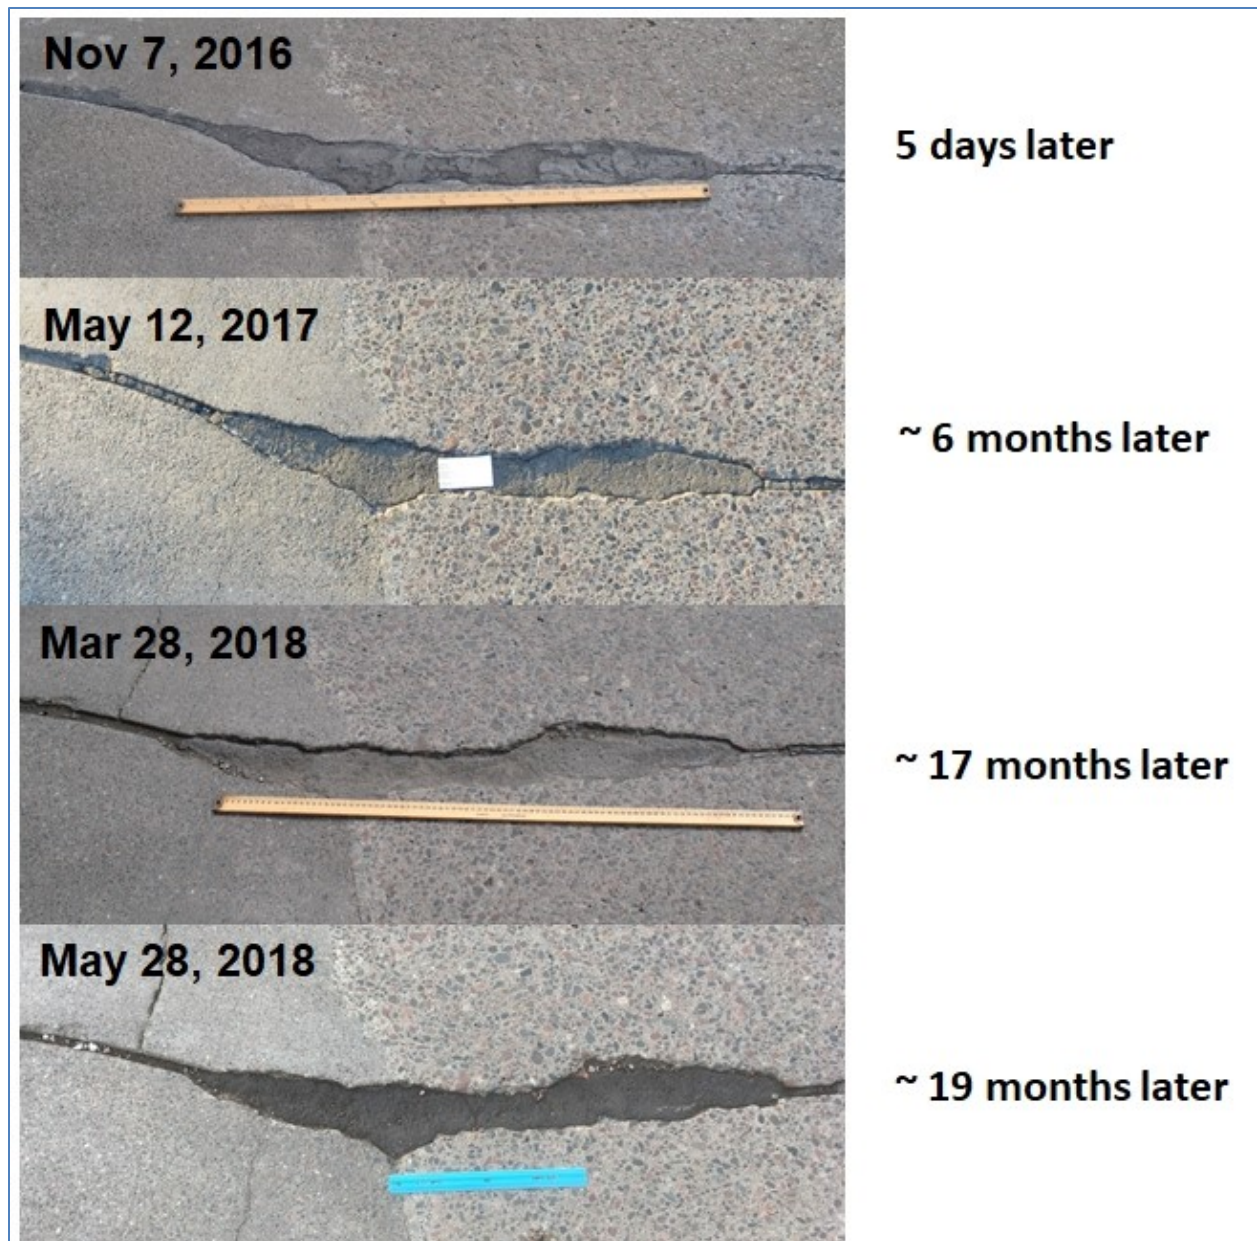
**Figure 2.59 Condition of Mesabi Avenue crack repair from November 7, 2016, to May 28, 2018.**

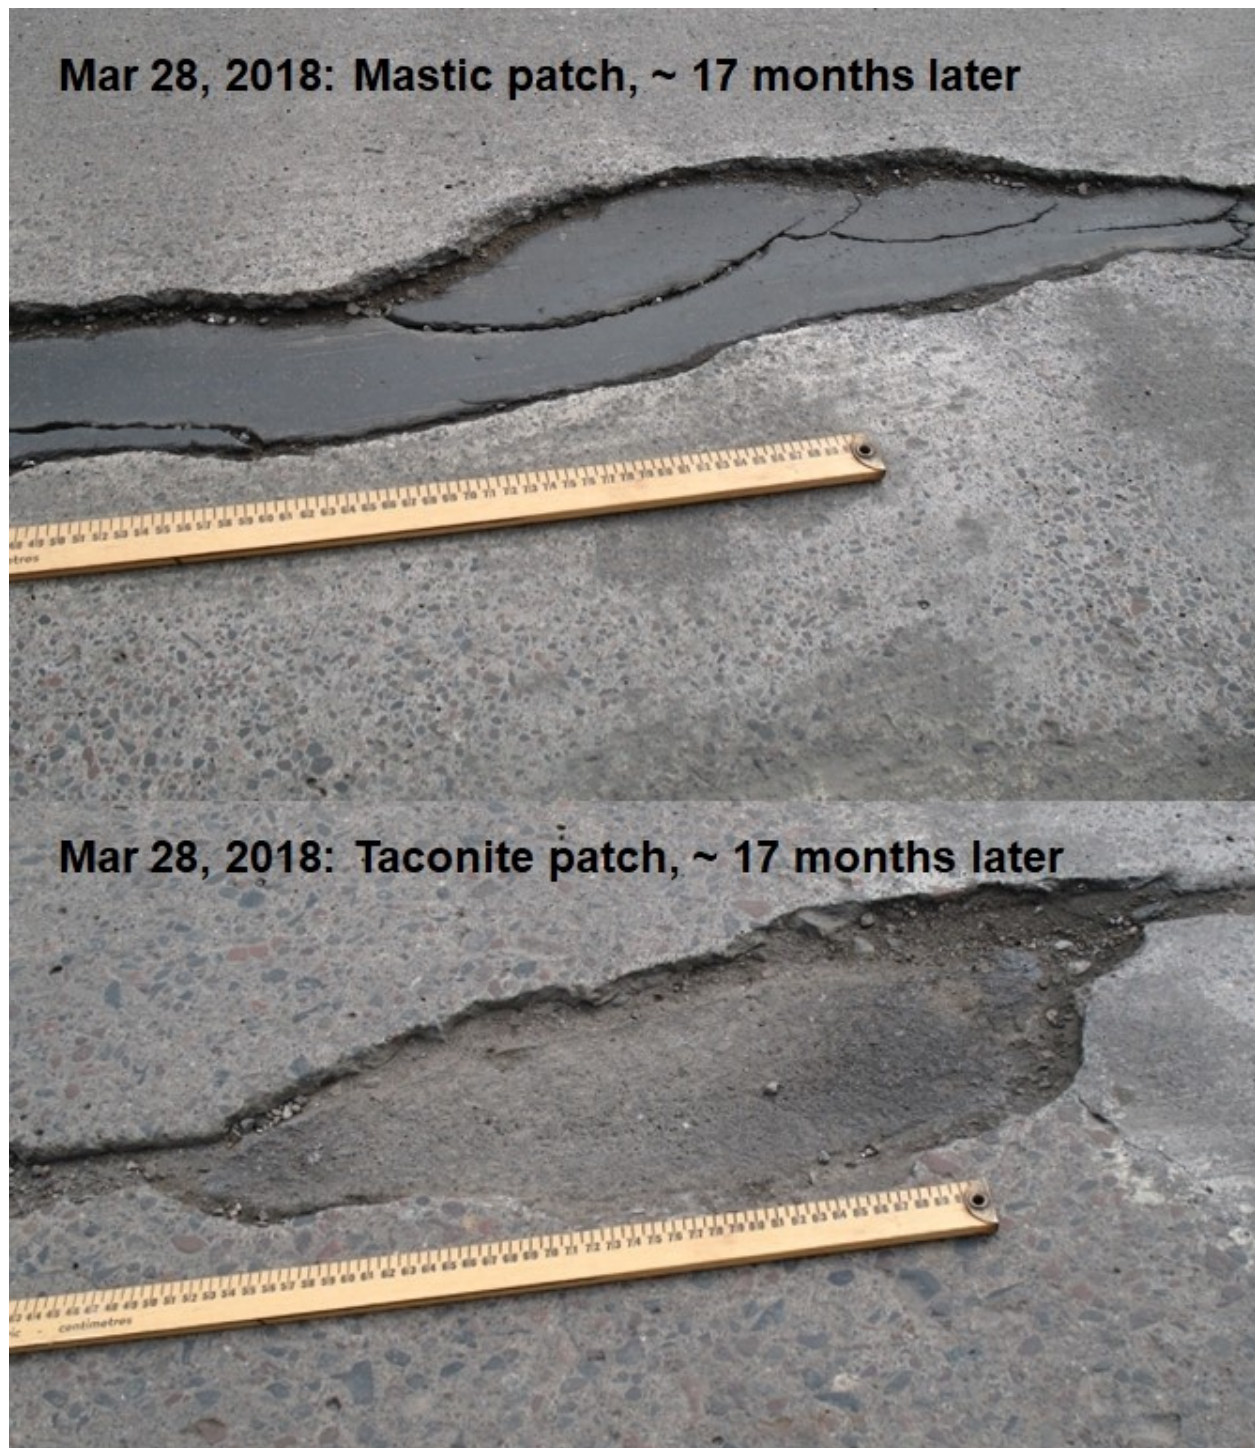
**Figure 2.60 Comparison of mastic and taconite patch repairs after 17 months (as of March 28, 2018).**

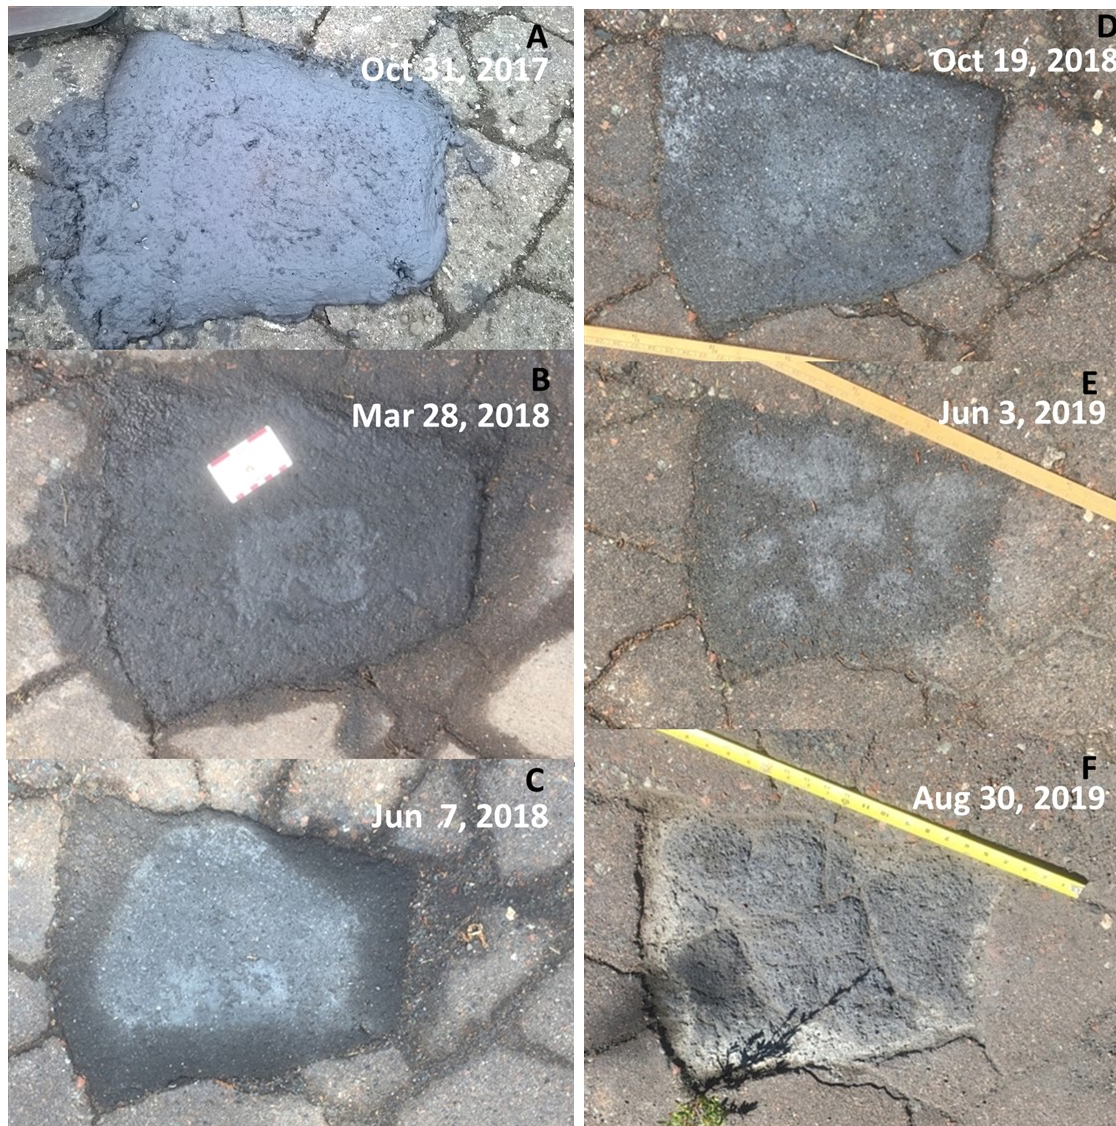
**Figure 2.62 October 31, 2017, NRRI parking lot repair: Completed repair (A); and conditions of repair on March 28, 2018 (B); June 7, 2018 (C); October 19, 2018 (D); June 3, 2019 (E); and August 30, 2019 (F).**

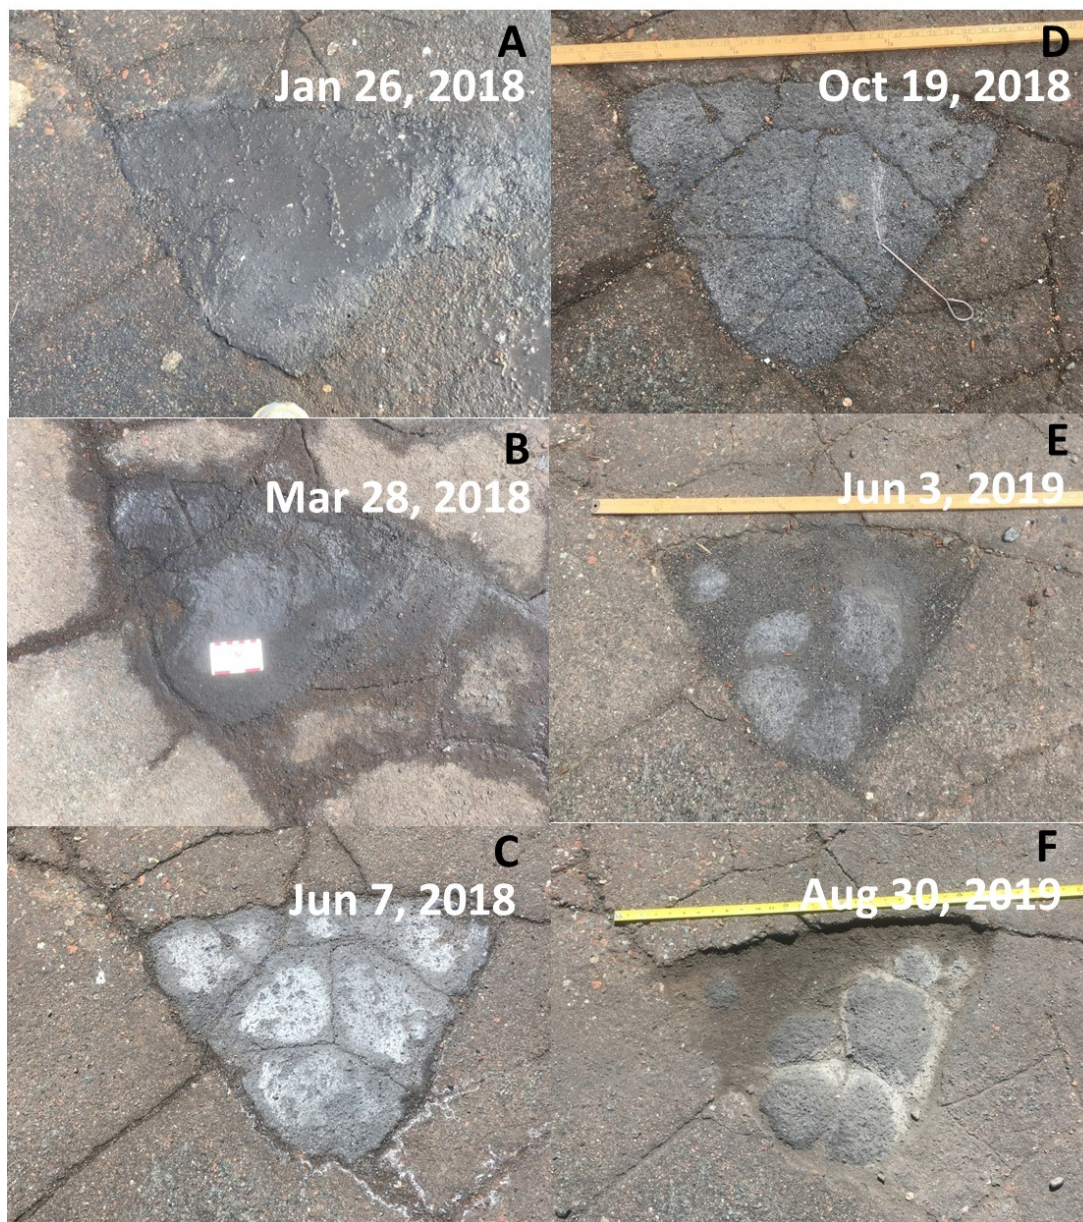
**Figure 2.64 Condition of the November 20, 2017 repair from January 26, 2018 to August 30, 2019.**

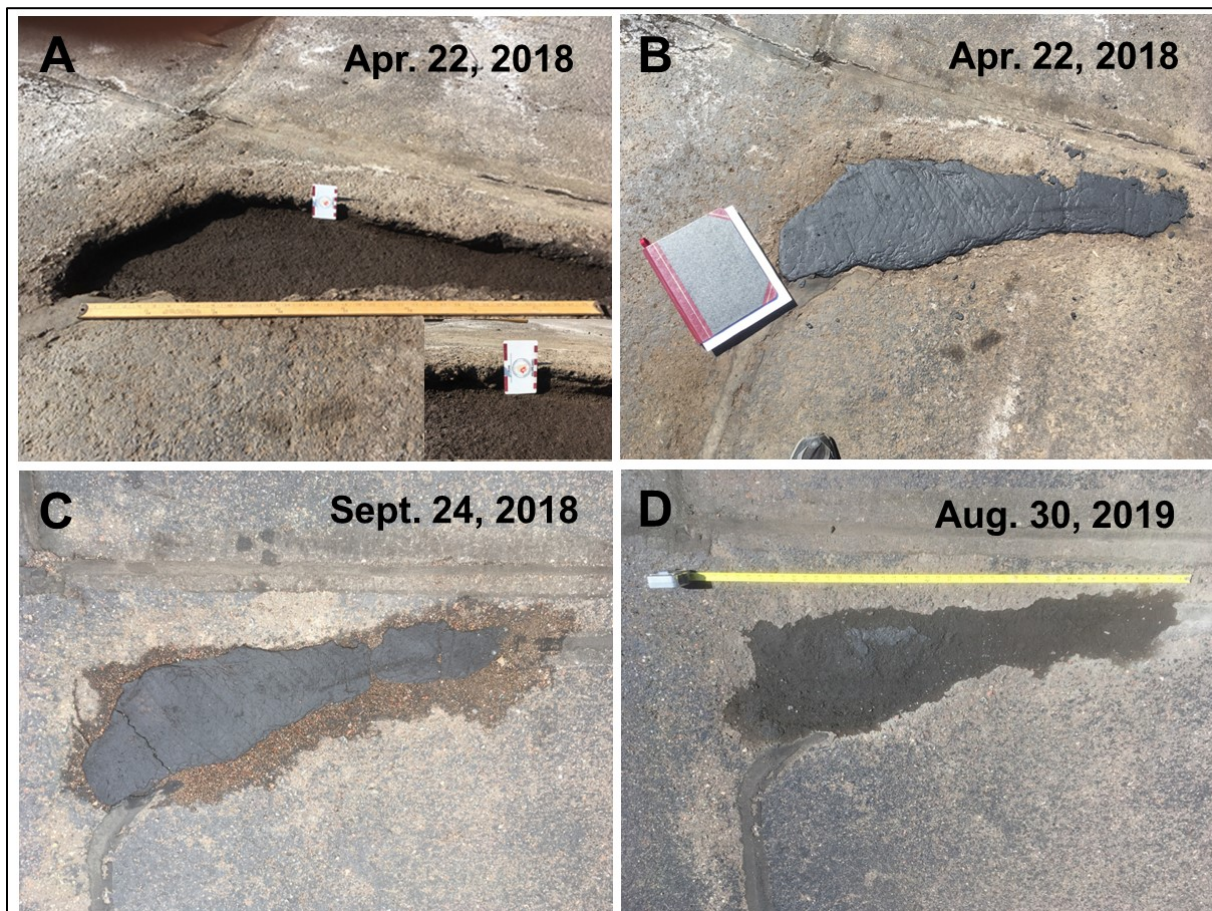
**Figure 2.65 April 22, 2018 NRRI parking lot repair: A) prepared hole, with inset photo showing depth; B) completed repair; C) condition of repair on September 24, 2018; and D) condition of repair on August 30, 2019.**

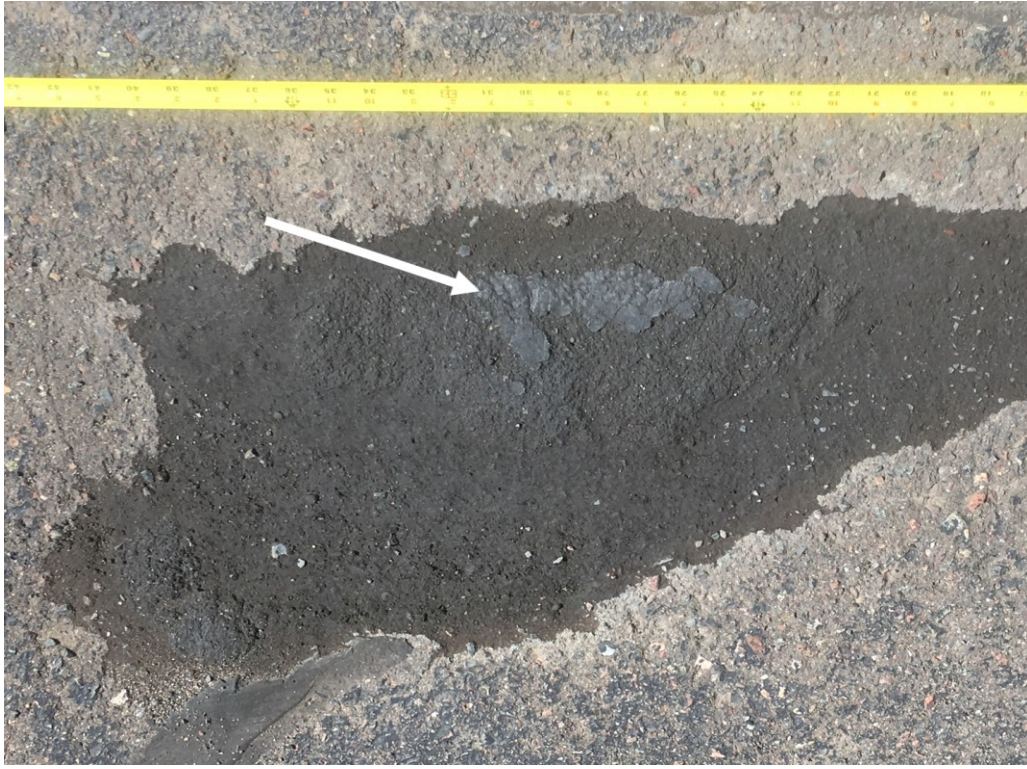
Figure 2.66 Close-up of April 22, 2018 repair, with arrow pointing to original remaining surface.

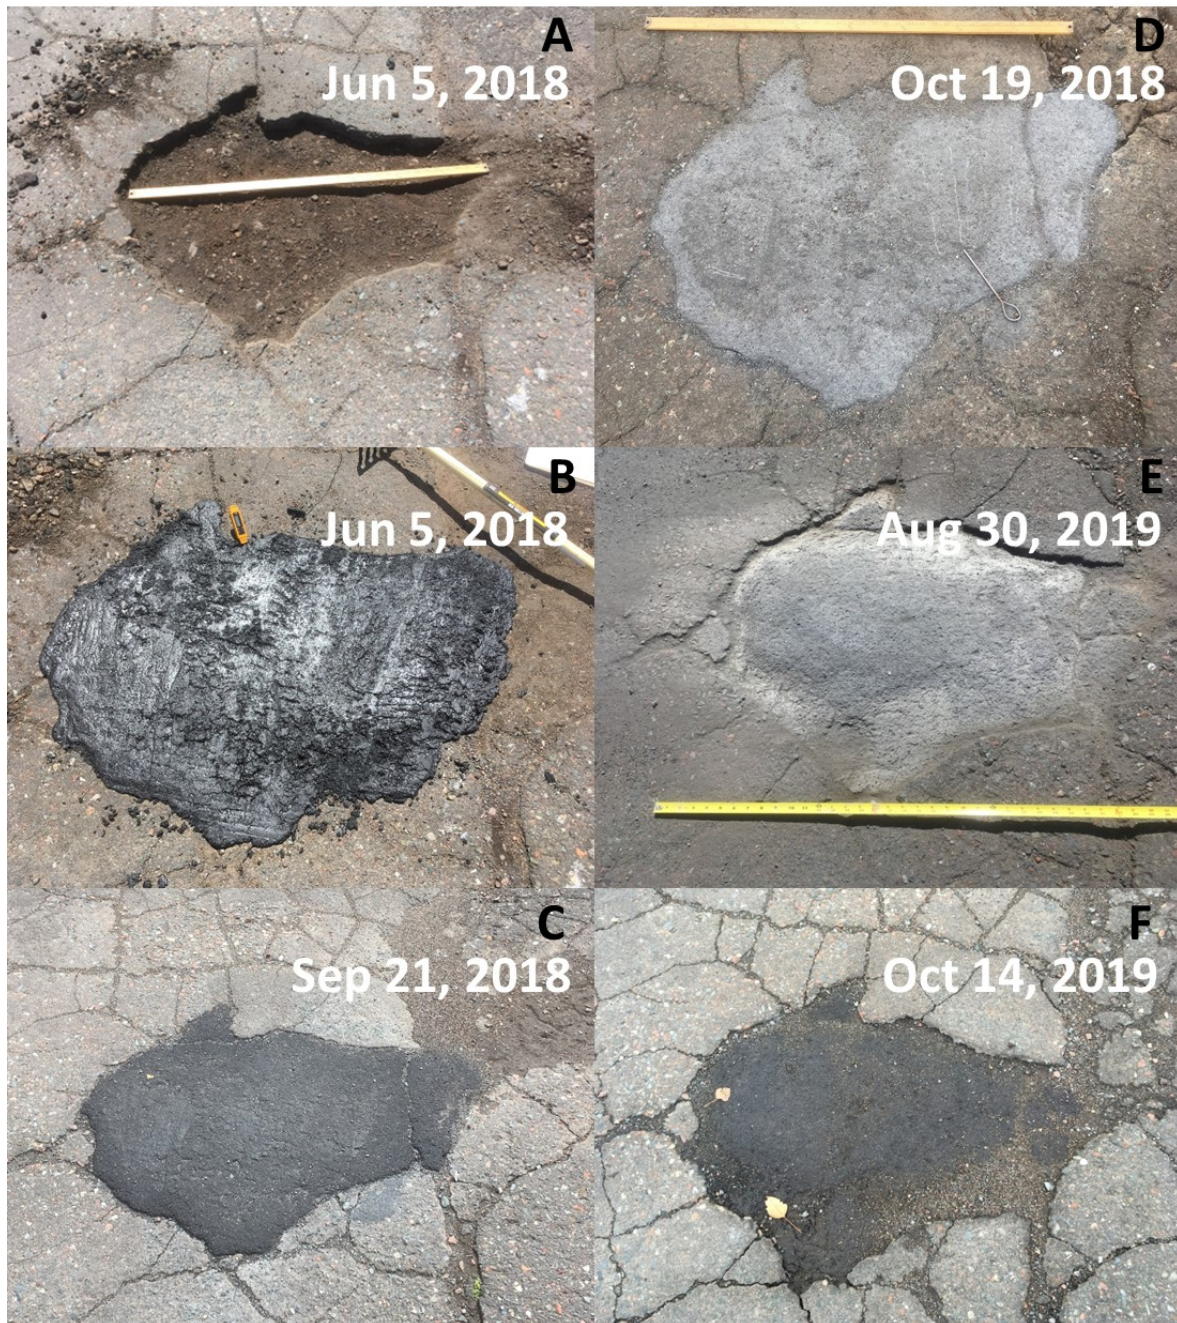
Figure 2.68 Condition of the June 5, 2018 repair from June 5, 2018 (A and B) to October 14, 2019 (F).

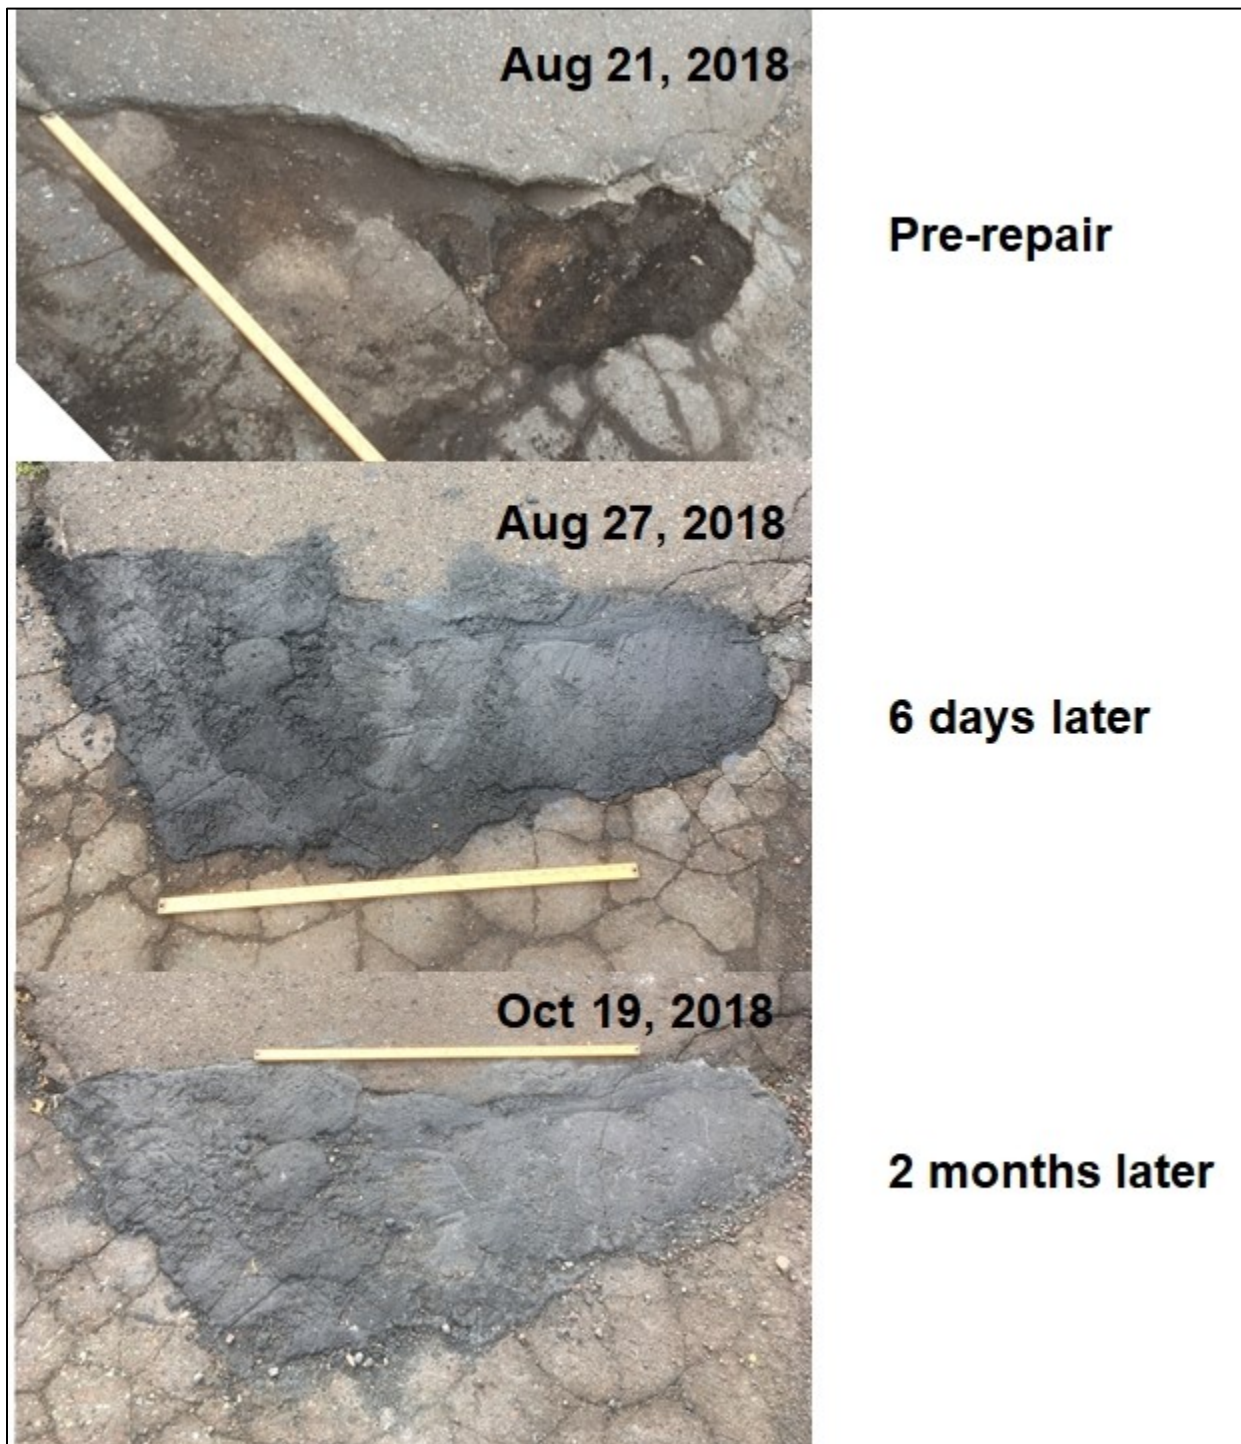
Figure 2.69 August 21, 2018, NRRI parking lot test repair condition through October 19, 2018 (yard stick for scale).

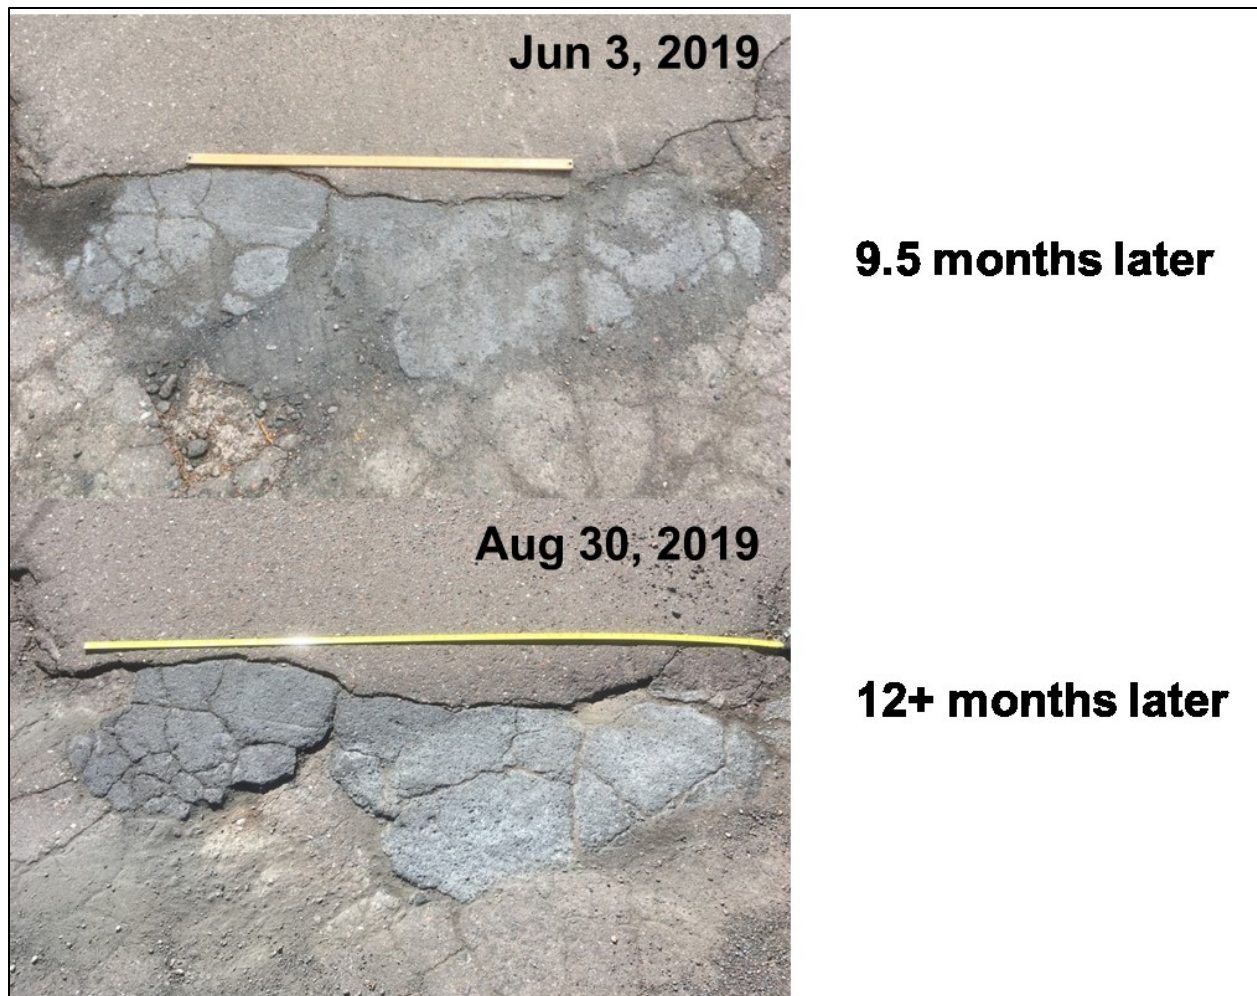
**Figure 2.70 August 21, 2018, NRRI parking lot test repair condition on June 3, 2019 and August 30, 2019 (yard stick for scale).**

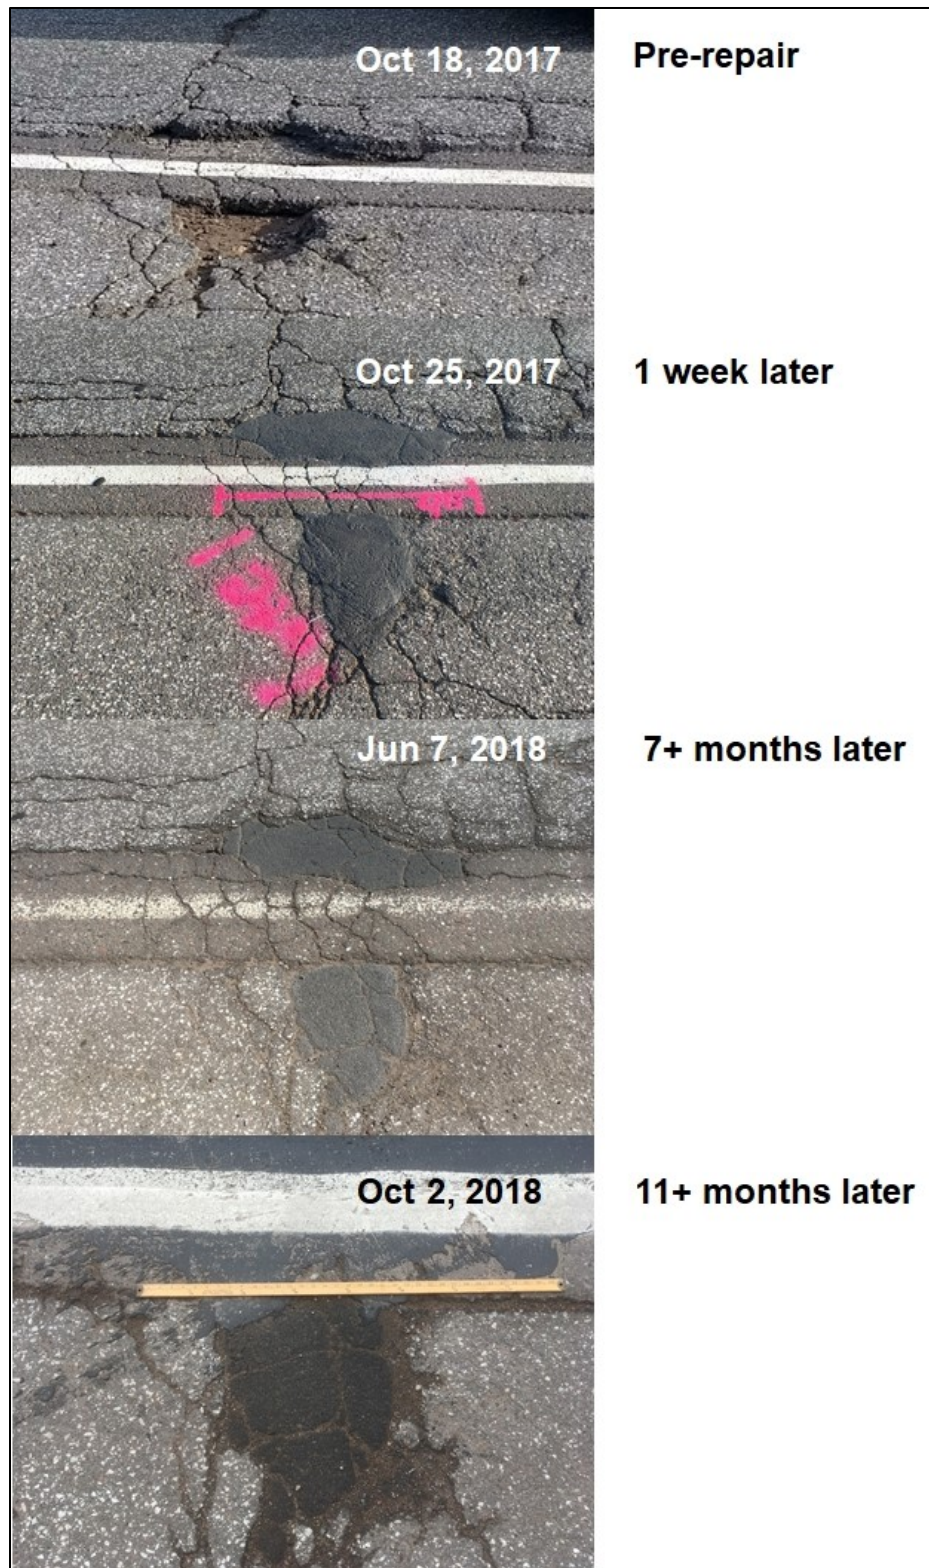
Figure 2.71 Condition of Proctor/Hwy 2 repair from October 18, 2017, to October 2, 2018.
