# Optimized Taconite-Based Pavement Repair Compound and Deployment System

**Lawrence Zanko, Principal Investigator**

Natural Resources Research Institute  
University of Minnesota-Duluth

Research Project  
Final Report 2019-46

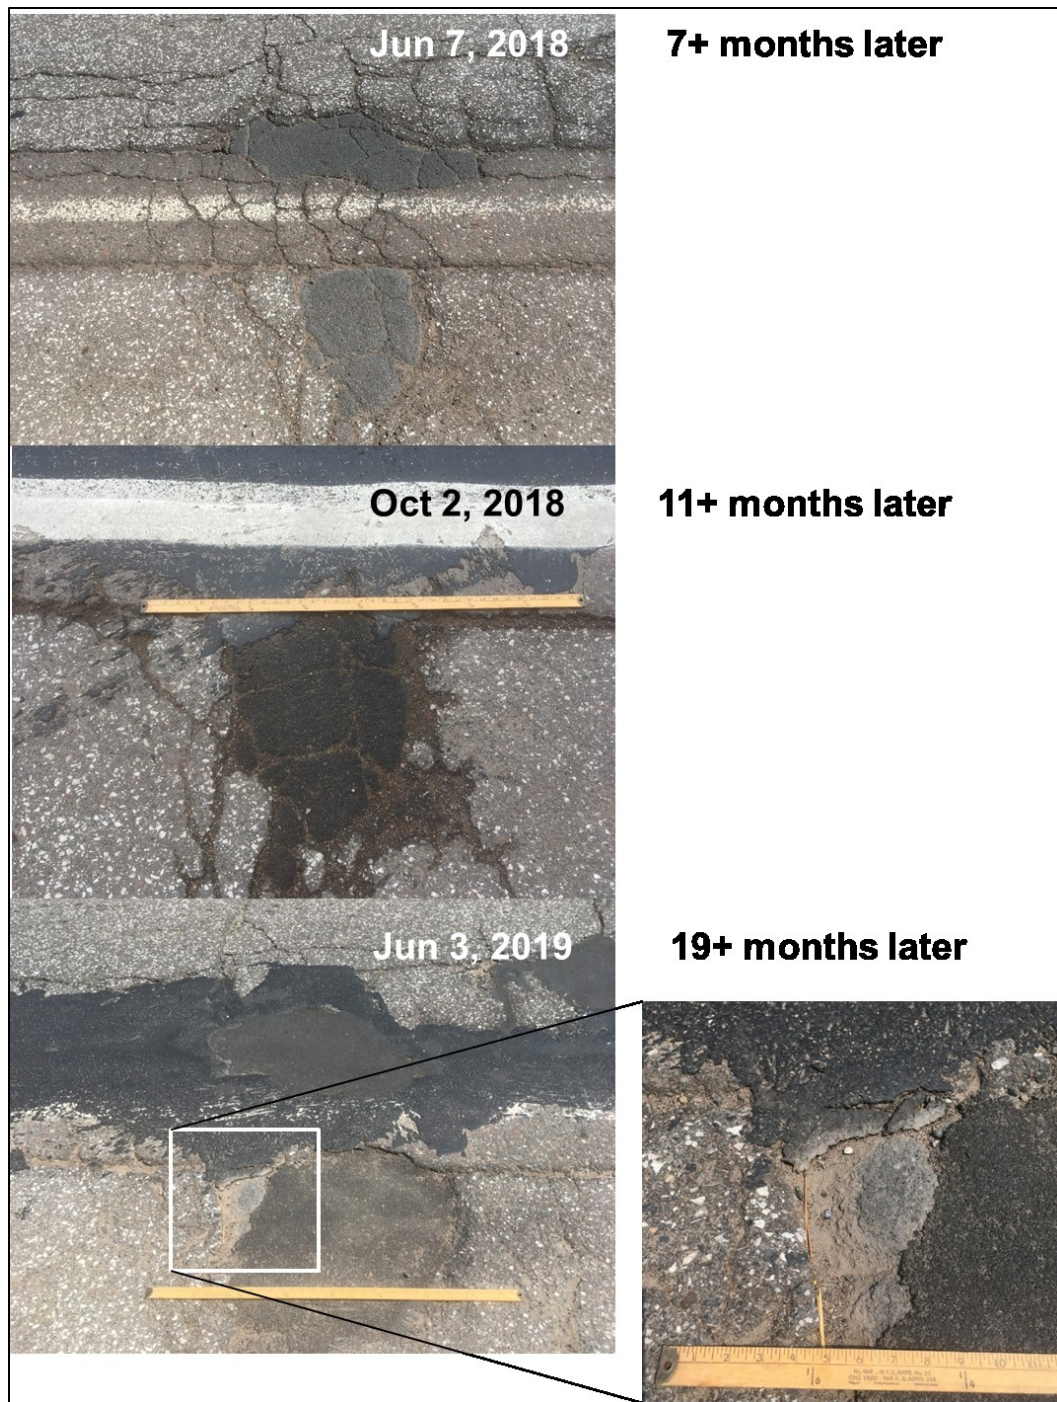
Figure 2.72 Condition of the October 18, 2017 Proctor/Hwy 2 repair: from June 7, 2018 to June 3, 2019.

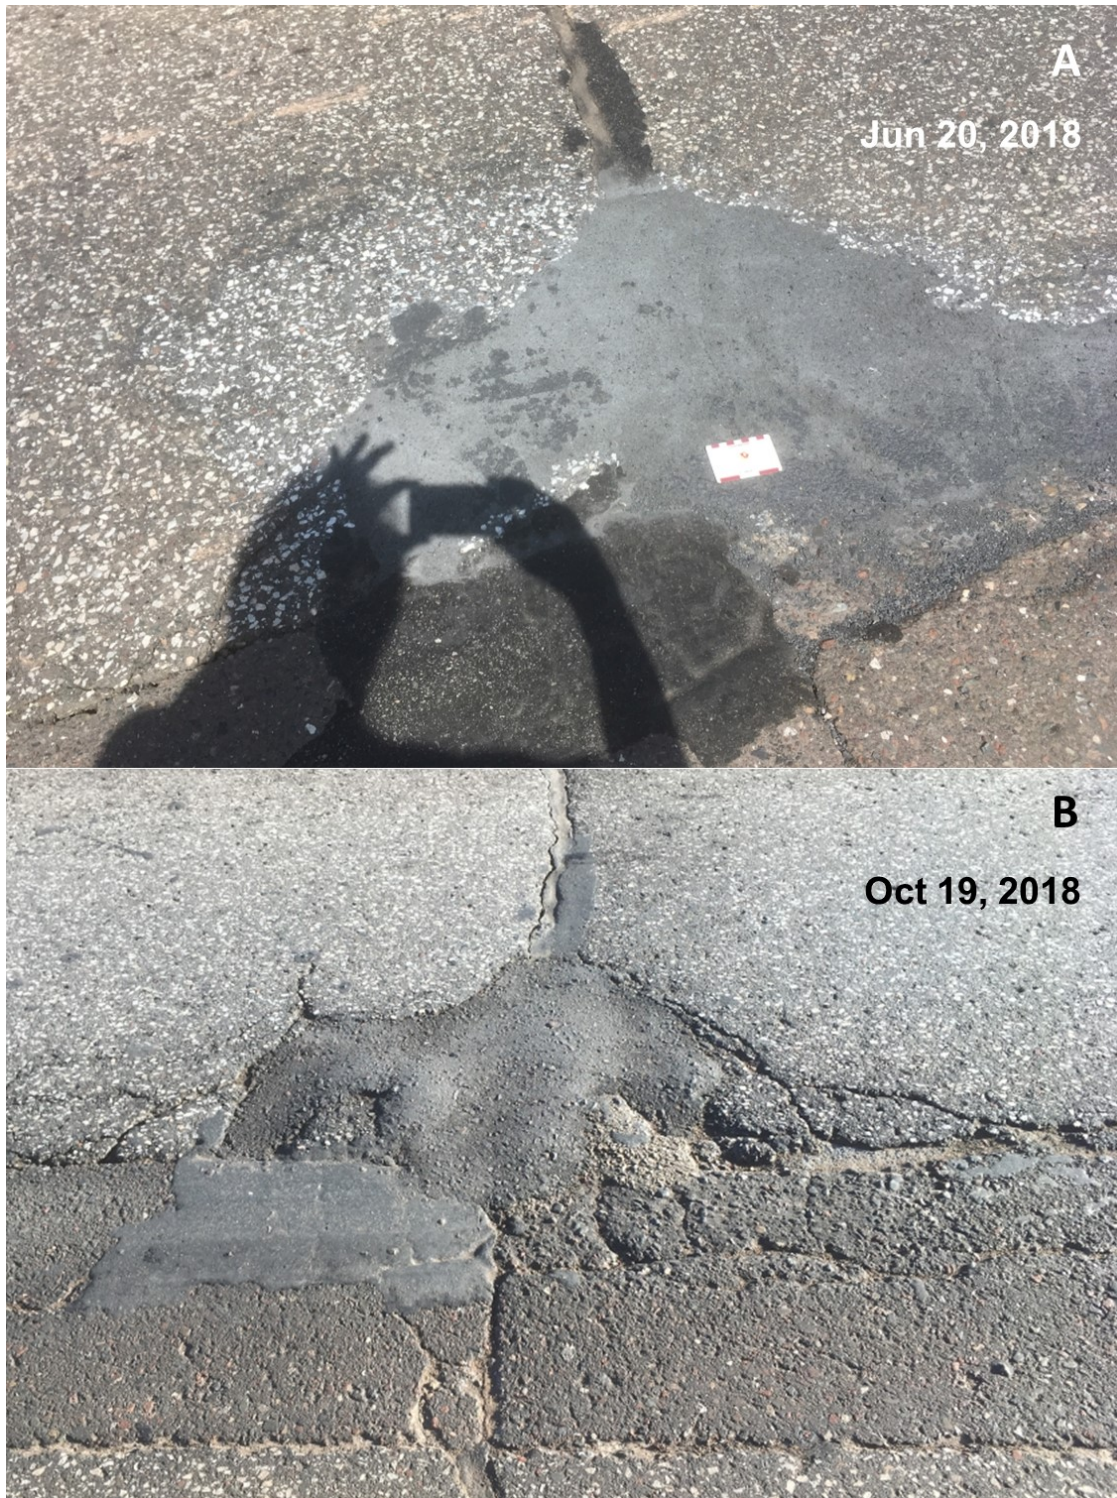
Figure 2.73 Condition of June 20, 2018 Proctor repairs on June 20, 2018 (A) and October 19, 2018 (B).

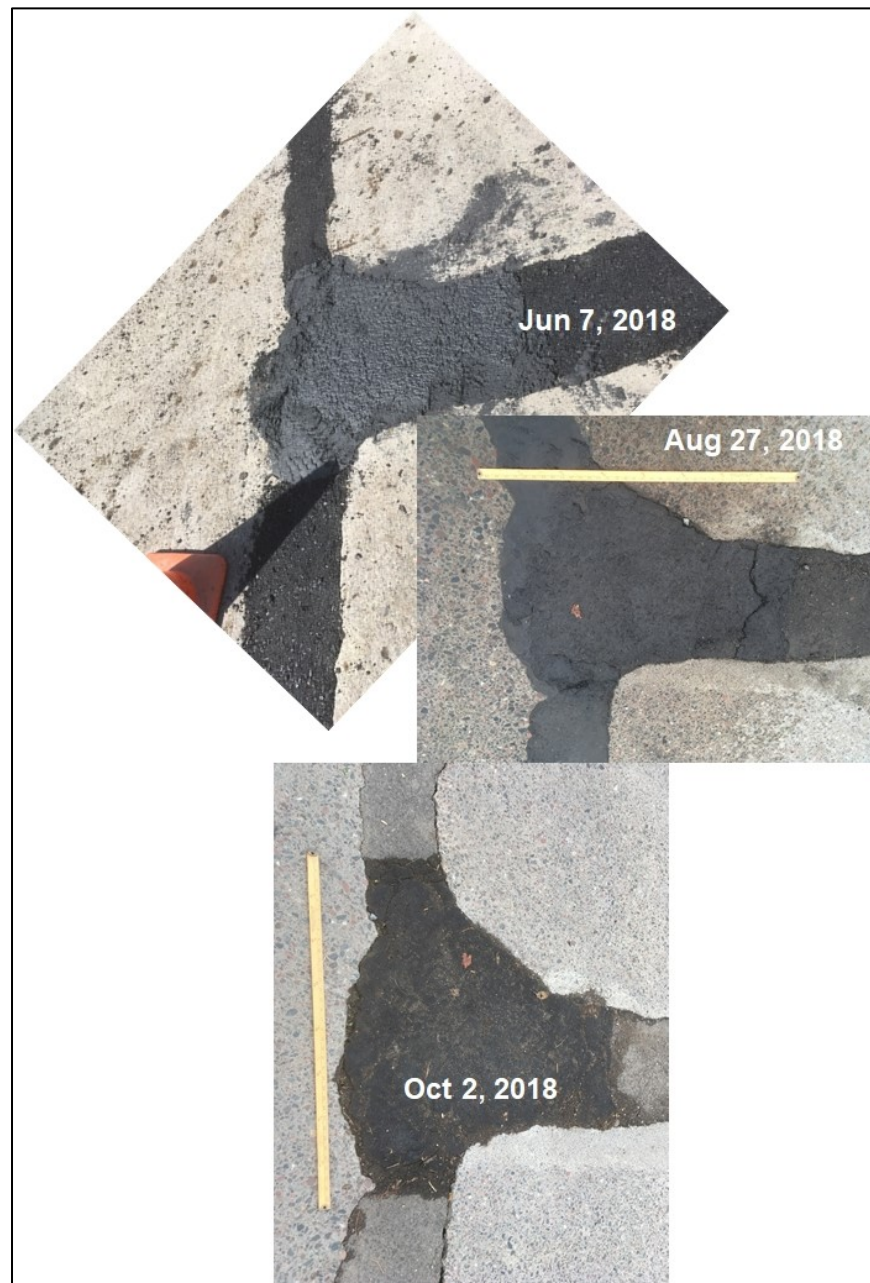
**Figure 2.74 Condition of June 7, 2018, city of Duluth field trial repair through October 2, 2018.**

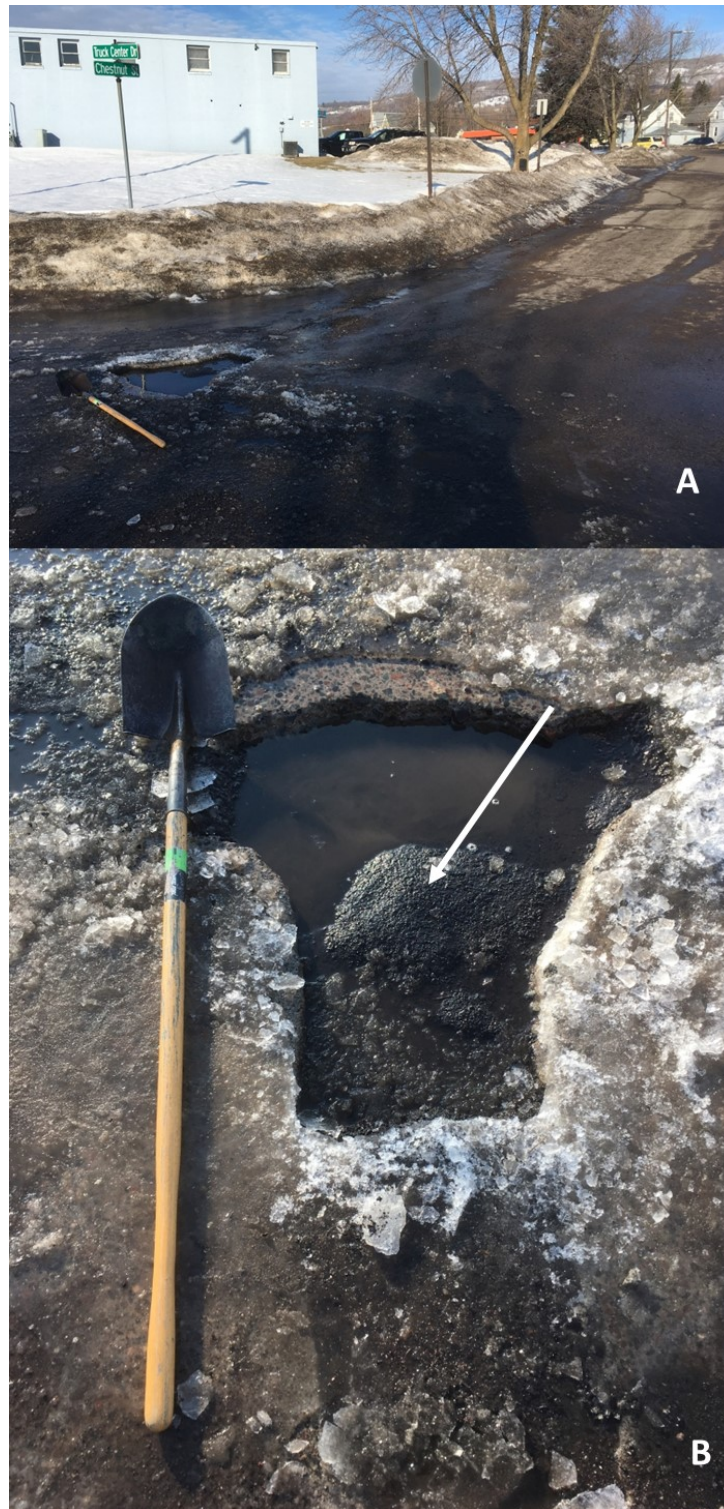
Figure 2.77 Site conditions (A); and resistant remnant of June 7, 2018, Duluth field trial repair (B); as of March 19, 2019.

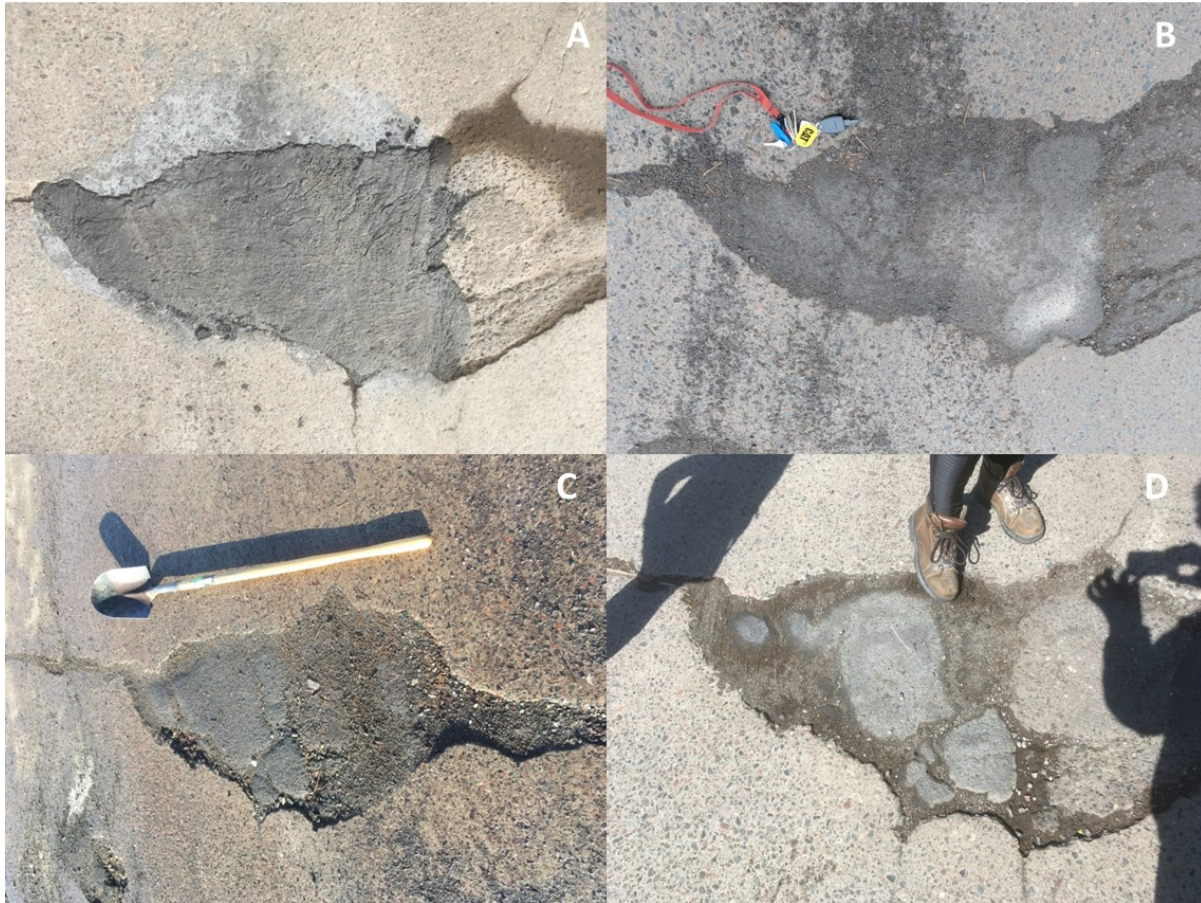
**Figure 2.78 Condition of June 6, 2018, city of Duluth field trial repair on: (A) June 7, 2018; (B) December 12, 2018; (C) March 19, 2019; and (D) August 29, 2019.**

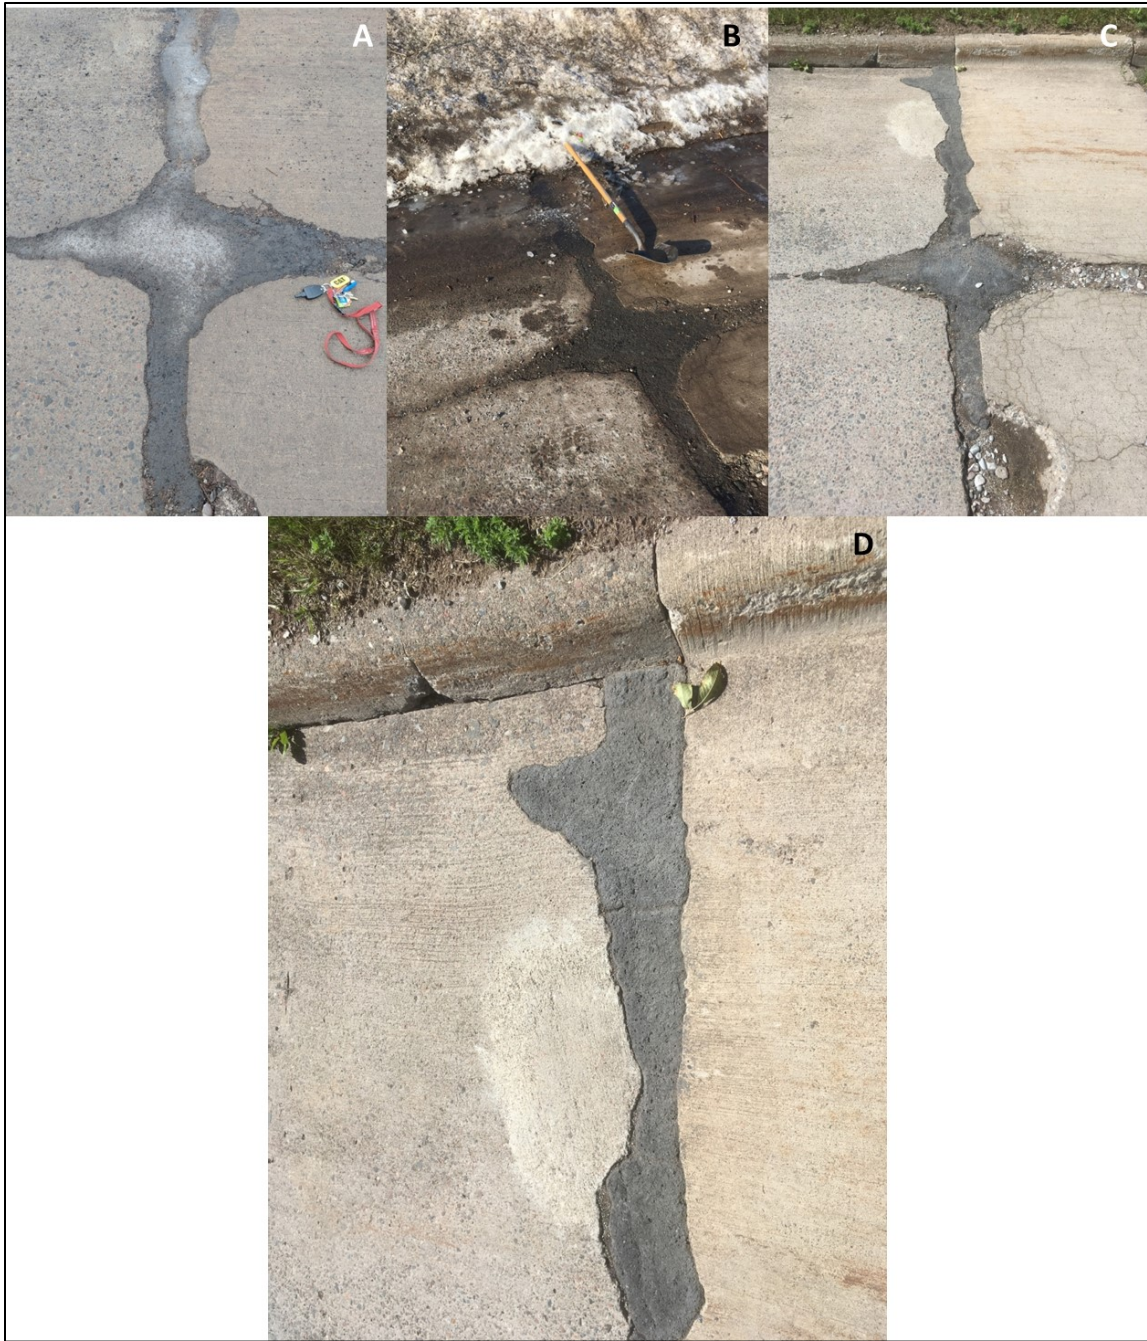
**Figure 2.79 Condition of September 27, 2018, city of Duluth field trial repair on: (A) December 12, 2018; (B) March 19, 2019; (C) August 29, 2019; and (D) August 29, 2019 (close-up).**

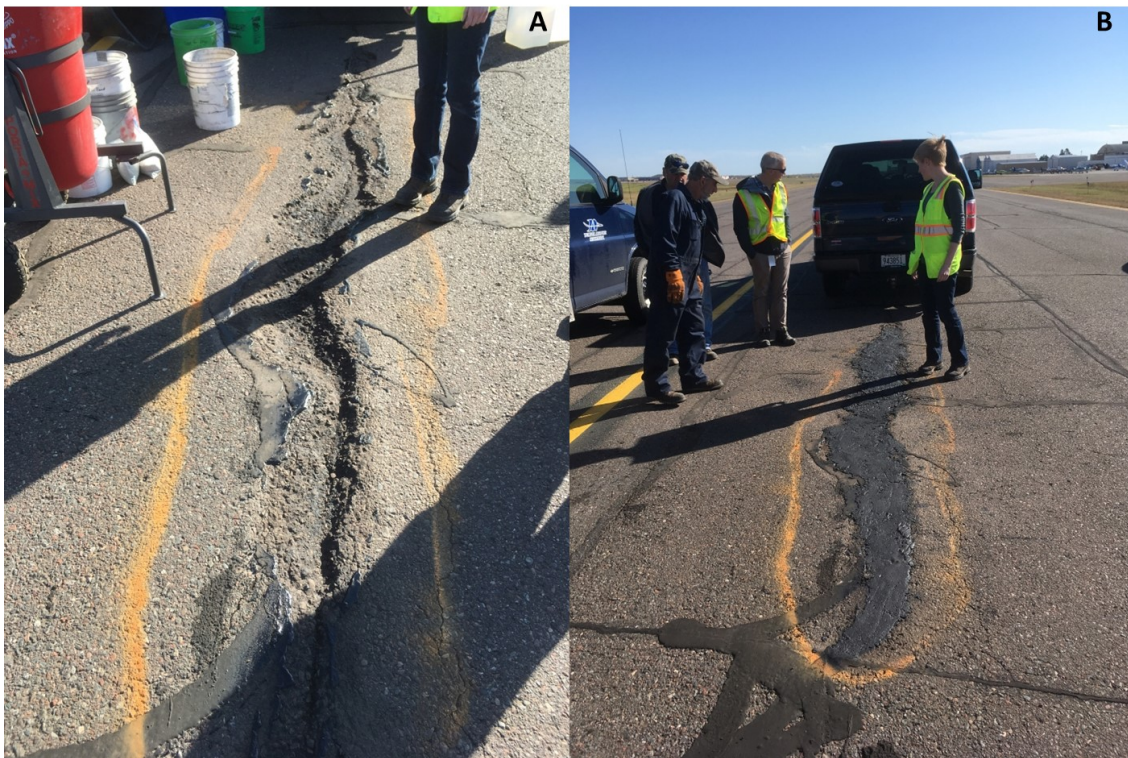
**Figure 2.98 Duluth Airport Authority taxiway repair before (A) and after (B); October 8, 2019.**

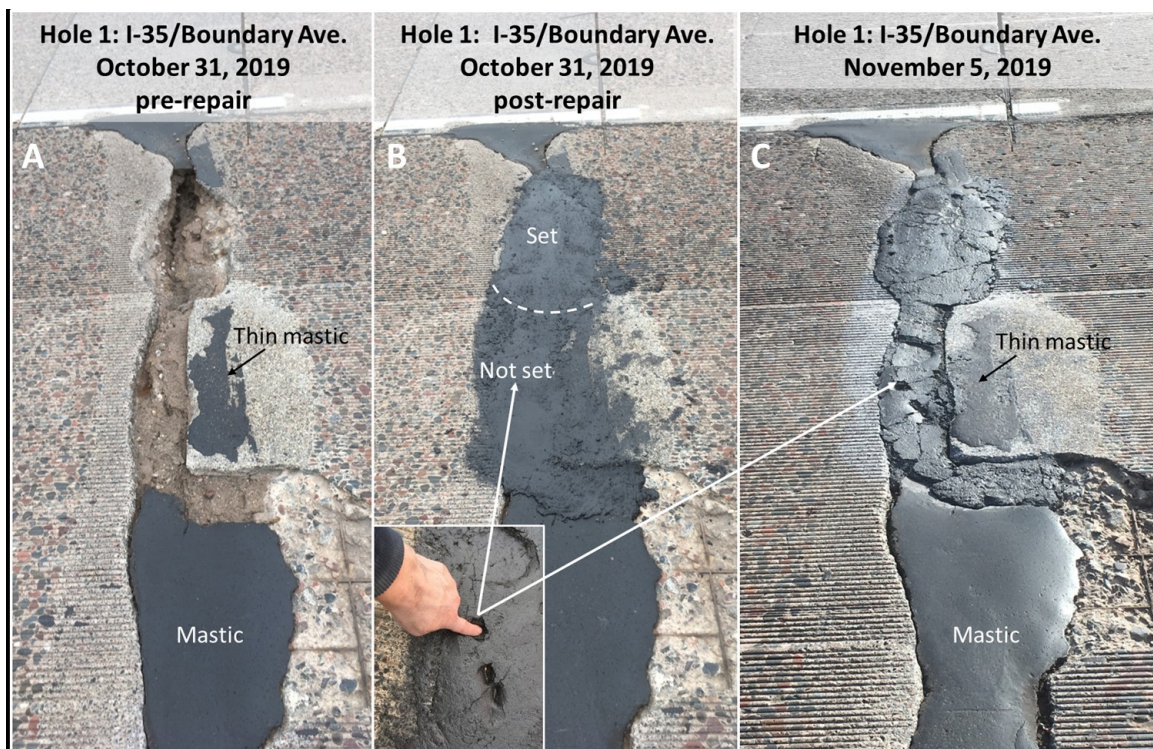
**Figure 2.104 Hole 1 repair at I-35/Boundary Avenue location: pre-repair (A) and post-repair (B) on October 31, 2019, with inset showing soft (not set) condition of the thinnest portion of the repair; and on November 5, 2019 (C).**

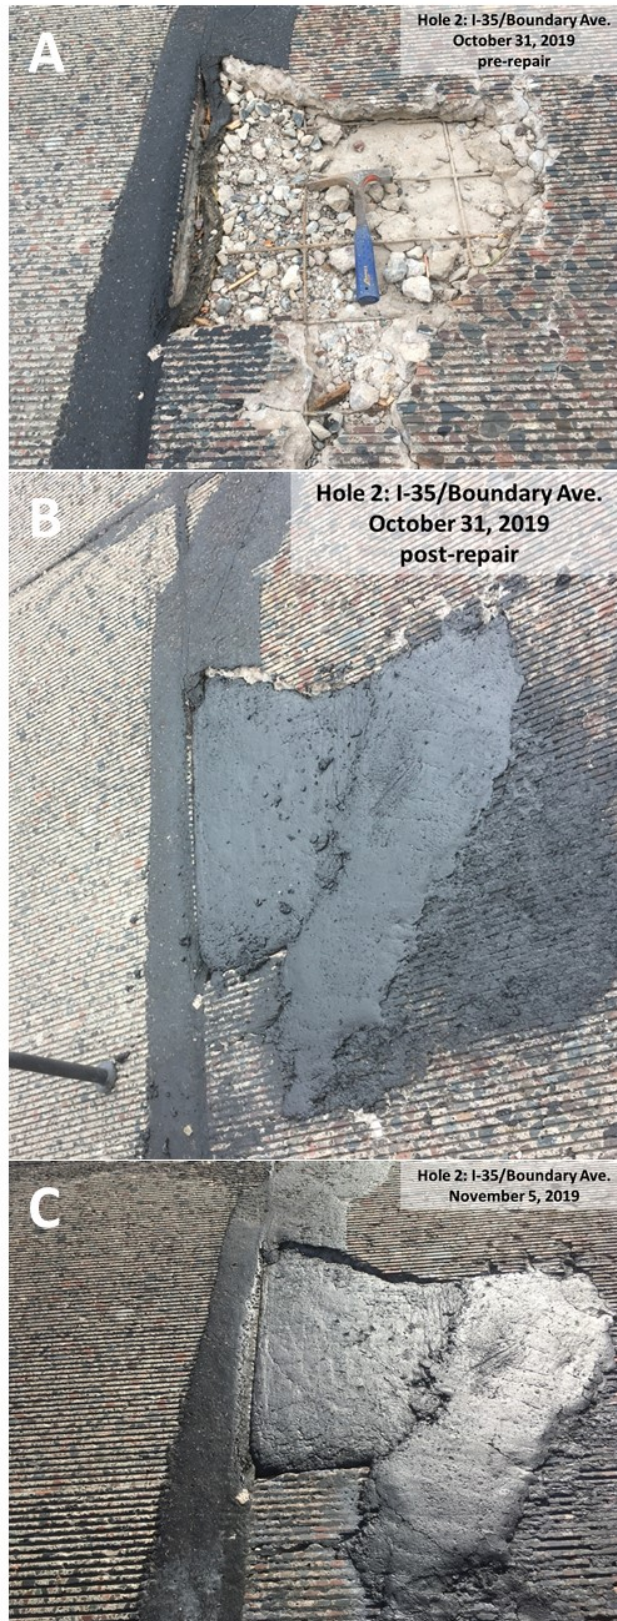
Figure 2.105 Hole 2 repair at I-35/Boundary Avenue location: pre-repair (A) and post-repair (B) on October 31, 2019; and on November 5, 2019 (C).
