Evaluation of Electrochemical Chloride Extraction, Fiber Reinforced Polymer Wraps, and Concrete Sealers for Corrosion Mitigation in Reinforced Concrete Bridge Structures

Mark R. Chauvin, Principal Investigator

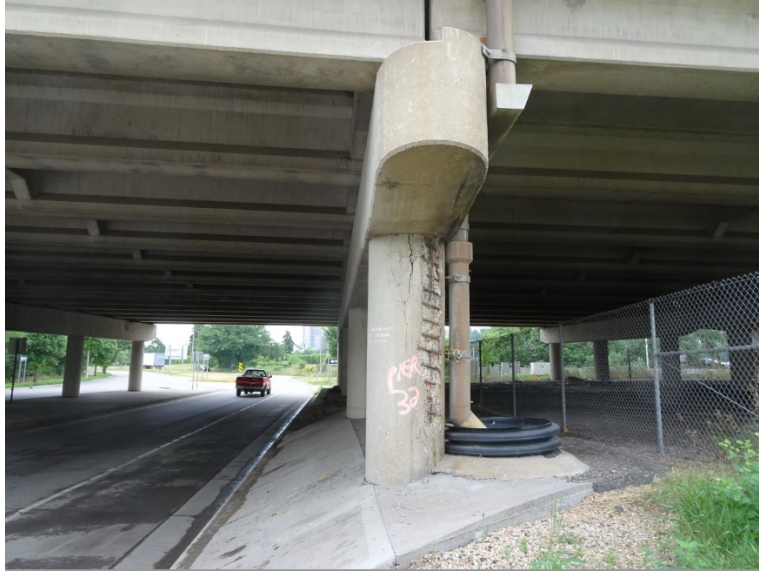
Figure 1.1 Typical corrosion damage in concrete bridge substructures

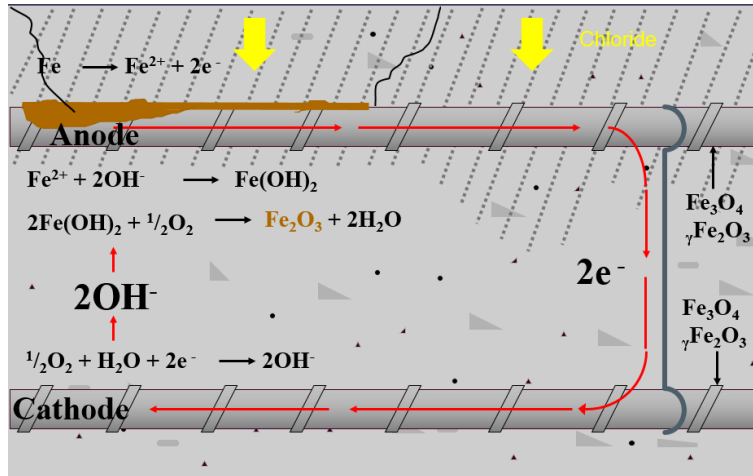
Figure 1.2 Schematic of macrocell corrosion in reinforced concrete

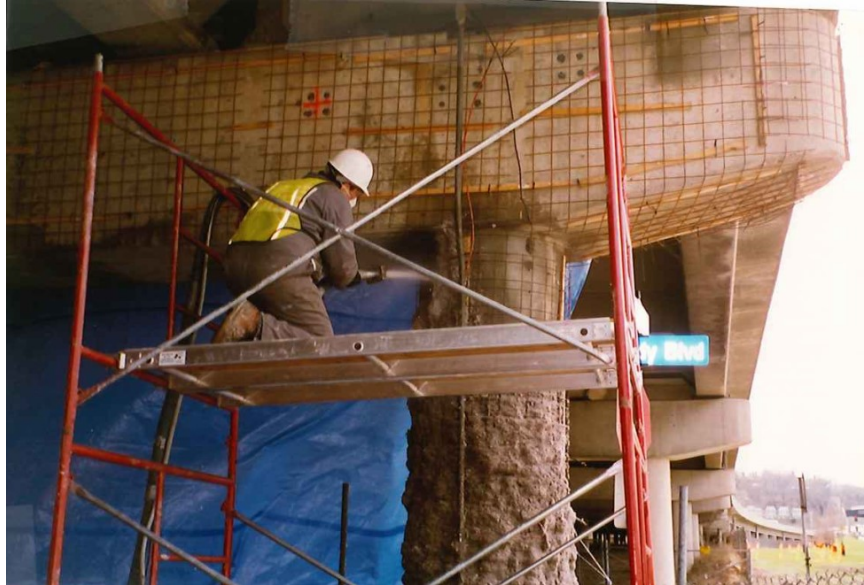
Figure 1.3 In-progress installation of ECE system

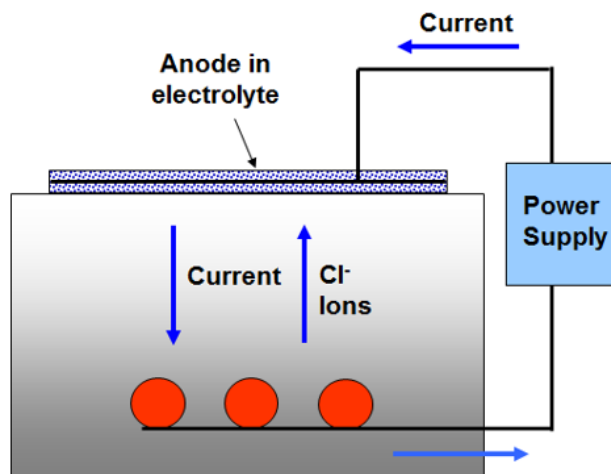
Figure 1.4 Schematic of the ECE process

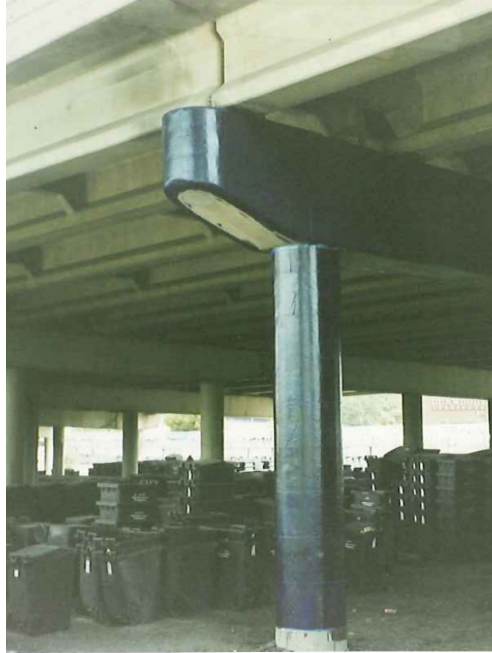
Figure 1.5 Typical FRP wrap installation on a bridge column

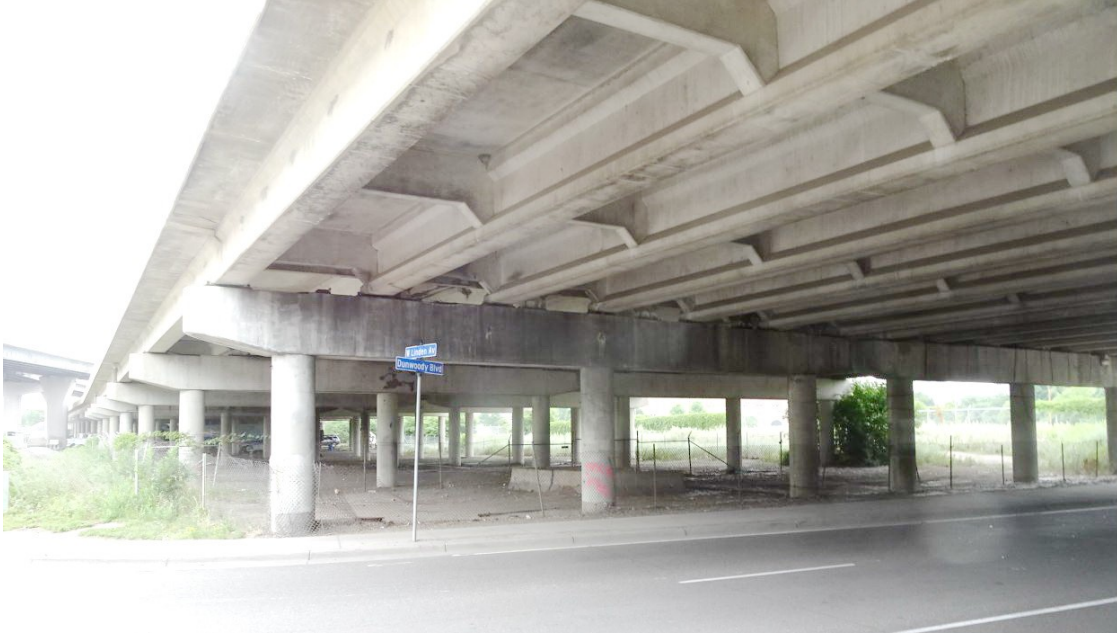
Figure 2.2 Bridge 27831 substructure, looking east at Pier 34WB and Pier 34EB

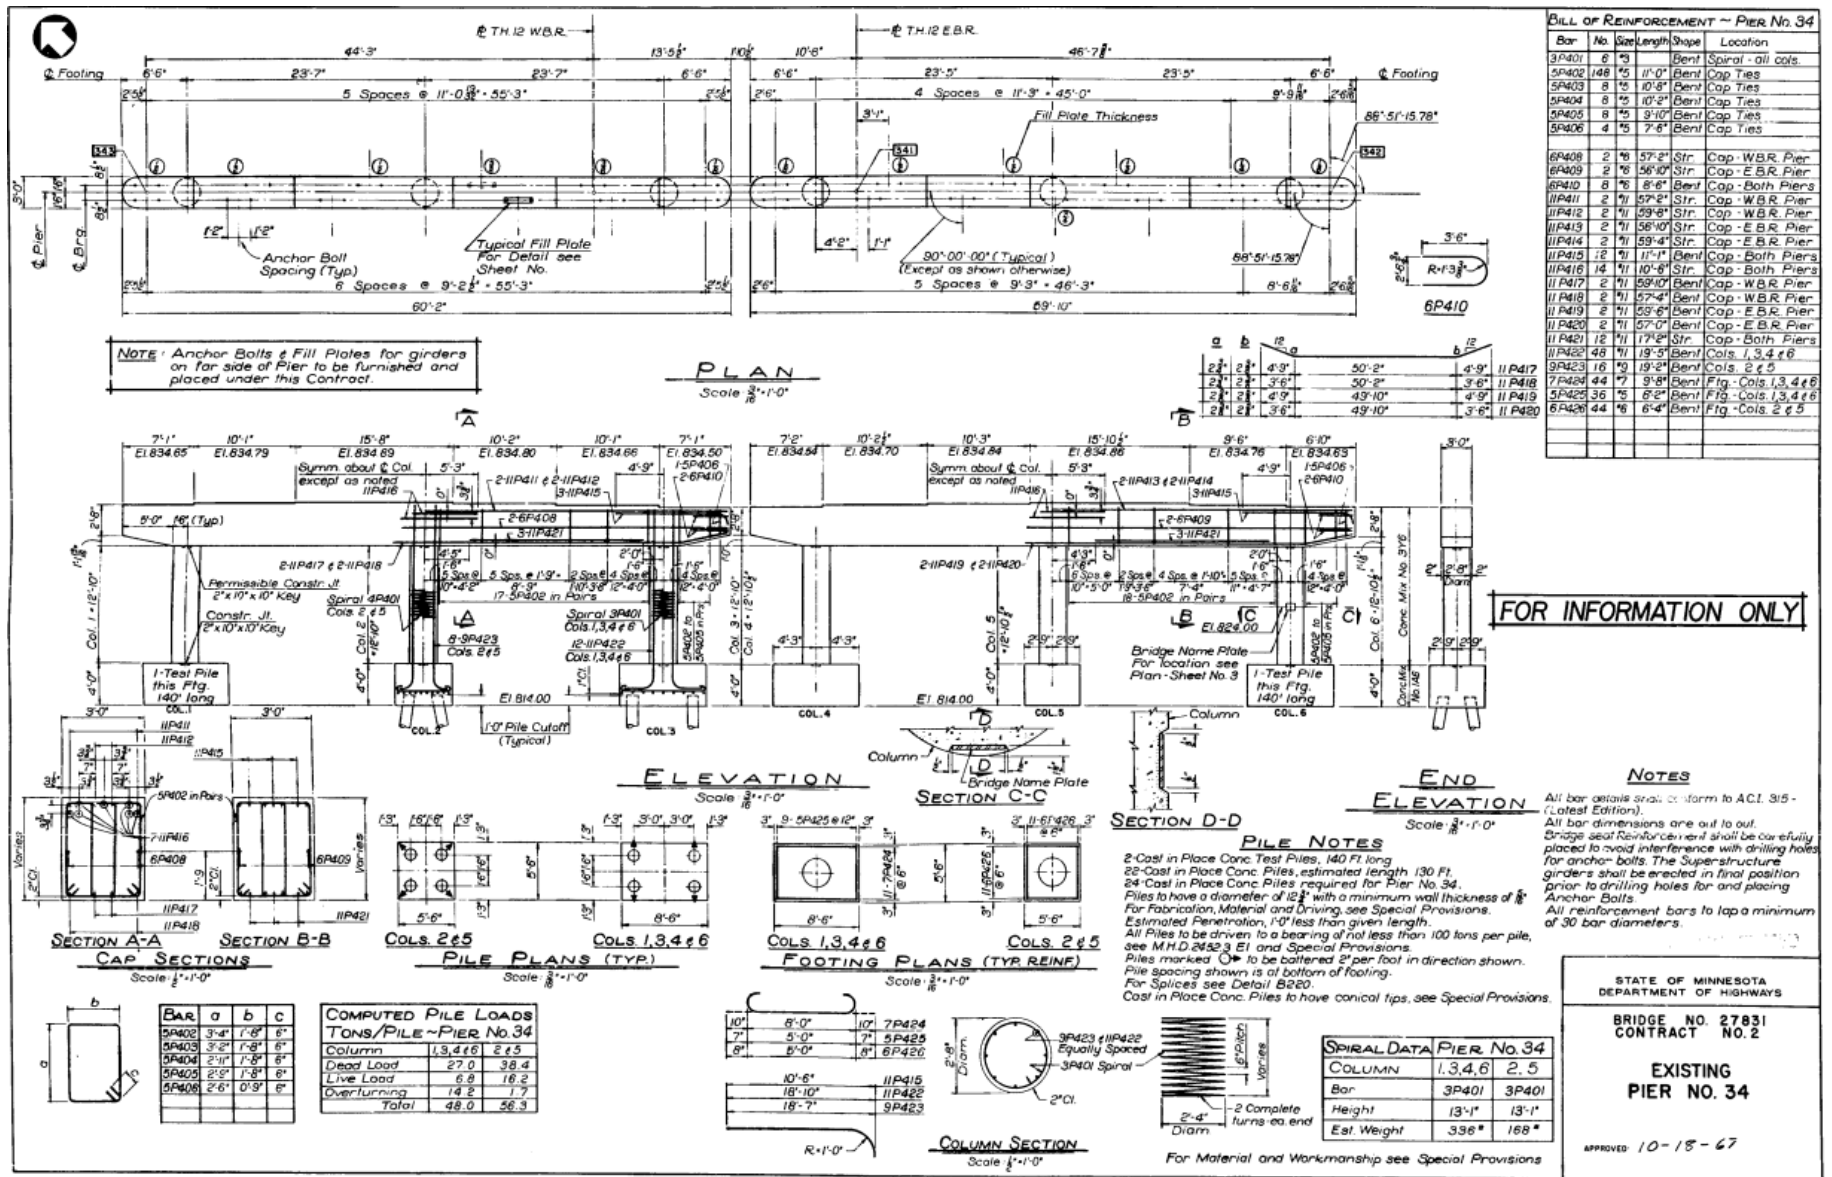
Figure 2.3 Bridge Drawings - Pier 34

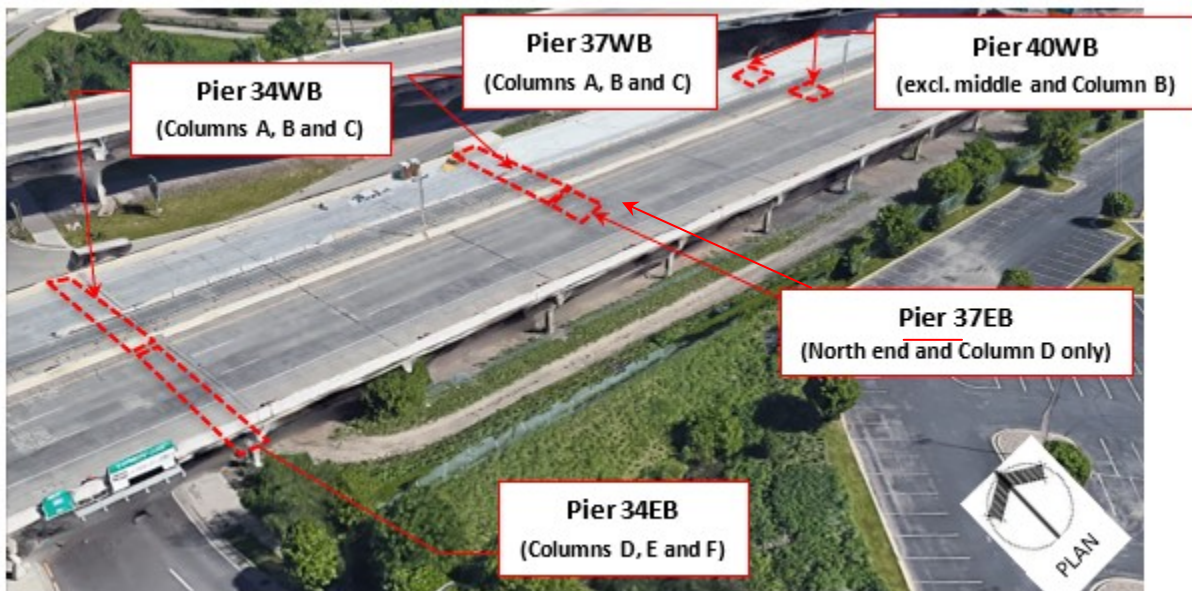
Figure 2.4 Aerial view of the portions of Bridge No. 27831 included in the 1998 study

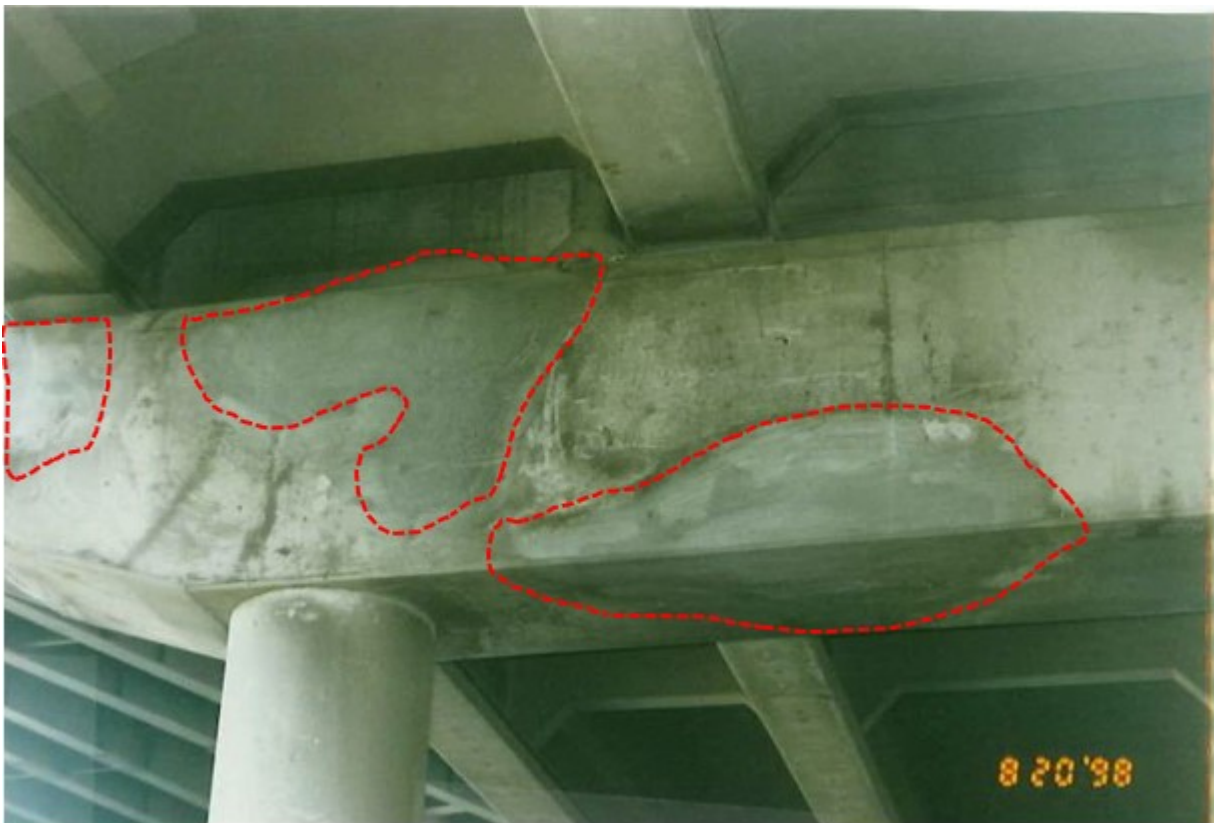
Figure 2.5 Example concrete repairs performed in 1997 (west face of Pier 40WB shown)

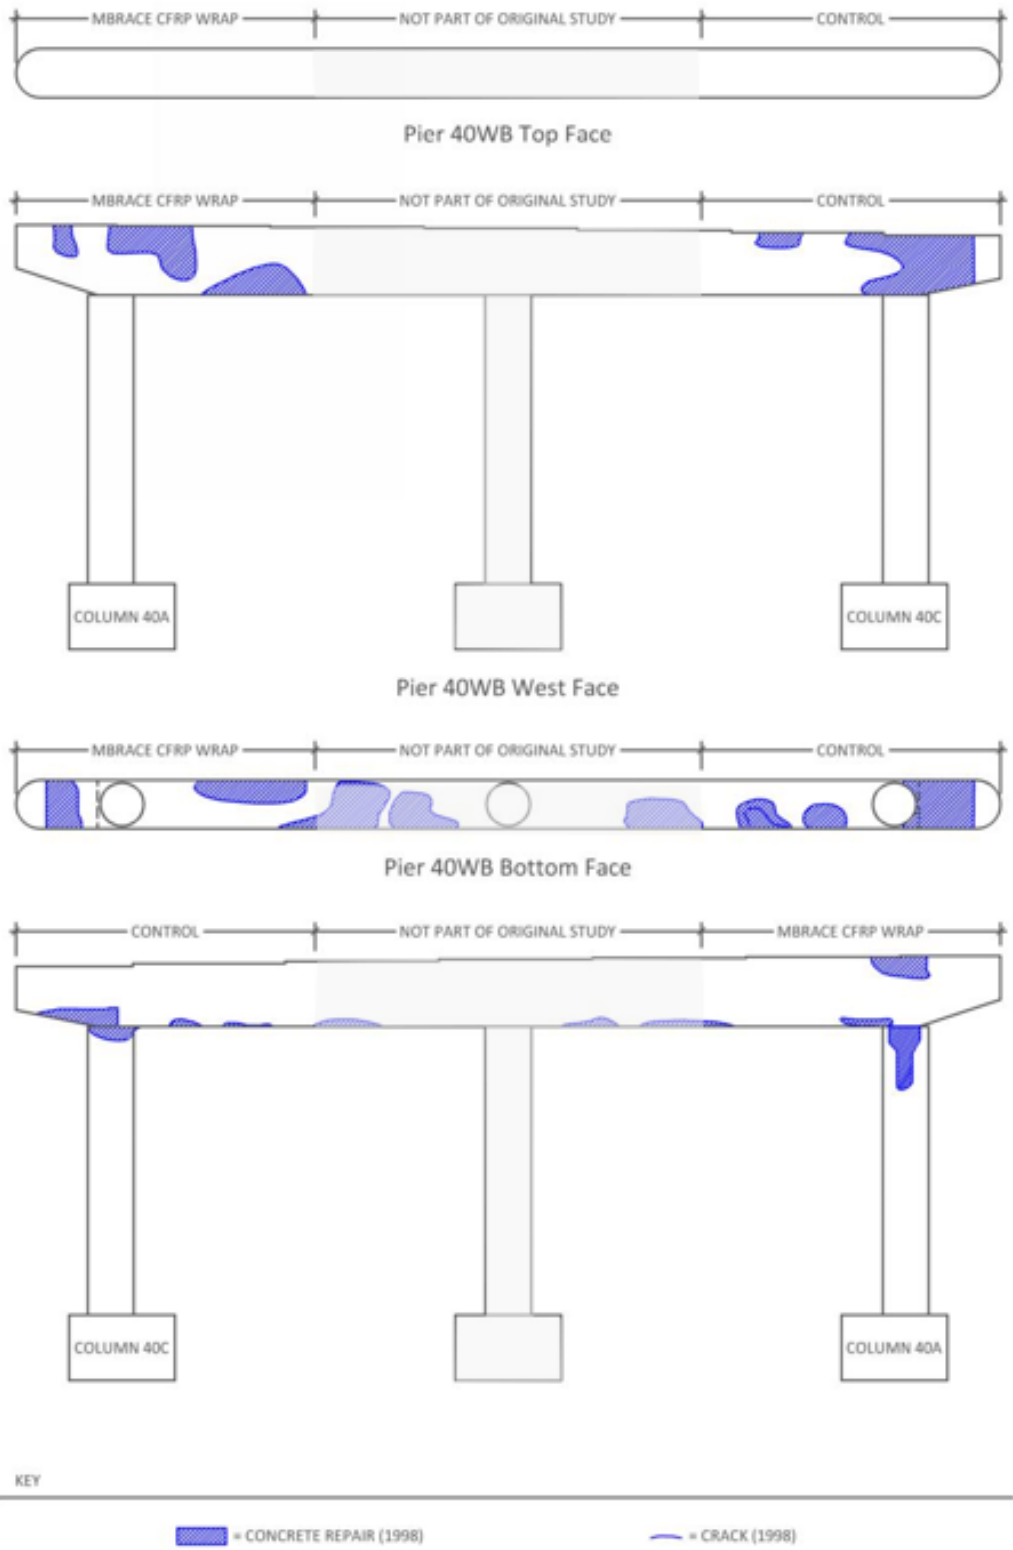
Figure 2.10 Pier 40WB - Areas of concrete distress and repair (blue shading) - 1998 study

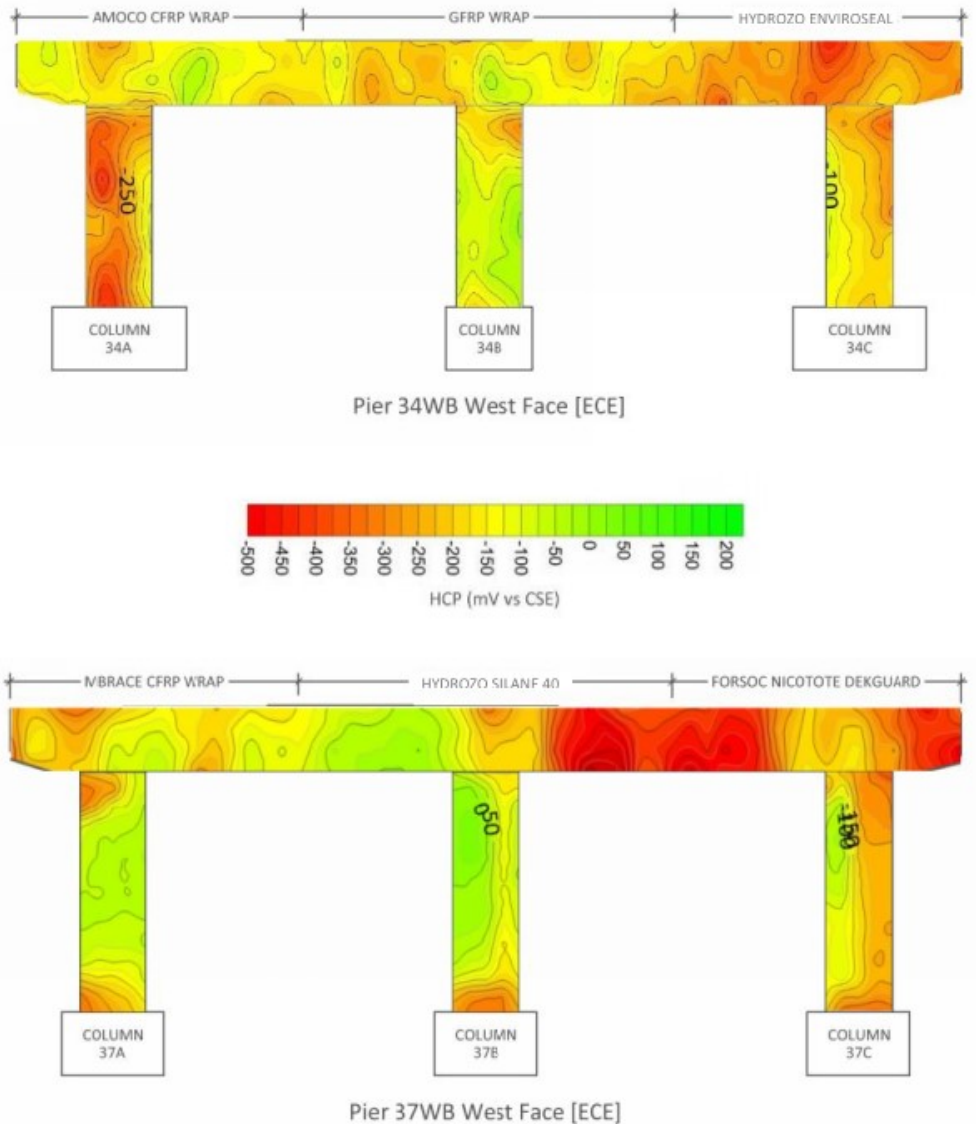
Figure 2.11 Pier 34WB and 37WB - Half-cell potential plots before ECE treatment

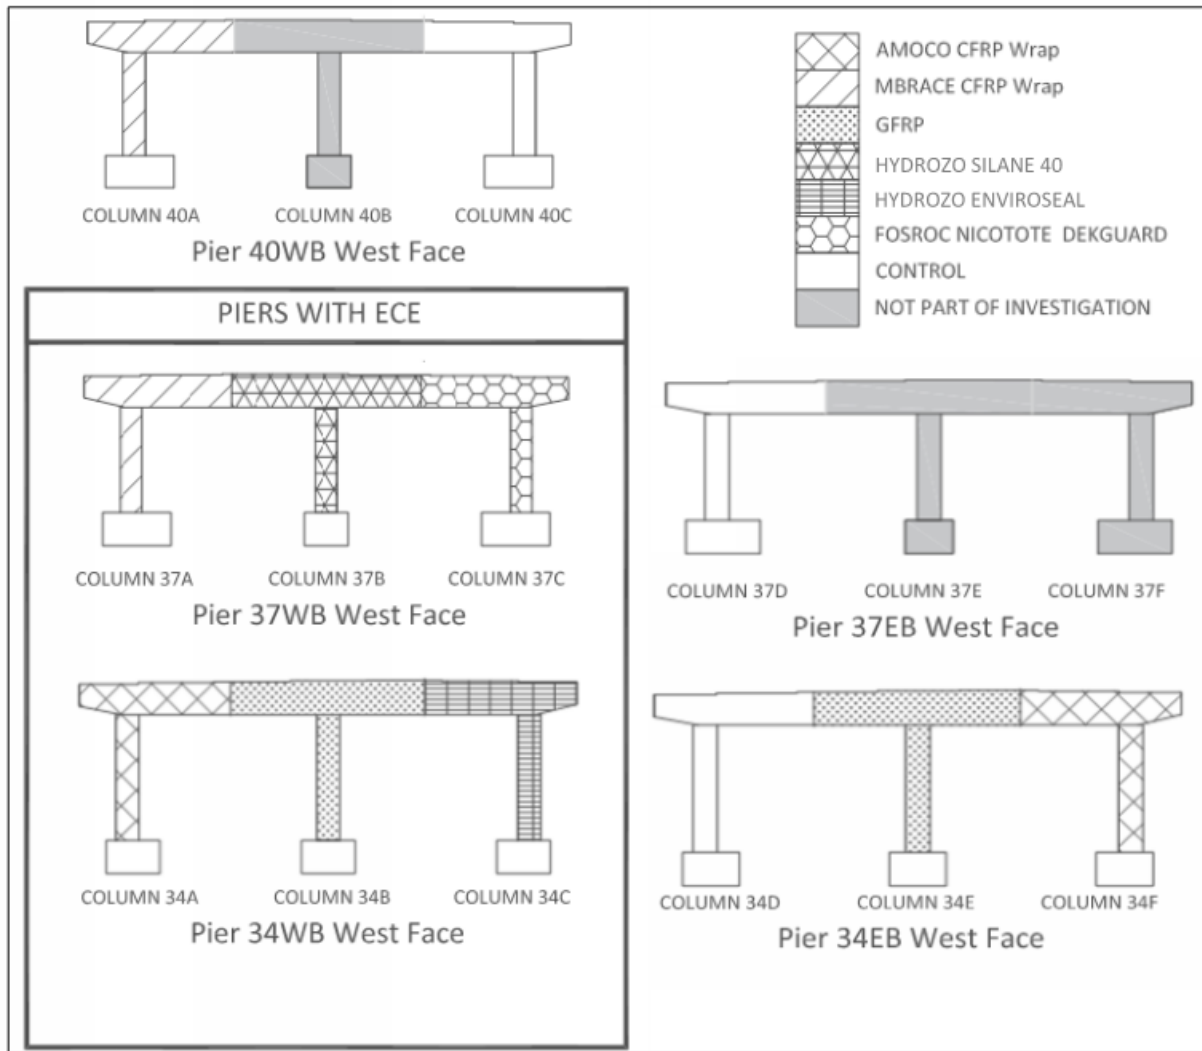
Figure 2.12 Summary of Corrosion Mitigation Strategy Installation Locations

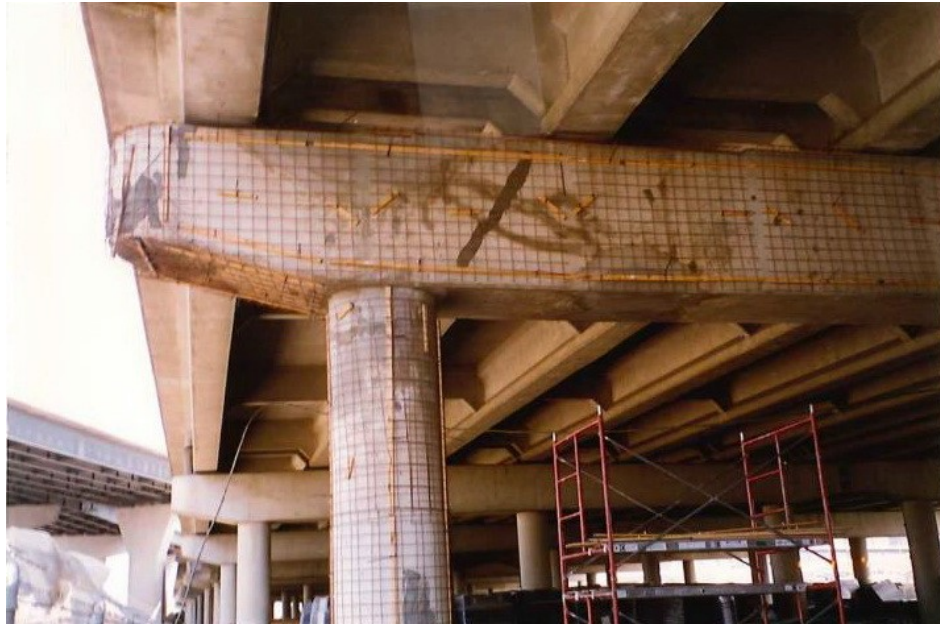
Figure 2.13 Pier 37WB - ECE installation in progress, prior to application of cellulose fiber

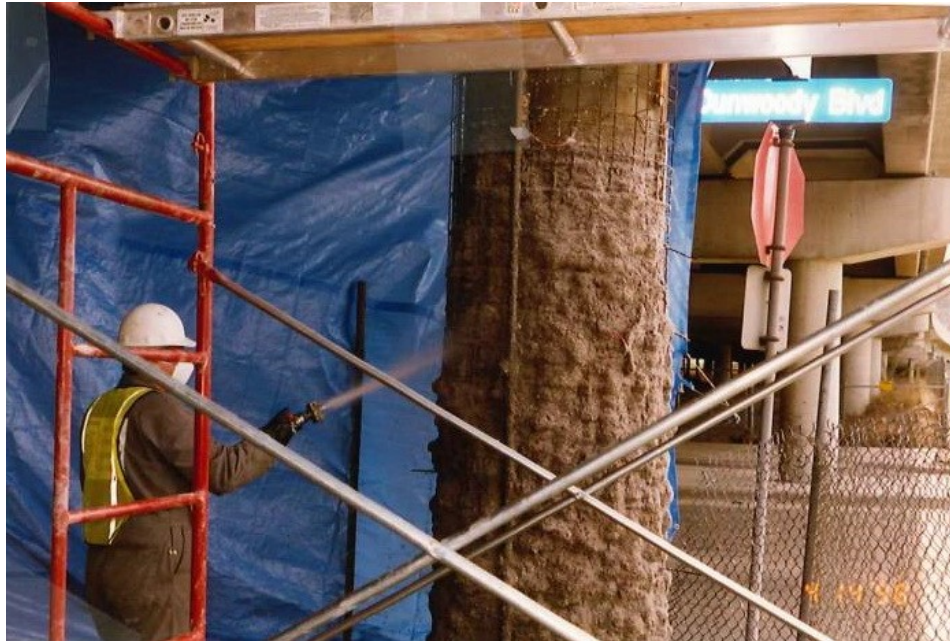
Figure 2.14 Pier 34WB - ECE installation in progress, during application of cellulose fiber

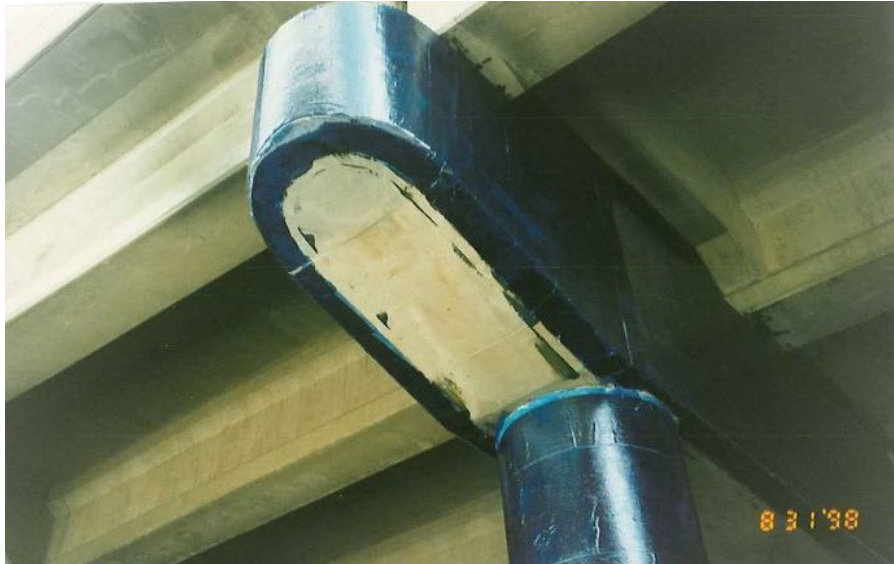
Figure 2.15 Pier 37WB - MBrace CFRP installation before application of UV coating.

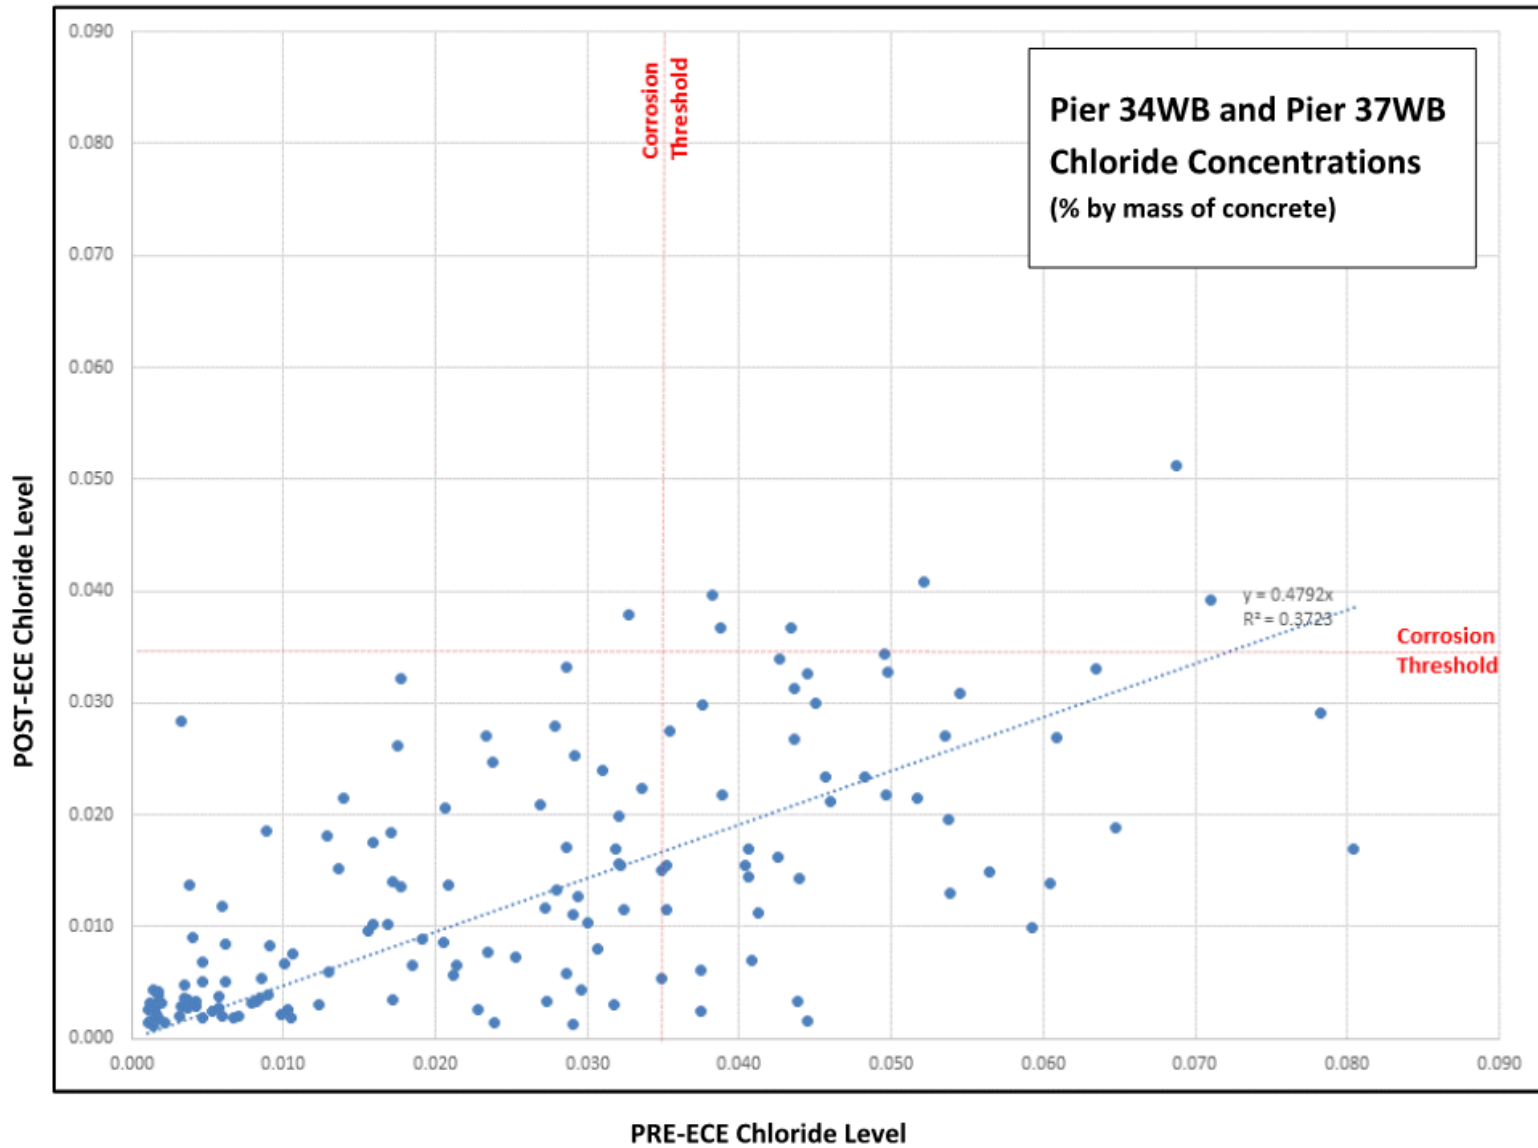
Figure 2.16 Scatter plot of pre-ECE (x axis) vs. post-ECE (y-axis) chloride levels

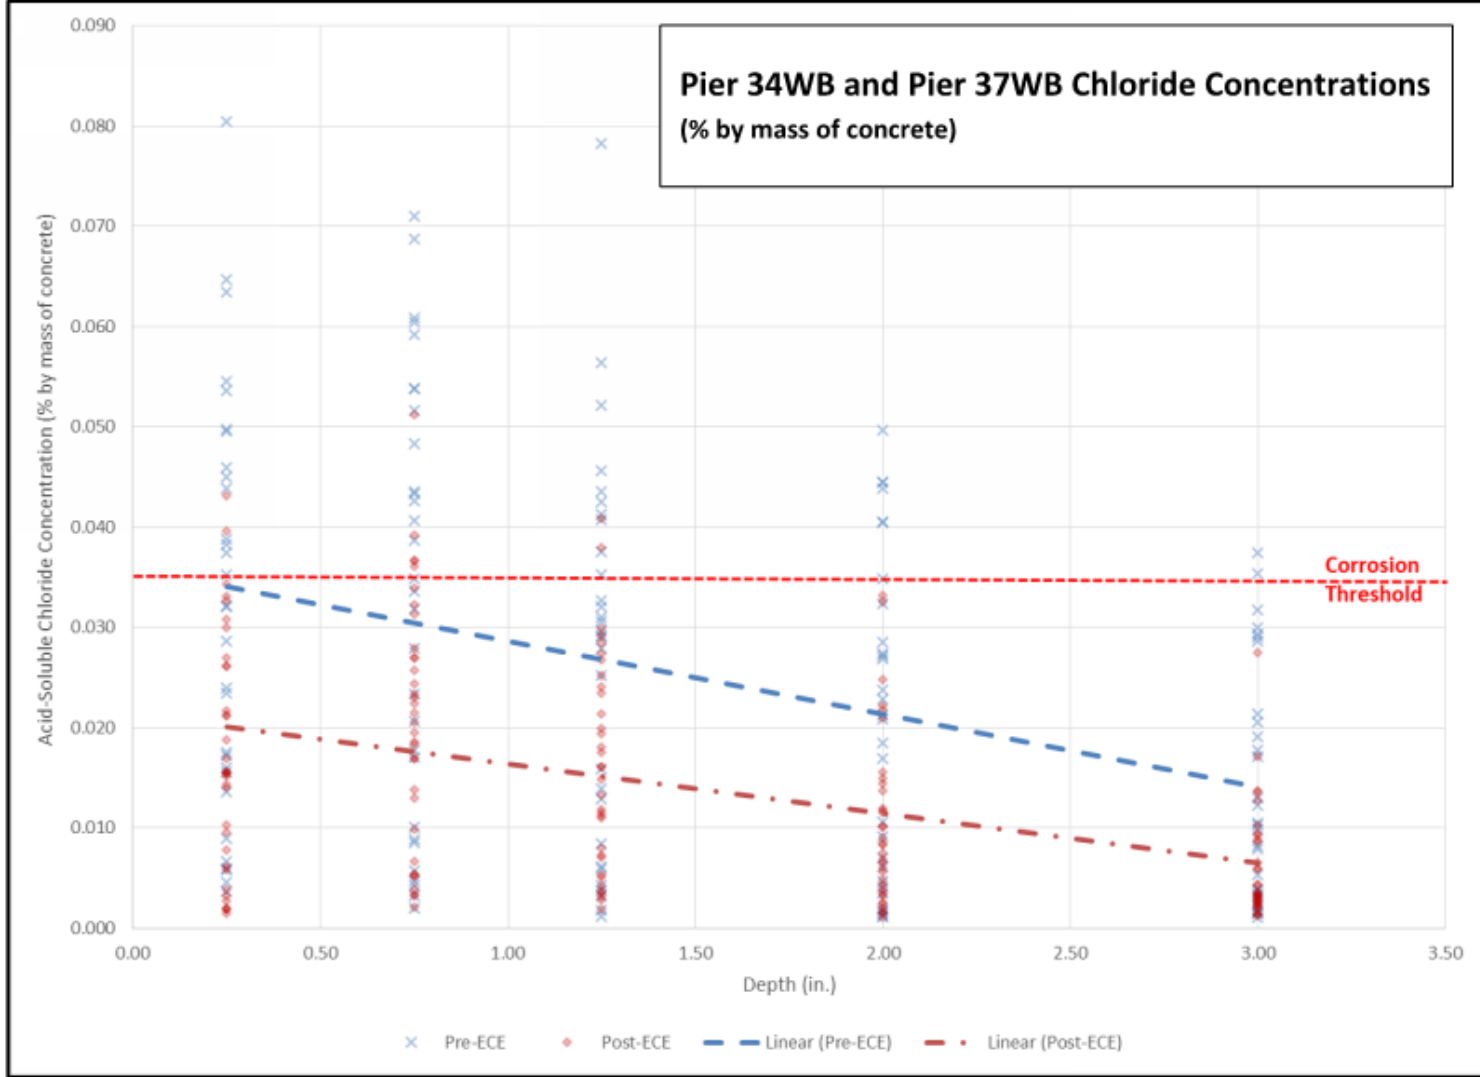
Figure 2.17 Comparison of pre-ECE vs. post-ECE chloride levels by horizon

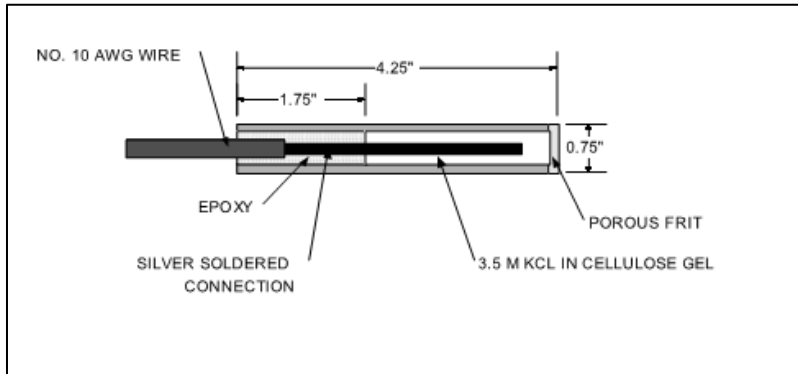
Figure 2.18 Schematic of embeddable Ag/Ag-Cl electrodes [11].

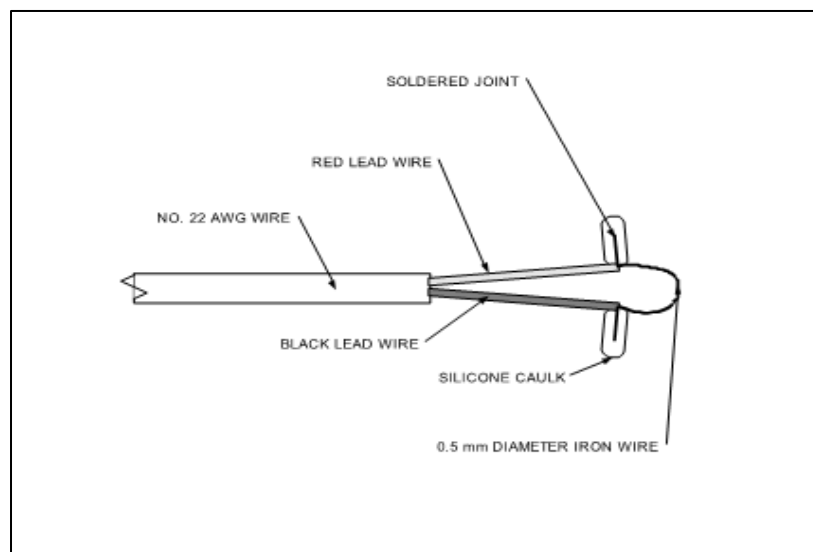
Figure 2.19 Schematic of a large resistivity-based corrosion probe [11].

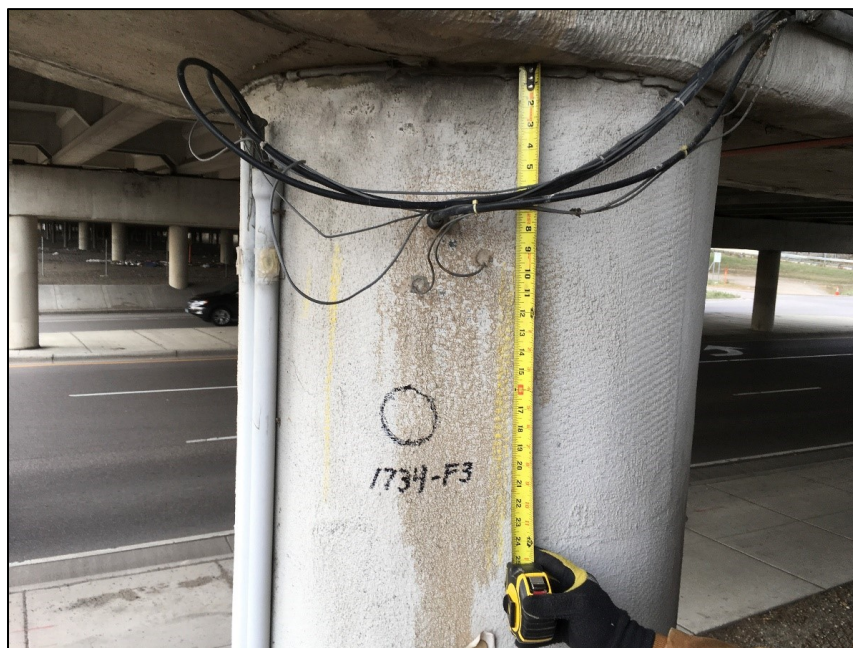
Figure 2.20 View of the instrumentation installed at Column 34F-3.

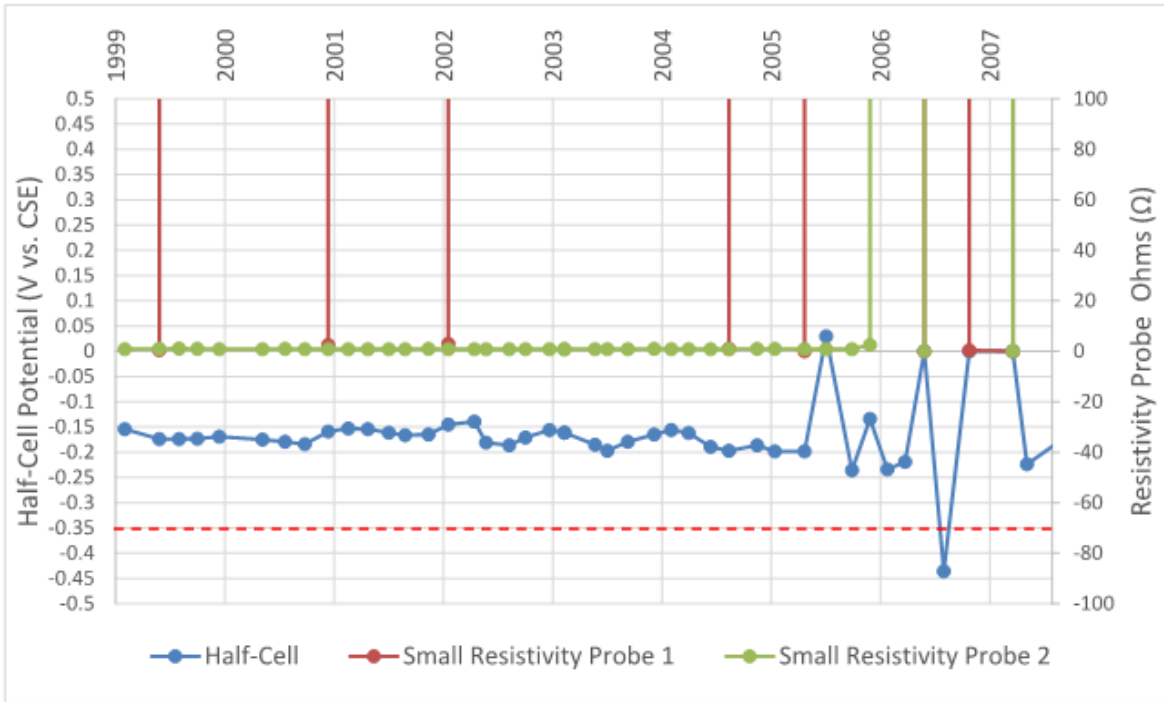
Figure 2.21 Plot of instrumentation data - Column 34C-3

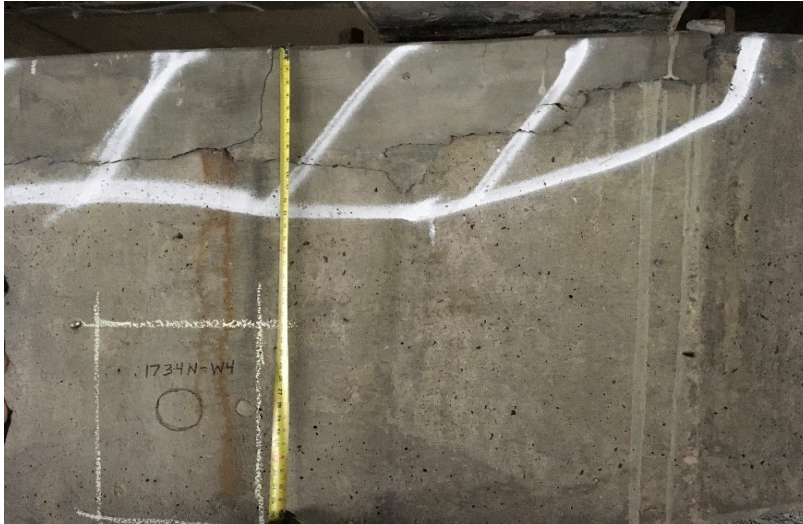
Figure 3.1 Pier 34WB - Example of distress identified on the west face of the pier cap

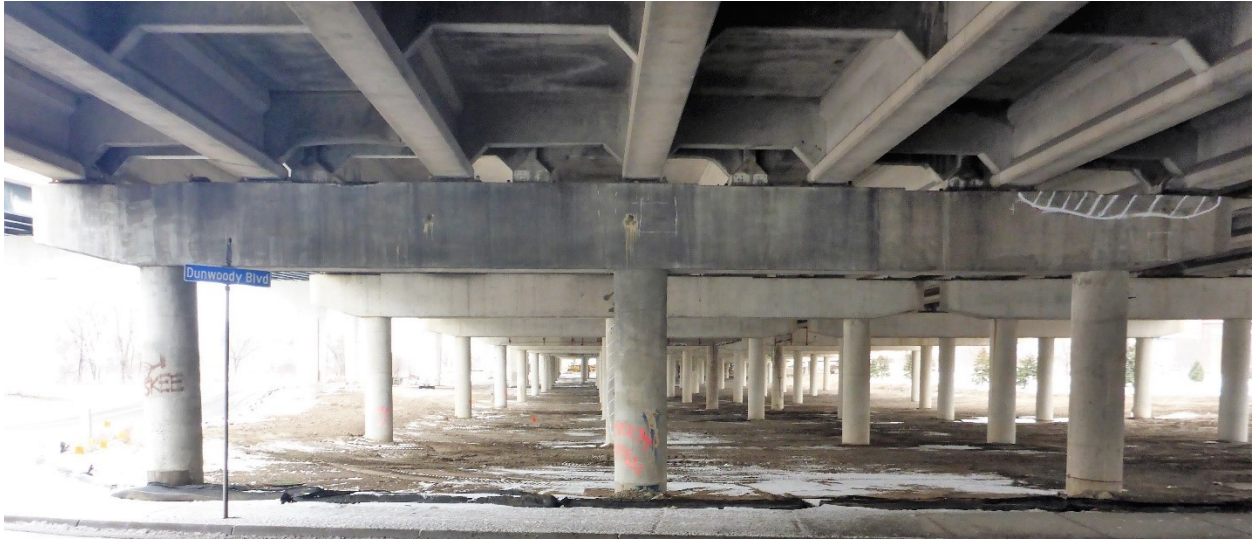
Figure 3.2 Pier 34WB - West Face

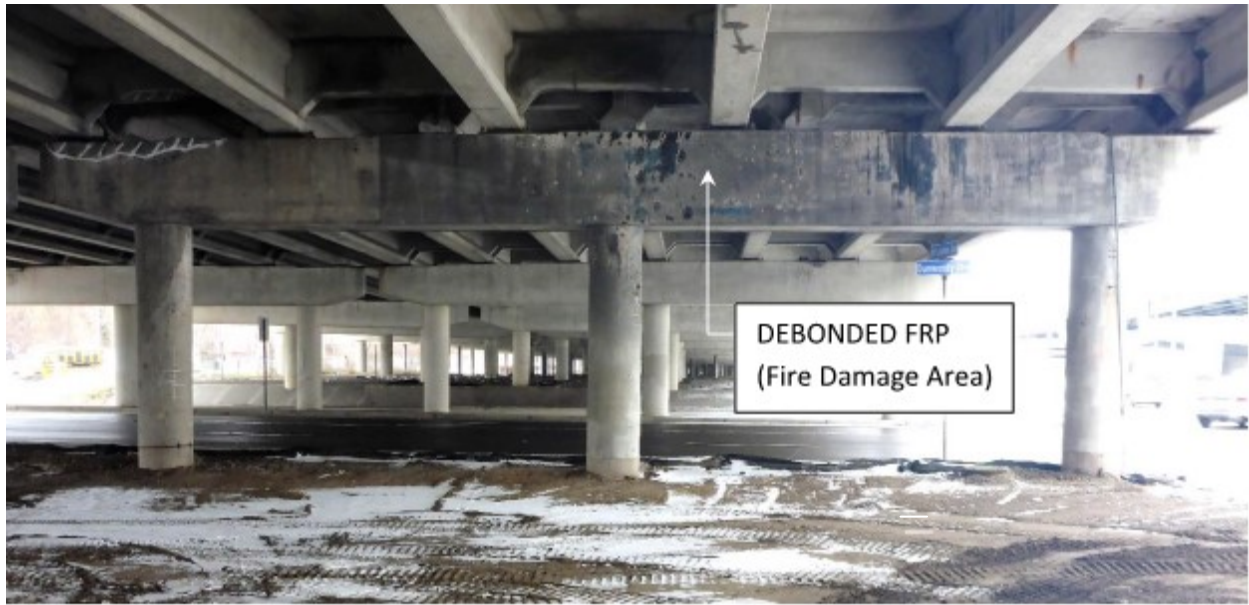
Figure 3.4 Pier 34WB - East Face

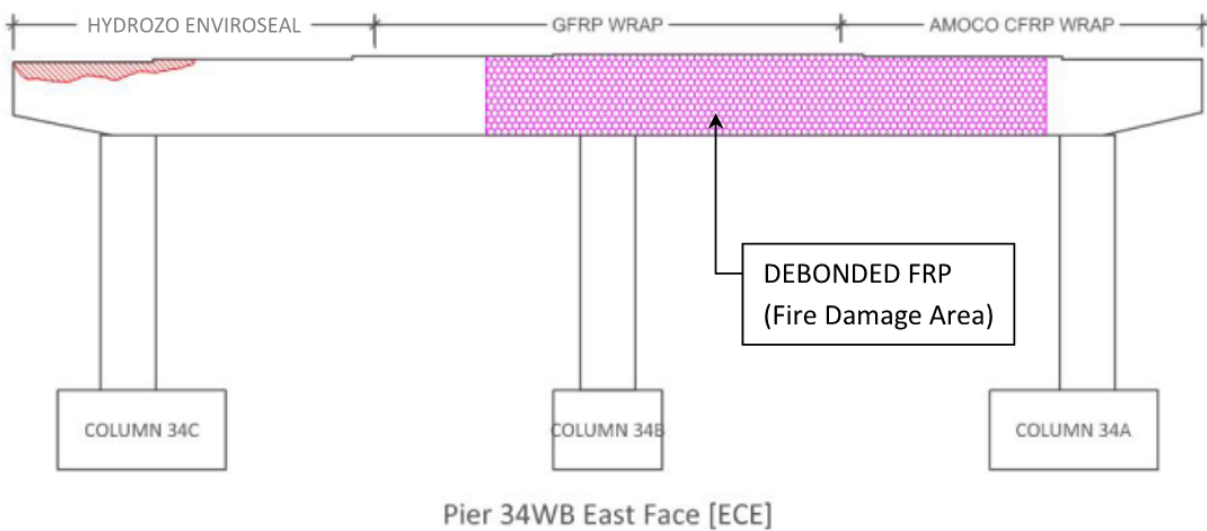
Figure 3.5 Pier 34WB - East Face - Overlay of 1998 repair areas (blue) and 2018 distress areas (red)

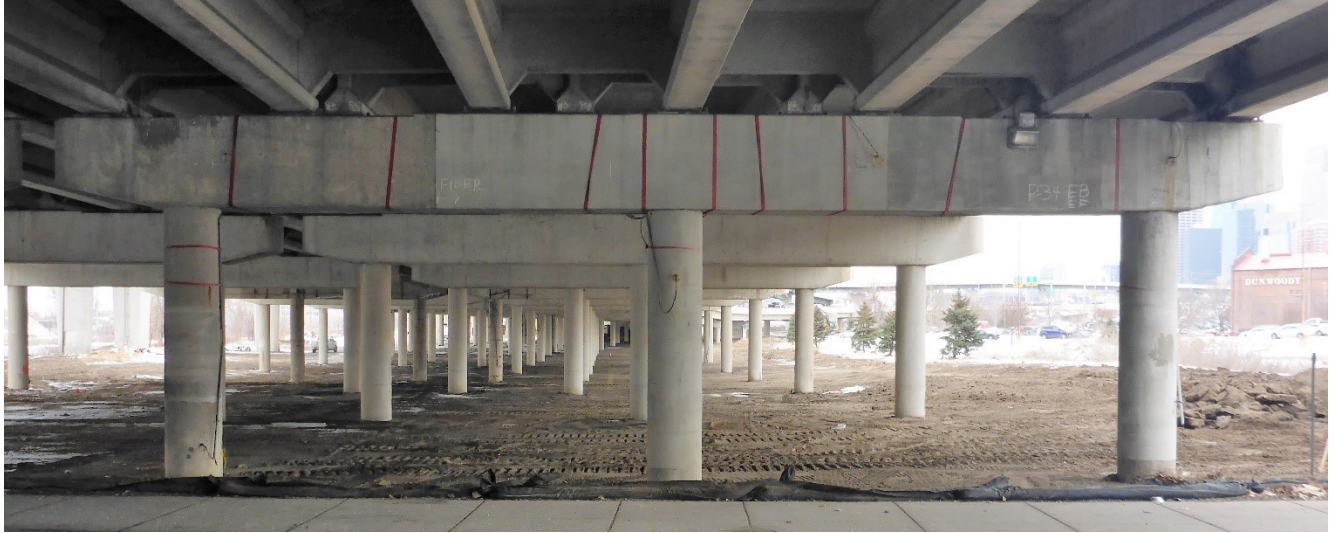
Figure 3.6 Pier 34EB - West Face

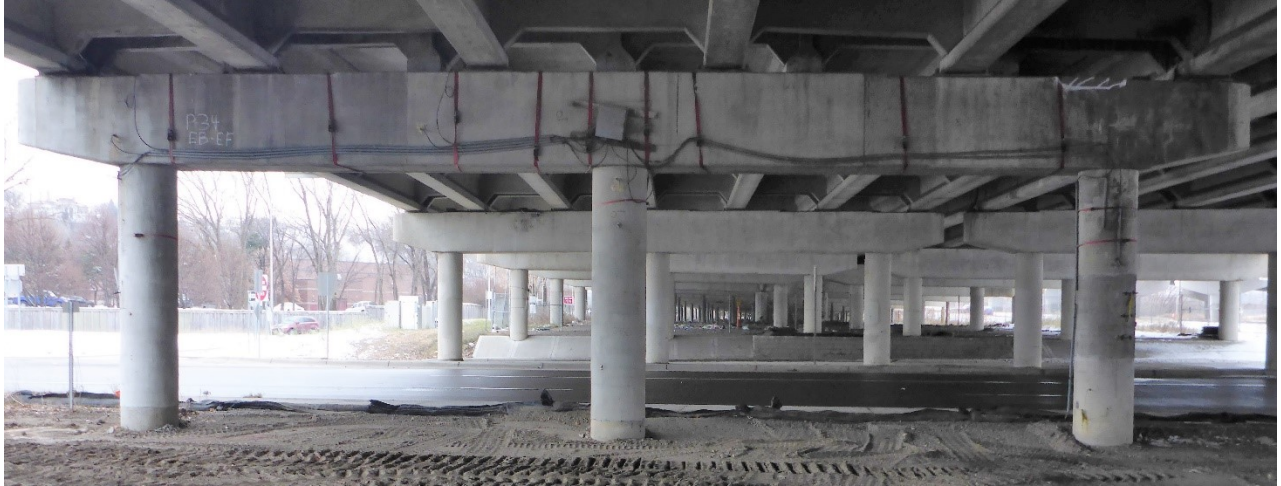
Figure 3.8 Pier 34EB - East Face

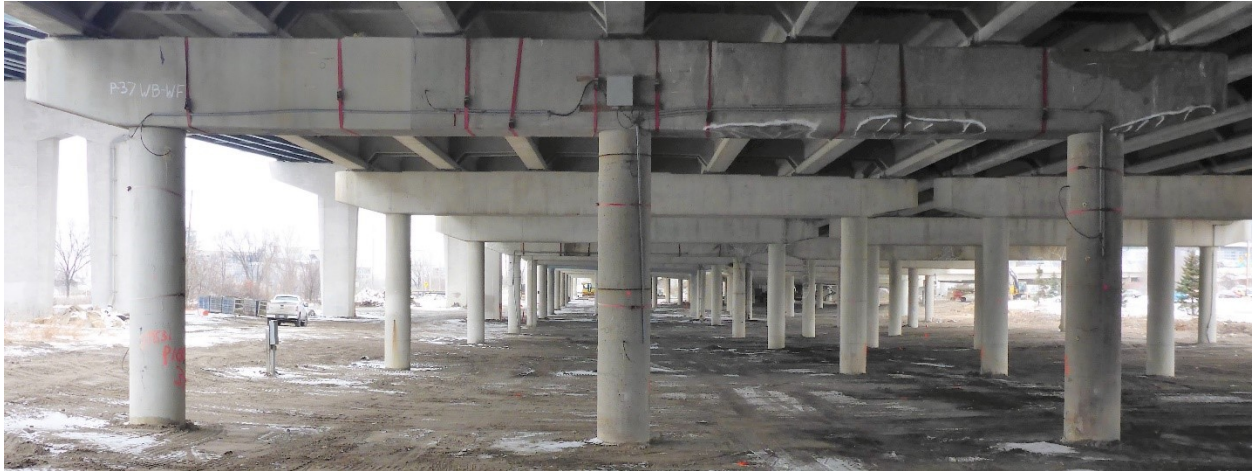
Figure 3.10 Pier 37WB - West Face

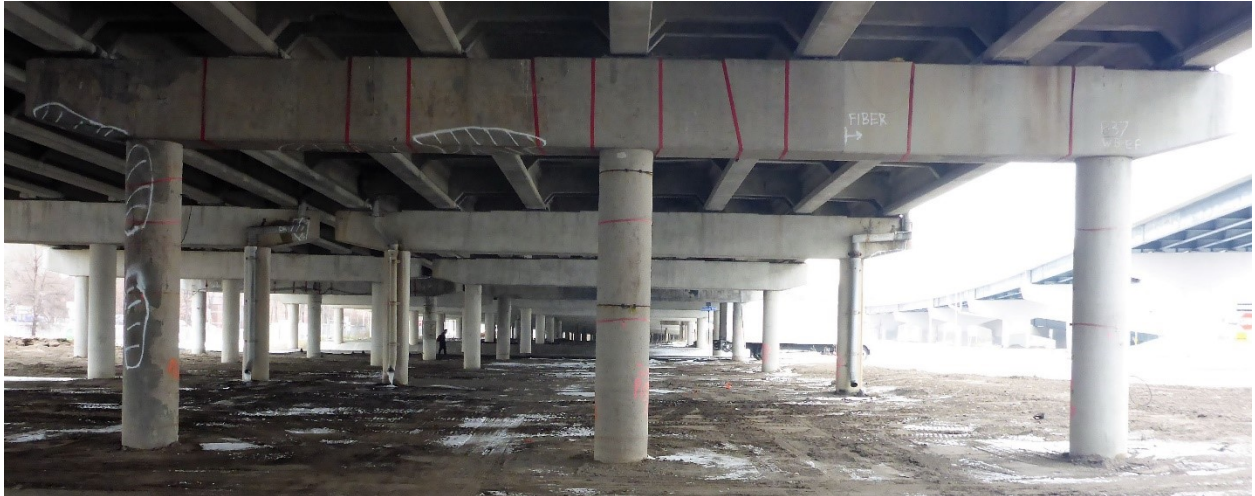
Figure 3.12 Pier 37WB - East Face
