Evaluation of Electrochemical Chloride Extraction, Fiber Reinforced Polymer Wraps, and Concrete Sealers for Corrosion Mitigation in Reinforced Concrete Bridge Structures

Mark R. Chauvin, Principal Investigator

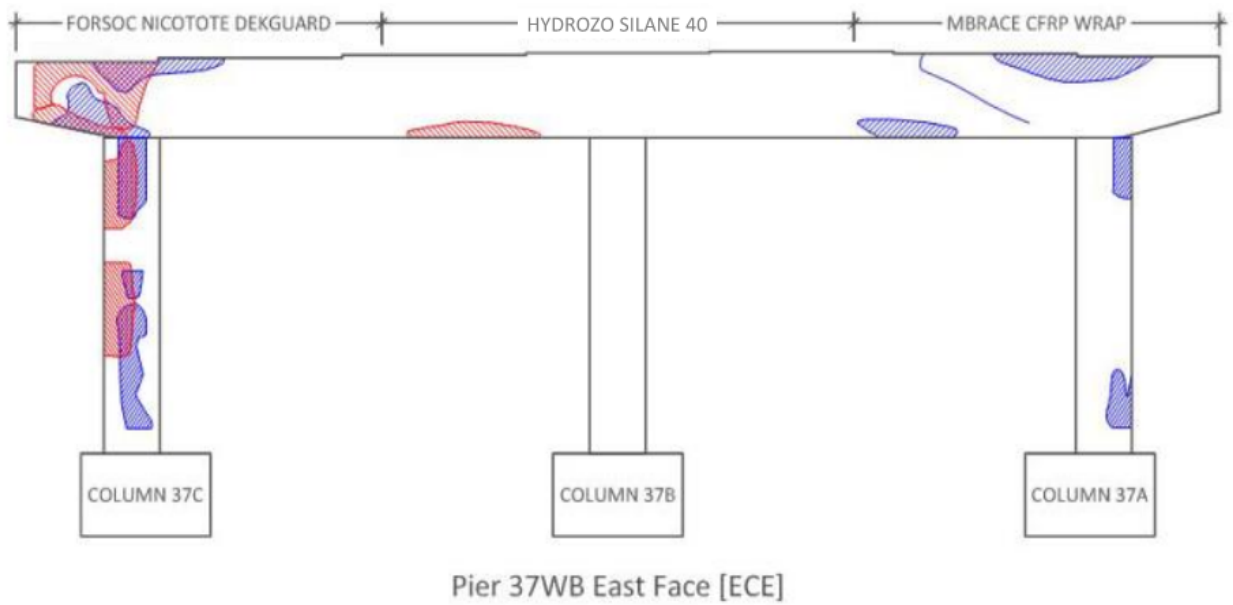
Figure 3.13 Pier 37WB - East Face - Overlay of 1998 repair areas (blue) and 2018 distress areas (red)

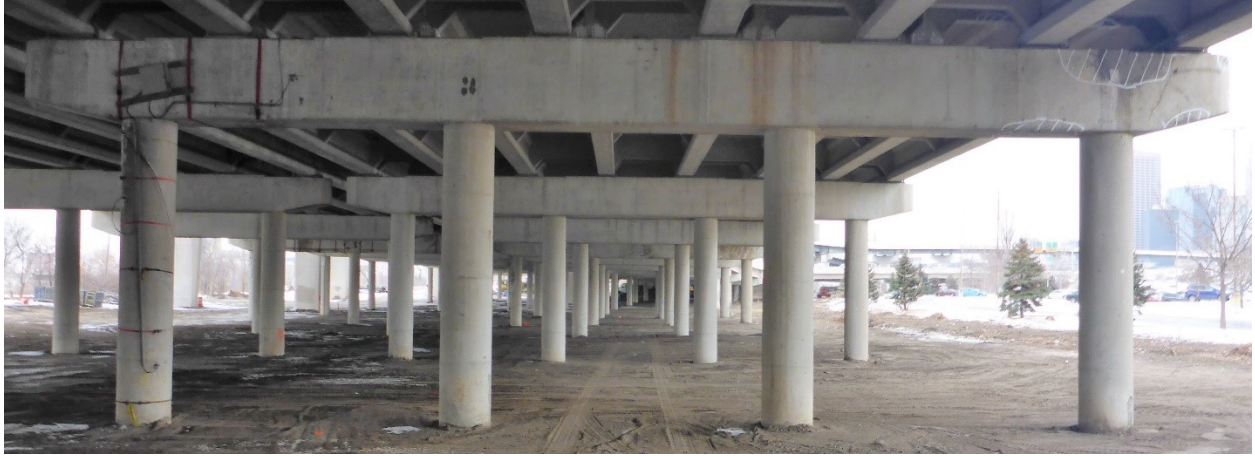
Figure 3.14 Pier 37EB - West Face

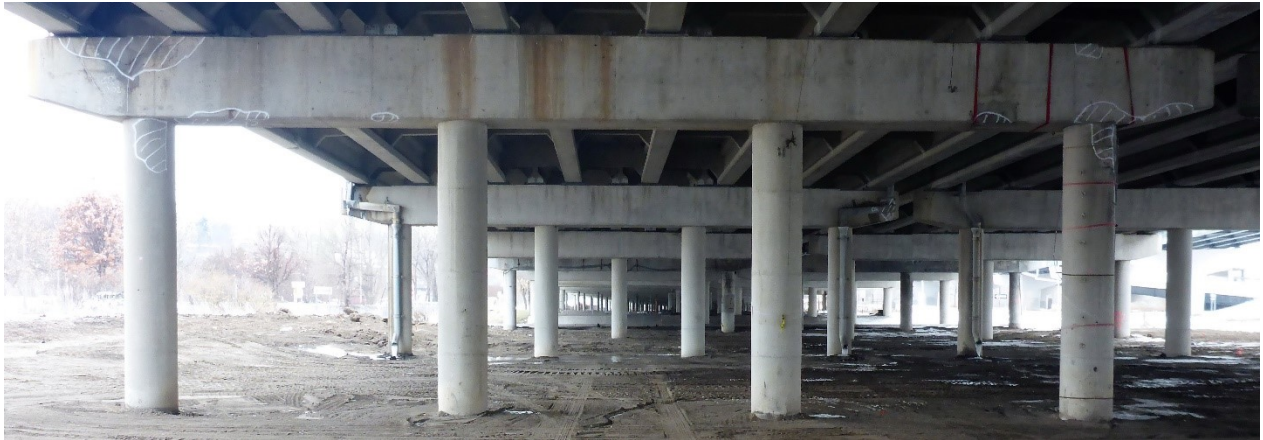
Figure 3.16 Pier 37EB - East Face

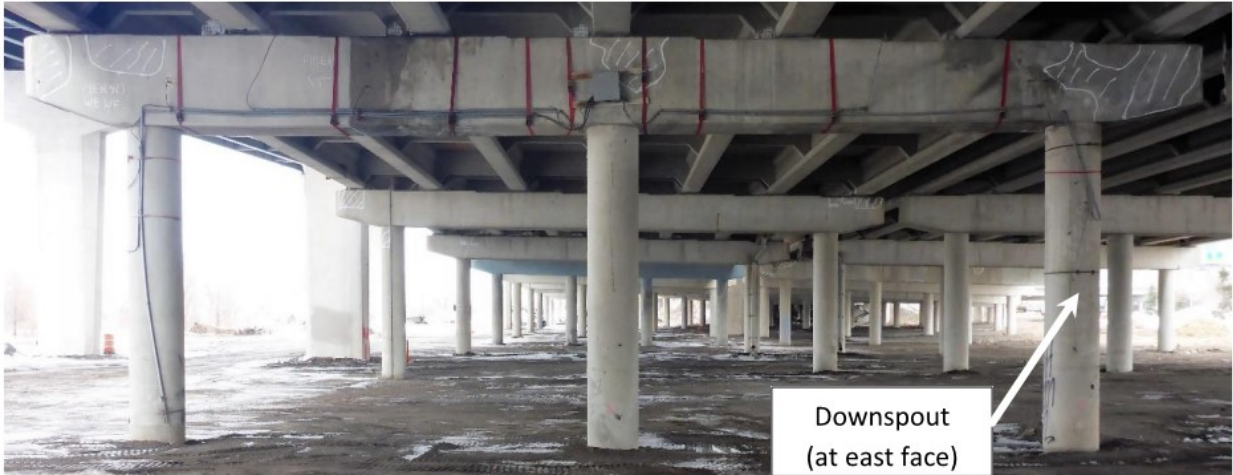
Figure 3.18 Pier 40WB - West Face

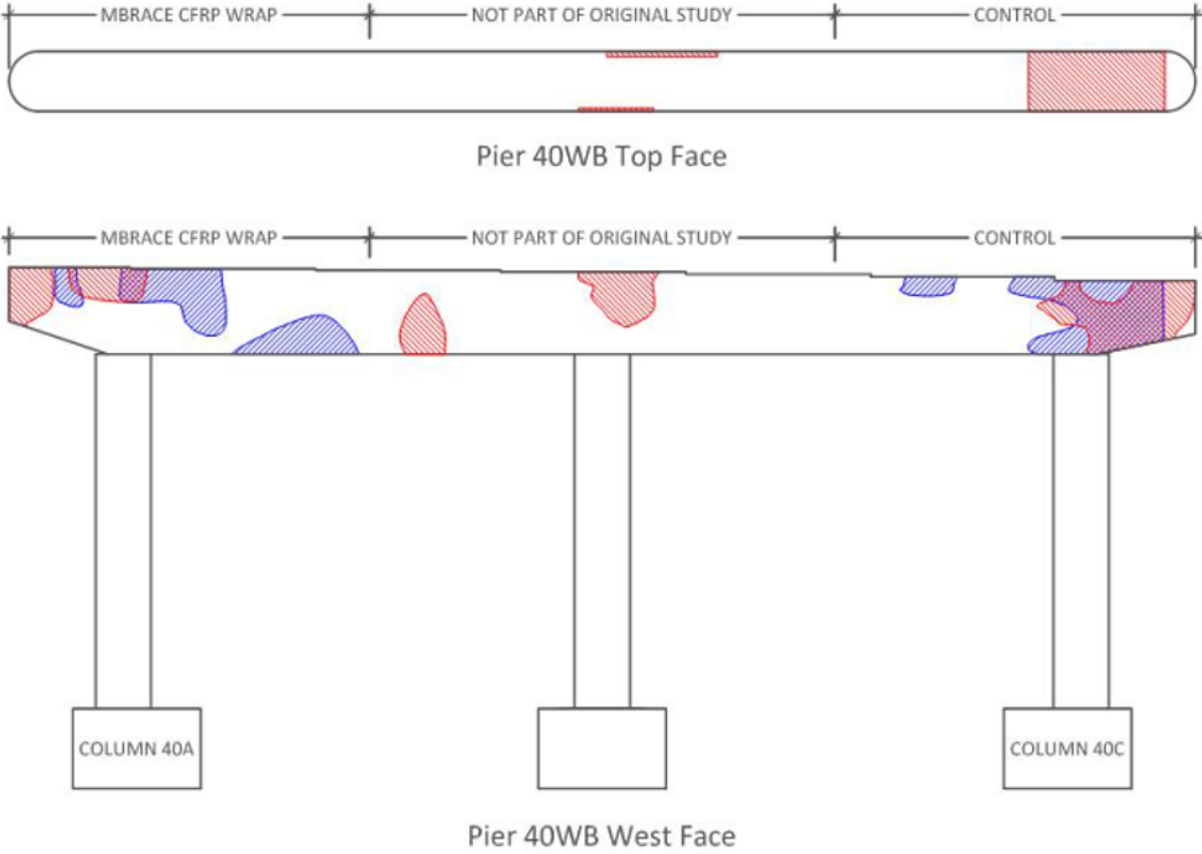
Figure 3.19 Pier 40WB - West Face - Overlay of 1998 repair areas (blue) and 2018 distress areas (red)

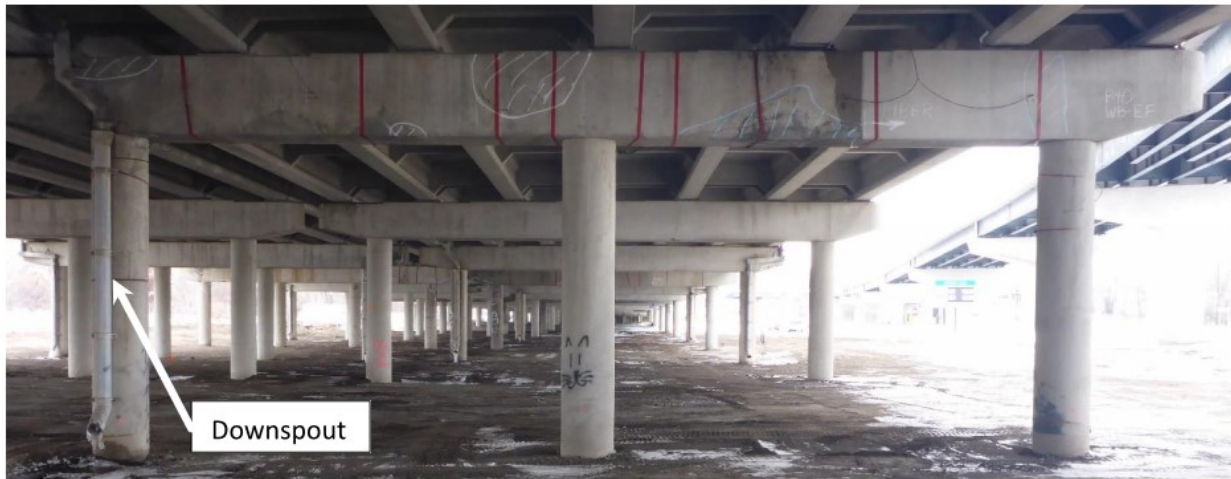
Figure 3.20 Pier 40WB - East Face

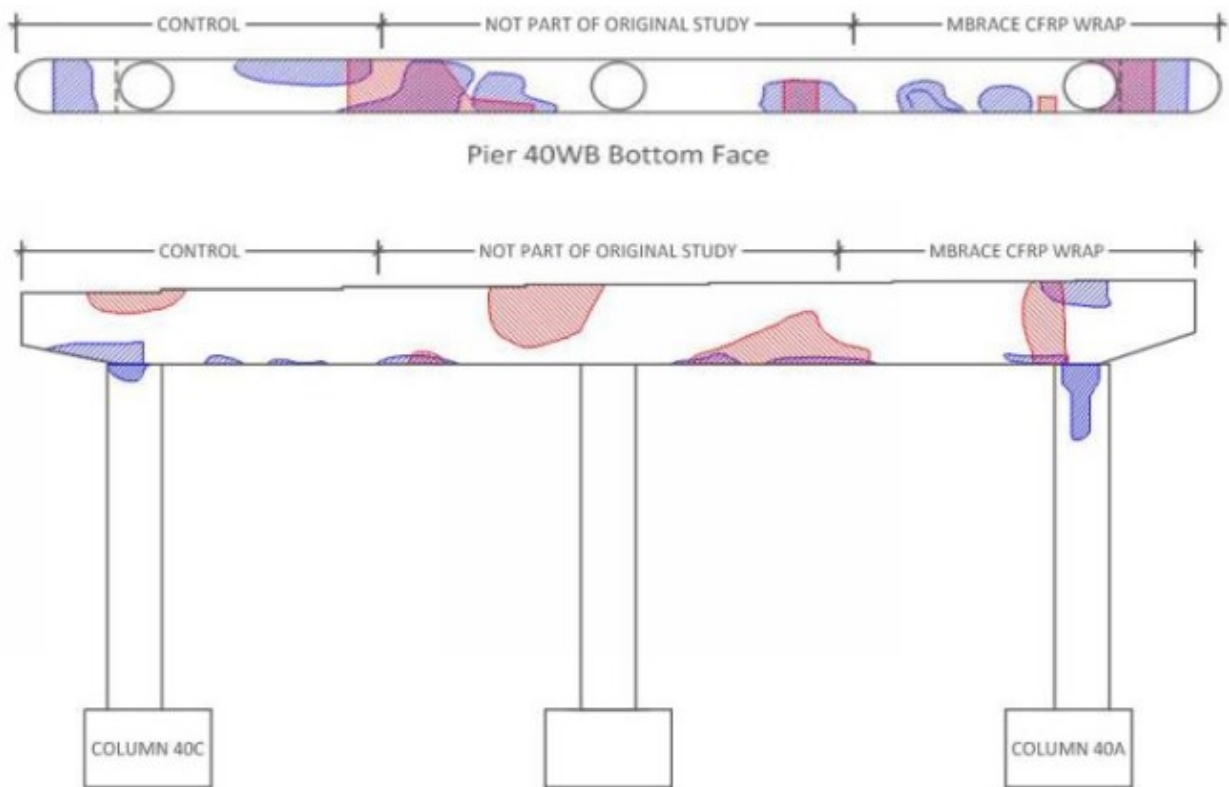
Figure 3.21 Pier 40WB - East Face - Overlay of 1998 repair areas (blue) and 2018 distress areas (red)

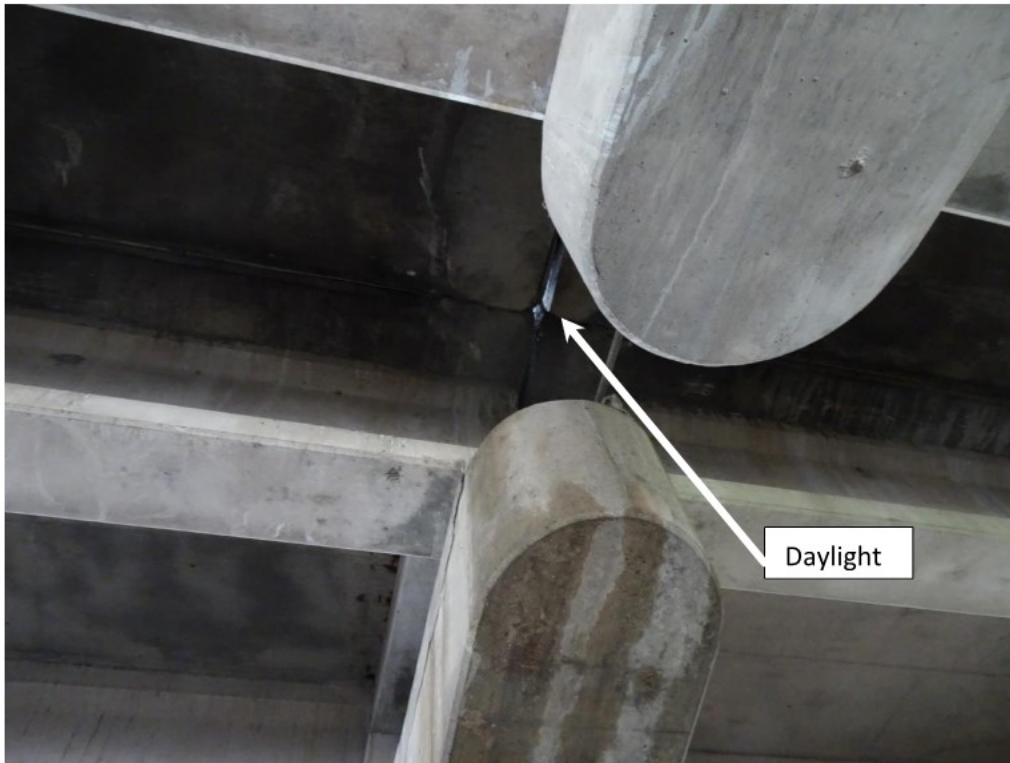
Figure 3.22 Pier 34WB - Daylight at deck joint and moisture staining below on end of pier cap.

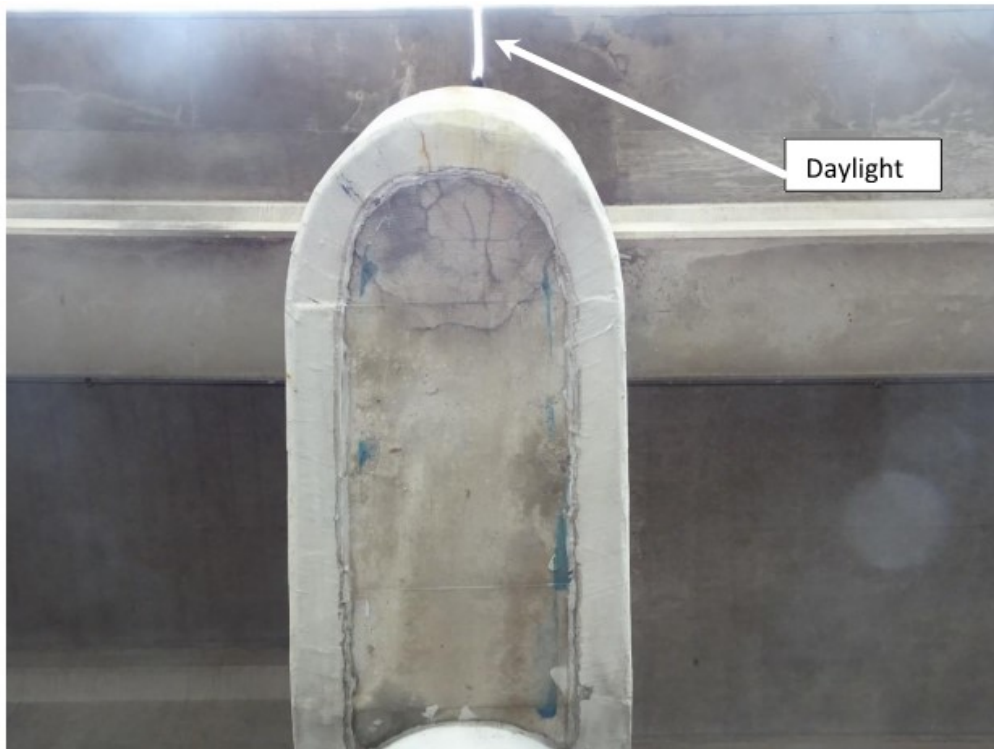
Figure 3.23 Pier 40WB - Daylight visible at a deck joint above the pier cap

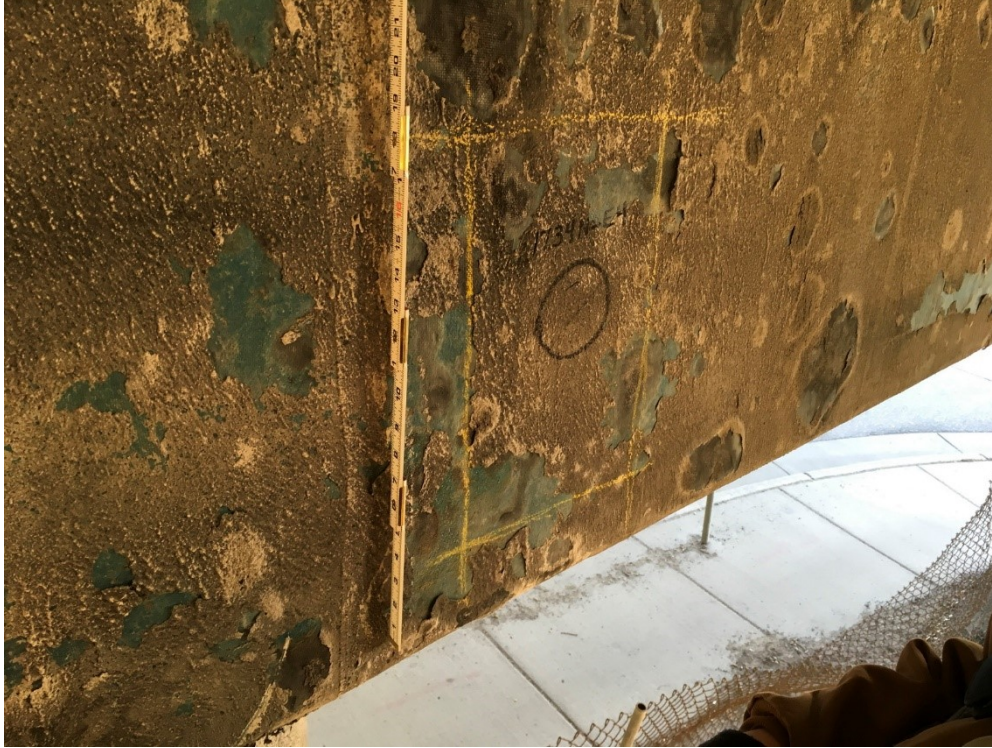
Figure 3.24 Pier 34EB - Fire damage to FRP applied on east face

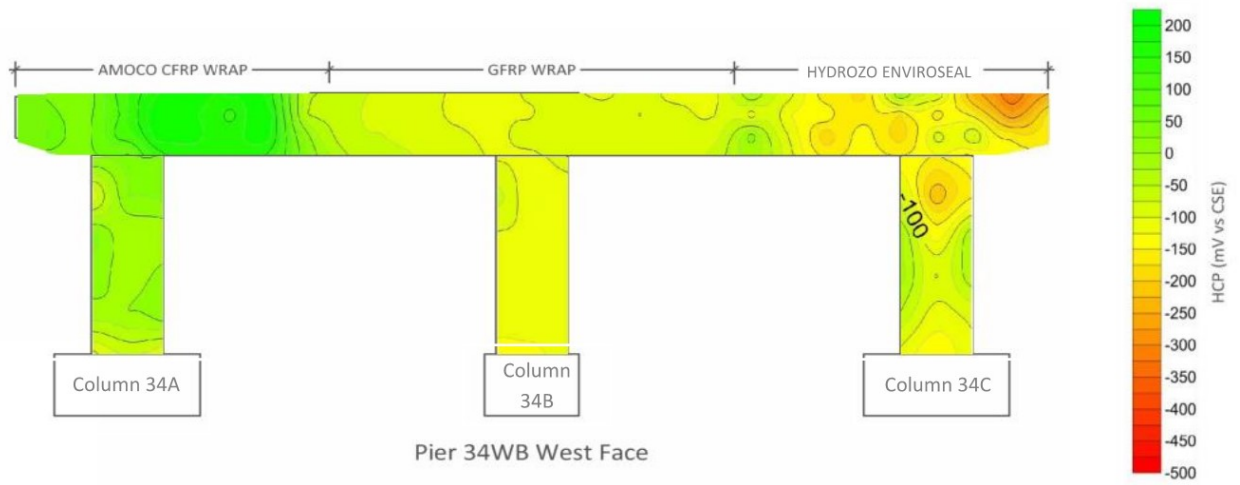
Figure 3.25 Pier 34WB [ECE] - Results of half-cell potential testing at west face

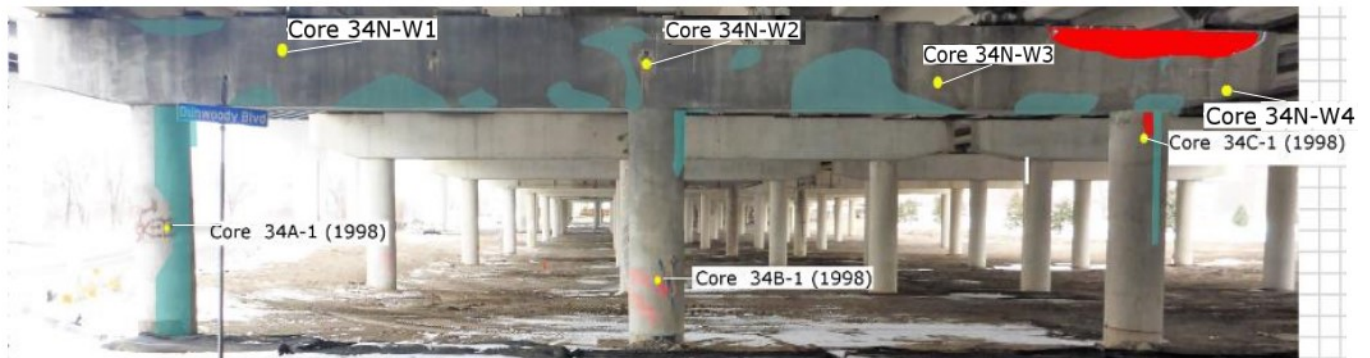
Figure 3.26 Pier 34WB [ECE] - West face - Delaminations in 2018 (red) and 1998 repair areas (blue)

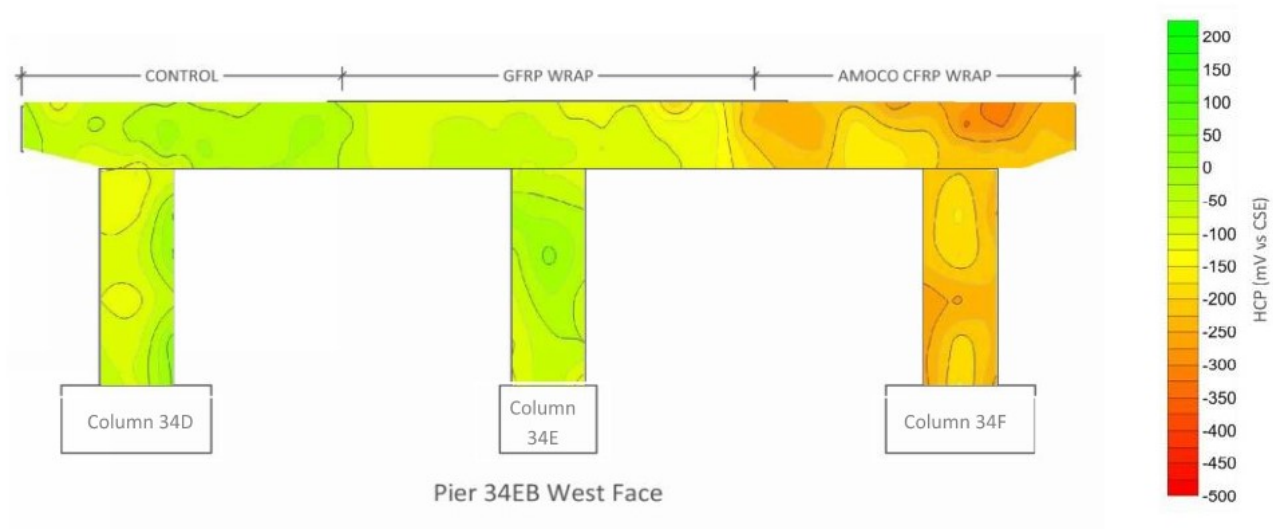
Figure 3.27 Pier 34EB - Results of half-cell potential testing at west face

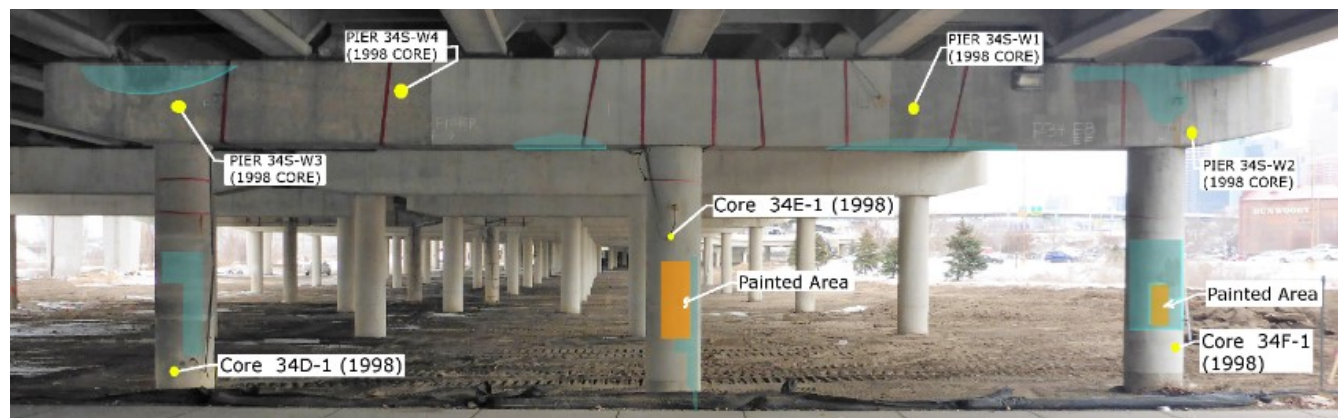
Figure 3.28 Pier 34EB - West face - Delaminations in 2018 (red) and 1998 repair areas (blue)

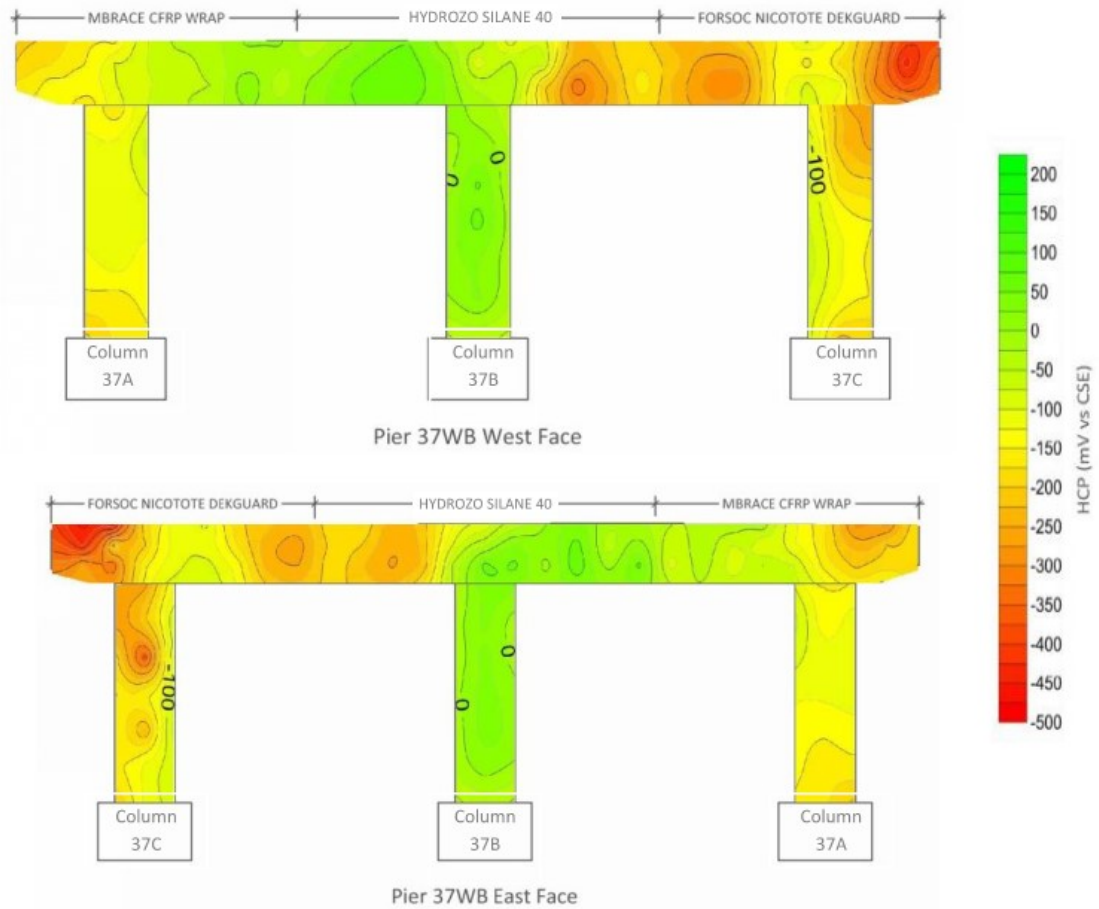
Figure 3.29 Pier 37WB [ECE] - Results of half-cell potential testing at west and east faces

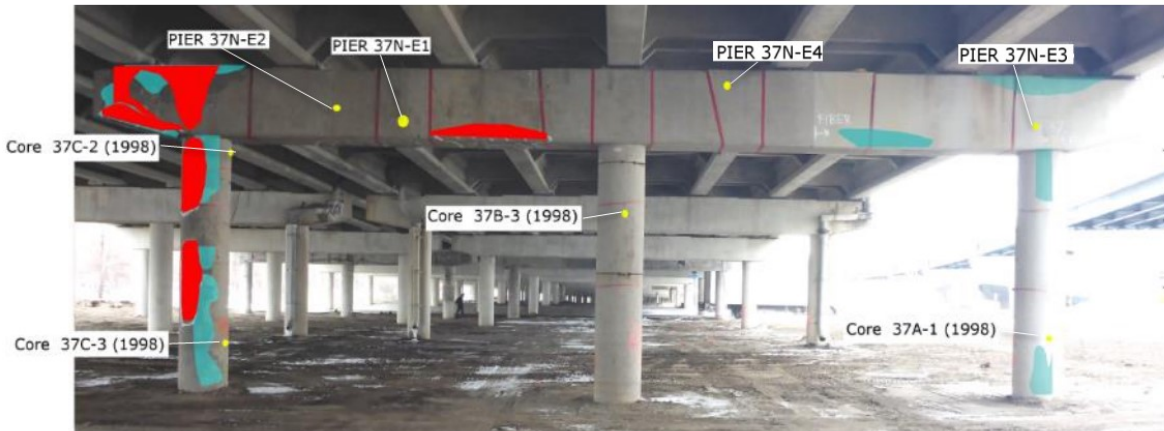
Figure 3.30 Pier 37WB [ECE] - East face - Delaminations in 2018 (red) and 1998 repair areas (blue)

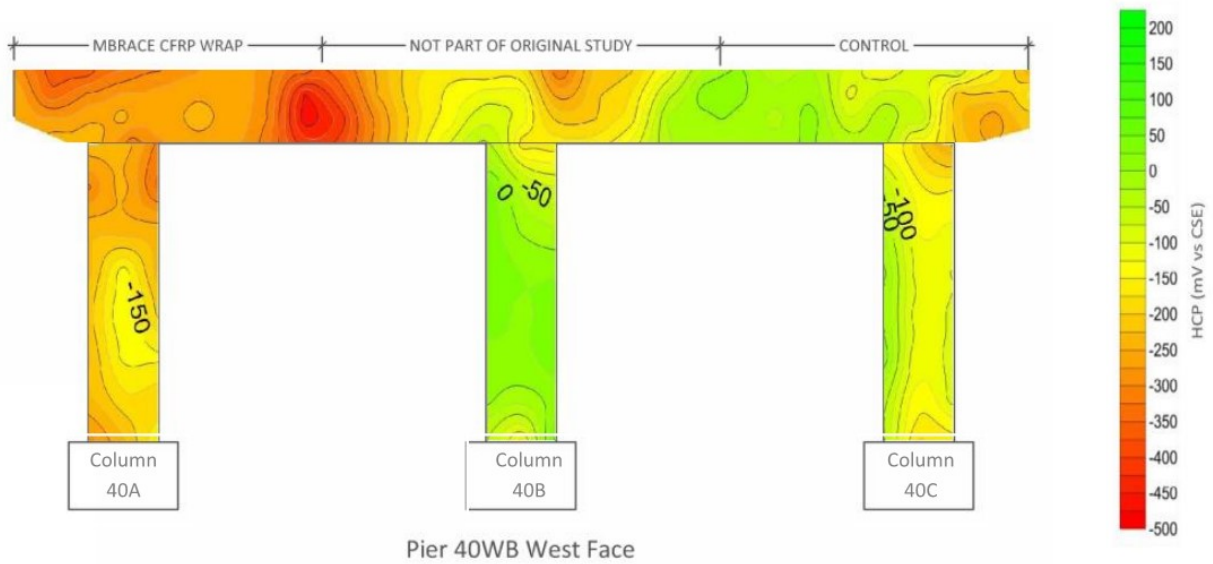
Figure 3.31 Pier 40WB - Results of half-cell potential testing

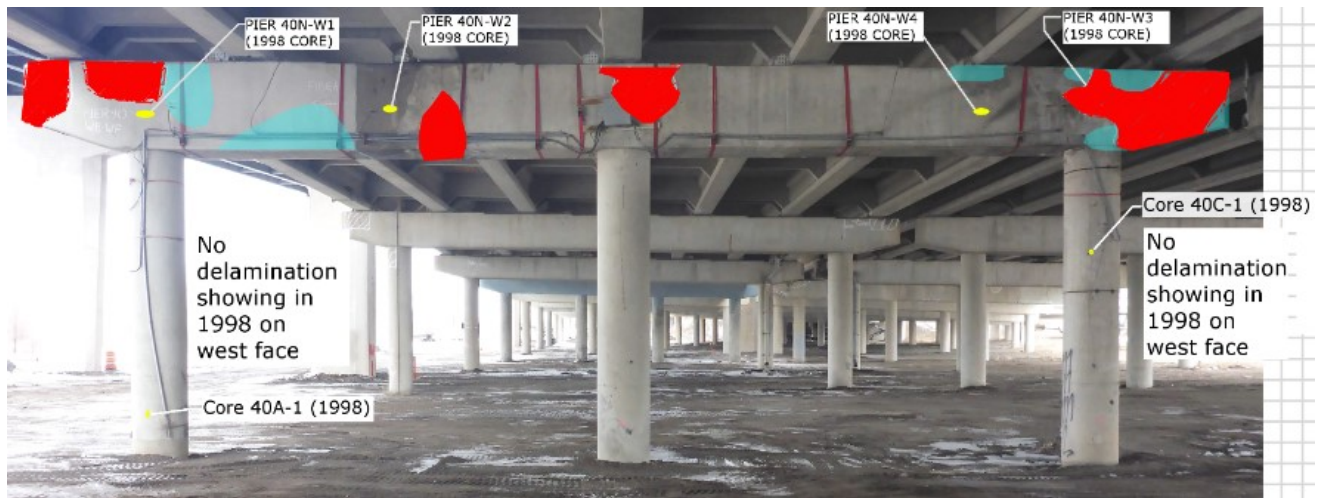
Figure 3.32 Pier 40WB - West face - Delaminations in 2018 (red) and 1998 repair areas (blue)

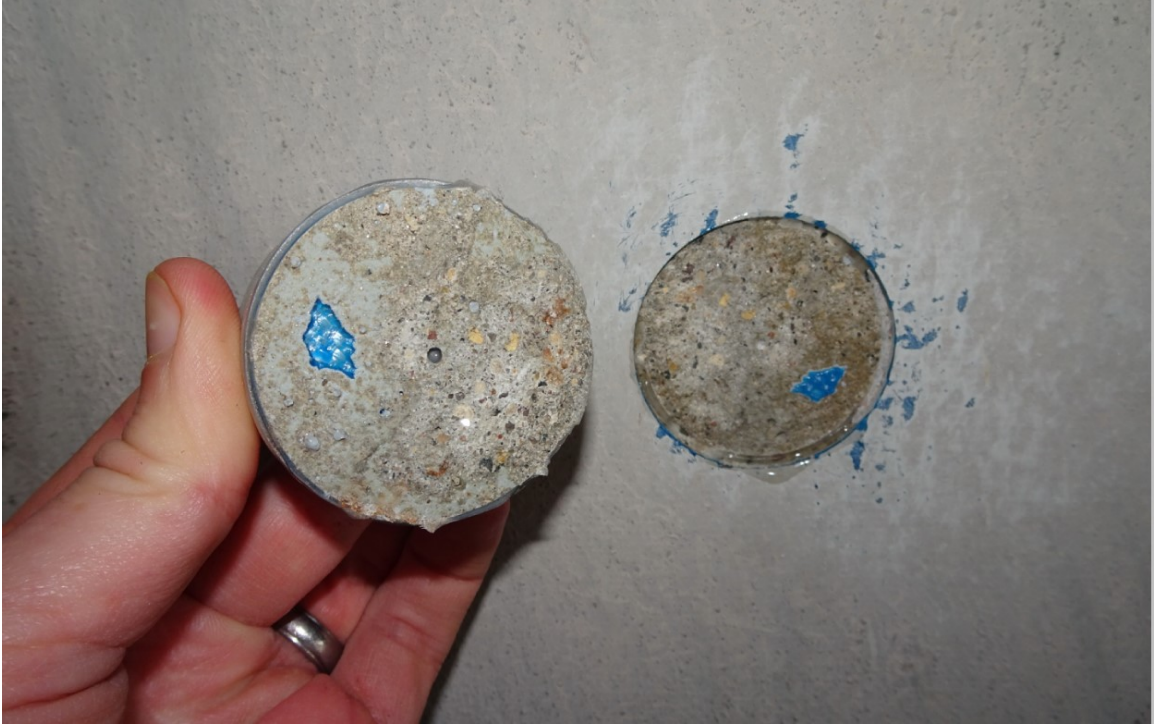
Figure 3.33 Pull-off testing of FRP wrap - cohesive failure in the concrete substrate

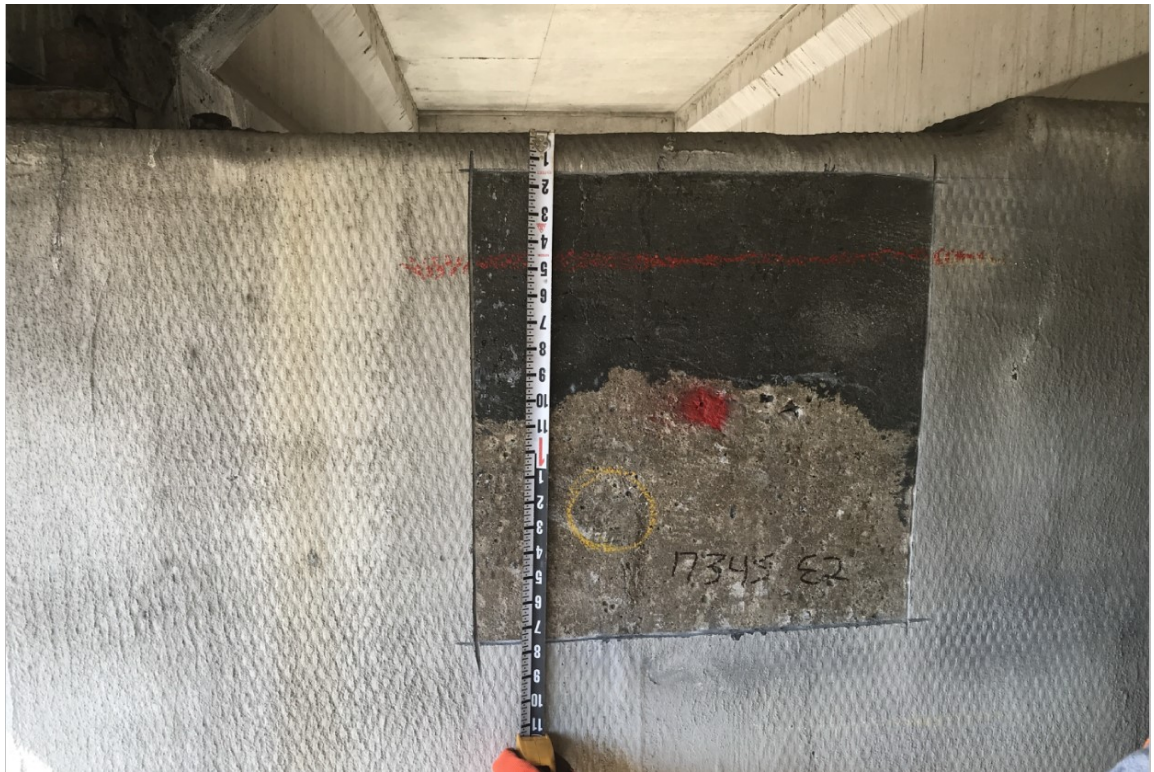
Figure 3.34 Pier 34EB - Example CFRP removal to facilitate locating of core sample

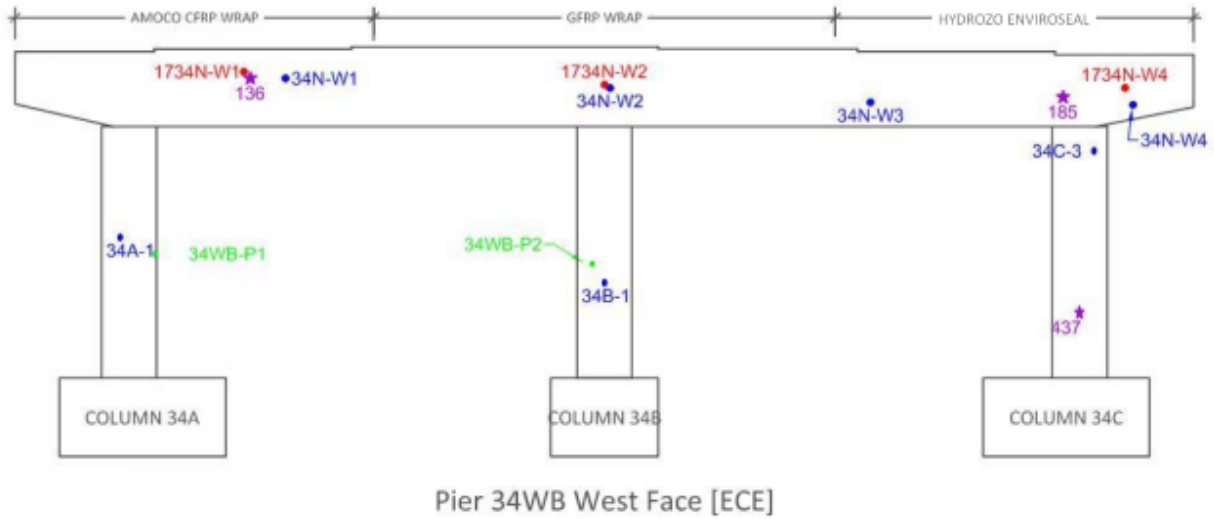
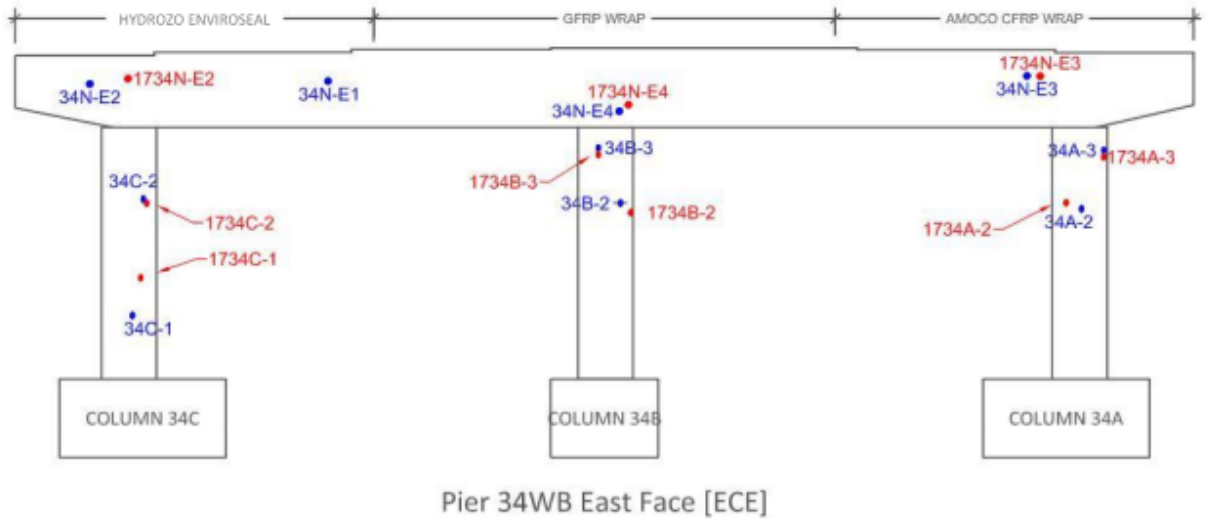
The concrete core locations of the 1998 study and the 2018 study are depicted in Figure 3.35 to Figure 3.39. Four-inch diameter concrete cores were extracted by MnDOT personnel at all identified locations. All core samples were obtained by drilling horizontally into the pier caps and columns and the work was performed in general accordance with ASTM C42 [16]. The concrete core samples were then provided to the authors and were shipped to the WJE Janney Technical Center (JTC) laboratory in Northbrook, Illinois for laboratory testing of chloride content and carbonation depth. The procedures and results of the testing are discussed in Section 3.3.

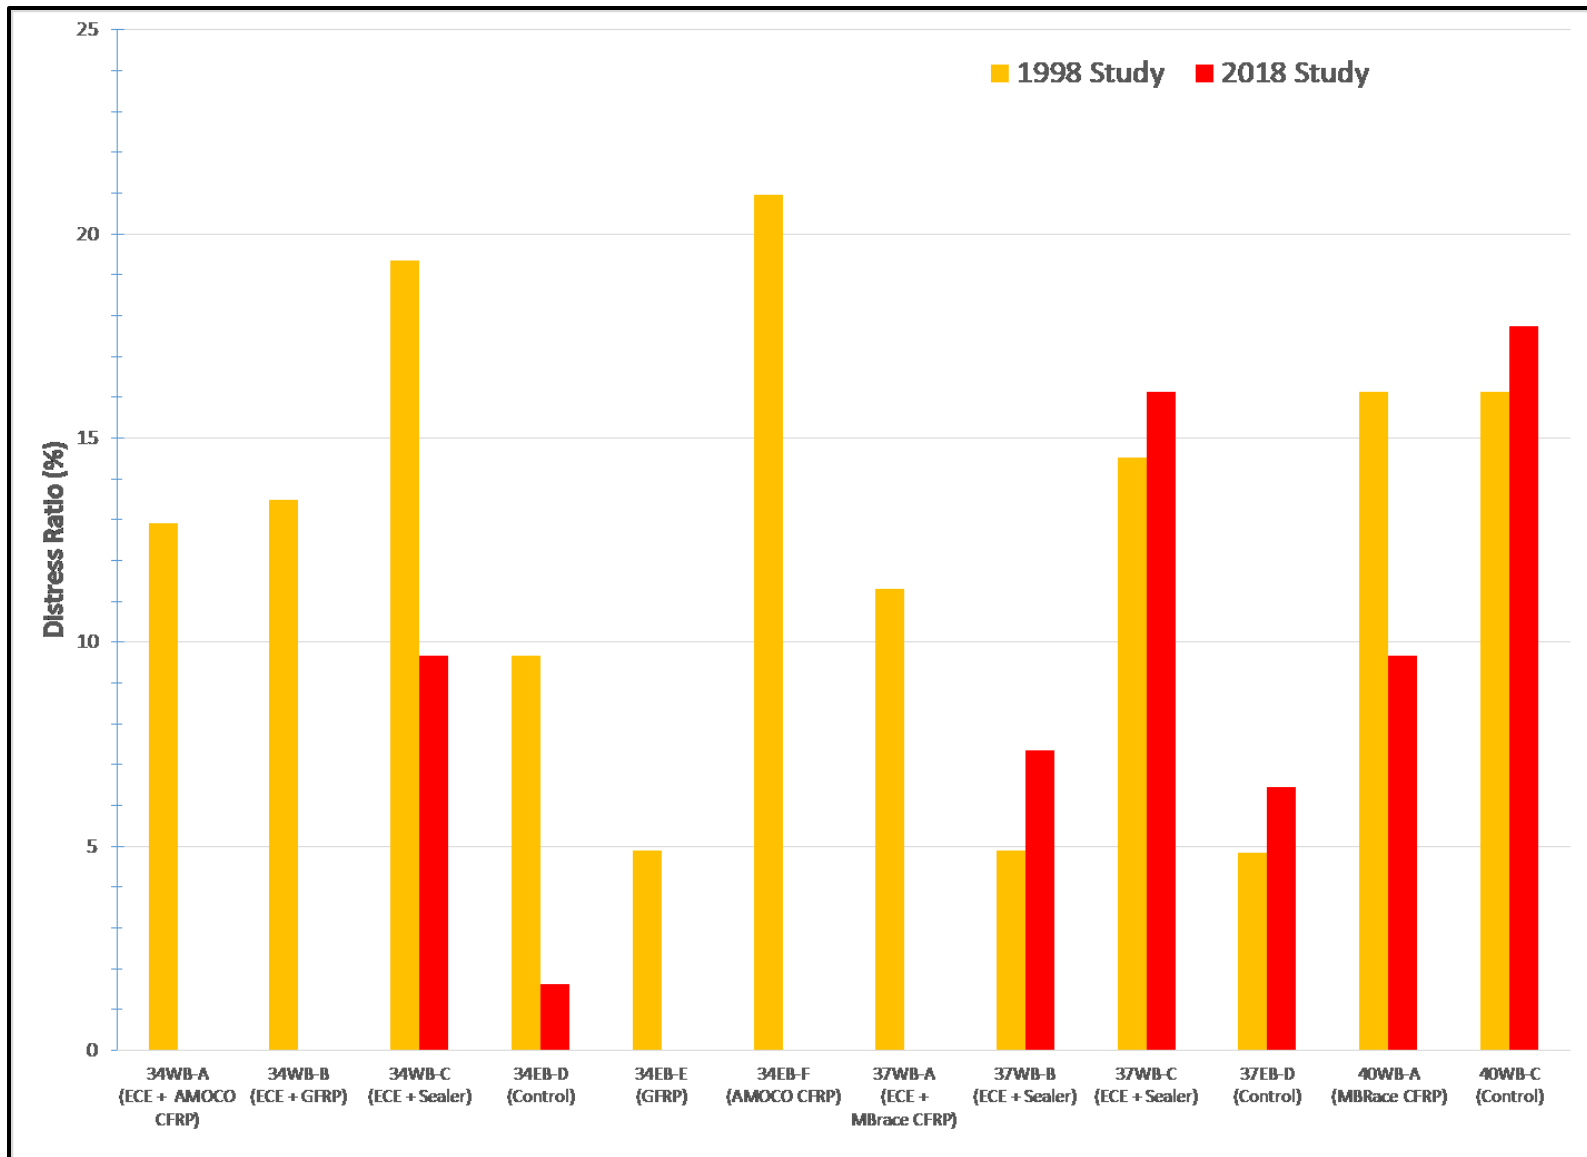
Figure 4.1 Comparison of distress ratio by section - 1998 vs 2018

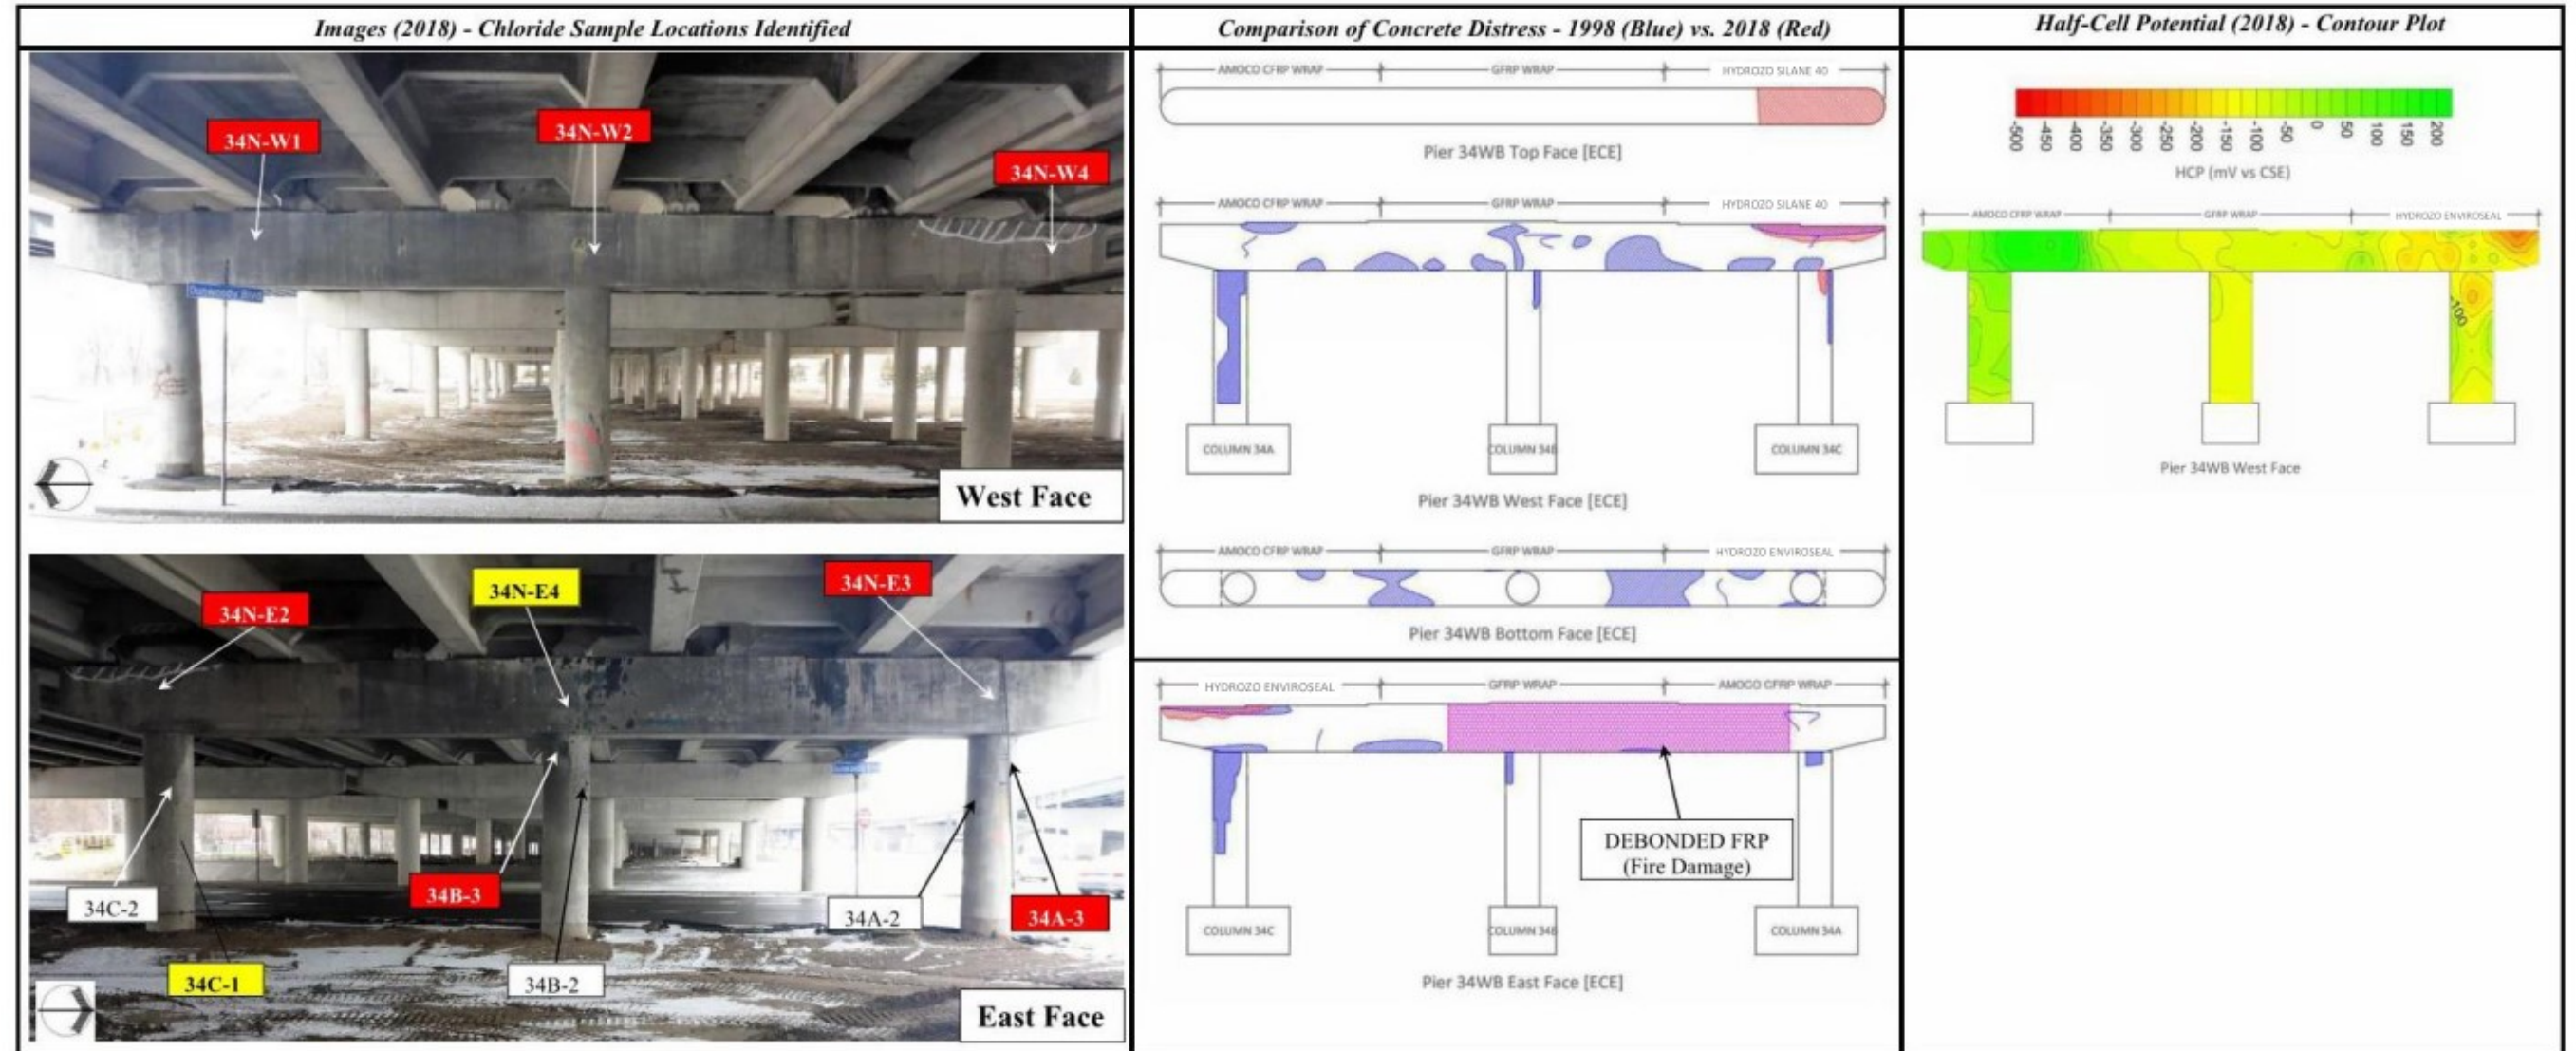
20 Year Review - Comparison of Chloride Content at Depth of Reinforcing Steel (1.5 - 2.5") vs. Corrosion Threshold (0.035% by weight of concrete)

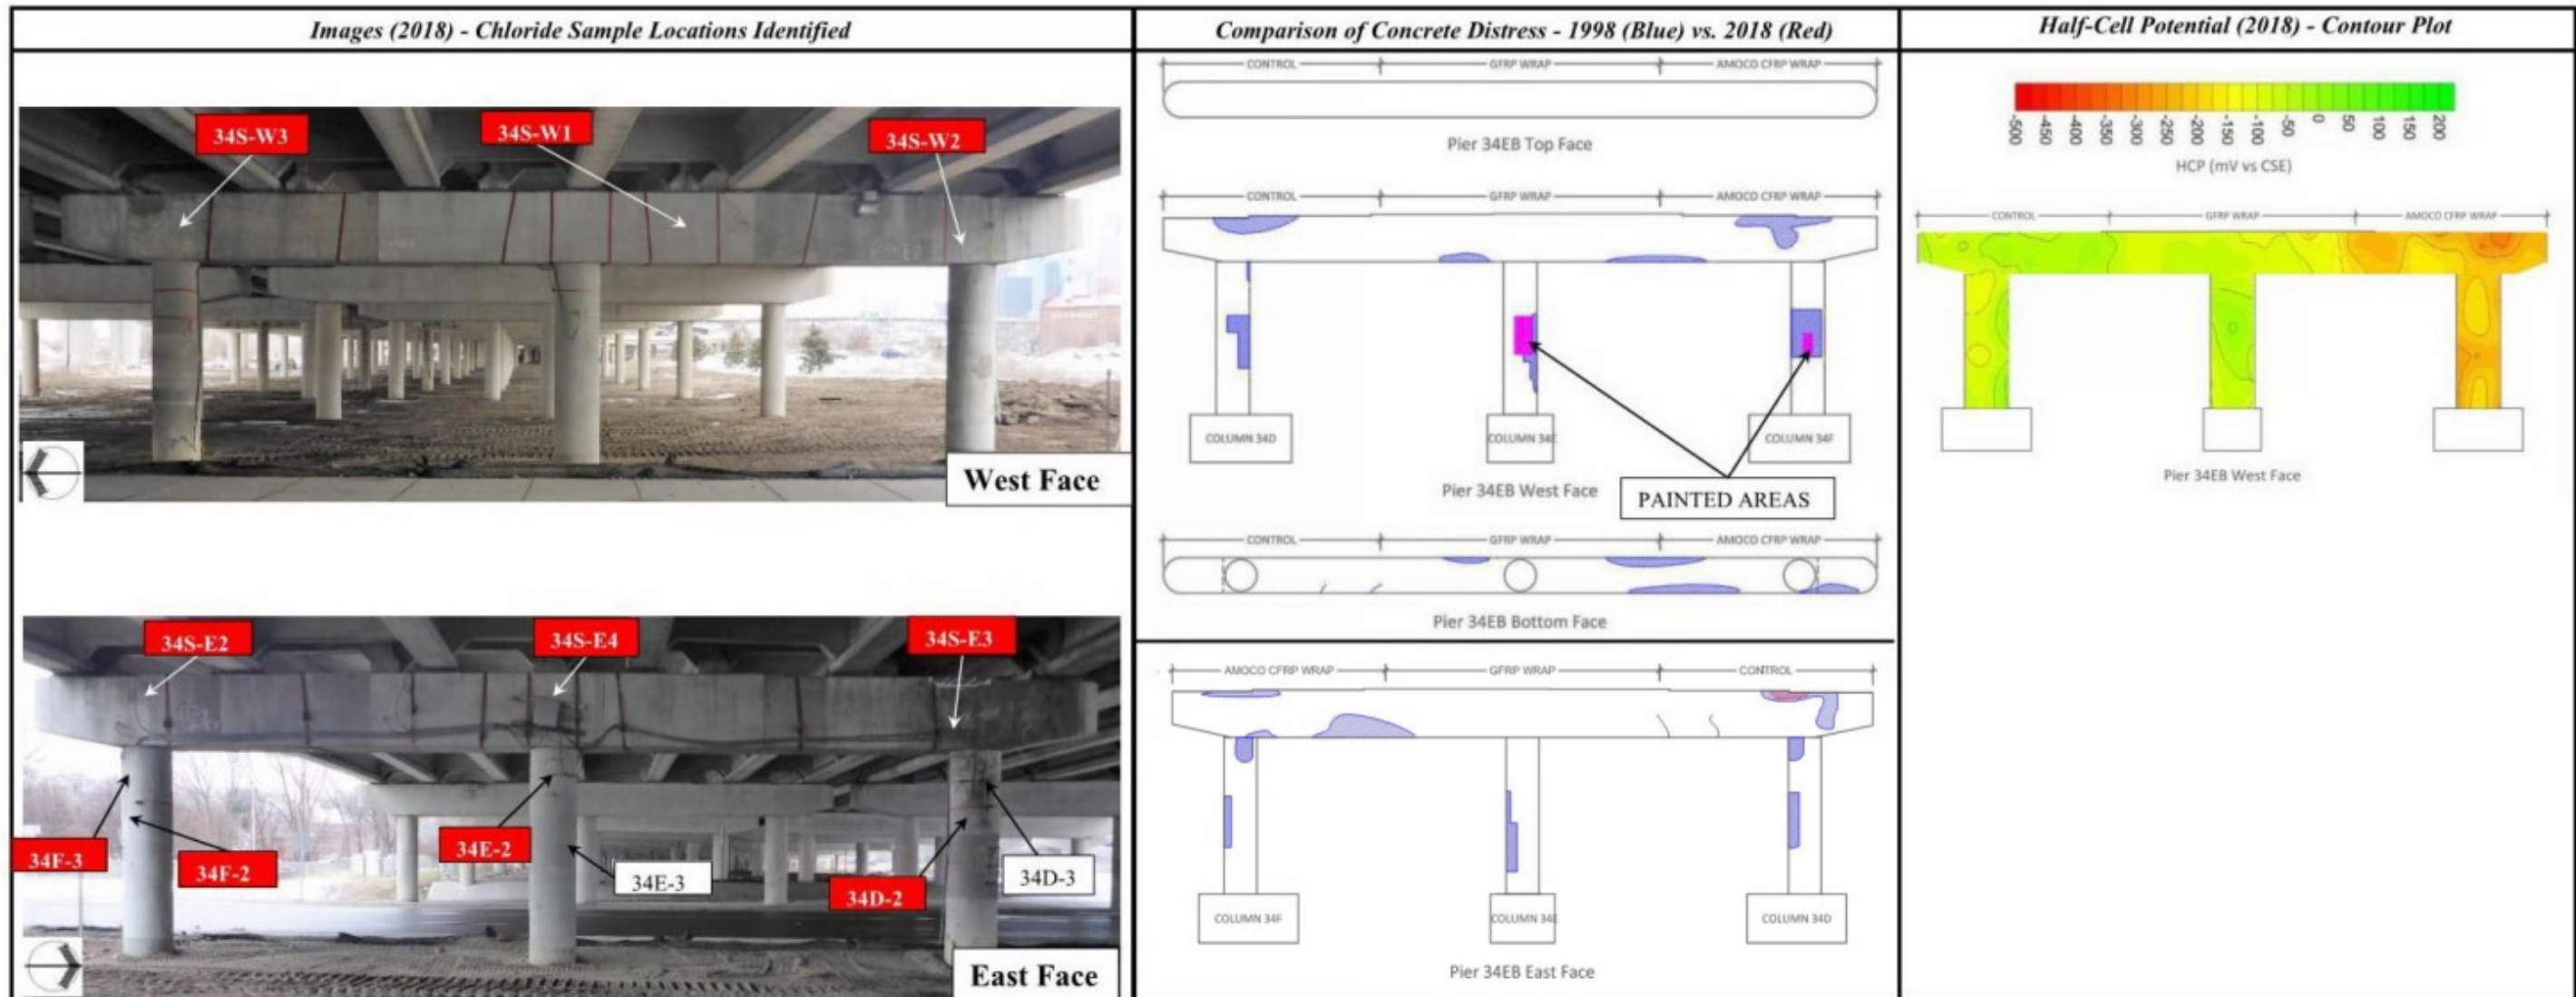
20 Year Review - Comparison of Chloride Content at Depth of Reinforcing Steel (1.5 - 2.5") vs. Corrosion Threshold (0.035% by weight of concrete)
