Evaluation of Electrochemical Chloride Extraction, Fiber Reinforced Polymer Wraps, and Concrete Sealers for Corrosion Mitigation in Reinforced Concrete Bridge Structures

Mark R. Chauvin, Principal Investigator

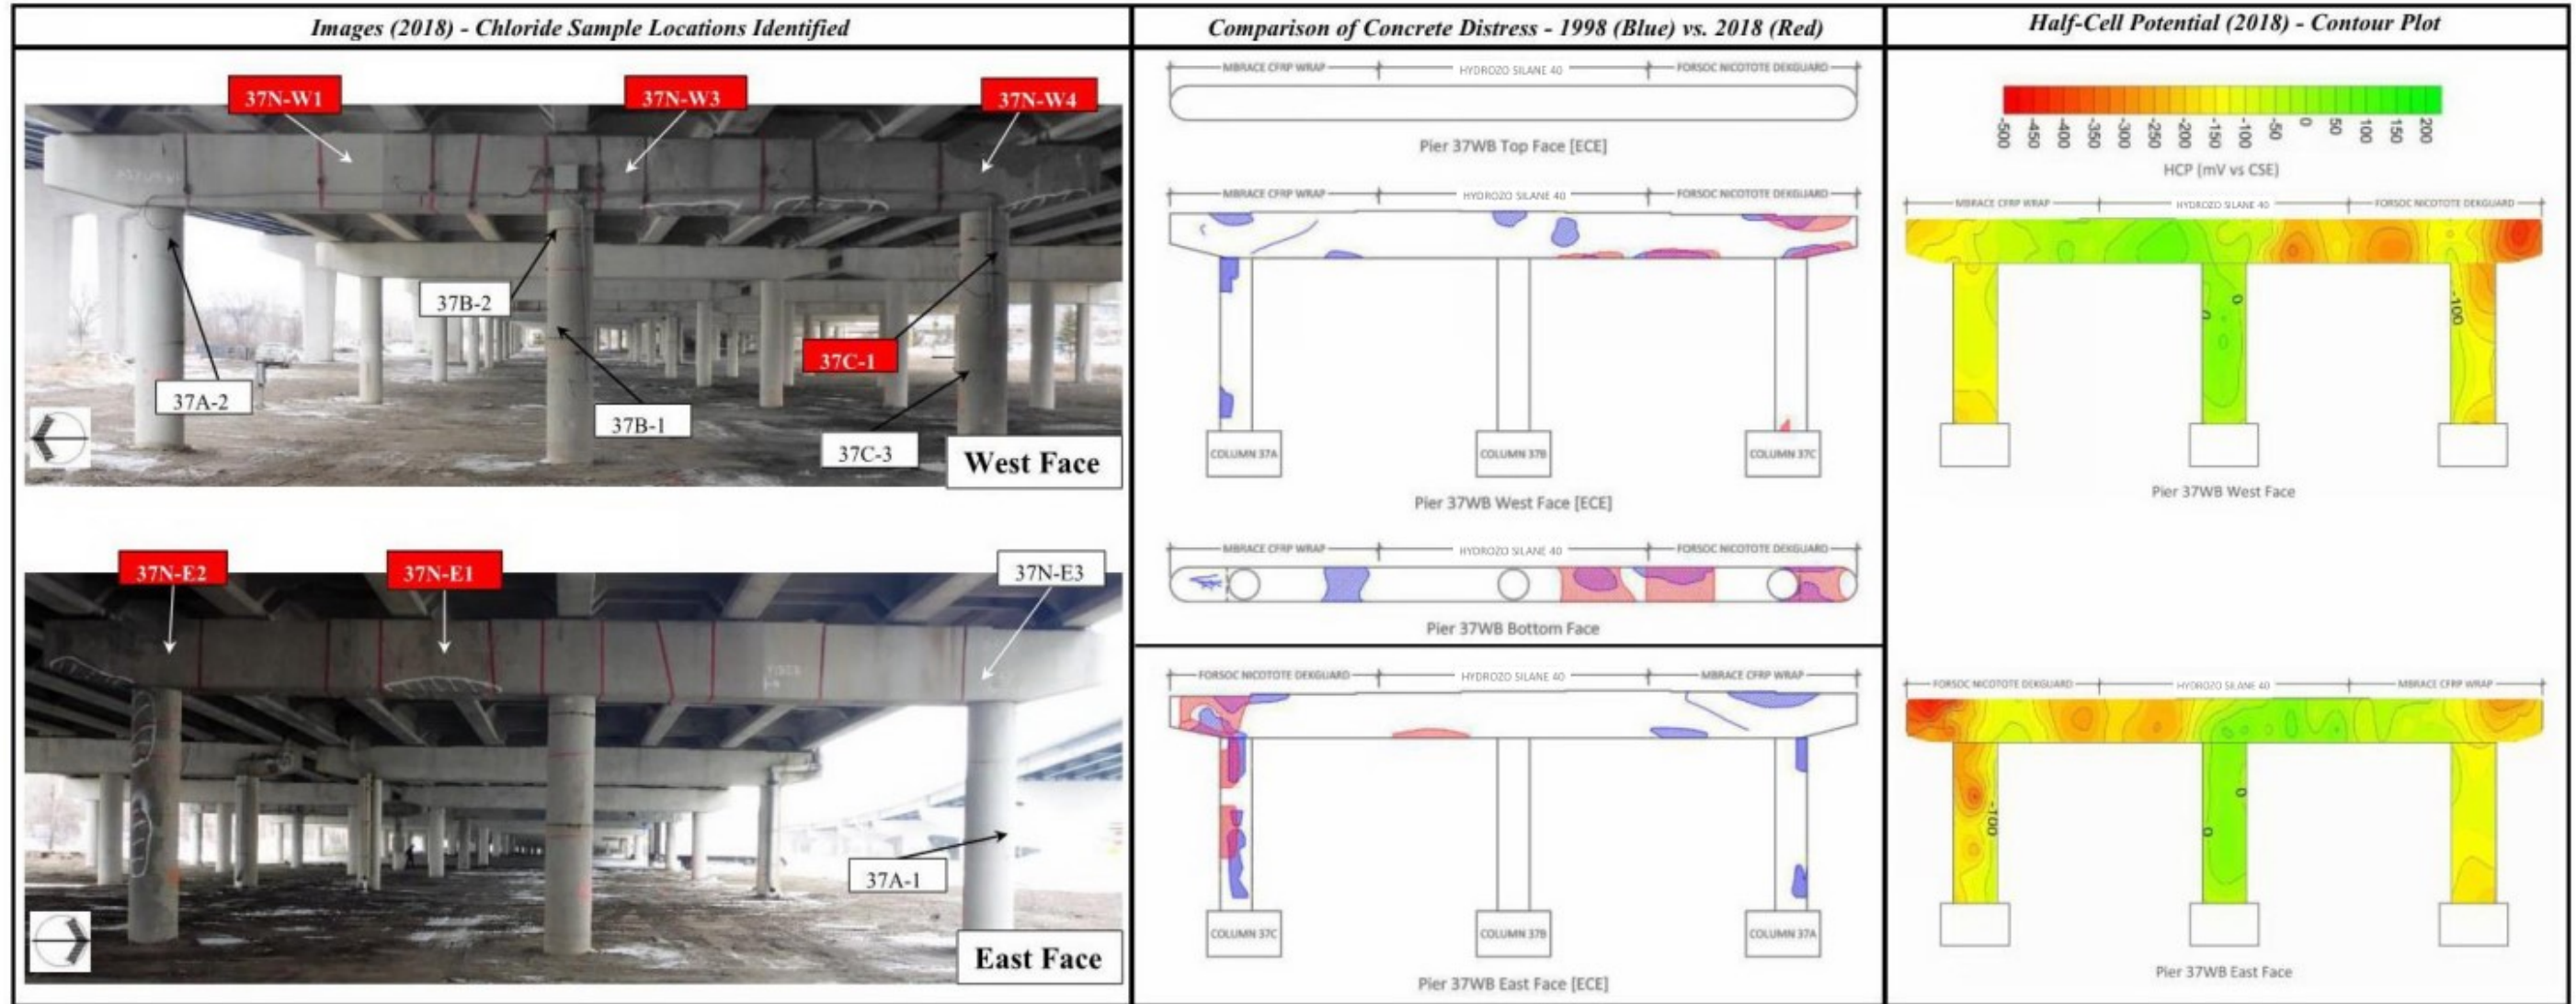
20 Year Review - Comparison of Chloride Content at Depth of Reinforcing Steel (1.5 - 2.5") vs. Corrosion Threshold (0.035% by weight of concrete)

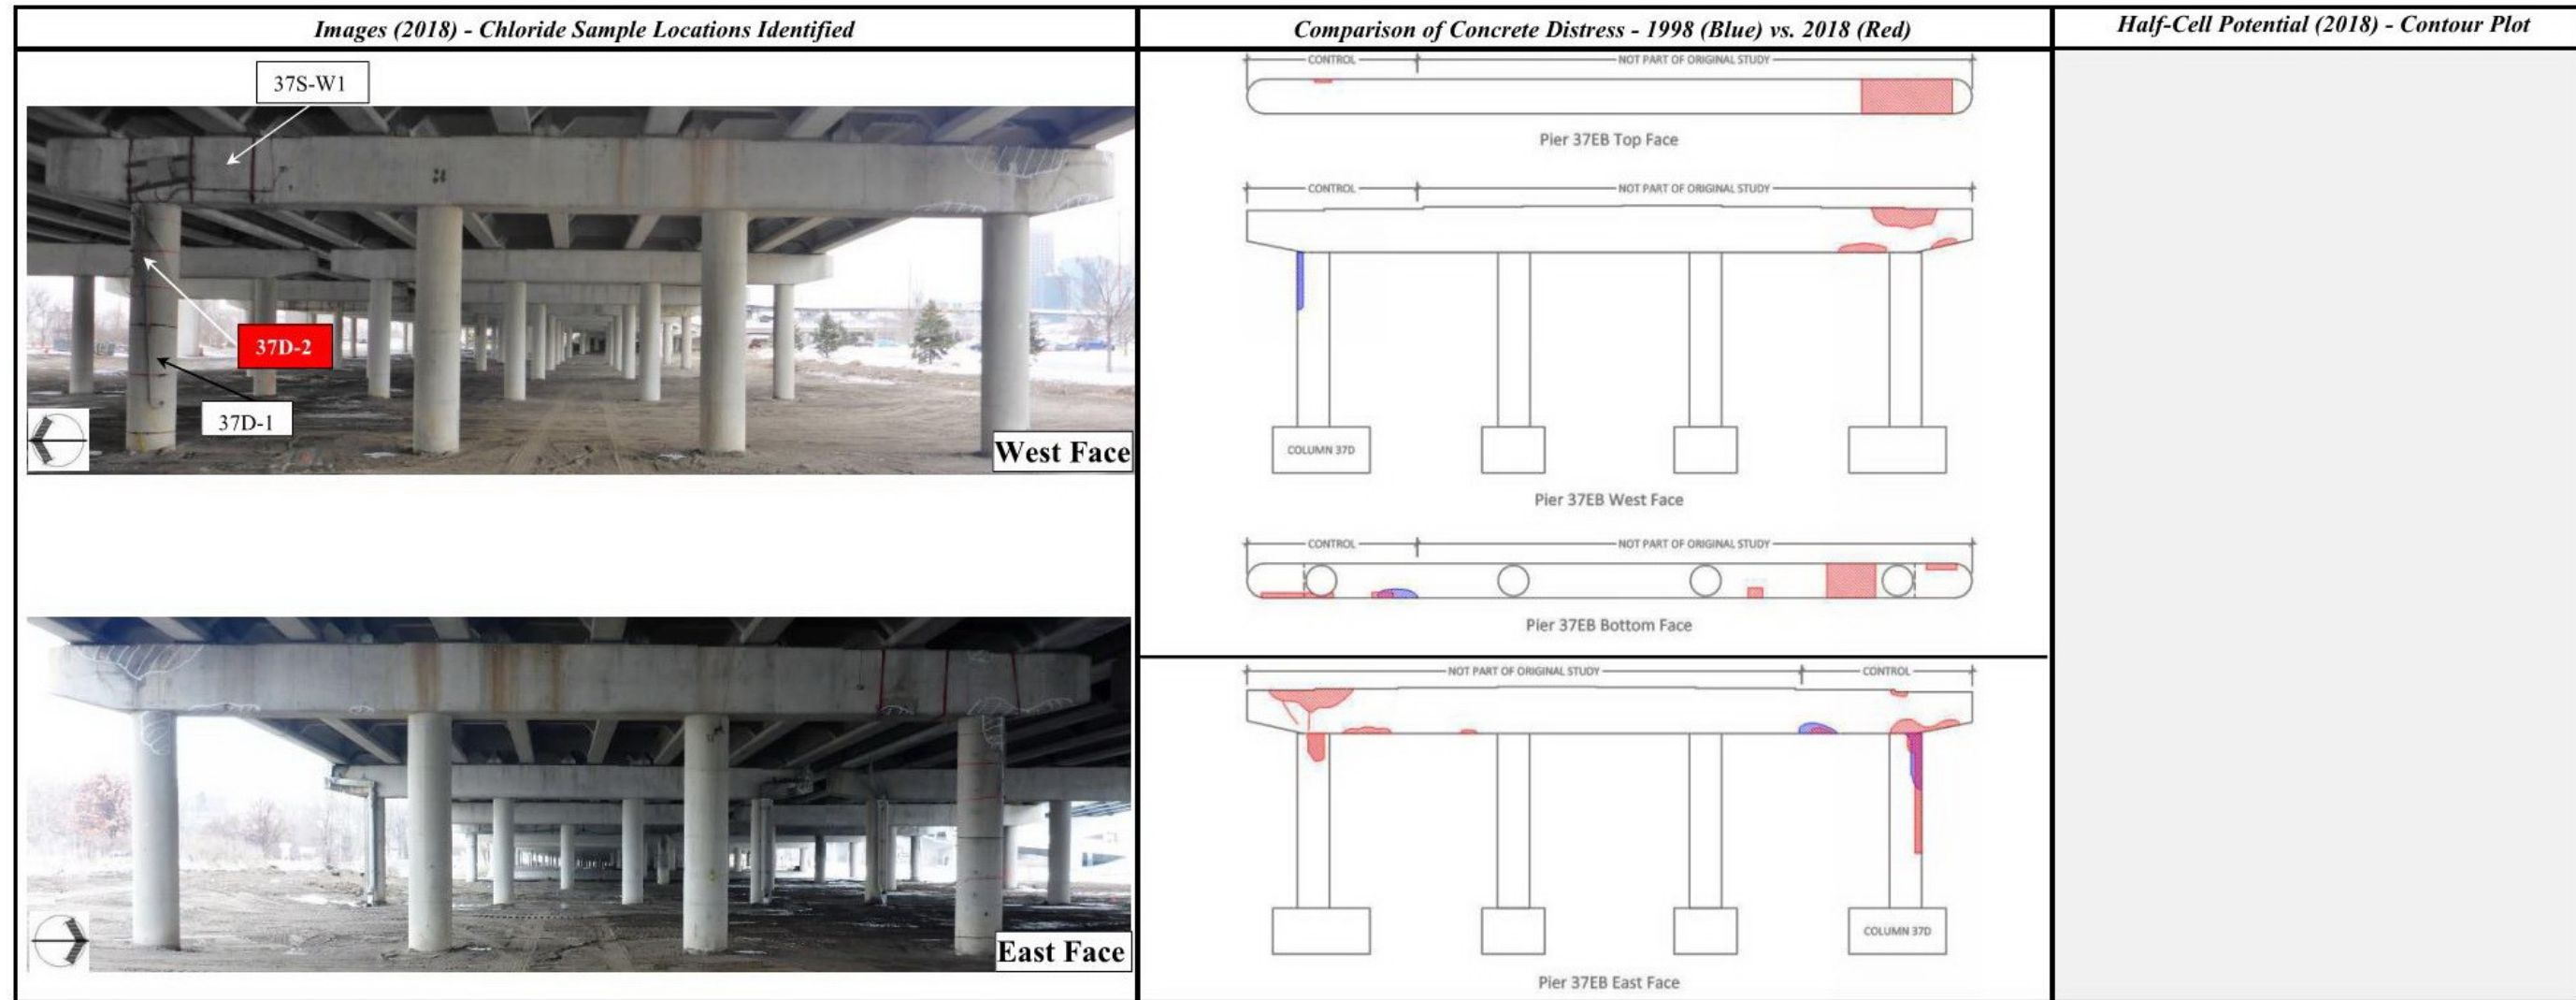
20 Year Review - Comparison of Chloride Content at Depth of Reinforcing Steel (1.5 - 2.5") vs. Corrosion Threshold (0.035% by weight of concrete)

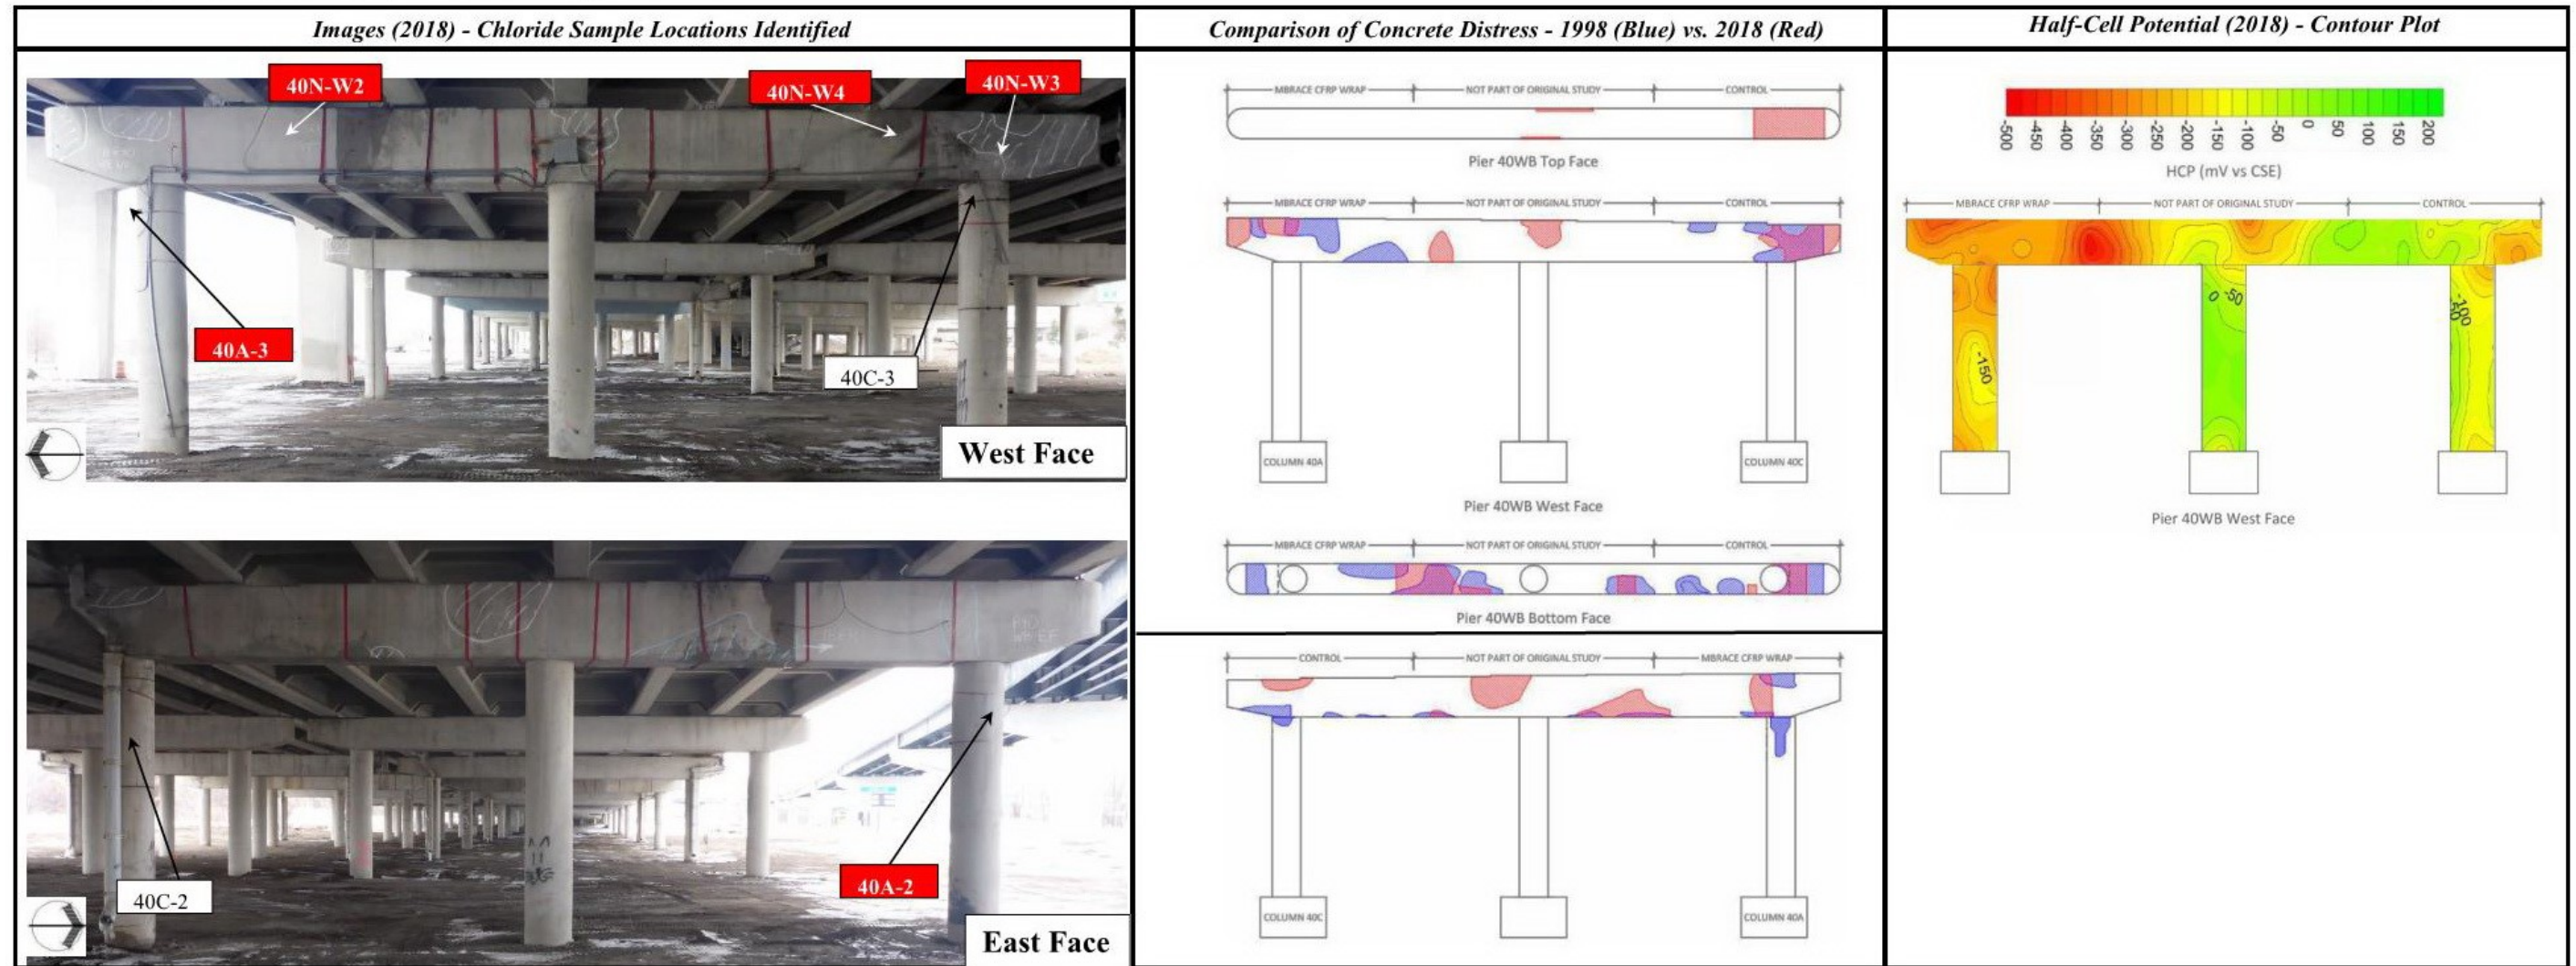
20 Year Review - Comparison of Chloride Content at Depth of Reinforcing Steel (1.5 - 2.5") vs. Corrosion Threshold (0.035% by weight of concrete)

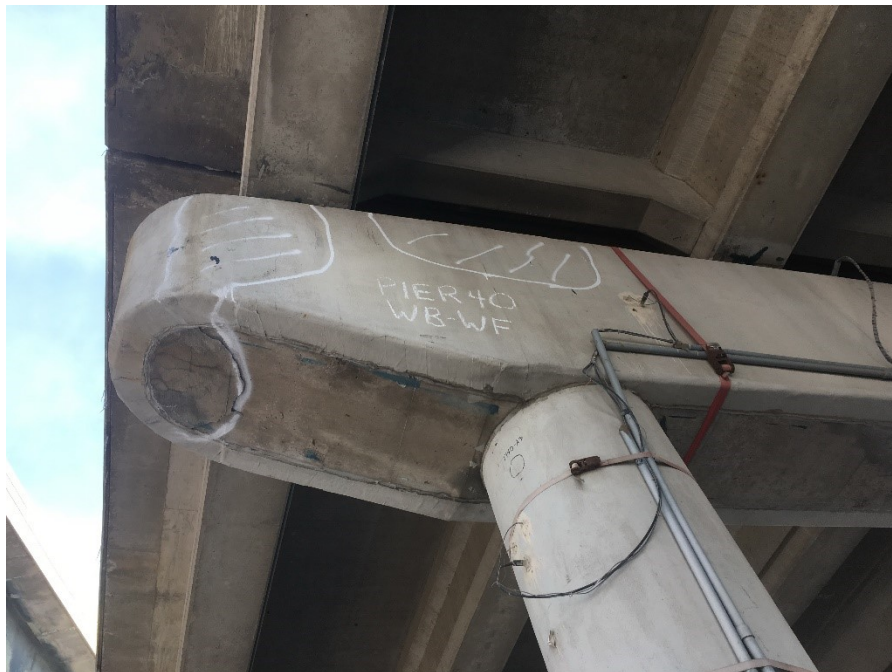
Figure 4.7 Pier 40WB [Non-ECE] - No FRP coverage of bottom pier cap surface (2018)

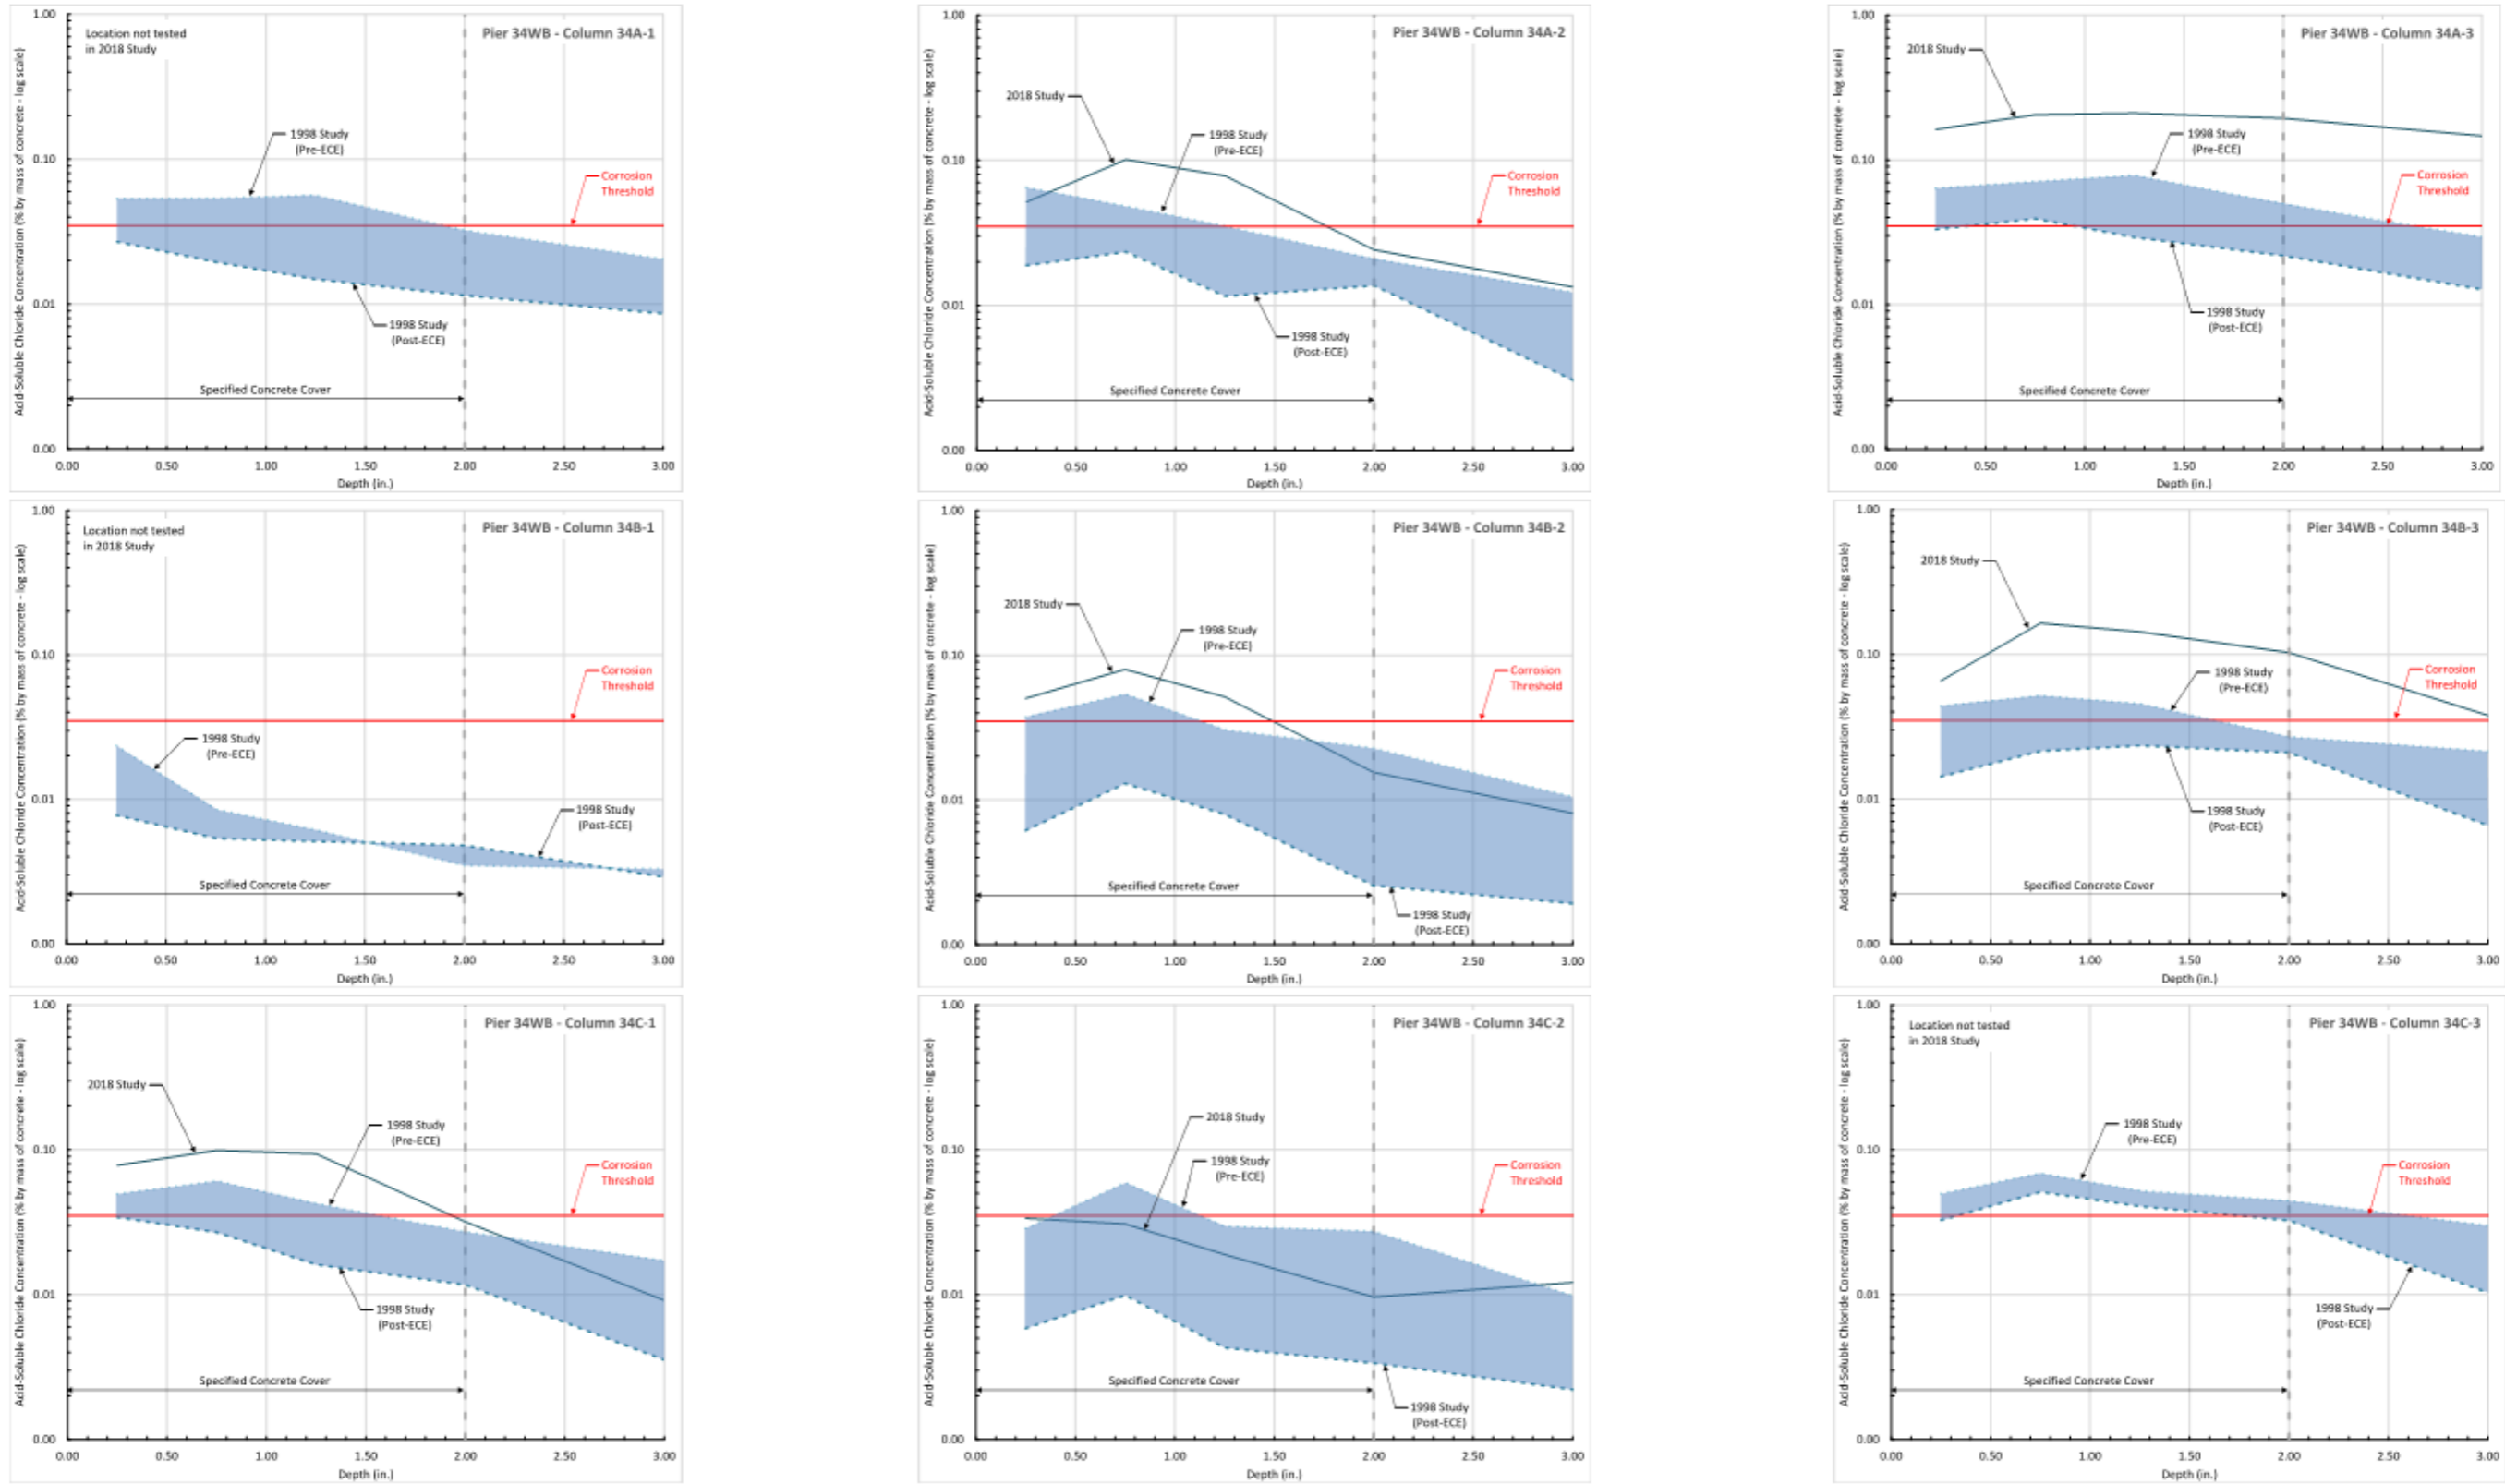
Figure 4.10 Pier 34WB [ECE] - Chloride Profiles - Columns 34A (top), 34B (middle), and 34C (bottom)

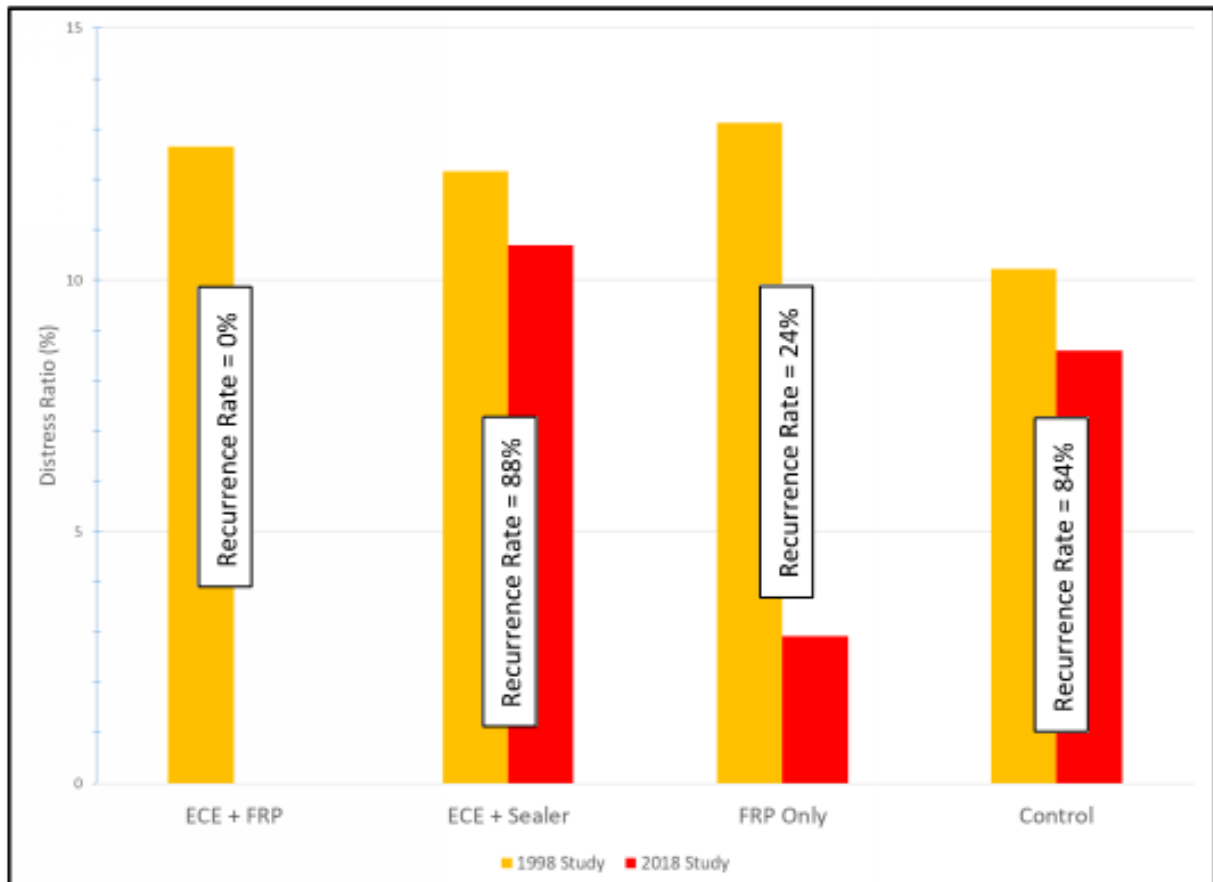
Figure 4.19 Comparison of distress ratio by treatment - 1998 vs. 2018

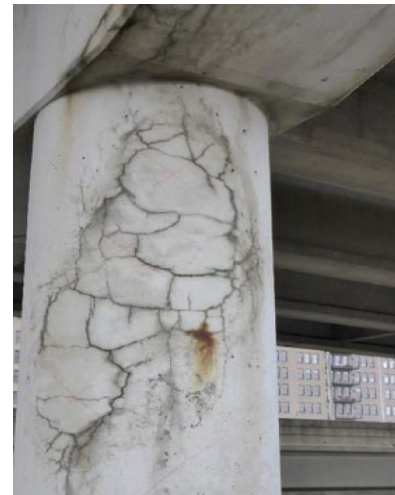
The 1998 bridge study was the only ECE application MnDOT had performed. Today, MnDOT has more history and experience with FRP. This experience includes FRP repairs to concrete bridge girders that sustained impact and, more recently, as a strengthening approach to pier caps and/or as a confining mechanism to concrete repairs where some section loss has occurred. Many recent studies suggest FRP confining pressure significantly slows corrosion even in chloride laden environments [6, 7, 8]. It is believed that reducing the ability of concrete repair shrinkage cracks to appear at the surface, or to be opened further with slight expansive forces, greatly reduces the availability of moisture and oxygen to get at the reinforcing steel, both of which are key components in the corrosion process. Although the

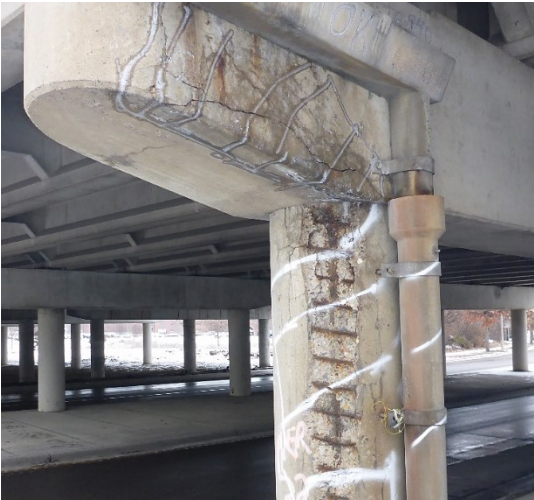
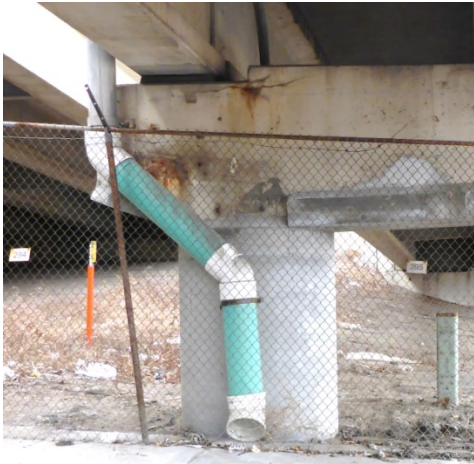
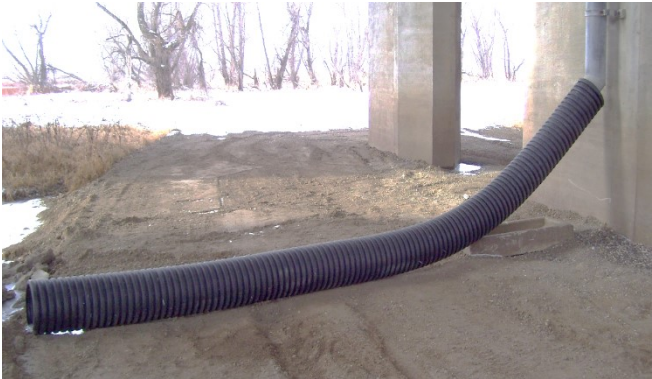
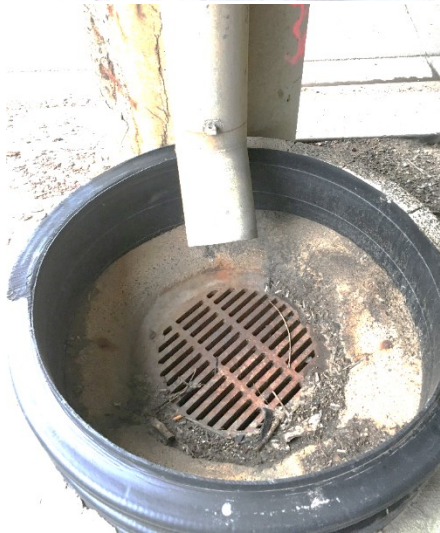
Bridge designers can often be narrowly focused on structural detailing, but greater detail coordination with drainage plans would be a valuable investment in terms of the service life of the structure. Where externally mounted scuppers and downspouts are unavoidable, significantly oversized closed piping systems with more modest elbow bends and cleanouts (upper-right image) are preferred over segmented downspout and trough systems (upper-left image), which offer installation flexibility but typically exhibit poor performance. At ground level, extensions to the downspout in the form of snorkels (bottom left) or large runoff basins (bottom right) are essential to preventing column corrosion.

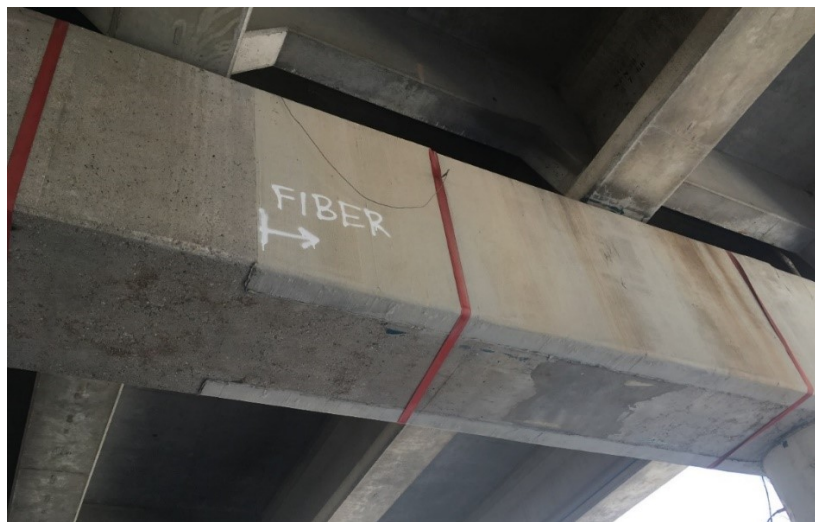
MnDOT proceeded with further trials on FRP enhancement of concrete repairs in 2017 based on industry research. Carbon fiber reinforced polymer (CFRP) was used due to its relatively low cost difference with glass fiber. CFRP also provides a higher strength supplement to compensate for minor reinforcement section loss due to corrosion that inherently caused the initial delamination. In this project, bands of FRP were detailed to confine repair areas at the pier caps. The use of bands was sufficient for strengthening objectives, allowed for potential moisture release between bands, and

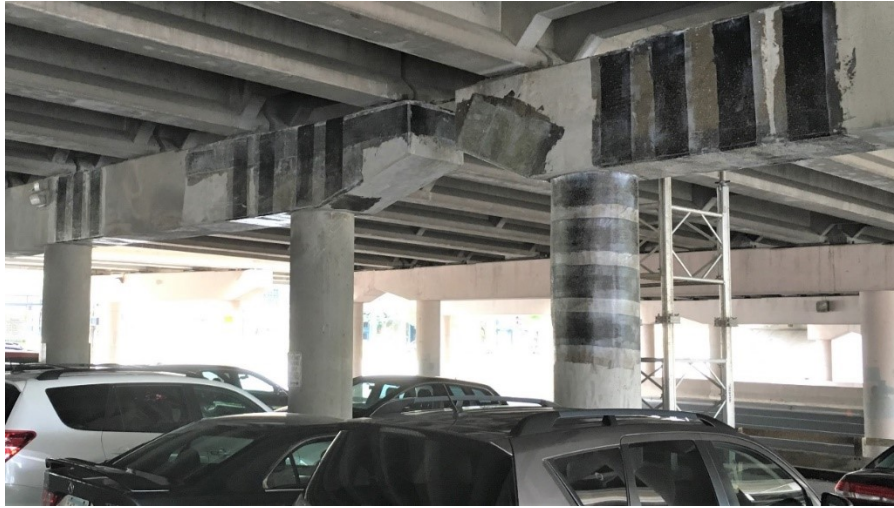
Following installation, the FRP bands and pier and column surfaces were coated over by breathable masonry finishes improving aesthetics to be nearly unobservable.

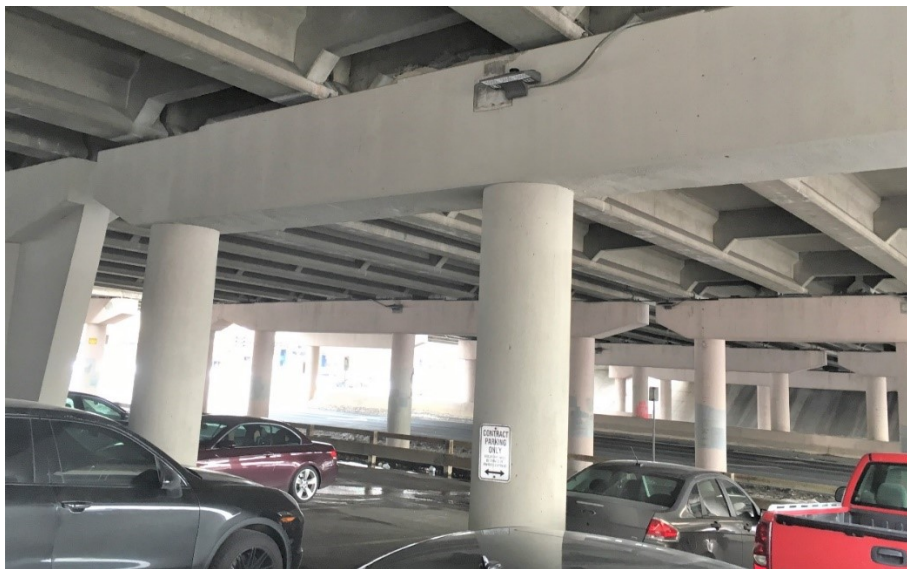
The ECE treatment comes at high construction costs and repair construction duration, at least for the scale of the project under study. From an agency investment perspective, the ECE tool may be applicable to historic concrete bridges where the service life expectation is undefined. For historic bridges, avoiding repeated repairs is of paramount concern because both the project delivery cost and repair cost are significantly more than for non-historic bridges. Historic bridge repairs should utilize strategies that have the most promise of durability and effectiveness to avoid repeat investment.

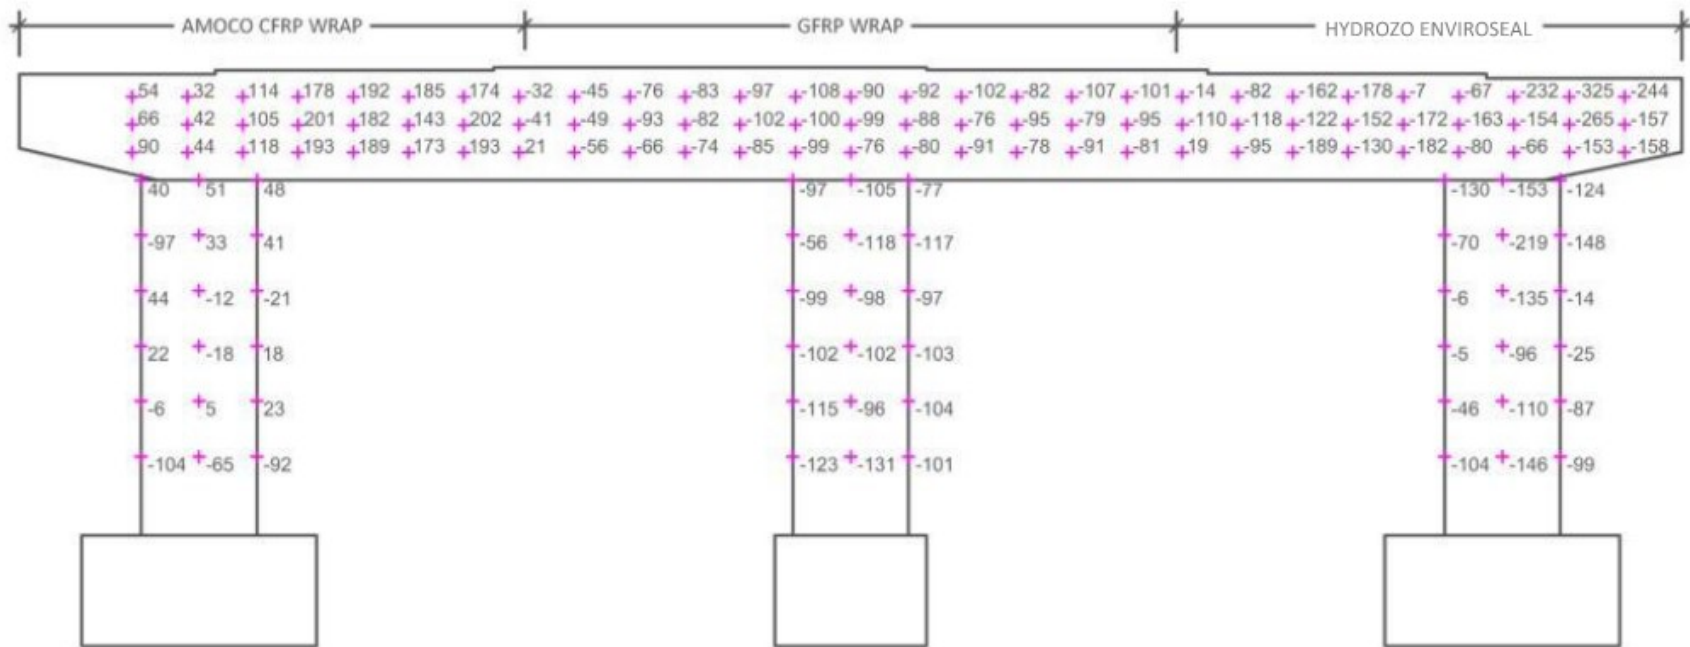
APPENDIX C: CORROSION POTENTIAL DATA - 2018 STUDY

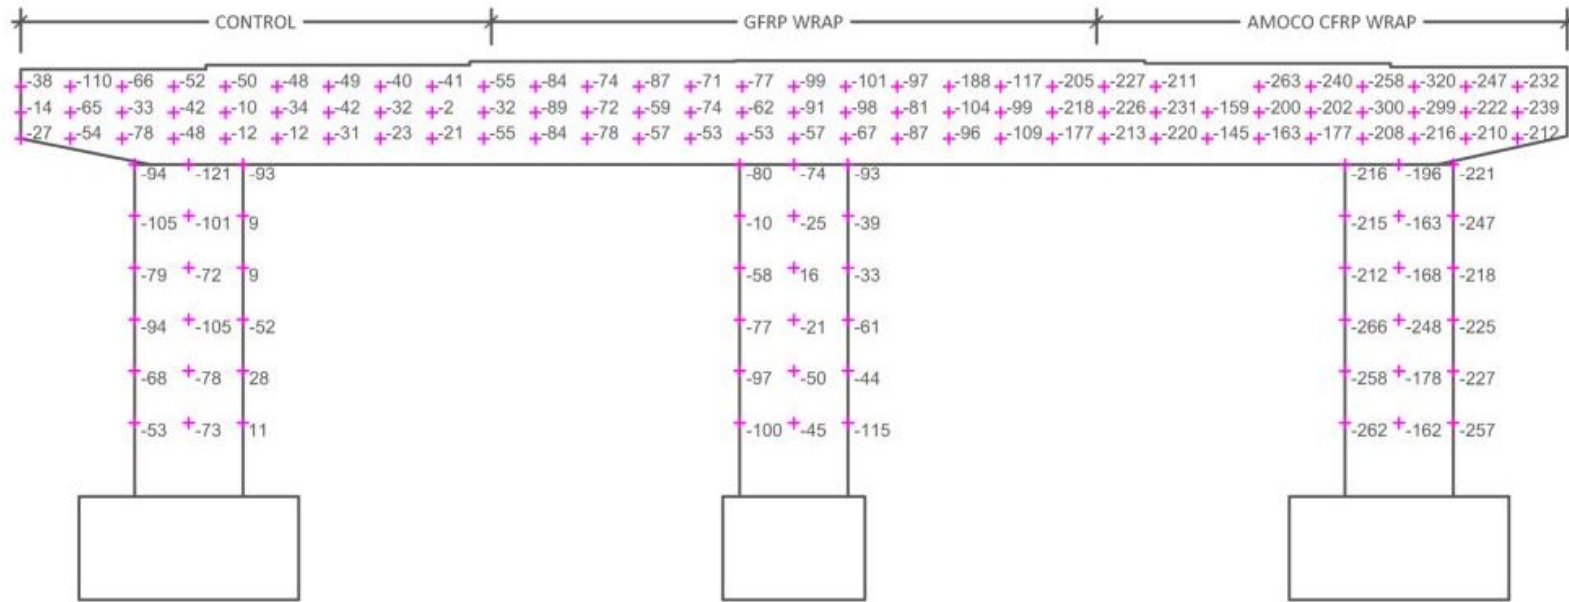
Figure C.1 Corrosion potential measurements (mV vs CSE) for west face of Pier 34WB [ECE].

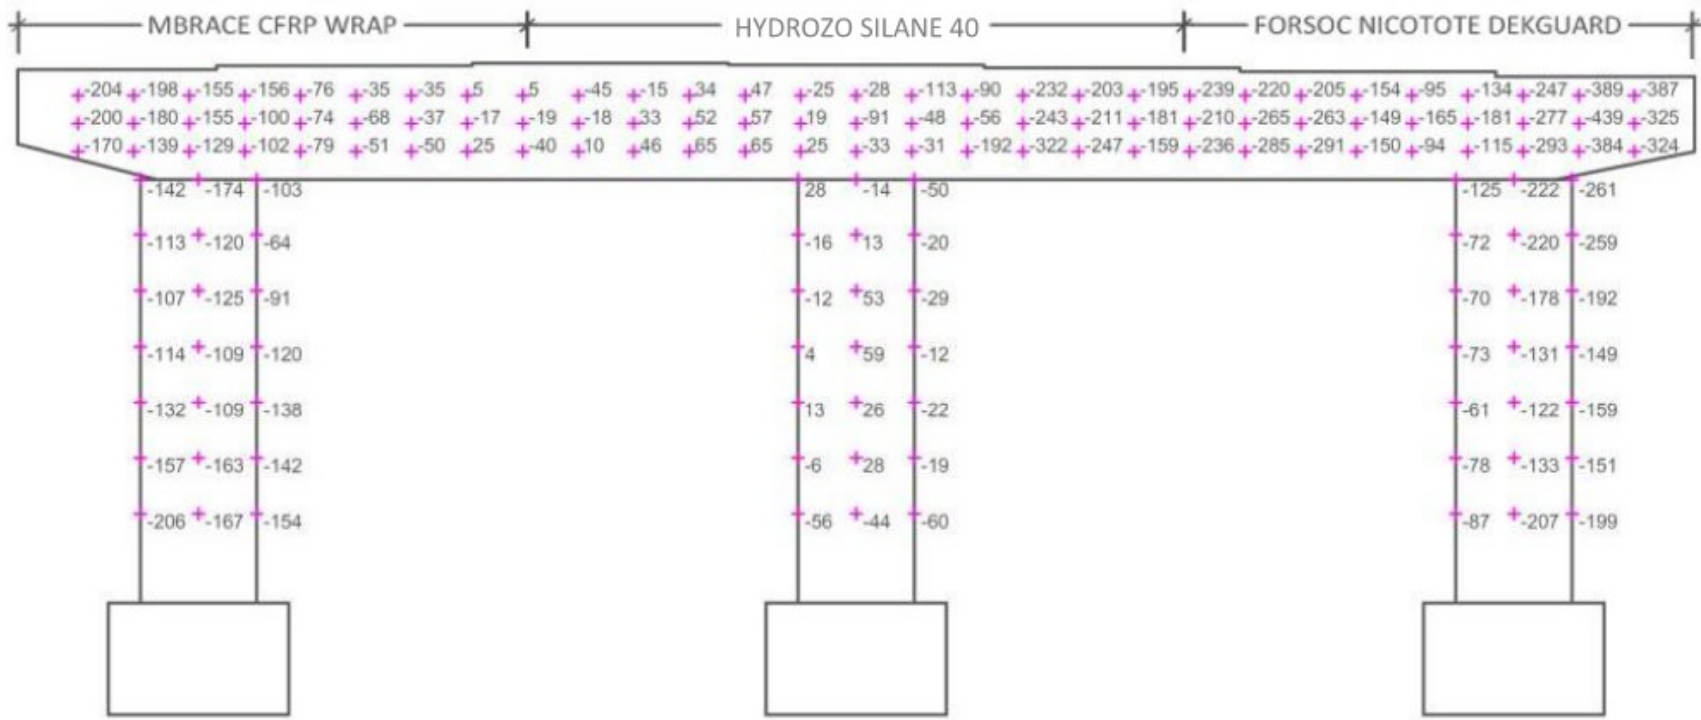
Figure C.2 Corrosion potential measurements (mV vs CSE) for west face of Pier 34EB [non-ECE].

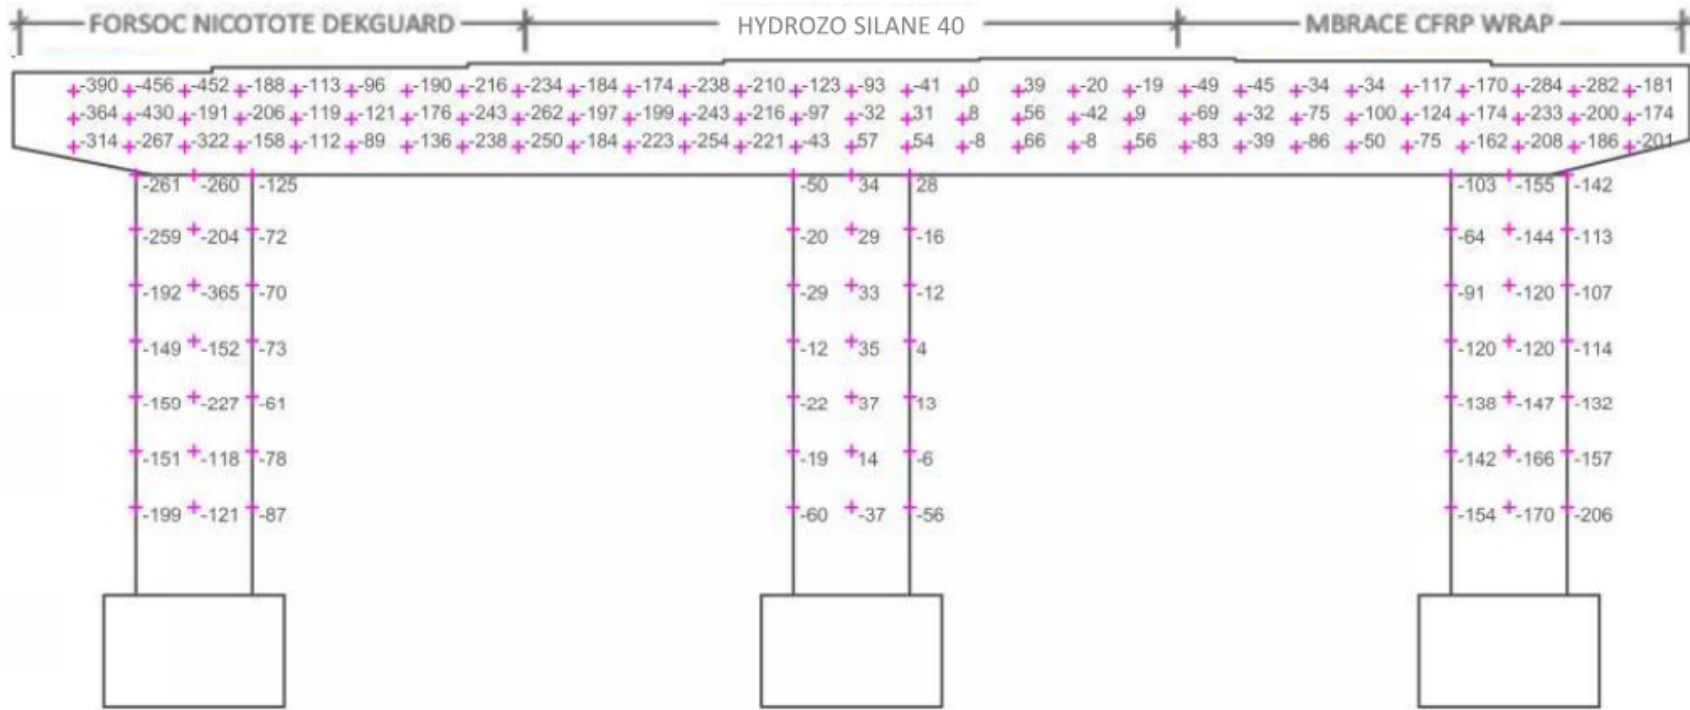
Figure C.3 Corrosion potential measurements (mV vs CSE) for west face of Pier 37WB [ECE].

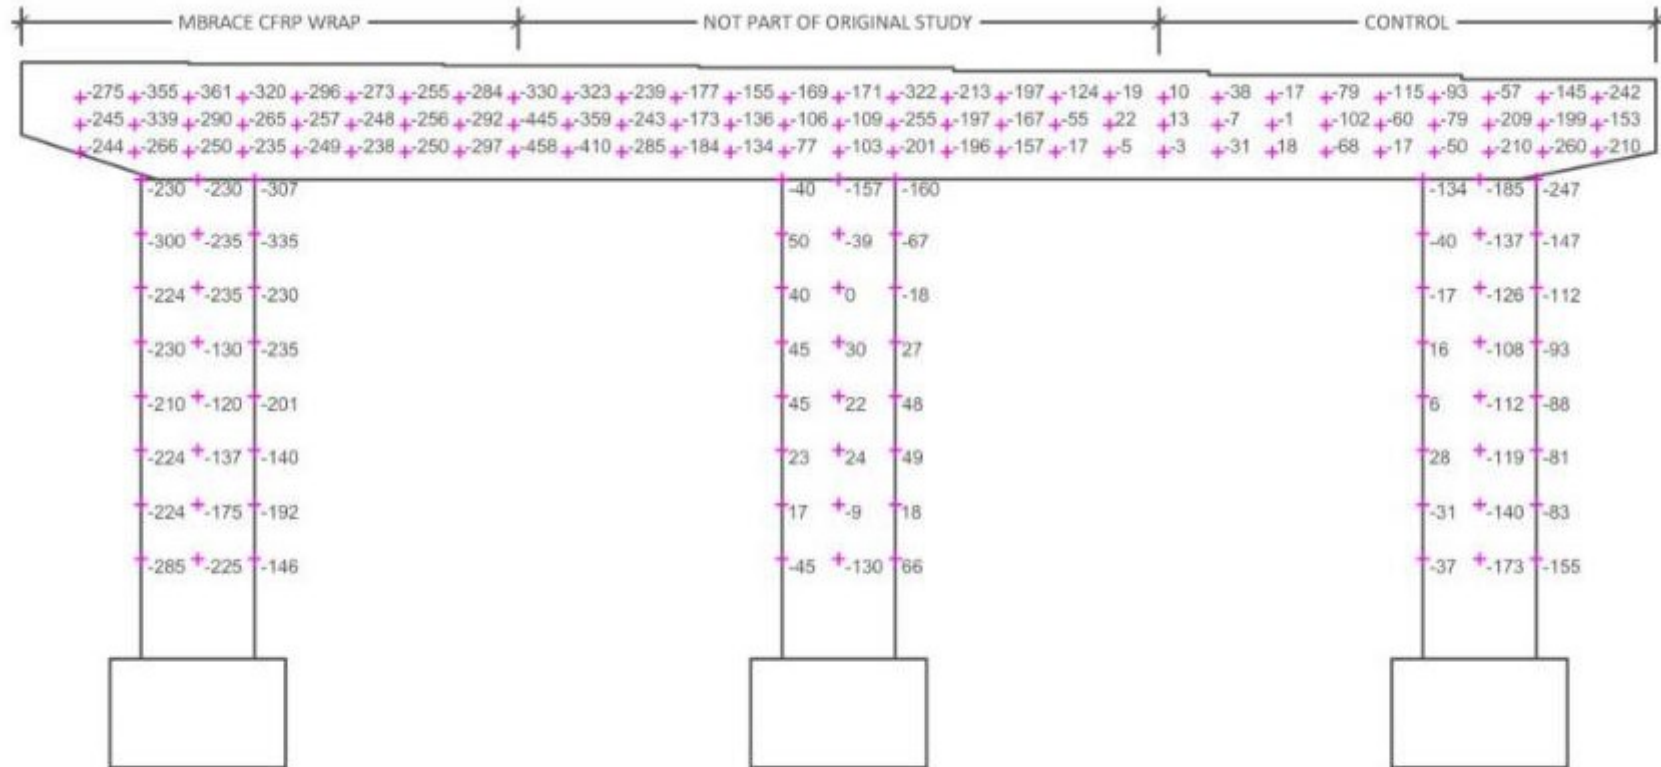
Figure C.4 Corrosion potential measurements (mV vs CSE) for east face of Pier 37WB [ECE].
