# Structures Research Services 2015-2017

## (Task 2 Final Report –Aluminum Truss Overhead Sign Support Flange Damage Assessment)

1. Report No. <b>FHWA/OH-2019-21</b>	2. Government Accession No.	3. Recipient's Catalog No.	
4. Title and Subtitle <b>Structural Engineering Research On-Call Services Task 2 - Aluminum Truss Overhead Sign Support Flange Damage Assessment</b>		5. Report Date (Month and Year) <b>September 2019</b>

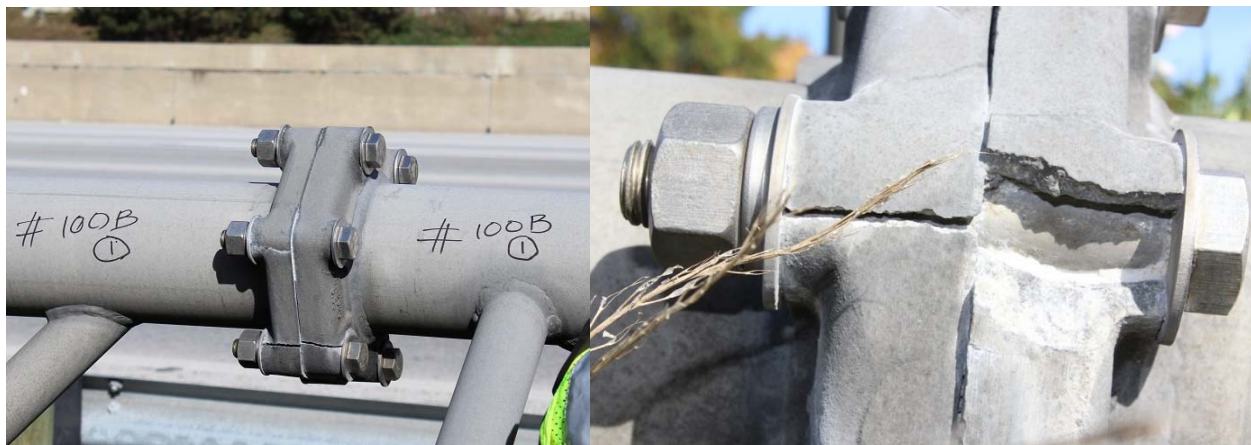
Routine maintenance of overhead signs by ODOT District 12 revealed cracking in the flange connectors for several aluminum support trusses. Figure 1 shows some cracked flanges. All the trusses with cracked flanges had six bolt hexagonal flanges instead of the circular eight bolt flanges shown on the standard drawings. The trusses with severely cracked flanges were immediately taken out of service and placed near the side of the roadway. The removed trusses were visited by the part of the research team in October of 2015 in order to review and catalog the cracked flanges prior to the trusses being cut up into more manageable sizes for removal from the site and future testing. Each flange position in terms of sign placement was recorded in case any of the cracking could be attributed to position based on loading. Documentation of the observations consisted of filling out a form to identify the truss, flange location, and map the cracking. It was noted that all the observed cracking originated at the bolt holes and propagated outward. A total of seven truss sections, approximately 12 feet long were delivered to Ohio University during November for future evaluation. The trusses were estimated to have been in service since the late 1970's.

**Figure 1: Typical Cracking (left) and Severe Cracking (right)**

At the level of investigation carried out, the hypothesis was confirmed. Evidence of galvanic corrosion between the stainless-steel bolt and washer and the aluminum flange was observed. The corrosion product was an aluminum oxide. Stress corrosion cracking was observed near the bolt. Ductile cracking on the outer surface was part of the evidence the stress corrosion cracking was localized near the bolt.

This leads to a postulated failure mechanism. Galvanic corrosion led to a reduction in density and strength of the aluminum, the anodic metal, and the initiation of stress corrosion cracking. The combination of section loss and stress corrosion cracking on the inner surface of the bolt hole combined with the cyclic loading of wind and truck's induced gusts caused the flanges to crack. The cracks propagated from the inner surface of the bolt hole to the outer surface.

- Remove one of the factors that contributes to galvanic corrosion (bimetallic joint, environment or electrolyte).
- The technique chosen depends on the number of cracks and their size. Some of the following are suggested:
  - If no cracking is visible and no mitigation measures have been carried out, coat the joint to eliminate the electrolyte
  - If moderate cracking and there are no mitigation measures, coat the joint to eliminate the electrolyte and shorten the inspection interval.
  - If extensive cracking, put a mechanical jacket on the joint and take steps to arrest corrosion.

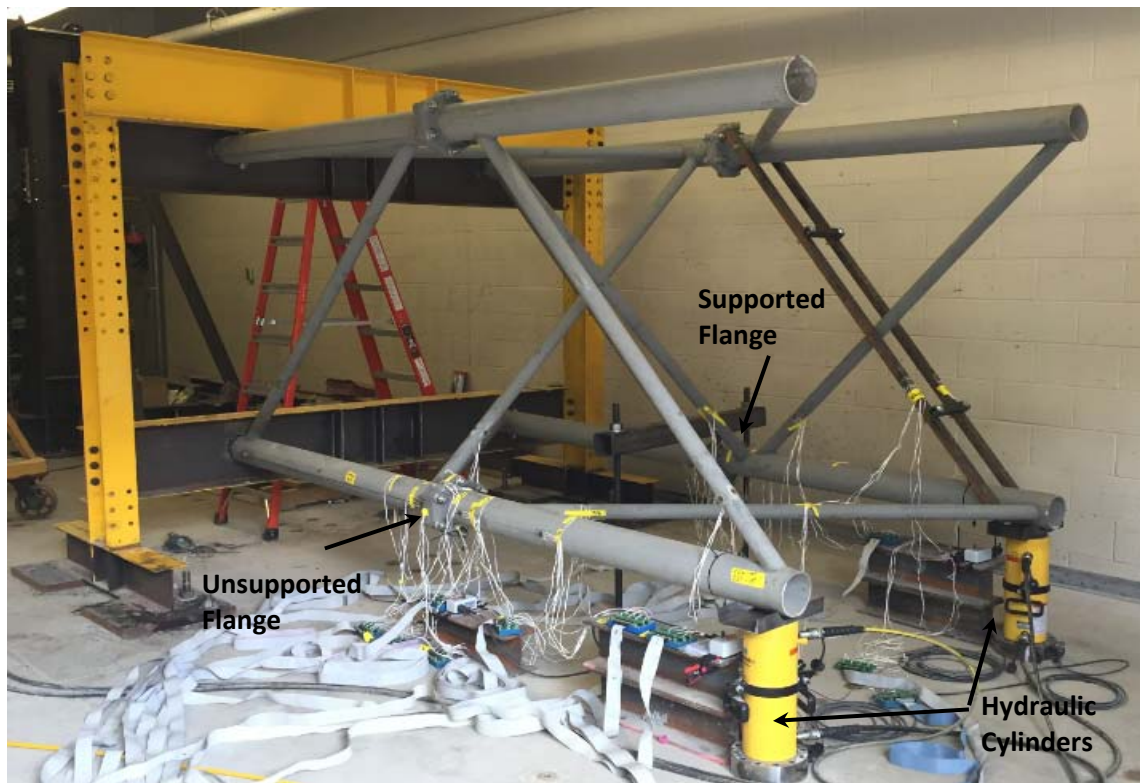
Once the analytical studies were completed, the actual testing was performed in a manner as close as possible to the analytical modeling. Figure 2 shows the test set up for the truss section. Note that the two bottom flanges were the primary test flanges as these flanges were primarily subjected to tension. To produce the results of the section modeling, the flange near the wall was supported. A variety of instrumentation was installed on the truss sections that were tested to measure deformations, strains, and the applied load from hydraulic cylinders.

Truss 100 section Joint B was the first section to be tested. This truss was originally located over East bound IR 480 at mile marker 17.6. The truss was chosen for testing because of the high overall Joint Damage Index. The tested flanges had damage indices of 11 which were slightly higher than average. The truss was positioned for testing by placing the back bottom flange in the support flange location and the top back flange in the unsupported flange position. Both cylinders reached the 10,000 lbs that was determined from the analytical modeling. No failure was observed in either of the bottom joints.

Figure 2: Truss Section Test
