Testing and Recommended Practices to Improve Nurse Tank Safety: Phase IV

U.S. Department of Transportation
Federal Motor Carrier Safety Administration

June 2022

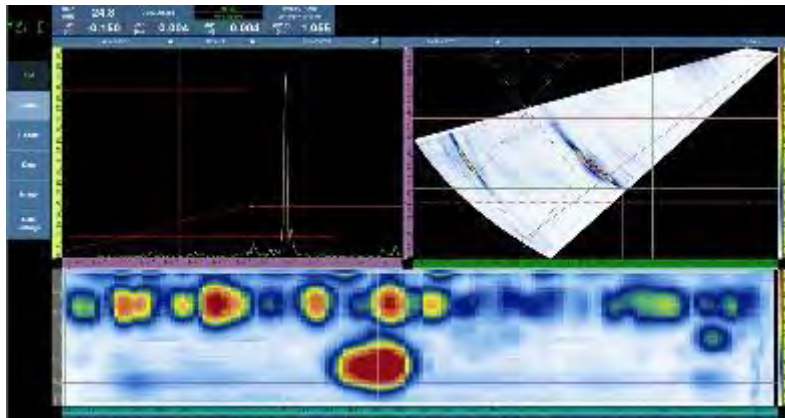
Figure 4. Screen. Output of a PA transducer.

Figure 4 shows an example output from a PA transducer. The weld line is shown at the top. Two cracks are seen, one severe (red, near the center of the image) and a smaller crack (green, right side of the image).

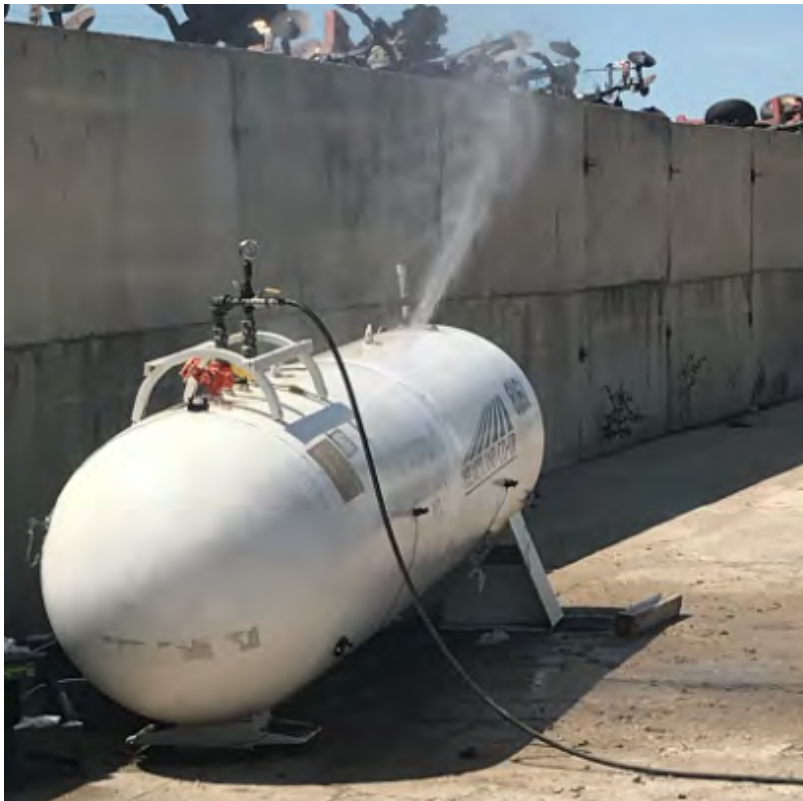
Figure 21. Photograph. Tank #8161 tested to failure.

When pressurized, the tank initially started leaking around the valve weld for the emergency pressure relief valve at the top of the tank. The pressure was dropped back to atmosphere, the leaking valve weld was reinforced with additional weld material. During the second pressurization of the tank, failure occurred along the center circumferential shell weld (as shown in Figure 21).

Surprisingly, no leaking was seen at any of the 20 possible points flagged by the pre-hydro PA test. It is unknown exactly how high the pressure was in the tank when failure occurred, since all

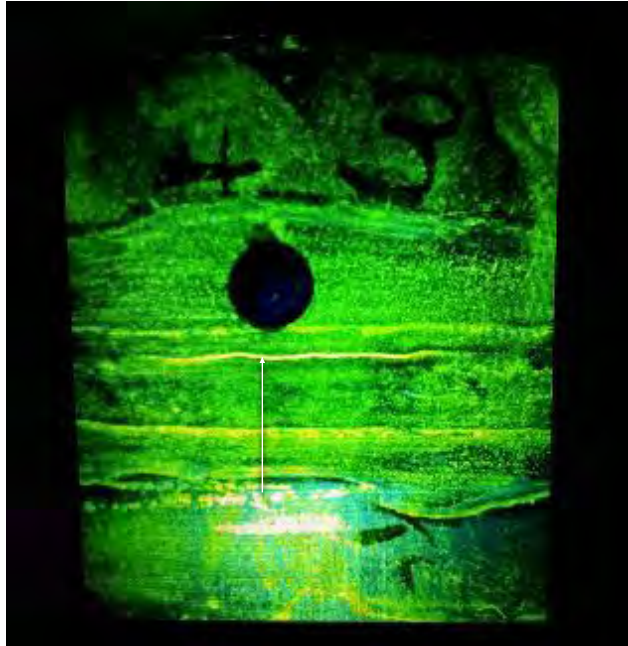
Figure 31. Image. MP results from nurse tank #8161 - Section 3 showing through-crack (indicated by an arrow) that resulted from overpressure.

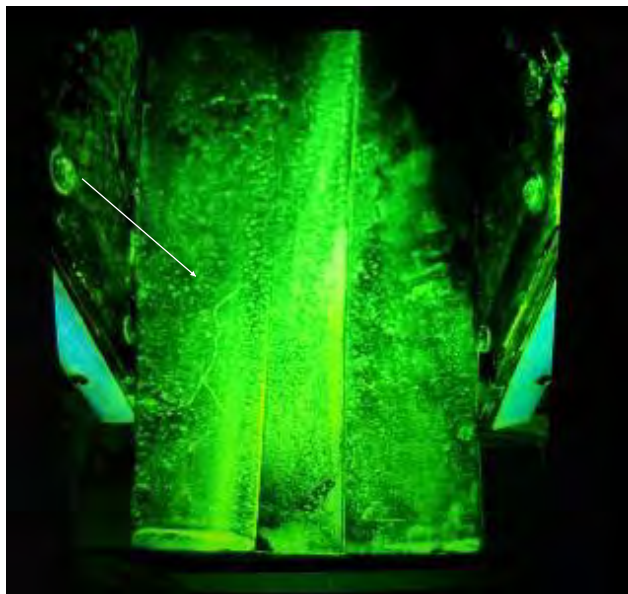
Figure 32. Image. MP results from nurse tank #8161 - Crack found in section 4 (indicated by an arrow).

The inability of MP to detect any of the other cracks flagged by PA is expected, given the presence of a joggle in these particular welds. Any cracks that exist below the joggle could not be imaged, and all of the cracks detected by PA were small and located within the joggle area.

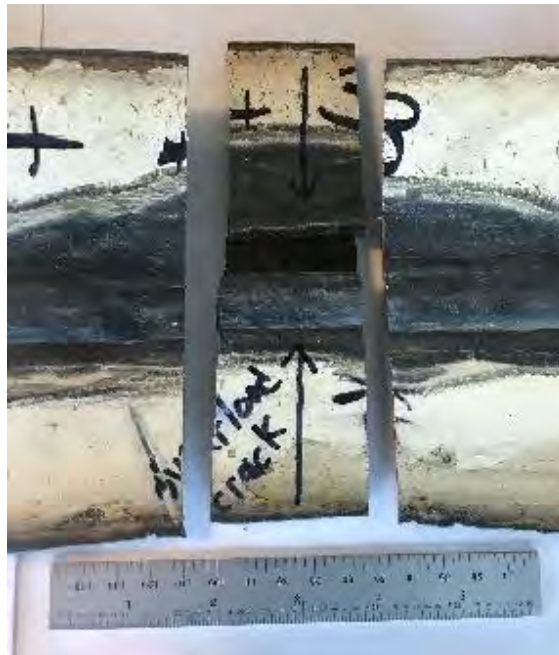
Figure 33. Photograph. Sectioned pieces from section 3 with through-crack and AE indications.

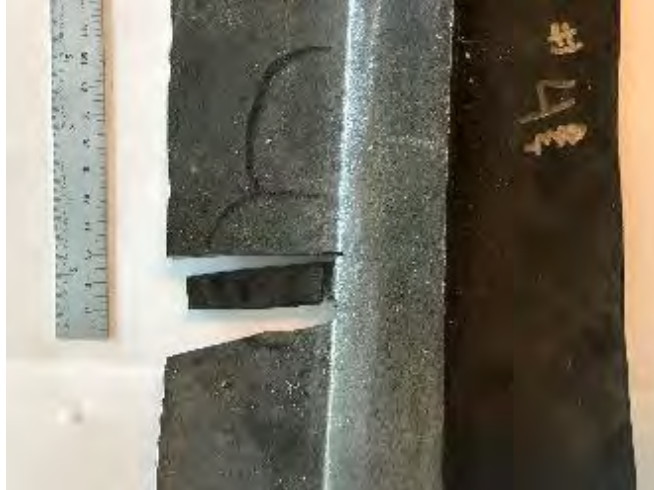
Figure 34. Photograph. Sectioned pieces from section 4 with AE and MP indications.

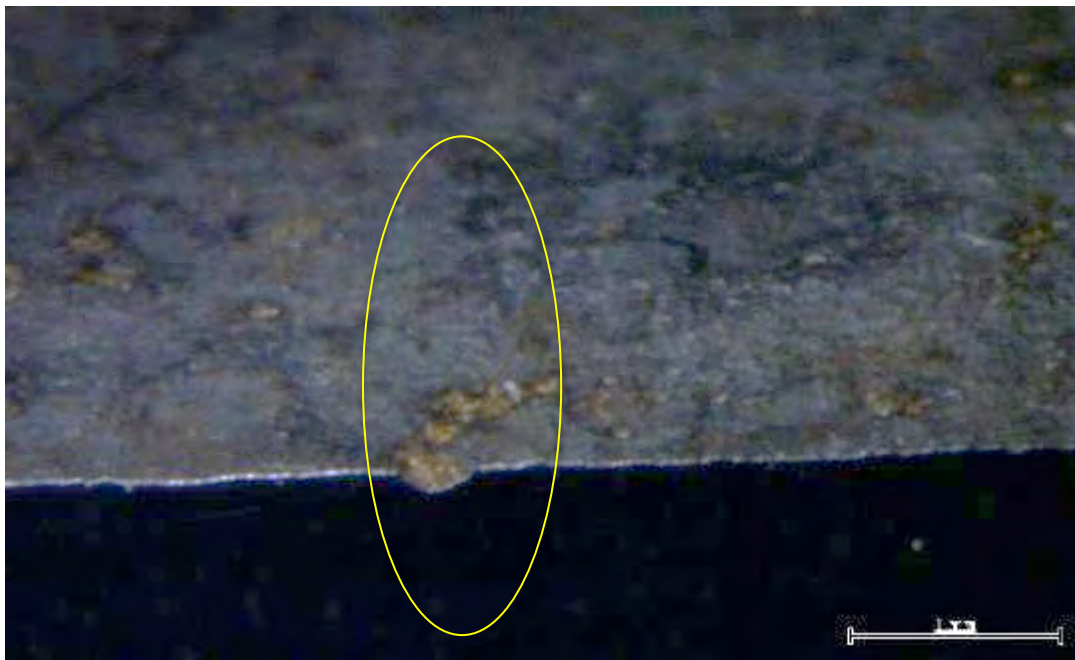
Figure 35 and Figure 36 show images obtained from the section 4 region where MP inspection indicated a crack. Despite polishing the sample in cross-section and etching, no clear sign of any type of crack was seen. A depressed region was seen on the surface of the piece. It is possible that this was responsible for the signal, or a crack does exist that is yet to be detected.

Figure 35. Image. Stereographic image of region of MP indication on section 4.

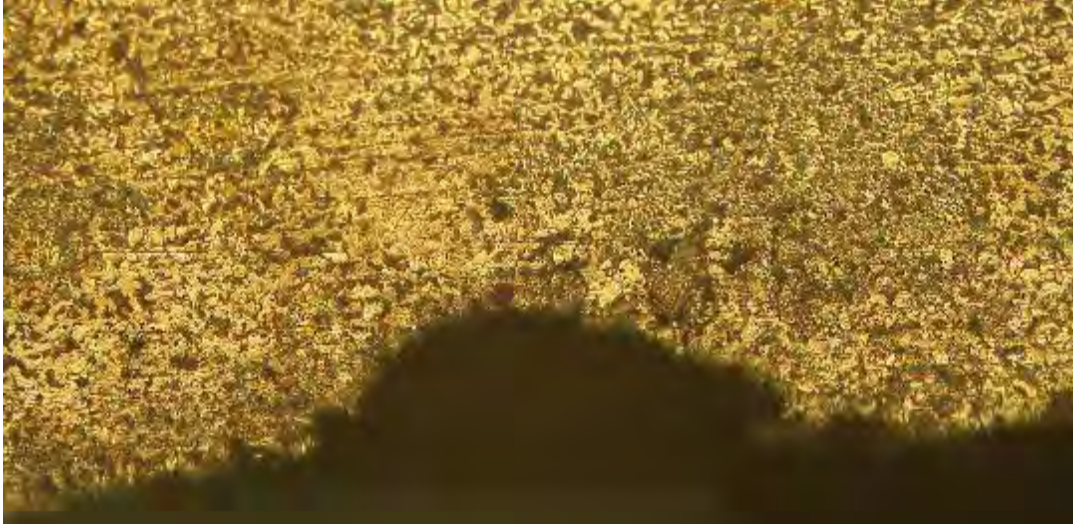
Figure 36. Image. Optical microscopy view of cross section across the region of the MP crack indication.

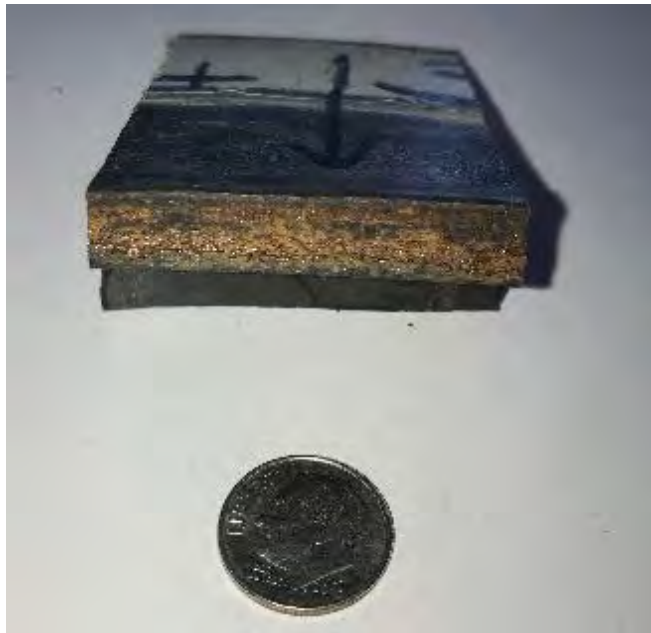
The cross-sectioned sample obtained from the through-crack located in section 3 is shown in macroscopic view in Figure 37 and in stereoscopic view in Figure 38. The section was covered with a large amount of oxidation products from the failure during the hydro test and had to be cleaned. Even after cleaning, a considerable amount of oxidation remained.

Figure 37. Photograph. Macroscopic view of section 3 through-crack.

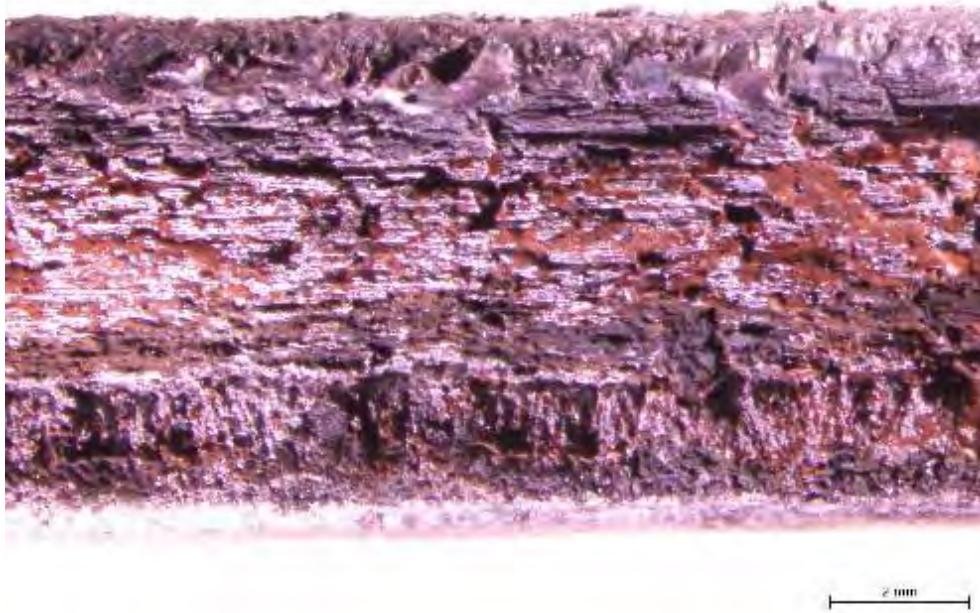
Figure 38. Image. Stereoscopic view of section 3 through-crack.

The fracture surface was extremely rough, indicative of macroscopic ductile failure, as would be expected in an overload condition. The obvious texturing seen macroscopically appeared related to the welds and the solidification microstructure.

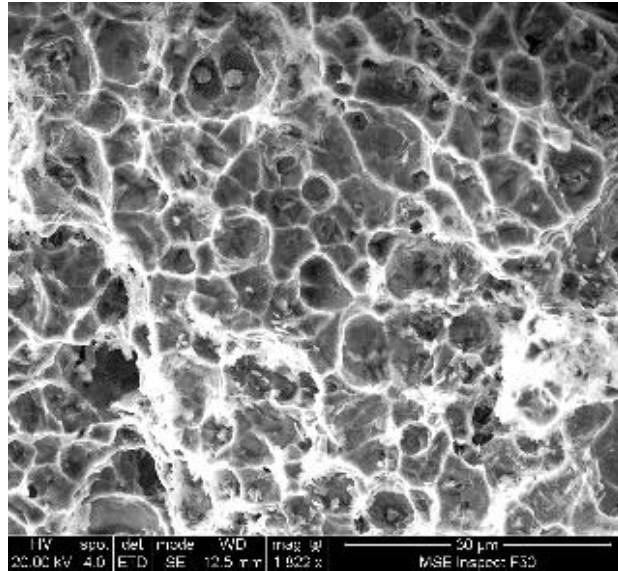
Scanning electron microscopy (SEM) examination showed ductile overload over the entire width of the fracture. No obvious signs of SCC were seen. It appears that overpressure caused a ductile overload of this region with pre-existing stress corrosion. The difference in appearance between the weld-side and base-side material is related to the grain structure within the material. Figure 39 (weld-side) shows a more equiaxed structure resulting from the molten pool. The aligned structure in Figure 40 (base-side) is likely related to the texture produced by rolling the steel used to fabricate the tank.

Figure 39. Image. SEM examination of through-crack of section 3 (weld-side).

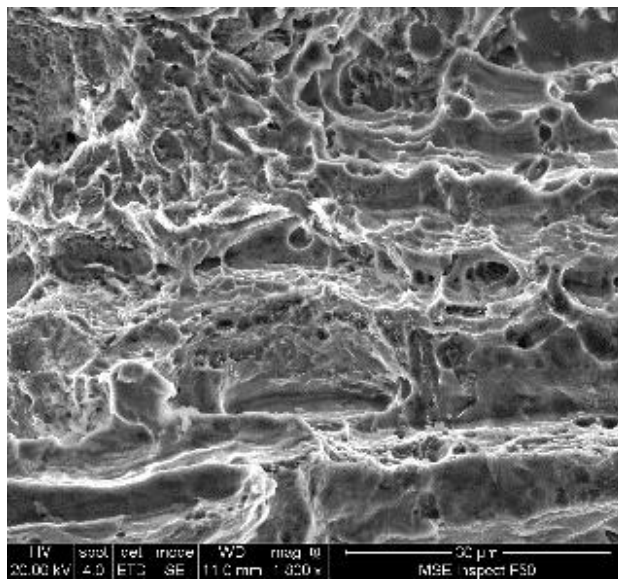
Figure 40. Image. SEM examination of through-crack of section 3 (base-side).
