ARIZONA DEPARTMENT OF TRANSPORTATION

REPORT NUMBER: FHWA-AZ88-202-1

SMALL SIGN SUPPORT ANALYSIS

Phase I Crash Test Program

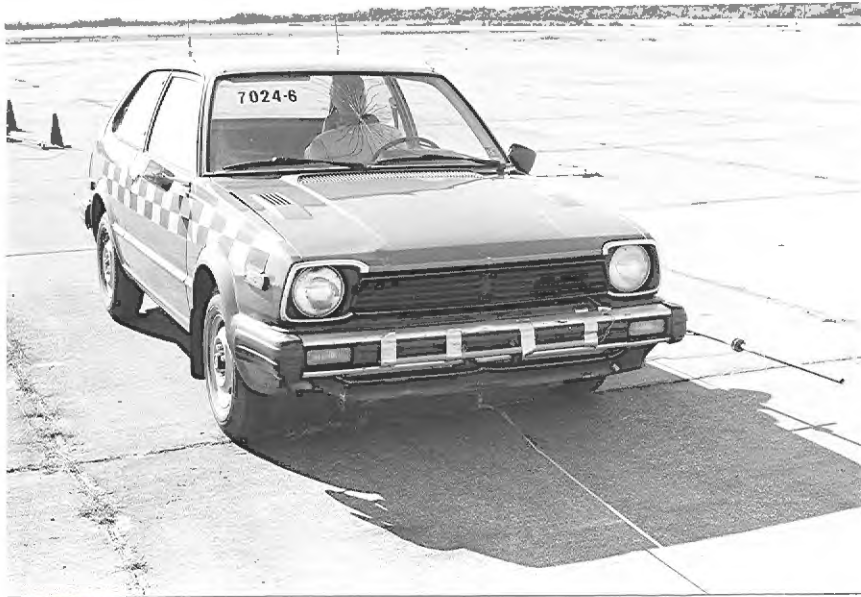
(cracks in windshield from Test 5)

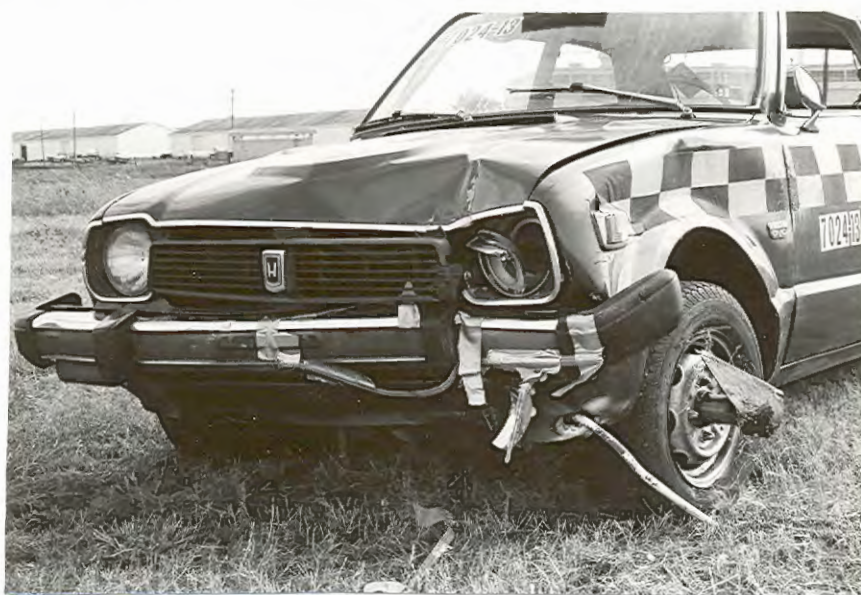
FIGURE A-97. TEST VEHICLE AFTER TEST 13.

Post-test roll attributed to
unsymmetrical brake application
and soil condition.
