Strategies to Reduce Burro-Vehicle Collisions in the Lake Pleasant Area

SPR-753
June 2022

Published by:
Arizona Department of Transportation
206 South 17th Avenue
Phoenix, AZ 85007
in cooperation with
Federal Highway Administration

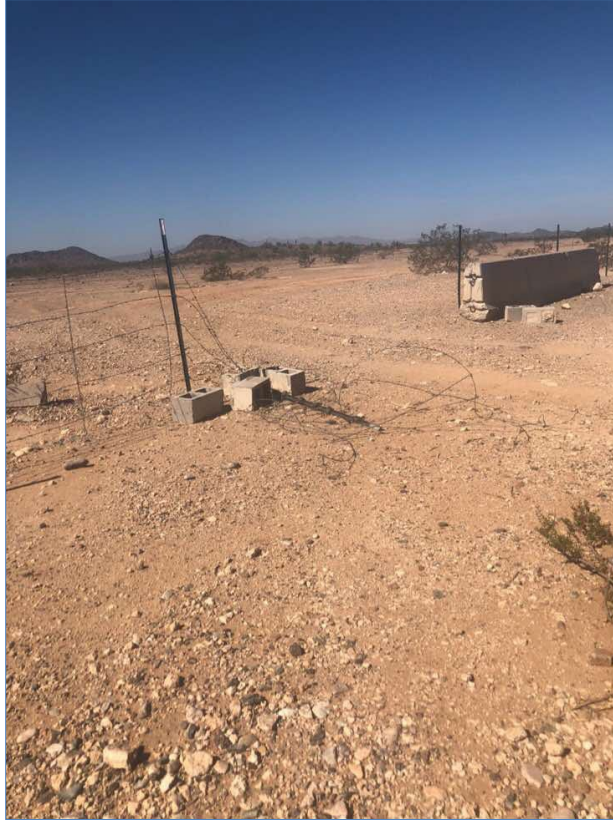
Figure 34. Burro-ROW Access Point Located During a BVC Site Investigation

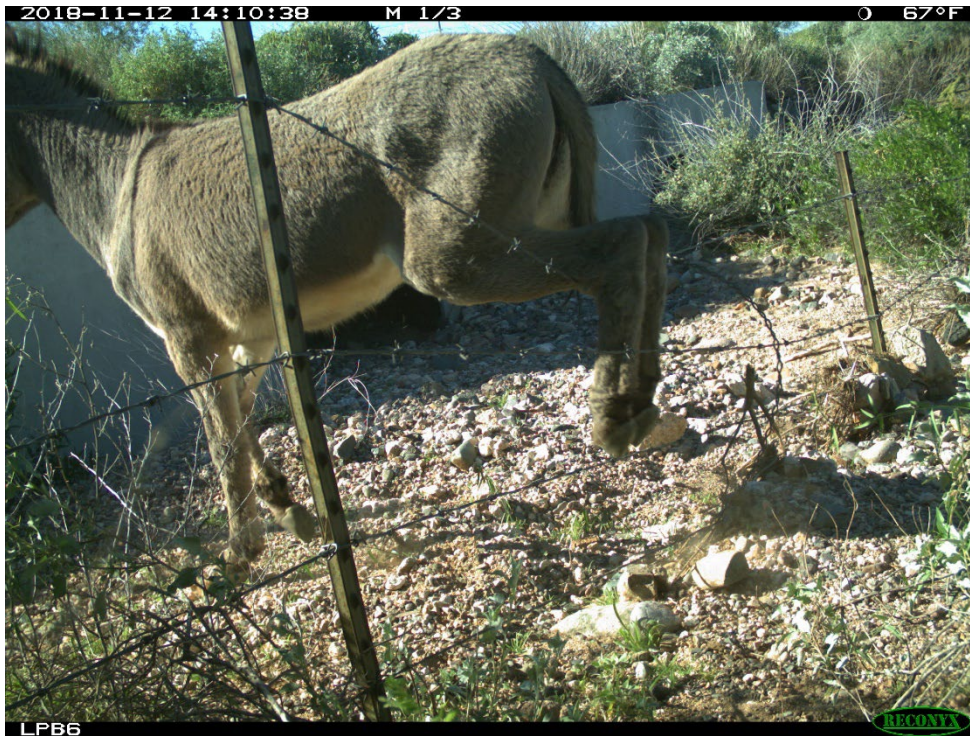
Figure 42. Burro Crossing a Low Top Wire Access Point

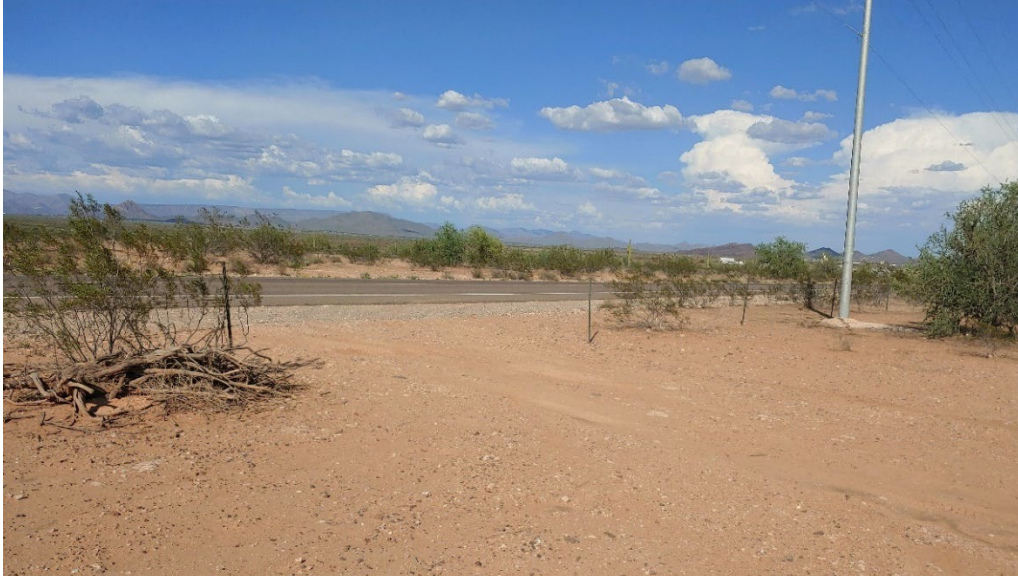
Figure 57. ROW Fence Cut to Access a Nearby OHV Trail

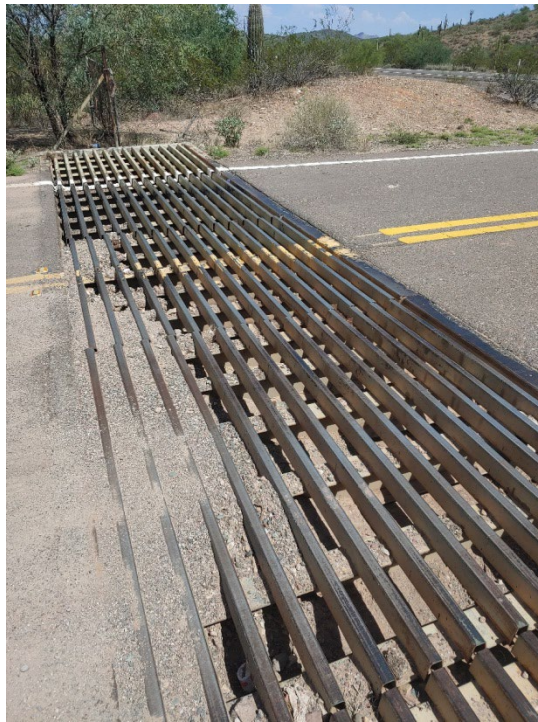
Single crossing guards with a width of 8 feet and vaults with less than 50 percent sedimentation effectively prevented burro-ROW access in all 26 instances documented by cameras. Burro movement data and BVC patterns did not suggest that burros entered ROW via crossing guards when sedimentation levels were maintained below 50 percent. At the beginning of the project, two crossing guards with more than 50 percent sedimentation were associated with BVC hot spots from the baseline period (2014 to 2016) (Figure 63). ADOT cleared these guards while repairing nearby fences. During the project period (2017 to 2019), these areas were no longer BVC hot spots. Previous studies also found that crossing guards with deeper pits present a more substantial barrier to ungulates than those with shallower pits (Huijser et al. 2015).

Figure 63. Crossing Guard with More Than 50 Percent Sedimentation

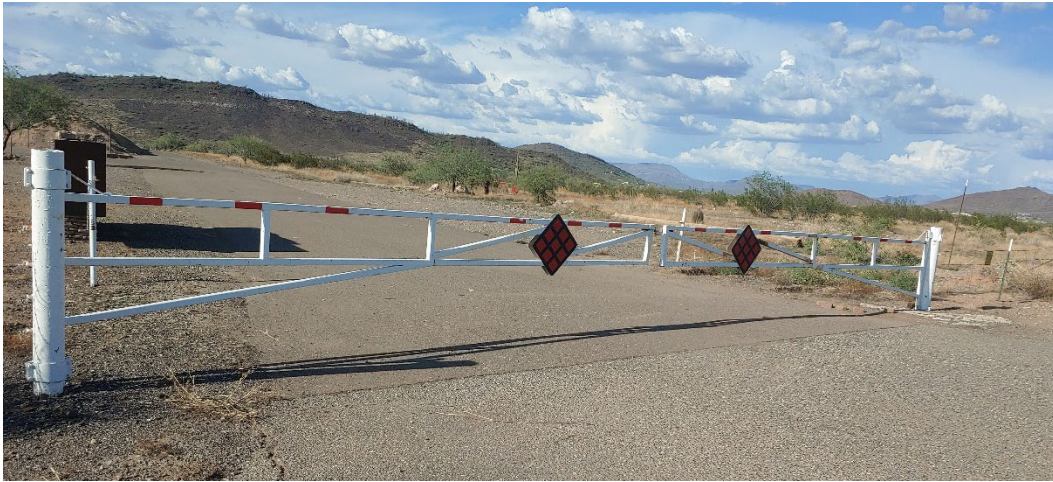
Figure 64. Single-Arm Gate with a Gap Greater Than 24 Inches Beneath the Bottom Bar

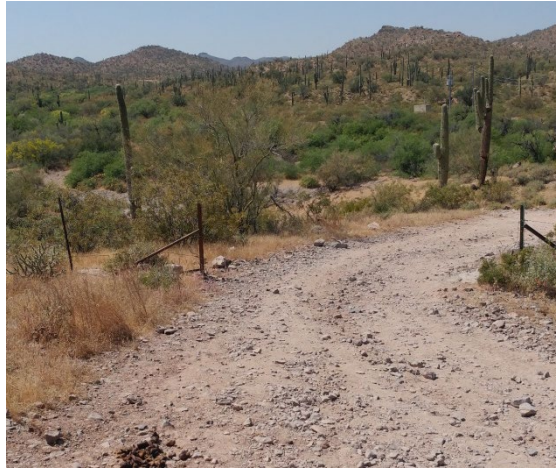
Figure 67. Unclosed Gate at ROW Access Point
