MDOT State Study 287—Evaluation of Ground Penetrating Radar as a Tool in Designing Maintenance and Rehabilitation Projects in Mississippi

Report Date: 12/18/2019

BURNS COOLEY DENNIS, INC.

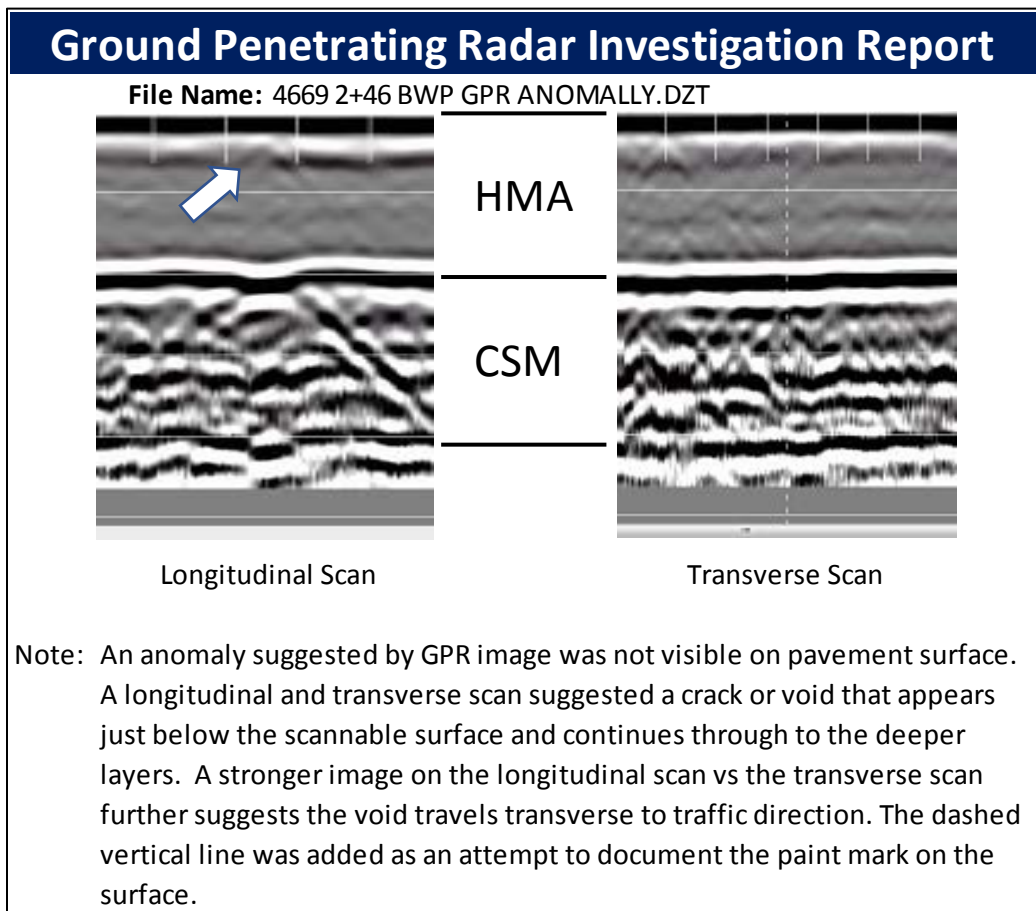
Figure 3: GPR Anomaly Identified at Station 2+46 - Section 4669

When revisiting the site, measurements were conducted to get close to the anomalies and the GPR was again used to find the specific anomalies. Figure 3 illustrates one of the anomalies that was observed between the wheel paths (BWP) at Station 2+46. As described in Figure 3, the anomaly was a parabola suggesting something occurring in a transverse direction

(longitudinal scan) just below the pavement surface as well as a discontinuity below the hot mix asphalt (HMA) layer. A core was cut at this location which showed an existing crack beginning just below the new HMA pavement surface layer and extending downward (Figure 4). The core cut at this location also revealed a crack within the cementitiously stabilized material (CSM) below the HMA.

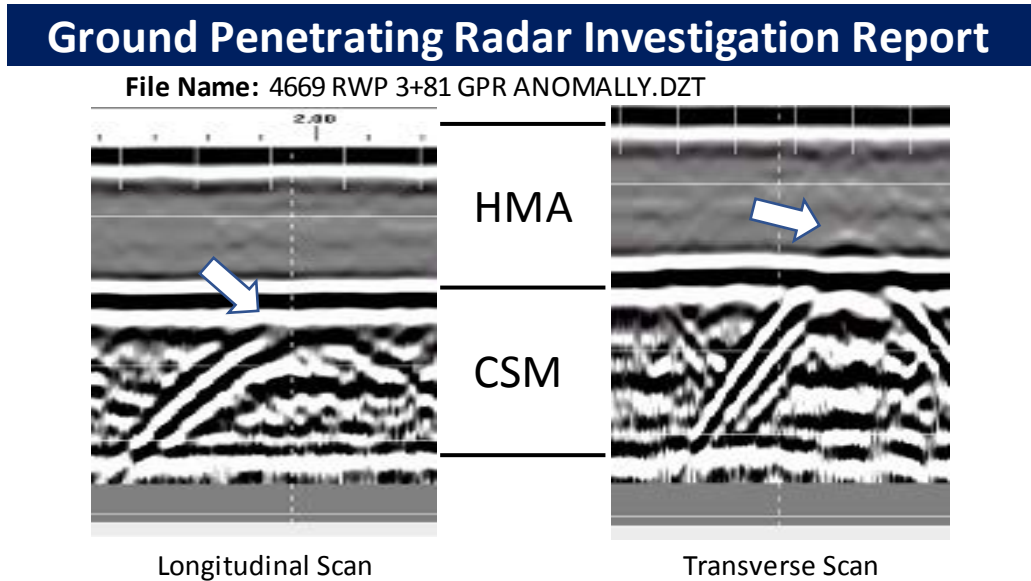
Figure 5: GPR Anomaly Identified at Station 3+81 – Section 4669

Figure 5 illustrates the GPR trace for an anomaly located in the right wheel path (RWP) at Station 3+81. As shown in Figure 5, a parabola indicating an anomaly was identified near the bottom of the HMA layer extending downward into the structure. A core was cut at this location (Figure 6). Evaluation of the core did not indicate the cause of the anomaly. A second core was not cut due to time constraints. Whether the anomaly was a false-positive or the core was cut in the wrong location is not known.

Note: GPR suggested an anomaly below the HMA that was not visible at the pavement surface. An exploratory core was made, with no crack found. Closer examination of the scan, (particularly the transverse view), reveals the parabola originating in the bottom portion of the HMA layer and extending downward. Catalyst for the anomaly was not identified. The dashed vertical line was added as an attempt to document the paint mark on the surface.

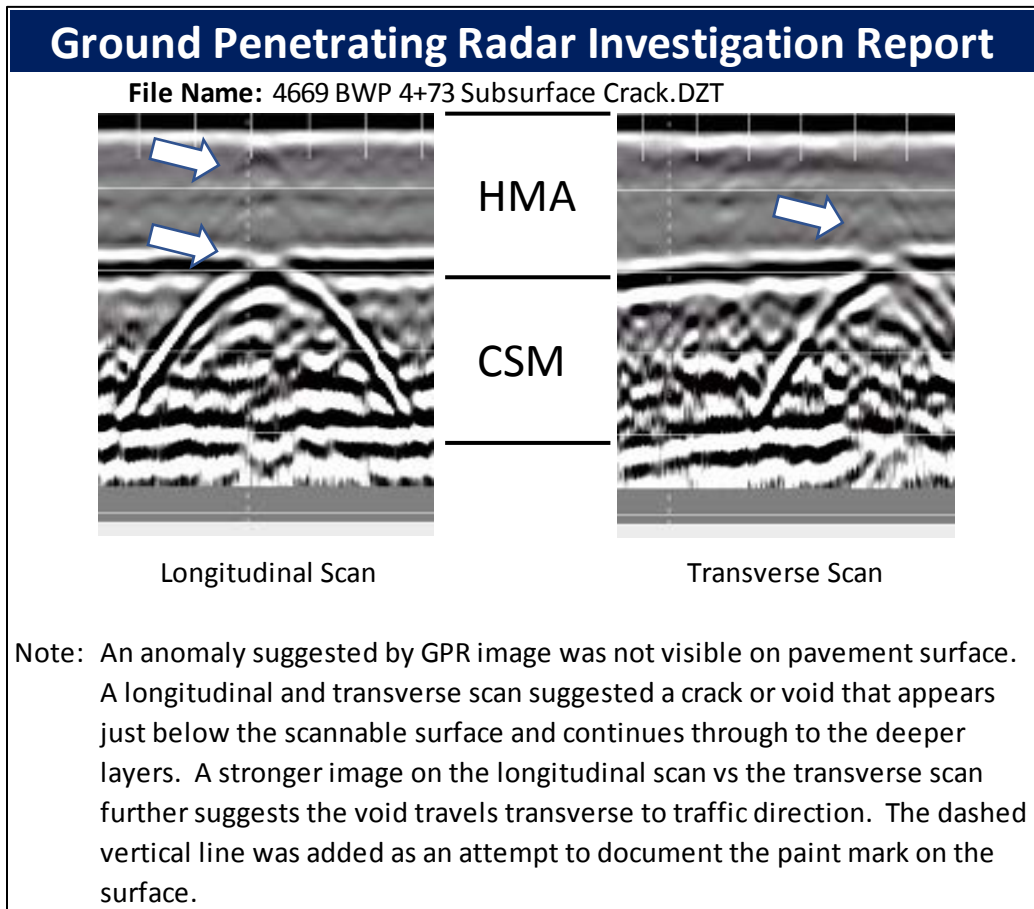
Figure 7: GPR Anomaly Identified at Station 4+73 – Section 4669

Figure 7 illustrates the GPR trace for an anomaly identified BWP at Station 4+73. Similar to the anomaly observed at Station 2+46, a parabola indicated something just below the new HMA layer extending downward toward the CSM layer. Figure 8 is a photo of the core cut at Station 4+73 and shows a crack beginning just below the new HMA layer extending downward through the CSM layer.

Recall back to Figures 7 and 8 from section 4669. Figure 7 showed the GPR trace for the pavement anomaly that caused the core to be cut. This GPR trace also showed the characteristic concave shape at the interface of the CSM and HMA layers. Figure 8 showed that

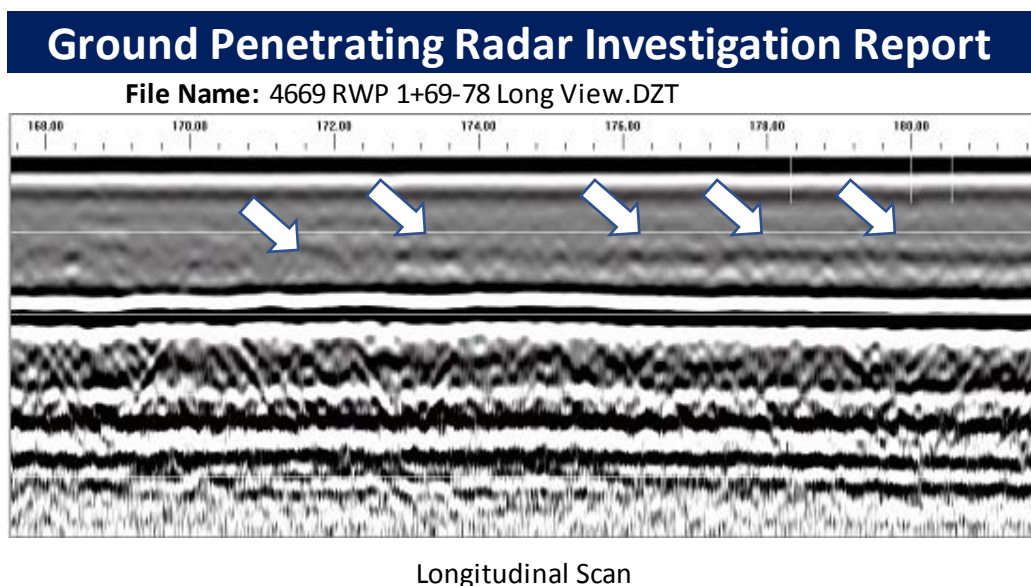
Figure 9 illustrates an anomaly longitudinally within the RWP between stations 1+68 and 1+78 highlighted by the white arrows superimposed onto the figure. The anomaly observed within Figure 9 is a darker line (in relation) approximately 2 to 3 in above the bottom of the HMA layer which is shown as the black/white/black sequence at approximately the half way point vertically within the trace. This anomaly suggests a contrast in the dielectric constant between two materials that drives the strength (brightness) of the reflection. Figure 10 illustrates the GPR traces transversely at Stations 1+65, 1+69 and 1+78. As shown within Figure 10, anomalies were observed at Stations 1+69 and 1+78. Figure 11 illustrates the cores cut at Stations 1+69 and 1+78. Cracks below the new HMA overlay of varying depths were found at these locations. Therefore, the contrast in the dielectric constant was most likely caused by the air of the crack versus the intact HMA above the crack.

Note: An anomaly in the right wheel path seemed to continue for several feet. This can sometimes indicate you are scanning directly above and in the same direction as the object in question. Cores were taken at 1+78, 1+69, and 1+65 to investigate and possibly predict a start and stop point. It is the contrast between the dielectric constant of the two materials that drives the strength (brightness) of a reflection. Because of the low dielectric of air, a phase inversion, or flip-flopping of the polarity sequence from white/black/white to black/white/black can occur.

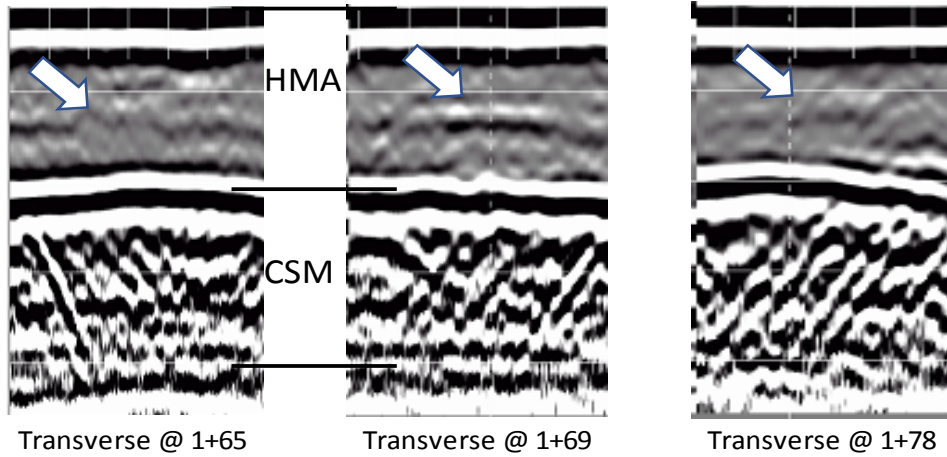
Figure 10: GPR Anomaly in the Transverse Direction at Stations 1+65, 1+69, and 1+78 – Section 4669

Note: Companion Transverse Scans were performed at 1+78, 1+69, and 1+65 to further pin-point the presence and position of the observed anomaly. Voids were observed in the 1+78 and 1+69 cores.

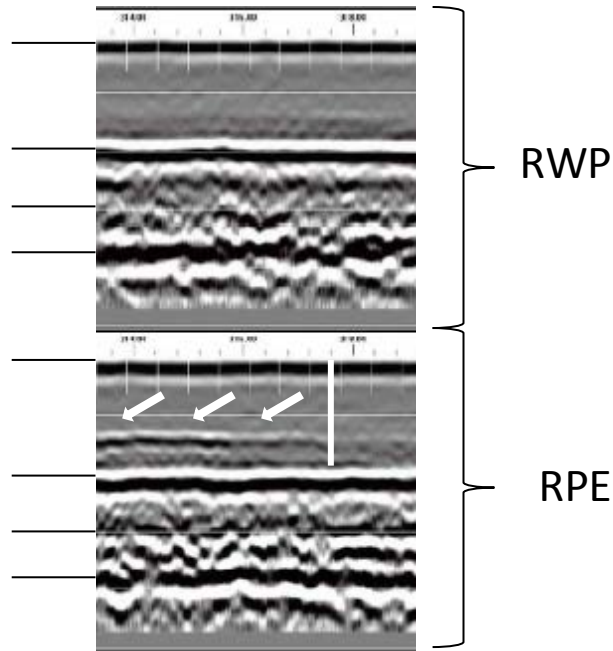
Figure 12: RWP and RPE Traces from Section 3163 near Station 3+16

The occurrence of potential stripping within the HMA was observed within Section 3163. Figure 12 illustrates the RWP and right pavement edge (RPE) traces within Section 3163 near station 3+16. Superimposed onto the left side of the traces are the typical pavement structure for the section. The top trace shows that the HMA for the RWP (top trace) is relatively consistent in color and shade. However, within the RPE trace (lower trace) there is a distinguishable darker line (highlighted by the white arrows within the figure) several inches above the interface between the HMA and CSM layers (white/black/white lines at bottom of HMA). This darker line in the RPE trace also has some characteristics of an interface in that faint white lines can be observed just above and below the darker line. The existence of this faint interface likely suggests a change in material properties that could indicate stripping or possibly delamination between HMA layers. A solid vertical white line has been superimposed onto the RPE trace to signify a potential boundary in which the anomaly ends. Stripping was observed within some cores cut from Section 3163.

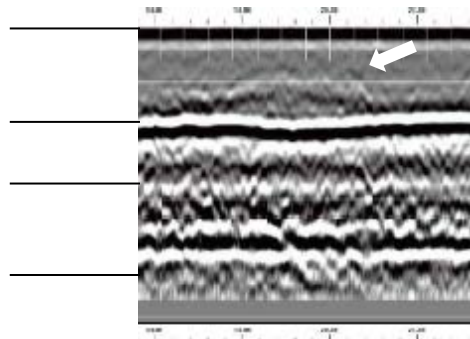
Figure 13: BWP Trace from Section 4834 near Station 0+19

Another instance of potential stripping was observed in Section 4834. Figure 13 illustrates the BWP trace for Section 4834 at approximately station 0+19. This figure shows a shadowing above the HMA/CSM interface (highlighted by the white arrow). This anomaly is an isolated area within the trace and may indicate stripping. However, cores cut in other areas of Section 4834 showed very little stripping.

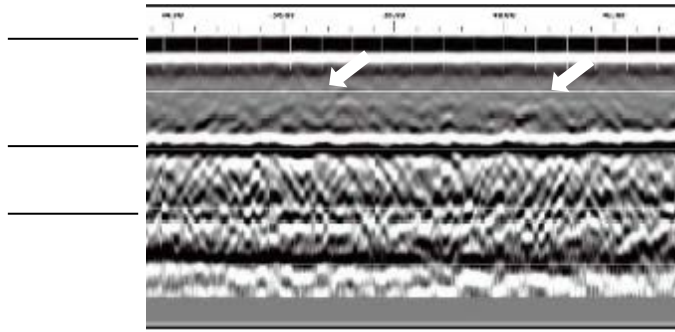
Figure 14: RWP Trace from Section 4864 near Station 0+45

Traces from Section 4864 also had anomalies within the HMA that could potentially be stripping. Figure 14 illustrates the RWP trace of section 4864 near station 0+45. As shown in the figure, there are some anomalies above the HMA/CSM interface and within the HMA. The anomalies appear as small wavy lines within the HMA. These anomalies may be indicating stripping. Stripping was observed within lower HMA layers for section 4864.

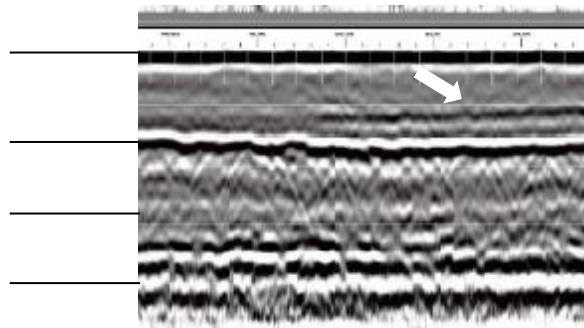
Figure 15: LWP Trace from Section 5244 near Station 0+52

Similar to Figure 12, Figure 15 shows a characteristic dark line within the HMA layer which may indicate stripping or possibly delamination for section 5244. The trace within Figure 14 is from the left wheel path (LWP) near station 0+52. As shown in Figure 15, this dark line is not visible on the left side of the figure which may indicate a boundary between stripped and non-stripped HMA. Stripping was observed within the lower HMA layers at a number of core locations within this section.

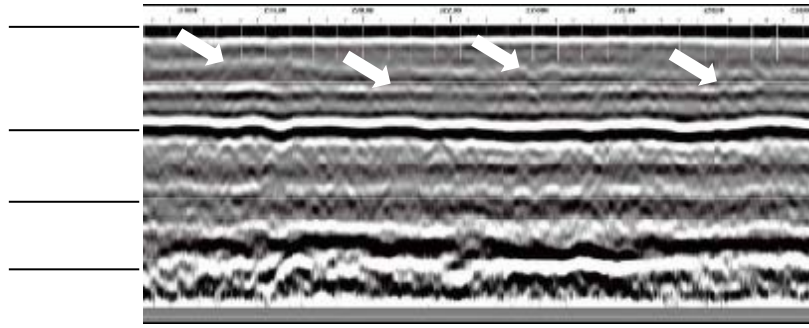
Figure 16: LPE Trace from Section 5244 near Station 2+24

Also, within section 5244, Figure 16 shows a layering within the HMA layer that could indicate stripping. This trace is from the left pavement edge (LPE) near station 2+24. Because this trace is at the LPE, it is near the longitudinal joint between lanes. The layering effect shown in the figure may be the GPR identifying the offset of longitudinal joints as the HMA structure was built.

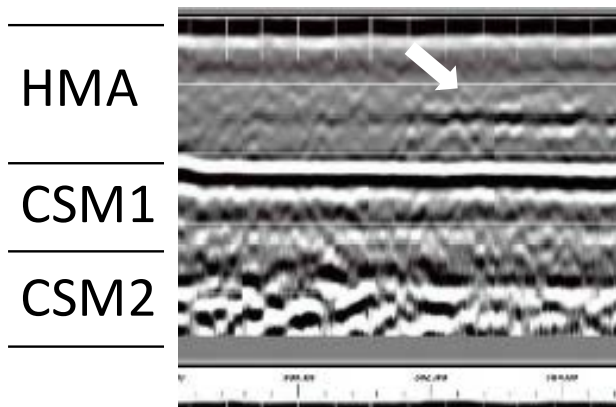
Figure 17: BWP Trace from Section 5230 near Station 3+00

The final example of possible stripping is from Section 5230 near station 3+00. Figure 17 illustrates the characteristic darker line above the HMA/CSM interface that was seen in other traces. For this particular location, cores were obtained for testing during SS No. 263. As illustrated within Figure 17, the darker line is a couple inches above the interface. The core shown in Figure 17 was cut within a couple feet of the location of the GPR trace. Two conditions are depicted within the picture of the core. First, stripping is observed a couple inches from the bottom of the HMA layer. Secondly, the layer in which the stripping occurred has also delaminated from the overlying layer.

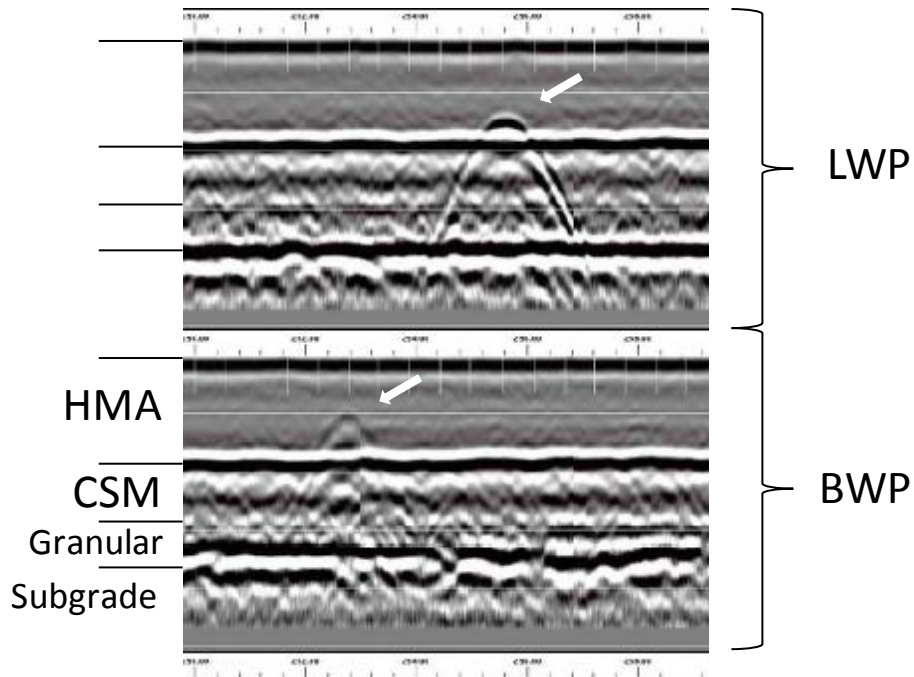
Figure 18: LWP and BWP Traces from Section 5230 near Station 2+54

Figure 18 illustrates the occurrence of cracks that appear to be limited to the bottom portion of the HMA layer in Section 5230. The top trace within Figure 18 is the LWP trace while the bottom is the BWP trace. Within both of these traces, an anomaly within the lower portion of the asphalt layer can be observed. Interestingly, the two anomalies have different appearances. Within the LWP trace, the anomaly is a large parabola, while in the lower trace the anomaly is a smaller parabola. It's unclear why the parabolas are different; however, one explanation could be the width of the cracks are different.

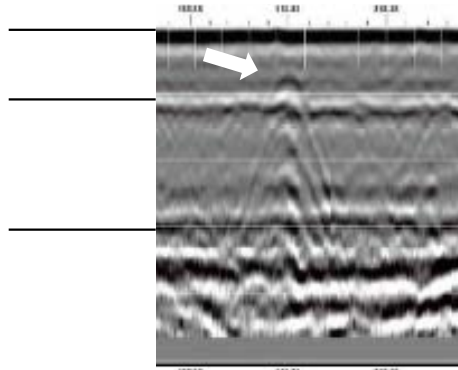
Figure 19: BWP Trace from Section 4784 near Station 1+98

Another instance of a potential crack within the lower part of the HMA layer is from section 4784. Figure 19 illustrates this potential crack. This trace is from BWP near station 1+98. As shown in the figure, the crack appears to be just a couple inches above the HMA/CSM interface.

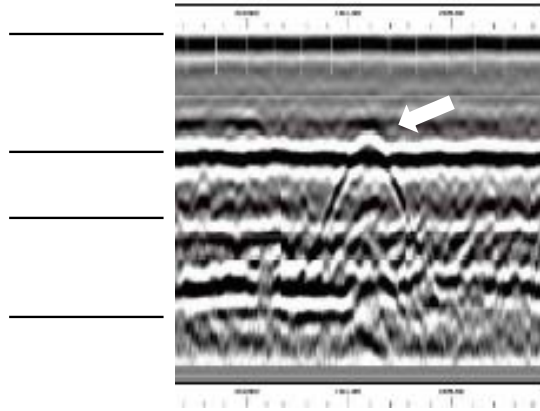
Figure 20: LPE Trace from Section 4834 near Station 1+02

Figure 20 illustrates another potential crack that is near the bottom of the HMA layer. This trace is from the LPE near station 1+02 within Section 4834. This particular anomaly appears to be right at or just above the HMA/CSM interface.

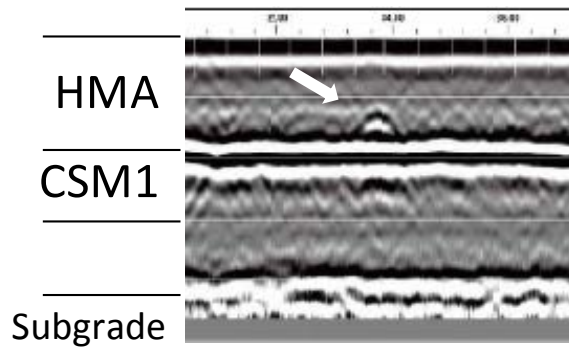
Figure 21: LPE Trace from Section 5210 near Station 0+34

A final example of a crack within the HMA layer that appears to be within the bottom portion of the layer is illustrated in Figure 21. This trace is from section 5210 near station 0+34 and represents the LPE. The small anomaly is just above the HMA/CSM interface. This anomaly is a little different than the others presented within this section. The other anomalies presented in this section had the characteristic parabola. Figure 21 does not show the parabola; rather, the anomaly is a convex shape that is isolated to the anomaly. Interestingly, there is a color change from black to white within the anomaly. Because of the color change, the anomaly could be a small void at the bottom of the layer or some type of foreign material.

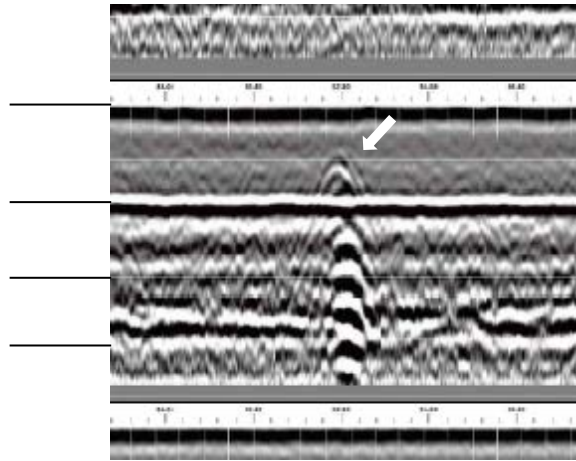
Figure 22: RWP Trace from Section 2580 near Station 0+92

In some instances, it appeared that the tops of cracks (anomalies) were within the middle of the HMA layer. These instances are based upon the top of the parabolas being about mid-level within the HMA layer. Figure 22 illustrates an anomaly that appears to begin at approximately mid-depth of the HMA layer. This trace is from the RWP near station 0+92 of Section 2580. As shown in the figure, a parabola exists within the middle portion of the HMA layer. The existence of this parabola suggests that a crack has potentially initiated mid-depth within the HMA layer, the crack existed prior to a mill and overlay, or reflected from the underlying CSM.

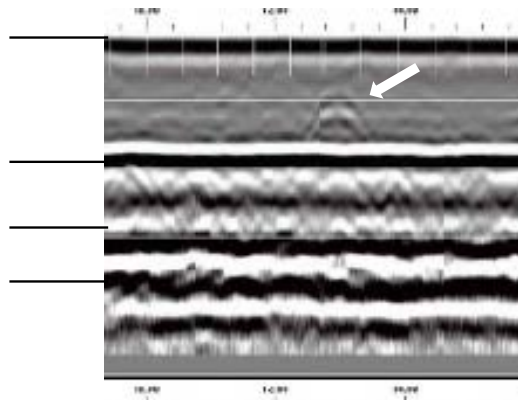
Figure 23: LWP Trace from Section 3163 near Station 0+12

Another instance of a potential mid-level crack was observed within Section 3163 near station 0+12. Figure 23 illustrates the LWP trace and the characteristic parabola indicating the crack. Interestingly, the interface between the HMA and CSM is very consistent, suggesting the crack (anomaly) is not reflected from the CSM. Also, the parabola does not appear to extend into the CSM layer.

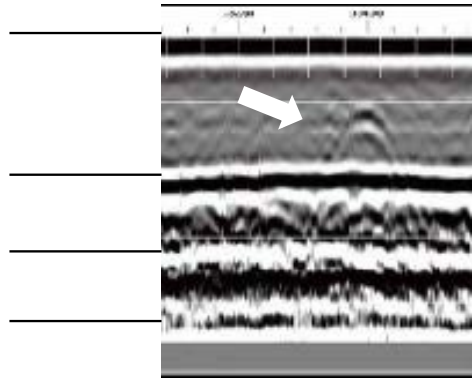
Figure 24: LWP Trace from Section 4588 near Station 3+34

Figure 24 illustrates a trace of the LWP near station 3+34 for section 4588. This figure shows a parabola that starts at approximately mid-depth of the HMA layer. The existence of these mid-layer anomalies is interesting. Three possibilities for these types of anomalies have been provided, if in fact they are cracks. Namely, these could be cracks that initiated mid-layer, reflected upwards from the CSM or existed prior a mill and overlay. The only method of determining the cause of these anomalies will be to core the pavements.

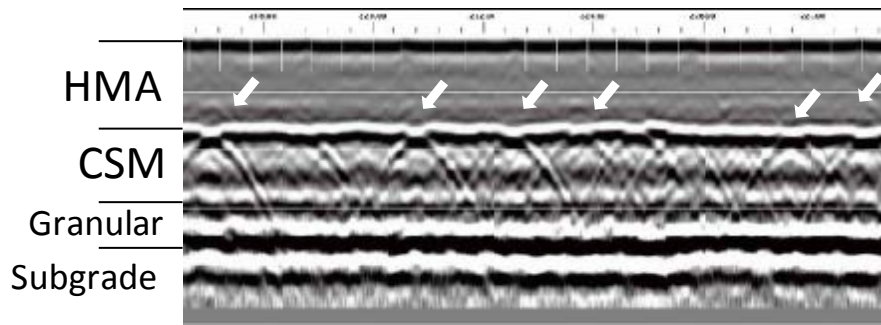
Figure 25: LWP Trace from Section 3163 near Station 2+16

Another common type of anomaly observed within the five full 500-ft traces was potentially a crack within the CSM layer. These instances were individual parabolas showing at the top of the CSM layer. A representative trace showing potential cracks within the CSM layer is illustrated within Figure 25. This trace is from the LWP of section 3163 near station 2+16. As shown by the white arrows within this trace, a number of potential cracks are illustrated. In addition to the parabola that begins at the interface between the CSM and HMA layers, one characteristic of these potential cracks within the CSM layer that is common is the distinct small concave shape at the interface. This characteristic was observed on many of the potential CSM layer cracks.

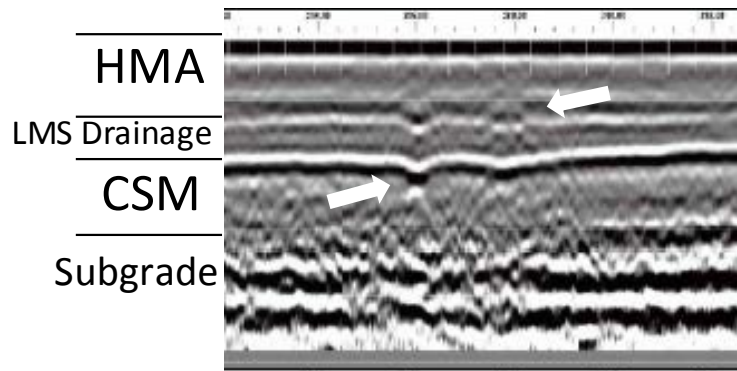
Figure 26: LPE Trace from Section 4782 near Station 2+86

Figure 26 illustrates another anomaly that likely shows a crack within the CSM layer. This trace is from the LPE of Section 4782 near station 2+86. This figure again shows the characteristic concave shape at the interface between the CSM and HMA layers. However, this trace also shows an anomaly above this concave shape that could suggest that the crack within the CSM layer has propagated upwards into the HMA layer (above the left white arrow). As discussed elsewhere in this report, it has been hypothesized that cracks reflected into the overlying HMA layer may not be directly above the CSM crack. Figure 26 suggests this may again be the case.

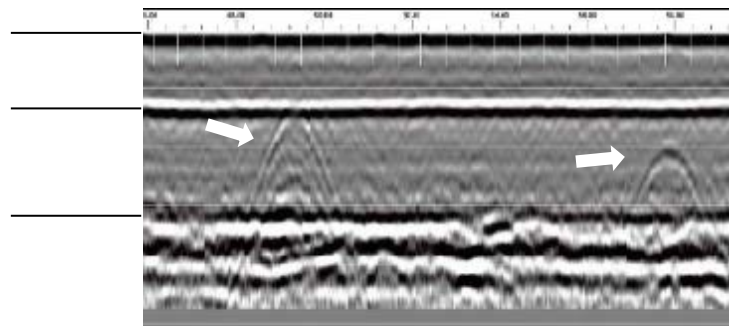
Figure 27: RPE Trace from Section 4784 near Station 0+50

Another instance of potential cracking within the CSM layer is illustrated within Figure 27. This figure shows the RPE trace from section 4784 near station 0+50. This figure shows two distinct parabolas, one at the top of the CSM layer and one at approximately the midpoint of the CSM layer. The occurrence of the anomaly in the middle of the CSM layer is interesting as only a single layer of CSM material was within the pavement structure. It is possible that if the anomaly is not a crack, it could be a large aggregate particle or some foreign material within the layer.

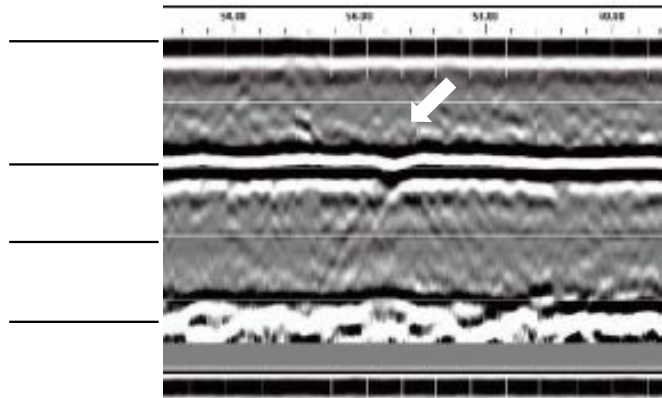
Figure 28: LPE Trace from Section 5210 near Station 0+58

Figure 28 illustrates the occurrence of an anomaly at the top of the CSM layer that appears to be a crack within the CSM layer. Figure 28 is the LPE trace from section 5210 near station 0+58. Similar to other traces indicating a crack within the CSM layer, a characteristic concave shape is located at the top of the parabola.

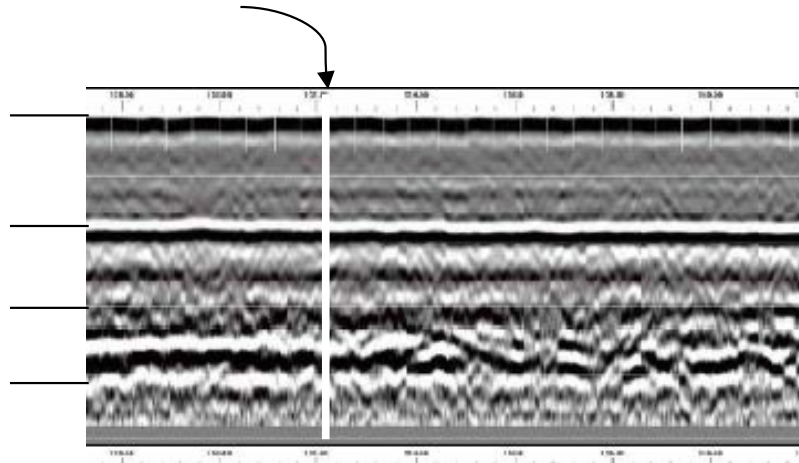
Figure 29: RWP Trace from Section 2580 near Station 1+34

Fatigue cracking within a CSM layer is a subsurface distress that would be vitally important when conducting a M&R design. A CSM layer that has fatigued will not have the same structural capacity as a CSM layer that is intact. Therefore, the areal extent of CSM fatigue would be important. Figure 29 illustrates a circumstance in which the GPR trace suggests fatigue cracking within the CSM layer. This trace is from the RWP of section 2580 near station 1+34. As shown on the figure, this section included two layers of CSM below the HMA layer. Based upon evaluation of all 16 sections included within Table 1, the characteristic that suggests the potential for fatigue within the CSM layer is the clarity of the interface, or the changes in clarity, of the interface between the CSM and underlying layer. As shown within Figure 29, the interface between the second CSM layer (CSM2) and subgrade is clear and distinctive on the left side of the figure. On the right side of the figure, the clarity of the interface is much less. A white vertical line was superimposed onto Figure 29 to indicate a potential boundary between an area in which the CSM is fatigued and the area which is not. Based on the figure, the first layer of CSM (CSM1) seems to be intact, while the boundary seems to be for the CSM2; however, without coring the specific layer and/or boundary cannot be verified.

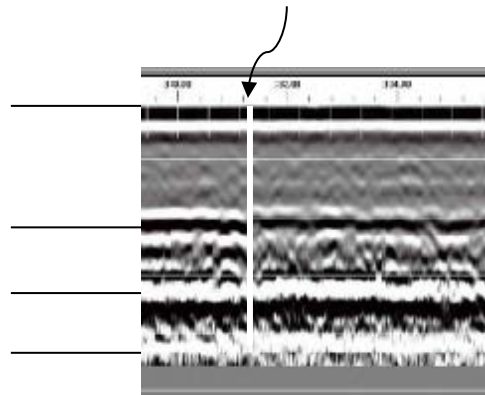
Figure 30: RWP Trace from Section 4588 near Station 3+34

Figure 30 illustrates another trace that suggests fatigue within a CSM layer. This figure shows the trace for the RWP of section 4588 near station 3+34. Figure 30 is different from Figure 29 in that the interface between the two CSM layers is reasonably consistent; however, the CSM1 material appears to be inconsistent on the right side of the superimposed boundary line. This could suggest that CSM1 is fatigued.

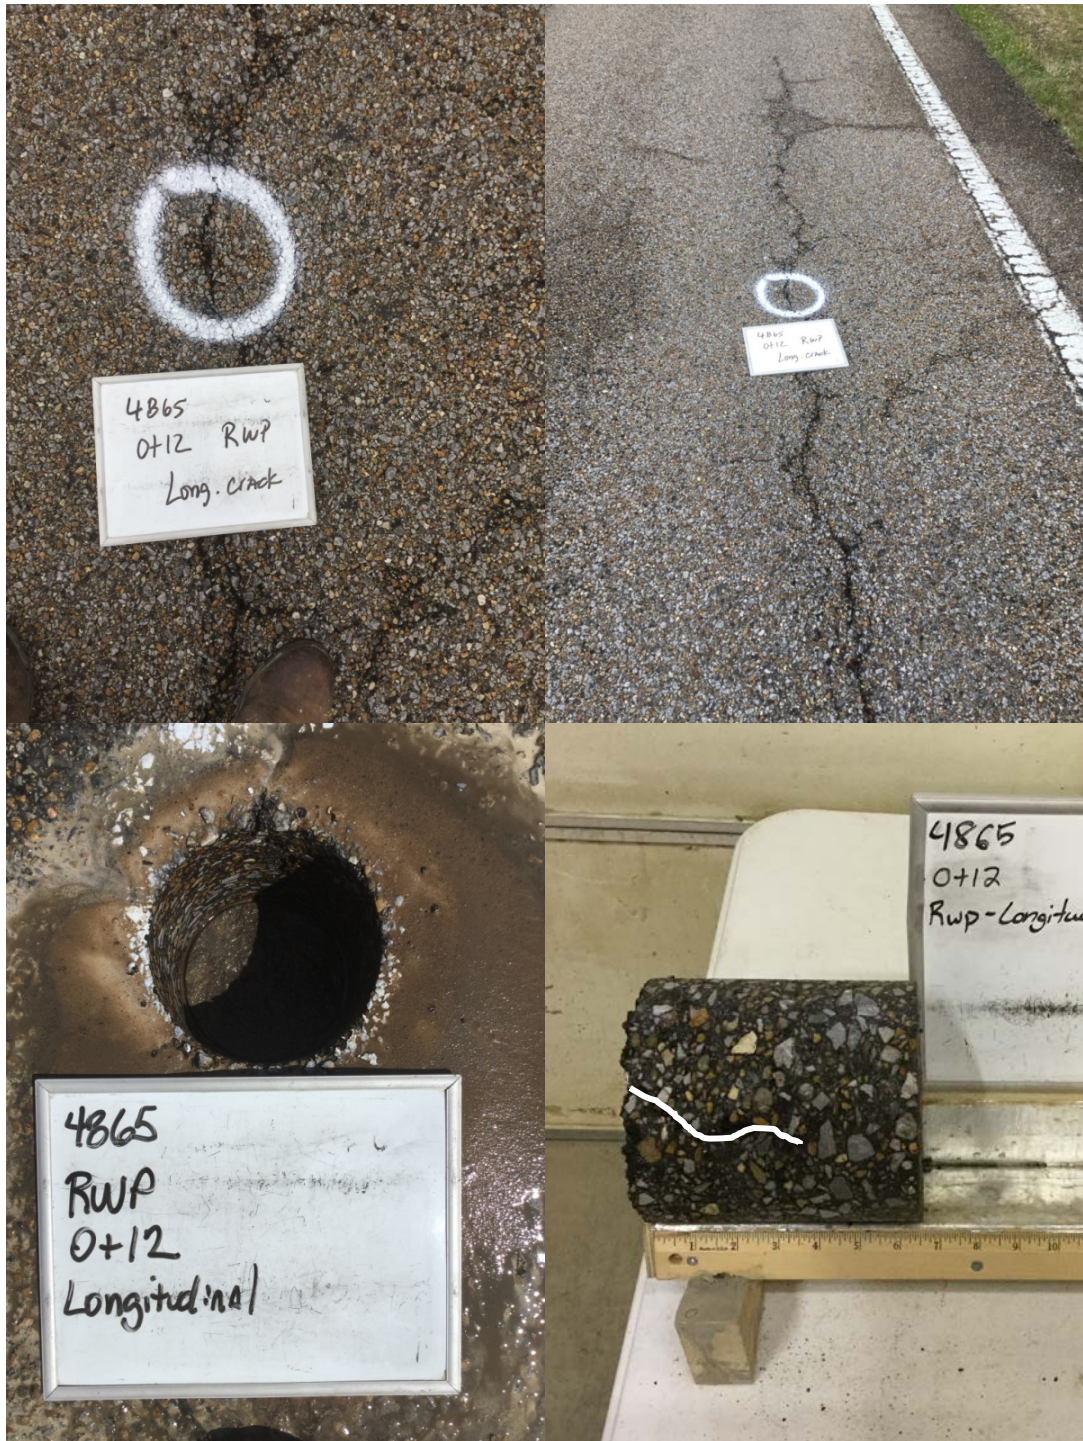
Figure 46: Pavement Surface and Core for Longitudinal Crack - Section 4865, Station 0+12

moderate to high severity at the pavement surface. However, the photograph of the core shows that the crack extends only about 4 in. into the pavement.
