**RP 270**

# **Development of an Inventory and Inspection Database Framework for Asset Management of MSE Walls**

Idaho Transportation Department

July 2019

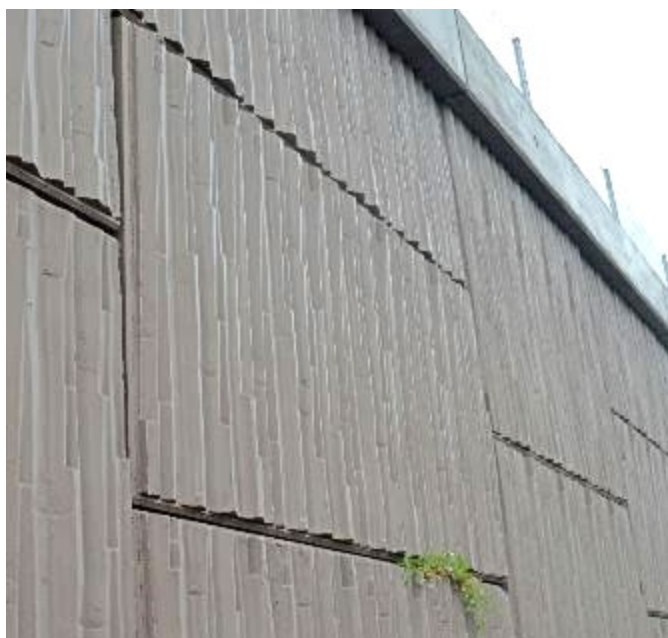
**Figure 6. Rectangular Wall Panel with Bulge and Vegetation noted at L = 41 feet**

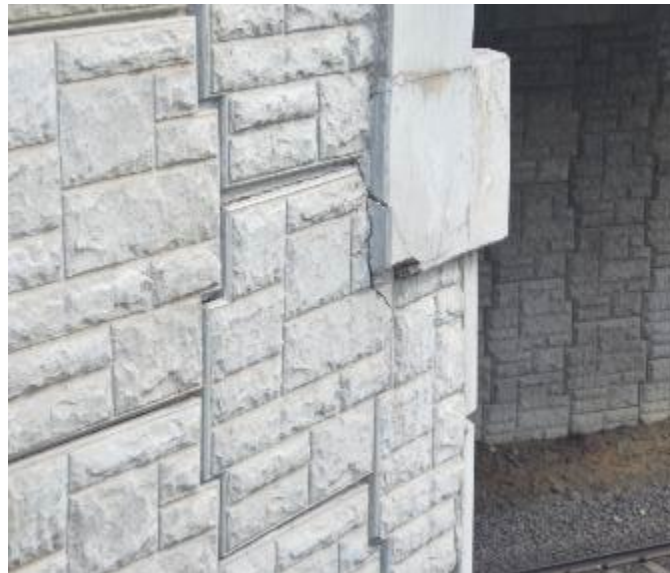
**Figure 8. Typical "Cruciform" Concrete Panel and Damage in Bearing Wall at L = 110 ft**

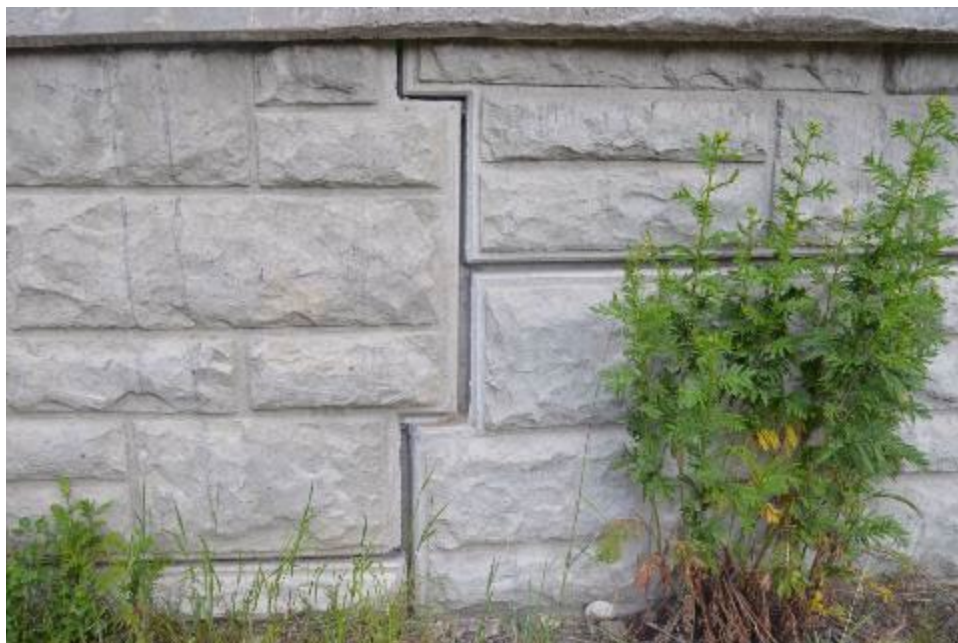
**Figure 9. Rotated Panel at L = 30 feet**

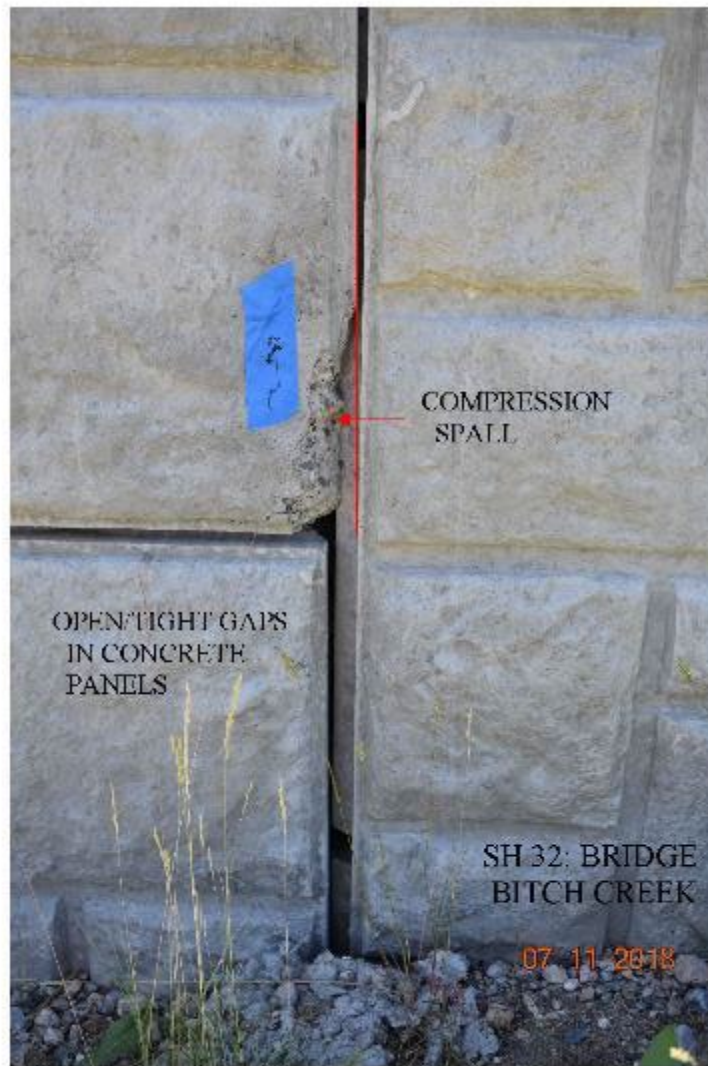
**Figure 21. Numbered Open/Tight Joints and Compression Spall in MSE Wall Panels**

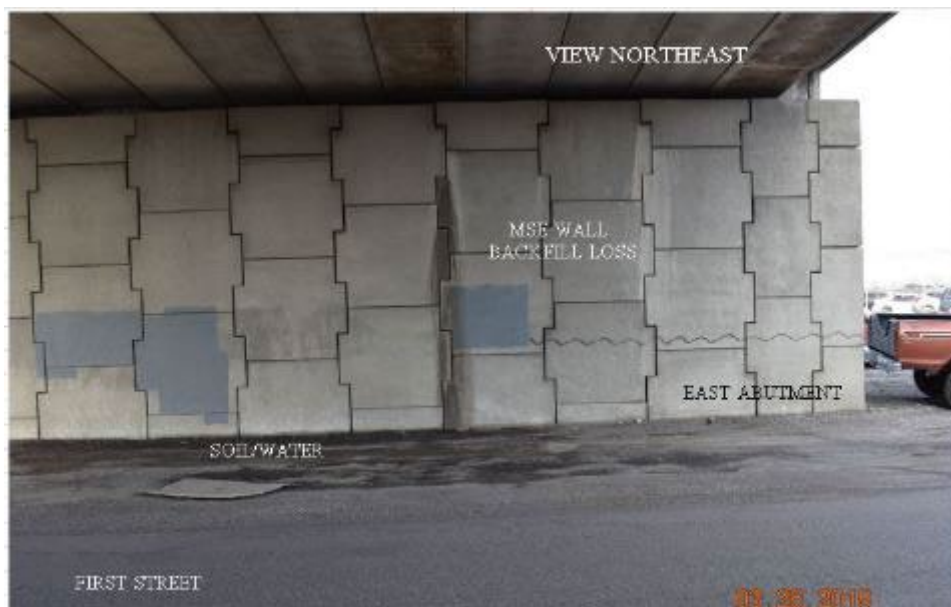
Figure 22. Soil/Water Flow (Piping) from MSE Wall 4 West Abutment Face, E. Gould Street Overpass

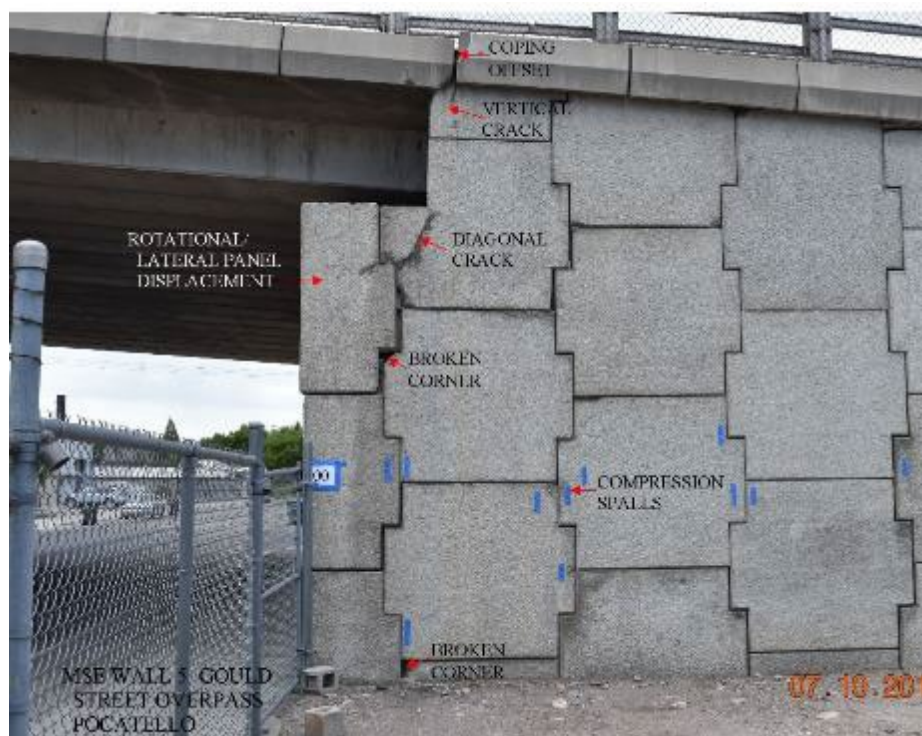
Gould Street/First Street Overpass: west bridge abutment; structural cracks and wall rotation/settlement

Figure 23. Severe Damage in MSE Wall 5 Beneath West Abutment of E. Gould Street Overpass

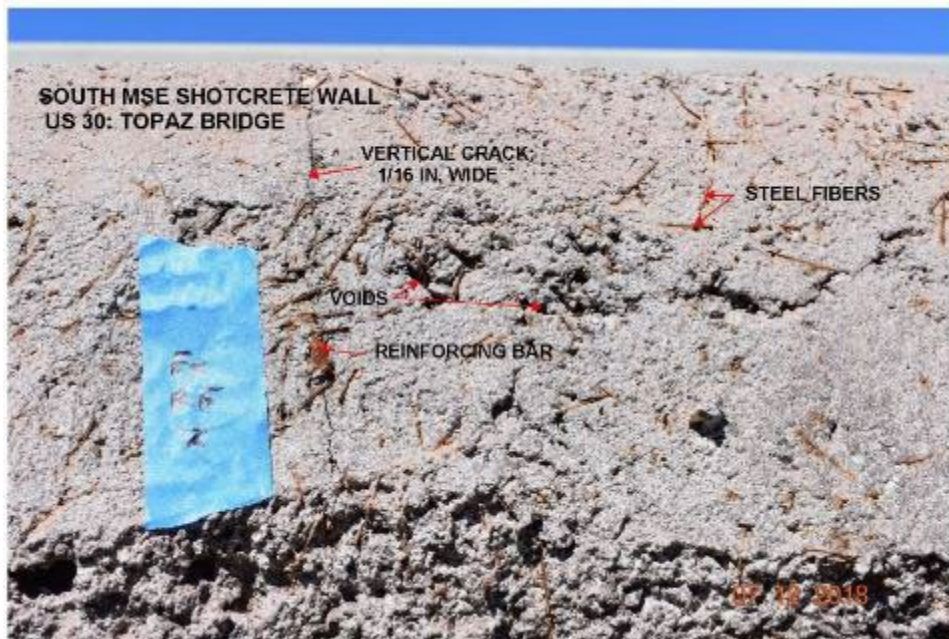
Figure 25. Vertical Cracks and Small Voids in Fiber-reinforced Shotcrete at Topaz Bridge

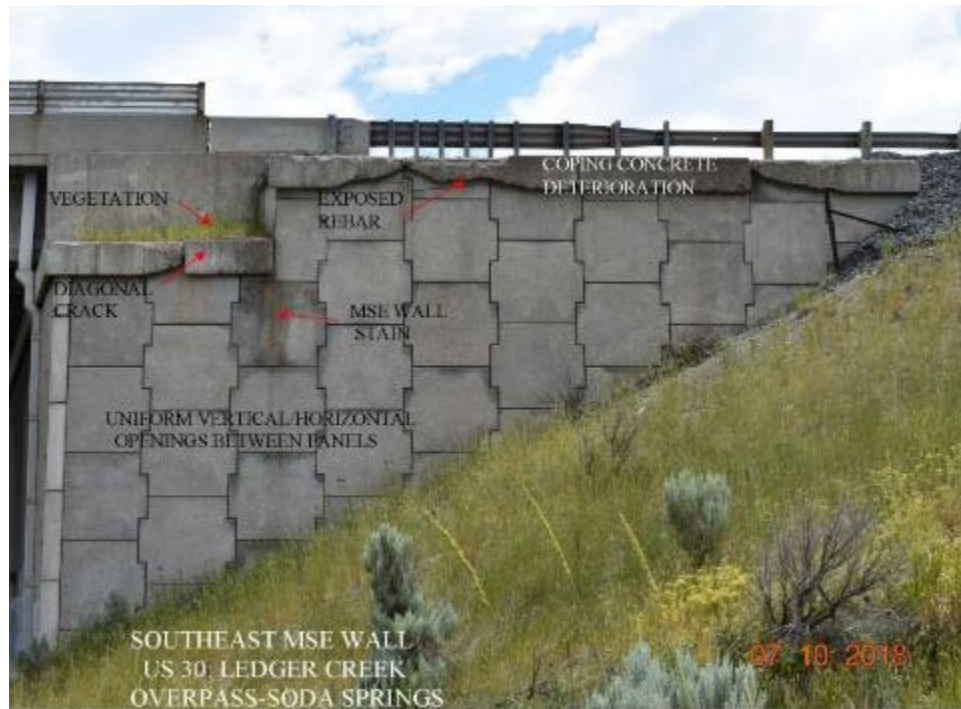
US-30 Ledger Creek Bridge: concrete coping deterioration

Figure 26. Severe Concrete Deterioration of MSE Wall Coping on Ledger Creek Bridge

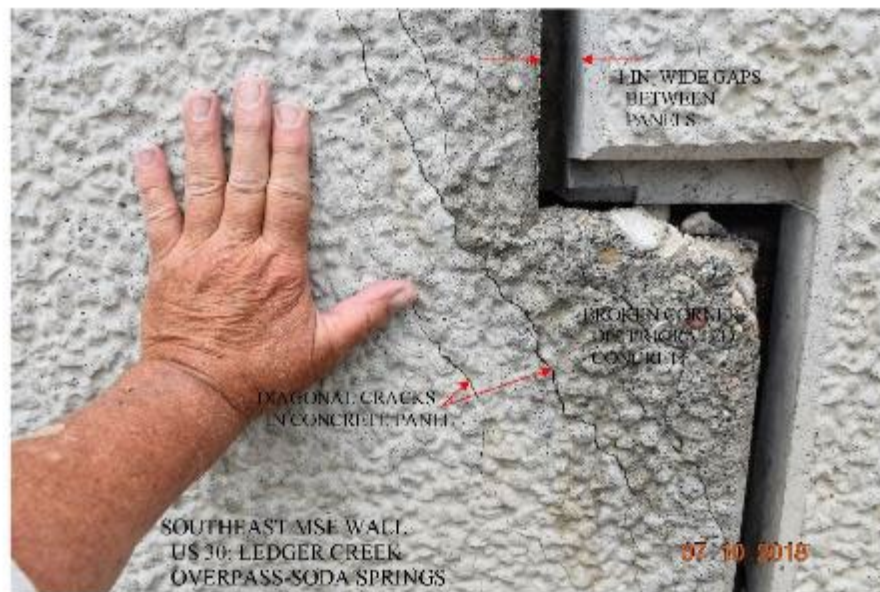
Figure 27. Concrete Deterioration and Diagonal Cracks in MSE Wall at Ledger Creek Bridge

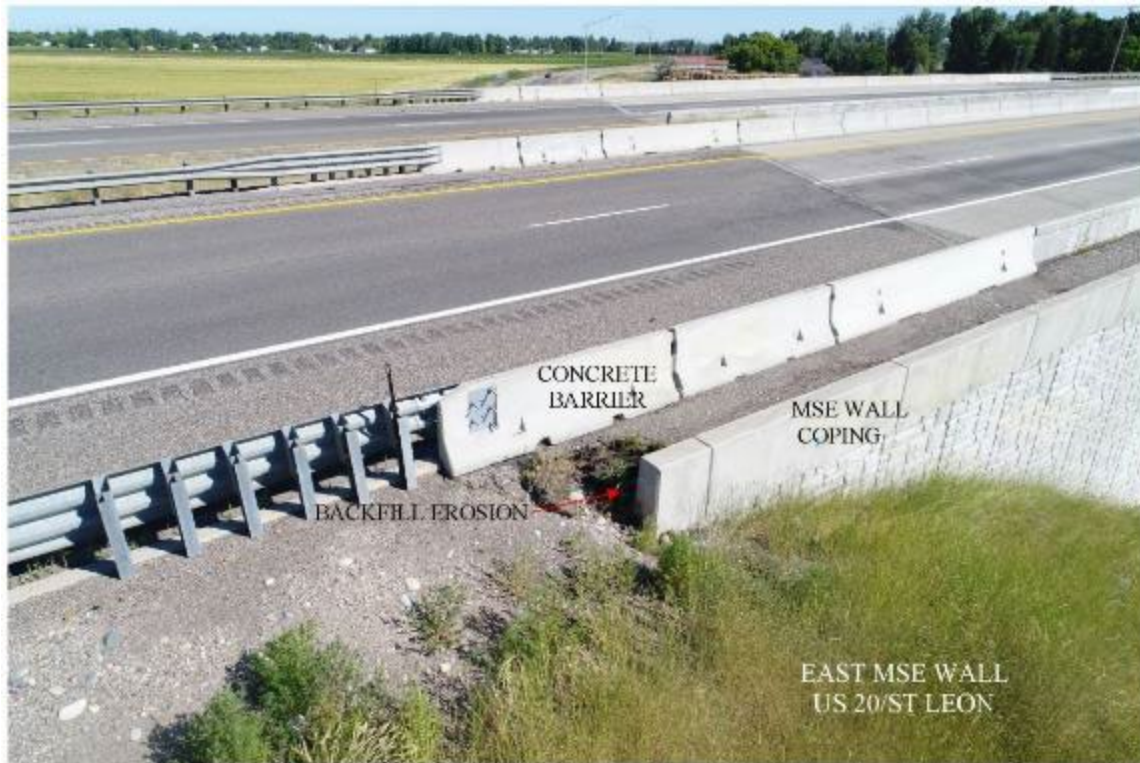
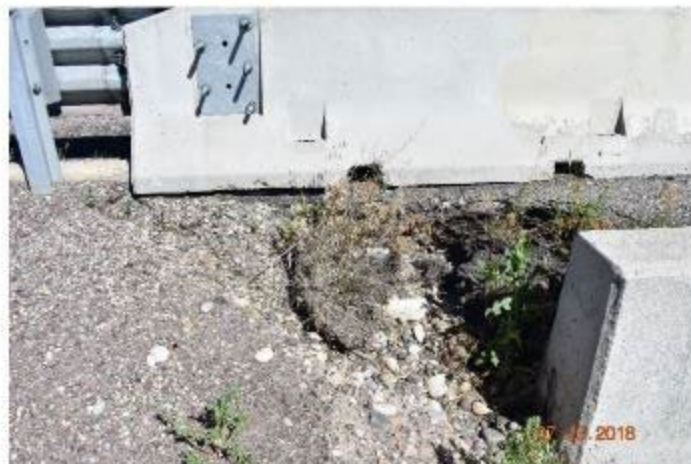
Figure 28. Erosion Along and Behind MSE Wall Coping and Concrete Barrier at US-20, St Leon Exit

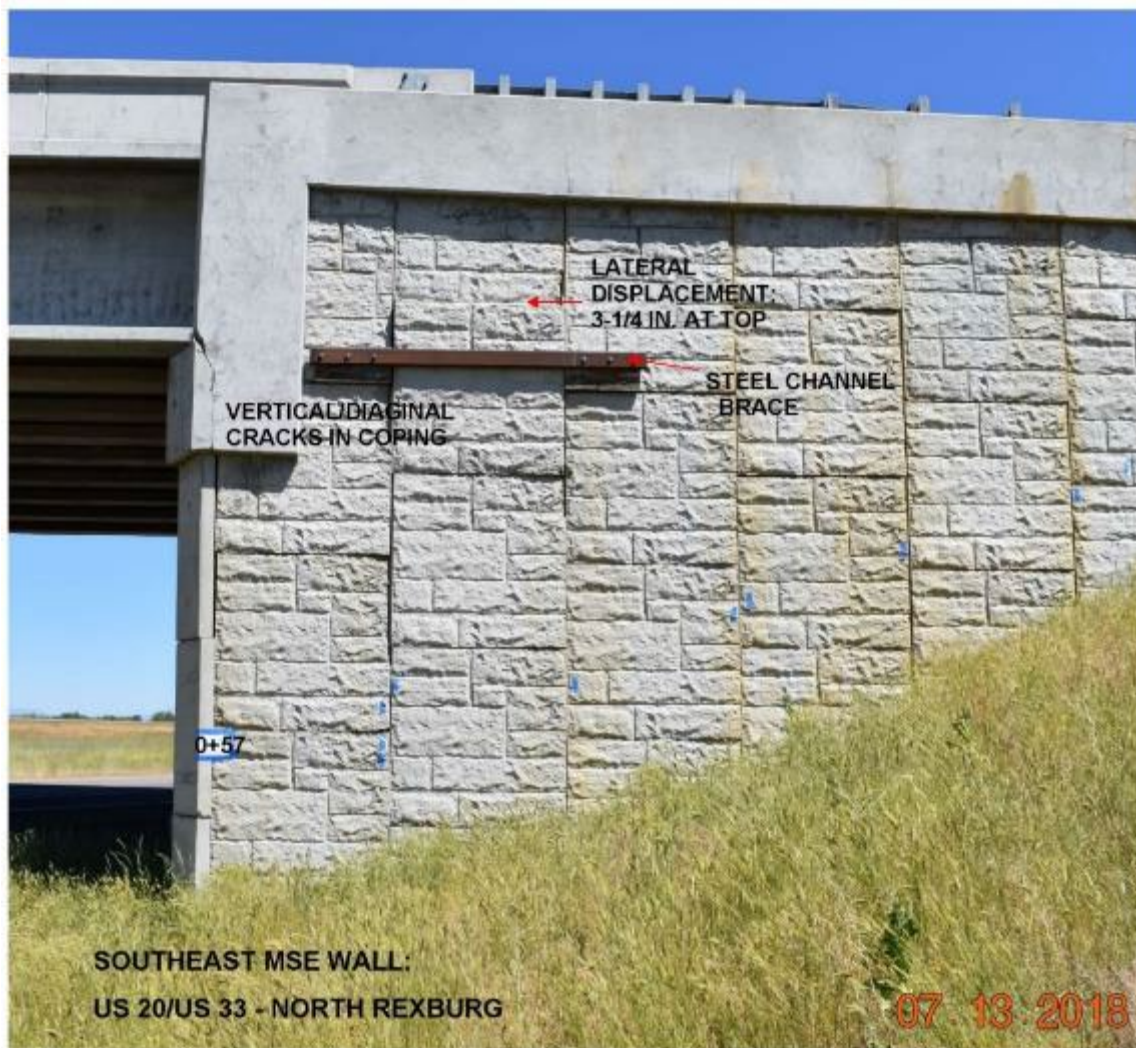
Figure 29. Lateral Displacement and Outward Rotation of MSE Wall Panels with Open and Tight Joints in Southeast MSE Wall at SH 33 Exit, US-20

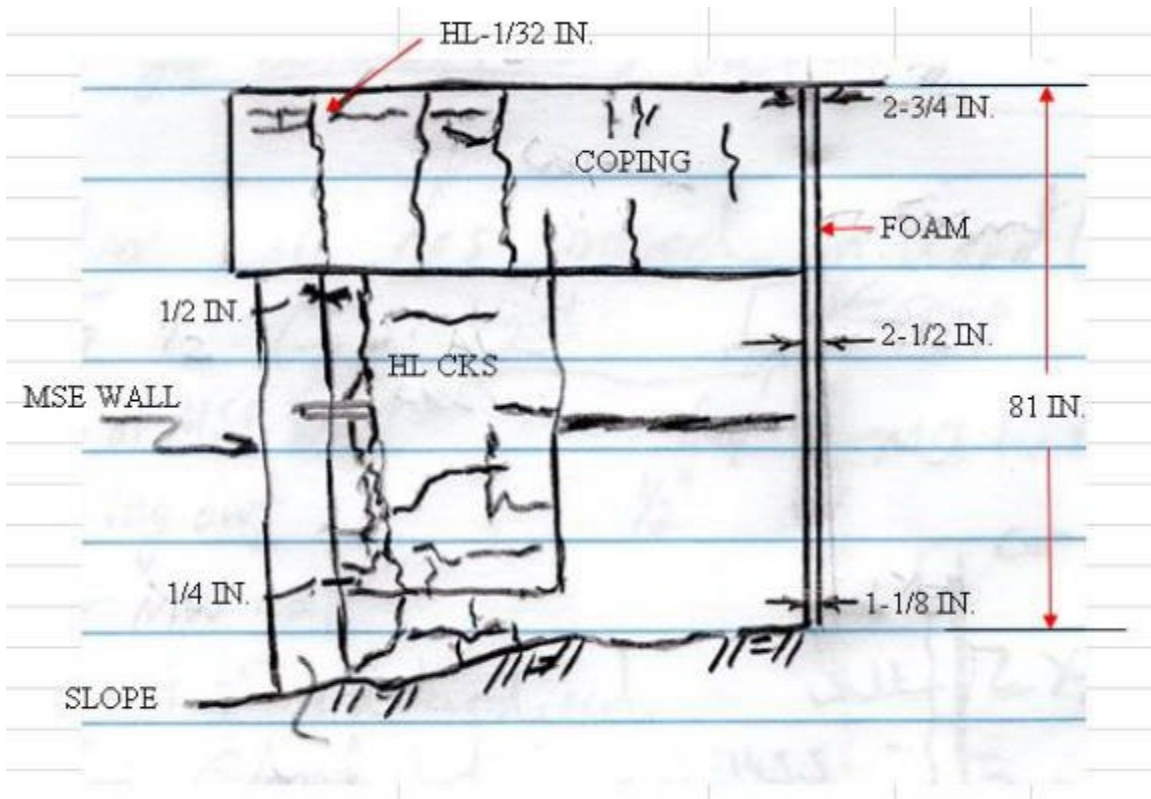
Figure 30. Damage Map of East MSE Wall at South Abutment of Bitch Creek Bridge, SH-32

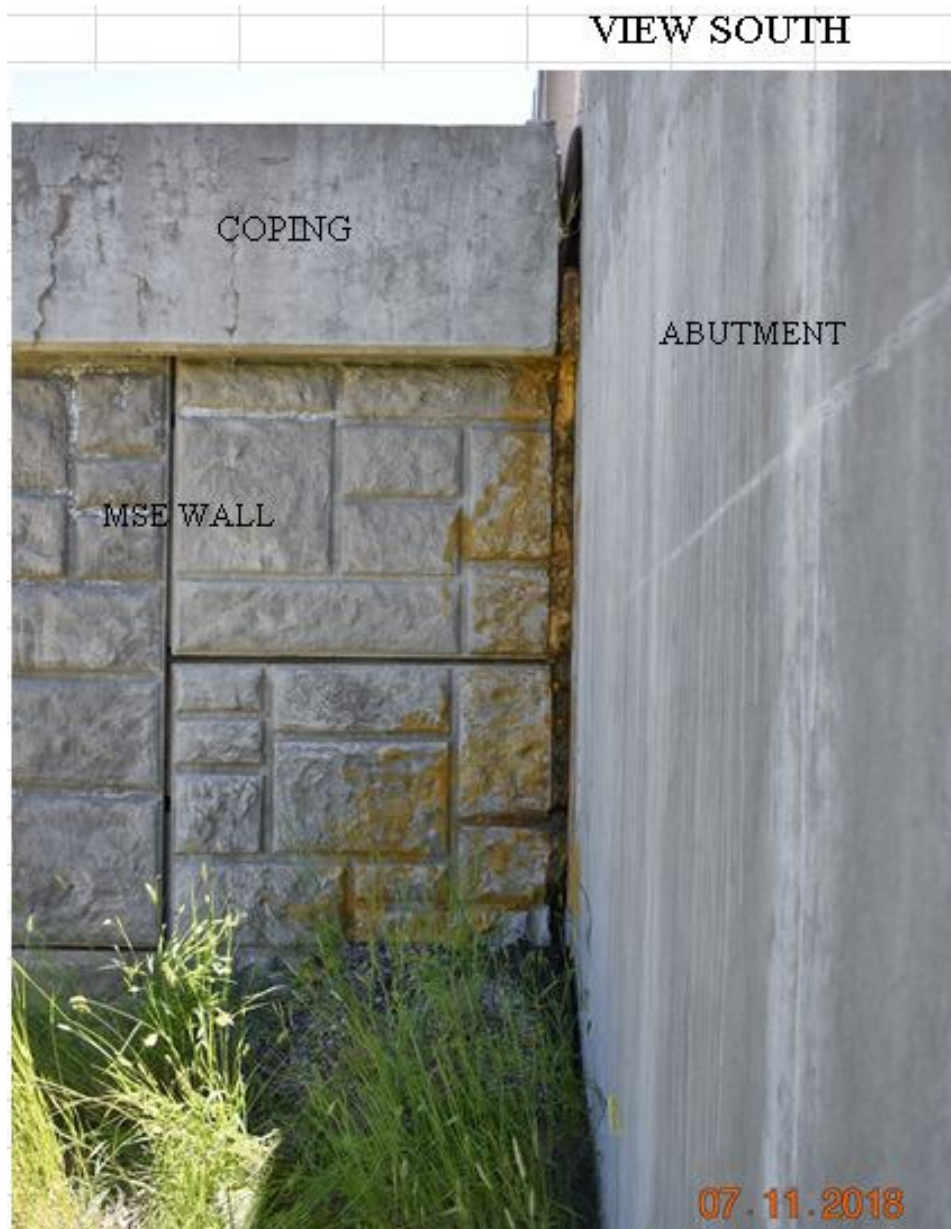
Bitch Creek Bridge, SH-32: MSE wall and abutment separation; longitudinal cracks in pavement adjacent to MSE wall built on embankment slope.

Figure 31. Photo of MSE Wall Damage at Interface with SE Abutment of Bitch Creek Bridge, SH-32

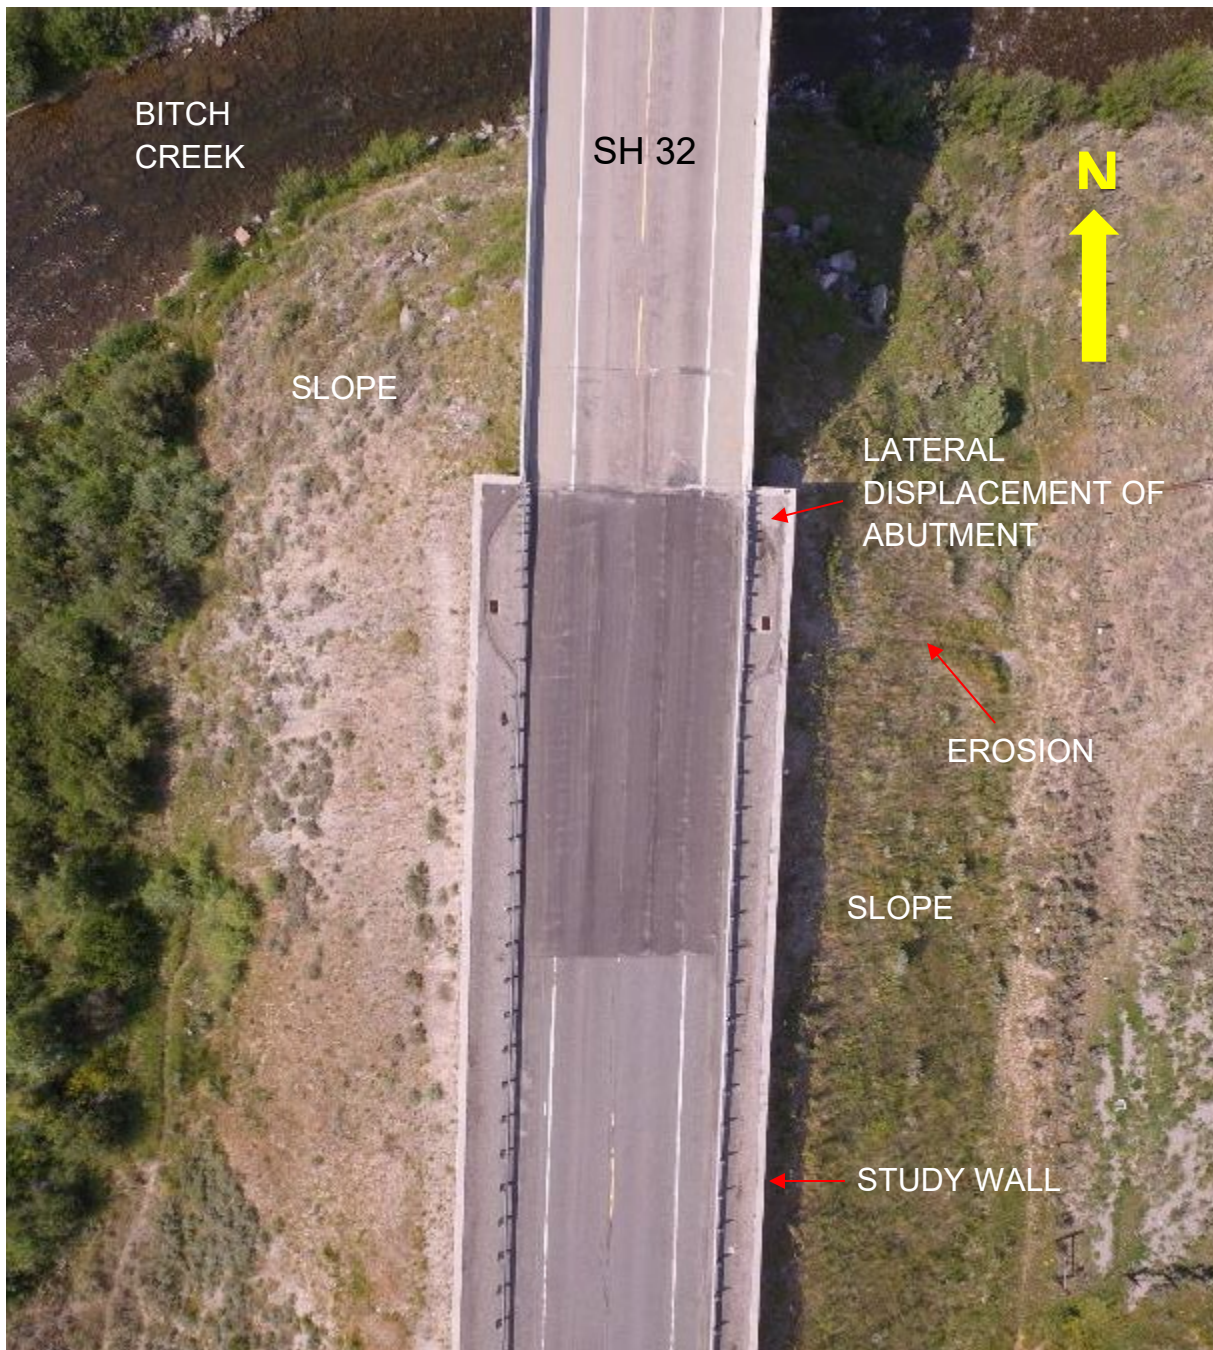
**Figure 32. sUAV Photo of Pavement Overlay in Area of MSE wall/Abutment Movement on Approach to Bitch Creek Bridge**

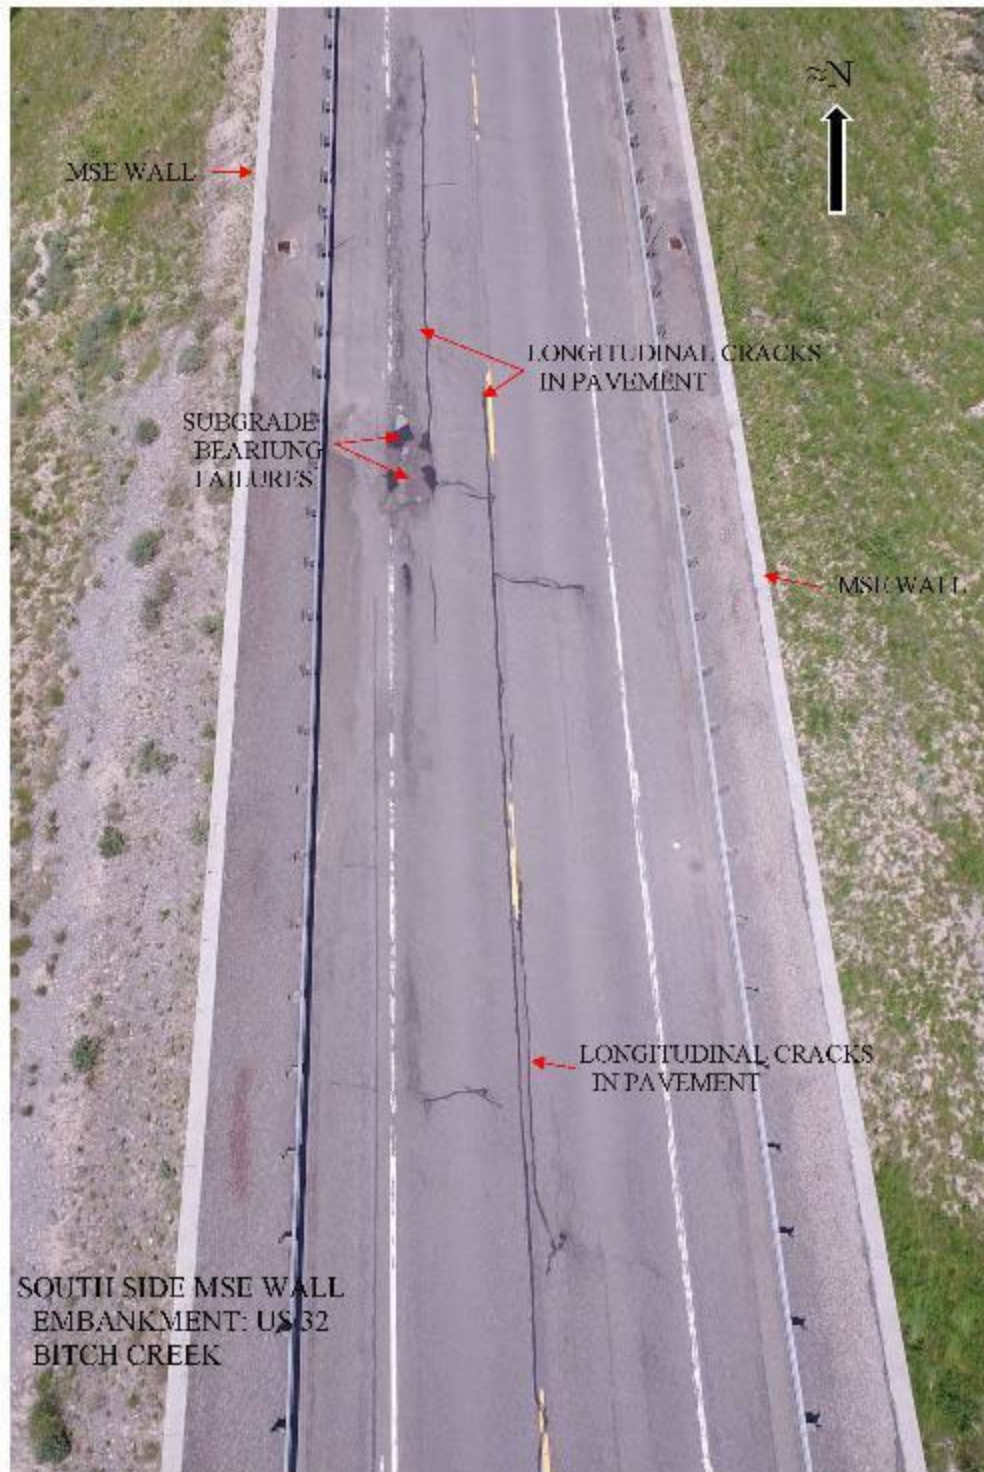
**Figure 33. sUAV Photo of Longitudinal Cracks in Pavement due to Lateral Slope Movement, Bitch Creek Bridge**

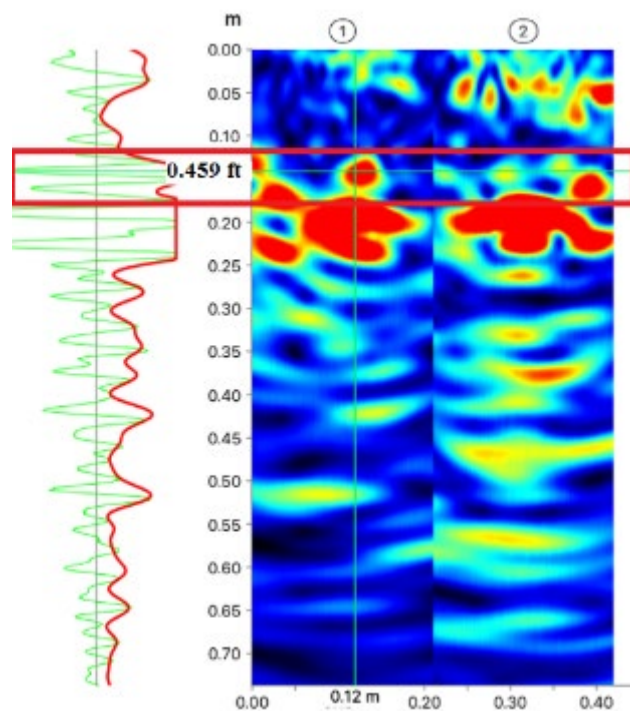
The back of the slab is estimated to be 0.16 meters (0.52 ft or 6.3 inches) from the front of the concrete (Box 1). Any readings greater than 0.16 m, which is the approximate thickness of the slab, should be ignored or discarded. Moreover, all the indicators in Box 4 are the echoes of the ultrasonic pulses that were transmitted into the slab. Depending on strength of the ultrasonic wave and the way in which it penetrates the concrete, one or two echoes may be recorded beyond the thickness of the slab. These echoes are the same representations as the thickness of the concrete and have no bearing on the condition of the backfill or reinforcement located behind the interior face of the slab.

**Figure 47. A-scan (left) and B-scan (right) of potential delaminated area in Wall D3-3**

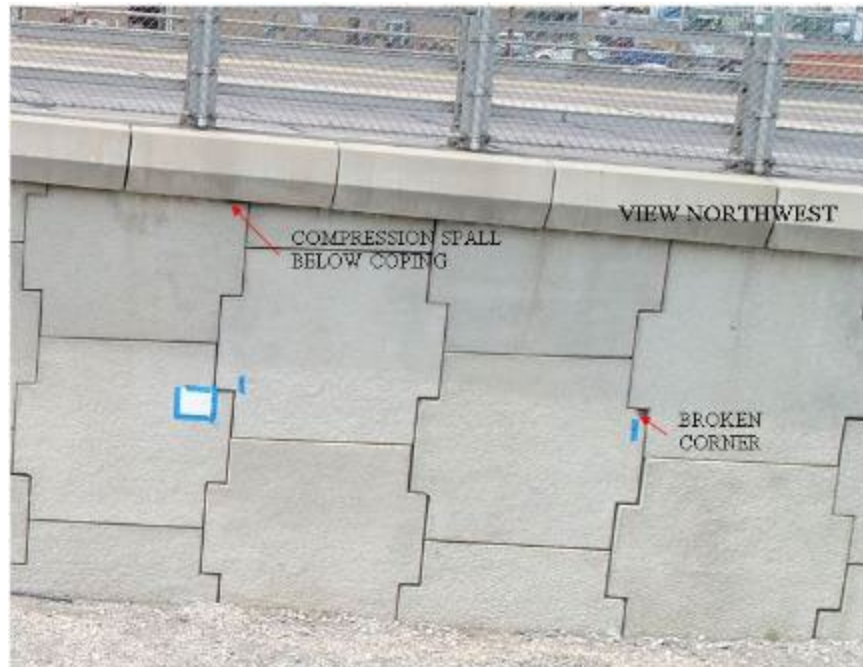
Figure 51. Broken Corner at STA 01+10, Gould Street Overpass, Wall 4

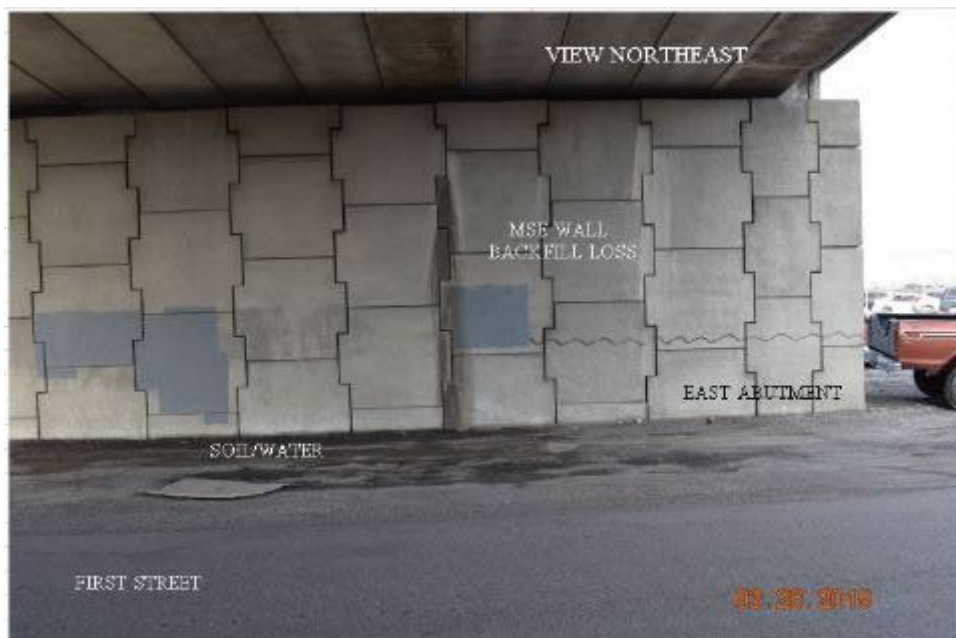
Figure 52. Backfill Loss, Gould Street Overpass, Wall 4

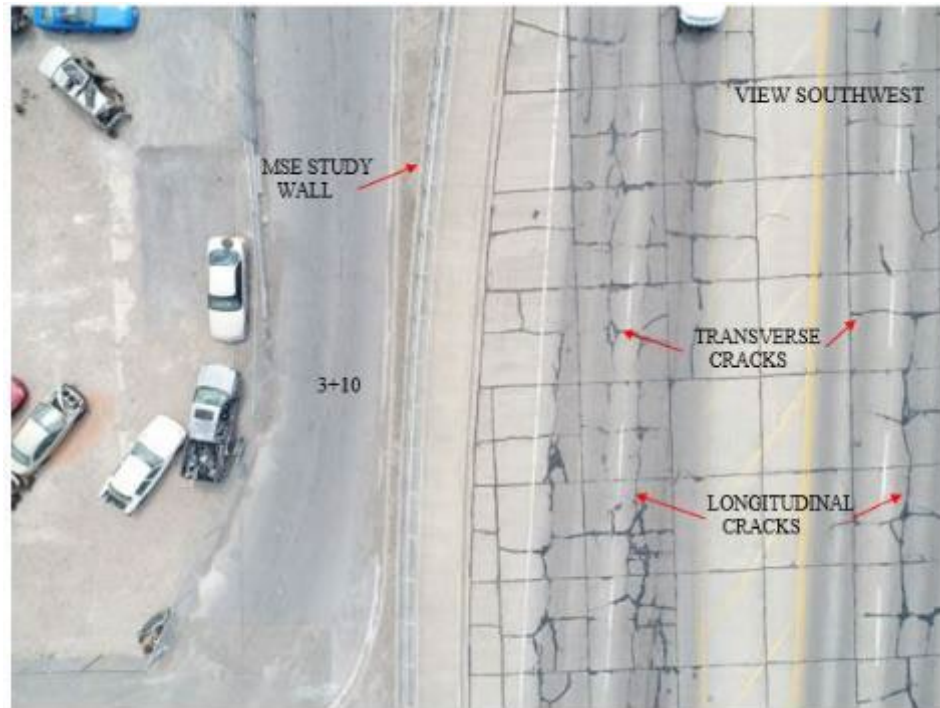
**Figure 53. sUAV Photo of Pavement Cracks, Gould Street Overpass, Wall 4**

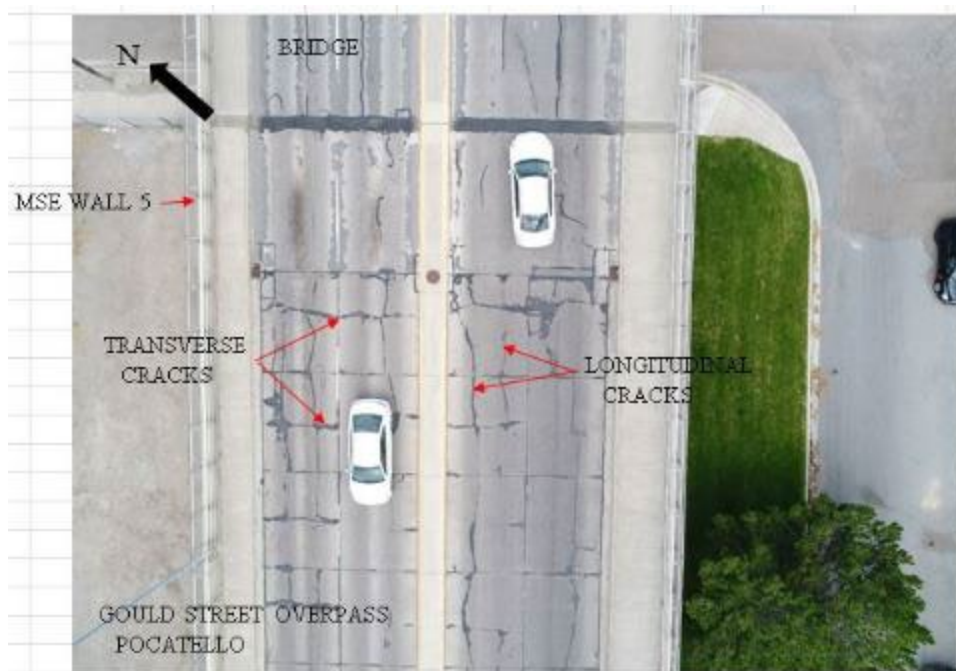
Figure 57. sUAV Photo of Pavement Cracks, Gould Street Overpass, Wall 5

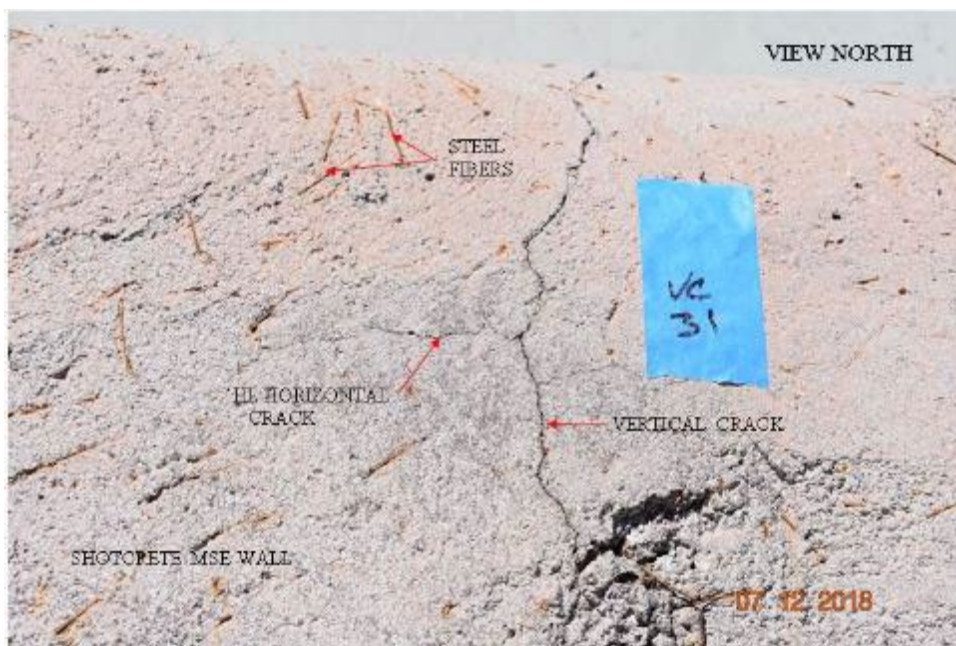
Figure 61. Vert. and Horiz. Cracks in MSE Wall Shotcrete, STA 2 + 37.1, Topaz Bridge

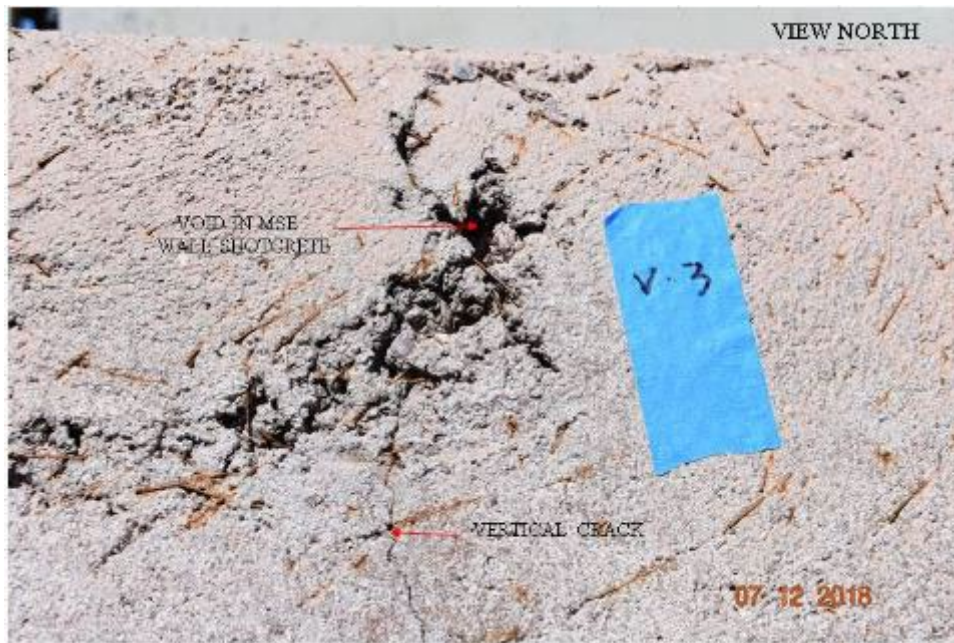
Figure 62. Void and Vert. Crack in MSE Wall Shotcrete, STA 1 + 92, Topaz Bridge

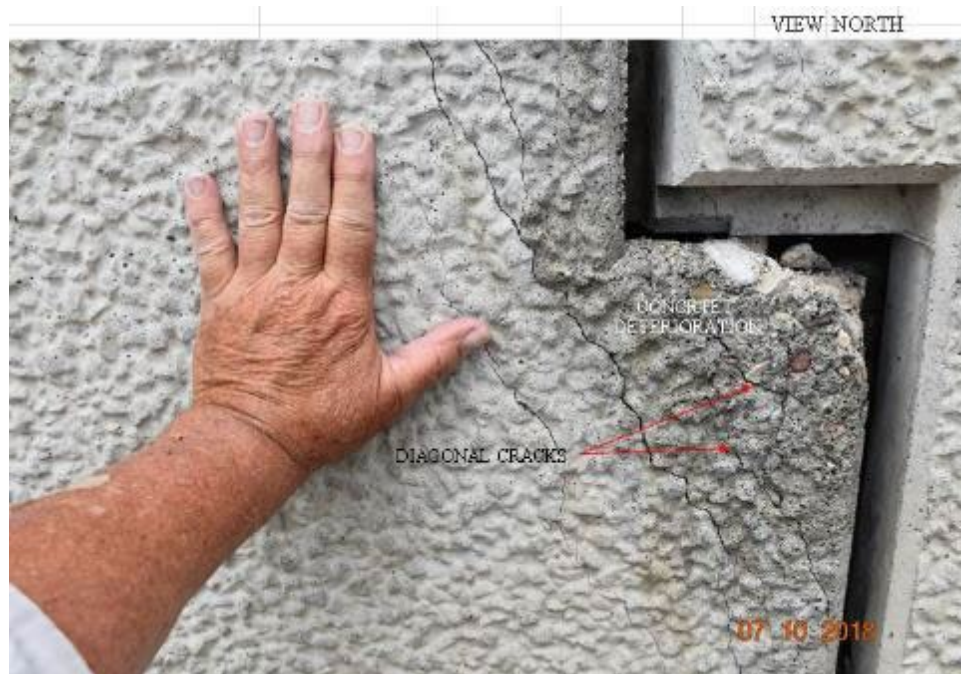
Figure 68. Diag. and Vert. Cracks (HL to 1/16 in) and Concrete Deterioration, Ledger Creek Bridge

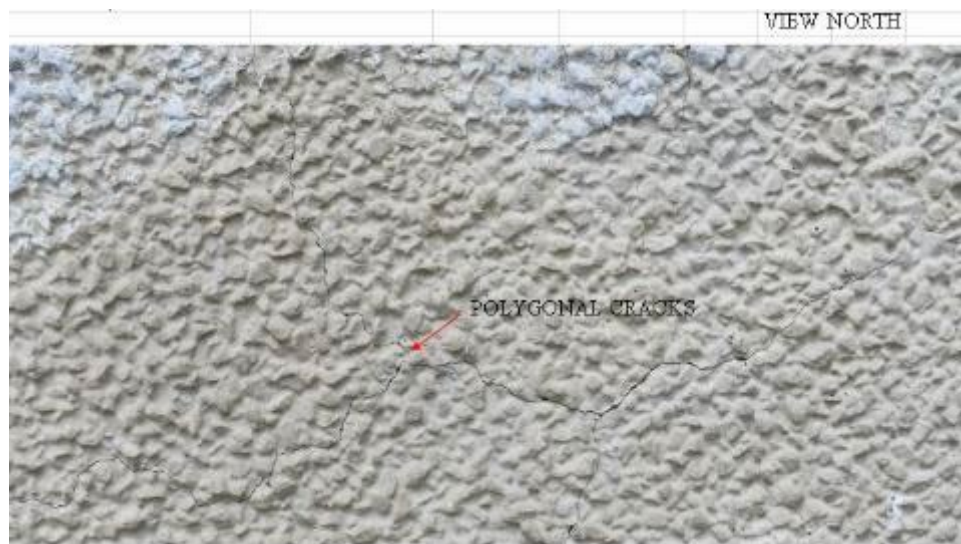
Figure 69. Polygonal Cracks (HL to 1/32 in) at STA 0+38, S. Wall, E. Abutment, Ledger Creek Bridge

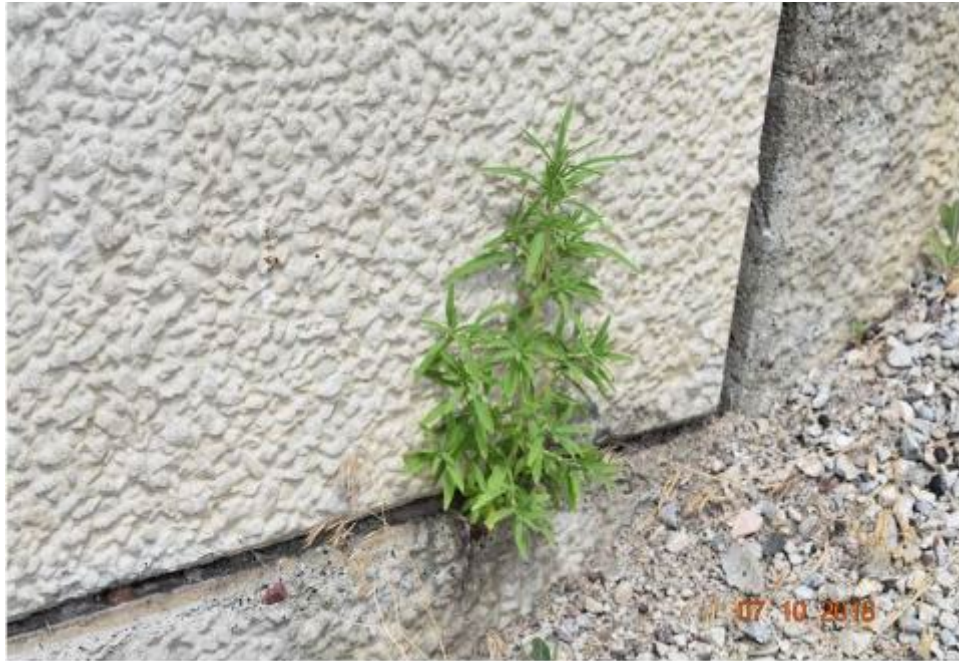
**Figure 70. Vegetation Growth, STA 0+41.7, S. Wall, E. Abutment, Ledger Creek Bridge**

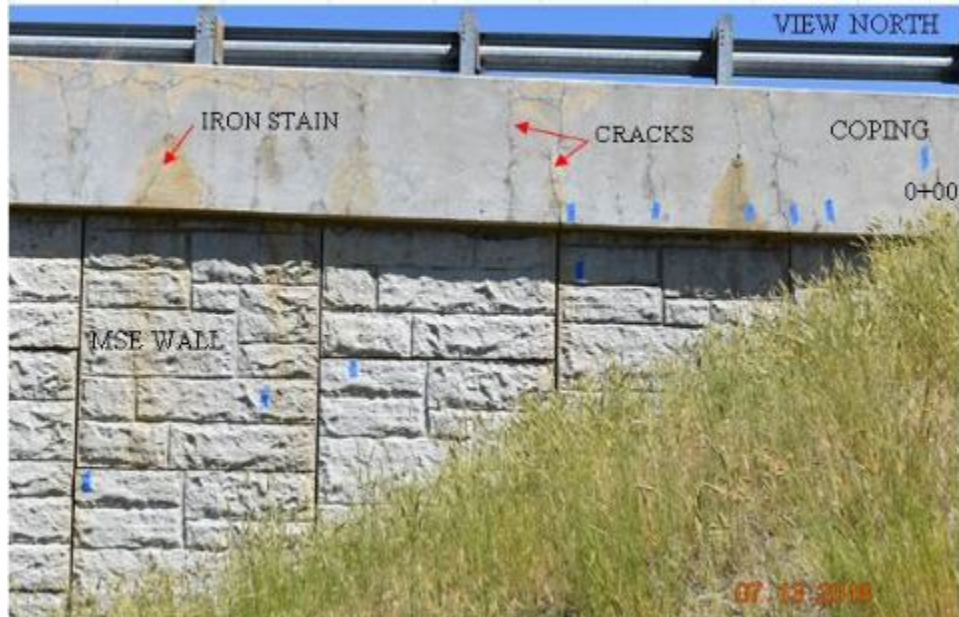
Figure 87. Close-up View of Coping Damage at S. MSE Wall, E. Abutment of SH-33 Exit at US-20

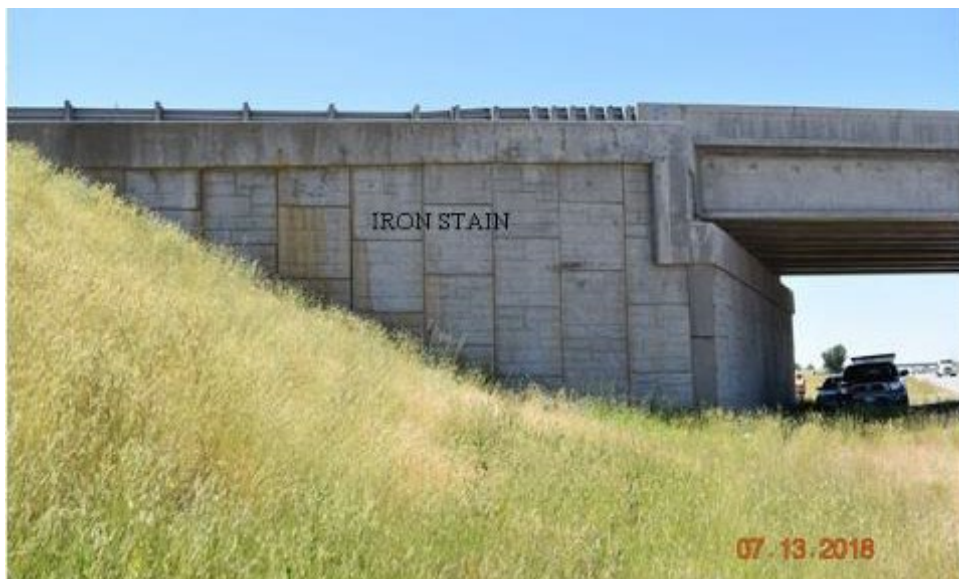
**Figure 89. Iron Staining and Coping Cracks, N. MSE Wall, E. Abutment of SH-33 Exit at US-20**

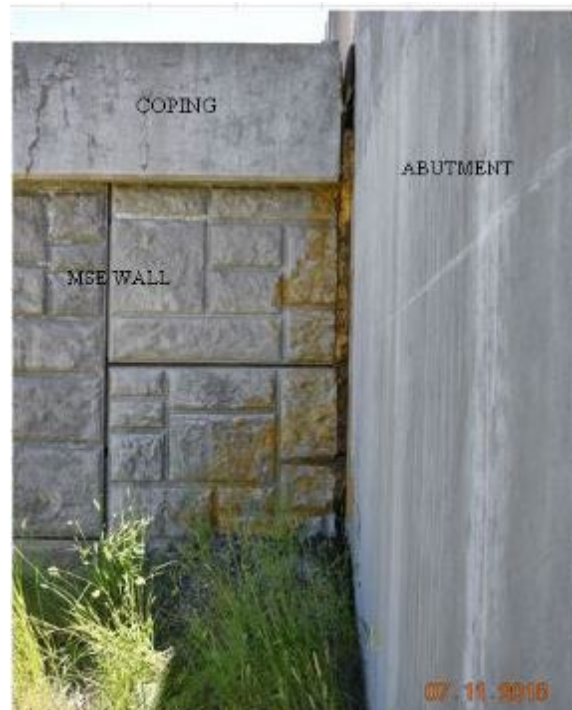
Figure 94. Lateral Displacement Damage at North End of South MSE Wall, Bitch Creek Bridge

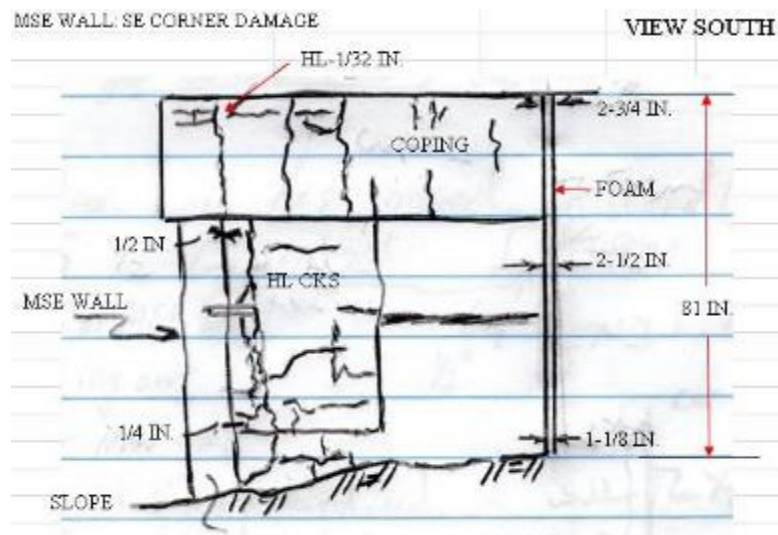
Figure 95. Map of Lateral Displacement Damage at North End of South MSE Wall, Bitch Creek Bridge

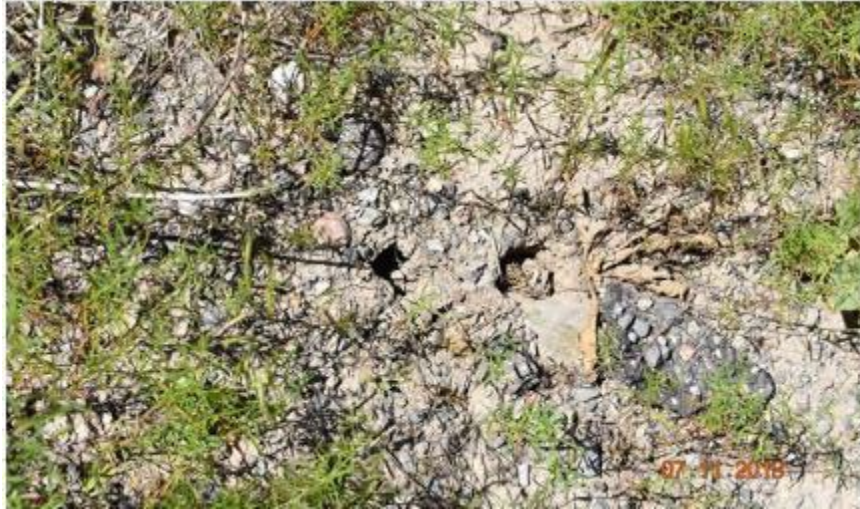
Figure 96. Animal Burrows at STA 2+77,1, South MSE Wall, Bitch Creek Bridge

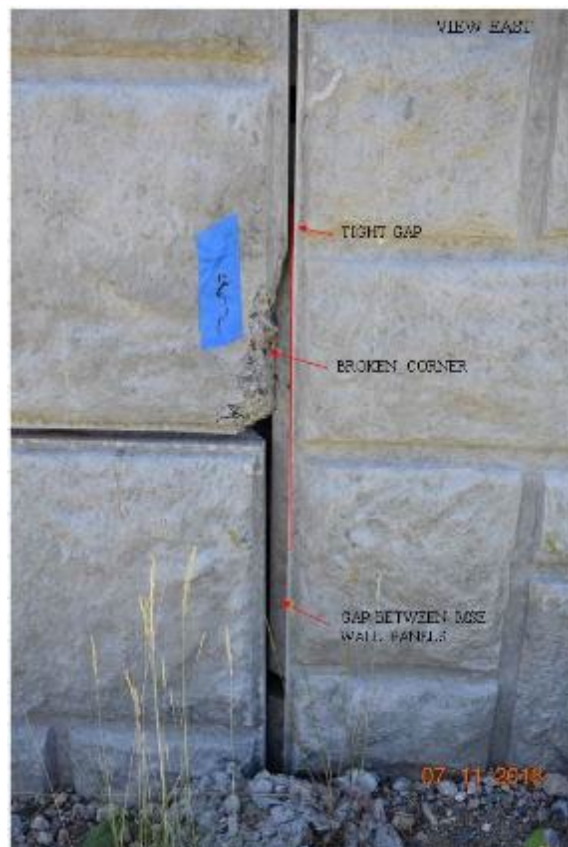
Figure 97. Broken Corner in East MSE Wall, South Abutment, at STA 0+17.1, Bitch Creek Bridge
