**RP 270**

# **Development of an Inventory and Inspection Database Framework for Asset Management of MSE Walls**

Idaho Transportation Department

July 2019

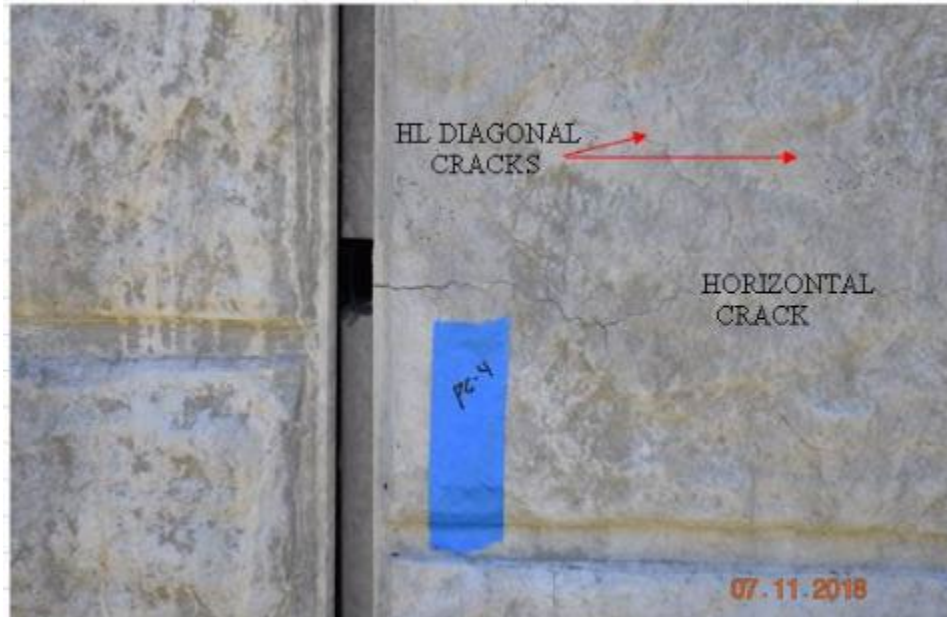
**Figure 98. Horiz. and Diag. Cracks in East MSE Wall, South Abutment at STA 0+77.1, Bitch Creek Bridge**

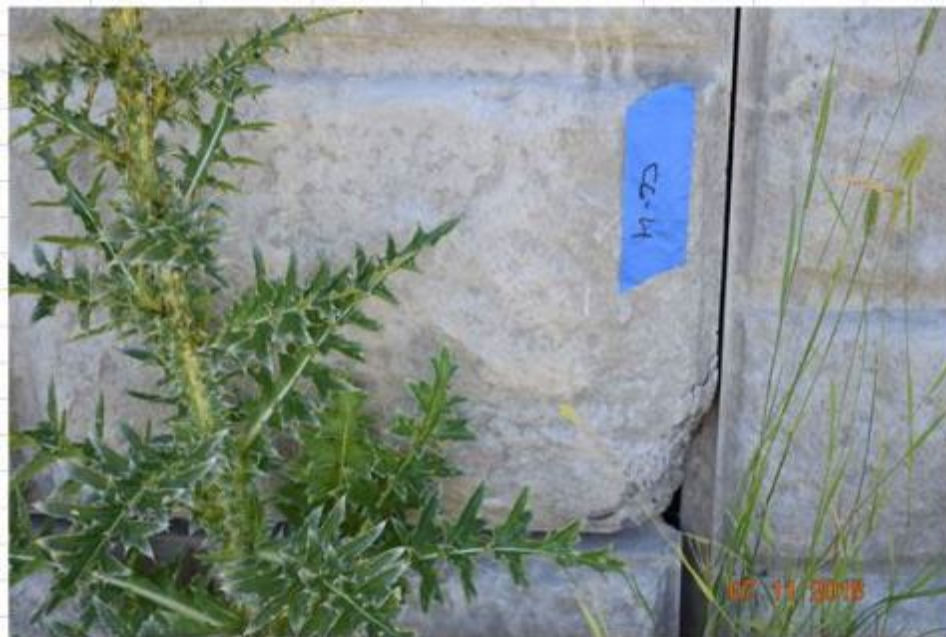
**Figure 99. Broken Corner in E. MSE Wall, S. Abutment at STA 0+47.1, Bitch Creek Bridge**

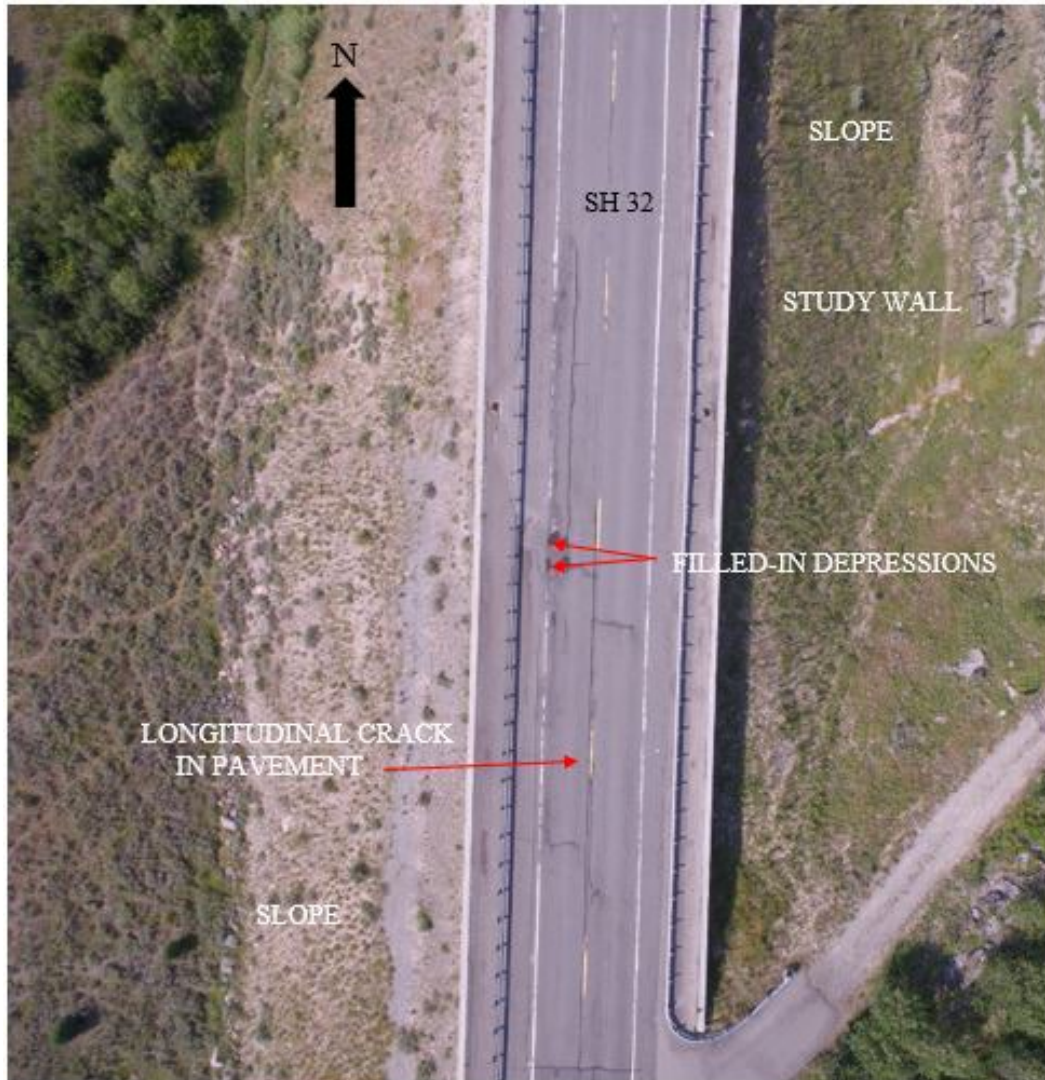
Figure 100. sUAV Photo of Longitudinal Cracks in Pavement from Lateral Slope Movement
