NVIC 4-85 CH-1

**NAVIGATION AND VESSEL INSPECTION CIRCULAR NO. 4-85 CHANGE 1**

**Subj: Change 1 to NVIC 4-85 of 29 May 1985, Subj: Recalls and Other  
Corrective Measures for Lifesaving and Fire Protection Equipment**

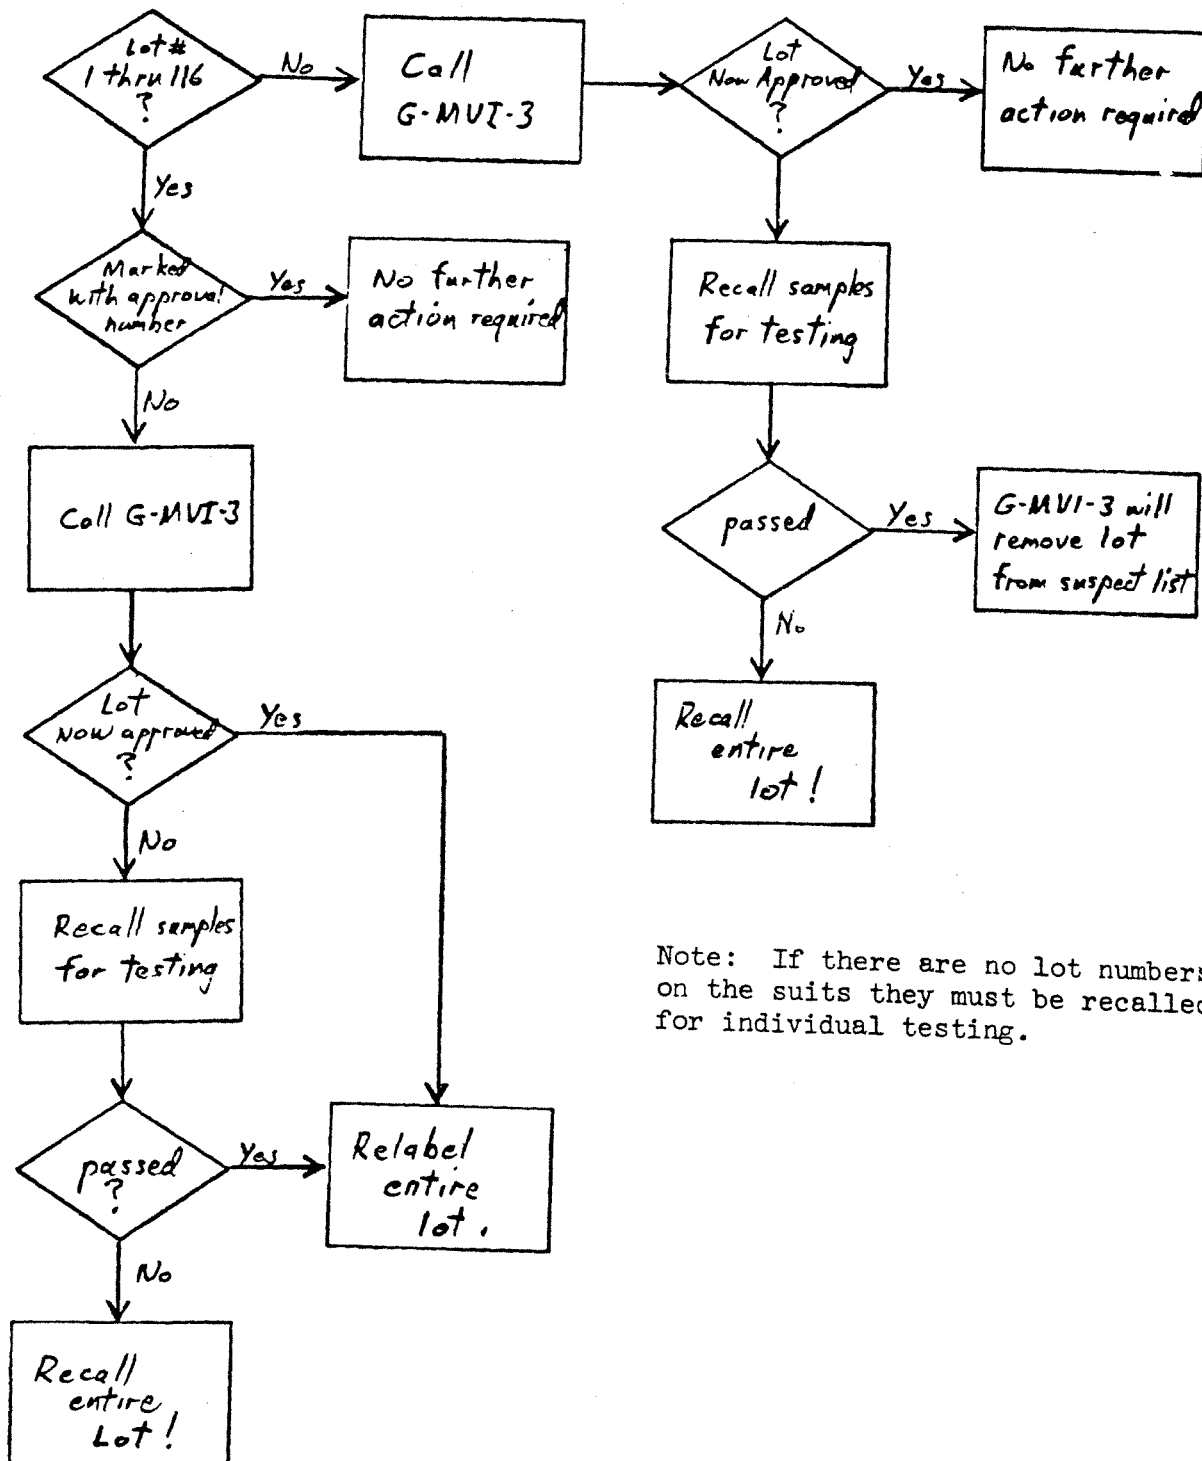
# FITZ-WRIGHT SUITS RECALL PROCESS

- a. Fitz-Wright exposure suits up to and including Lot 116 were inspected and tested for Coast Guard approval by Warnock Hersey Professional Services but were not marked with an approval number on the suit.
- b. Production inspection has since been taken over by Underwriters Laboratories (UL), but suits from lot numbers 117-132, 134, and 136-137 may have been labeled as Coast Guard approved even though they were not inspected and tested at the factory by Warnock Hersey or UL.
- c. Some Fitz-Wright suits have been found to have no lot numbers, and their factory inspection status can not be determined.

- c. The flow chart on the following page is provided to guide decisions on testing and relabeling.

Note: If there are no lot numbers on the suits they must be recalled for individual testing.

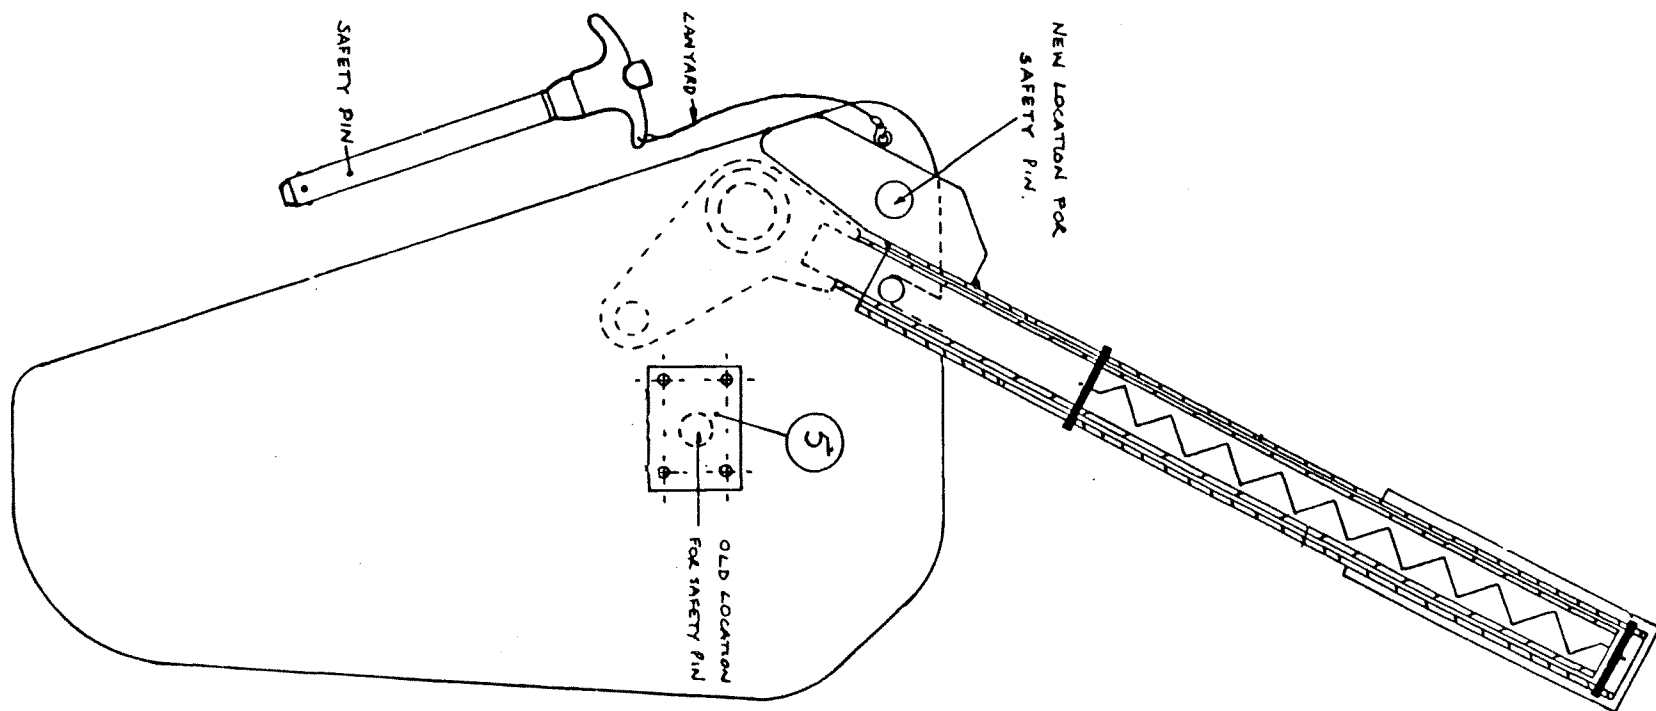
1. PROBLEM. The safety pin on the Titan release gear operating handle used in certain Watercraft America lifeboats, can be inserted before the handle is in the safe, fully closed position. In this condition, the release hooks may appear to be fully closed, but may unexpectedly open when a load is applied.

- a. Titan release gear with approval number 160.033/69/0 must be modified. Titan gear that has been modified can be identified by the cover plate over the old safety pin hole (item 5 on the drawing on the following page), and by the plate added to the release gear handle to accommodate the new safety pin location (see "NEW LOCATION FOR SAFETY PIN" on the drawing).

3. ACTION.
  - a. Vessel and MODU operators having Watercraft America lifeboats equipped with Titan gear having approval number 160.033/69/0 shall make sure the release gear is modified in accordance with Watercraft America drawing SP-201 and Engineering Instruction P-131, both dated 28 October 1985. The Coast Guard Officer in Charge of Marine Inspection shall be notified before the modification work begins. The drawing and instruction may be obtained from:

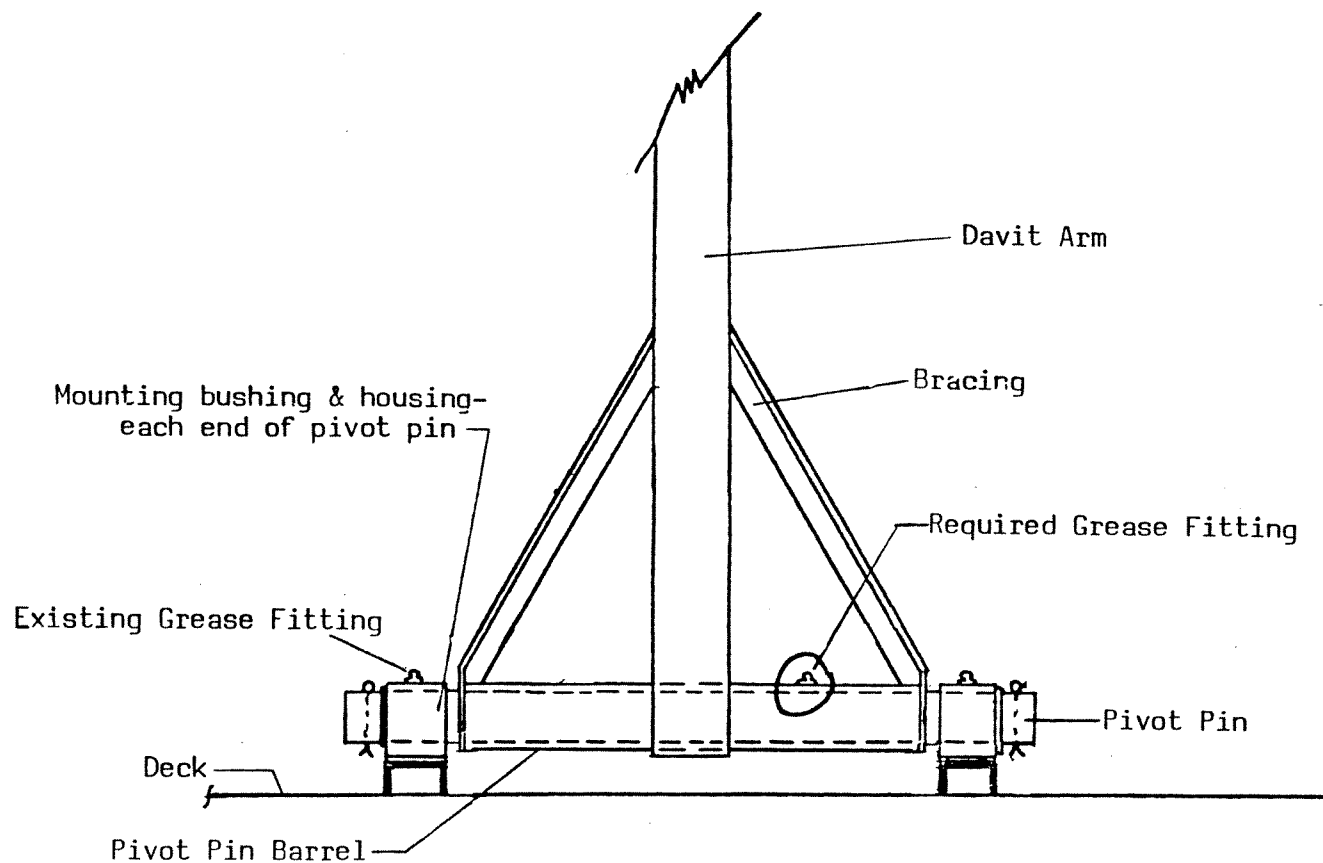
Looking Inboard at Davit Arm Base

1. PROBLEM: The pivot pins of certain mechanical davits arranged as shown in the figure on the following page, are subject to corrosion and seizure, due to water accumulation inside the pivot pin barrel.
2. ACTION: To prevent corrosion and seizure of the pivot pin, the pivot pin barrel should be equipped with a lubrication fitting as shown in the figure. Grease should be applied to this fitting regularly to exclude accumulated water in the barrel in order to permit easy operation of the davit.
  - a. Modification of mechanical davits to add this lubrication fitting is authorized. The Coast Guard Officer in Charge of Marine Inspection shall be notified before the modification work begins.
  - b. Coast Guard inspectors will require the addition of lubrication fittings to the pivot pins of mechanical davits where it is evident that water accumulation and corrosion is a problem.

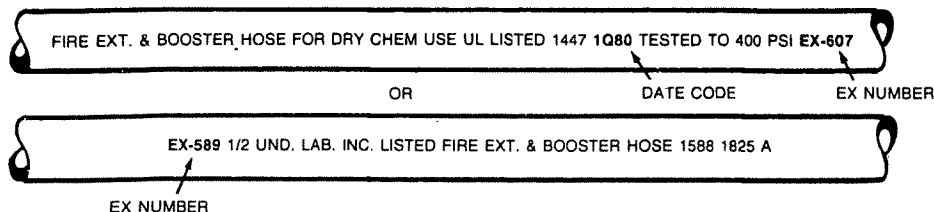
**ILLUSTRATION 1**

1. If extinguisher has a yellow "Inspected" sticker on the front, go to step 9.
2. Find U.L. Listing information printed on hose (either white print or molded on hose cover). (See illustration 1 below.)

3. If there is no printing, or printing is unreadable, replace hose assembly and destroy old hose.
