## NAVIGATION AND VESSEL INSPECTION CIRCULAR NO. 1-84

Subj: Lack of Topstitching on Some Type I Personal Flotation Devices (PFDs) Ref: (a) 46 CFR 160.006-2

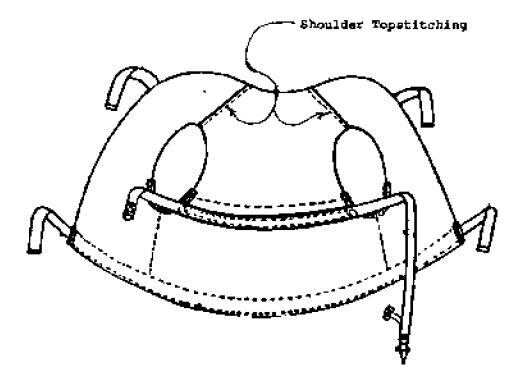
- 2. <u>BACKGROUND</u>. We have received several failure reports concerning Gladding Corporation (now Paris Southern Corporation) AF 500, Model 3, Type I PFDs, approval number 160.002/78/0. After examining these PFDs, we found that the required topstitching was omitted from the shoulder seams. This severely weakens the shoulder of the device, allowing the shoulder seams to be pulled apart rather easily. To date, the problem has been detected in Lots 9, 10, 16, 17, 24, 25, 28, and 32. Therefore, all Lots initially inspected between approximately September 1980 and March 1982 should be identified as possibly having the defect. Illustrations of the construction of the shoulder seam with and without topstitching are shown below:

The locations of the seams in question are shown in the following illustration:

3. <u>DISCUSSION</u>. The manufacturer has agreed to repair the devices or provide instructions on how to repair the devices. If a device is returned to them, the manufacturer will add the topstitching and return the device to the owner, free of charge. If the owner wants to repair the devices without returning them to the manufacturer, the owner must notify the Officer in Charge, Marine Inspection prior to making the repairs as specified in reference (a). Instructions for making the repair will be provided free by the manufacturer. The manufacturer's address is:

- a. Vessel owners/operators and Coast Guard personnel should closely check any Gladding Corporation (now Paris Southern) AF 500, Model 3, Type I PFDs, approval number 160.002/78/0 manufactured between approximately September 1980 and March 1982 to see if the topstitching has been omitted. If there is no topstitching, the problem should be corrected as discussed in Paragraph 3.
- b. Officers in Charge, Marine Inspection should normally allow the repairs to be made provided the owner has appropriate equipment and thread and agrees to follow the manufacturer's instructions.
