TREASURY DEPARTMENT
UNITED STATES COAST GUARD

NAVIGATION AND VESSEL INSPECTION CIRCULAR NO. 11-63

Subj: LSTs as unmanned barges; structural reinforcement and drydocking; hull inspection requirements

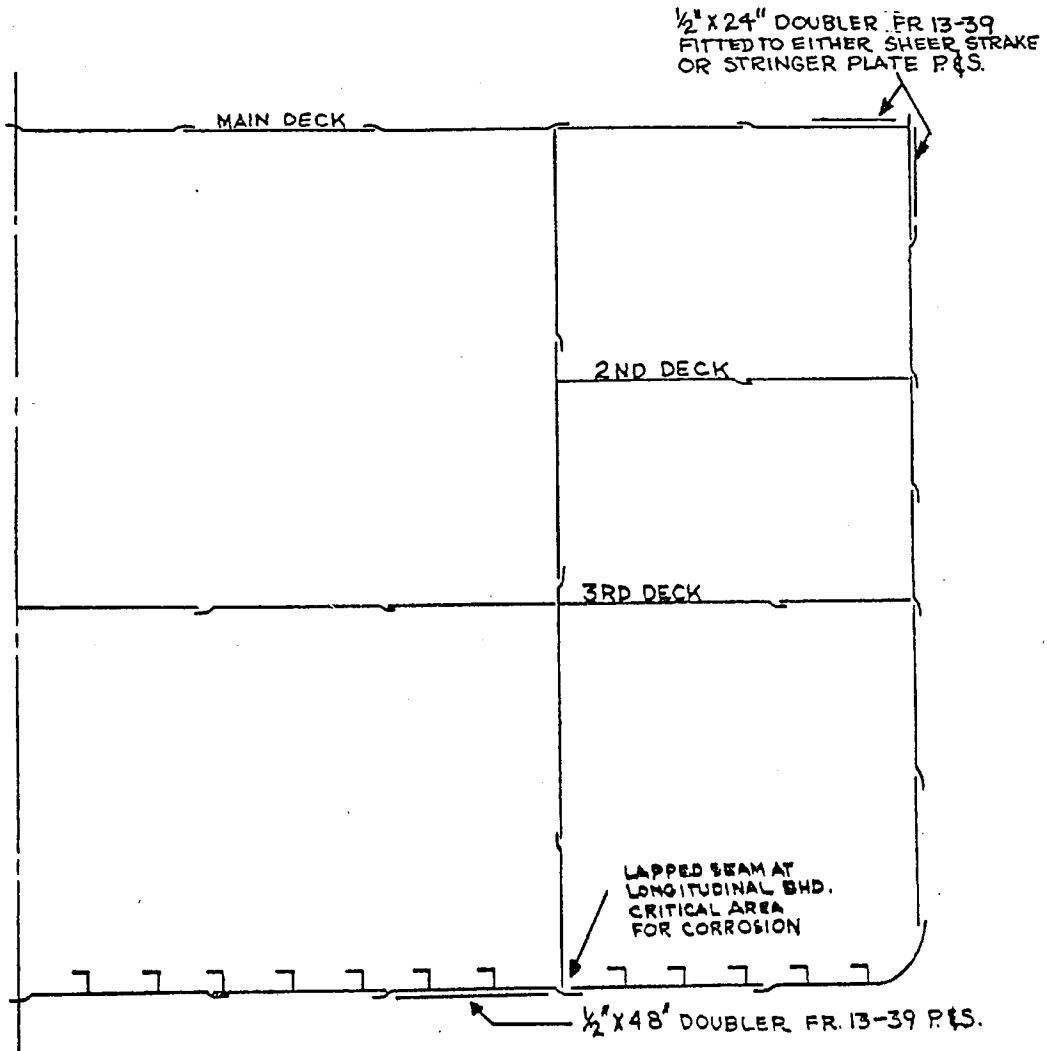
FIG. 1

TYPICAL SECTION - LST
SHOWING STRUCTURAL REQUIREMENTS FOR UNMANNED OPERATION

- (2) Continuous longitudinal bottom doublers $\frac{1}{2}$ " x 48" shall be fitted port and starboard on the bottom shell as shown in Figure 1. These doublers shall extend from Frame 13 to Frame 39. The lapped seams in way of the longitudinal bulkheads shall be sound with no significant localized wastage in the plating adjacent to the welds (Fig. 5). Where such wastage is apparent the lapped seam shall be removed and the required doubler shall be centered on the longitudinal bulkhead as shown in Figure 6.

- (3) A continuous longitudinal sheer strake or stringer plate doubler $\frac{1}{2}$ " x 24" shall be fitted port and starboard as shown in Figure r. These doublers shall extend from Frame 13 to Frame 39. If the mean operating draft of the vessel is to be 12' or less, consideration may be given by the Commandant to omit these doublers depending upon the nature and severity of the intended service.

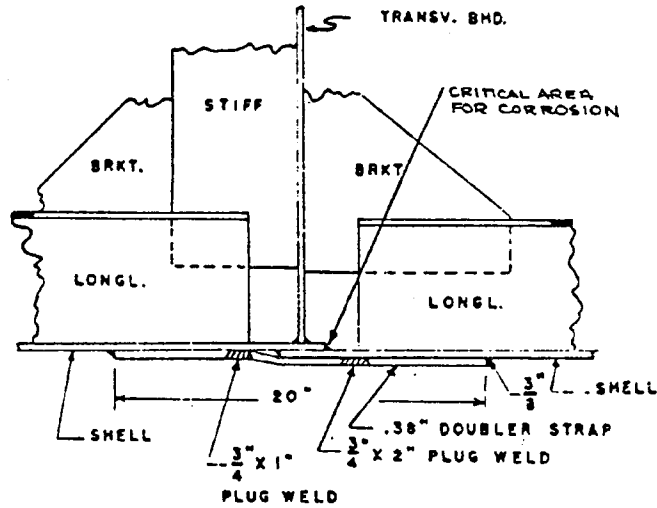
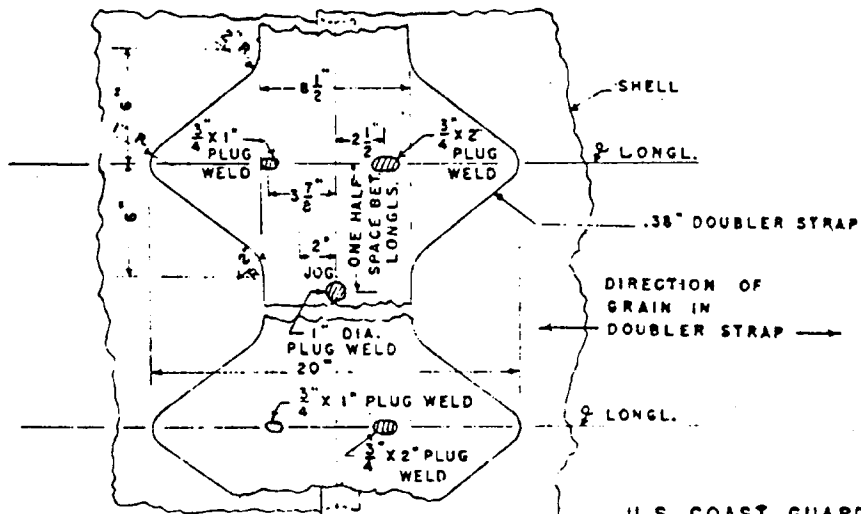
FIG. 3 ELEVATION

STRAP REINFORCEMENT OF SHELL LAPPED BUTTS, FRGS. 13-35 INCL.

- (1) Existing lapped butts in shell and deck plating at Frames 13-35 inclusive shall either be reinforced by the fitting of scalloped doubler straps as shown in Fig. 3, or be modified as shown in Fig. 4. Where the reinforcement shown in Fig. 3 is used, existing welds in the lapped butts, both internal and external, must be sound with no significant localized wastage in the plating adjacent to the welds. This is especially important at the internal welds of the butts in the bottom plating (Fig. 3). Where such wastage is apparent the bottom butts shall be reworked in accordance with the method shown in Fig. 4.

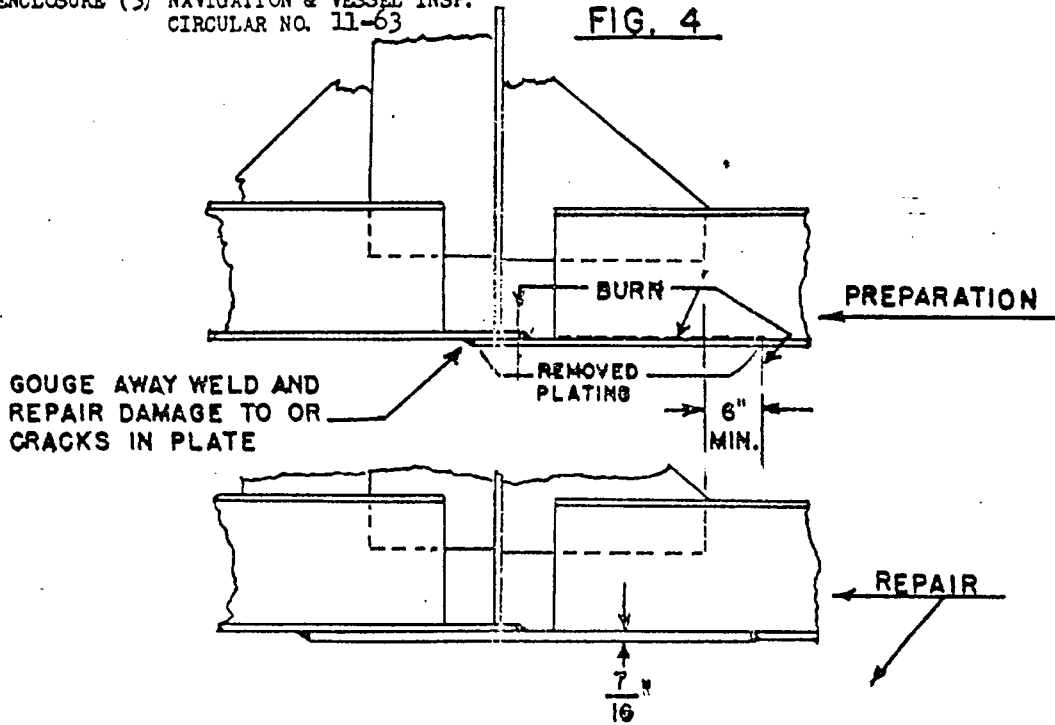
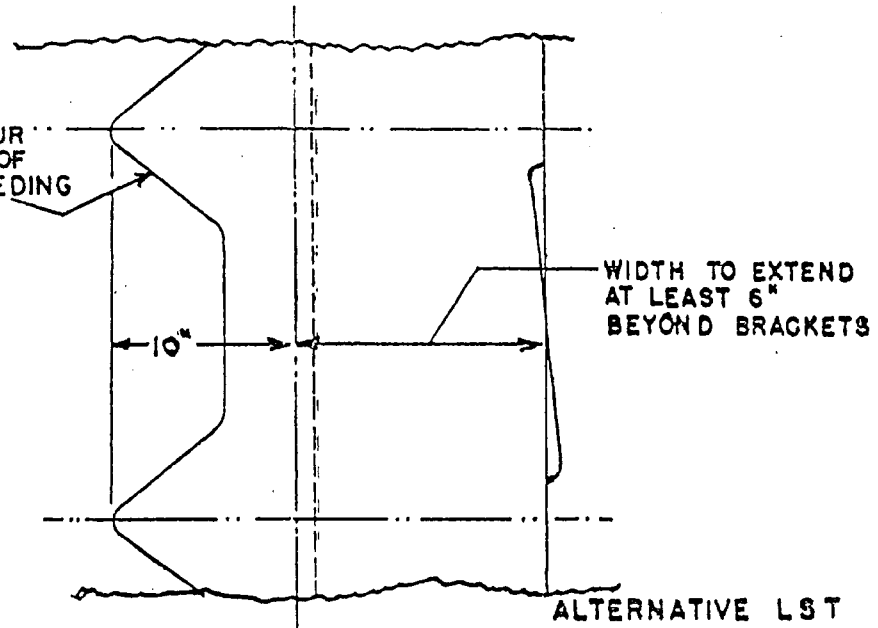
FIG. 4

ALTERNATIVE LST
HULL BUTTS ALTERATION
U.S. COAST GUARD
M.M.T. 9 MARCH 1956
ALT. 18 AUG. 1956

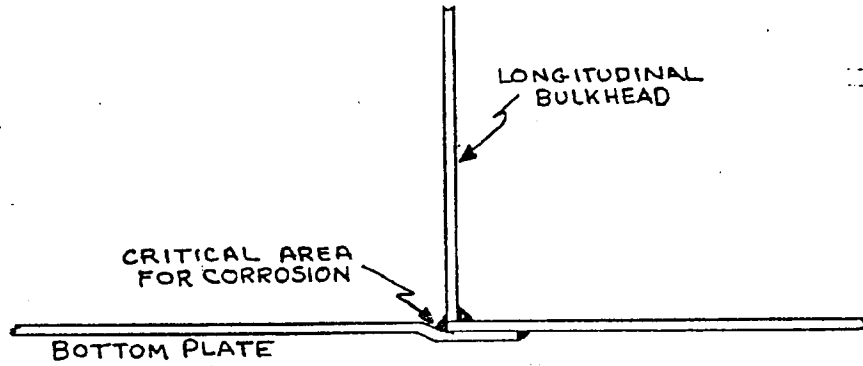
FIG. 5

- b. In LST hulls built during World War II shell and deck plating butts were made as laps at bulkheads, and joggled laps were used for seams, including the critical connection of the garboard strakes under the center vertical keel (no flat plate -keel being fitted)) and the critical bottom -seams under the longitudinal bulkheads. These points are susceptible to accelerated corrosion and to possible metal fatigue (figures 1, 3 and 5). Furthermore, the plating concerned is generally thinner than that of a normal merchant vessel of the same size.

TYPICAL LAPPED SEAM AT LONGITUDINAL BULKHEAD
ORIGINAL CONSTRUCTION

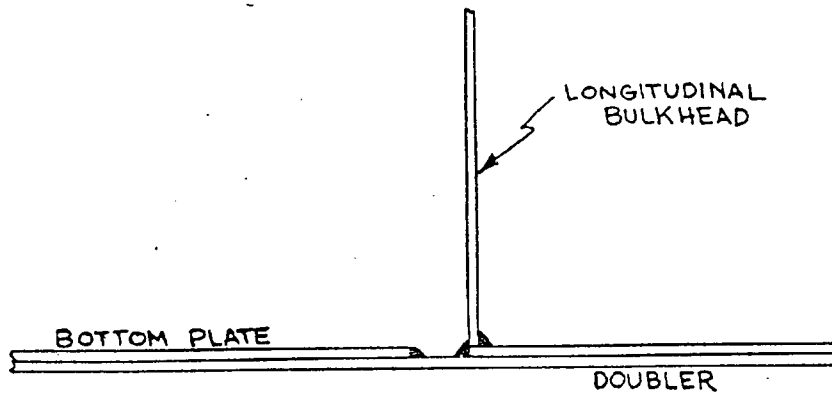
FIG. 6

ALTERNATE METHOD OF INSTALLING BOTTOM DOUBLER
IN WAY OF LONGITUDINAL BULKHEAD
