**DOT/FAA/TC-22/17**

# **Bonded Repairs of Composite Wing Panel Structure: Phase 3, Bonded Repair Size Limits Study for Solid Laminates with Double- Sided Scarf Panels**

June 2022

Final report

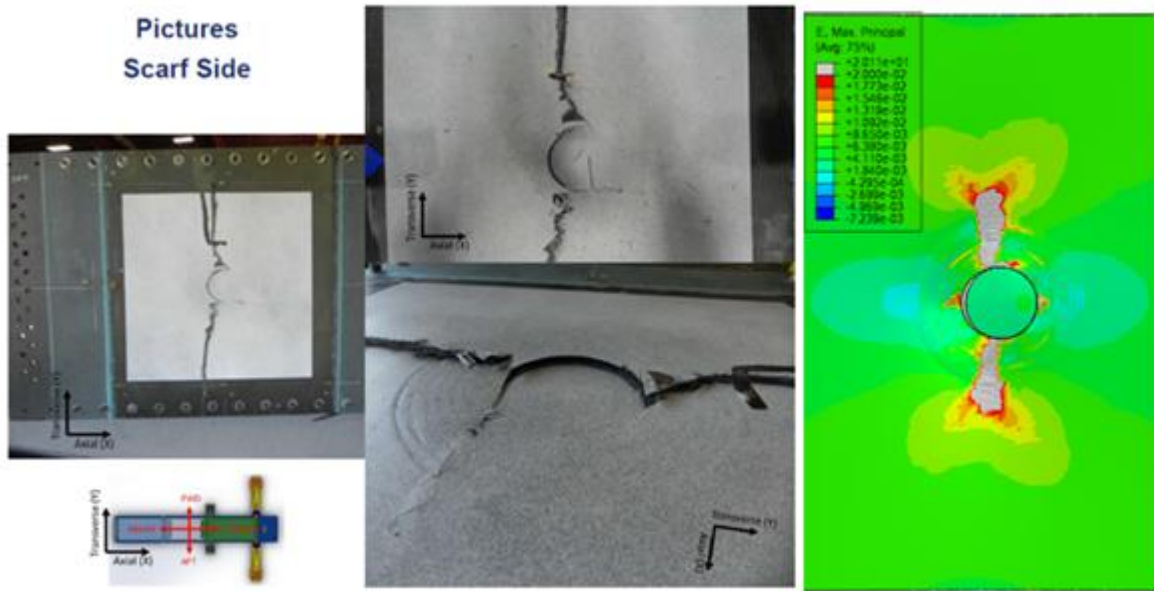
Figure 11. Final failure mode correlation between test and PFA

One of the most significant findings during this phase of testing was that one remaining perfectly bonded patch did not improve the residual strength at all (see results from Table 2). From a free-body analysis under tensile loading, one can hypothesize that due to the prying moment induced by the eccentricity from the pristine region to the scarfed region, the peel stress in the bondline would be high and caused premature failure of the bondline and hence deemed the patch entirely ineffective. This hypothesis was confirmed by PFA analysis of the double-sided scarf with single-sided repair patch, panels 9 thru 11. In this model, adhesive bondline was modeled with 3-D cohesive elements with damage initiation and progression properties derived from fundamental tests (static tension, shear, Mode-I & II fracture energy measurements using double cantilever beam (DCB) and end notch flexure (ENF) tests). Table 3 lists such properties for the adhesive used. Figure 10 shows the adhesive failure index contour at 5300  $\mu\epsilon$  and on the right are simulated axial strain histories as a function of applied load fraction. Both the initiation of bondline failure and final two-part failure strains at gage IS6 (at the center of patch on the interior side) correlate with test results very well. So is the final failure mode (Figure 11).

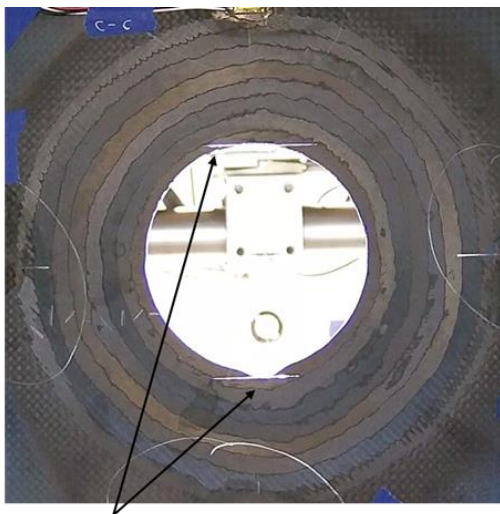
Crack in the first ply

a. Image of scarf indicating matrix cracking in the first ply

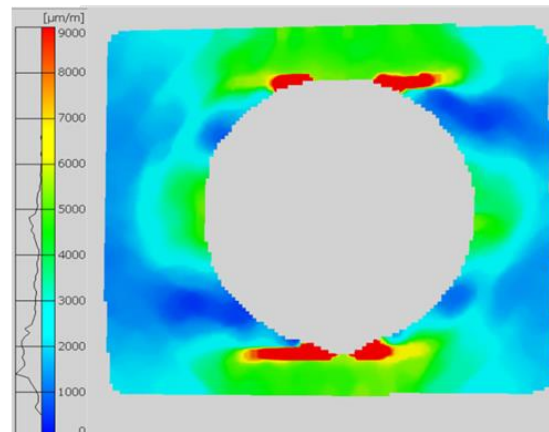
b. Von-mises strains in the scarf region showing stress concentration in the first ply

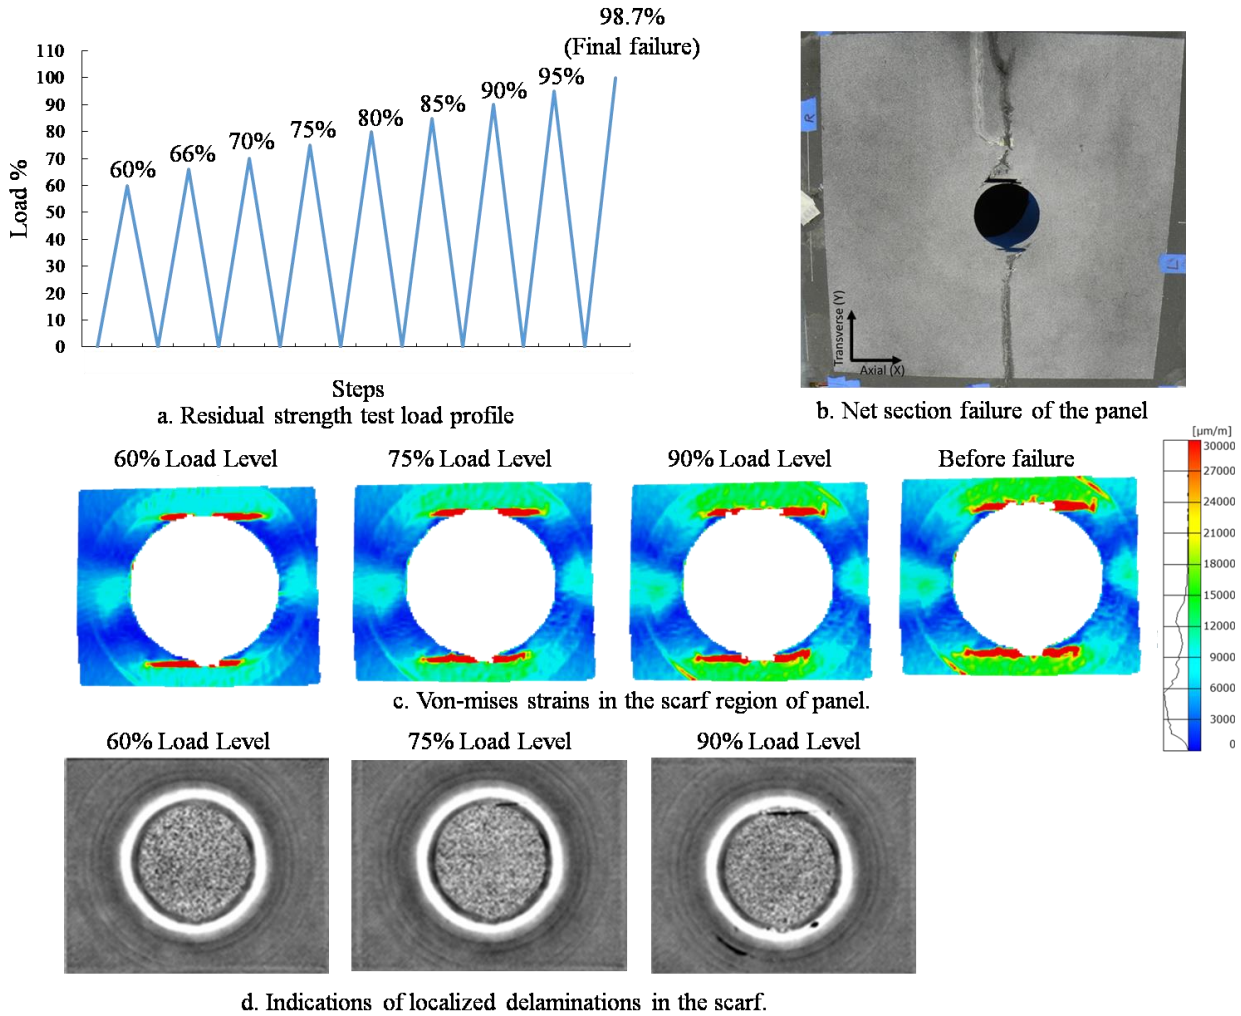
Figure 14. Panel 7 residual strength test; a) load spectrum, b) DIC, c) thermography results

After the initial strain survey, panel 7 was subjected to residual strength test. The panel was loaded quasi-statically in a saw-tooth profile, increasing the load level up to the predicted critical loads of panel 4 with failed (cavity) full depth scarf (95,698 ft-lb<sub>f</sub>), which was considered as 100%. The load profile is shown in Figure 14a. During loading, damage formation was monitored visually using high-magnification cameras and DIC. After each loading, the scarf region was inspected using the flash thermography system. Detailed strain gage results for all the panels collected during residual strength tests are provided in appendix C.

The cracks at the 6 o' clock and 12 o' clock locations, which developed during initial strains surveys, barely progressed till the final failure. Post-test DIC data analysis was able to detect the slight crack progression as shown in Figure 14c. Neither thermography inspections nor visual inspections were able to detect progression of these cracks. In addition to the 6 o' clock and 12 o' clock cracks, the delaminations initiated at 2 o' clock and 8 o' clock locations in the 5<sup>th</sup> ply (first 0° ply from the top). This occurred at increment 7 (90 % load level; 86,128 lb<sub>f</sub>-ft) and is shown in Figure 14c and d. Apart from slight progression in the above mentioned cracks and delaminations, the scarf region remained intact all the way up to the final failure of the panel. The panel failed catastrophically along the net section, at the applied moment of 94,418 lb<sub>f</sub>-ft (Figure 14b). The images of the failed panel are shown in Figure 15. The final failure initiated from the cracked first plies at 6 o' clock and 12 o' clock locations. As the load was increased, the crack extended to the 8<sup>th</sup> ply (45° ply), and then further turning along the 45° direction going past the 7<sup>th</sup> (90° ply) and 6<sup>th</sup> (-45° ply), all the way to the 5<sup>th</sup> ply (first 0° ply from the top). Once the 0° ply fibers failed, damage progressed through the net section causing sudden catastrophic failure of the panel. All these events happened in the last load step and very rapidly. Neither DIC system nor visual cameras were able to capture the final stages of damage progression. Images of the failed panels and flash thermography results are provided in appendices E and F.

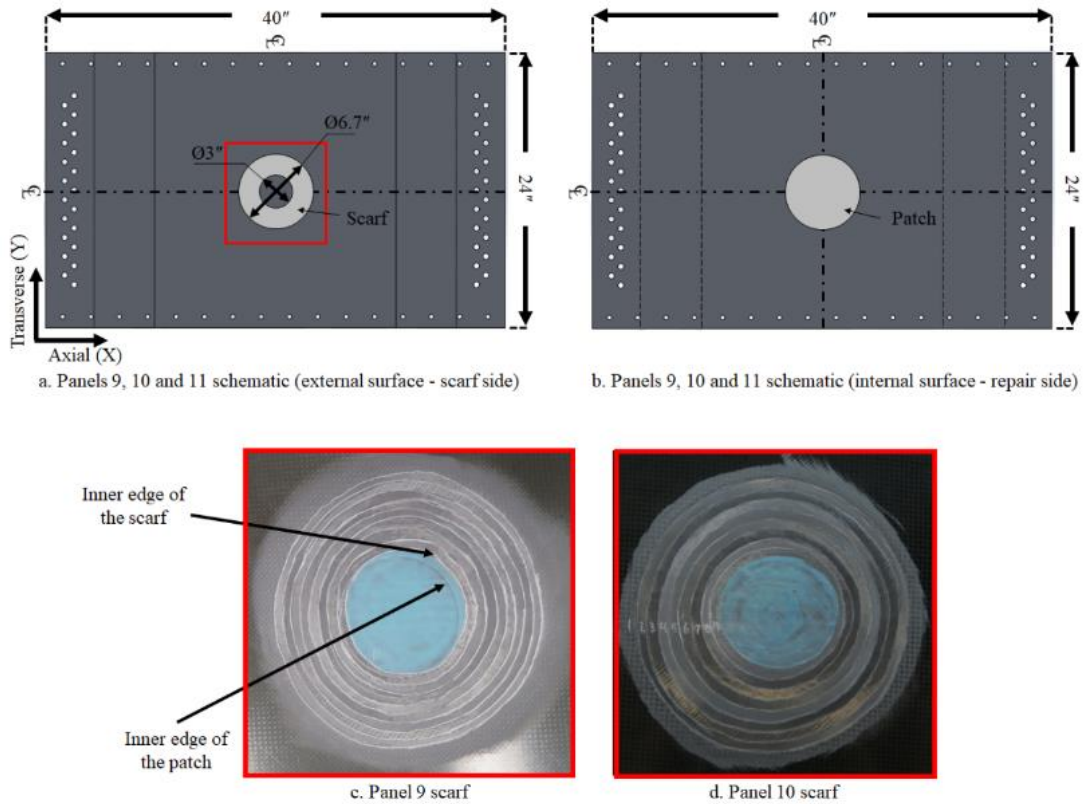
Figure 20. Images of Panels 9 and 10 showing the offset between patch and scarf in panel 9

The offset between the scarf and the patch in panel 9 did introduce local stress concentration in the inner edge of the scarf, but the effect of this offset was very local and did not affect the far-field strains in the panel, as shown in Figure 22. As shown in the figure, the axial strains measured using strain gages for panels 9, 10 and 11 were very similar for the same strain survey load-levels. Also shown is an excellent comparison of strains between the in double-sided scarf panel with single-sided repair patch (panels 9, 10 and 11) and half-depth scarf panel 5 during strain survey loading. Although for panels 9, 10 and 11 the load transfer from the parent material to the patch will not be as smooth and continuous as panel 5 due to the bondline (Figure 5), a good bond is able to transfer the load perfectly. Thus at strain survey loads, the double-sided scarf with single sided patch configuration works as the half-depth scarf configuration and shows similar strain distribution.

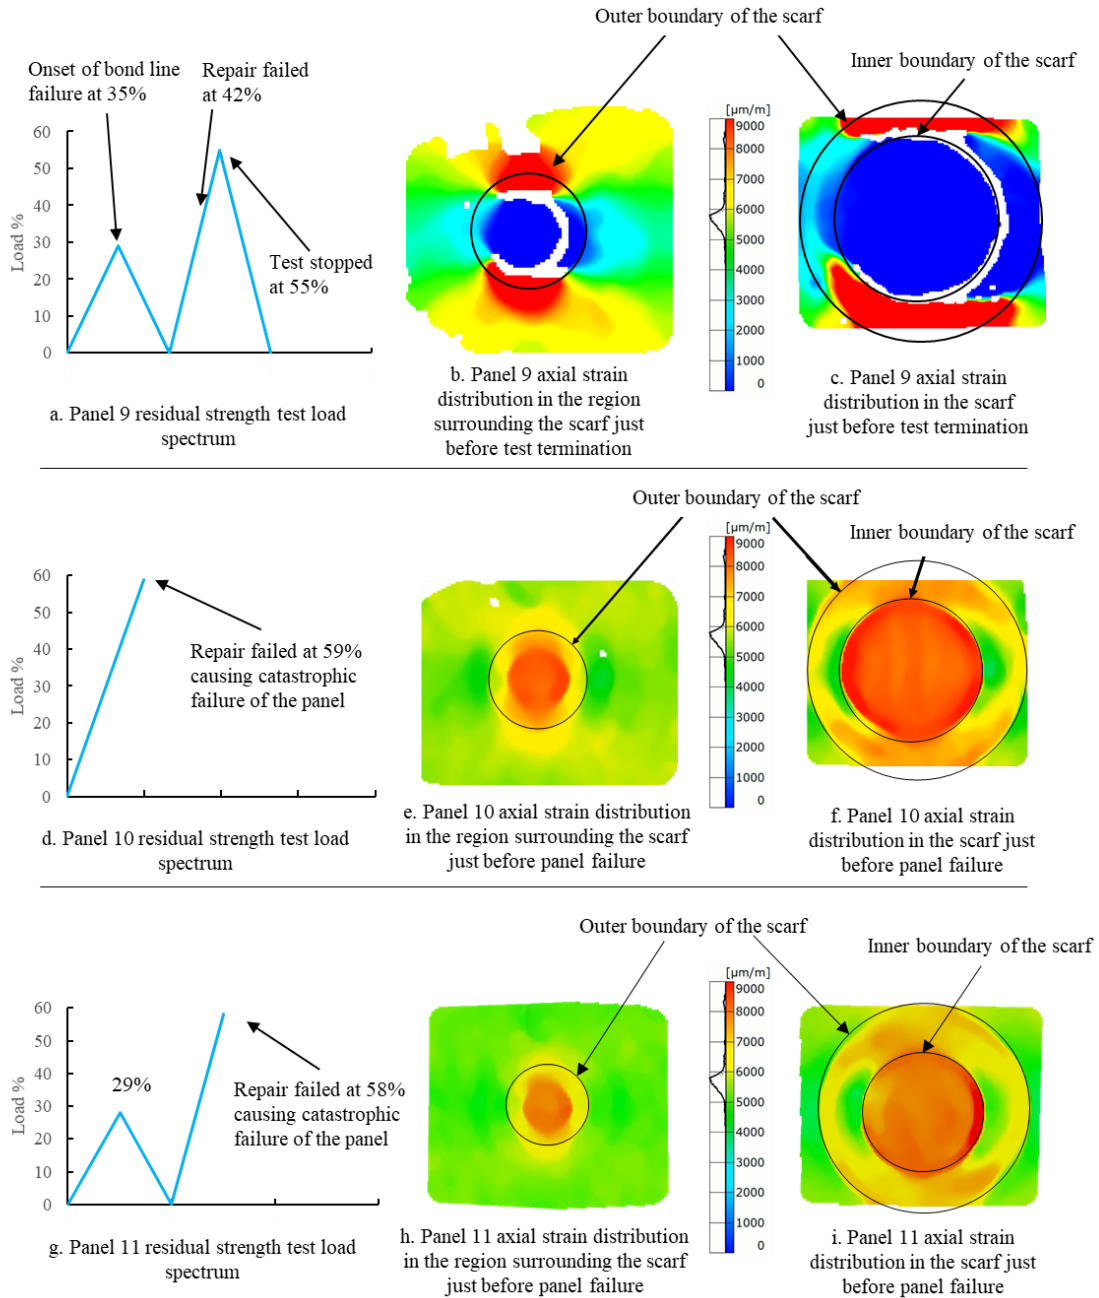
Figure 24. Ultimate load DIC strain fields for (a-c) panel 9, (d-f) panel 10, and (g-i) panel 11

Panels 10 and 11 were subjected to similar residual strength test. The loading profile, axial strain distribution in the vicinity of the scarf and within the scarf just prior to panel failure measured using the DIC system for panels 9, 10 and 11 are shown in Figure 24. As shown in the figure, the axial strain distribution in panel 10 scarf just prior to failure was symmetric at 3' o clock and 9' o clock locations, thus providing negligible indication of the path of load transfer. The panel failed

catastrophically along the net section at 59% load level. In panel 11, the axial strains in the scarf shows a slightly higher stress concentration at the 3’o clock location, which indicated that the patch is separating from the parent material at the 9’ o clock location causing the strain to rise at the 3’o clock location. Further, the panel failed at 58% load level. The failure was so sudden that neither DIC nor the video cameras were able to capture the progression of failure.

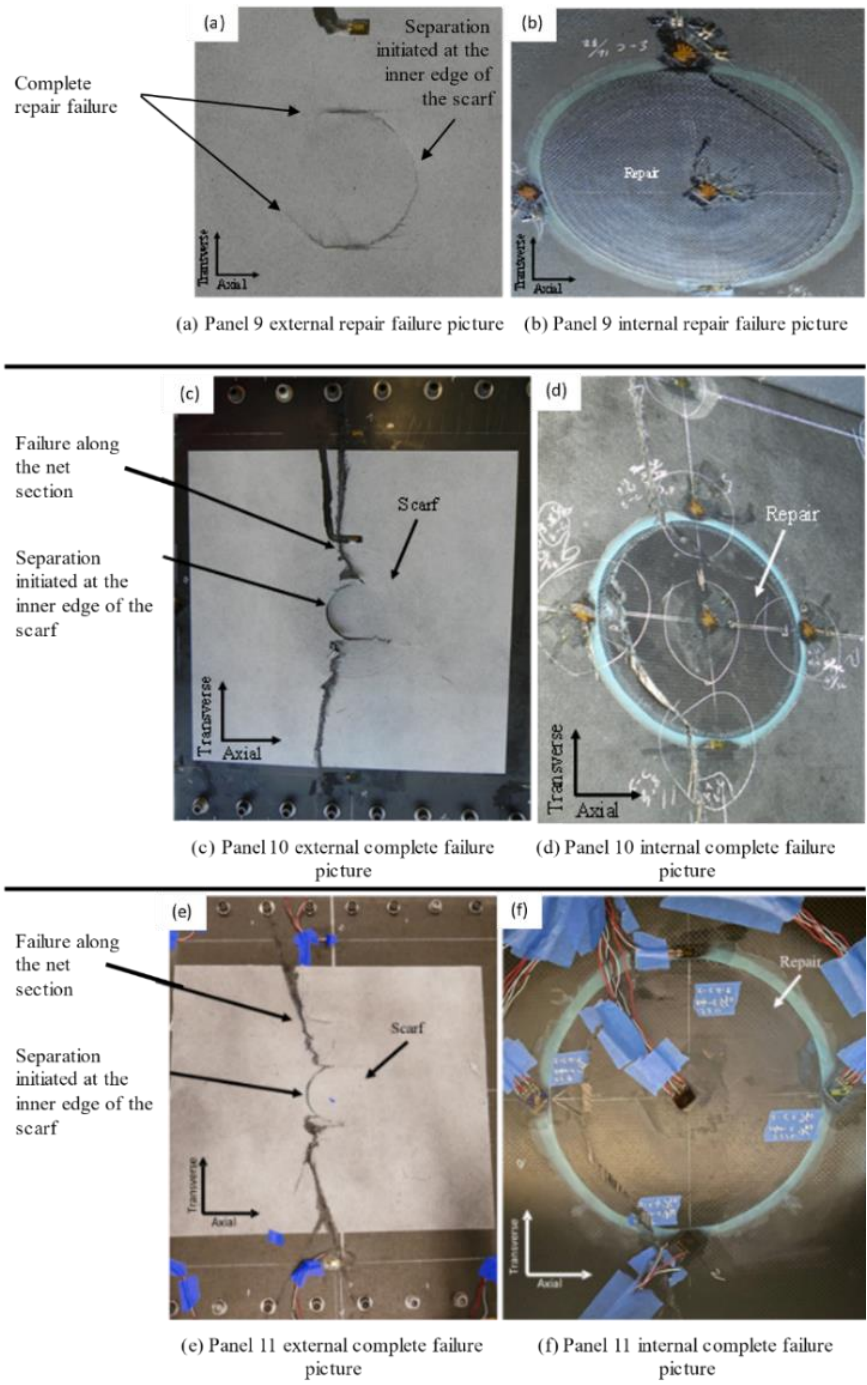
Figure 25. Post-failure pictures of (a,b) panel 9, (c,d) panel 10, and (e,f) panel 11

The images of failed panels 9, 10, and 11 are shown in Figure 25. In general, bondline failure of the repair patch occurred first followed by rapid catastrophic net-section fracture of the panels.

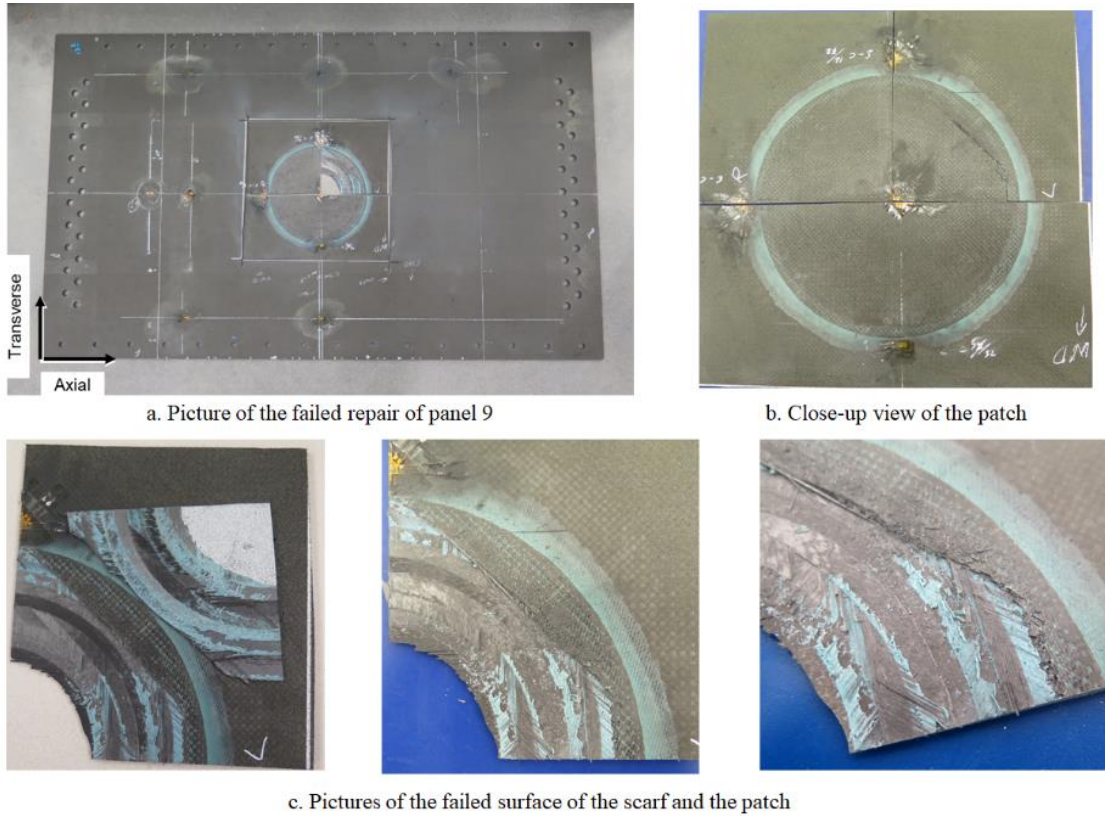
Figure 26. Post-test visual inspection of failed panel 9 (repair patch side)

As mentioned above, panels 10 and 11 failed catastrophically and for panel 9, the test was stopped before complete failure to inspect the fractured surfaces. The images of the fractured panel 9 bondline is shown in Figure 26.

The pictures of the interface between the patch and scarf shows the bondline failure and separation between the patch from the parent material and thus transferring the load to the net section leading to the catastrophic failure of the panel.

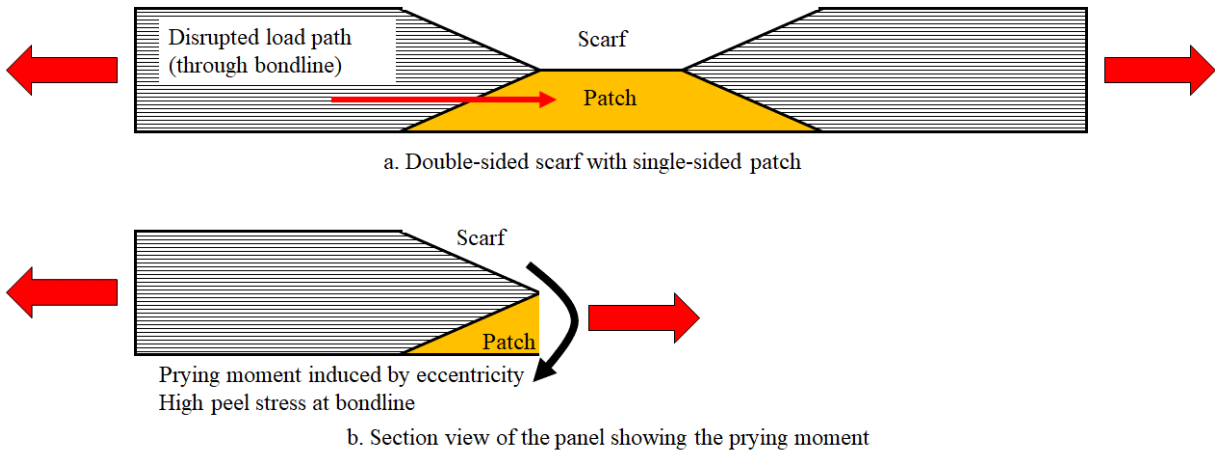
Figure 27. Schematics showing the prying moment induced by the eccentricity

The bondline failure can be explained via Figure 27. As shown in the figure, a single-sided repair patch resulted in an eccentrically loaded moment and higher peel stresses causing the bondline failure. It should be mentioned that there was no substructure in these panels. The presence of stringers would have reduced the eccentricity and peel stresses on the bond by transferring more load on the stringer and reducing the prying moment.

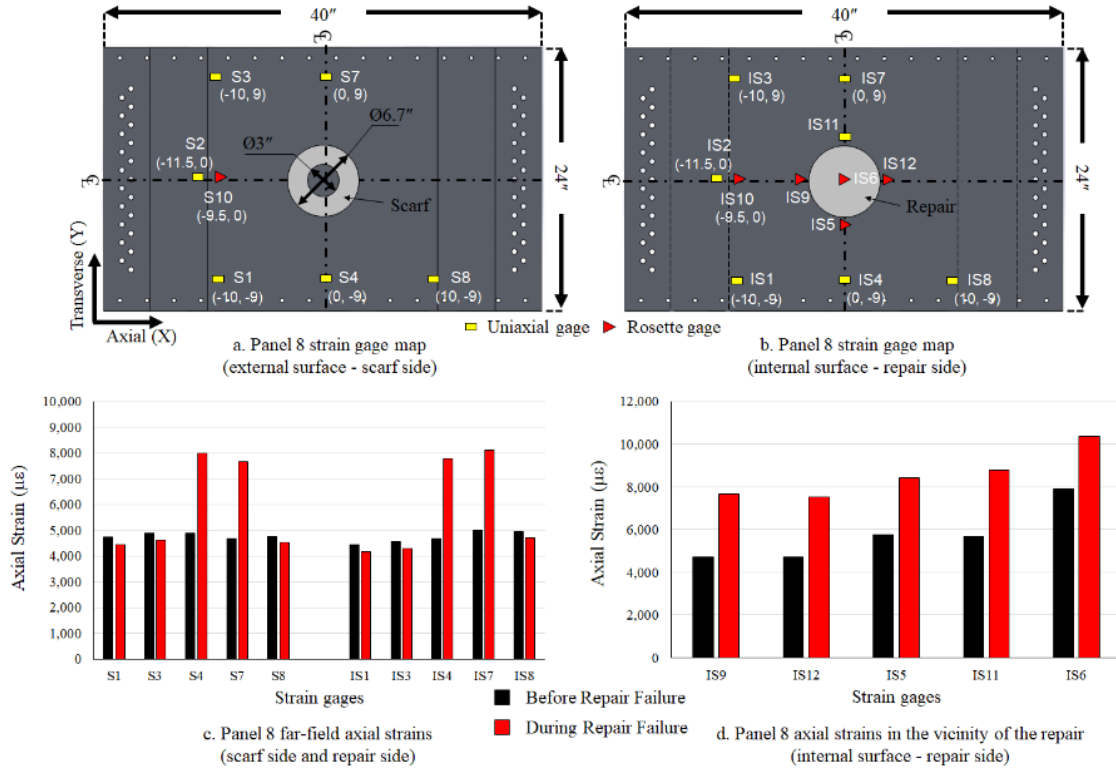
Figure 28. Panel 10 axial strains captured just before and during the repair failure

The load transfer leading up to the failure of the panel can be studied by the strain gage results. As an example axial strains measured prior to and during repair failure for panel 10 are shown in Figure 28. As shown in Figure 28c, during the repair failure the strains at the ends of the panel reduced (strain gages S1, S3, S8 and IS1, IS3, IS8) but the strains in the net section increased significantly (strain gages S4, S7 and IS4, IS7) indicating the load transfer to the net section of the panel. The strains in the vicinity of the patch (strain gages IS5, IS9, IS11 and IS12) shown in Figure 28d also rise significantly due to the load transfer. Figure 28d also shows the strains at the patch edge at 9 o' clock position (IS9) were slightly higher than at 3 o' clock position (IS12) indicating the failure initiated from the 9 o' clock position, which was confirmed by visual inspection of the panel after failure. Overall, the strain gages were able to capture the load transfer prior to the panel failure.

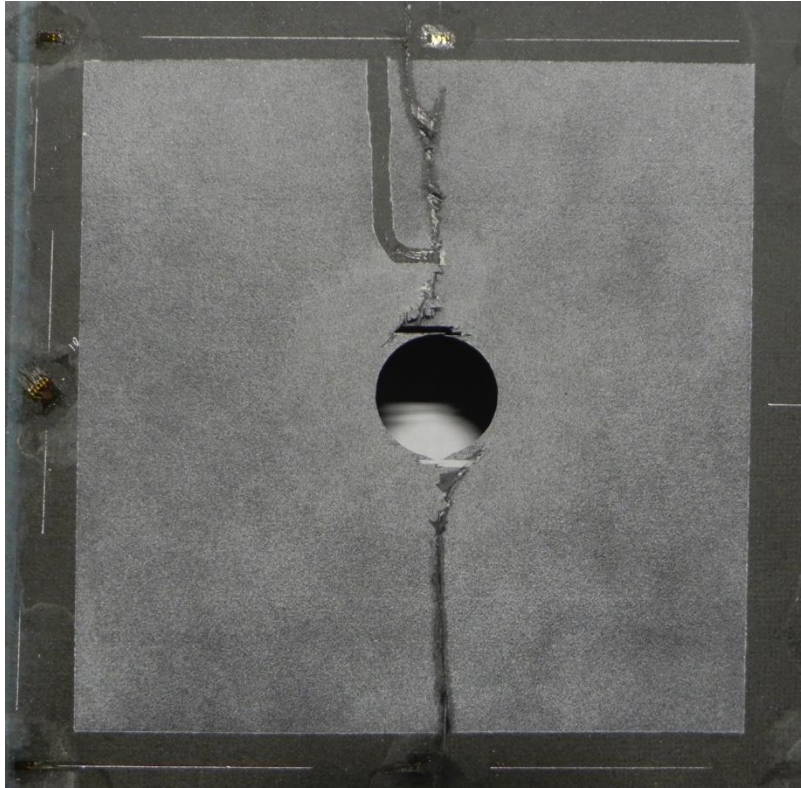
Figure E-2. Panel 7 net section failure, external surface

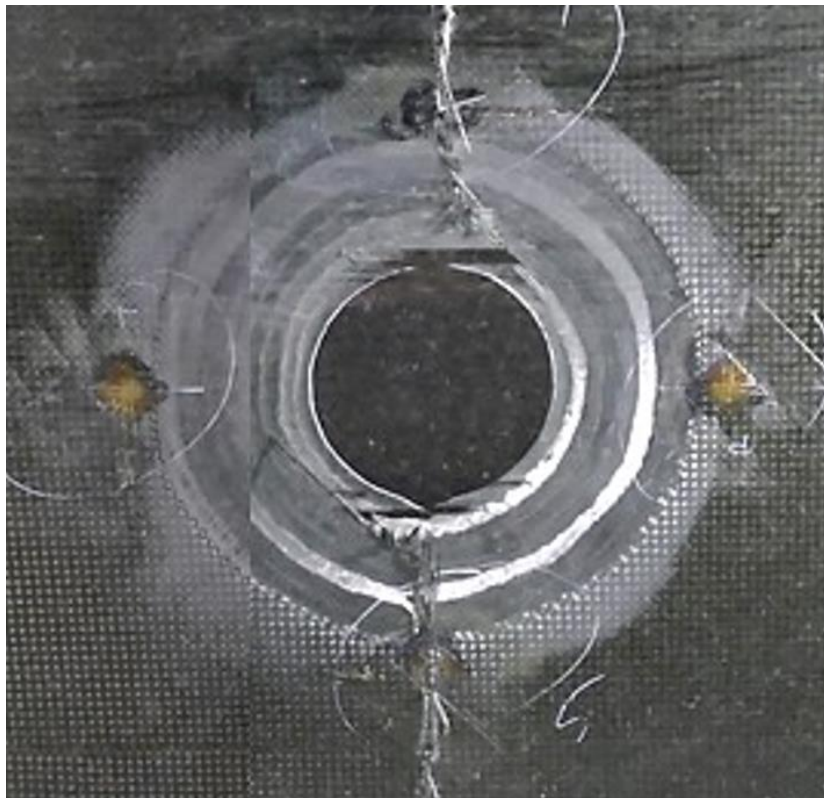
Figure E-1. Panel 7 scarf failure, internal surface

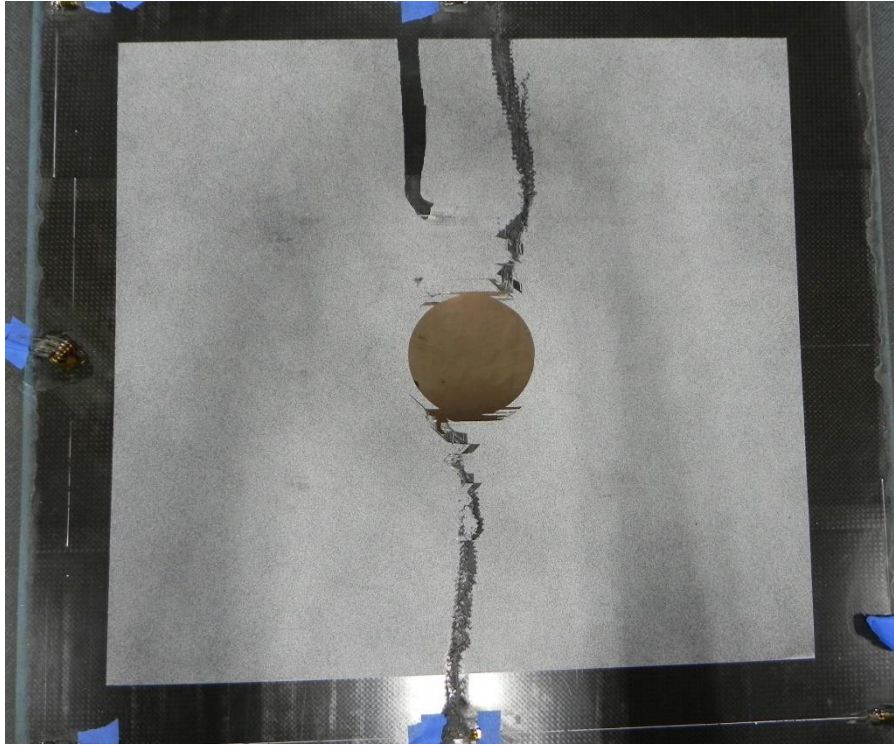
Figure E-3. Panel 8 net section failure, external surface

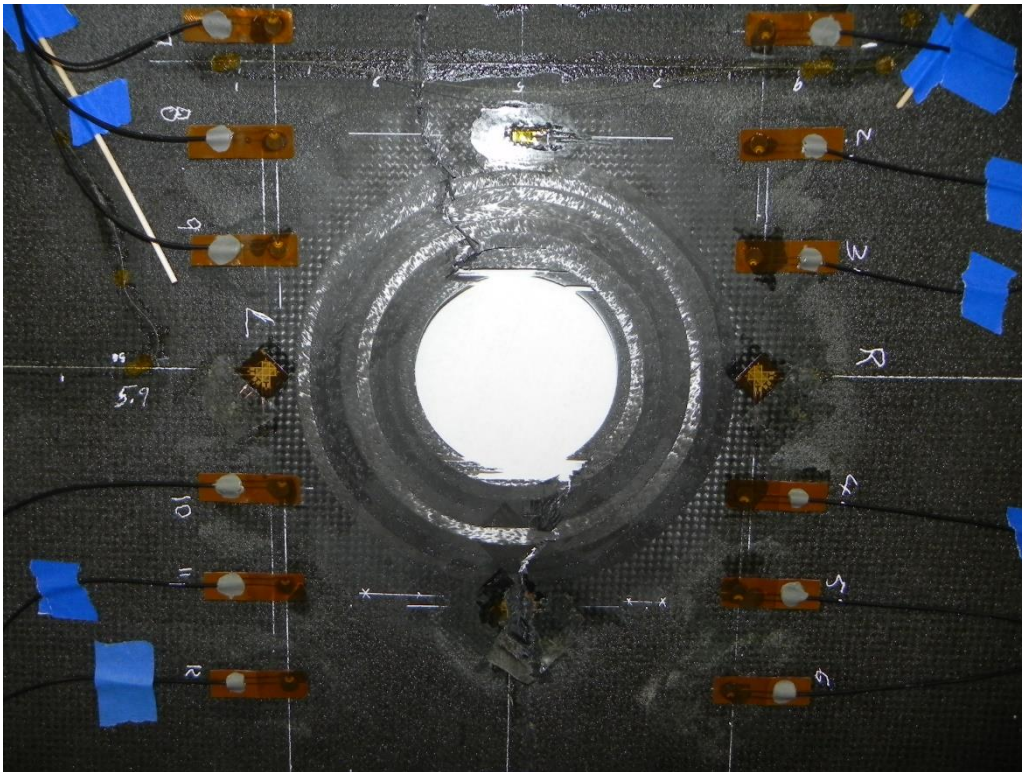
Figure E-4. Panel 8 scarf failure, internal surface

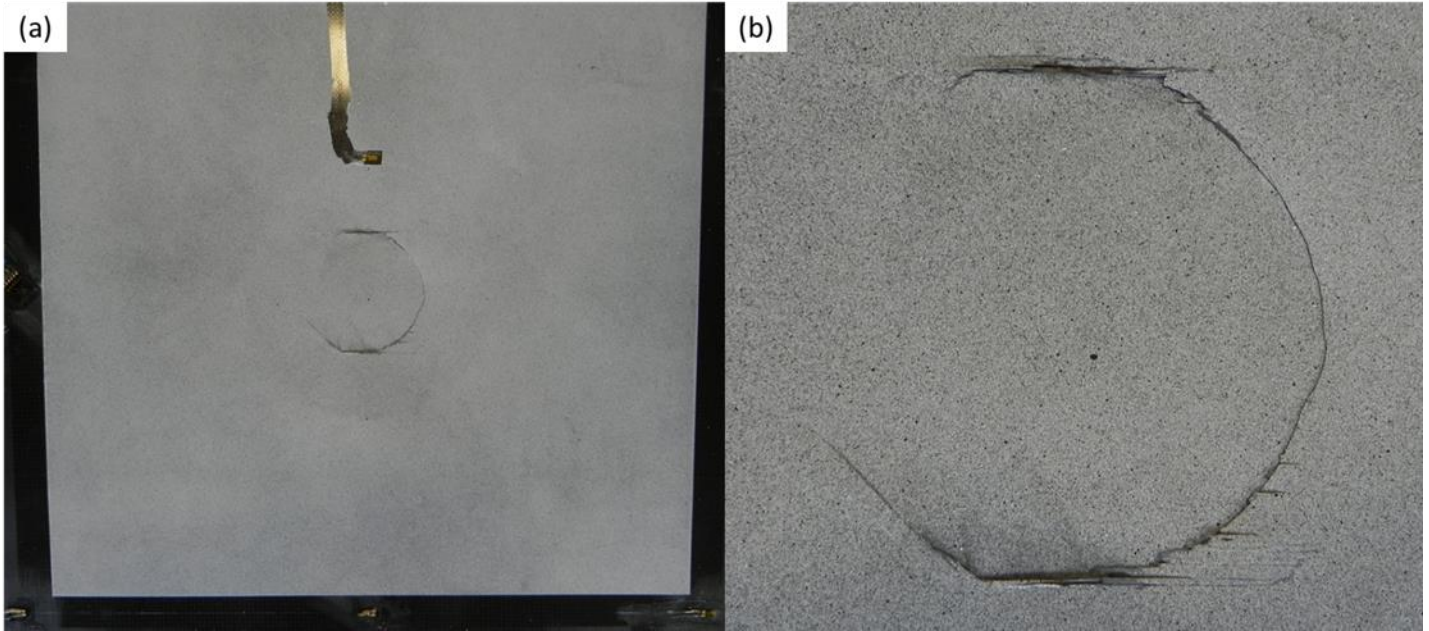
Figure E-6. Panel 9 (a) patch failure, external, (b) focused patch failure

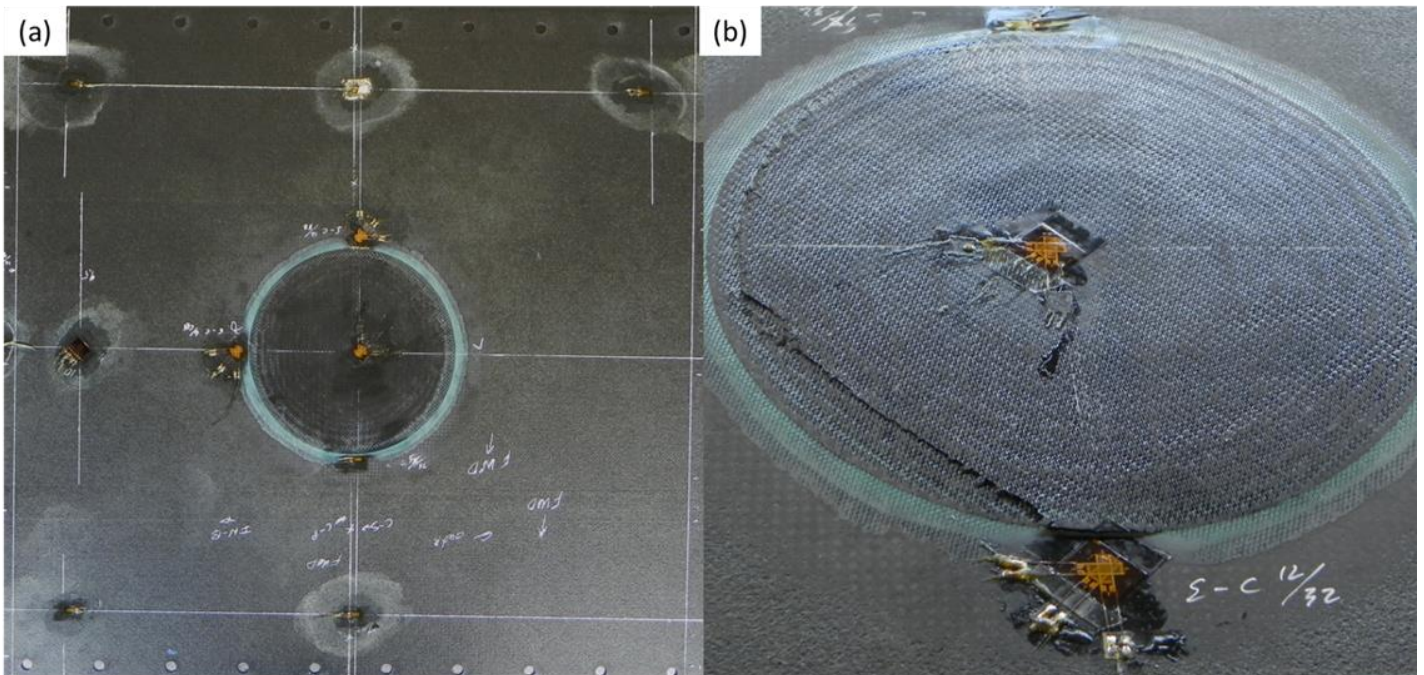
Figure E-5. Panel 9 (a) patch failure, internal surface, (b) focused patch failure

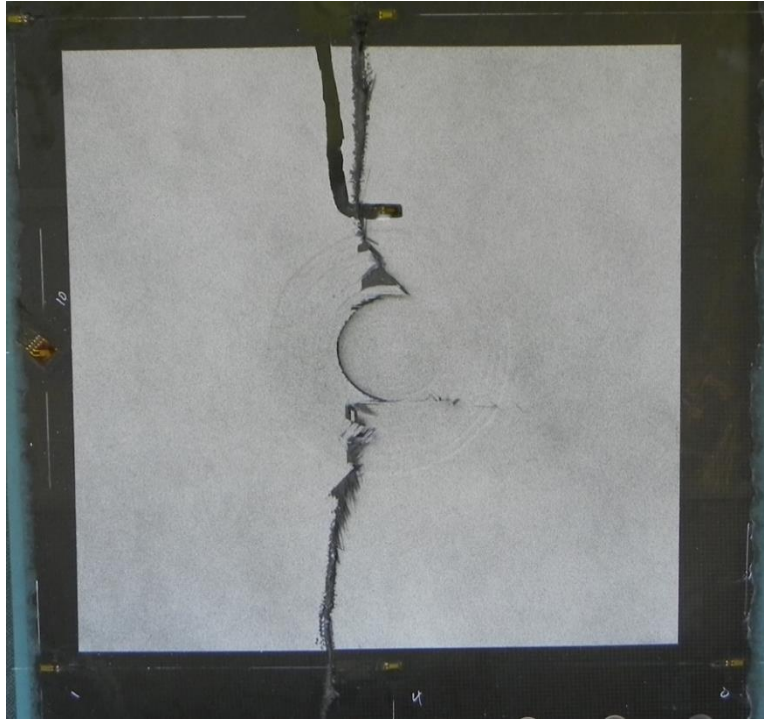
Figure E-7. Panel 10 patch and net section failure, external surface

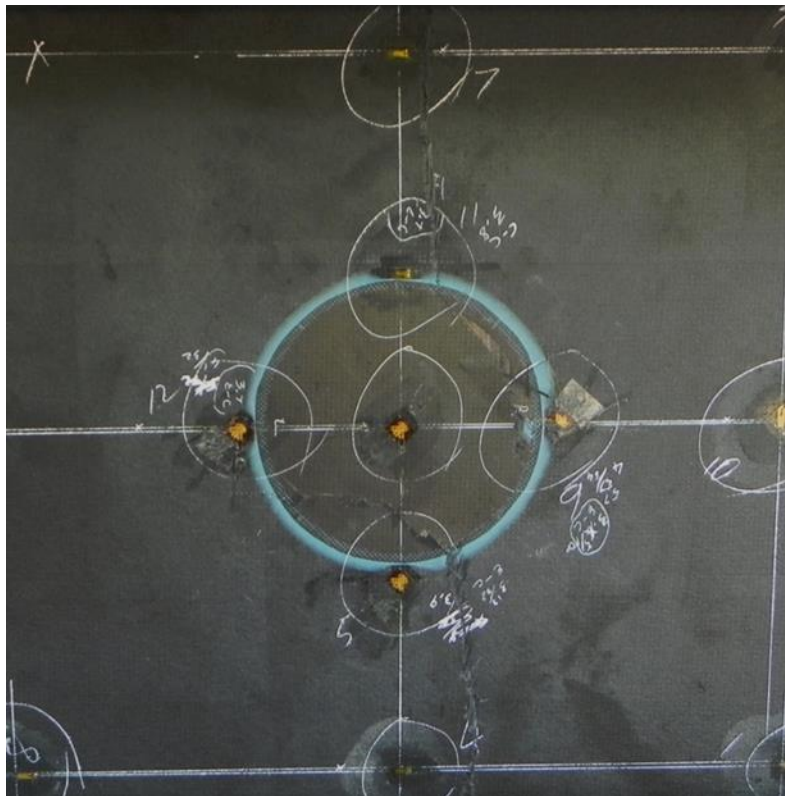
Figure E-8. Panel 10 patch and net section failure, internal surface

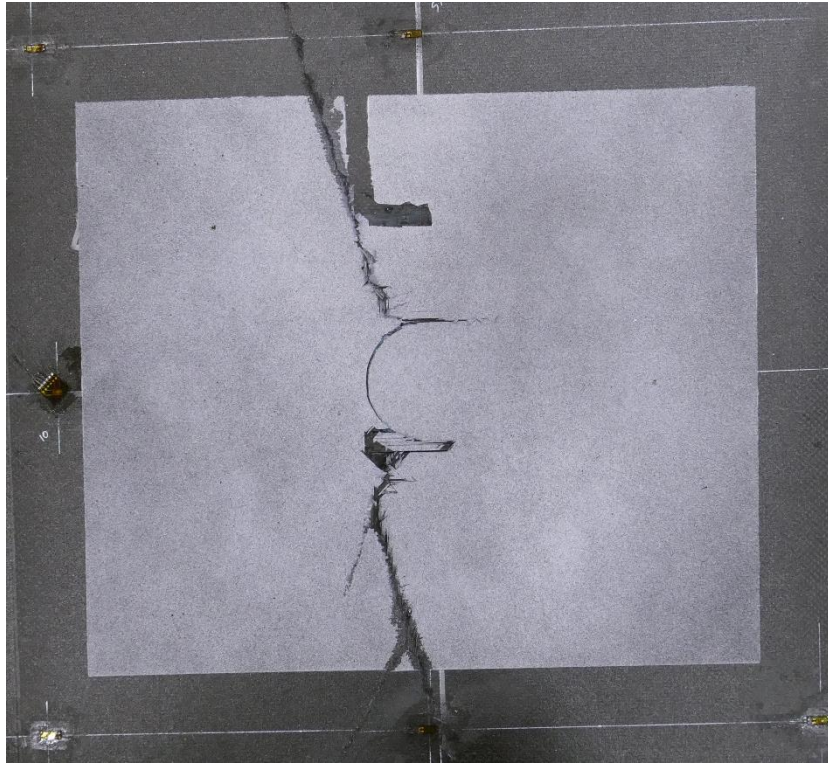
Figure E-9. Panel 11 patch and net section failure, external surface

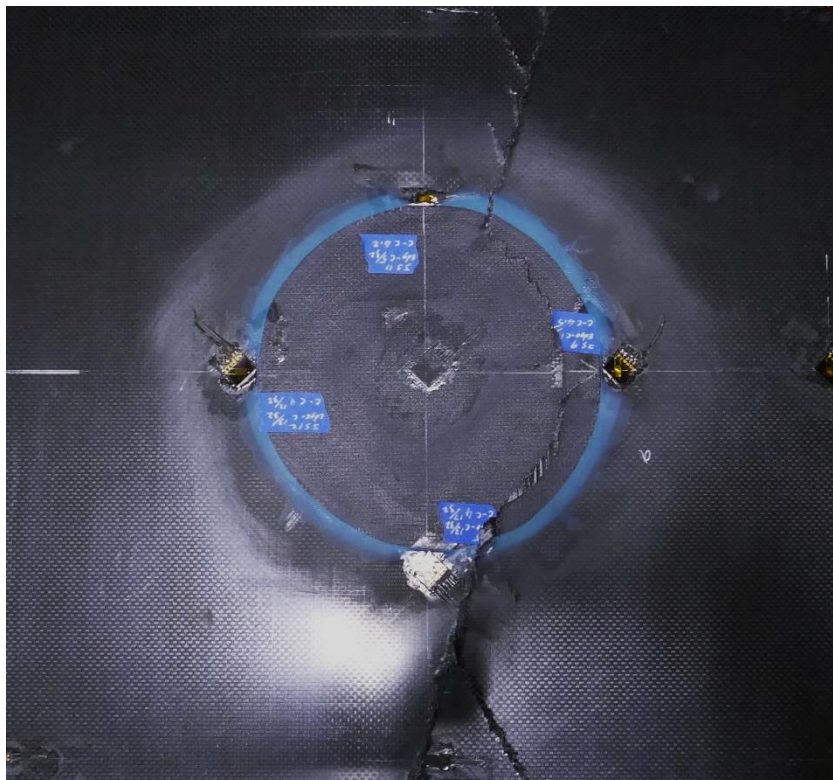
Figure E-10. Panel 11 patch and net section failure, internal surface
