Bridge Deck Surface Profile Evaluation for Rapid Screening and Deterioration Monitoring

FINAL REPORT
September 2022

Submitted by: Adriana
C. Trias-Blanco
Assistant Professor

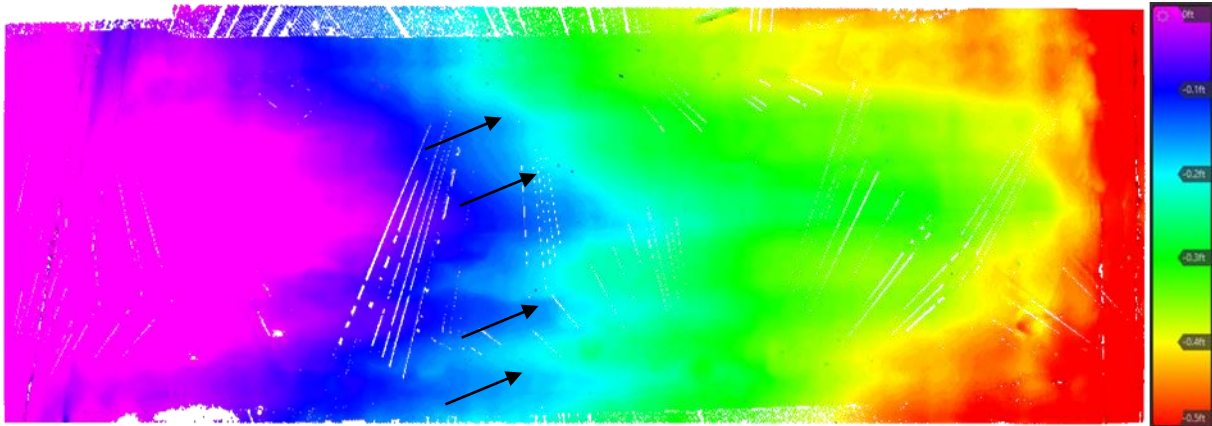
Bridge 0954163 presented a rutting of approximately 36% of the total deck area. The arrows in Figure 15 indicate the presence of rutting on the scanned deck. While the grayed areas on Figure 16, represent the approximated rutting area on the deck. The percentage of rutting area was estimated by adding the grayed squares and dividing this amount by the total number of squares that cover the area of the deck, multiplied by 100. Figure 17 presents a plan view of the top surface of the deck as reference.

Figure 15. Structure 0954163 - Elevation map, evidence of rutting.

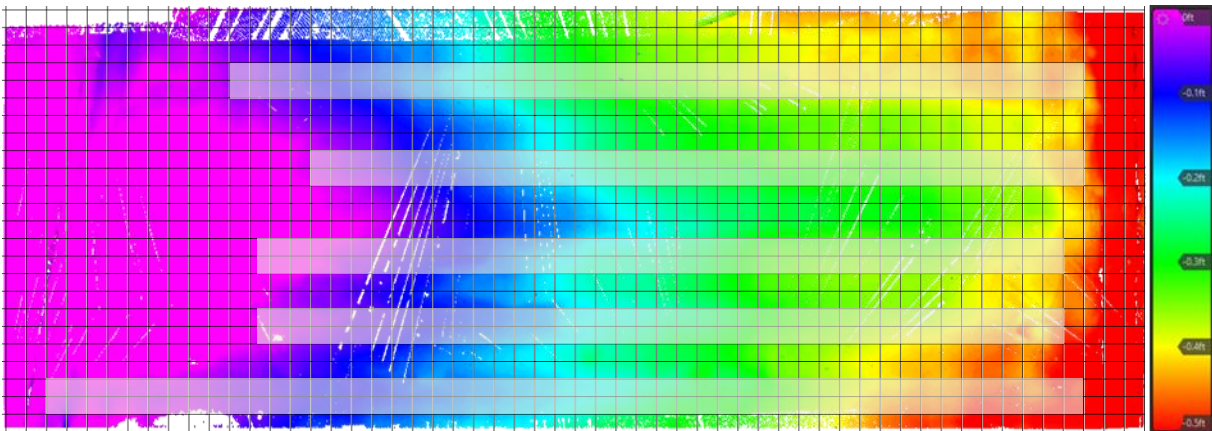
Figure 16. Structure 0954163 - Rutting areas on bridge deck.

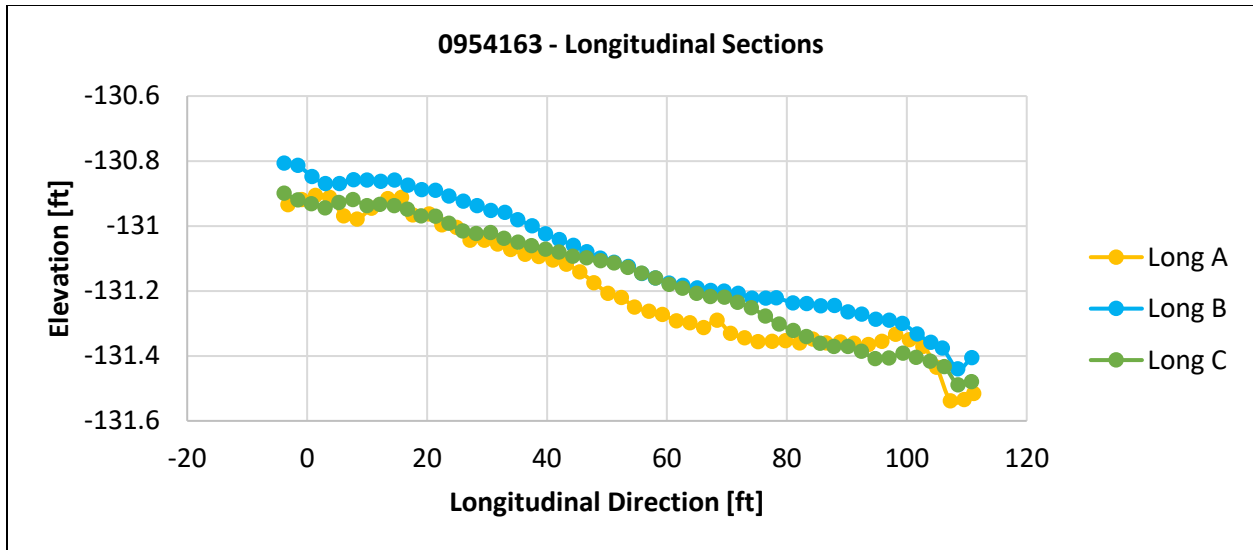
The longitudinal cross sections generated for this structure show several low points as indicated in Figure 20, which are areas where water is more likely to sit for longer periods accelerating the damage of the reinforcing steel. Additionally, the longitudinal slope was estimated to be of 0.5% slowing the water drainage. From Figure 21, the transverse cross section slope is estimated to be between 0 to 0.8%, which is below the recommended 2%. The plan view presented on Figure 18 indicates the location of the longitudinal and transverse section within the deck.

Figure 20. Structure 0954163 - Longitudinal Sections.

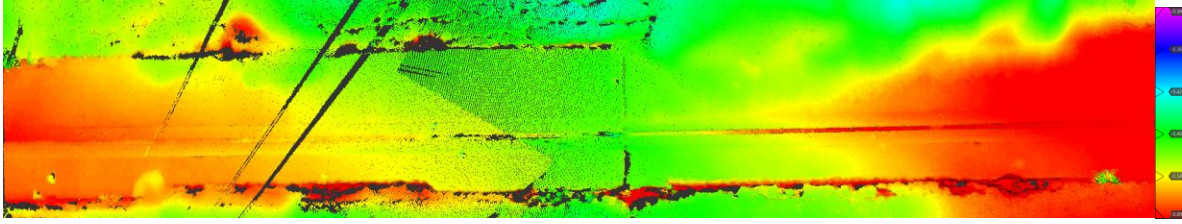
Additional analysis was performed at the location of the joints. LiDAR was capable of detecting the surface of the deteriorated joints. Figure 22 helps visualize the condition of the East joint and the surrounding area, while Figure 24 presents information for the West joint. The lines present on these and other images are originated due to the passing of cars/trucks during data collection, which generates a gap in the point cloud. Following the scope of work of this project, the analysis of the joints will be limited to measuring approximated area of damage. Following the same percent area estimation for calculating the presence of rutting, the East joint presented 18% of deteriorated area, as seen in Figure 23. Similarly, the West joint of the bridge deck presented 39% of deteriorated area, as seen in Figure 25.

Figure 22. Structure 0954163 - East joint: (a) Elevation, (b) RGB.

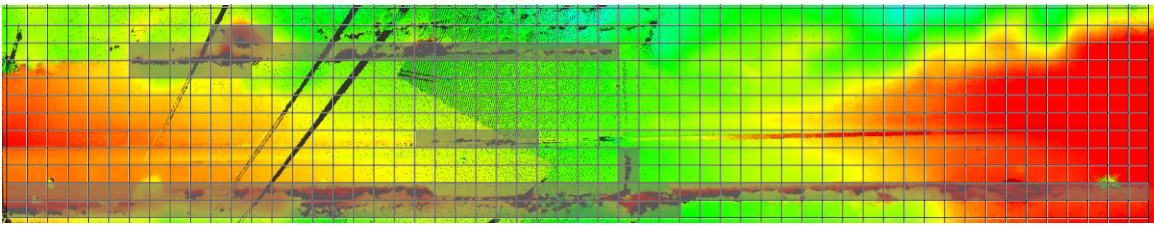
Figure 23. Structure 0954163 – Deteriorated areas of the East joint.

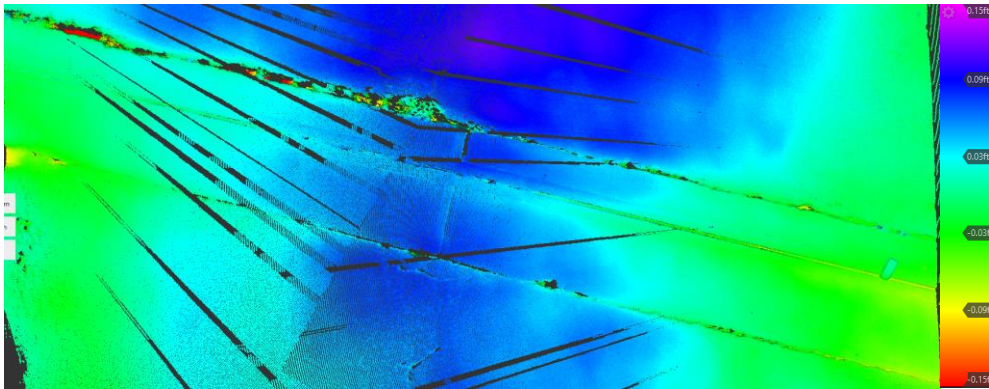
Figure 24. Structure 0954163 - West joint: (a) Elevation, (b) RGB.

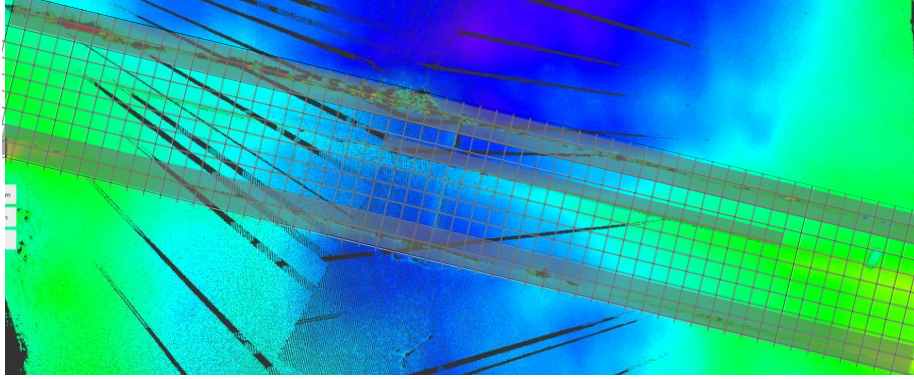
Figure 25. Structure 0954163 - Deteriorated areas of the West joint.

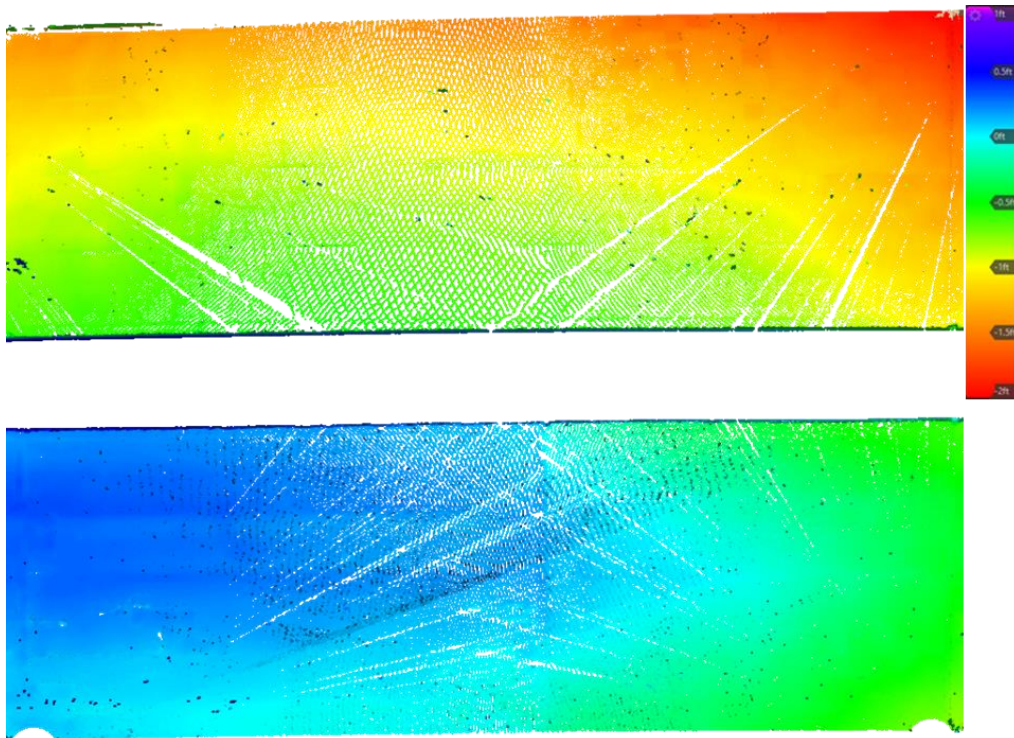
Bridge 0416151 presented large flat areas that are explained through Figure 26 and Figure 28. Where, Figure 26 represent the variation in elevation of the deck's top surface, while Figure 28 highlights the areas considered flat, since the variation in elevation or slope is inexistent. Figure 27 presents an RGB view of the deck's top surface. The presence of flat areas within the deck affects how the water runs off the structure. In these areas water is more likely to sit and percolate inside the deck, increasing the risk for corrosion of the reinforcing steel.

Figure 26. Structure 0416151 - Elevation map.

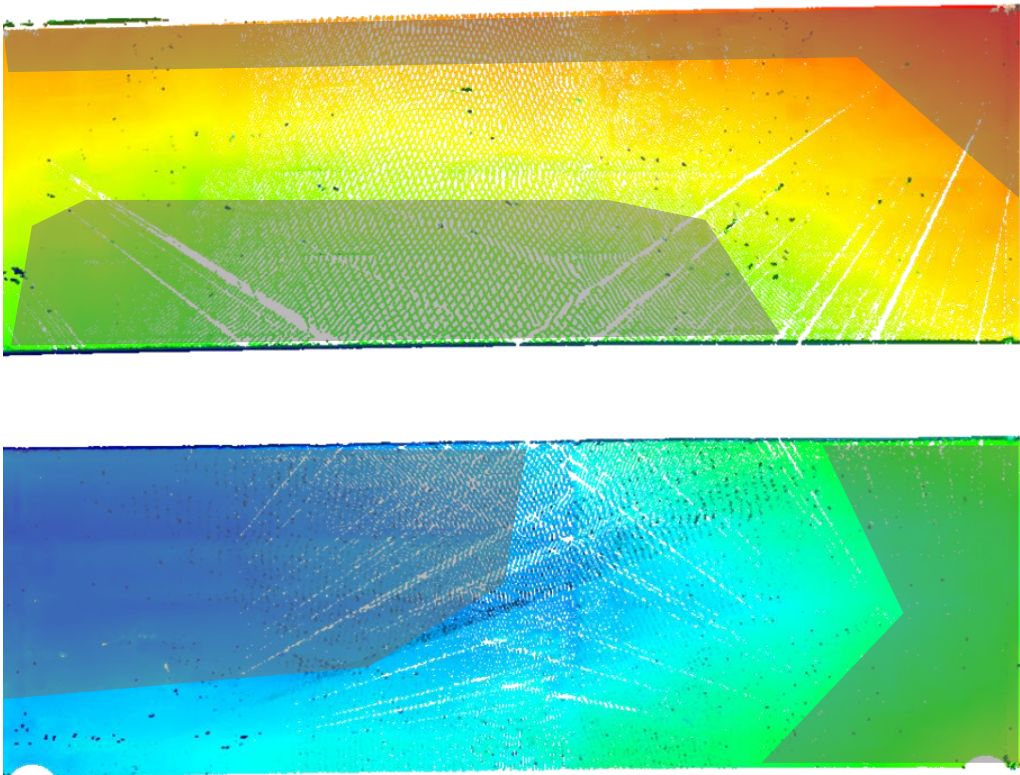
Figure 28. Structure 0416151 - Deck flat areas (Grayed).

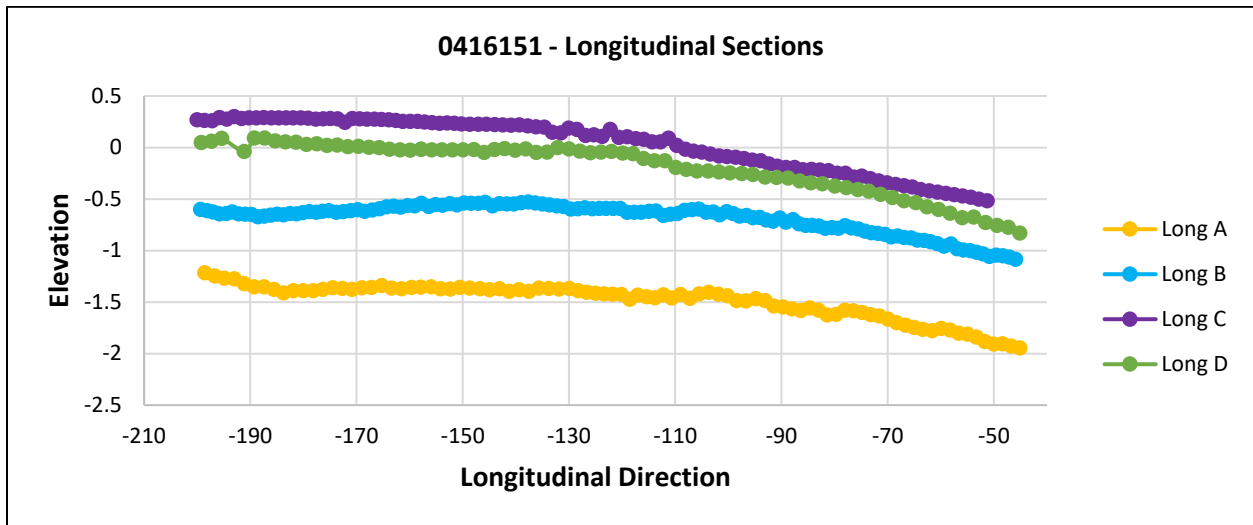
The peaks present of Figure 31 and Figure 32, represent the potential presence of irregularities on the deck's surface, e.g. small potholes. The noticeable gap found on Figure 32, is due to the presence of a barrier.

Figure 31. Structure 0416151 - Longitudinal Sections.

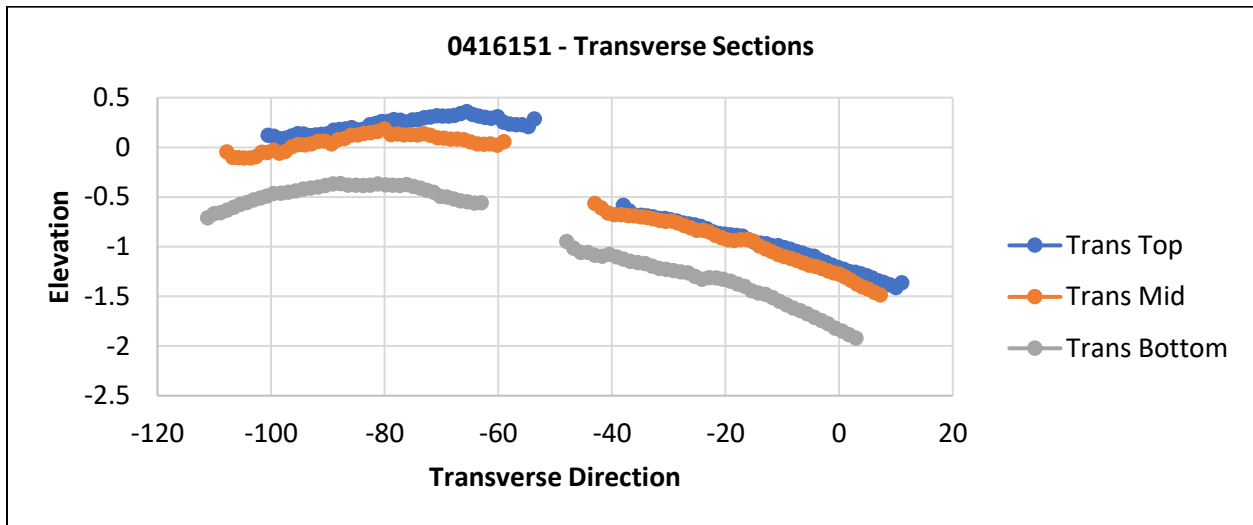
Figure 32. Structure 0416151 - Transverse Sections.

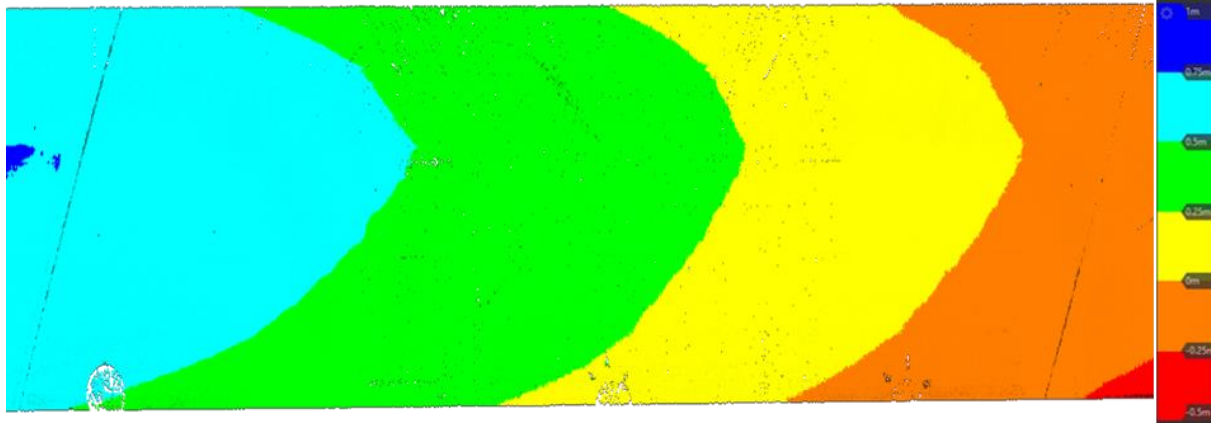
The elevation map presented in Figure 33, combined with the longitudinal slope estimated from Figure 37 which was estimated to be between 1 to 1.5%, indicate the presence of proper surface conditions for water to run off the deck without difficulty. Moreover, the transverse slope estimated from Figure 38 was found to be approximately 2%. Structure 361632N does not present clear evidence of potential areas susceptible to early deterioration. It is important to indicate that, based on the findings of Figure 37, the first half (upstream) of the deck presents lower slope than the second half of the deck, this could alter the performance as water sits longer on flatter areas causing faster deterioration. Figure 34, presents an RGB view of the deck's top surface.

Figure 33. Structure 361632N - Elevation map.

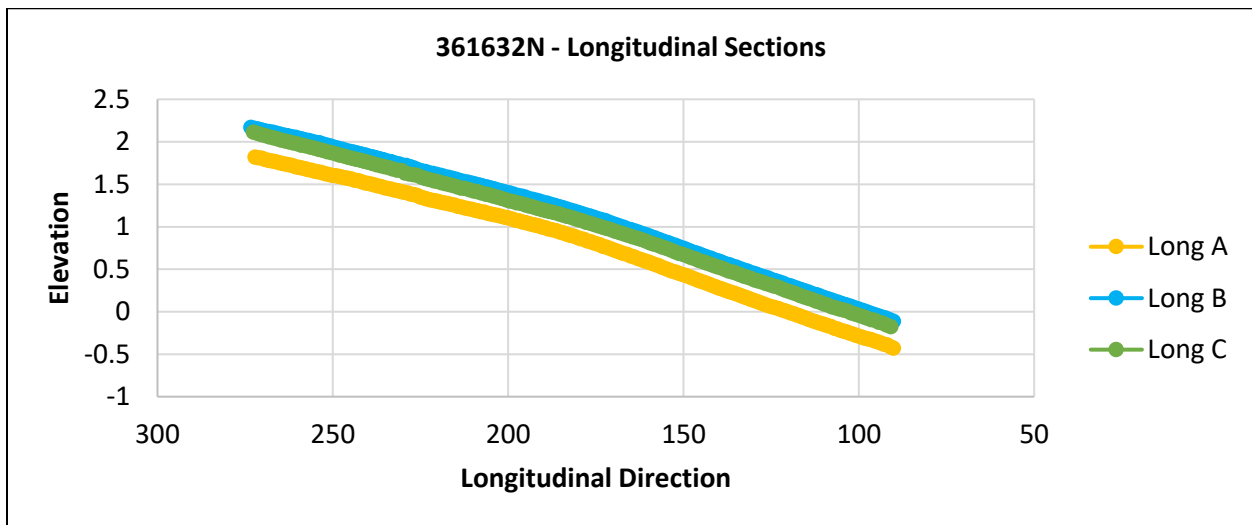
Figure 37. Structure 361632N - Longitudinal Sections.

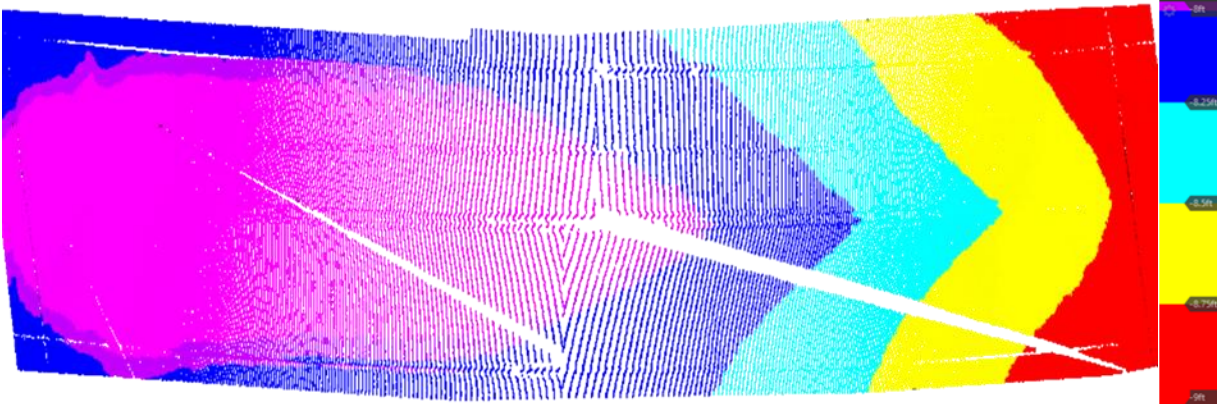
Structure 0821155 is a newly constructed structure. It can be seen from the left side of Figure 45 and Figure 49, the presence of a flatter region, which can be an area of concern if the long term. The transverse cross section slope of the deck is approximately 1.4%, slightly below the recommended 2%, this was estimated from the data found on Figure 50. Figure 46, presents an RGB view of the deck's top surface.

Figure 45. Structure 0821155 - Elevation map.

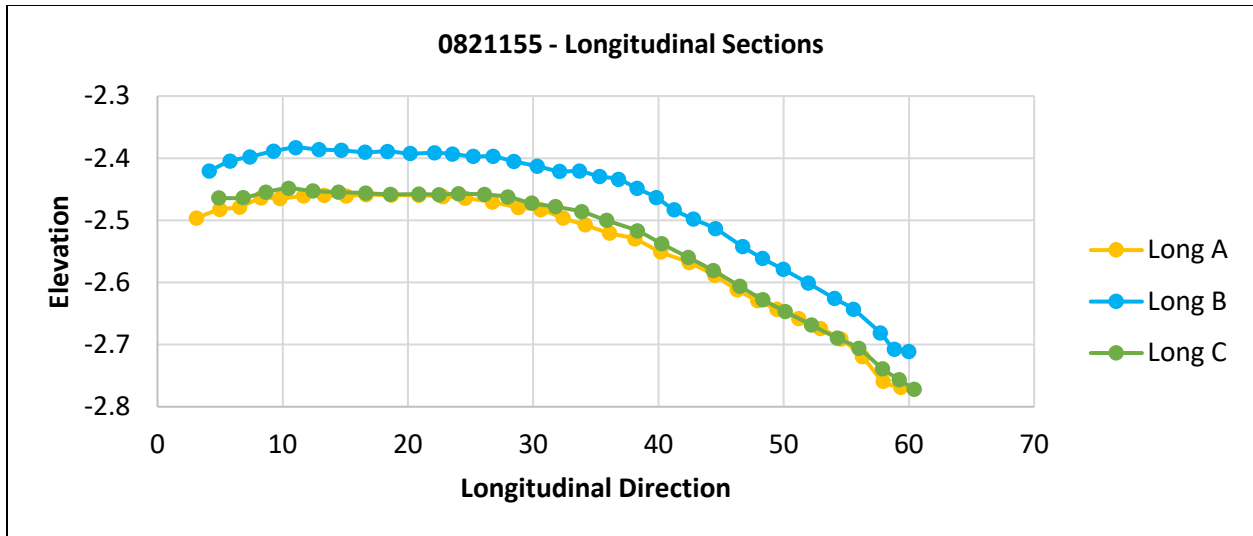
Figure 49. Structure 0821155 - Longitudinal Sections.

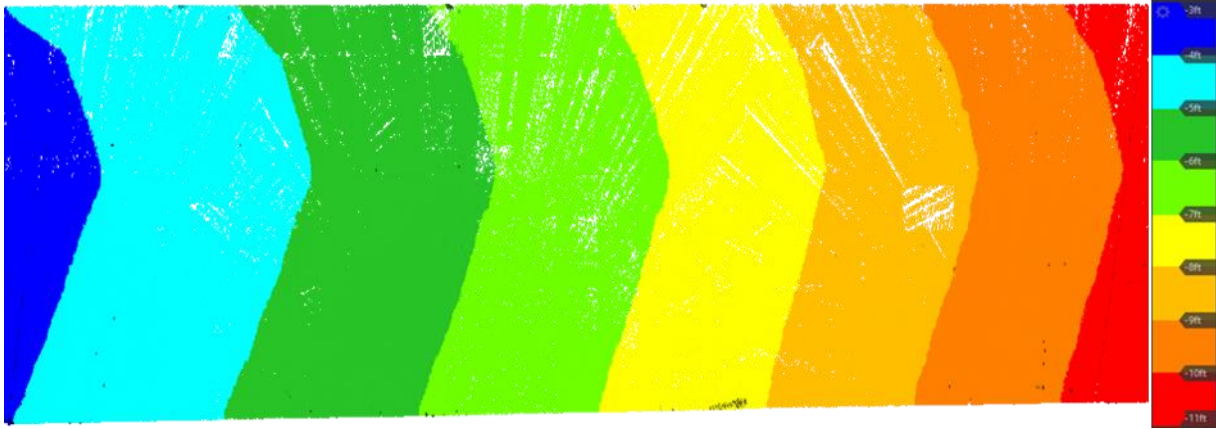
Structure 1317154 presents a uniform longitudinal slope of approximately 3% as seen and estimated from Figure 51 and Figure 55. The transverse slope estimated from Figure 56 is approximately 1.6%, slightly below the recommended 2%. There is not a clear area of concern where early deterioration would occur. It is important to highlight the low transverse slope found on this deck. The plan view presented on Figure 53, indicates the location of the longitudinal and transverse section within the deck, where Long A, Long B, Long C, and Long D are the cross section on the longitudinal direction, while Trans Top, Trans Mid, and Trans Bottom are the cross sections on the transverse direction. Figure 54 presents an approximate location of each of the aforementioned cross sections within structure 0821155.

Figure 51. Structure 1317154 - Elevation map.

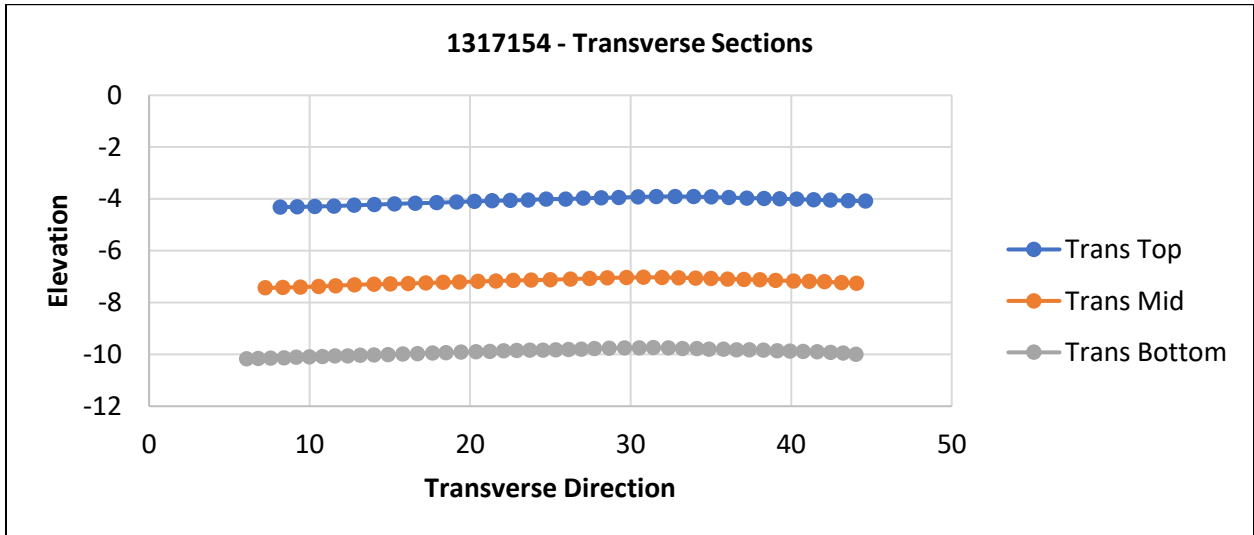
Figure 56. Structure 1317154 - Transverse Sections.

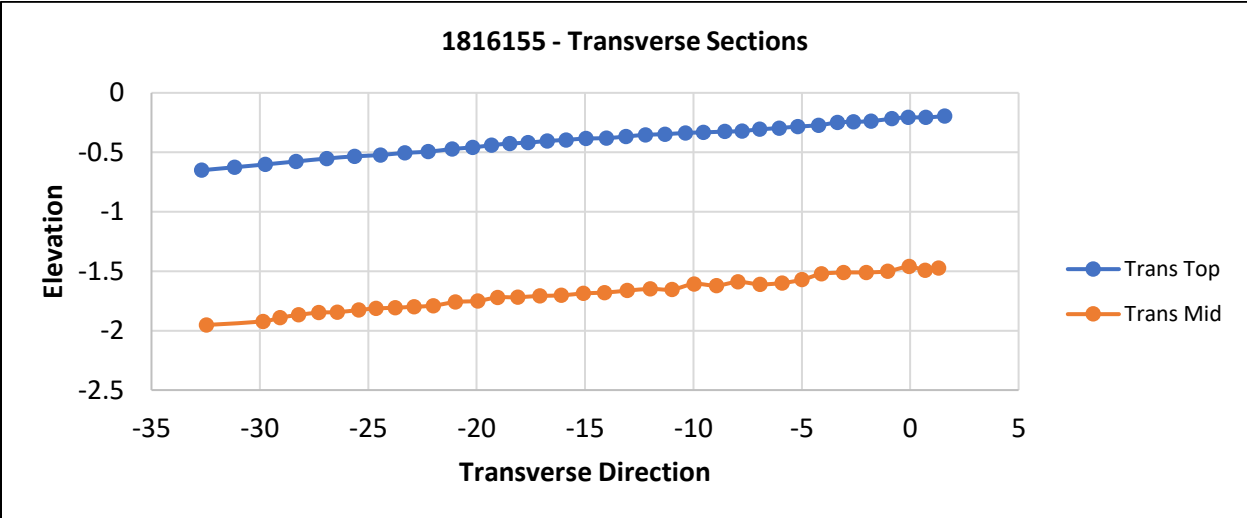
Structures 1816154 and 1816155 will be compared in this section, since these structures were included on this project as a case study presented by NJDOT. The twin bridges originally presented different levels of deck condition (3 for 1816155, and 6 for 1816154) which was a concern since the structures see the same level of traffic and have same dimensions of their structural components. Figure 58 and Figure 63 show the elevation maps of the top surface of the structures. Both structures present a longitudinal slope of approximately 2.3%, which can be estimated from Figure 61 and Figure 66. Structure 1816154 presents a transverse slope between 1 and 1.3% (see Figure 62), while structure 1816155 presents a uniform transverse slope of 1.3% (see Figure 65).

Figure 67. Structure 1816155 - Transverse Sections.
