# EVALUATION OF ENGINEERED-POLYMER COMPOSITE TIE PERFORMANCE IN REVENUE SERVICE

## SUMMARY

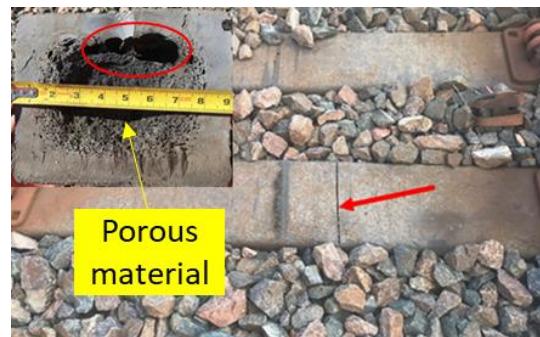
Tie center cracking was the primary defect observed. A total of 31 Type A ties experienced the center cracking issue as of April 2021. All the center cracked ties were pulled out for inspection and replacement. Upon further inspection, researchers found that the cracked plane was typically associated with internal conditions (Figure 2). Due to the manufacturing process, all the EPC ties have a porous texture (i.e., small air bubbles less than 1/2 inch) in the core, as shown in Figure 2. However, the

cracked ties were generally associated with voids over 1 inch (red circle in Figure 2) or the presence of multiple voids close to one another. It is worth mentioning that, despite failing in service, the installed ties passed the manufacturers' quality control (QC) inspection using X-ray. Therefore, the current QC process may need to be improved to control the size of voids or the presence of a certain size of void within a certain distance of another.

Figure 2. Tie center cracking and tie cross section on the cracked plane

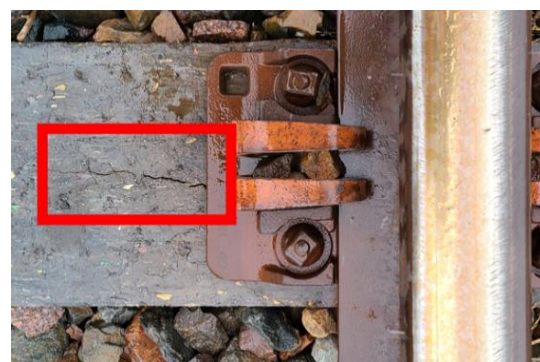
Only one Type B tie had spike-hole cracking (Figure 3). This defect was also found on this tie type on the HTL [2]. This type of crack typically initiates at the spike hole and propagates to the edge of the ties.

Figure 3. Tie spike-hole cracking

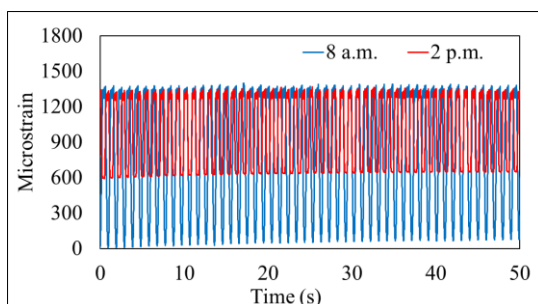
Strain data also showed that temperature could affect the tie center bending behavior. The strain on the top surface at the tie center was measured at two different times of the day. The data in Figure 4 shows the strain measurements collected on the same EPC tie under the same type of train loading in the morning and in the afternoon.

**Figure 4. Tie bending strain in the morning and afternoon**

Average temperatures at the tie top surface were 50°F (morning) and 90°F (afternoon). The ambient temperatures were around 50°F (morning) and 72°F (afternoon). The strain range in the morning (8 a.m., blue lines) was

around 1,400 microstrain; however, it fell to 800 microstrain in the afternoon (2 p.m., red lines).

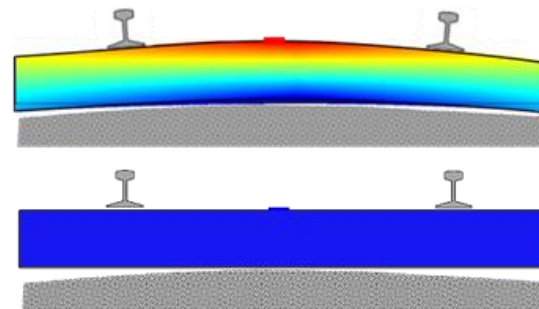
EPC tie material is generally more sensitive to temperature change than wood; this high-density polyethylene (HDPE) can expand 10–20 times more than wood [3]. The hypothesis for the variation in the bending strain throughout the day is that the EPC ties were straight in the morning when the temperature was more uniform within the body of the ties. When the ties were straight, the center-bound ballast support condition only supported the center of the ties, causing more center bending. However, with the differential temperatures between the top surfaces and the rest of the tie in the afternoon, the ties expanded more on the top surface, causing them to bend and become more conformal with the ballast surface. This would improve the support conditions and, in turn, reduce the strain range. A conceptual illustration of the tie shape change due to temperature is shown in Figure 5.

**Figure 5. Tie shape at different temperature conditions**
