Rapid Seismic Repair of Column to Footing Connections – Phase 2

Alaska Department of Transportation & Public Facilities

1. AGENCY USE ONLY (LEAVE BLANK)		2. REPORT DATE May 31, 2022		3. REPORT TYPE AND DATES COVERED FINAL REPORT, Jan. 2019 through May 2022
4. TITLE AND SUBTITLE Rapid Seismic Repair of Column to Footing Connections – Phase 2			5. FUNDING NUMBERS

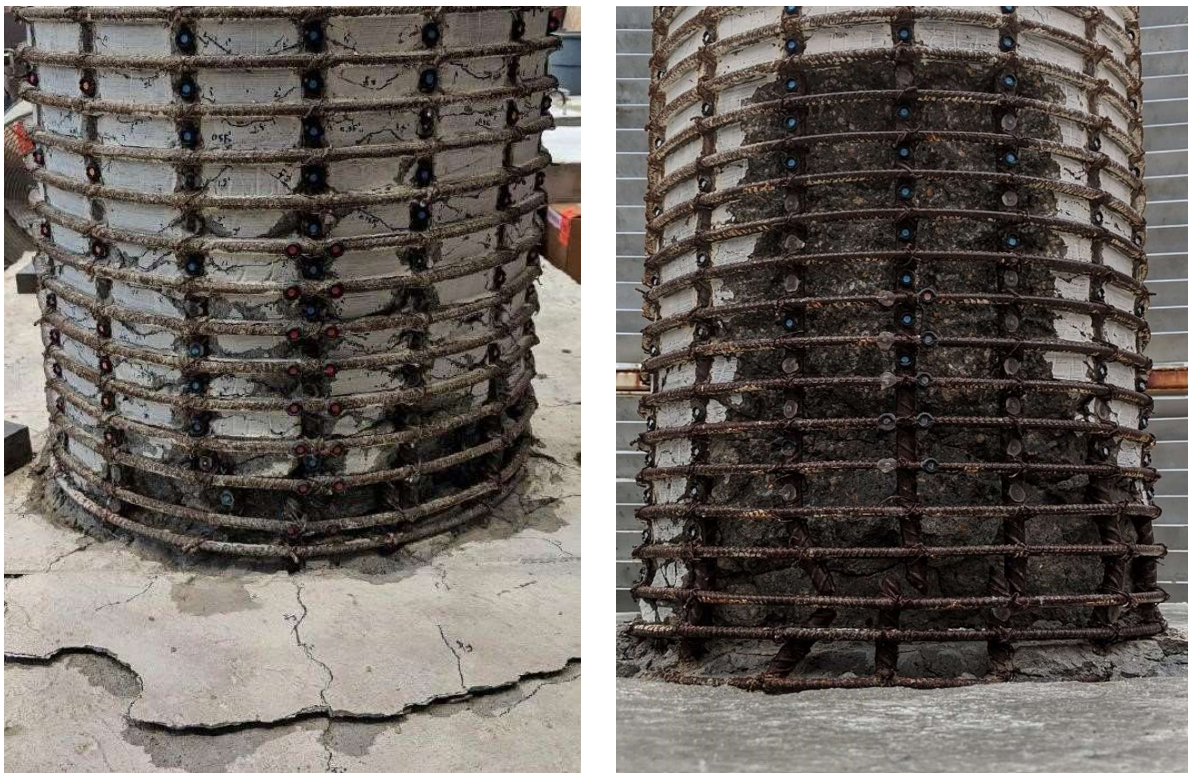
Figure 3.4: Before and After Removal of Damaged Concrete.

within the height of the repair should be removed. This ensures that the fresh repair grout will completely surround the fractured bar and is a necessity to fully anchor the bar within the repair. An example before and after of this step is shown in Figure 3.4. On the left, the damaged column is shown with large cracks near the base being evidence of the loose concrete that needs to be removed. For this column, the three frontmost bars were fractured during the original test, so within the height of the repair the concrete around the bars was removed, which can be seen on the right. Although the exact depth for concrete removal around the fractured bars has not been studied in this project, it is recommended to remove at least a the nominal maximum aggregate size around the bar (shown in Figure 3.5).

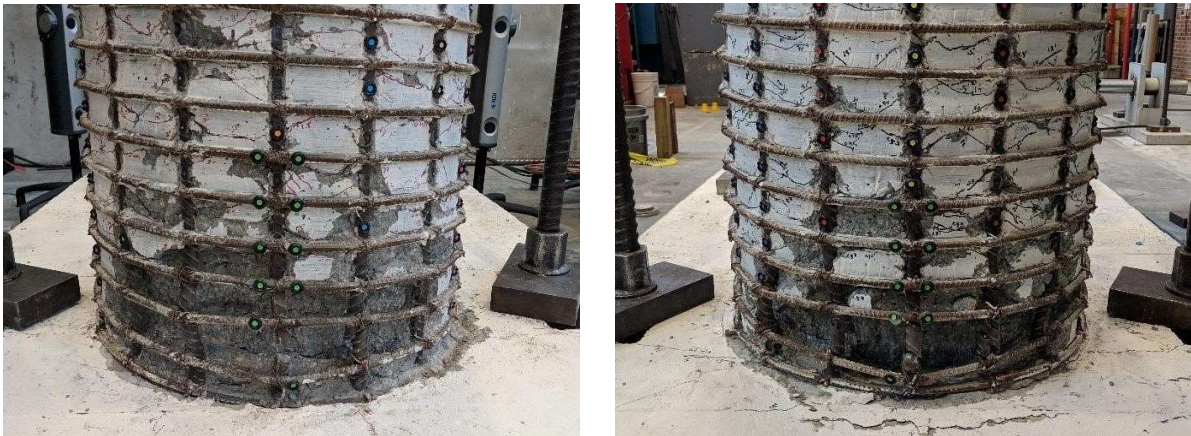
The column repaired in this test was severely damaged, having 7 longitudinal bar fractures along with a substantial loss in core concrete. The repair was designed following the steps described in Section 5.1. The damaged state of the column is shown in Figure 4.1, and the repaired cross section and bolt configuration are shown in Figure 4.2. The properties for the original column, comparison column, and repair are summarized in Table 4.1.

Figure 4.1: Damaged Column for Repair #1 on the North (left) and South (right) sides.

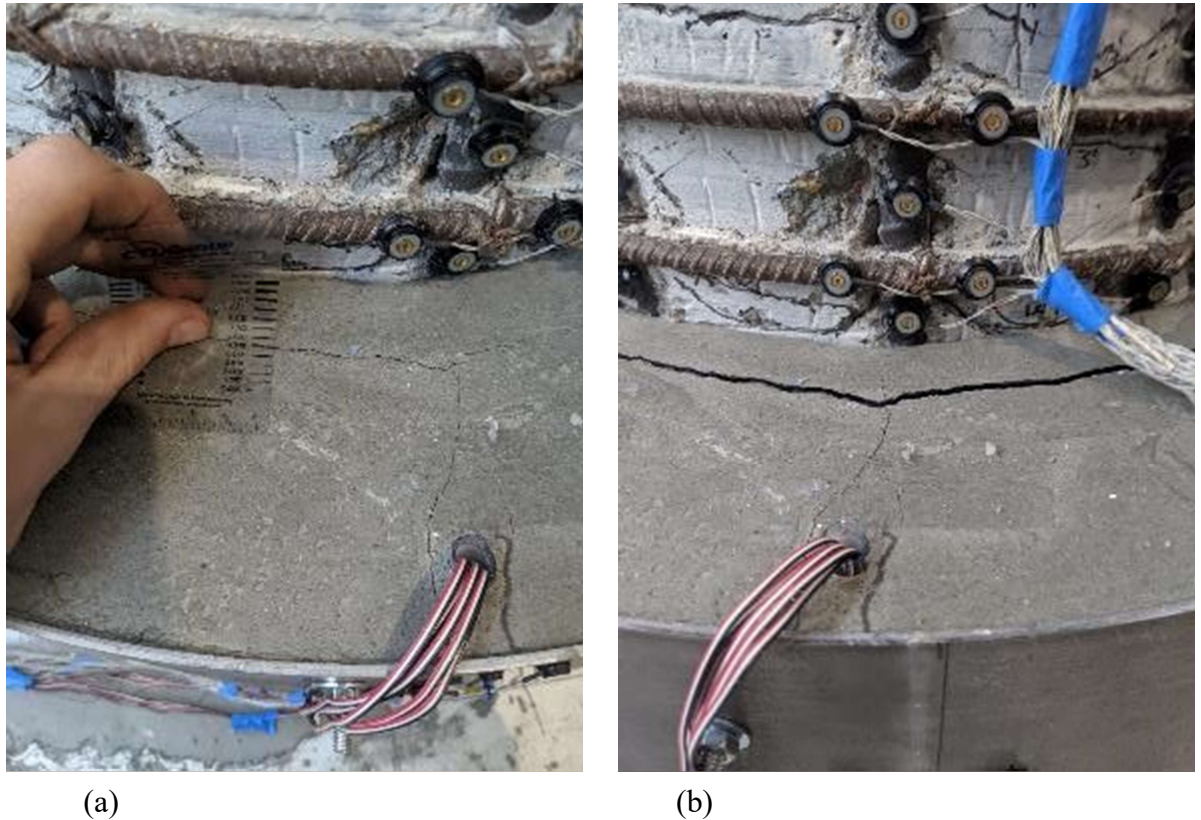
Figure 4.3: Cracking of the Top of Repair Grout at (a) $\frac{1}{4} F_y'$ and (b) F_y' .

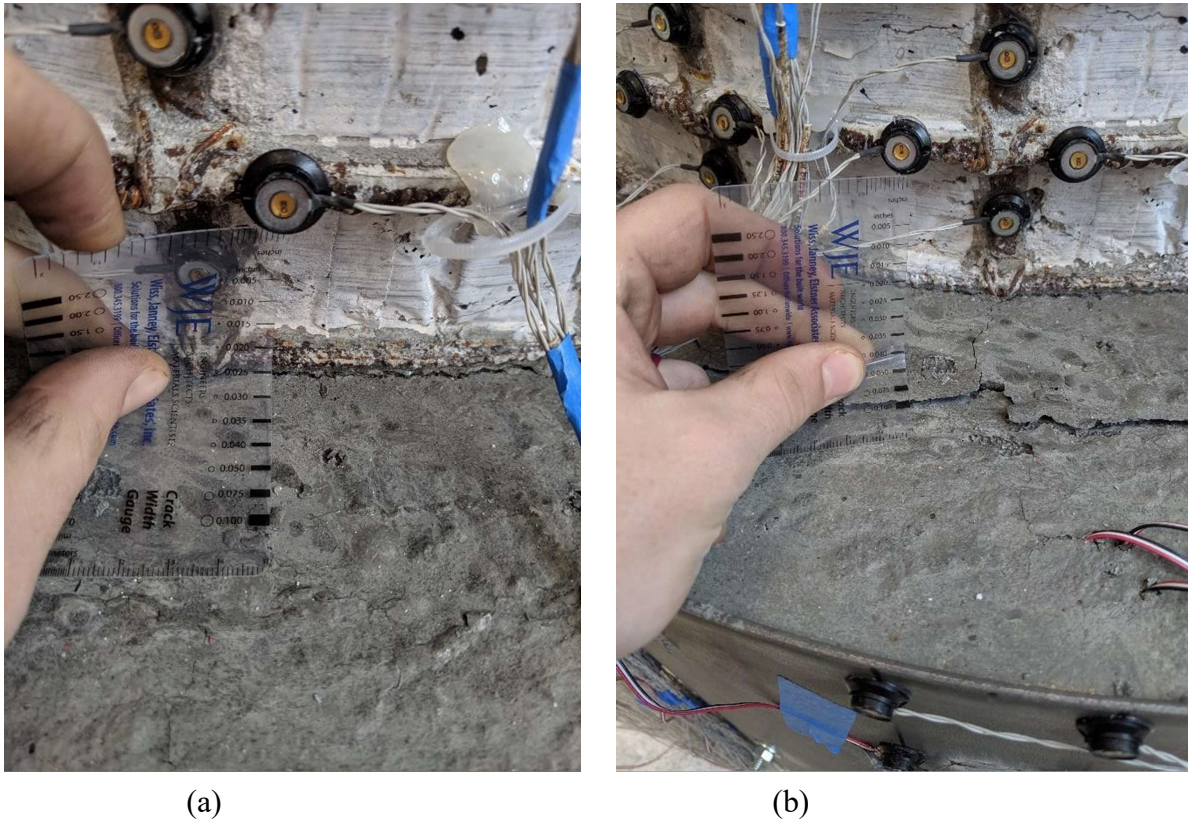
Figure 4.14: Cracking of the top of repair grout at (a) $\frac{1}{2} F_y'$ and (b) ductility 1.

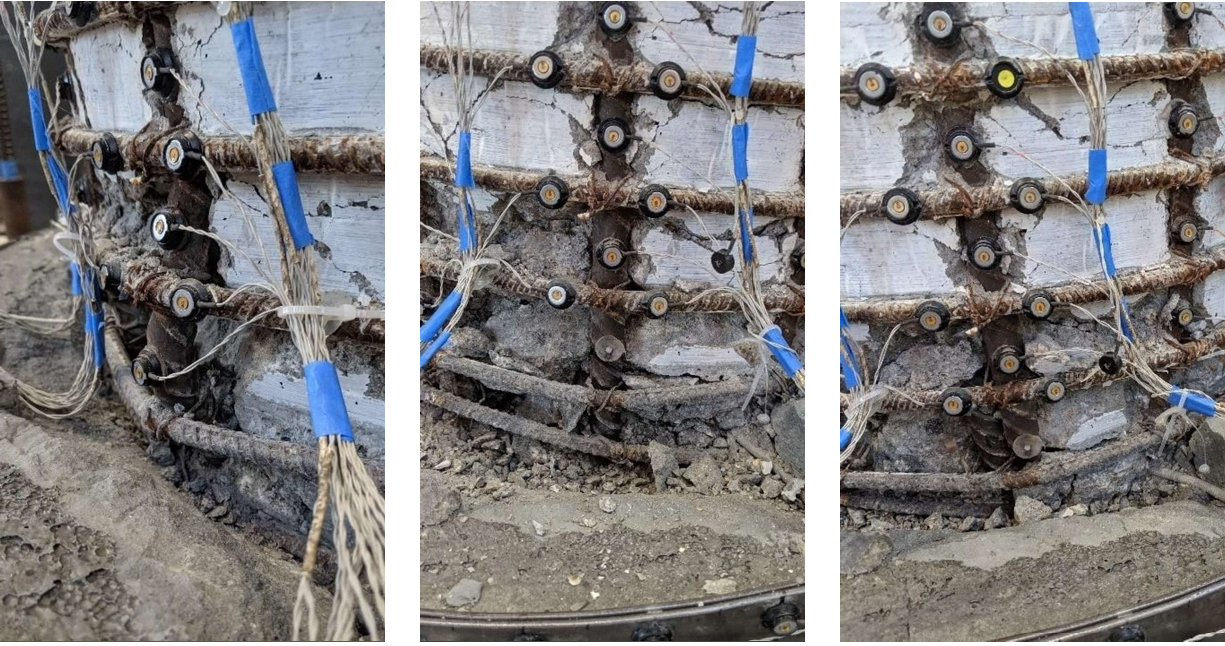
Figure 4.17: Final cycles of N6 showing (left) buckling, (middle) fracture, and (right) next compression cycle.

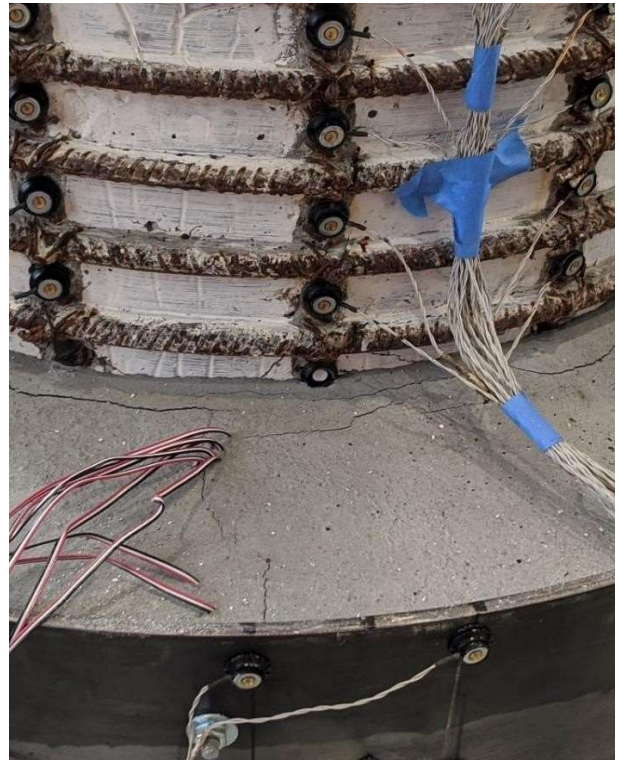
Figure 4.27: Circumferential cracks in grout at $\frac{1}{2} F_y'$ for the North (left) and South (right).

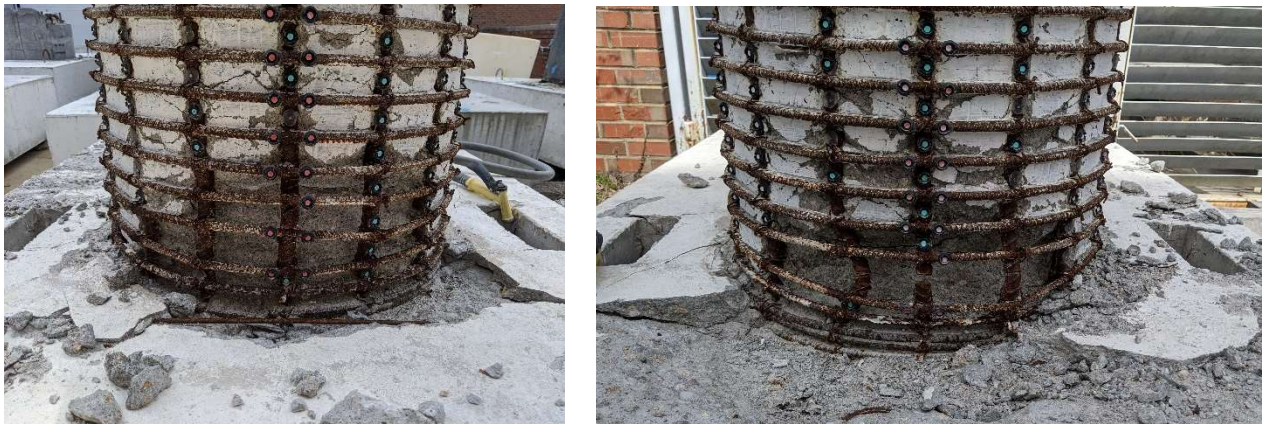
The initial damage condition of this column was 3 fractured bars on each side. The repaired column was subjected to the same axial load and displacement history as the original column. This repair maintained the use of the thicker steel sleeve from Repair #3, with the focus of evaluating the impact of chipping perimeter concrete around both fractured and unfractured bars. To accomplish this, the perimeter concrete was chipped around the fractured bars on the South side and concrete was chipped around all of the bars on the North side. Figure 4.40 shows the damage conditions prior to chipping perimeter concrete. The column after the concrete was chipped is shown in Figure 4.41. The properties for the original column and repair are summarized in Table 4.4.

Figure 4.40: Repair conditions for the North (left) and South (right) sides.

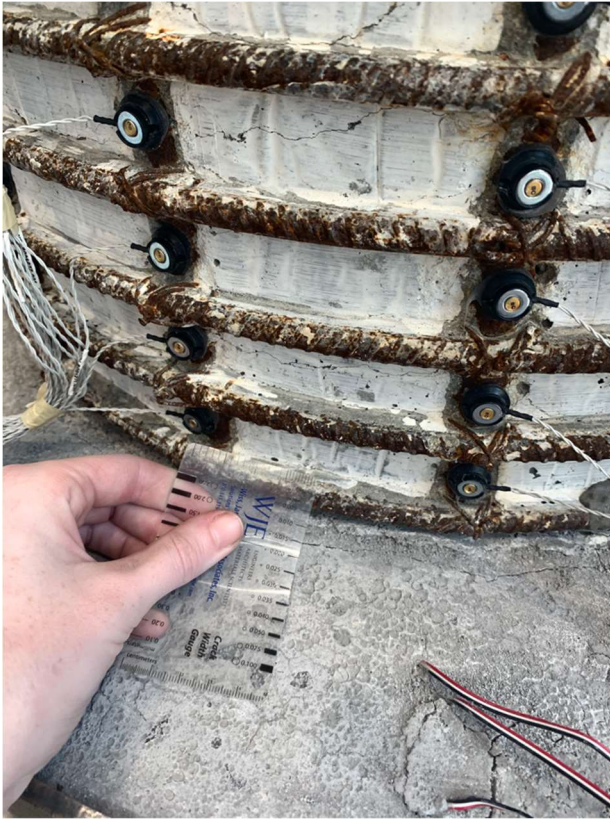
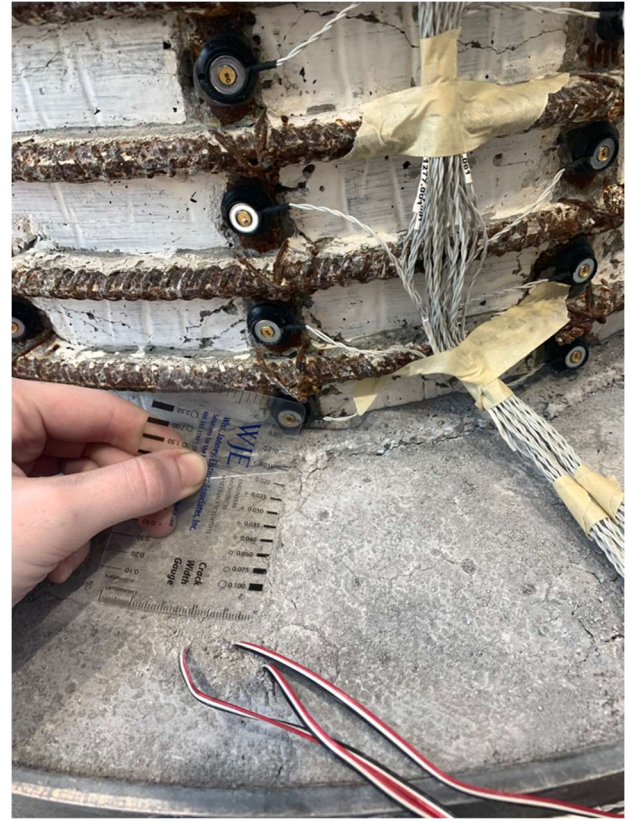
Figure 4.42: Circumferential cracks in the top of repair grout at $\frac{1}{2} F_y'$ for the North (left) and South (right) sides.

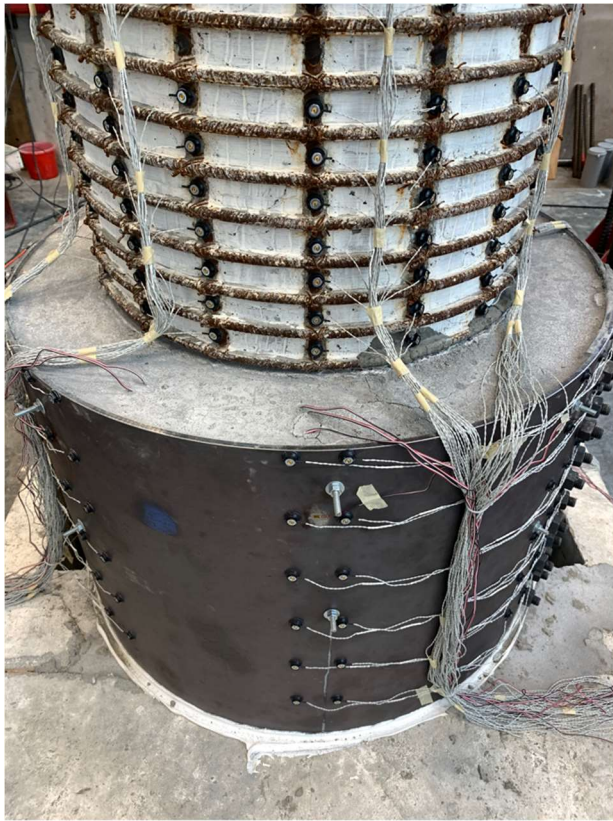
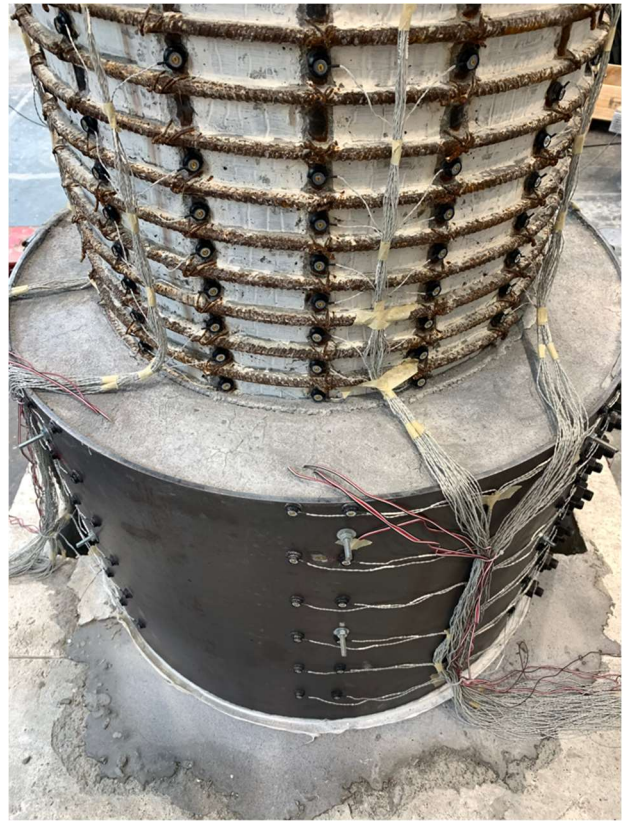
Figure 4.43: Comparison of grout cracking during ductility 1 for the North (left) and South (right) sides.

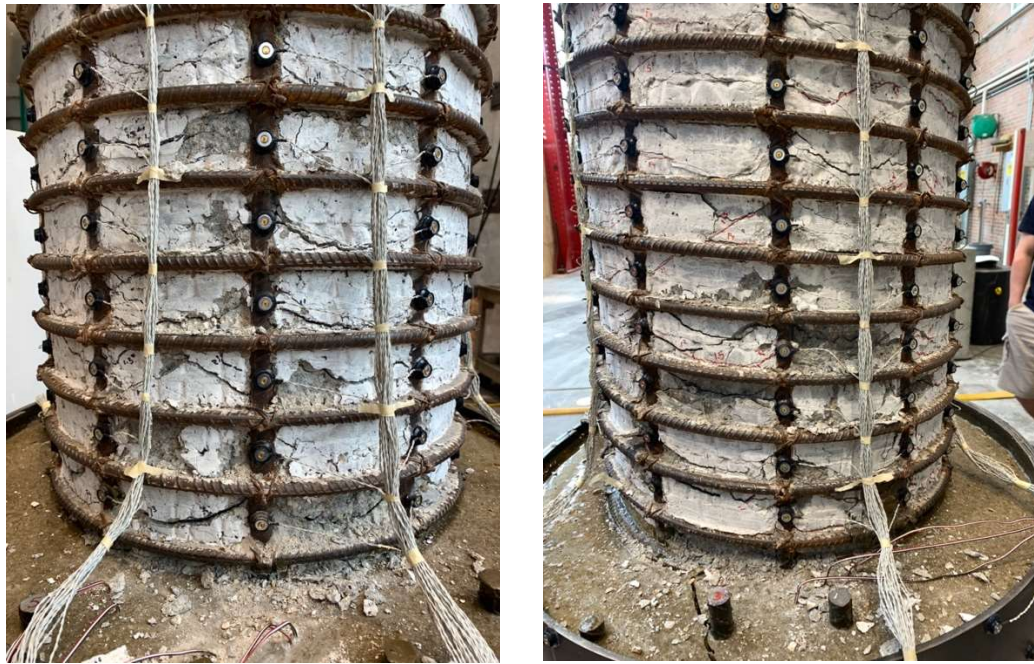
Figure 4.84: Damage During Ductility 4 of the North (left) and South (right) Sides.

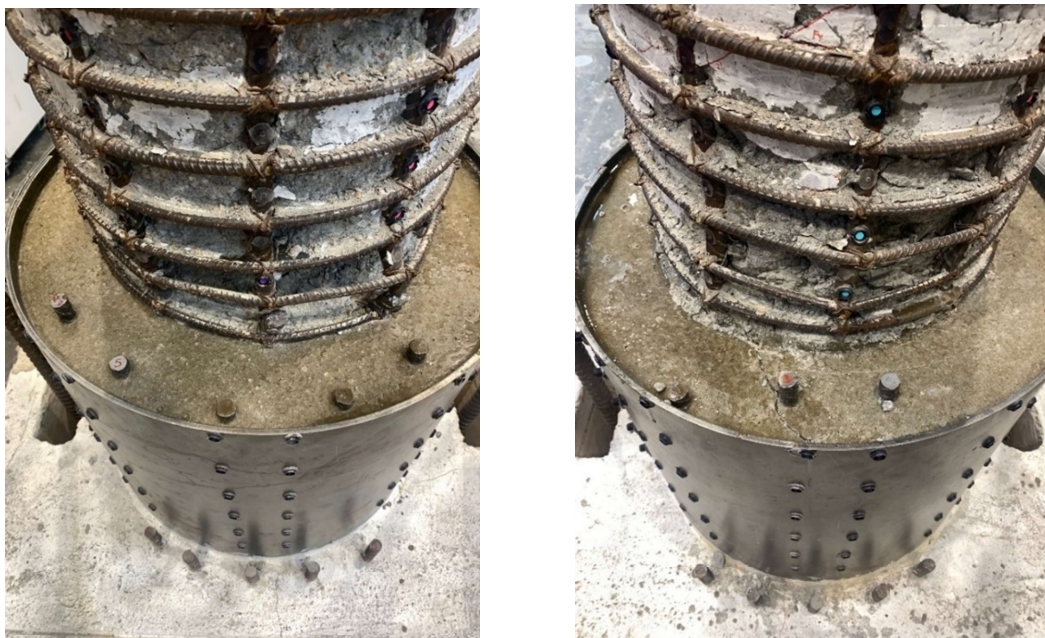
Figure 4.85: Damage after the test when all loose concrete was removed of the North (left) and South (right) sides.

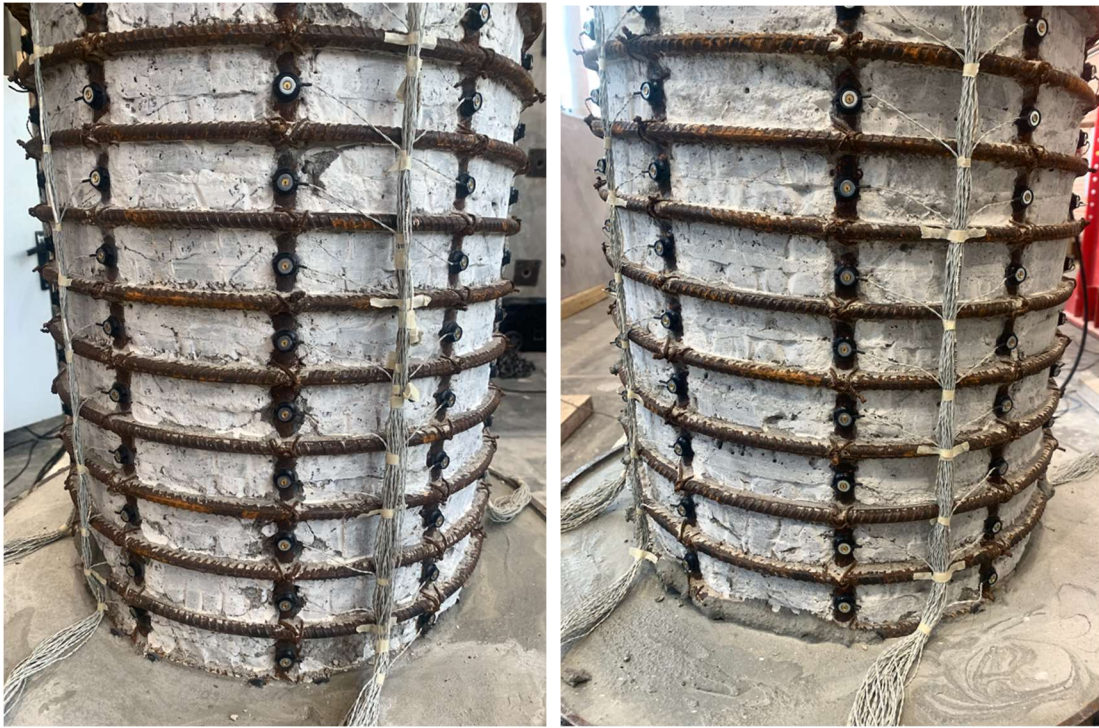
Figure 4.92: Initial Damage of the North (left) and South (right) Sides.

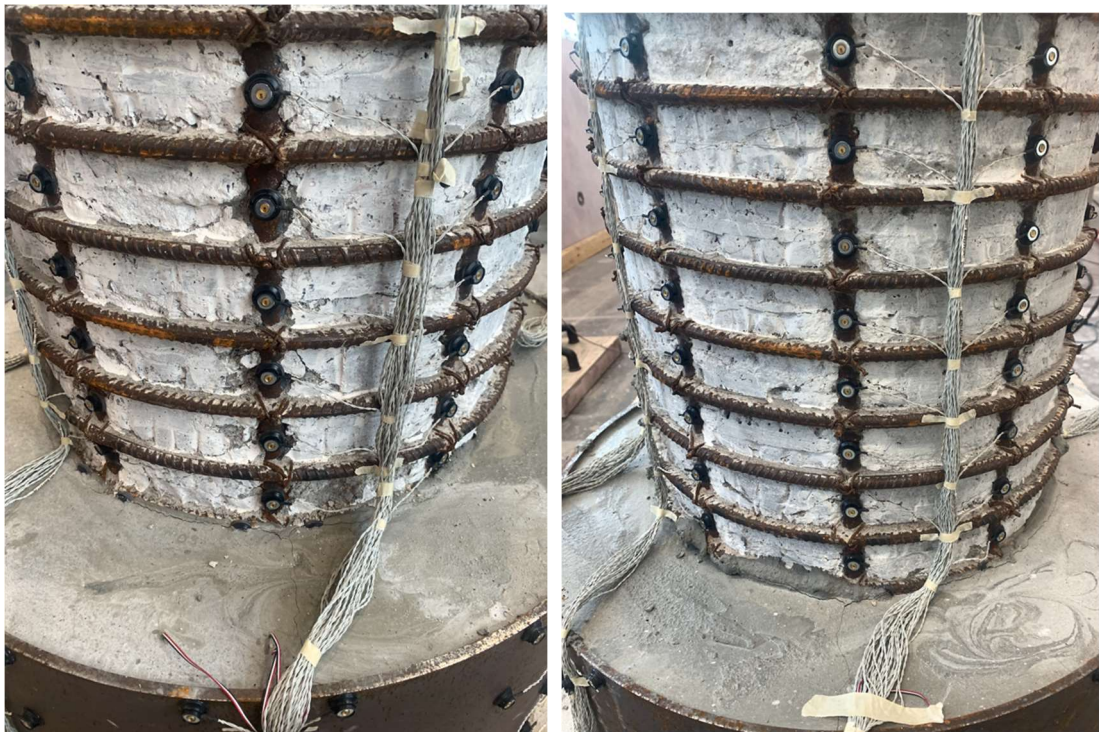
Figure 4.93: Damage During Ductility 1 of the North (left) and South (right) Sides.

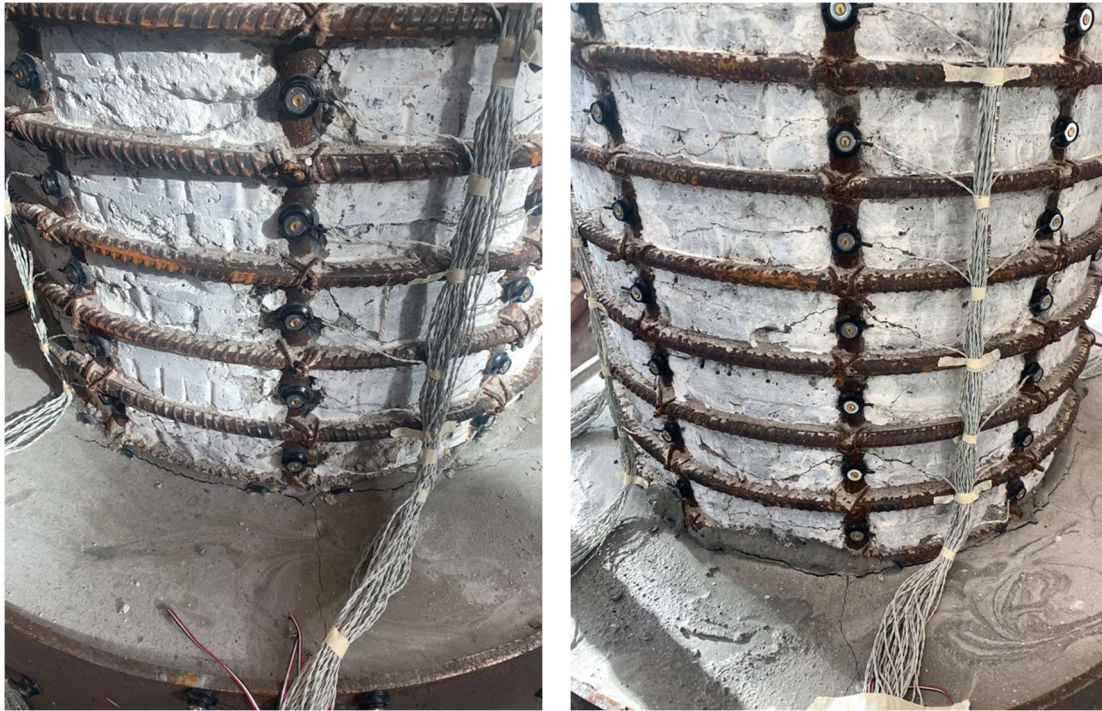
Figure 4.94: Damage During Ductility 2 of the North (left) and South (right) Sides.

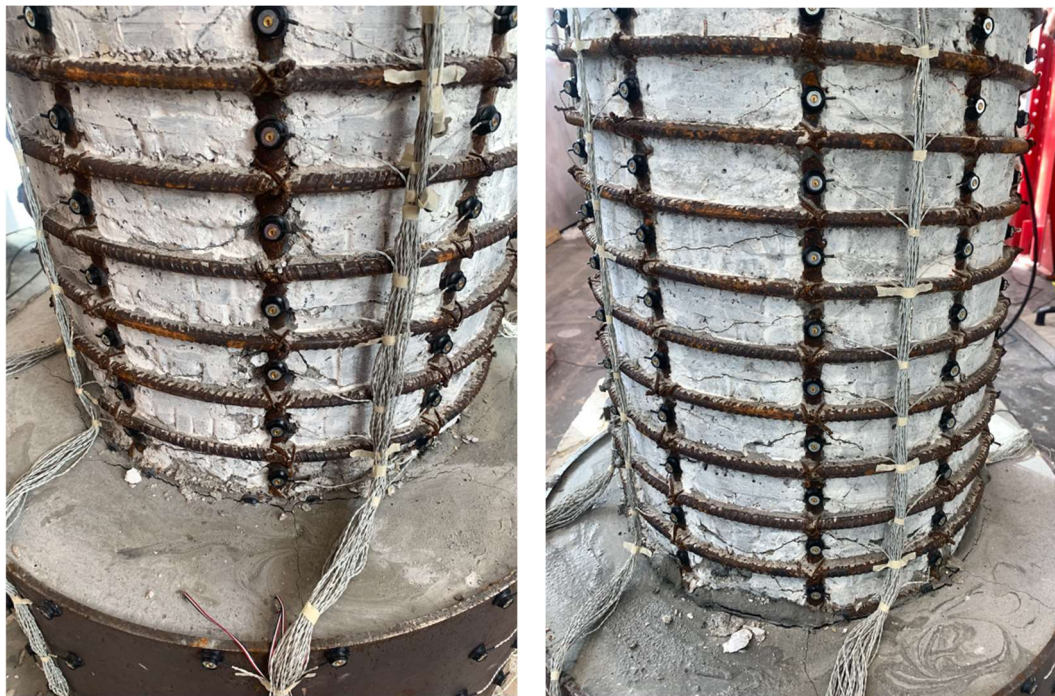
Figure 4.95: Damage During Ductility 3 of the North (left) and South (right) Sides.

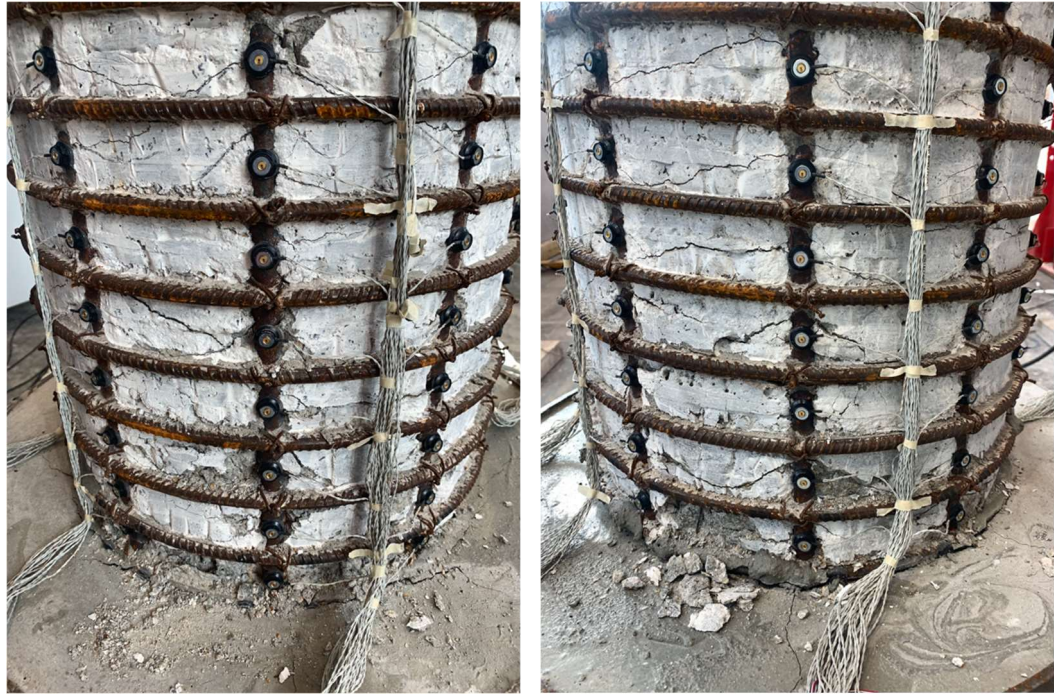
Figure 4.96: Damage During Ductility 4 of the North (left) and South (right) Sides.

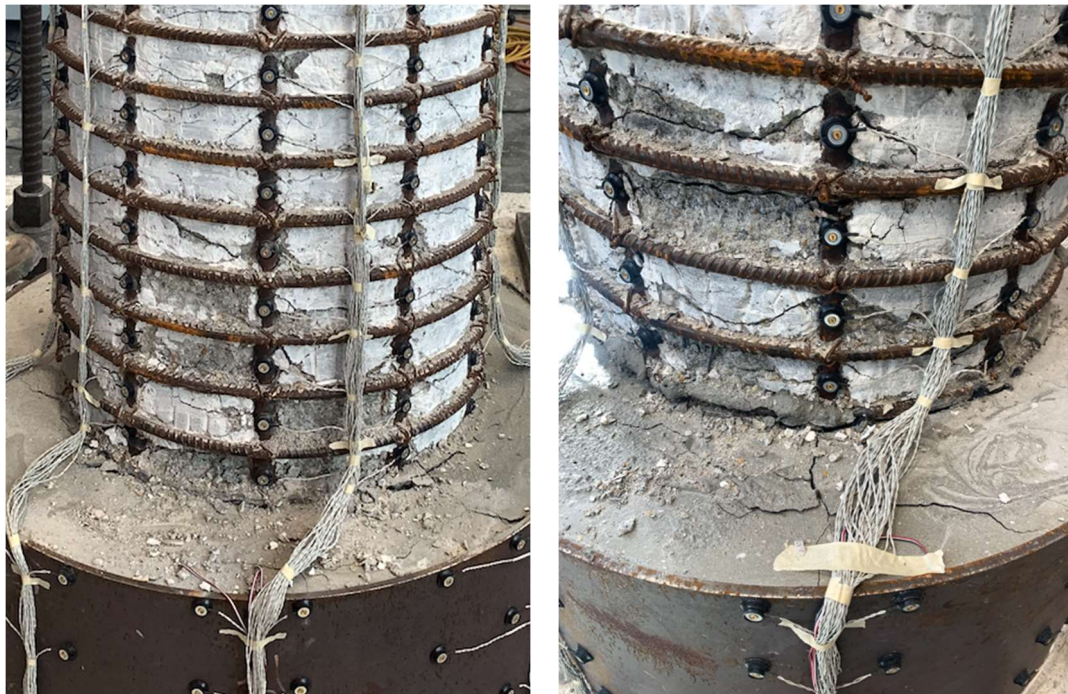
Figure 4.97: Damage During Ductility 5 of the North (left) and South (right) Sides.

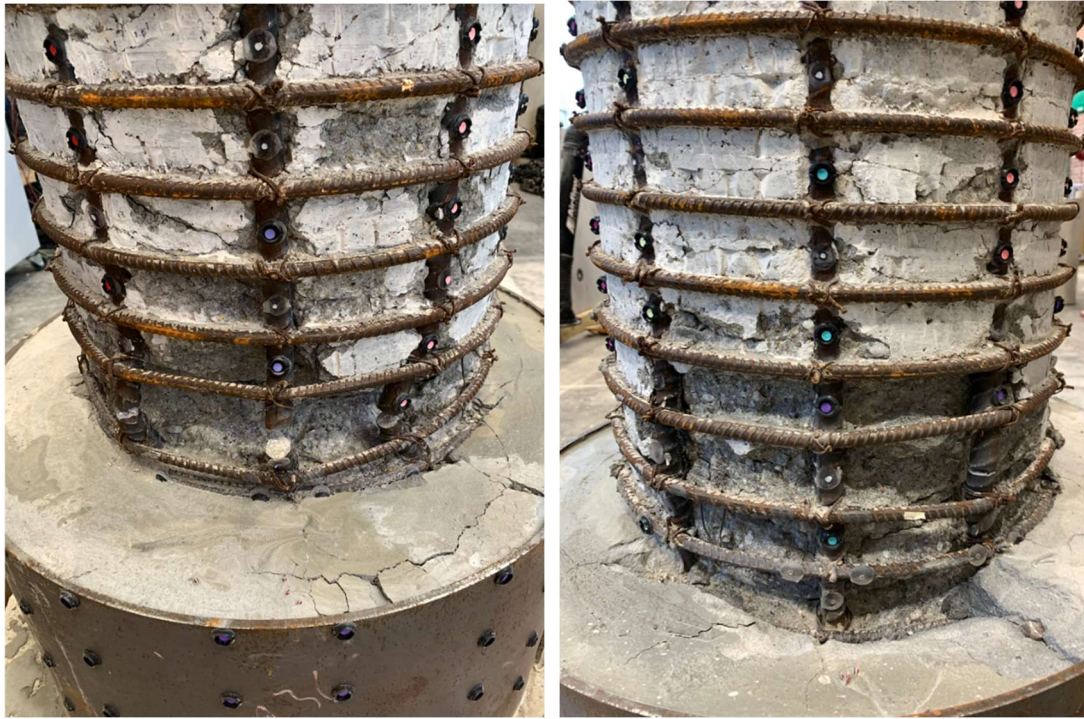
Figure 4.98: Final Damage of the North (left) and South (right) Sides.

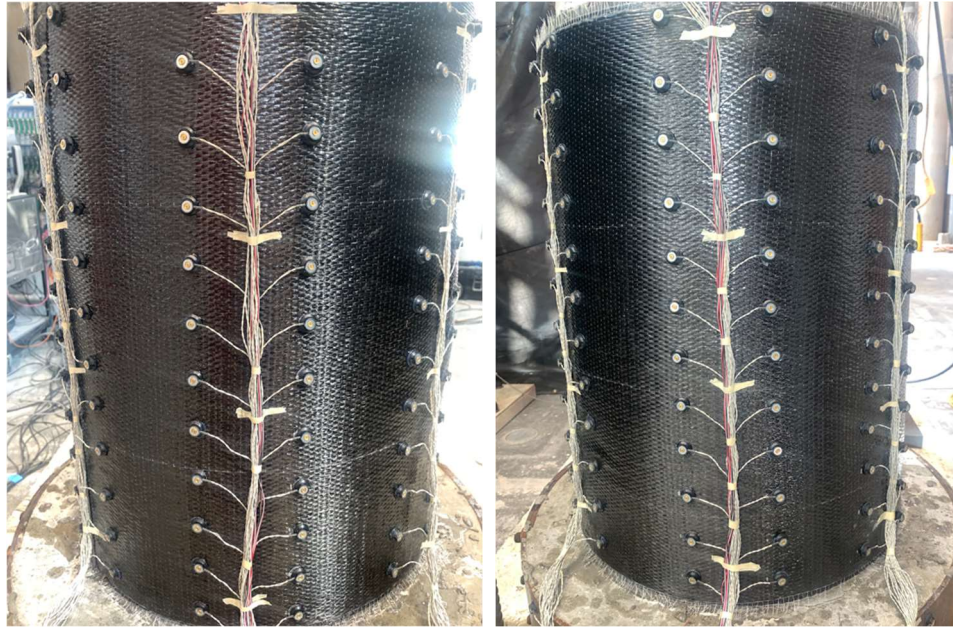
Figure 4.103: Damage During Ductility 1.5 of the North (left) and South (right) Sides.

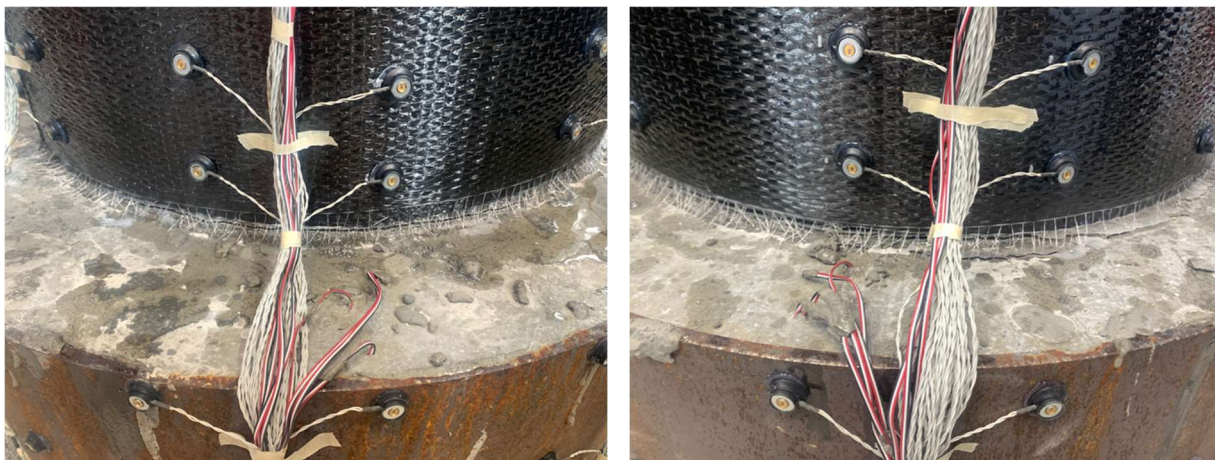
Figure 4.104: Damage During Ductility 2 of the North (left) and South (right) Sides.

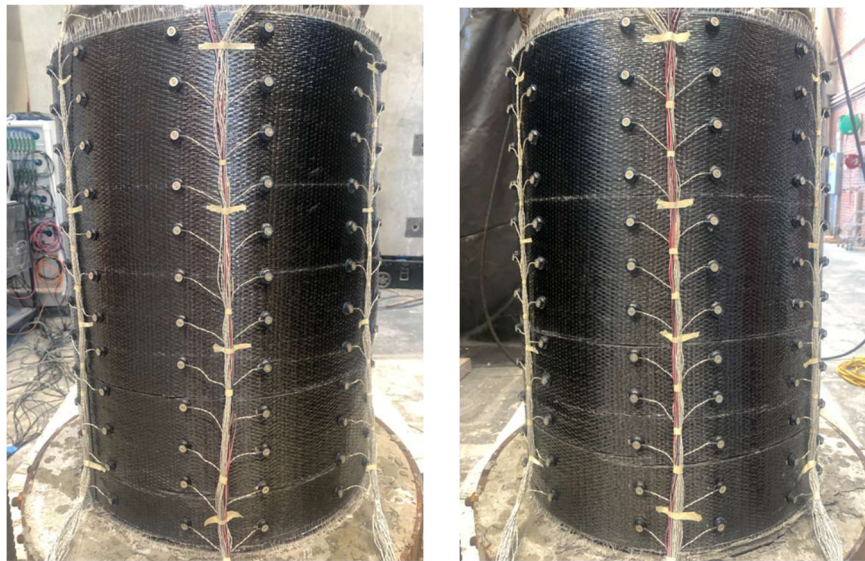
Figure 4.106: Damage During Ductility 6 of the North (left) and South (right) Sides.

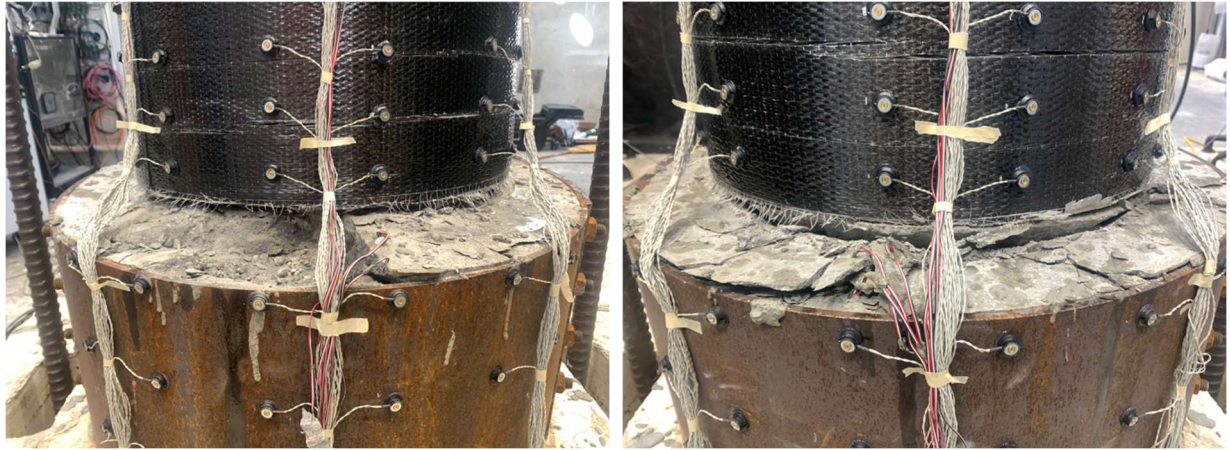
Figure 4.107: Final Damage of the North (left) and South (right) Sides.

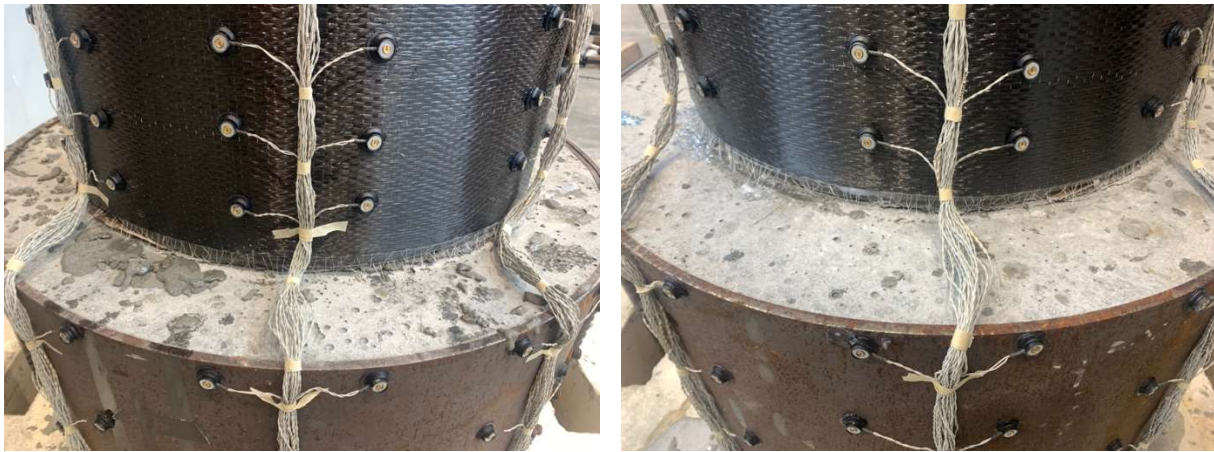
Figure 4.114: Damage During Ductility 1.5 of the North (left) and South (right) Sides.

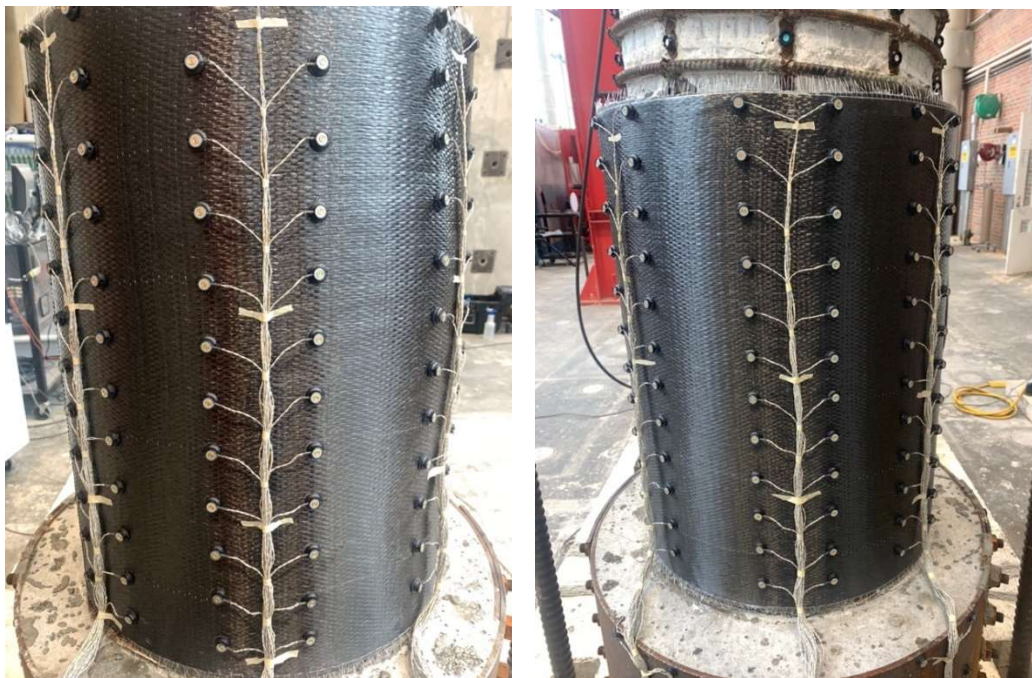
Figure 4.115: Damage During Ductility 2 of the North (left) and South (right) Sides.

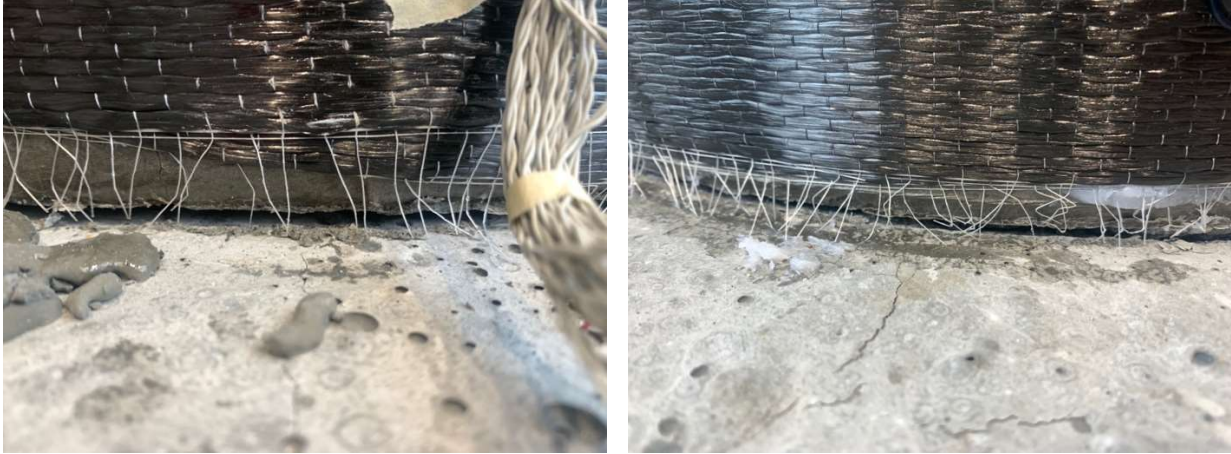
Figure 4.116: Damage Below CFRP During Ductility 2 of the North (left) and South (right) Sides.

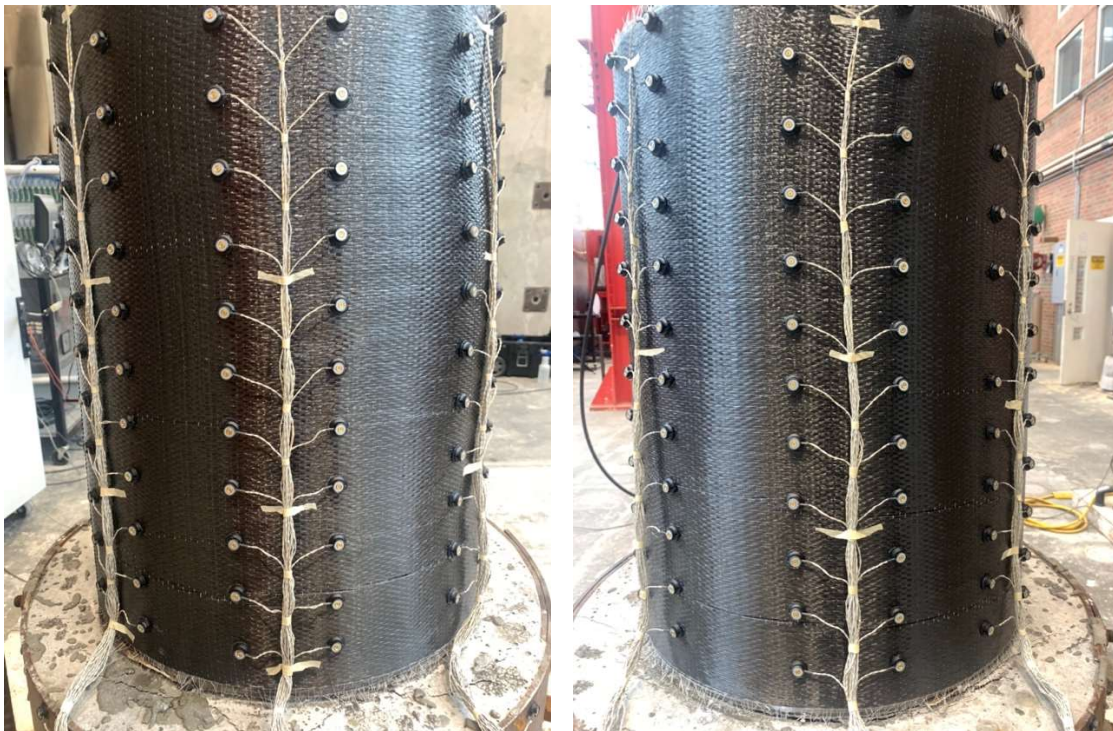
Figure 4.117: Damage During Ductility 3 of the North (left) and South (right) Sides.

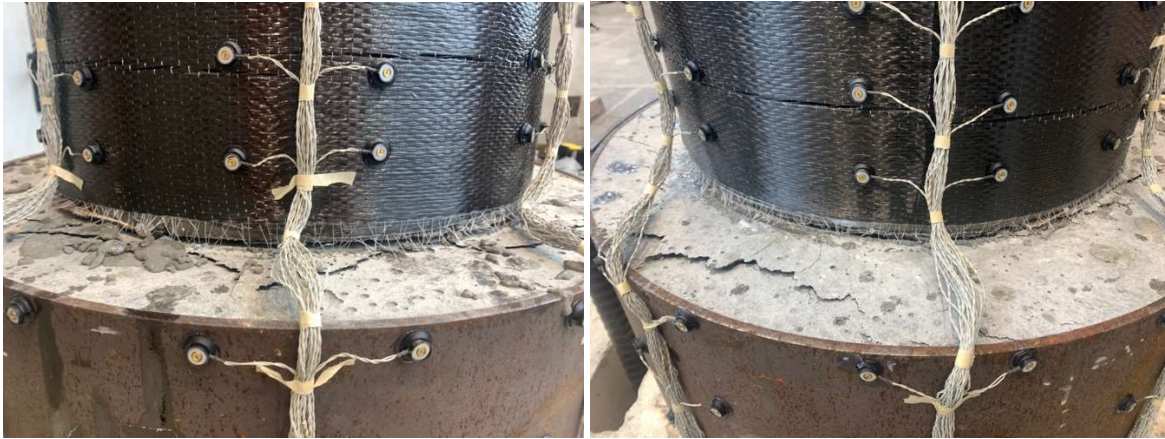
Figure 4.118: Damage Below CFRP During Ductility 3 of the North (left) and South (right) Sides.

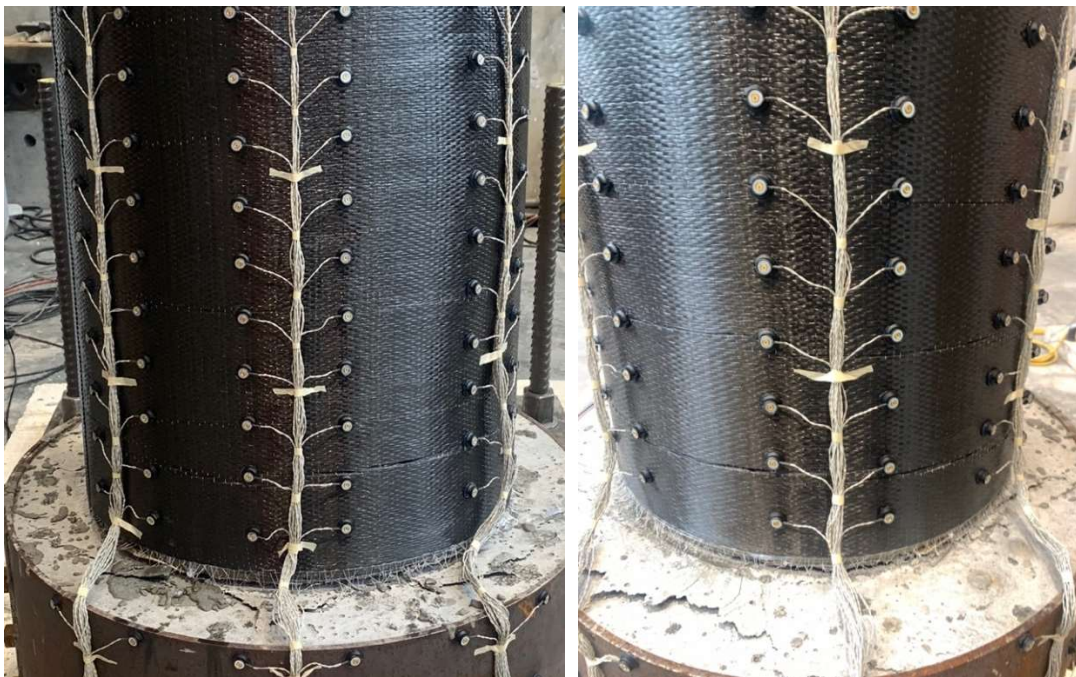
Figure 4.119: Damage During Ductility 4 of the North (left) and South (right) Sides.

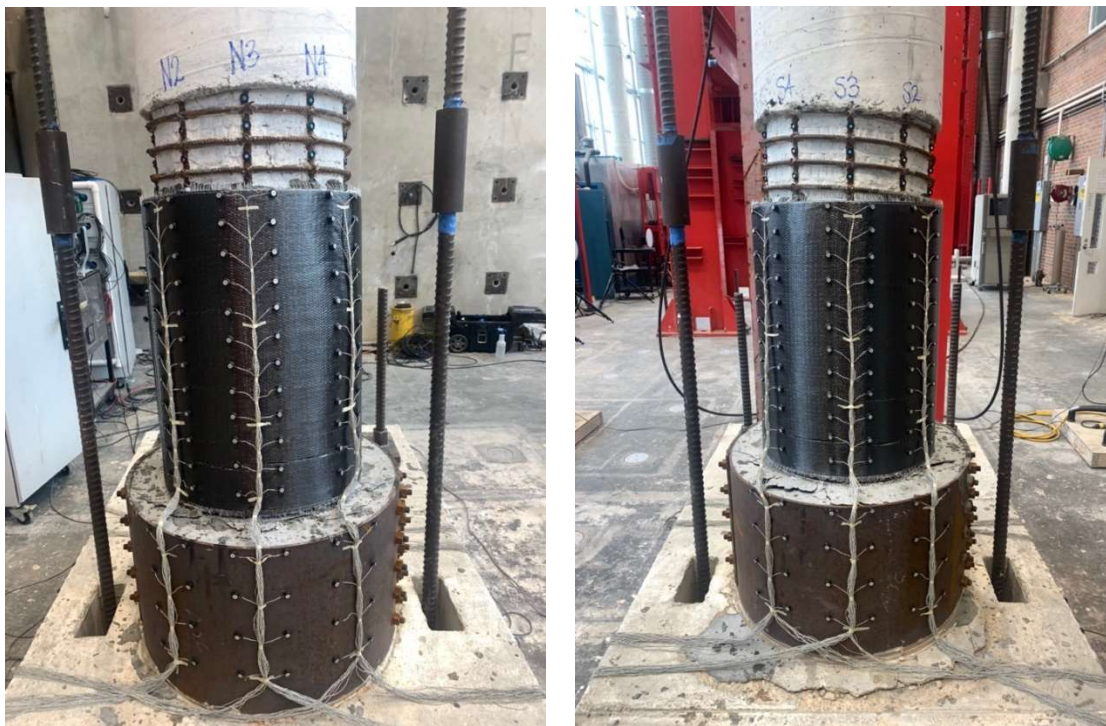
Figure 4.120: Damage During Ductility 5 of the North (left) and South (right) Sides.

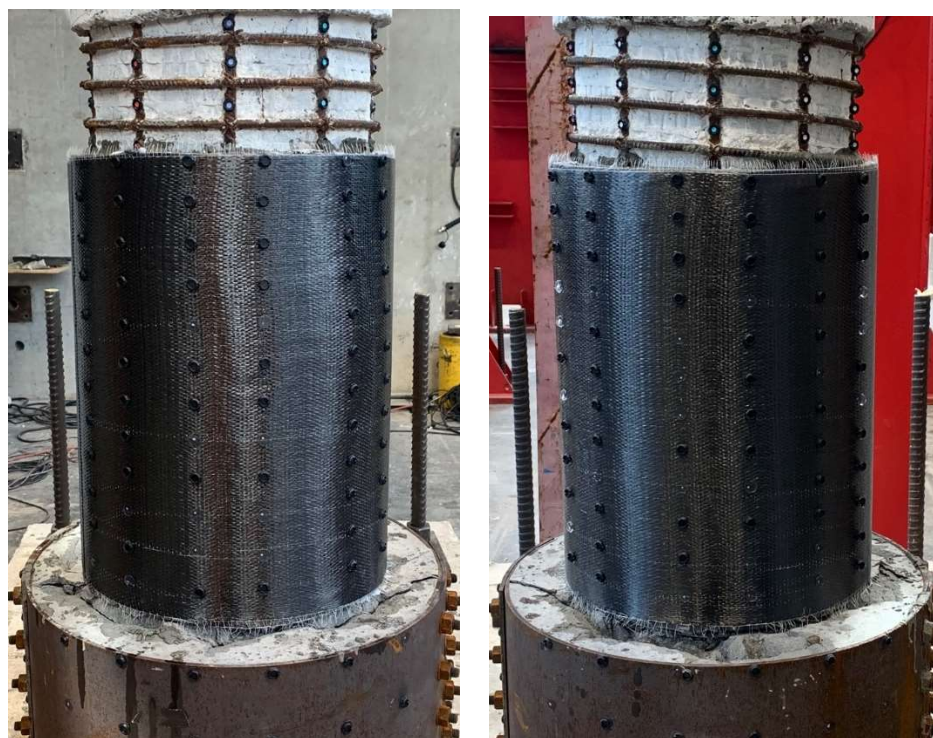
Figure 4.121: Final Damage of the North (left) and South (right) Sides.
