Impact of Water/ Cementitious-Based Concrete Mix Design Specification Changes on Concrete Pavement Quality

July 2018

Research Project
Final Report 2018-25

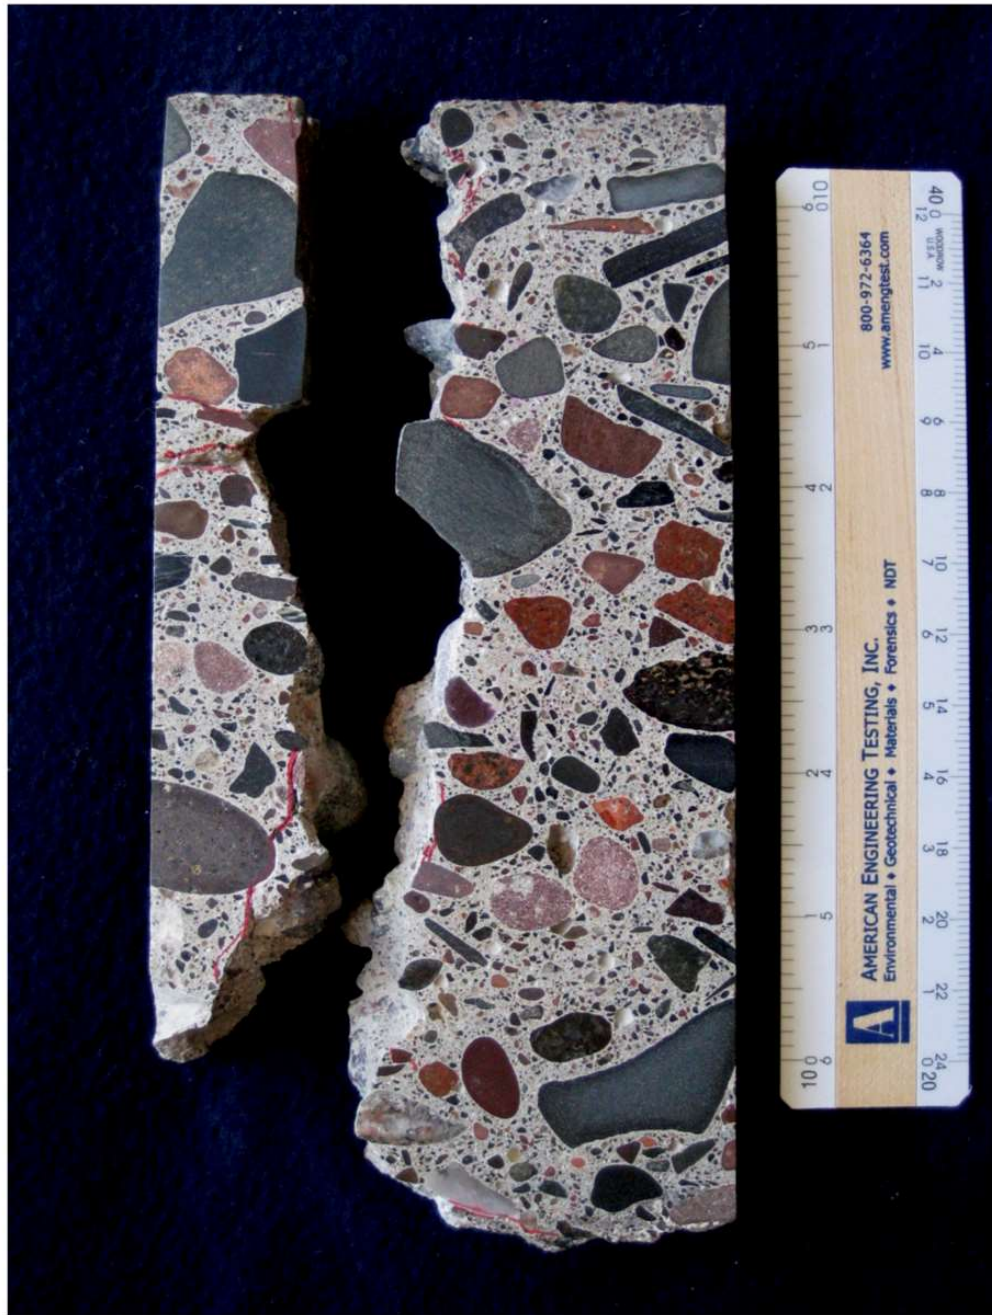
SAMPLE ID: 0987-127, 3B **DESCRIPTION:** Sawcut and lapped cross section of core exhibits significant mass loss along the joint plane. Incipient spalling is mapped in red ink.

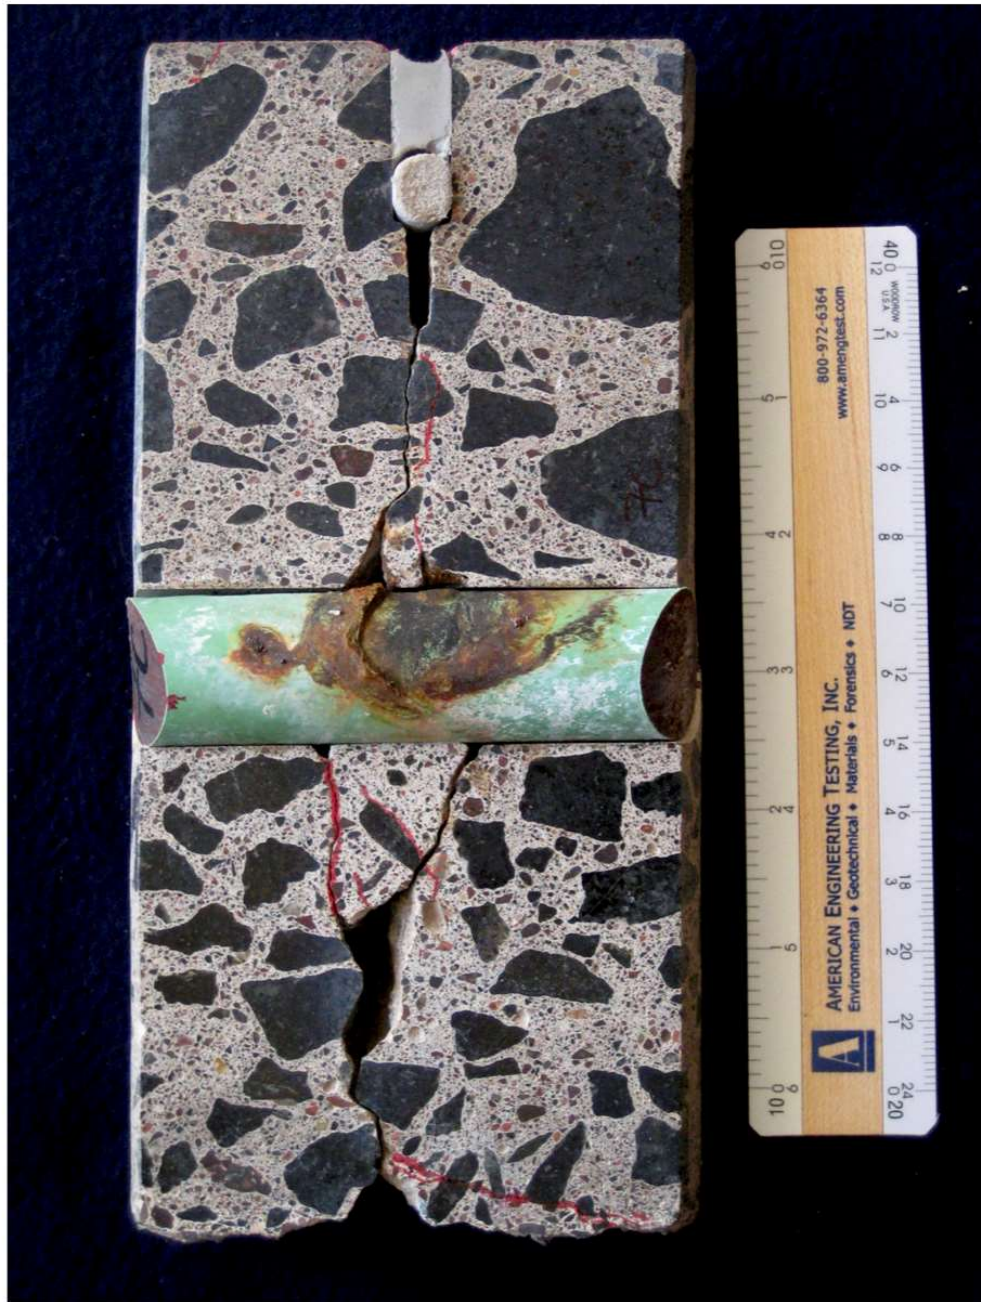
SAMPLE ID: 3805-67, 7C **DESCRIPTION:** Sawcut and lapped cross section of core. The core exhibits tight interlock of the joint crack and intersects an epoxy-coated dowel exhibit the initiation of corrosion. The silicone was well-bonded to both side of the sawcut.

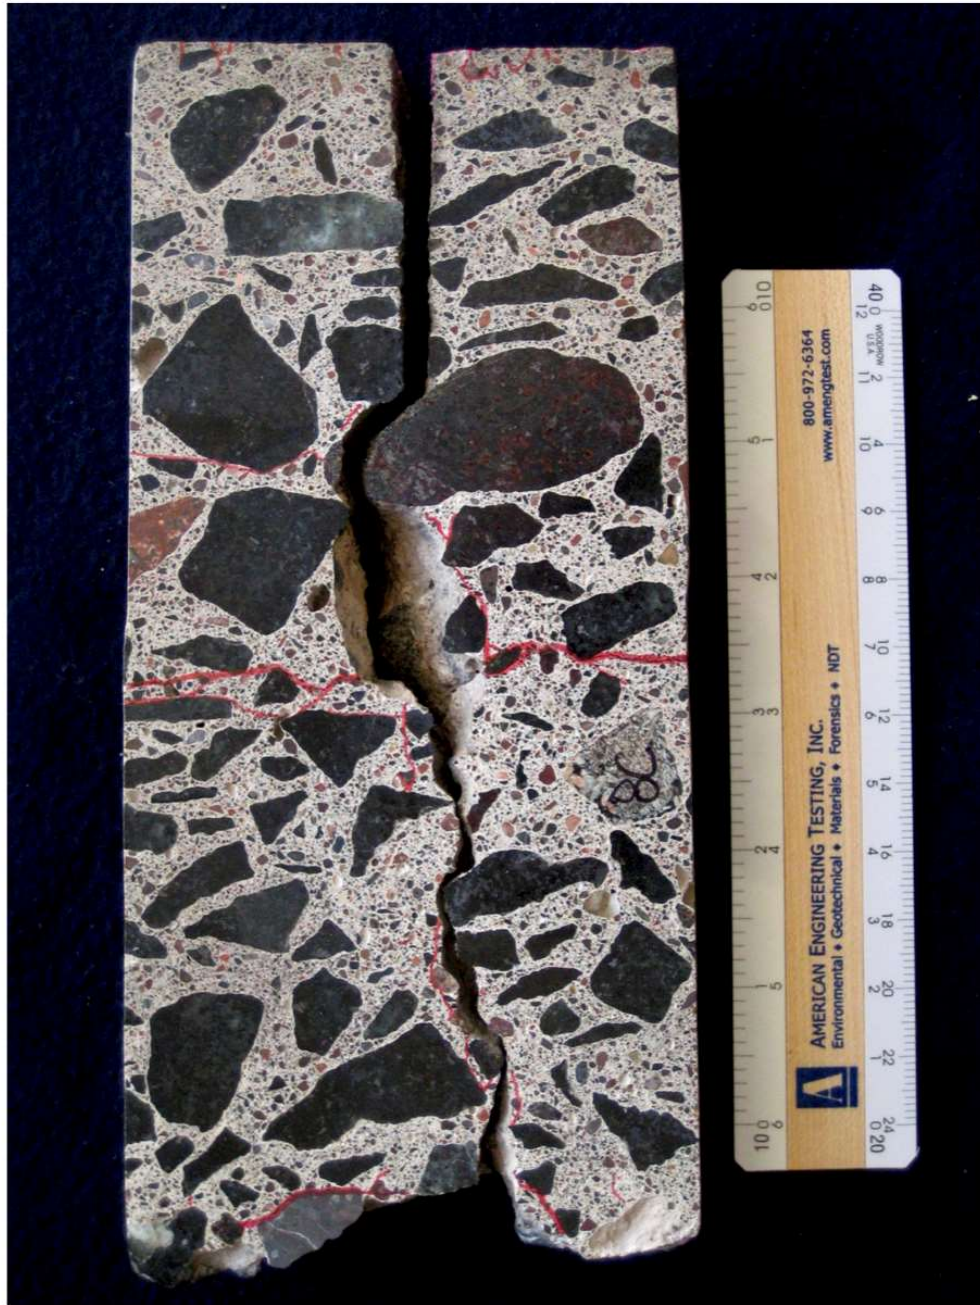
SAMPLE ID: 3805-67, 8C **DESCRIPTION:** Sawcut and lapped cross section of core. The core exhibits somewhat tight interlock of the unsealed joint crack. Incipient vertical spalling was present between 65mm and 210mm depth in the joint. Missing concrete below sawcut in this image may be related to fracturing and loss during sample preparation.

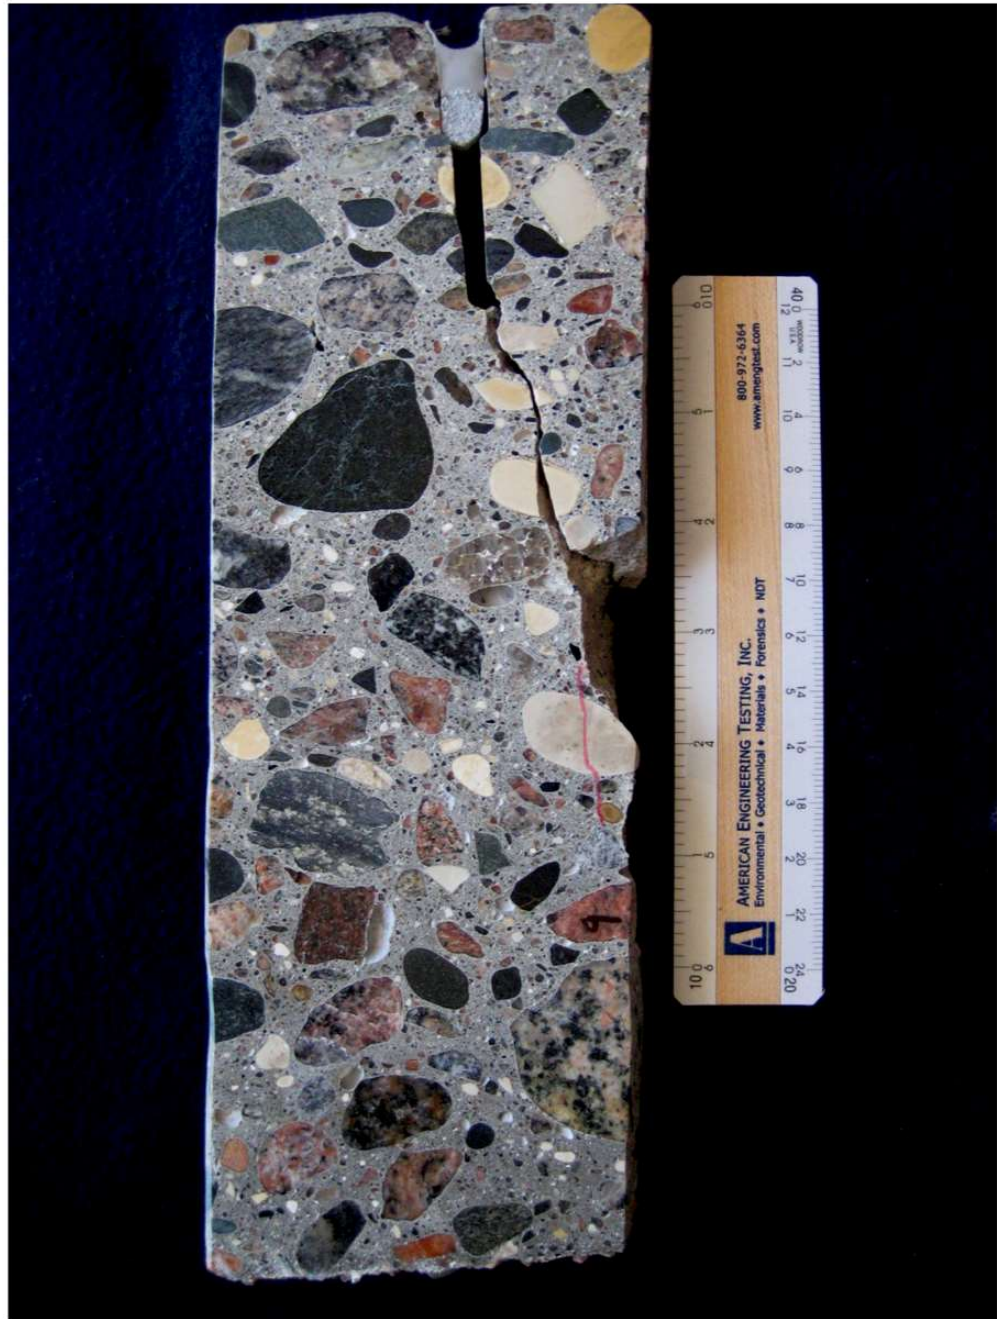
SAMPLE ID: 6019-22, 9 **DESCRIPTION:** Sawcut and lapped cross section of core. The silicone sealant was bonded to both sides of the sawcut. Note the apparent later-aged cracking bisects coarse aggregates.

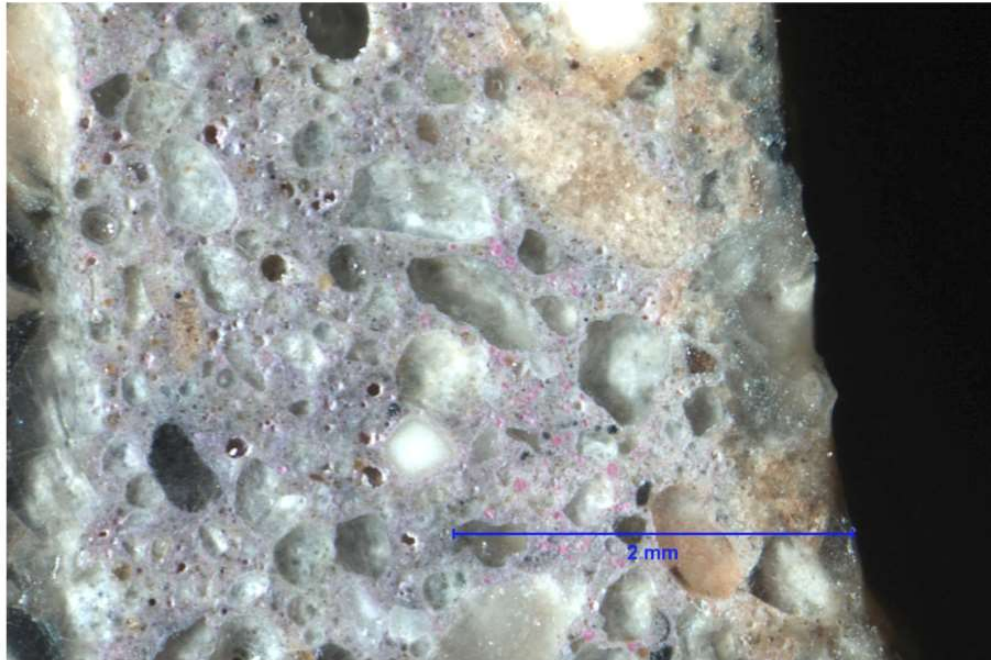
SAMPLE ID: 6019-22, 9 **DESCRIPTION:** Fine entrained-sized air void spaces directly adjacent to the joint crack plane are mostly filled with secondary ettringite; stained purple.
MAG: 5x

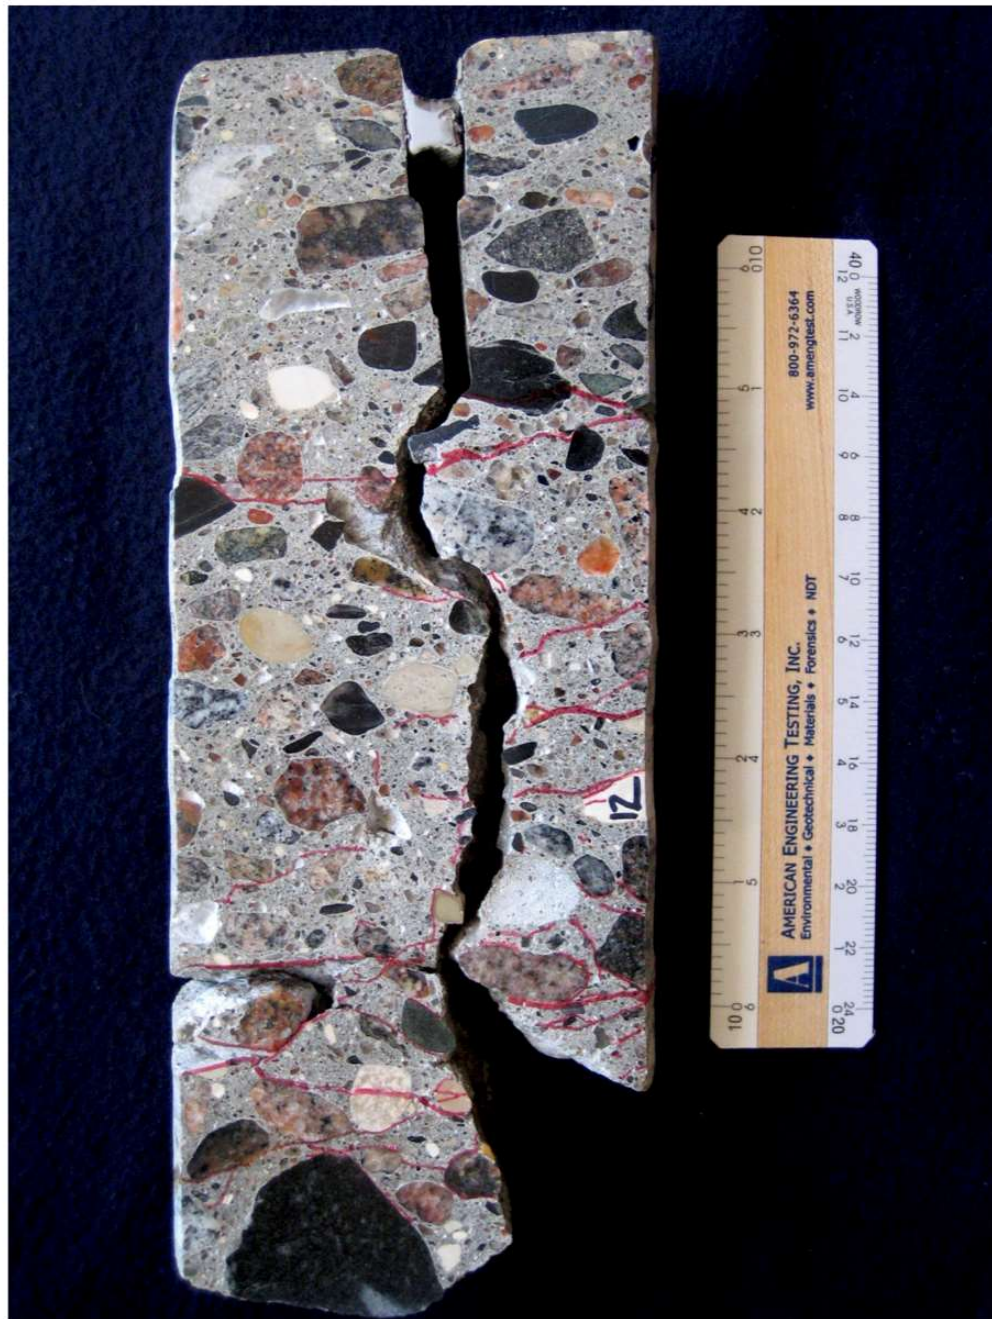
SAMPLE ID: 6019-22, 12 **DESCRIPTION:** Sawcut and lapped cross section of core. The silicone sealant was de-bonded from one side of the joint. Sub-horizontal fractures, macrocracks, and microcracks are mapped in red ink. Some were pre-existing; Some were likely produced during coring and preparation. Concrete mass loss was to 8mm wide along the length of the joint crack.

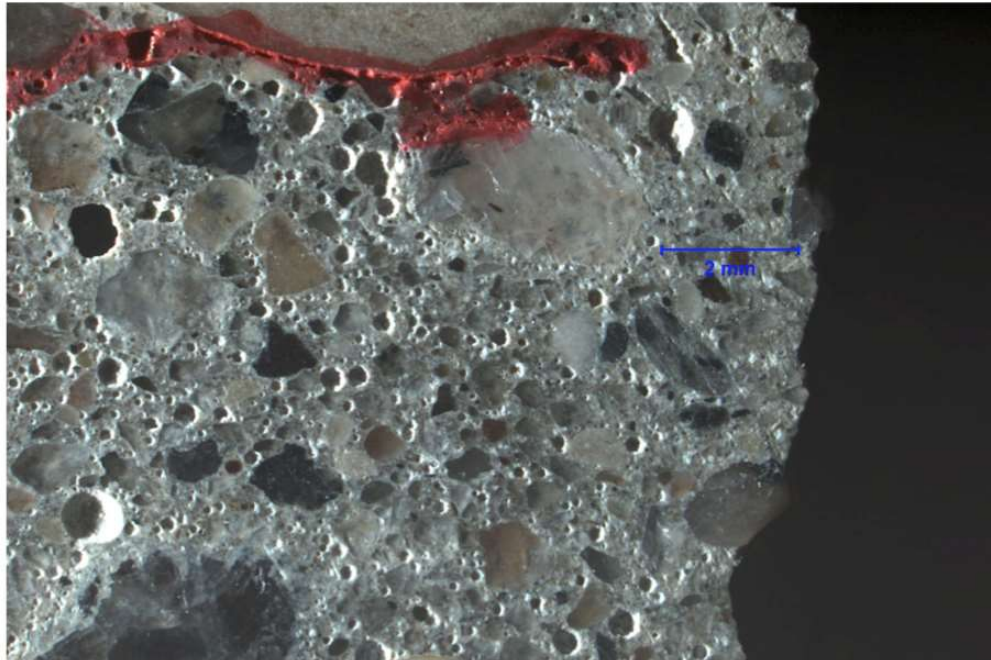
SAMPLE ID: 6019-22, 12 **DESCRIPTION:** Fine entrained-sized air void spaces directly adjacent to the joint crack plane are mostly filled with secondary ettringite; at 130mm depth from the top surface.
MAG: 10x

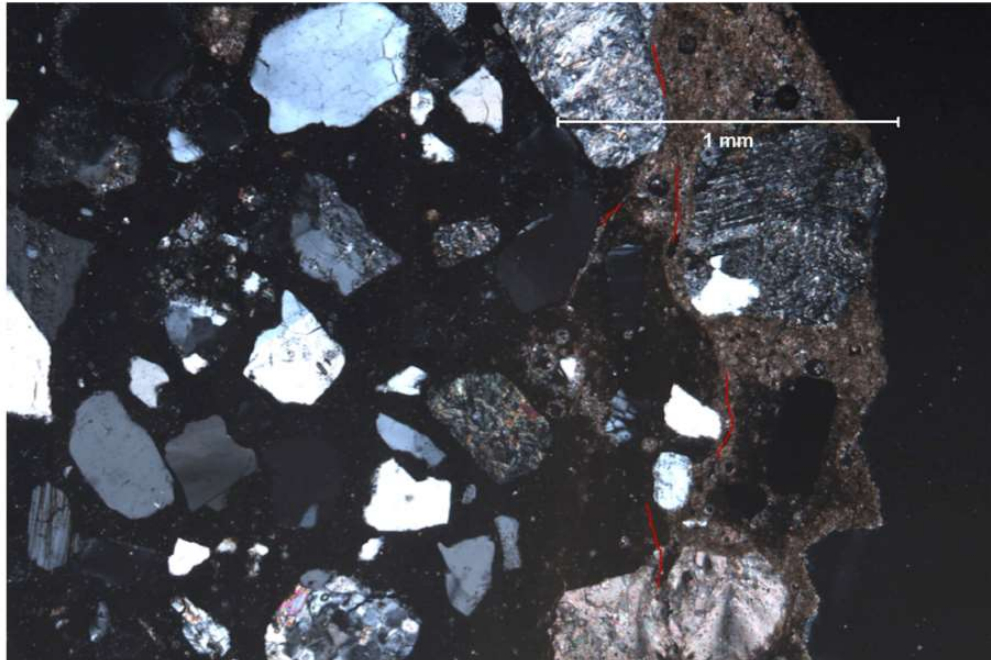
SAMPLE ID: 6019-22, 12 **DESCRIPTION:** Carbonation (lighter colored paste) proceeds to 1mm depth from the joint crack plane at 98mm depth from the top surface. Microcracking is mapped in red dashed line.
MAG: 40x

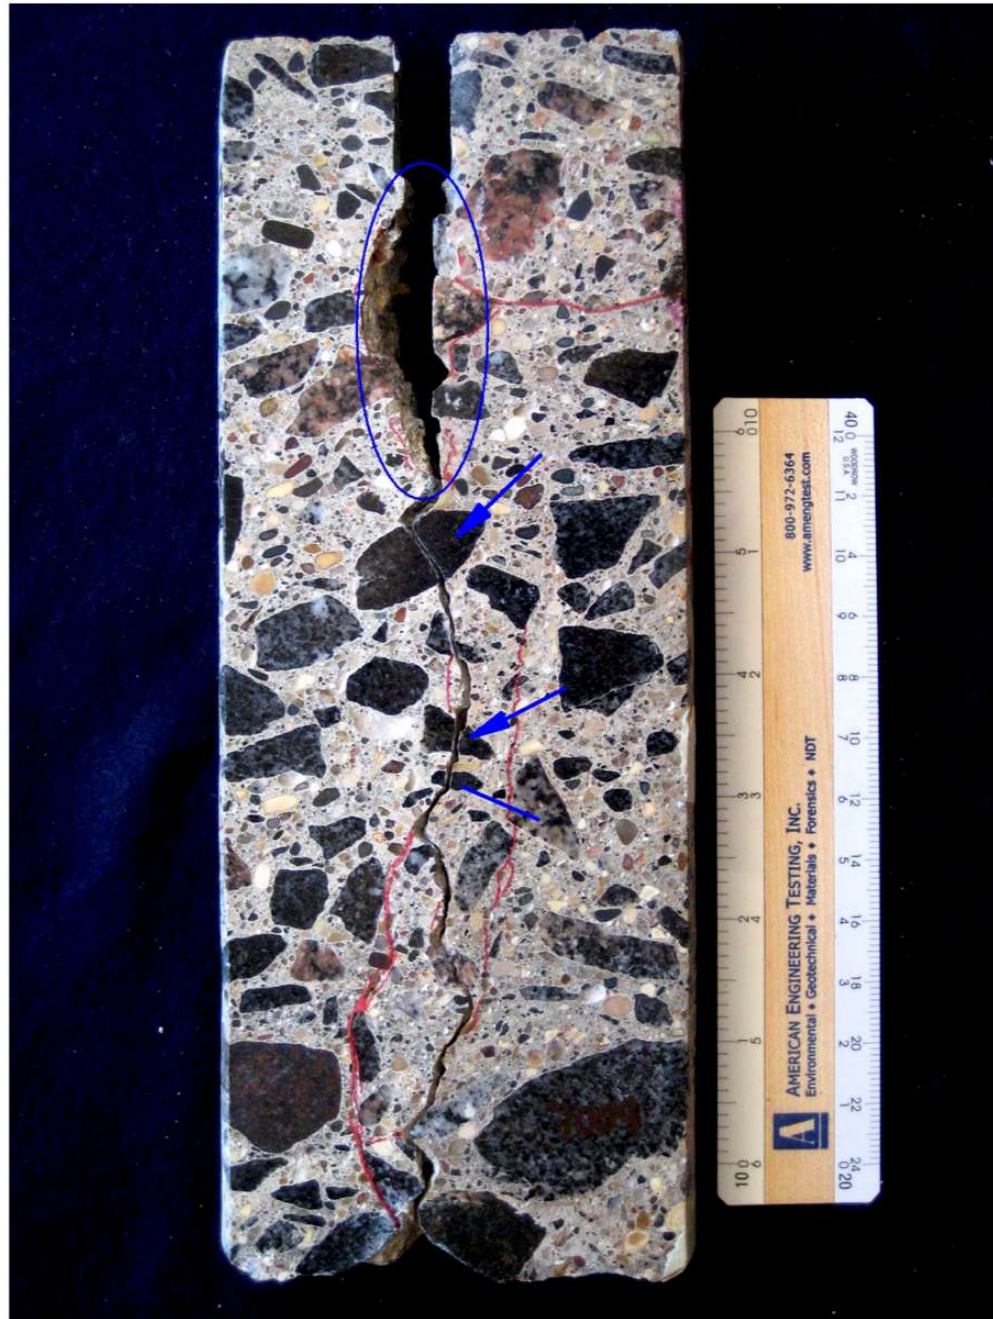
SAMPLE ID: 7380-199, 7009 **DESCRIPTION:** Sawcut and lapped cross section of core. The silicone sealant was completely de-bonded from one side of the joint. Sub-vertical microcracks adjacent to the joint crack are mapped in red ink. Note bisected coarse aggregates (arrows) suggesting late crack activation. Mass loss (tunneling) occurs directly below the sawcut (circled).

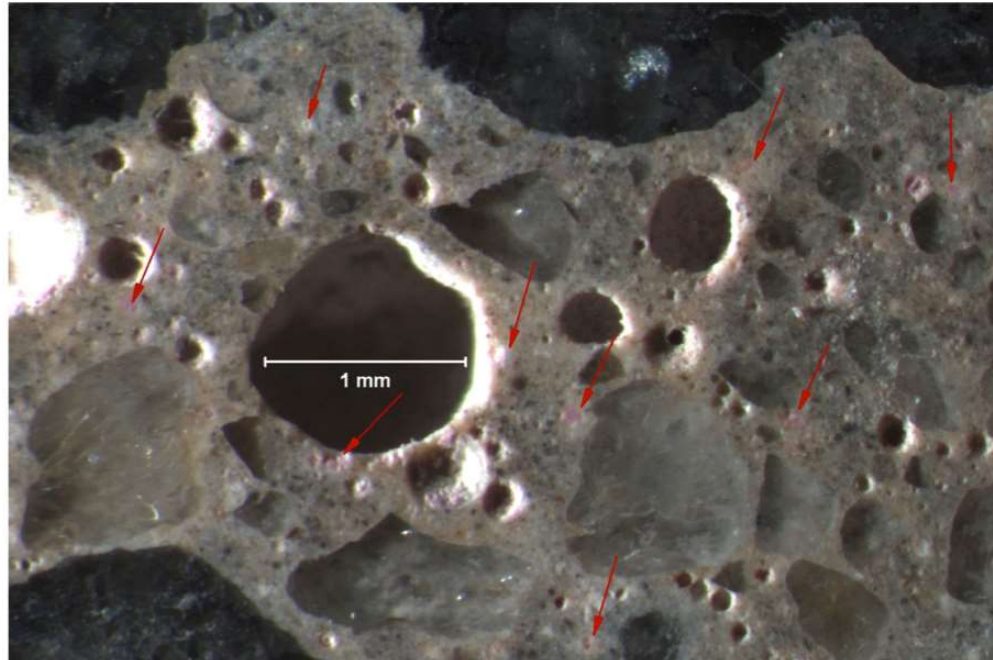
SAMPLE ID: 7380-199, 7009 **DESCRIPTION:** Overall view of air void system at 70mm depth in the core and 25mm from the distressed joint plane. Note (stained) ettringite-filled air voidspaces (arrows).
MAG: 15x

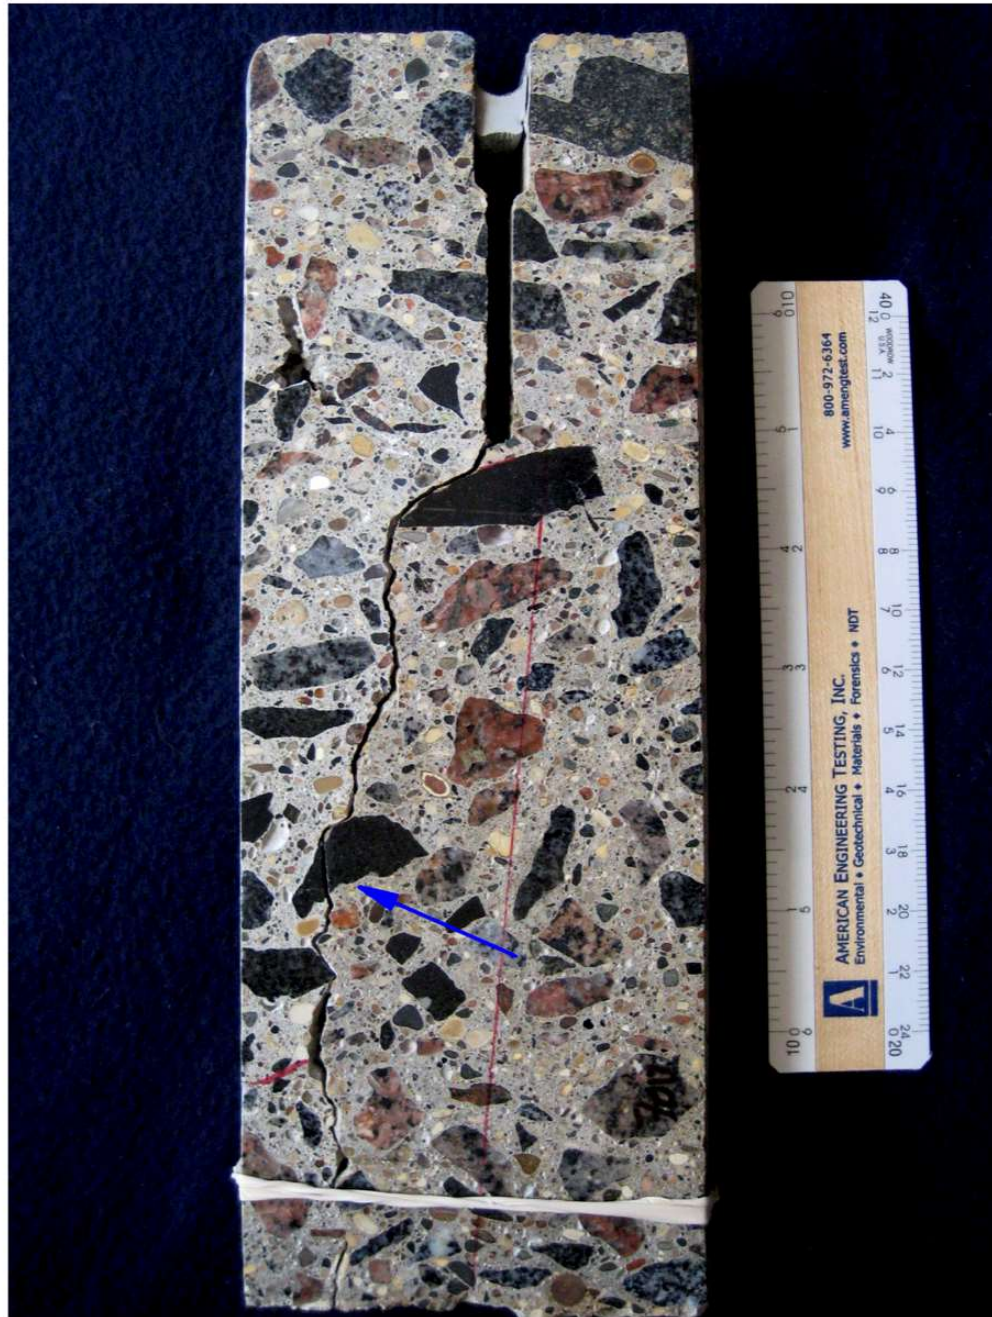
SAMPLE ID: 7380-199, 7012 **DESCRIPTION:** Sawcut and lapped cross section of core. The silicone sealant was well bonded to both sides of the joint. Note bisected coarse aggregate (arrow) suggesting late crack activation. No mass loss was detected.

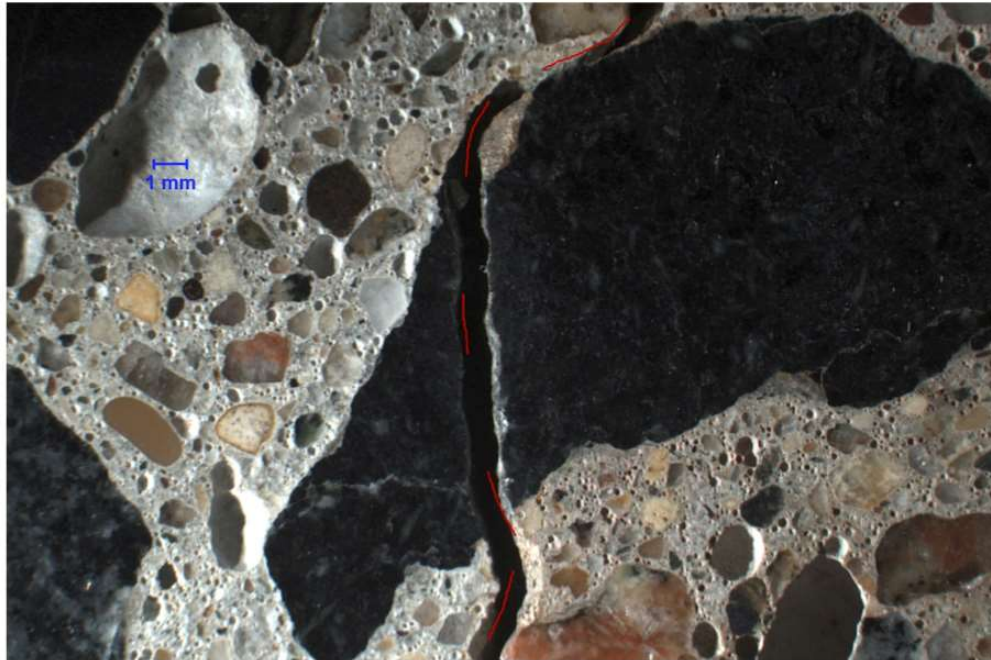
SAMPLE ID: 7380-199, 7012 **DESCRIPTION:** Cracked coarse aggregate at 165mm depth in the joint crack.

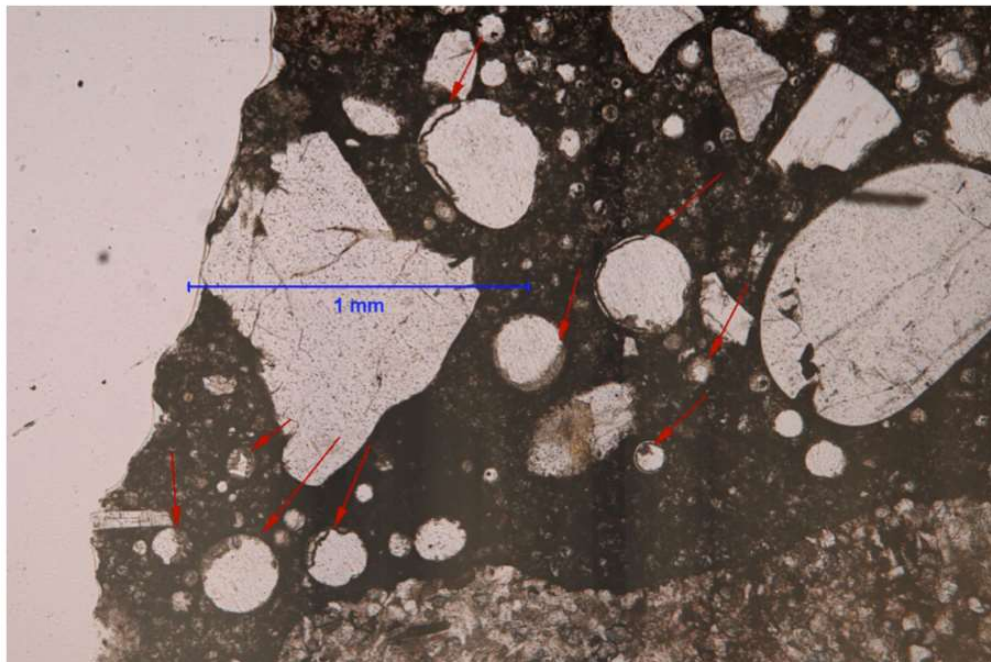
SAMPLE ID: 7012, 7380-199 **DESCRIPTION:** Occurrences of ettringite on the linings of voidspaces at 140mm depth and directly adjacent to the joint crack (L).

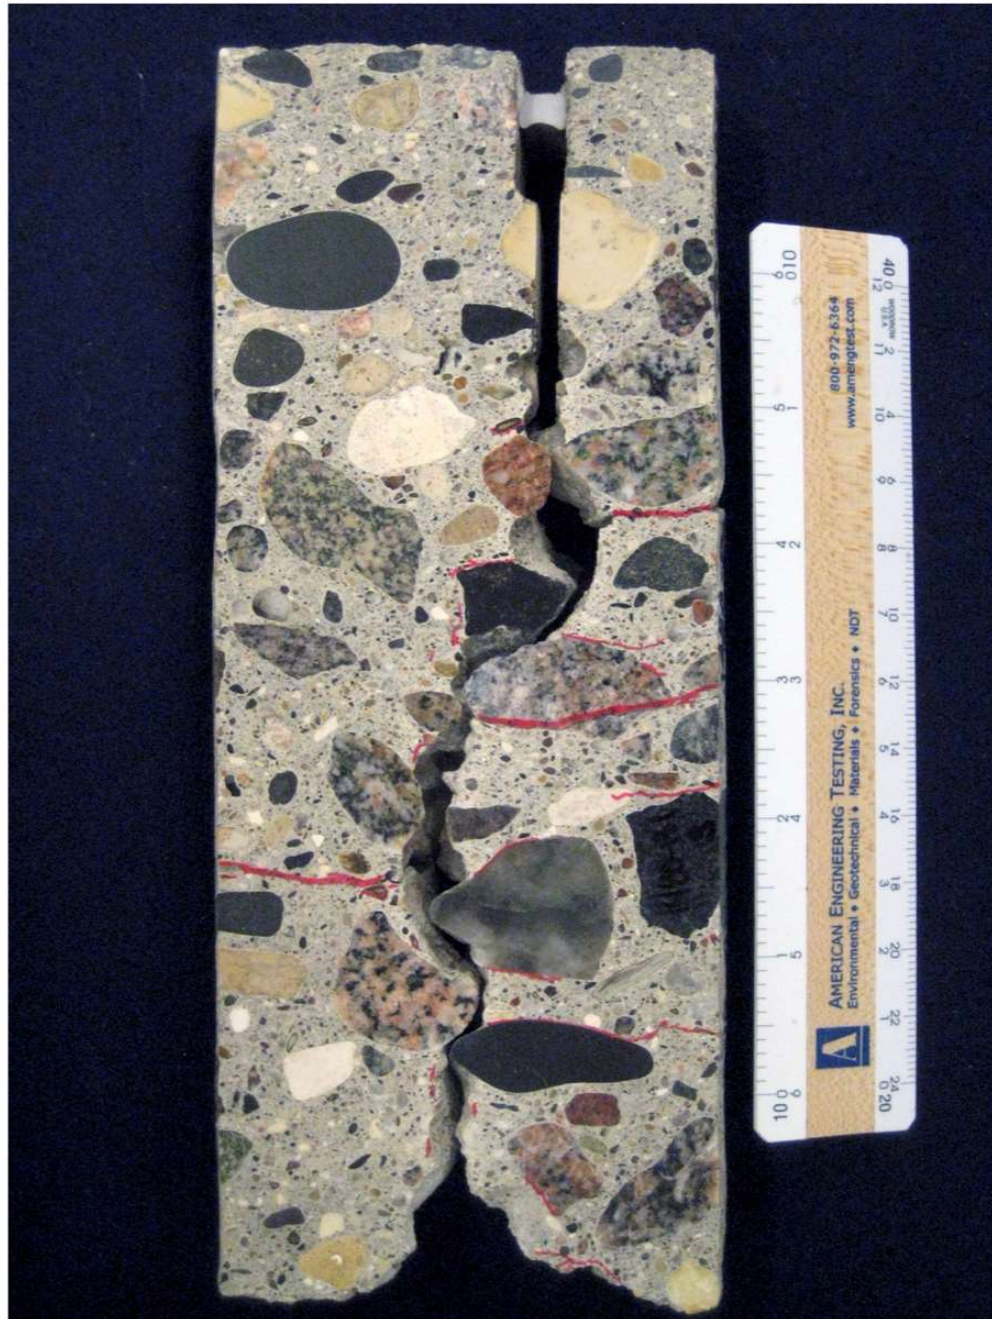
SAMPLE ID: 1480-131, 3 **DESCRIPTION:** Sawcut and lapped cross section of core. The core exhibits significant loss of paste along the joint crack. Microcracking is mapped in red ink.

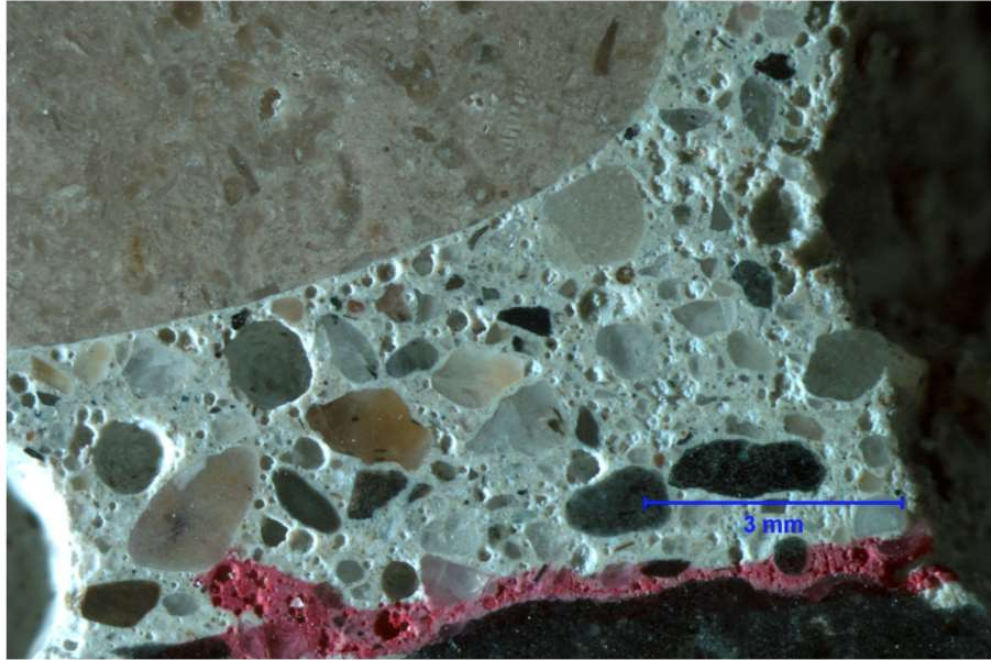
SAMPLE ID: 1480-131, 3 **DESCRIPTION:** Fine entrained sized air void spaces within 3mm of the joint crack surface (R) are mostly filled with secondary ettringite. Image at below 90mm depth in the joint.
MAG: 15x

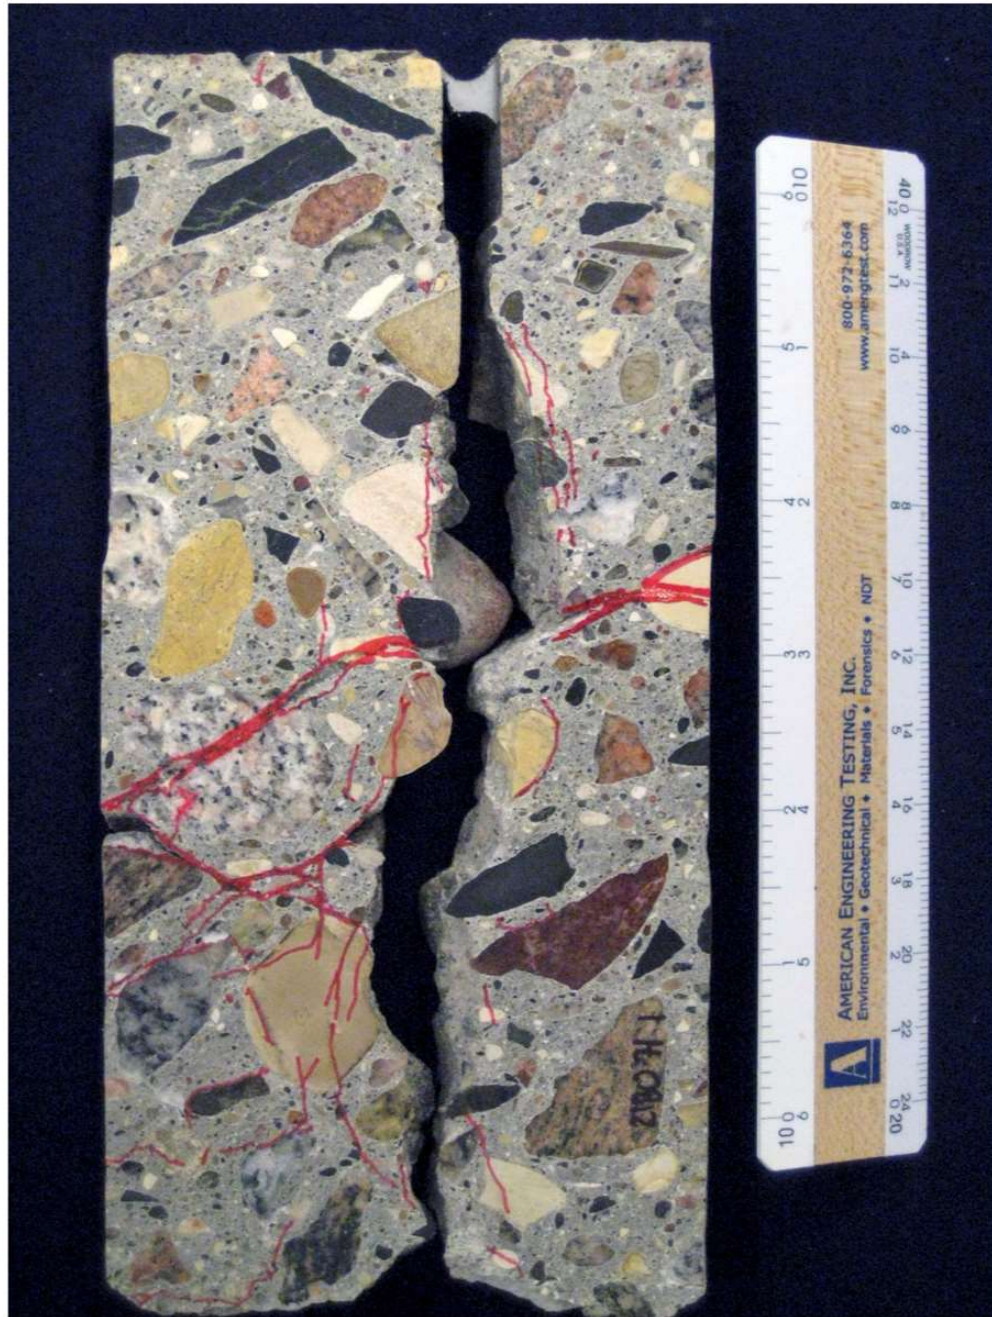
SAMPLE ID: 2180-71, 1 **DESCRIPTION:** Sawcut and lapped cross section of core. The joint crack exhibited significant incipient distress in the paste and carbonate coarse aggregates. Microcracking is mapped in red ink.

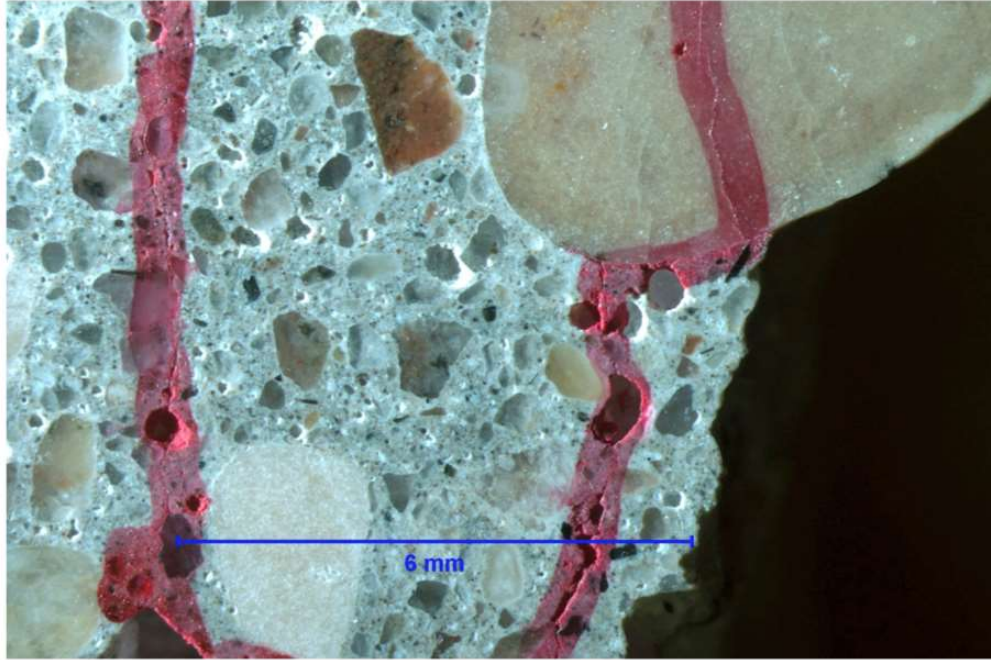
SAMPLE ID: 2180-71, 1 **DESCRIPTION:** A noticeable loss of entrained air voidspaces in the paste adjacent to the distressed joint face at 115mm depth in the concrete. Sub-vertical microcracking (incipient spalling) is mapped in red ink.
MAG: 15x

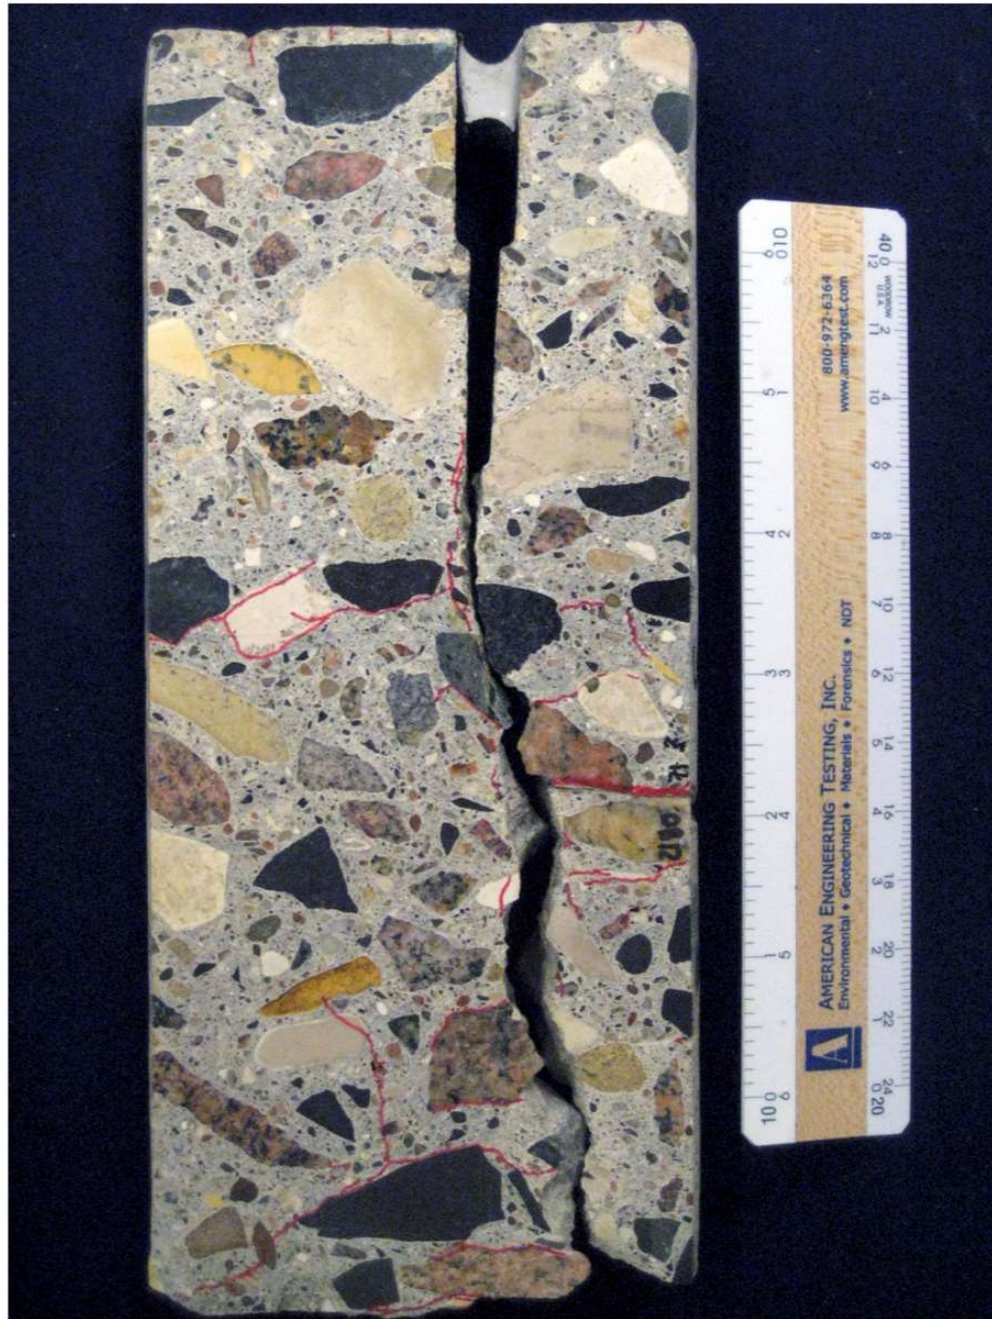
SAMPLE ID: 2180-71, 3 **DESCRIPTION:** Sawcut and lapped cross section of core. The joint crack exhibited mass loss and incipient distress in the paste and carbonate coarse aggregates. Microcracking is mapped in red ink.

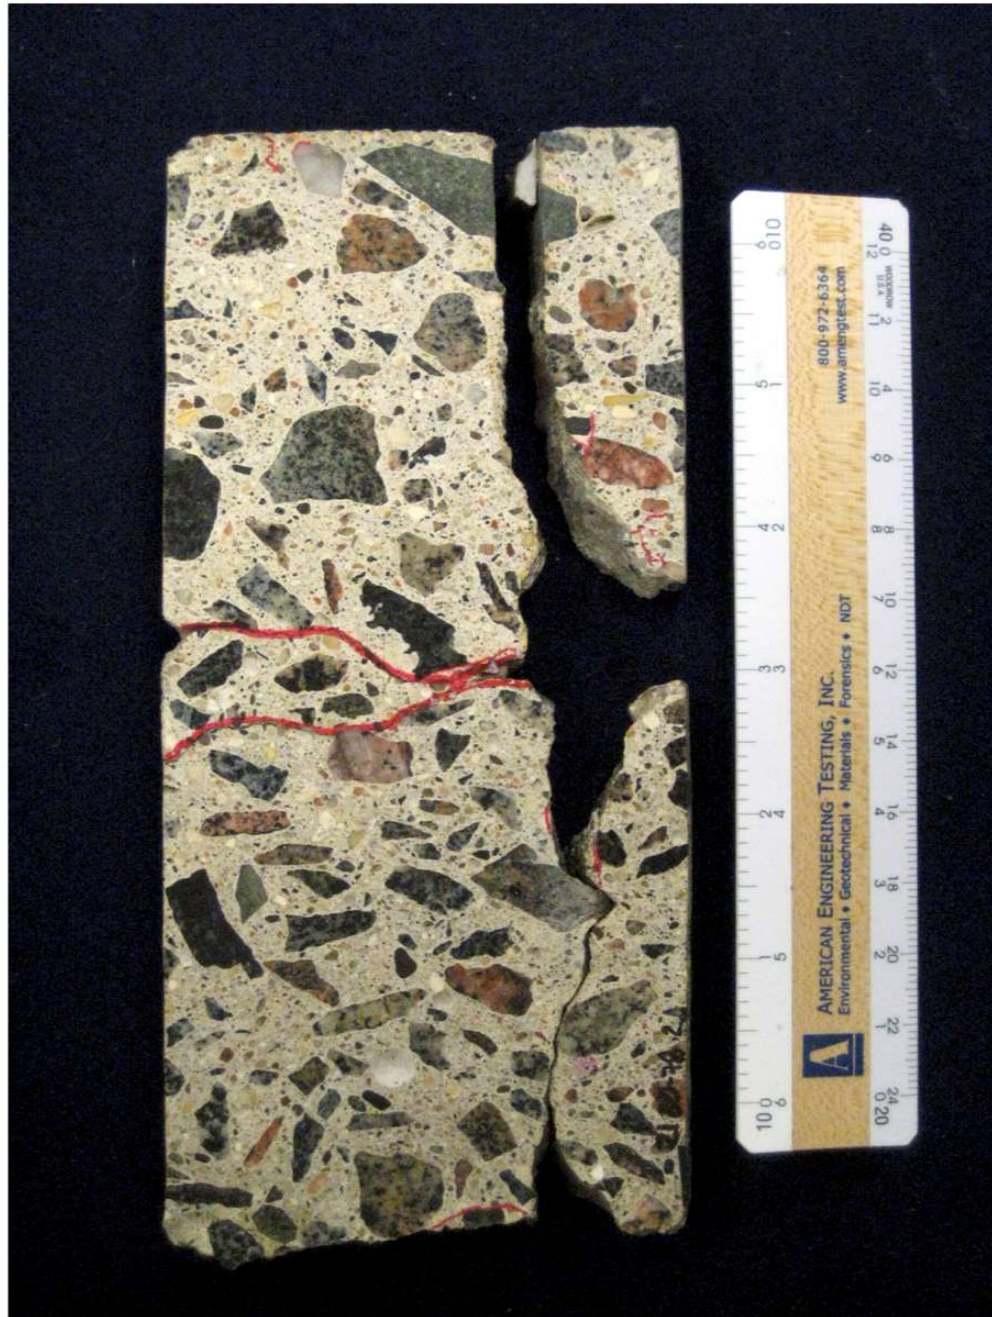
SAMPLE ID: 2180-78, 3 **DESCRIPTION:** Sawcut and lapped cross section of core. The joint crack exhibited no distress. Missing mass was corroded dowel and concrete likely lost during coring. Fractures (wide) and microcracking is mapped in red ink.

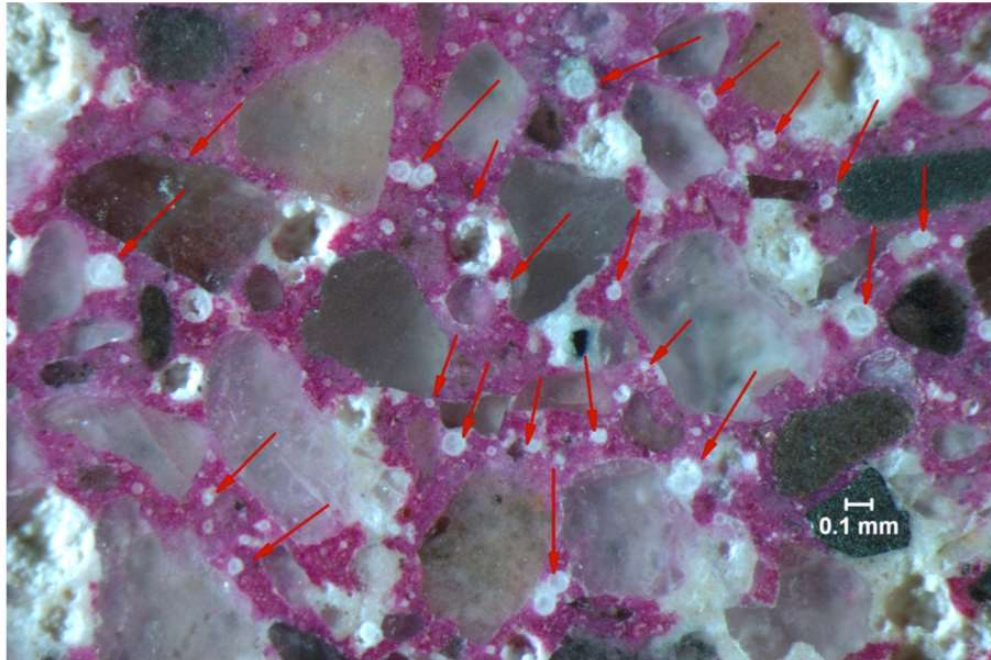
SAMPLE ID: 2180-78, 3 **DESCRIPTION:** Fine entrained air voidspaces filled with white secondary ettringite are obvious in paste stained with phenolphthalein at 10mm from the joint and 167mm depth from the top surface.
MAG: 50x

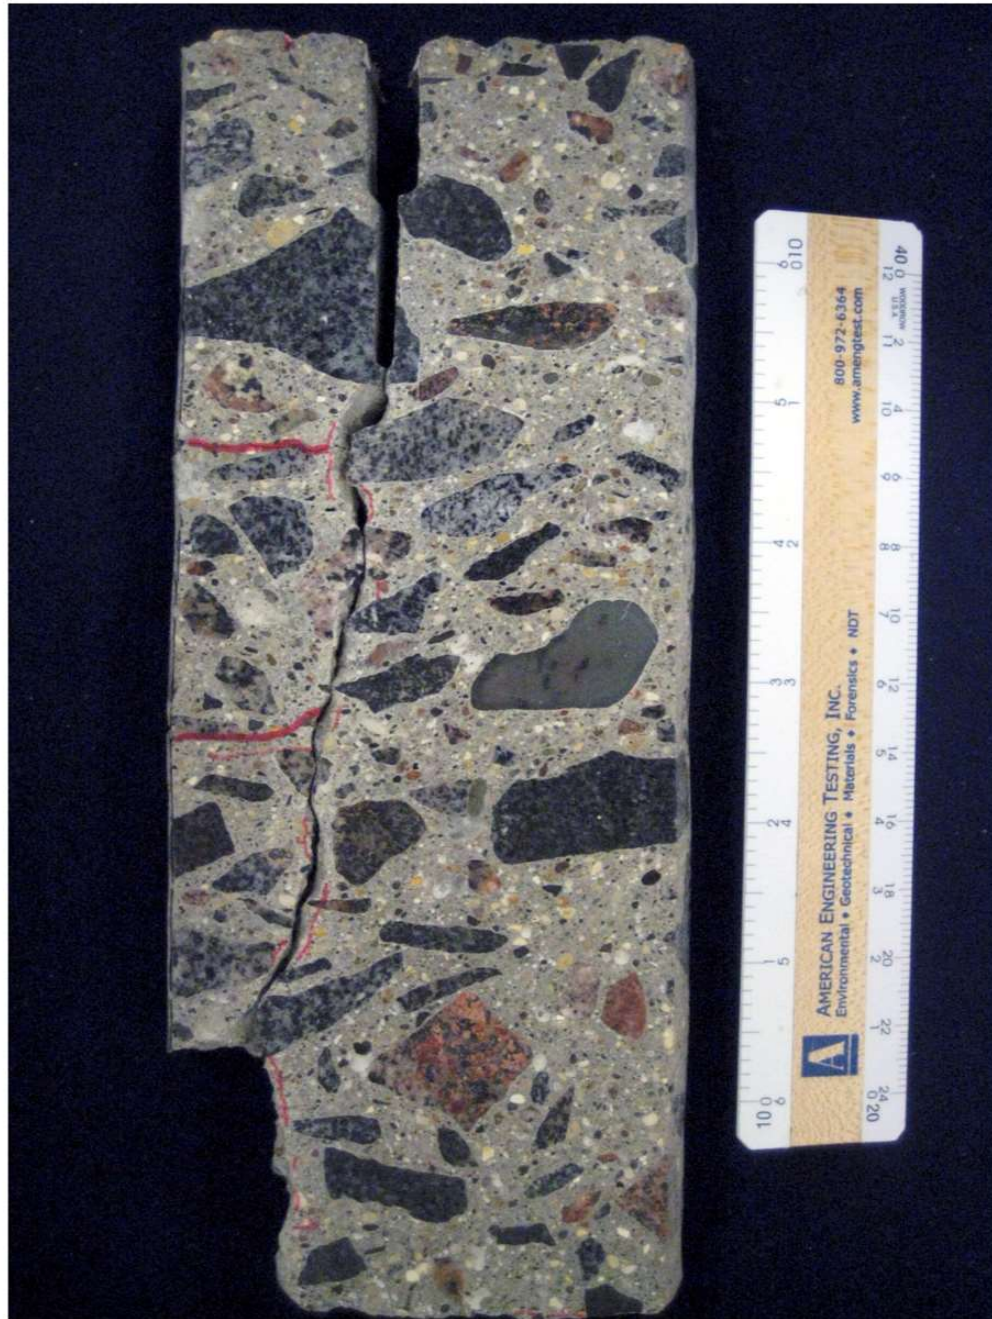
SAMPLE ID: 2180-80, 4 **DESCRIPTION:** Sawcut and lapped cross section of core. The joint crack exhibited some mass loss and incipient distress mapped in red ink. Sub-horizontal fractures are also mapped in thicker red ink.
