Impact of Water/ Cementitious-Based Concrete Mix Design Specification Changes on Concrete Pavement Quality

July 2018

Research Project
Final Report 2018-25

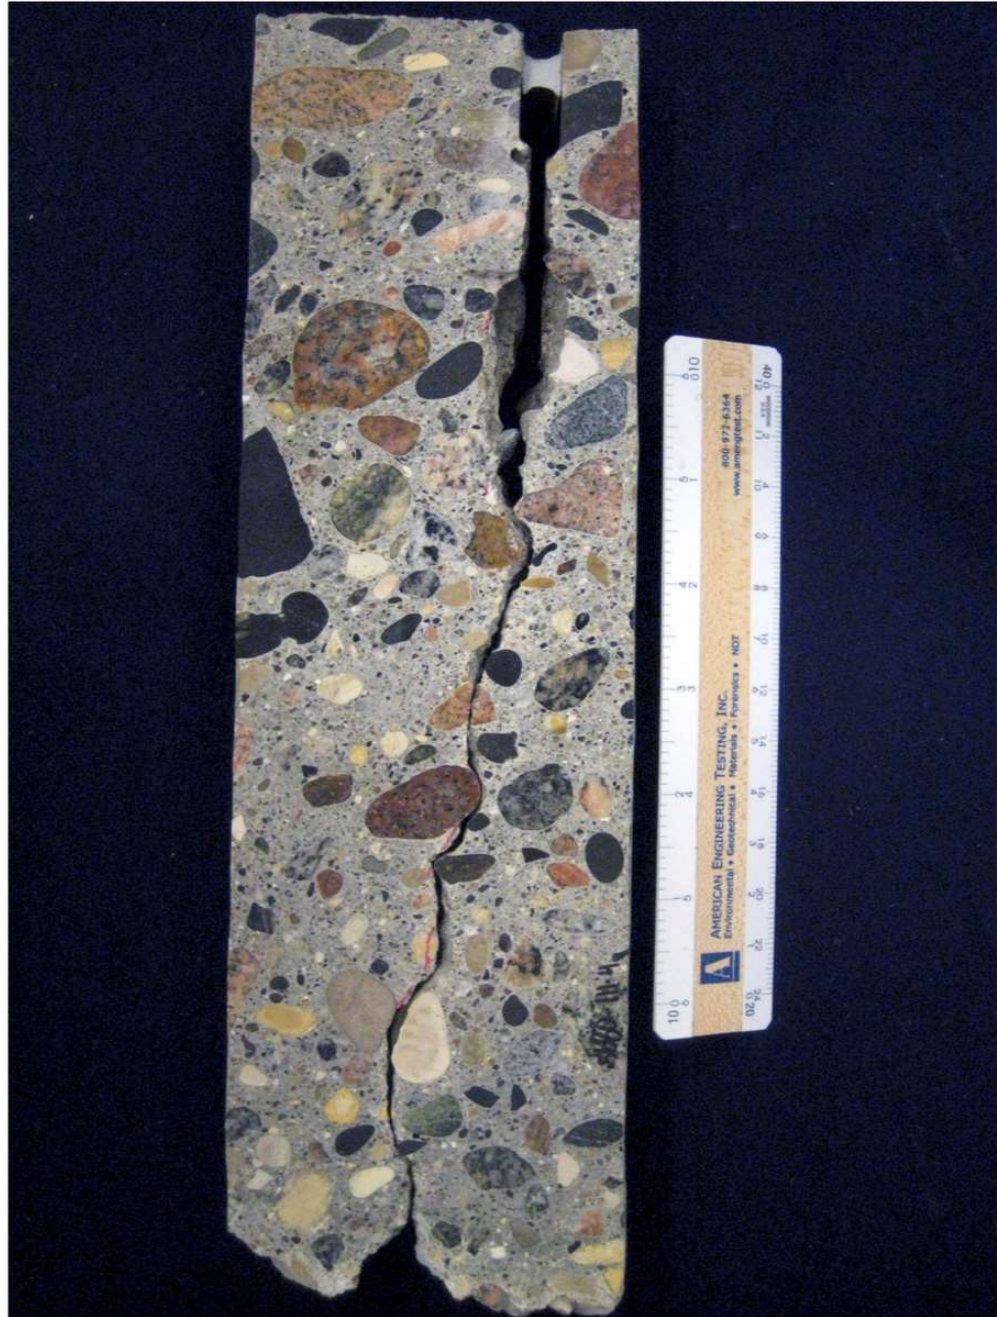
SAMPLE ID: 5680-111, 4 **DESCRIPTION:** Sawcut and lapped cross section of core. The joint crack exhibited "tunneling" around the base of the sawcut.

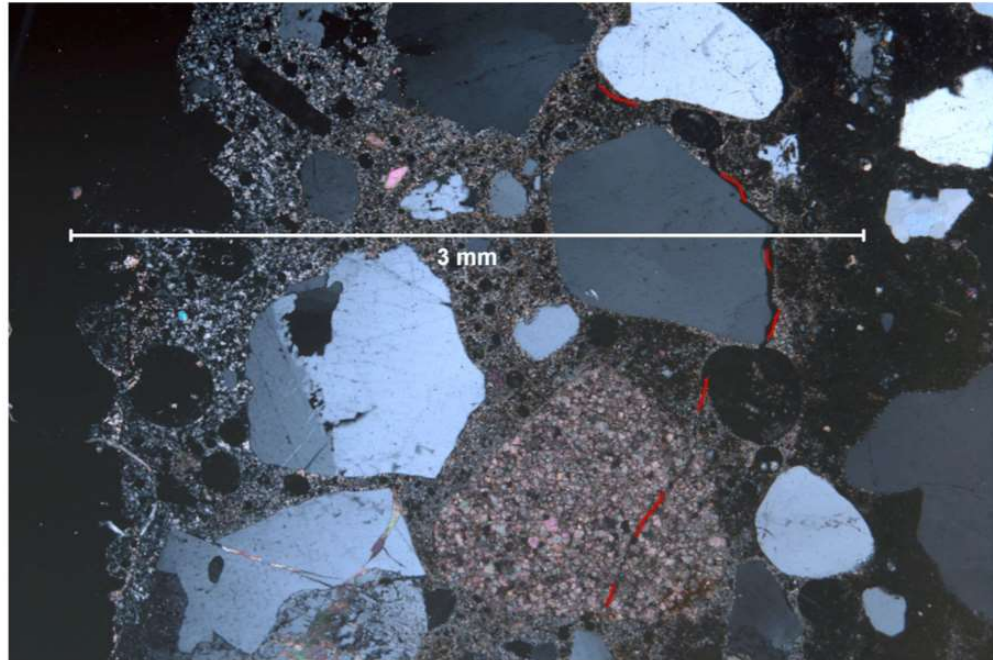
SAMPLE ID: 5680-111, 4 **DESCRIPTION:** Carbonation (brightly colored paste) proceeded to 3mm depth from the joint surface (left); in thin section under cross polarized light. Sub-vertical, incipient spalling is mapped in red dashed line.
MAG: 40x

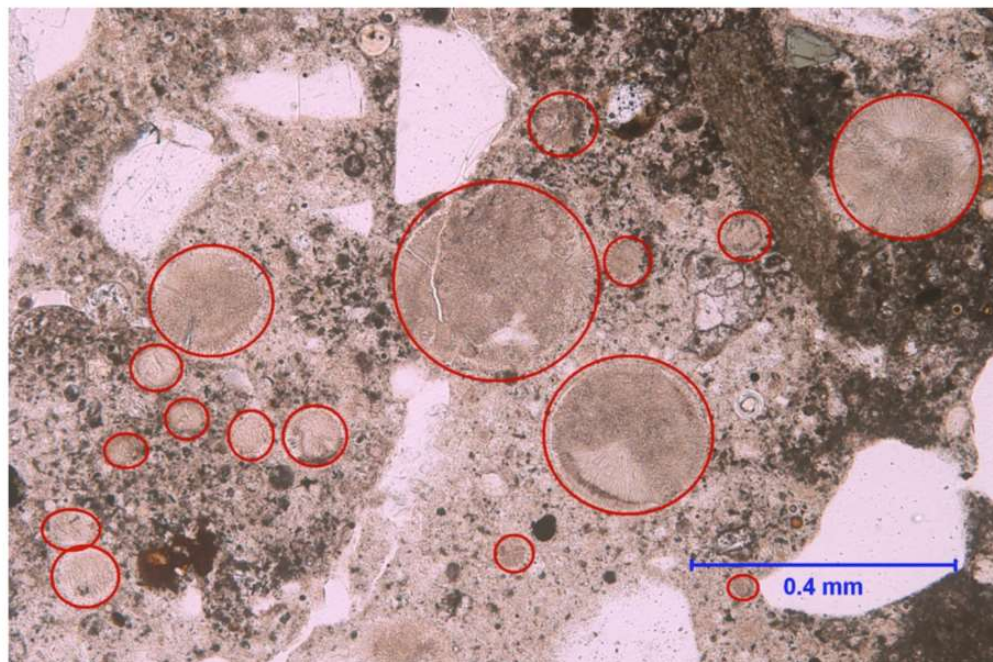
SAMPLE ID: 5680-111, 4 **DESCRIPTION:** Secondary ettringite-filled entrained sized voidspaces in the paste within 3mm of the distressed joint face; in thin section under plane polarized light, at mid-depth in the core.
MAG: 100x

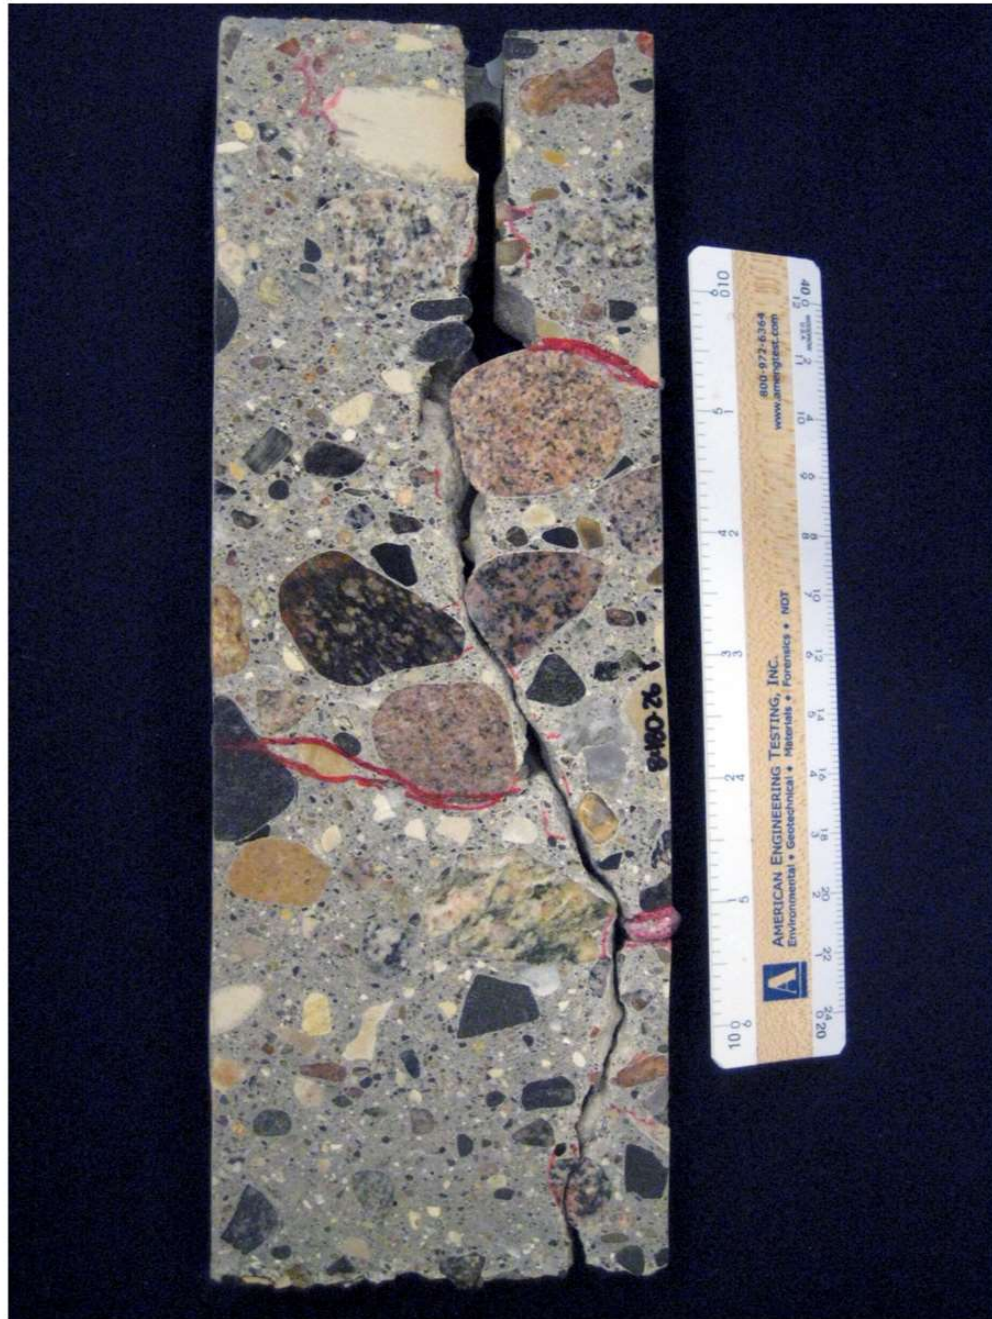
SAMPLE ID: 8480-26, 1 **DESCRIPTION:** Sawcut and lapped cross section of core. The joint crack exhibited emerging "tunneling" around the base of the sawcut. Pre-existing sub-horizontal fractures are mapped in red ink.

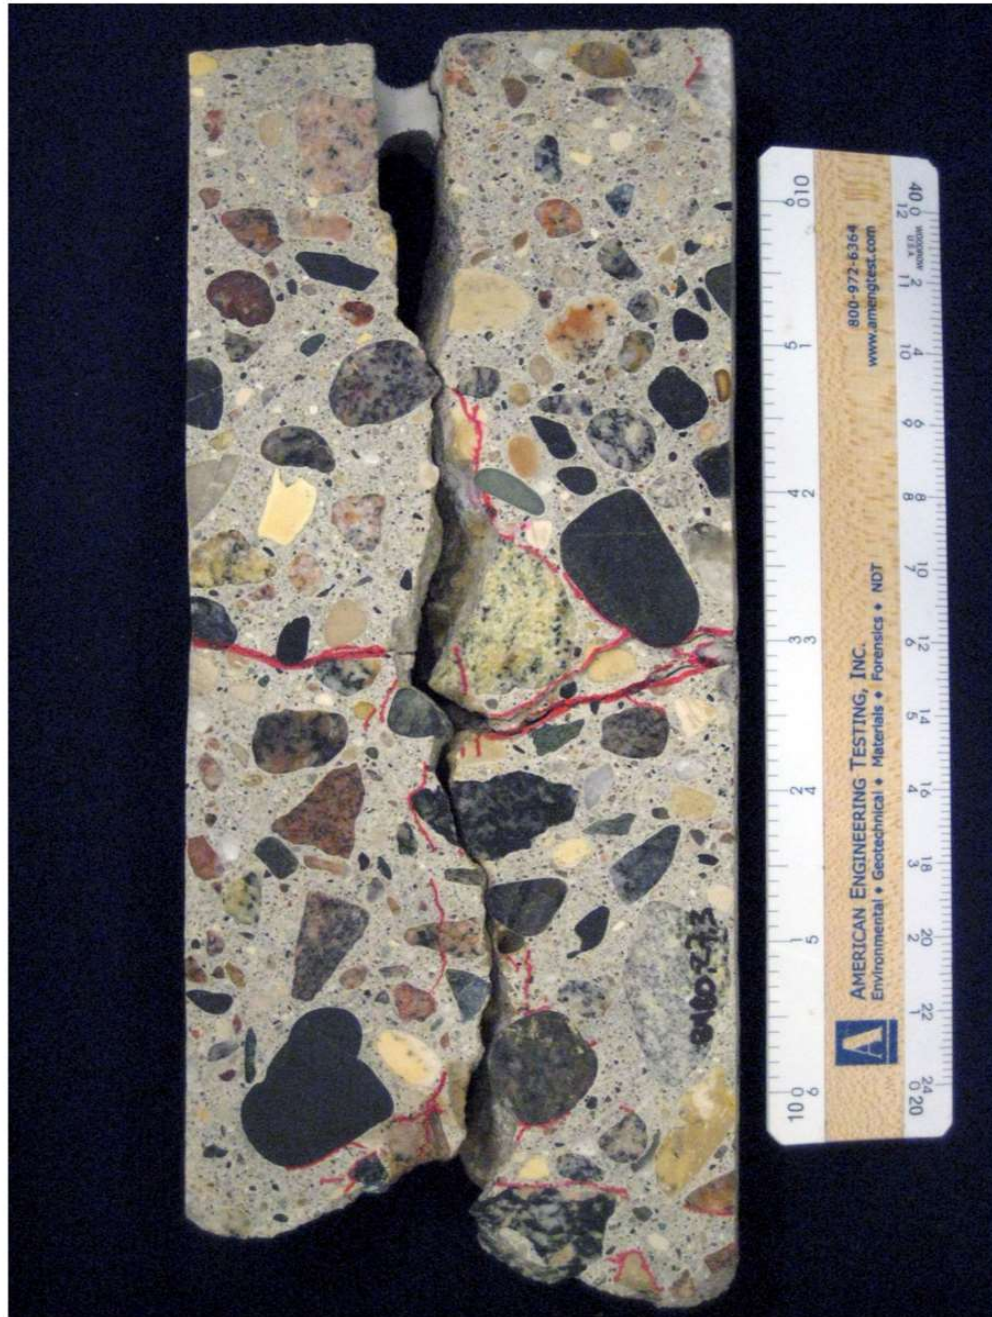
SAMPLE ID: 8480-27, 3 **DESCRIPTION:** Sawcut and lapped cross section of core. The joint crack exhibited some splayed micro-cracking along the joint crack. Pre-existing sub-horizontal fracturing intersecting a corroded dowel is mapped in red ink.

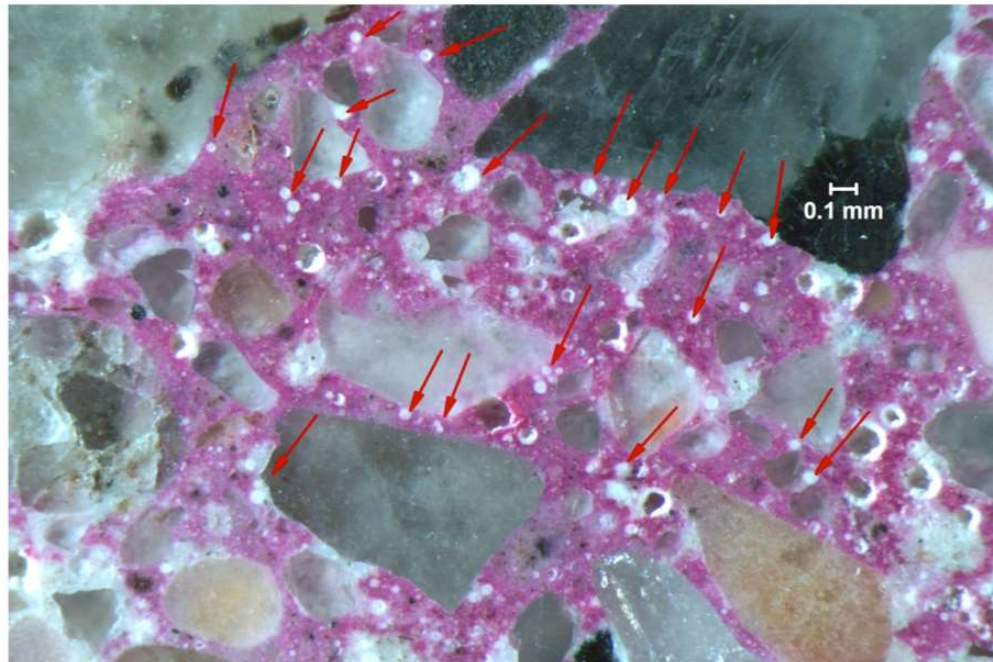
SAMPLE ID: 8480-27, 3 **DESCRIPTION:** Fine, entrained-sized, secondary ettringite-filled voidspaces in the phenolphthalein-stained paste at 100mm depth from the top surface and 13mm depth from the joint crack.
MAG: 50x

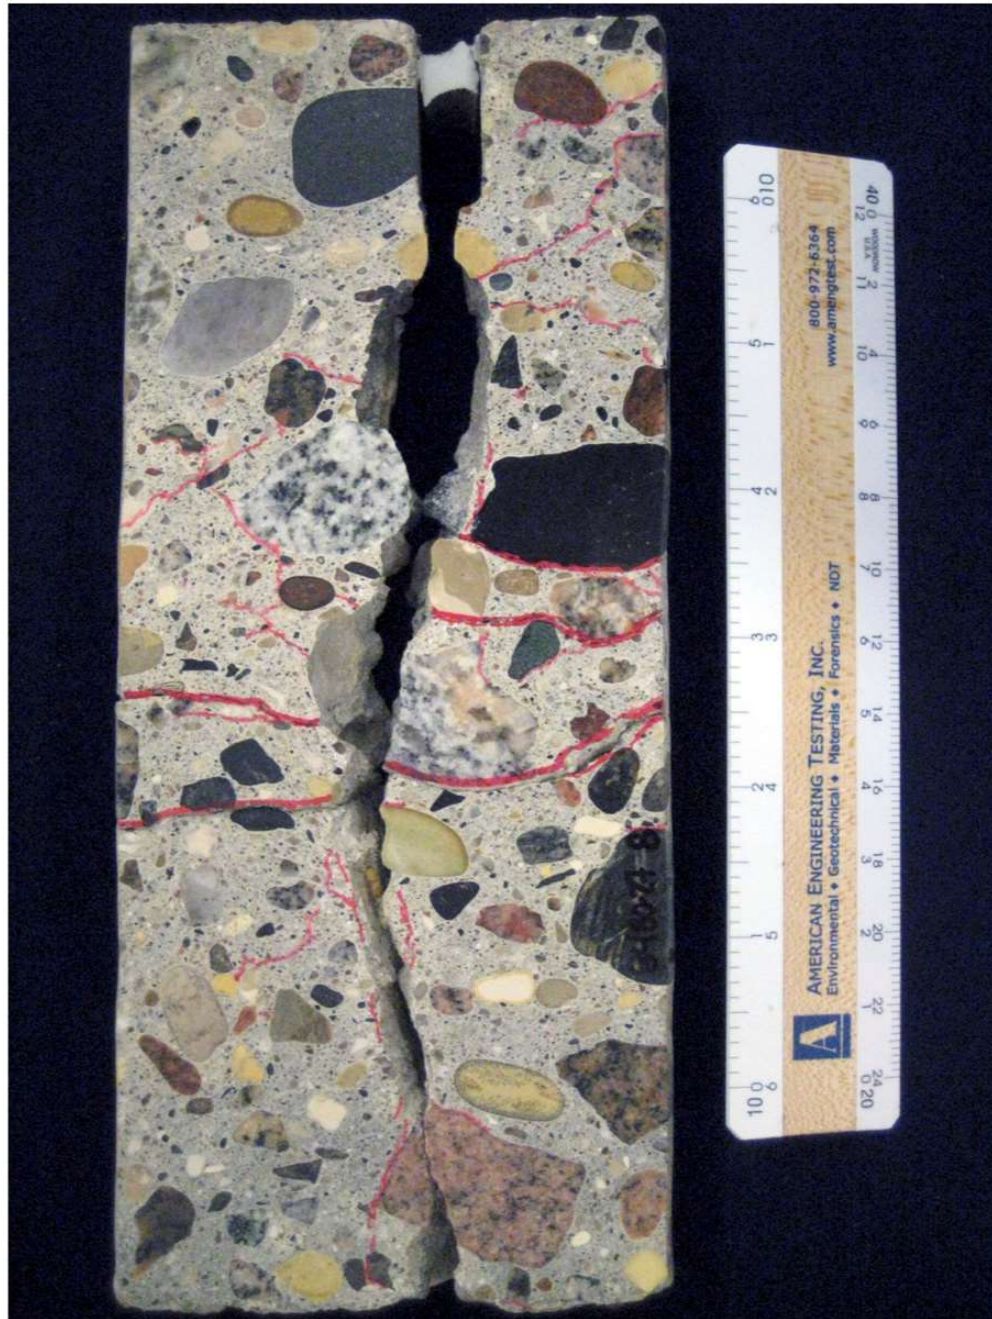
SAMPLE ID: 8480-27, 8 **DESCRIPTION:** Sawcut and lapped cross section of core. The joint crack exhibited significant mass loss below the base of the sawcut (tunneling). Microcracking and sub-horizontal microcracking (thicker) is mapped in red ink.

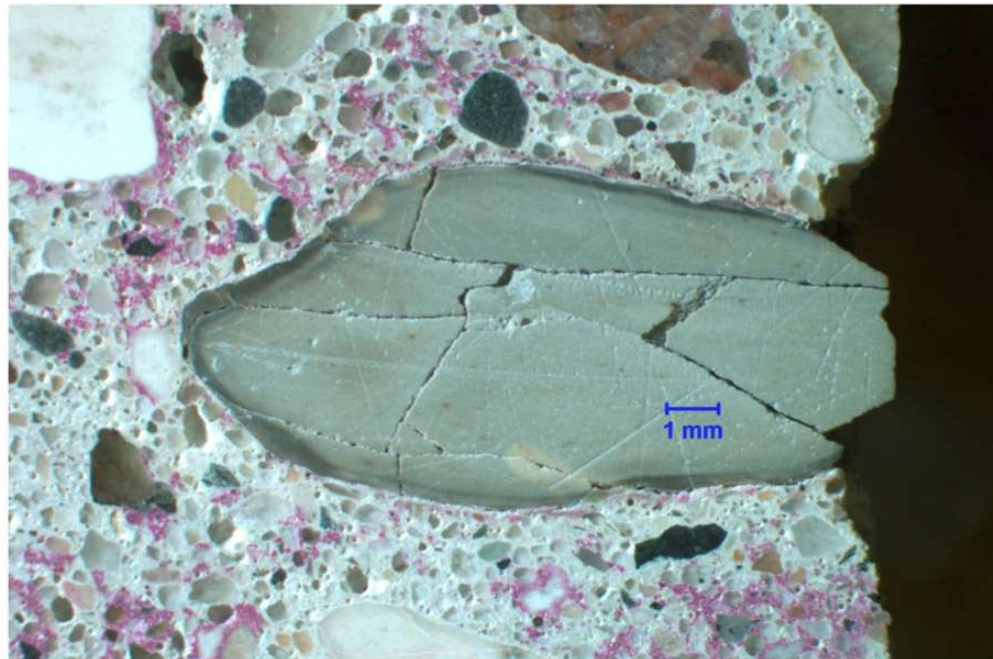
SAMPLE ID: 8480-27, 8 **DESCRIPTION:** Deleterious shale coarse aggregate particle intersected by the joint crack
plane (right).
MAG: 5x

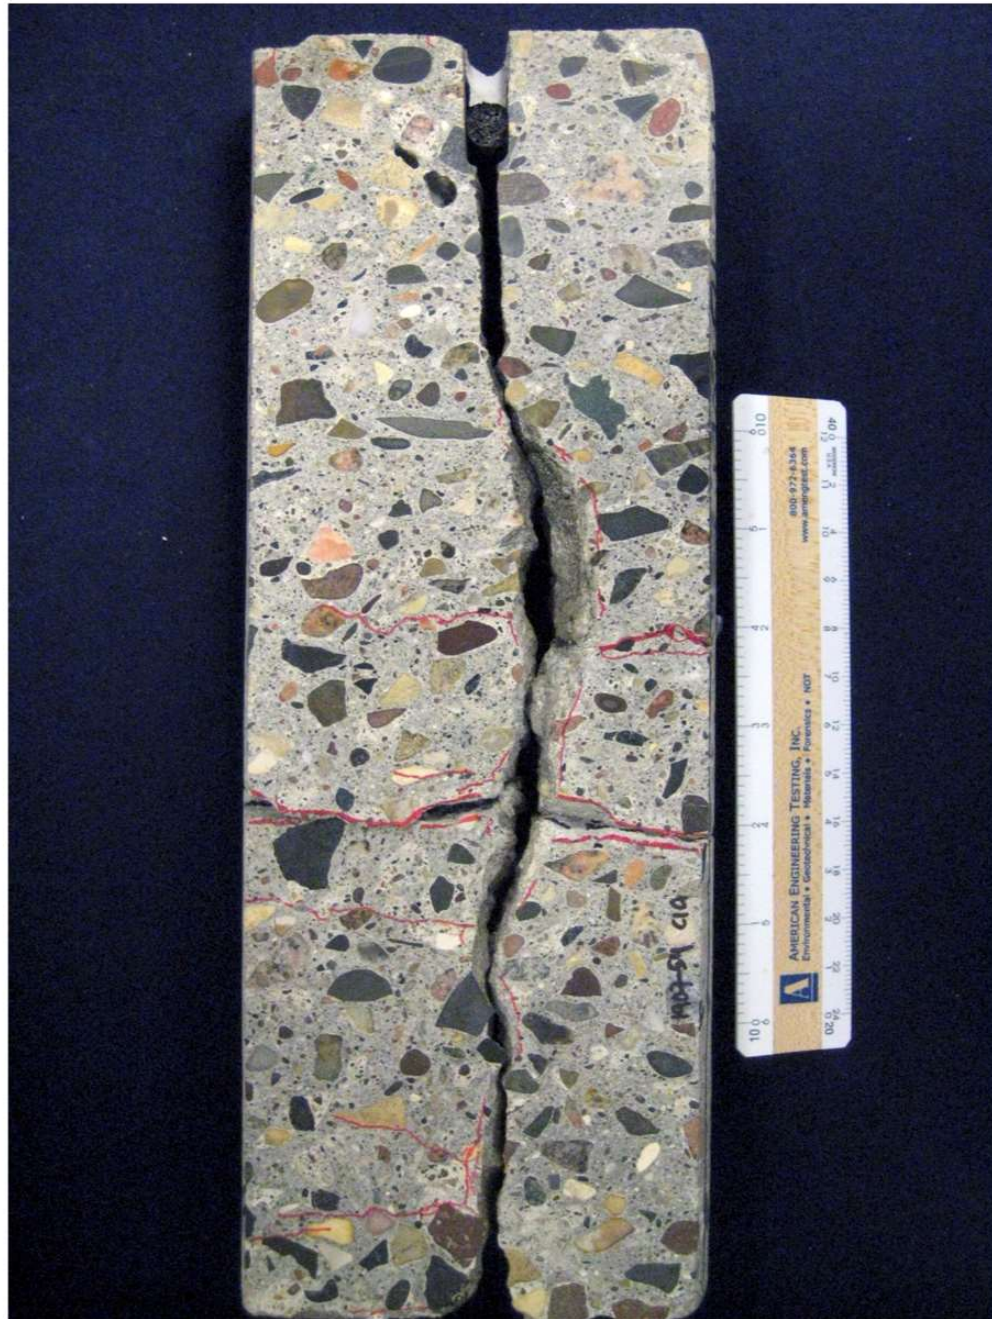
SAMPLE ID: 1907-54, C-1A **DESCRIPTION:** Sawcut and lapped cross section of core. The joint crack exhibited distress with the greatest concrete mass lost between approx. 100mm and 190mm depth from the top surface. Microcracking is mapped in red ink.

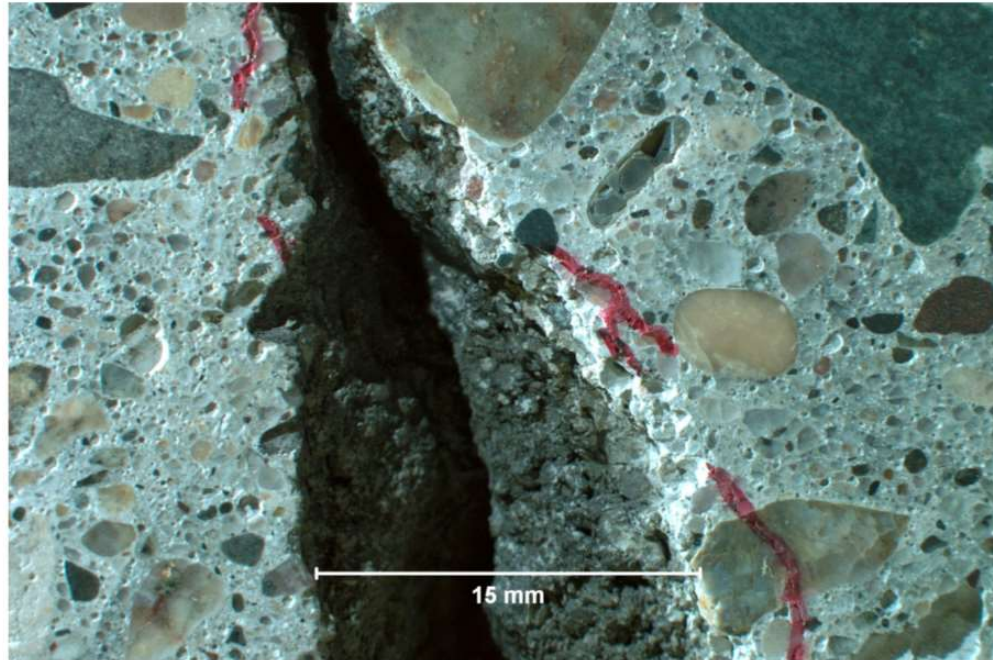
SAMPLE ID: 1907-54, C-1A **DESCRIPTION:** The greatest mass loss along the joint occurs at greater than 100mm depth in the joint. Incipient spalling is mapped in red ink.
MAG: 5x

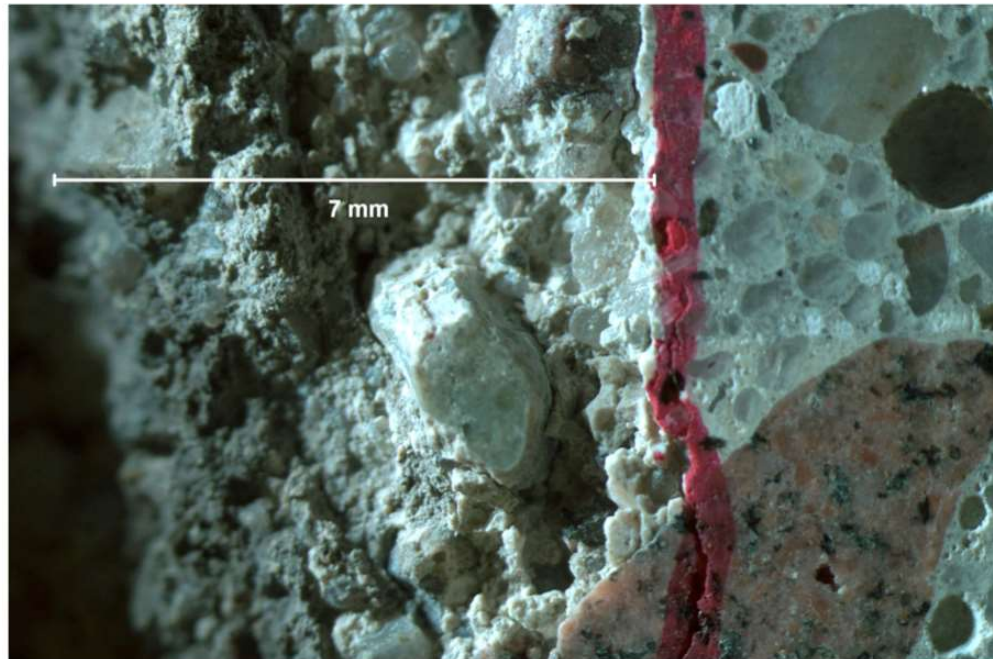
SAMPLE ID: 1907-54, C-1A **DESCRIPTION:** Severely distressed concrete paste at greater than 160mm depth in the joint. Note lack of (empty) entrained air voids to the right of the microcrack mapped in red ink.
MAG: 15x

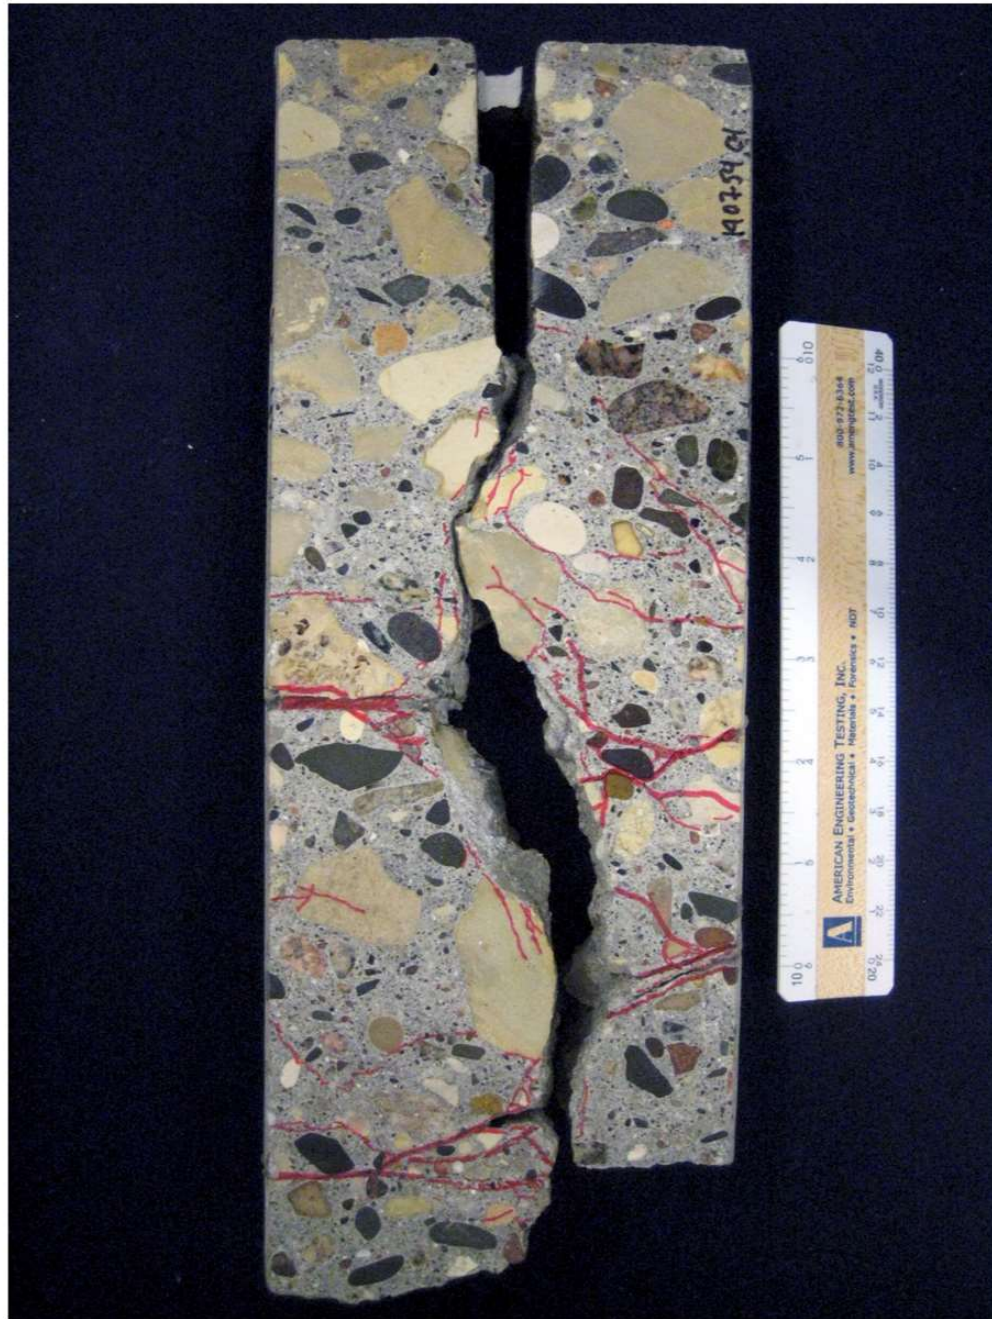
SAMPLE ID: 1907-54, C-4 **DESCRIPTION:** Sawcut and lapped cross section of core. The joint crack exhibited distress with the greatest concrete mass lost between approx. 160mm and 225mm depth from the top surface. Microcracking is mapped in red ink.

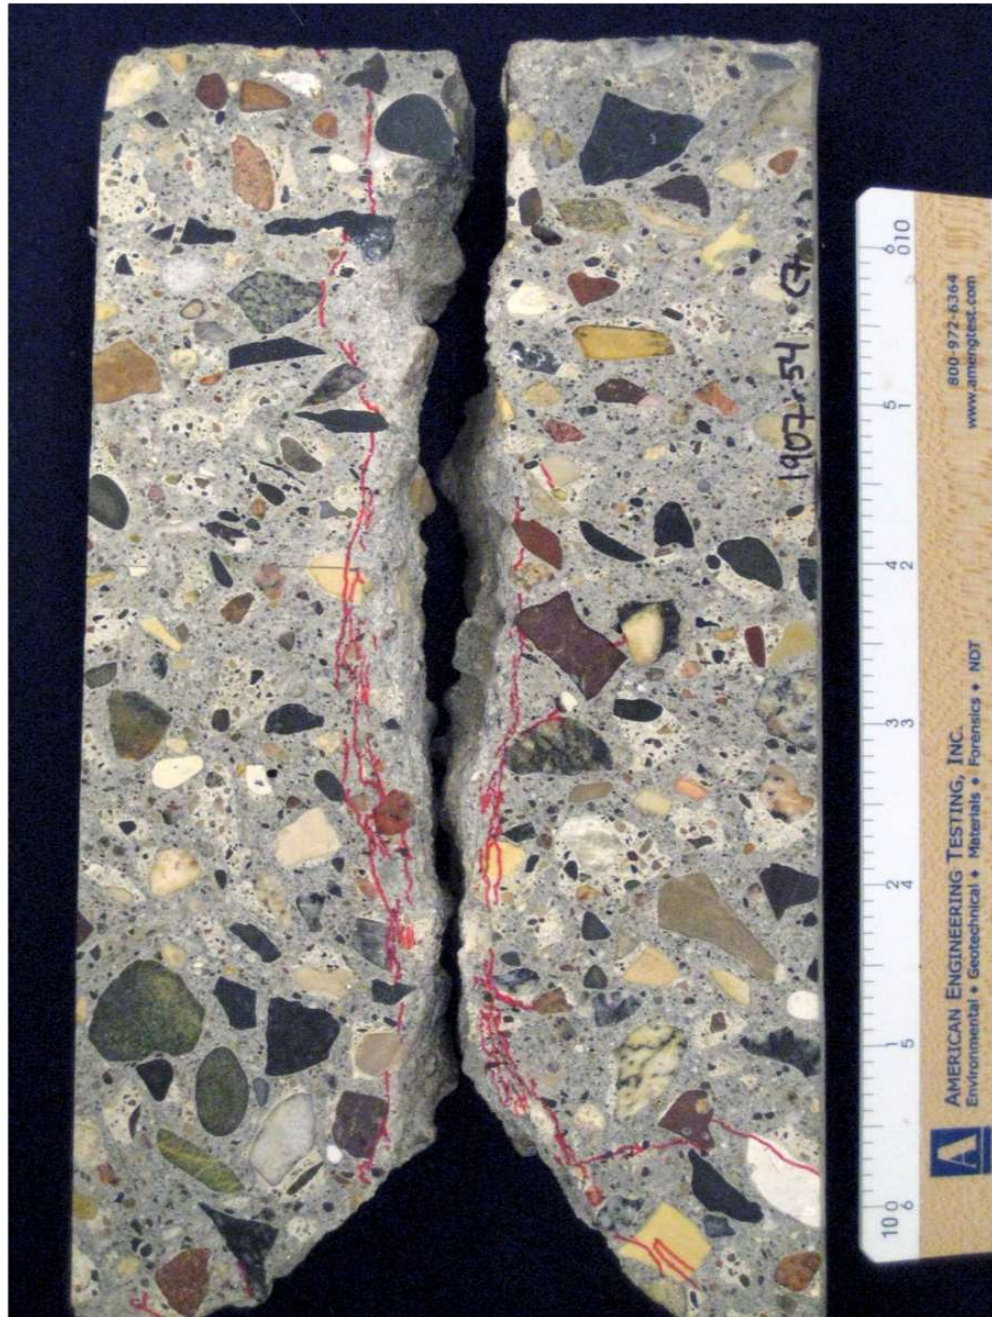
SAMPLE ID: 1907-54, C-7 **DESCRIPTION:** Sawcut and lapped cross section of core. The joint crack exhibited significant incipient distress. Microcracking is mapped in red ink.

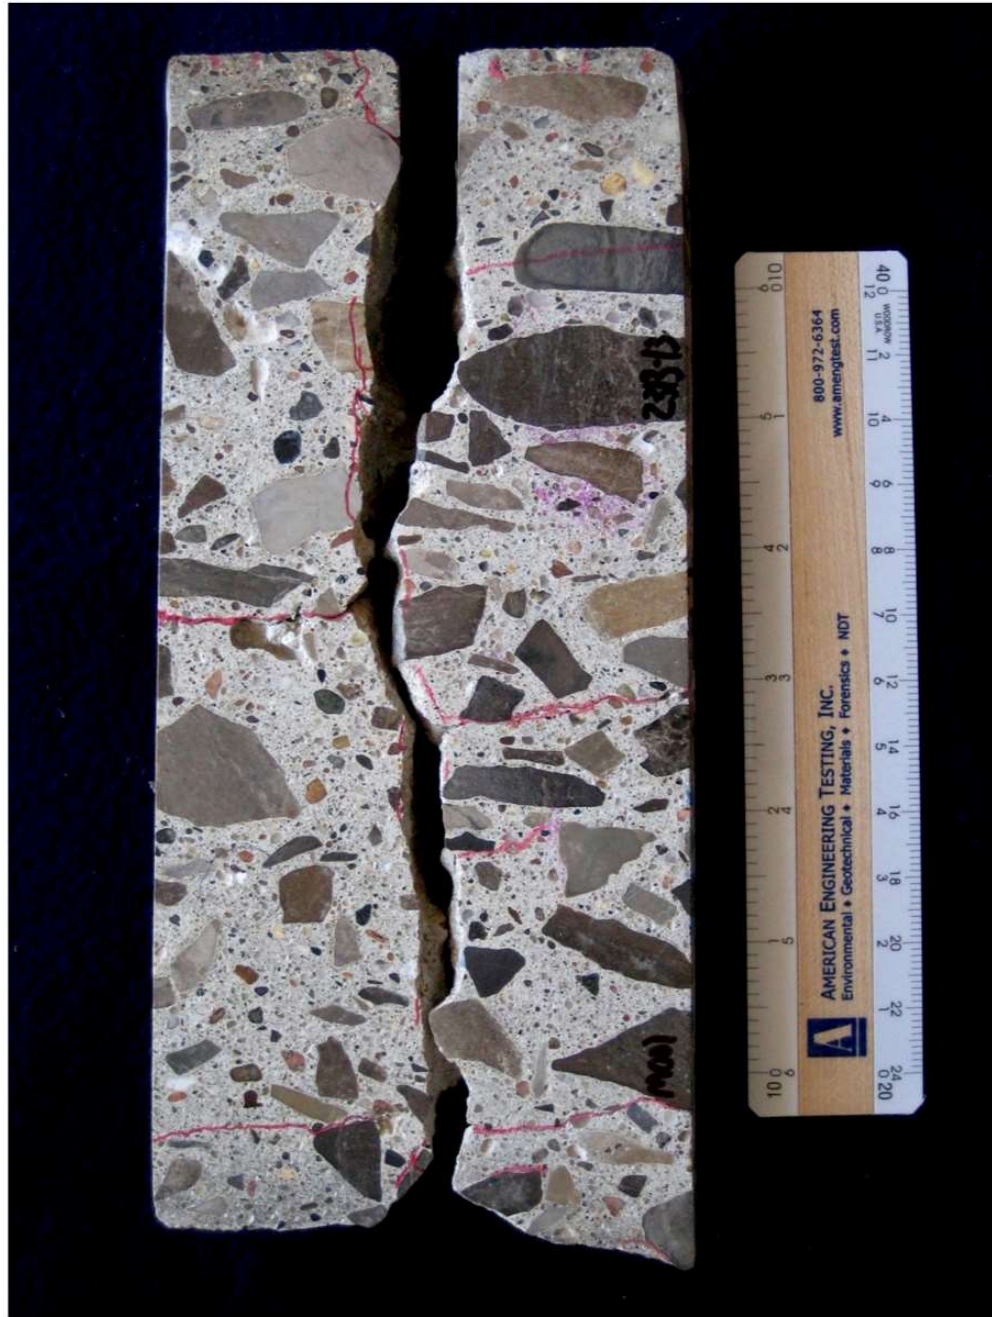
SAMPLE ID: 2313-13, M001 **DESCRIPTION:** Sawcut and lapped cross section of core exhibits mass loss along the joint plane; especially at the base of the sawcut. Joint was originally neoprene(?) sealed. Incipient spalling and sub-horizontal fractures (epoxied) are mapped -in red ink.

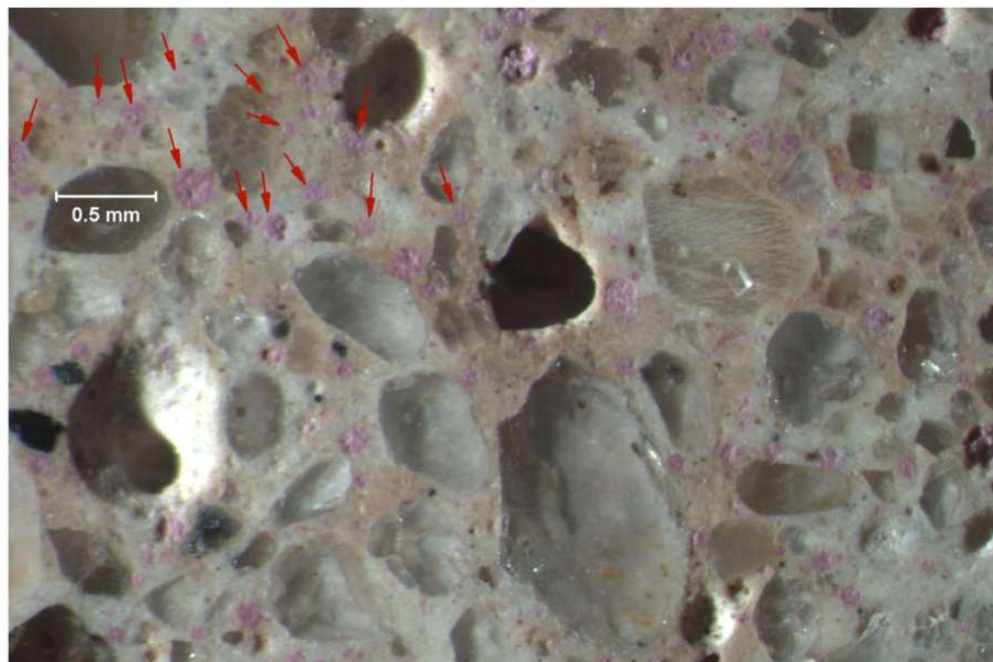
SAMPLE ID: 2312-13, M001 **DESCRIPTION:** Ettringite-filled air void spaces (stained) at 146mm depth from the top surface and 8mm depth from the distressed joint plane. Nearly all finer entrained air voidspaces are filled with secondary ettr.
MAG: 30x

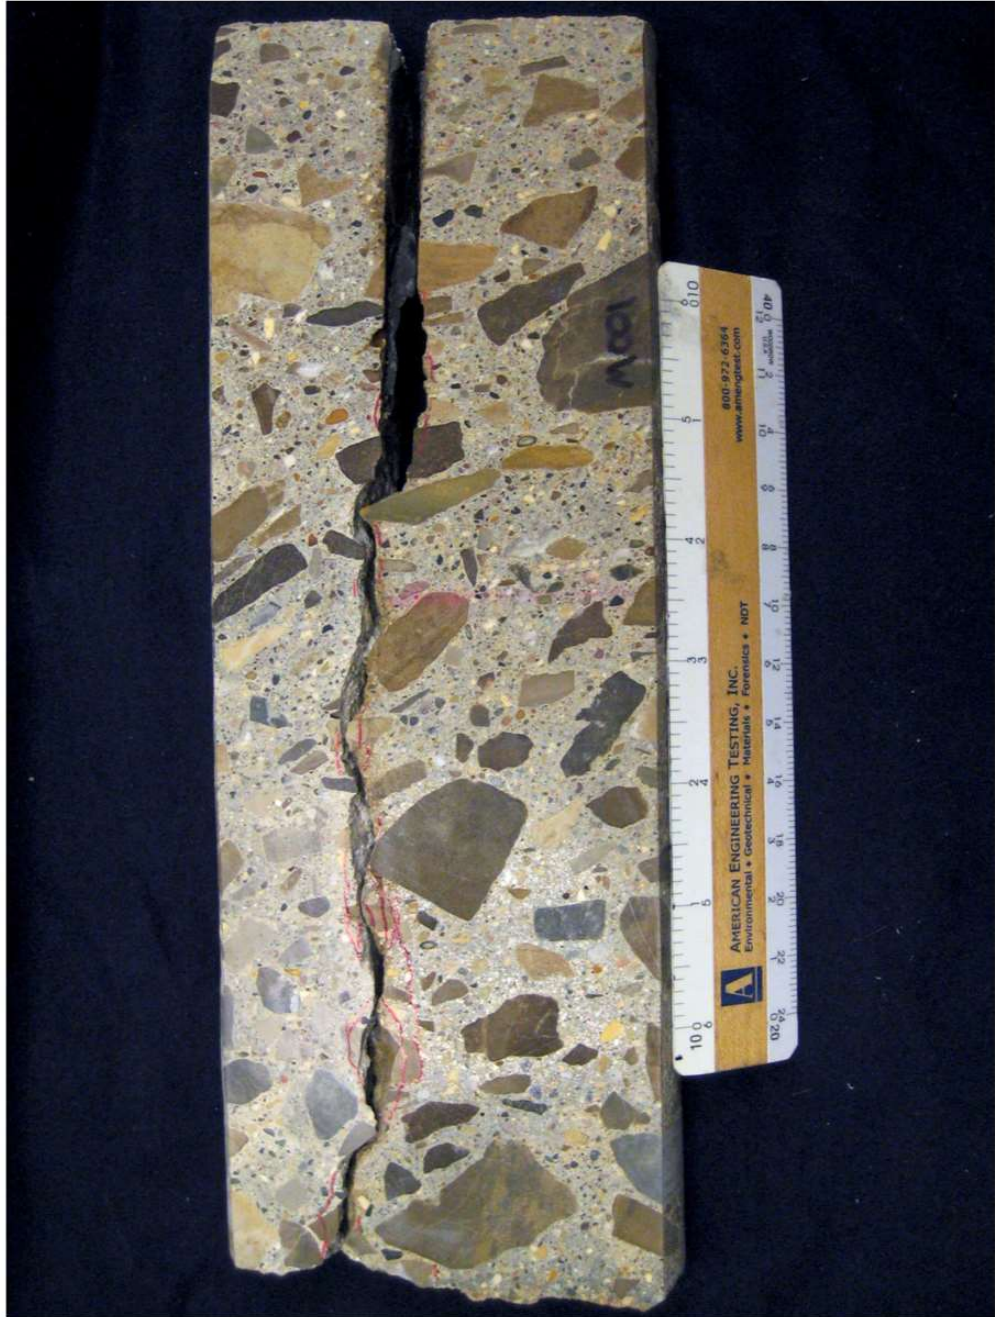
SAMPLE ID: 2480-88, M001 **DESCRIPTION:** Sawcut and lapped cross section of core. The single sawcut control joint was originally sealed with "hot pour". Note distress in the form of sub-vertical incipient spalls mapped in red ink.

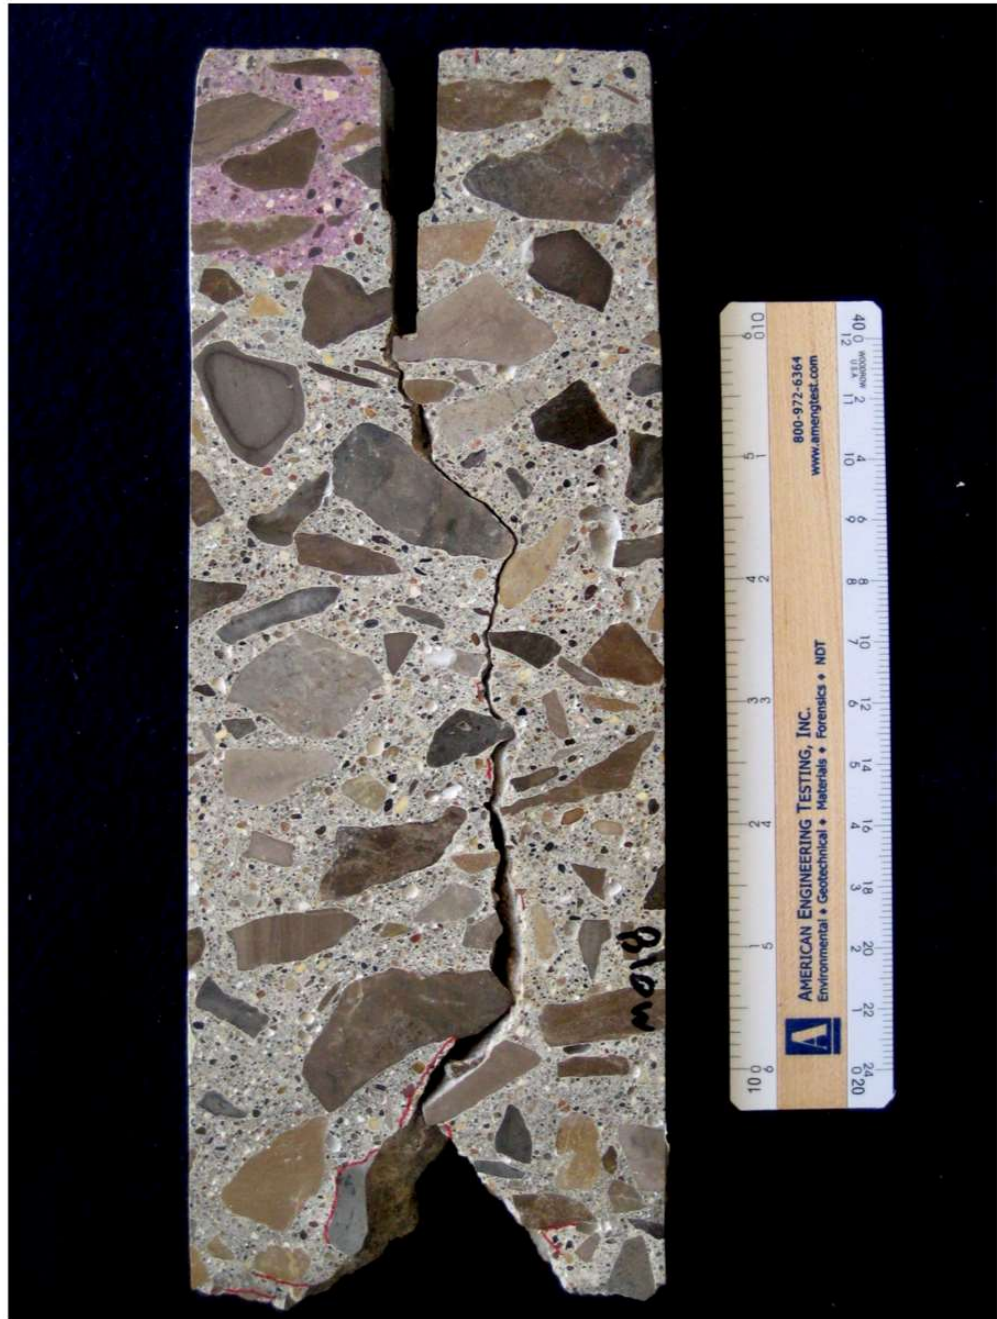
SAMPLE ID: 2480-91, M018 **DESCRIPTION:** Sawcut and lapped cross section of core. The core exhibits tight interlock of the joint crack with some apparent moderate-angled spalling at the base of the joint.

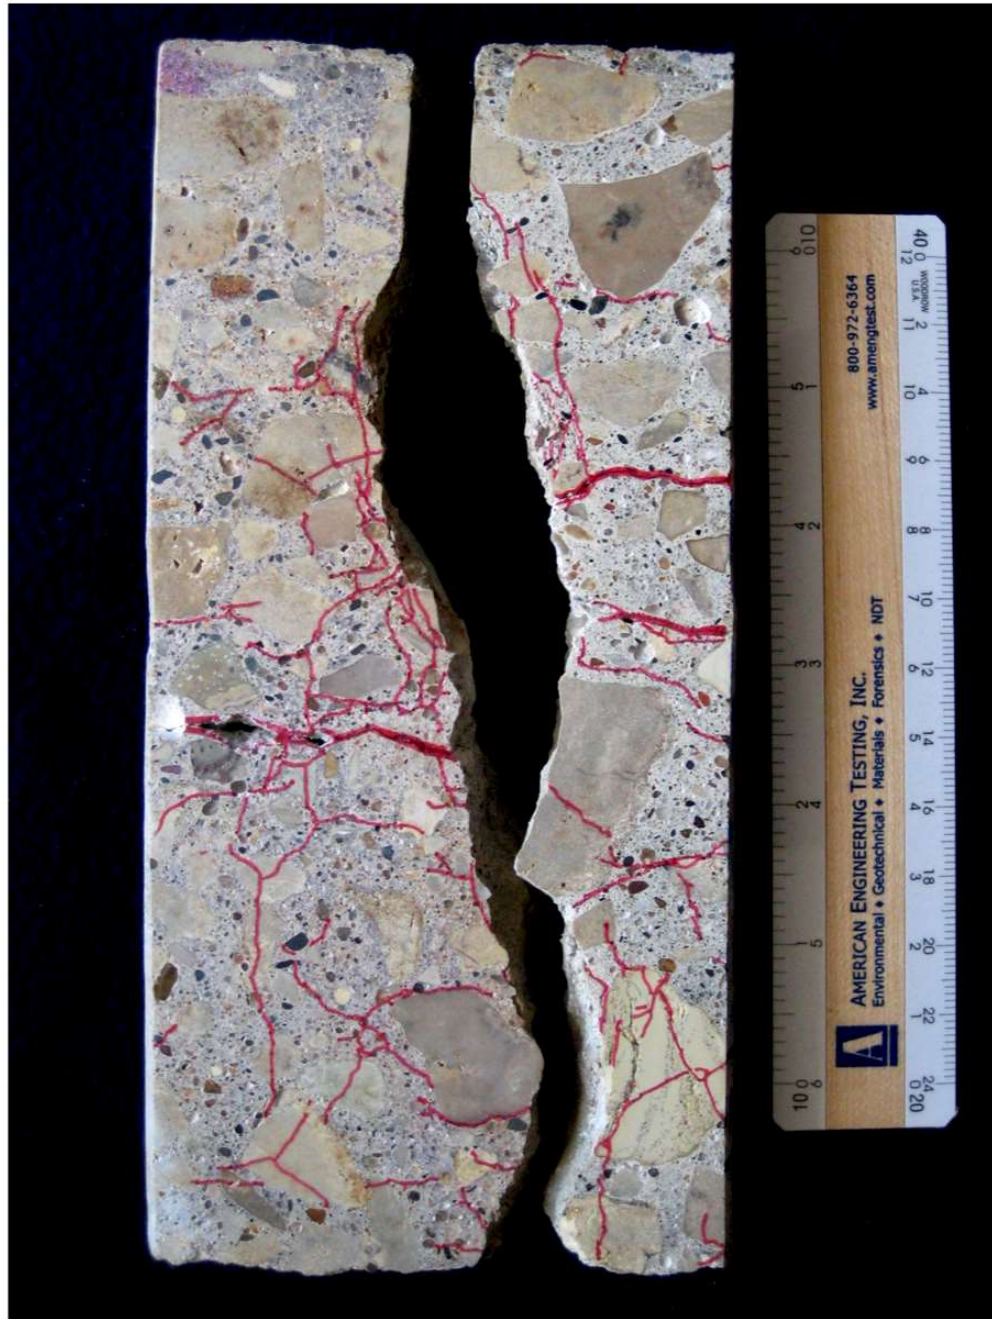
SAMPLE ID: 5507-47, M004 **DESCRIPTION:** Sawcut and lapped cross section of core. The silicone sealant was completely de-bonded from both sides of the sawcut. Microcracking is mapped in red ink. The coarse aggregates exhibit apparent "d-cracking". Note the widest loss of paste between approx..40mm and 120 mm depth.

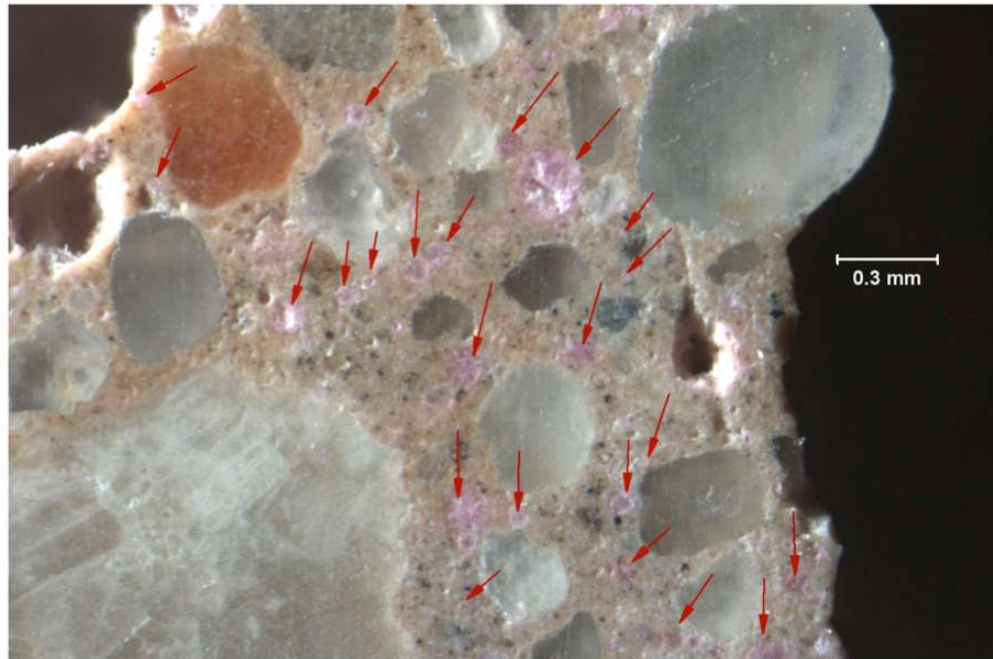
SAMPLE ID: 5507-47, M004 **DESCRIPTION:** Ettringite filled entrained sized voidspaces (stained purple) in the concrete directly adjacent to the distressed joint plane.
MAG: 50x
