Corrosion-Induced Durability Issues and Maintenance Strategies for Post-Tensioned Concrete Bridges

PUBLICATION NO. FHWA-HRT-22-090

SEPTEMBER 2022

U.S. Department of Transportation
Federal Highway Administration

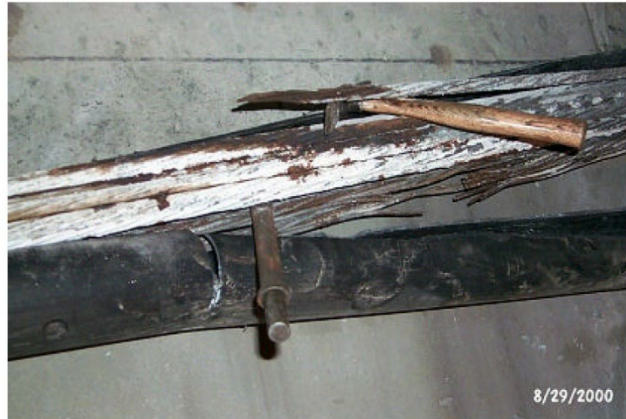
A second deteriorated tendon, which was not ruptured but severely damaged, was discovered in another span. The PE duct was cracked, and 11 strands were fractured in the free length of the tendon. It was apparent that the penetration of moisture and air through the cracked ducts caused corrosion to start. The tendon's condition is shown in figure 3.

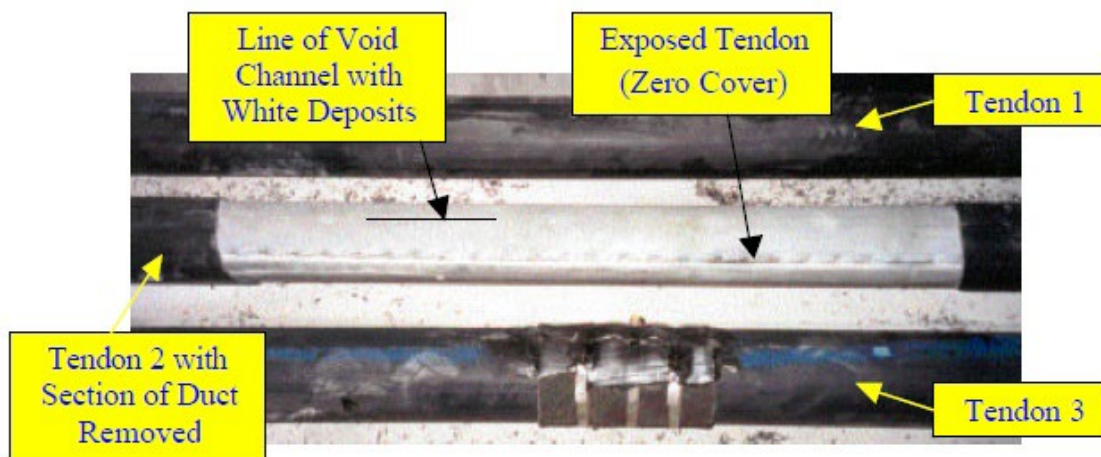
- Nonuniformly distributed microscopic (4 mil or smaller) and macroscopic voids were observed in many areas. It appeared that the expansive admixture generated the microscopic voids.
- Glassy aluminum powder particles, a component of the expansive admixture, were observed on the grout's surface.
- Periodic circumferential hairline shrinkage cracks were present in the grout along the entire tendon length.
- The grout was dry, and no moisture traces were found wherever the duct was removed.
- A white powdery deposit, a sign of grout segregation, was observed along a void channel on a tendon. It was believed that the channel was formed by air and bleed water during the grout segregation process. Figure 4 shows a photograph of this condition.

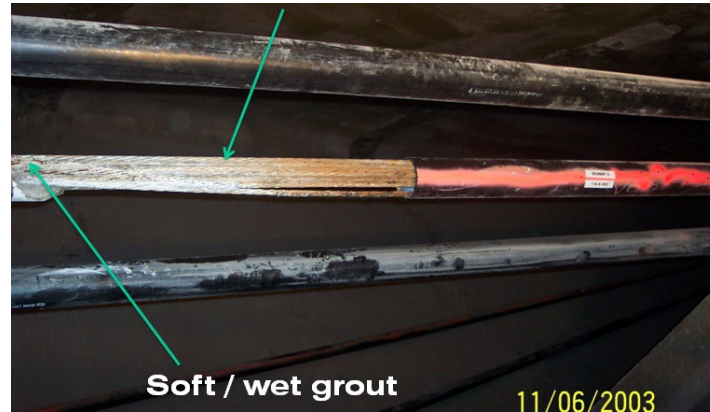
One of the inspected external tendons contained soft/wet grout, which proved that the segregated grout could occur in old neat cement grout. The tendon in question is shown in figure 9.

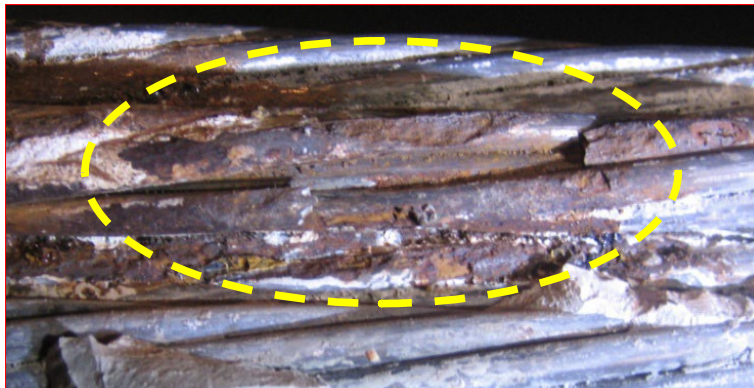
Corrosion also damaged another tendon due to ponding water near a clogged drain hole in the bottom slab of a box girder. Both tendons were replaced in 2007. In late 2007, MFL testing was conducted on approximately 17 mi of external tendons (approximately 3,200 sections) and identified a severely corroded tendon. A closeup of its corroded wires is shown in figure 11.

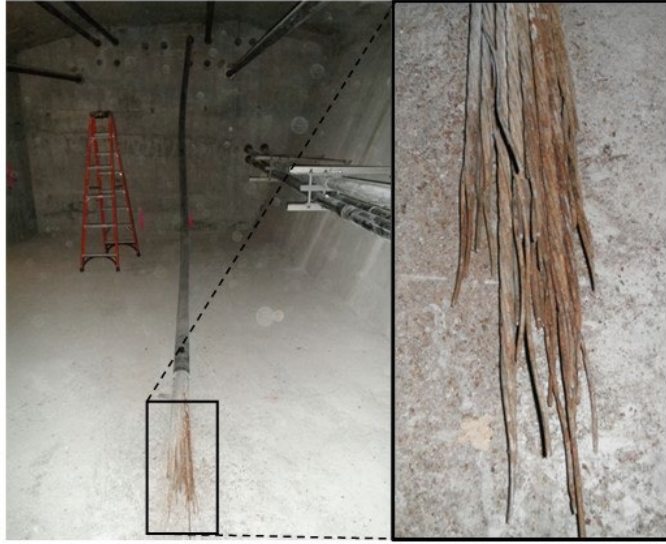
The first tendon failure occurred in the upper horizon portion of a sloped tendon section adjacent to an upper deviator. Figure 15 shows, on the left, the as-discovered condition when the failed tendon fell to the girder floor, and on the right, the complete separation of entire strands due to severe corrosion.

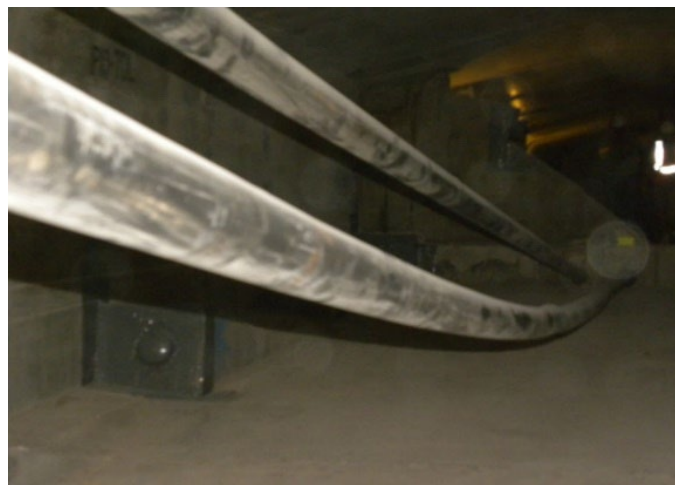
Figure 17 shows the condition of the second failed tendon at the time of discovery. Severe corrosion damage took place at the west face of the upper deviator.

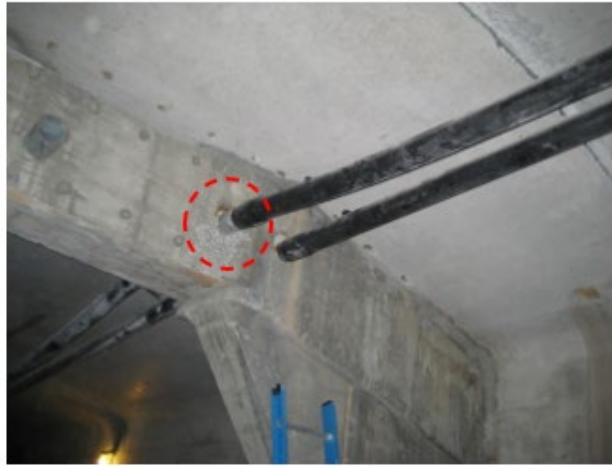
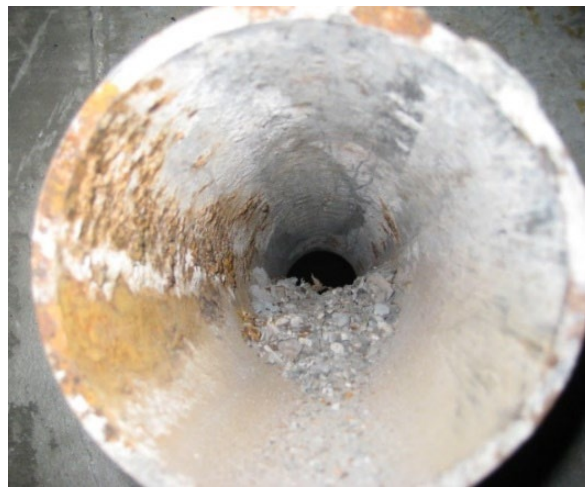
A. Deviator of the failed tendon.

Figure 18 shows the affected deviator (see figure 18-A) and interior of the galvanized steel pipe (see figure 18-B). Horizontal bands of corrosion products can be seen on the pipe's interior wall between 8 and 10 o'clock.

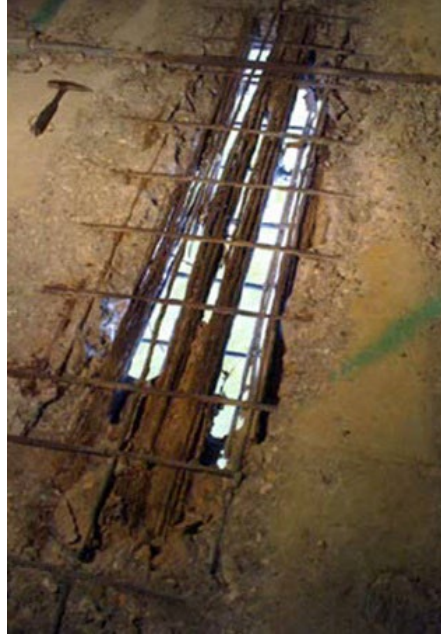
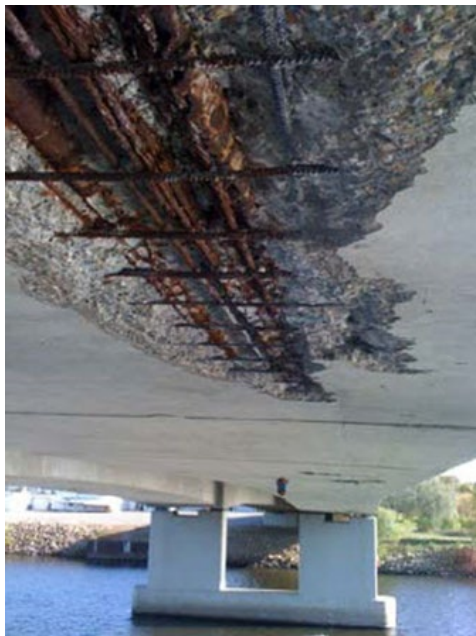
A. Interior condition.

The exterior bottom slab surface of the eastbound and westbound box girders also exhibited longitudinal cracks, efflorescence, rust stains, and concrete spalling. A very short drainage outlet pipe beyond the bottom slab (see detail “A” in figure 31) caused the corrosive water to wet the nearby bottom slab and initiated corrosion. Figure 32 shows an interior view of concrete damage and severely corroded tendons in the bottom slab (see figure 32-A) and an exterior view of another location experiencing similar damage (see figure 32-B).

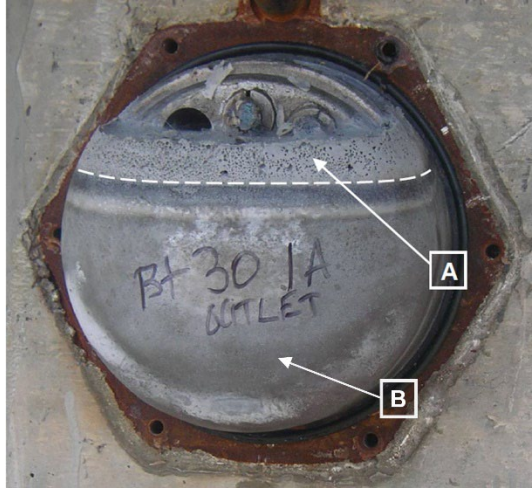
During the construction of the Carbon Plant Road Bridge (Corpus Christy, TX) in 2010, two problems were noted on PT straddle caps. Each cap had five internal tendons, and each tendon contained 13 to 19 strands. They were grouted with a commercially available, prepackaged, non-bleed/thixotropic grout product. When the grout caps were removed, grout voids, exposed strands, and segregated grout were found. Also, water was pouring out beneath the grout cap. Figure 35 shows defective grout conditions.

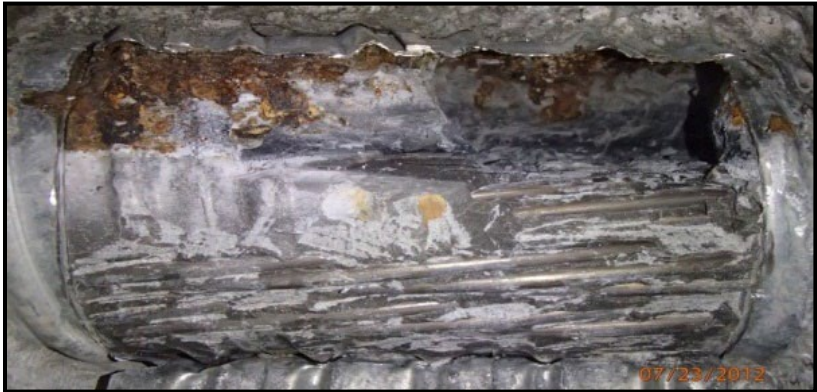
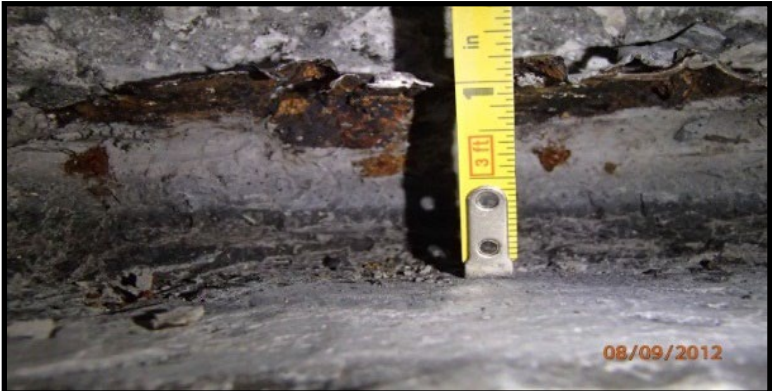
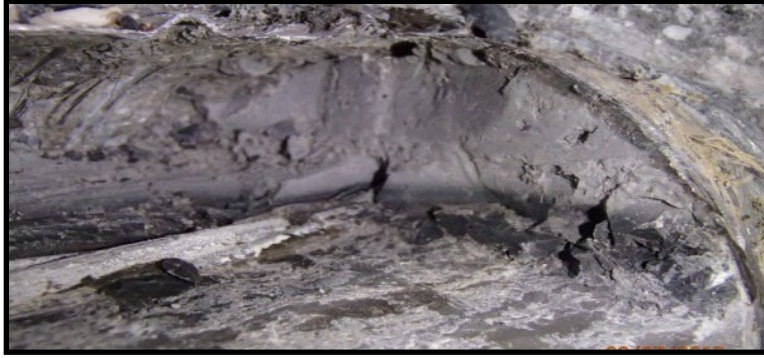
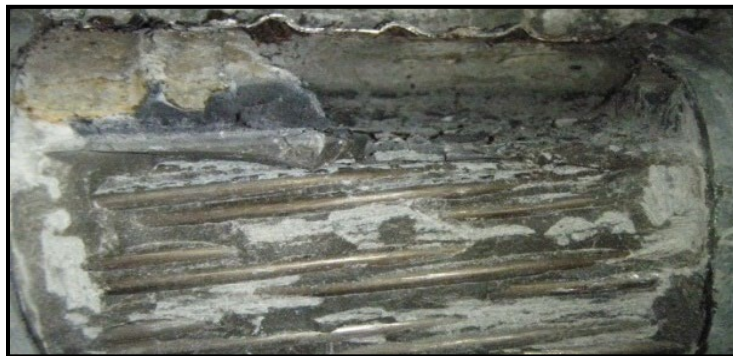
The Wonderwood Bridge was built in 2003 and carries State Road 116 over the intracoastal waterway in Jacksonville. To increase structural capacity, more strands were jammed into the ducts and restricted the flow of grout. The bridge experienced significant grouting problems, including soft/wet grout during construction using a prepackaged grout product. Two inspections were carried out in 2012. The inspectors found 16 corroded metal ducts, 15 tendons with minor strand corrosion, and 14 tendons with soft/wet grout. Figure 40 shows four opened internal tendons where soft/wet grout was found.

A. Exposed tendon condition 1.

B. Exposed tendon condition 2.

C. Exposed tendon condition 3.

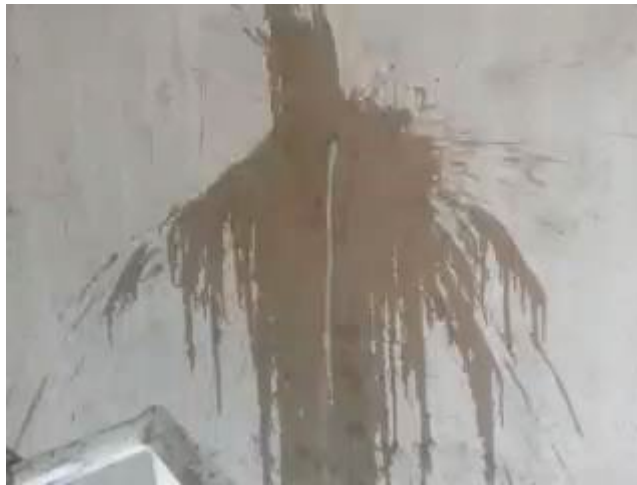
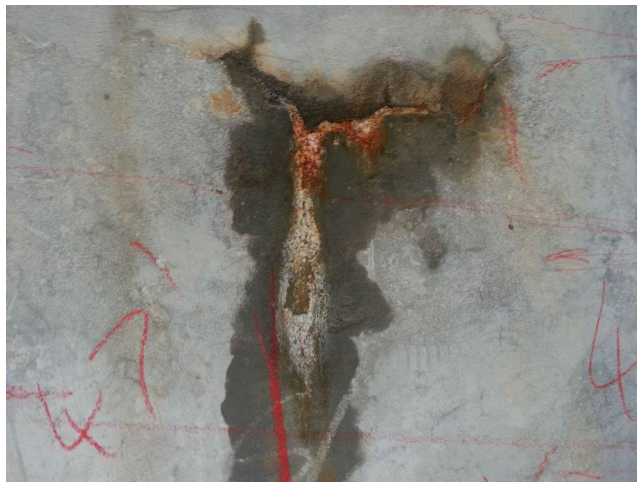
Two other PT bridges constructed in 2006, the Lord Delaware and Eltham Bridges, experienced tendon corrosion problems due to improper grouting work. Between the two bridges, all 84 tendons in 28 continuous, 880-ft-long spliced girders likely contained segregated (soft) grout, water, and voids. IE inspection identified the problem areas and inspection holes revealed soft grout and water. Elevated levels of iron and sulfate ions were found in the sampled water. Water, efflorescence, and rust stains could be seen on the exterior surface as well. Figure 41-A shows a stream of water coming out of an internal tendon through an inspection hole, and figure 41-B shows a sign of ongoing tendon corrosion.

A. Water coming out.

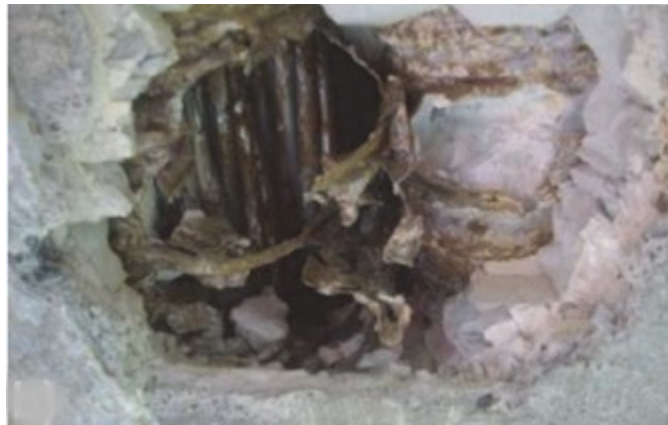
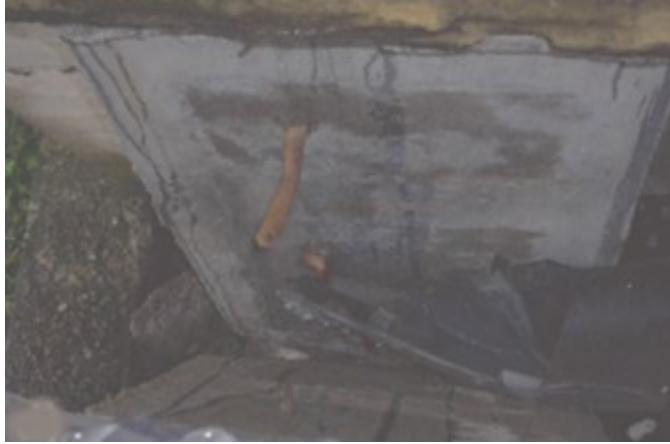
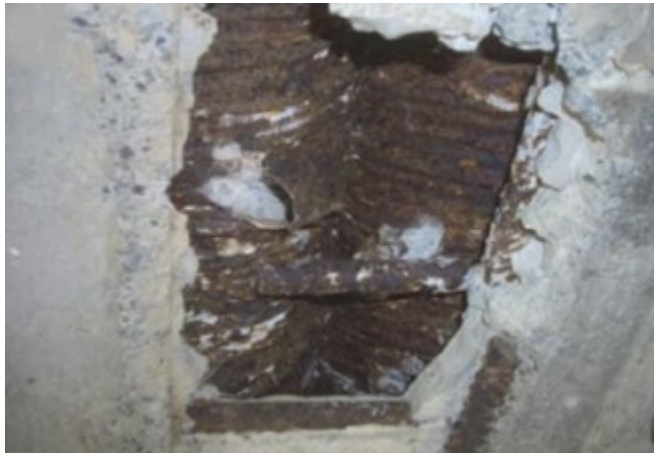
Figure 50. Photos. Flaws found in the internal tendons.⁽⁸¹⁾

While the exterior concrete appeared visually to be in good condition, investigations revealed construction flaws, including a lack of grout in the internal tendons (see figure 50-A) and improperly sealed grout vent tubes (see figure 50-B). Severe corrosion of the metal ducts was also observed (see figure 51).

A. Empty duct indicating lack of grout in the internal tendon.

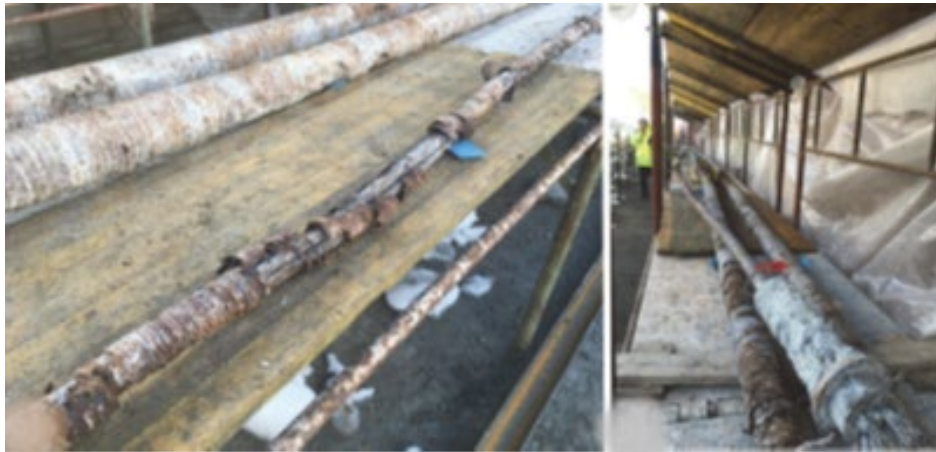
Visual inspections confirmed that the collapse was triggered by a shear failure in one of the joints due to the absence of the equilibrating action of the prestressing force. Even though the overall external condition appeared to be good, the strands did not have sufficient grout protection at the collapsed joint, which led to a corrosion-induced tendon failure. Lack of redundancy in the prestressing members, inadequate grout injection inside the tendons, and inaccessibility for structural inspections were noted. Figure 53 shows the severely corroded PT tendons of the collapsed ramp after they were extracted from the concrete.

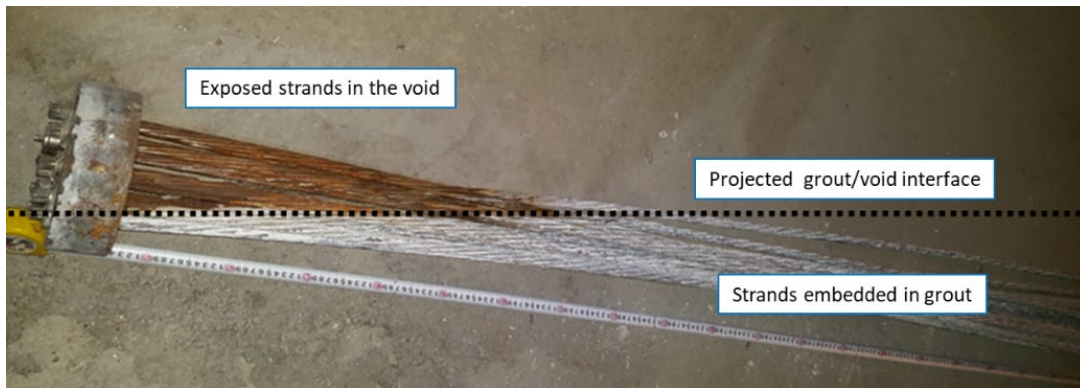
Other locations of the bridge also experienced corrosion problems. Figure 57 shows a corroded anchorage zone consisting of an assembly of corroded strands and an anchor head extracted from a diaphragm close to the failed tendon.

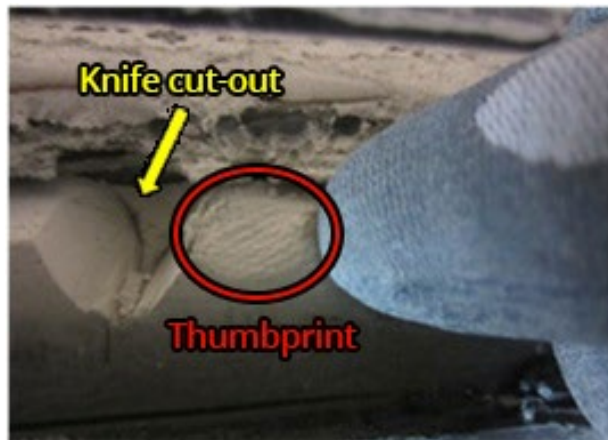
Soft/wet grout was found in many opened tendon sections as well. Some grout samples contained more than 50 percent moisture content (mean moisture content = 38 percent). The cause or origin of the wet grout could not be determined. However, the wet grout did not result in corrosion of the strands. Figure 60 shows a thumbprint next to a spot cut out with a knife on a claylike soft/wet grout (see figure 60-A) and a freshly exposed strand showing no corrosion soon after the wet grout was removed with fingers (see figure 60-B). The latter condition reconfirmed that soft/wet grout itself does not always trigger corrosion.

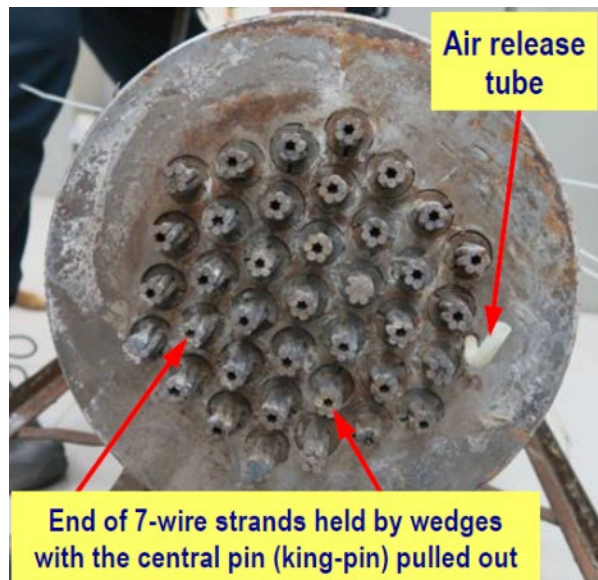
A. Overview of failed P5 anchor head shows strands attached. Modified by FHWA.

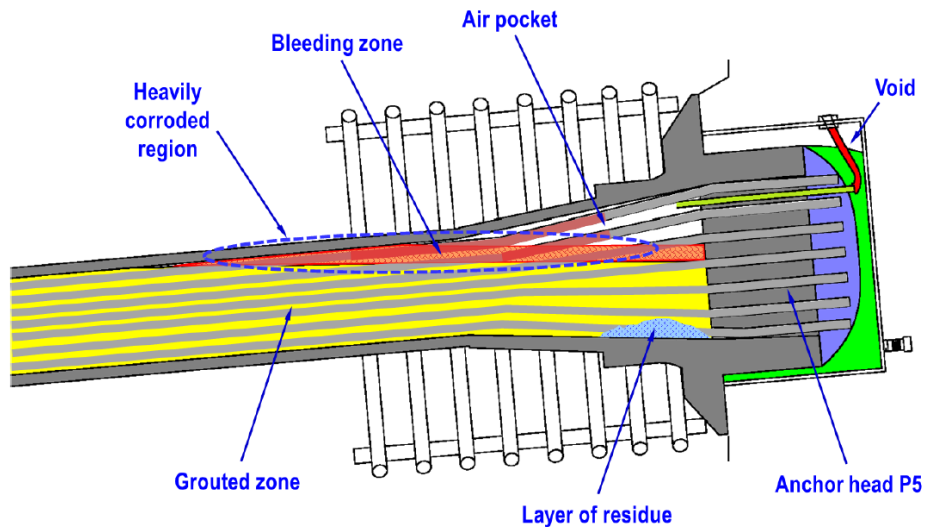
However, the grout vent tube at the P5 anchor head was not filled with grout, and traces of grout residue were observed inside the tube. Similar morphology was found at the interfacial region between the air pocket and the segregated grout layer. Figure 69 illustrates corrosive conditions near the failed P5 anchor head schematically.

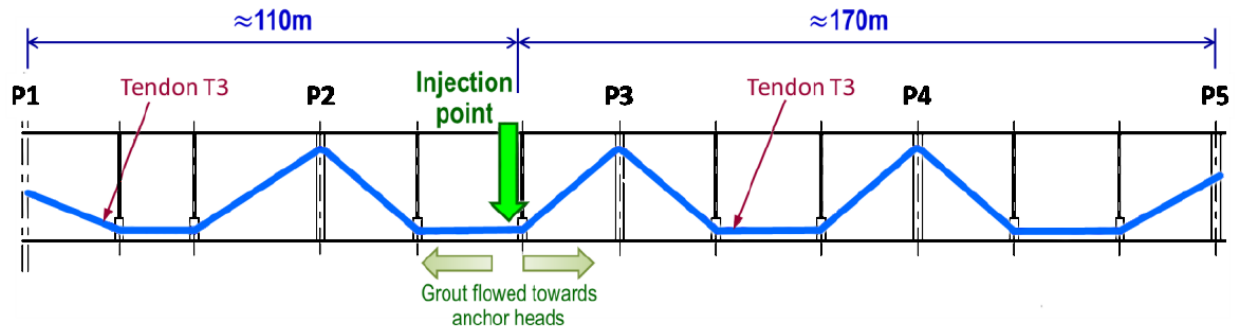
It was speculated, based on a pressure test conducted in the duct prior to stressing the tendon, that a high water-cement ratio, originating from the bleed water and possibly the residual water as well, had created deficient grout. The residual water collected at the duct's low point would have been pushed through in front of the fresh grout mix toward the anchorage zones at piers 1 and 5. The mixture of fresh grout and excessive water at the grout front may have promoted grout segregation. The grout vent tube at the P1 anchor head did not appear to experience any blockage problem. From these observations, investigators suspected unbalanced grout pressures had formed at the P1 and P5 anchor heads due to uneven distances from the grout injection point: 361 ft (P1) versus 558 ft (P5). Figure 70 illustrates a situation of unbalanced pumping pressure along the failed T3 tendon.
