Technical Assistance Report 14-02TA-B

## **Evaluation of Rutting Distresses on I-20 Near Minden, LA**

LTRC Project No. 14-02TA-B

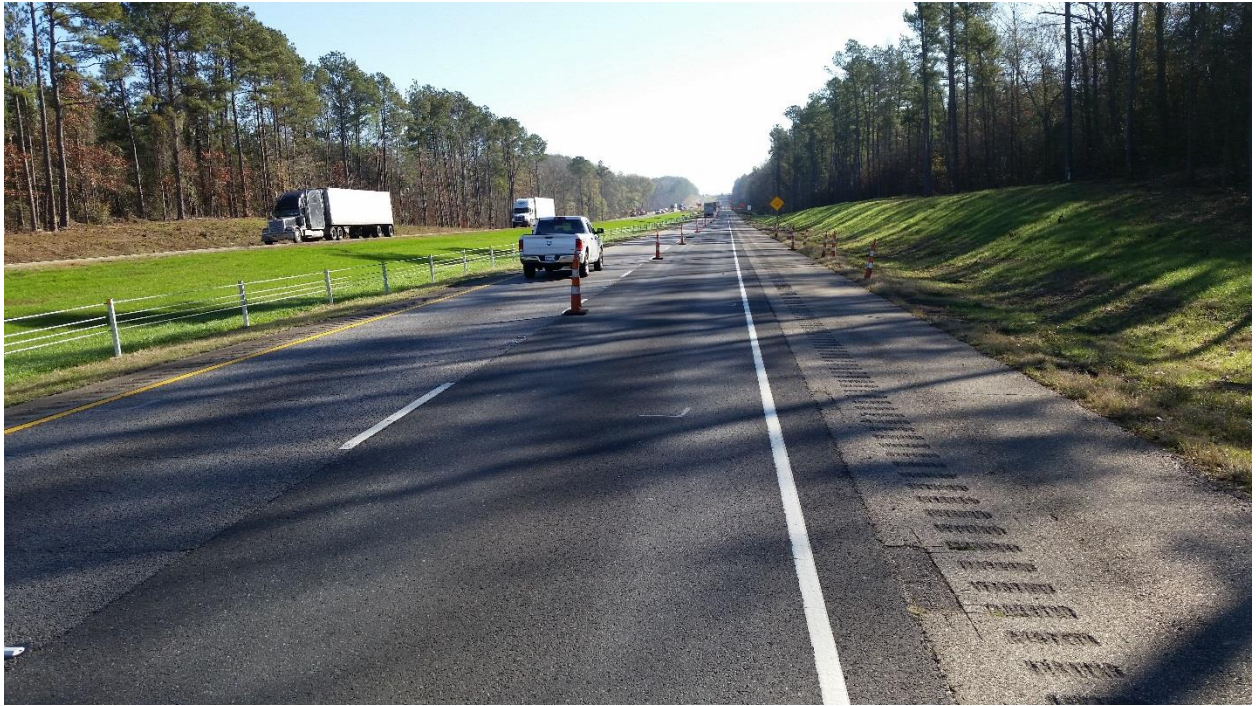
**Figure 2**  
**I-20 eastbound lane rutting**

Noticeable rutting has been an issue for many years on a corridor of I-20, in both eastbound and westbound lanes, located near Minden, LA, and near the Webster-Bienville parish line. At the request of the DOTD designers and District 04 engineers, the Louisiana Transportation Research Center (LTRC) asphalt research group performed a small scale forensic evaluation in December 2014. The request was made because a reconstruction project is planned and scheduled in an attempt to remediate the rutting issues observed. Also, the district recently milled approximately five miles of the westbound outside lane to alleviate a surface drainage issue and also had to close the eastbound outside lane due to severe rutting. Figure 1 shows the milled section on the west bound lane. Figure 2 shows severe rutting on the eastbound lane.
